# NAVAL AIR PROPULSION CENTER

ROTOR FRAGMENT PROTECTION PROGRAM: STATISTICS ON AIRCRAFT GAS TURBINE ENGINE ROTOR FAILURES THAT OCCURRED IN U. S. COMMERCIAL AVIATION DURING 1979

PROPULSION TECHNOLOGY AND PROJECT ENGINEERING DEPARTMENT NAPC-PE-80 OCTOBER 1982 NASA-CR-168163

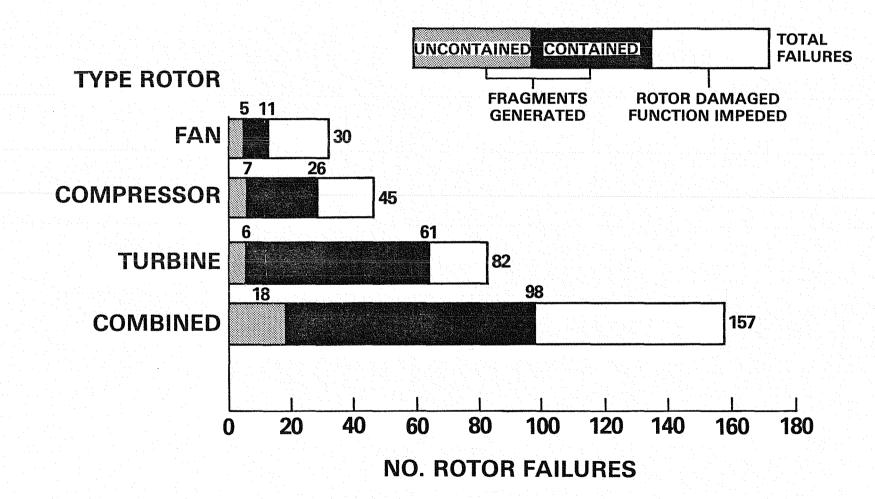
FIGURE 1

a. Figure 1 shows that 157 rotor failures occurred in 1979. These rotor failures accounted for approximately 7.4% of the 2124 shutdowns experienced by the gas turbine powered U. S. commercial aircraft fleet during 1979.

Rotor fragments were generated in 98 of the failures experienced and, of these, 18 (18.4% of the fragment producing failures) were uncontained. This represents an uncontained failure rate of 2.5 per million gas turbine engine powered aircraft flight hours, or 1.2 per million engine operation hours. Approximately 7.3 million and 21.5 million aircraft flight and engine operating hours, respectively, were logged by the U.S. commercial aviation fleet in 1979.

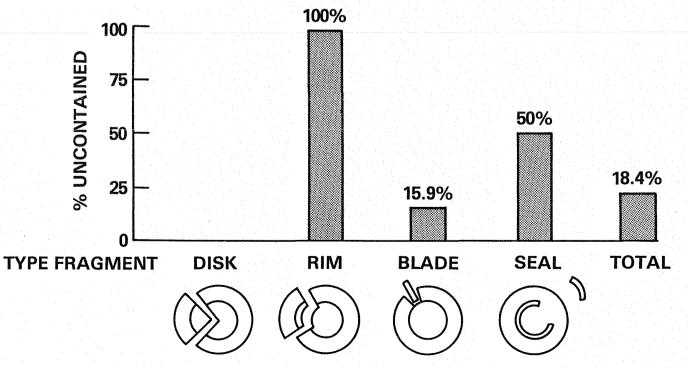
## COMPONENT AND FRAGMENT TYPE DISTRIBUTIONS FOR CONTAINED AND UNCONTAINED ROTOR FAILURES<sup>(1)</sup> – 1979

b. Figure 2 shows the distribution of rotor failures that produced fragments according to the engine component involved -- fan, compressor, turbine; the types of fragments that were generated; and the percentage of uncontained failures according to the type fragment generated. These data indicate that:

(1) The incidence of turbine-rotor-fragment-producing failures was approximately 2.4 times greater than that of compressor-rotor-fragmentproducing failures; these corresponded to 62.2% and 26.5%, respectively, of the total number of rotor failures. Fan rotor failures accounted for 11.2% of the fragment producing failures experienced.

(2) Blade fragments were generated in 96.0% of the rotor failures; 15.9% of these were uncontained. The remaining rotor fragment failures (4.0%) produced rim and seal fragments, of which 100% and 50%, respectively, were uncontained.

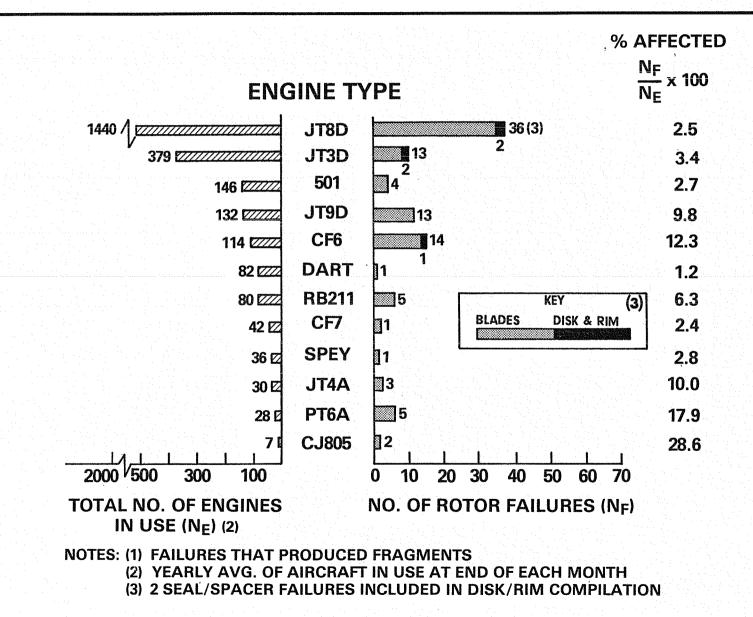
## THE INCIDENCE OF ROTOR FAILURE<sup>(1)</sup> IN U.S. COMMERCIAL AVIATION ACCORDING TO ENGINE TYPE AFFECTED – 1979

c. Figure 3 shows the rotor failure distribution among the types of engines that were affected, and the total number of that type engine in use.

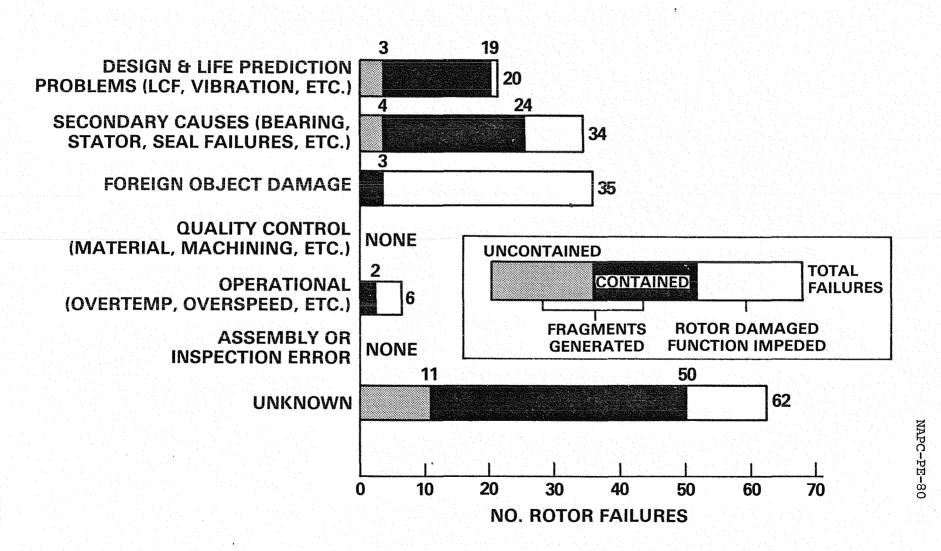
## **ROTOR FAILURE CAUSE CATEGORIES – 1979**

d. Figure 4 shows what caused the rotor failures to occur. Of the known causes of failure<sup>(1)</sup>, the dominant causal factors were: (1) Foreign Object Damage (FOD) (36.8%); (2) Secondary causes (35.8%), and (3) Design and Life Prediction Problems (21.1%).

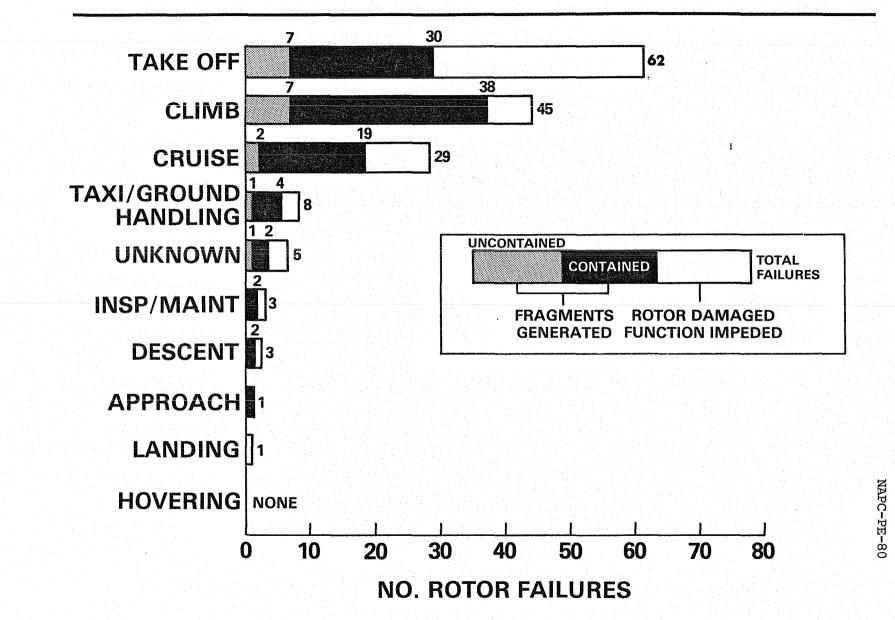
FIGURE 5

e. Figure 5 indicates the flight conditions that existed when the various rotor failures occurred. Approximately 68% of the 157 rotor failures occurred during takeoff and climb stages of flight. Approximately 69% of the rotor fragment producing failures, and 78% of the uncontained rotor failures, occurred during these same stages of flight. The highest percentage of uncontained rotor failures were experienced during takeoff (39%), and climb (39%). One uncontained failure was not included in the compilation because the cause and flight condition are unknown.

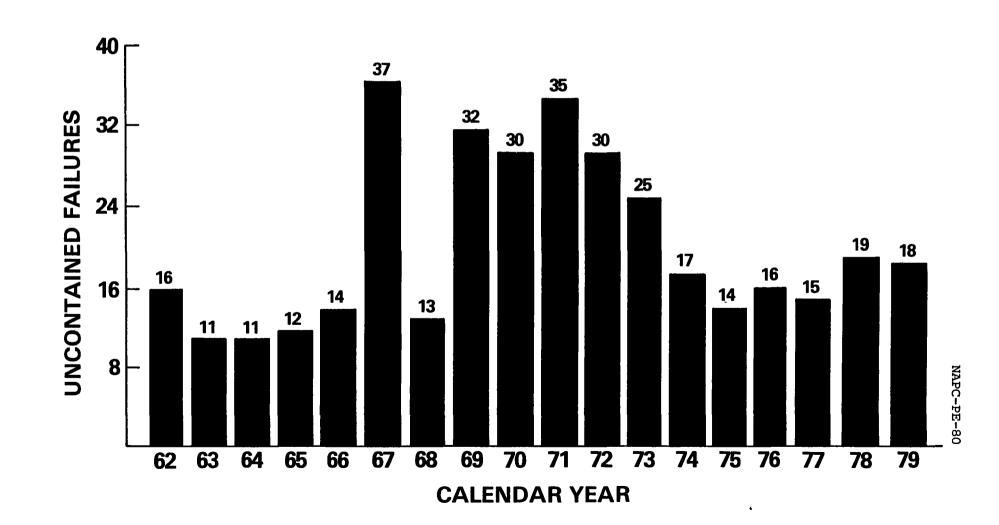
**FIGURE 7**

g. Figure 7 shows the annual incidence of uncontained rotor failures in commercial aviation for the years 1962 through 1979. During 1979, the incidence of uncontained rotor failure decreased by one over the previous year, 1978. Over the past five years, 1975 through 1979, an average of 16.4 uncontained rotor failures per year have occurred. During this same time period, the rate of uncontained rotor failures has remained relatively constant at an average of approximately one per million engine operating hours.
