NASA Technical Memorandum 84637

FLIGHT SERVICE EVALUATION OF COMPOSITE COMPONENTS
ON BELL 206L AND SIKORSKY S-76 HELICOPTERS

DONALD J. BAKER

MARCH 1983

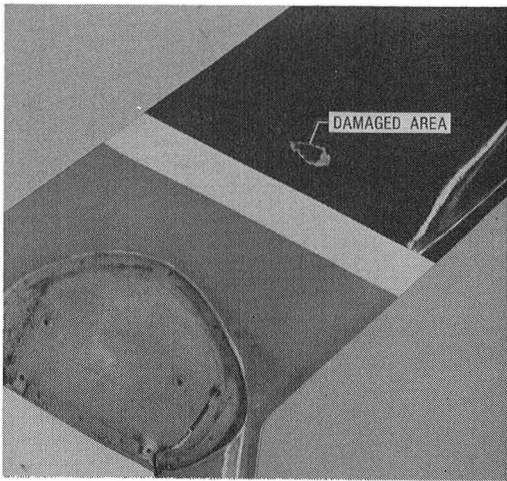
aircraft has 1308 hours of service. The litter doors have not been damaged in service. One baggage door was damaged when closed on an oversize cargo and was subsequently repaired with fiberglass/epoxy. The forward fairings have not been damaged in service. Four vertical fins have been damaged in service. A 5.1 cm x 5.1 cm (2.0 in. x 2.0 in.) area was broken out of the trailing edge of one vertical fin when the aircraft, equipped with floats, autorotated into a river. A second fin was damaged on both the leading and trailing edges and the tail skid was broken when hit by another helicopter while on the ground. The leading edge had cracks over a 30.5 cm (12.0 in.) length and the trailing edge was disbanded over an 45.7 cm (18.0 in.) length. These two vertical fins were repaired with fiberglass/epoxy. The tail skid was removed and replaced with a new skid. Damage to the third vertical fin resulted from wind blown debris while the helicopter was on the ground and is shown in figure 10. The damaged area was removed, an epoxy filler was applied, and an external titanium patch was bonded in place. The fourth fin was destroyed in a ground transportation accident.

Figure 10. Damaged Bell 206L Graphite/Epoxy Composite Vertical Fin.

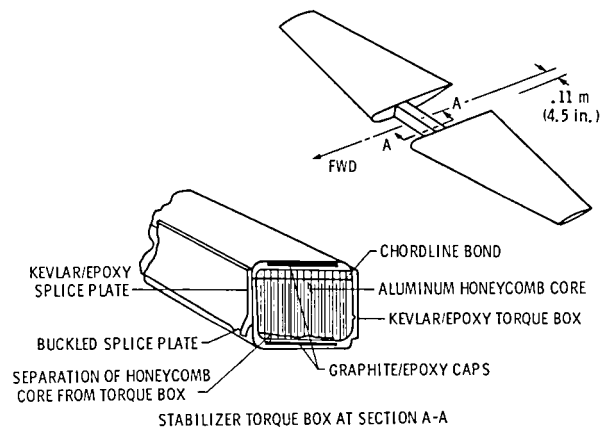
The first horizontal stabilizer removed from service had accumulated 1600 flight hours over a 17 month period in the Lake Charles, LA area. No defects were found during inspection of the stabilizer. Deflection from the proof load was the same as in the initial acceptance test. Plots of strain as a function of limit load are shown in figure 17. The tension strain response was linear up to 160 percent of design limit load (DLL) and then increased at a reduced slope until the maximum applied load of 220 percent of DLL was reached. The compression strain response was linear to 120 percent of DLL and then increased at a reduced slope until 170 percent of DLL was reached. There was no increase in compression strain after 170 percent of DLL. At 220 percent of DLL a loud "snap" was heard and the load dropped to 150 percent of DLL. Attempts to increase the load beyond the 150 percent DLL resulted in deflection until the test fixture limit was reached. Visual inspection of the stabilizer indicated a buckle in the splice plate on the left hand leading edge of the spar. Teardown of the component indicated a loss of shear transfer capabilities between the composite material and the metal honeycomb (figure 18). At 220 percent of DLL, the shear load had been transferred to the Kevlar/epoxy torque box and eventually buckled the splice plate. The structure still supported 150 percent of DLL but with reduced rigidity. The stabilizer tested for certification did not fail but reached the maximum deflection allowed by the fixture at 268 percent of DLL. Additional tests will be necessary to determine if the change in failure mode is the result of environmental degradation of the composite

Figure 18. Schematic of S-76 Composite Stabilizer Static Fracture Modes.
