**NASA
Technical
Paper
2087**

December 1982

Lightning Attachment Patterns and Flight Conditions for Storm Hazards '80

Bruce D. Fisher,
Gerald L. Keyser, Jr.,
and Perry L. Deal

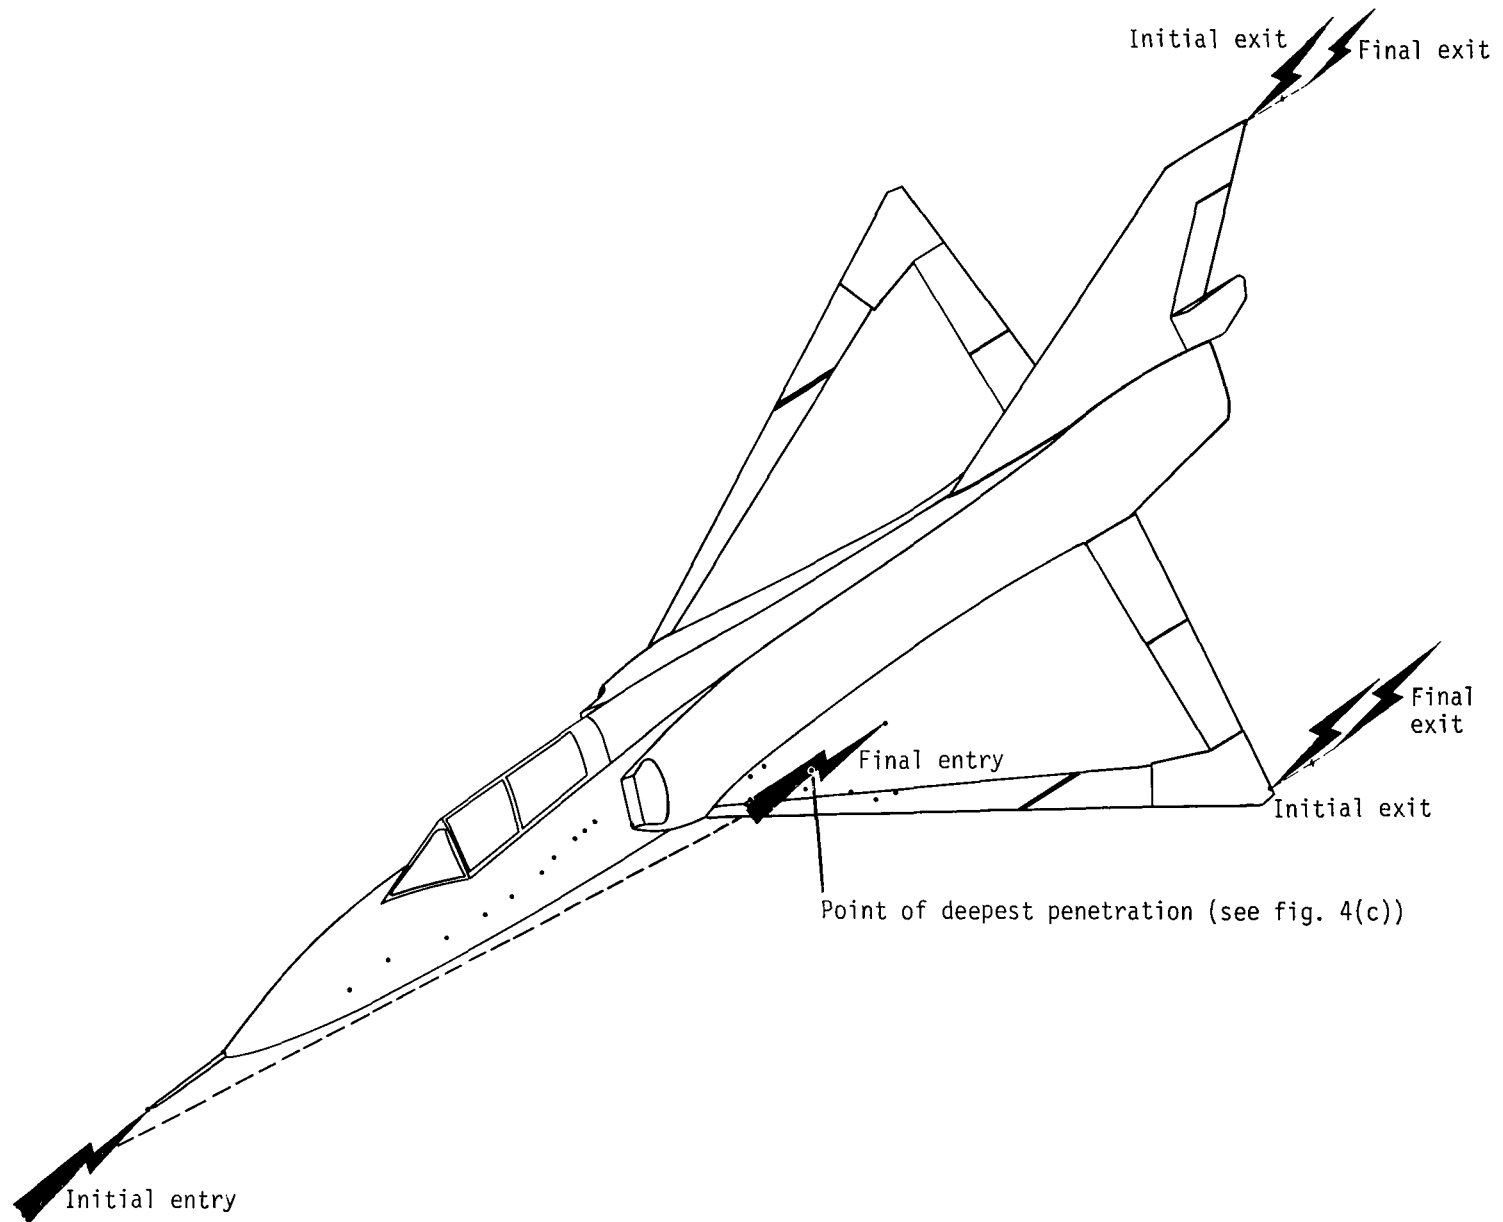
Figure 3.- Lightning attachment points for lightning strike 1, flight 80-018, June 17, 1980.

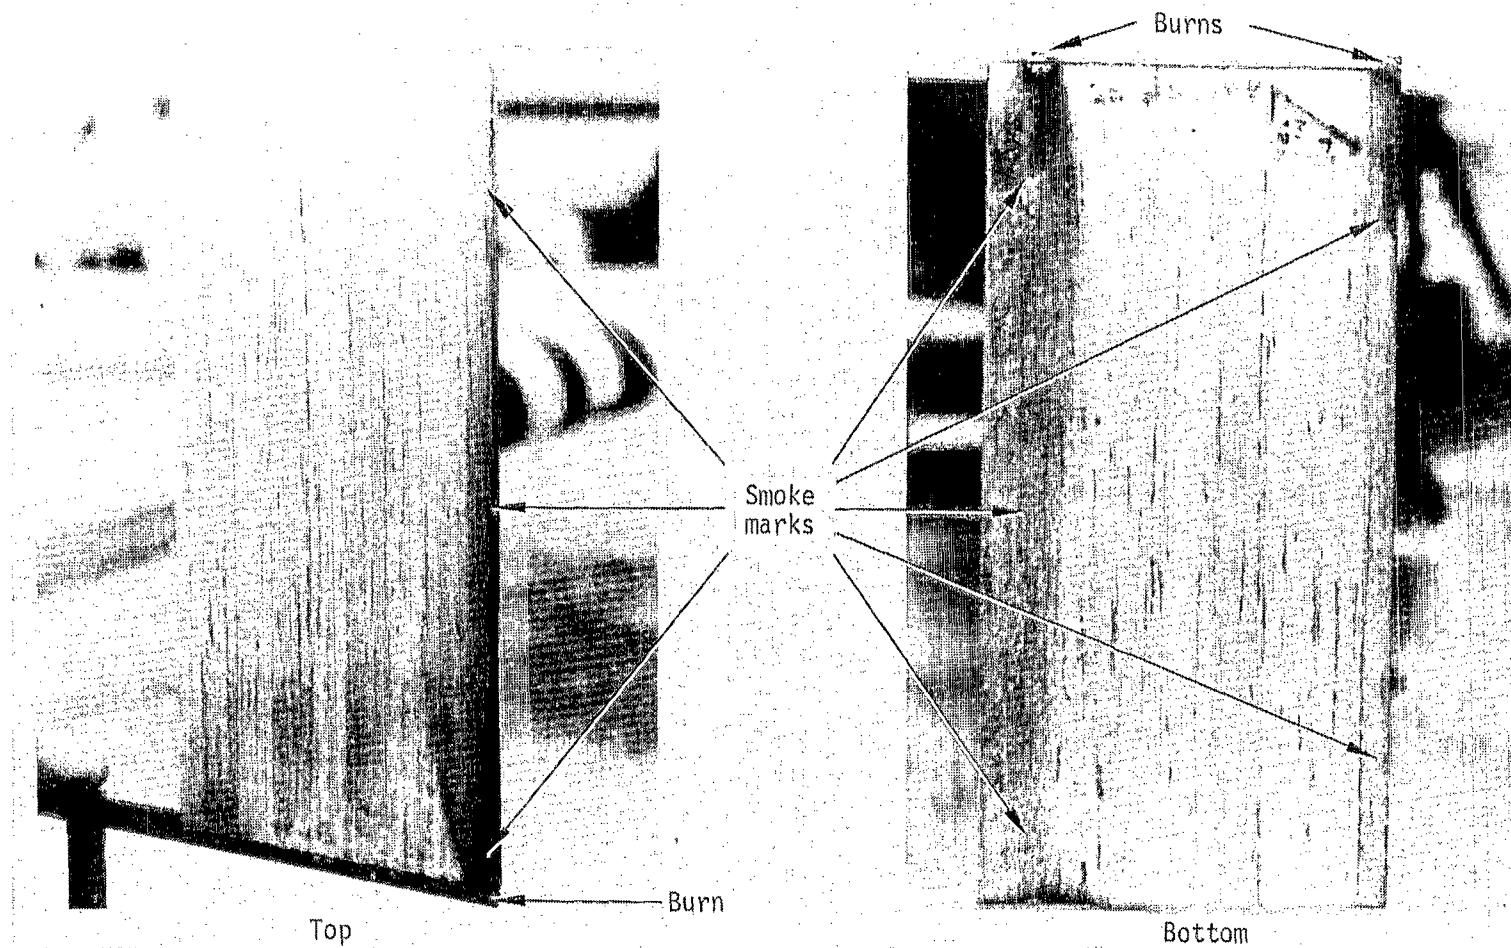
L-82-192

(a) Angle-of-attack vane.

Figure 4.- Lightning damage to F-106B research airplane from strike 1, flight 80-018, June 17, 1980.

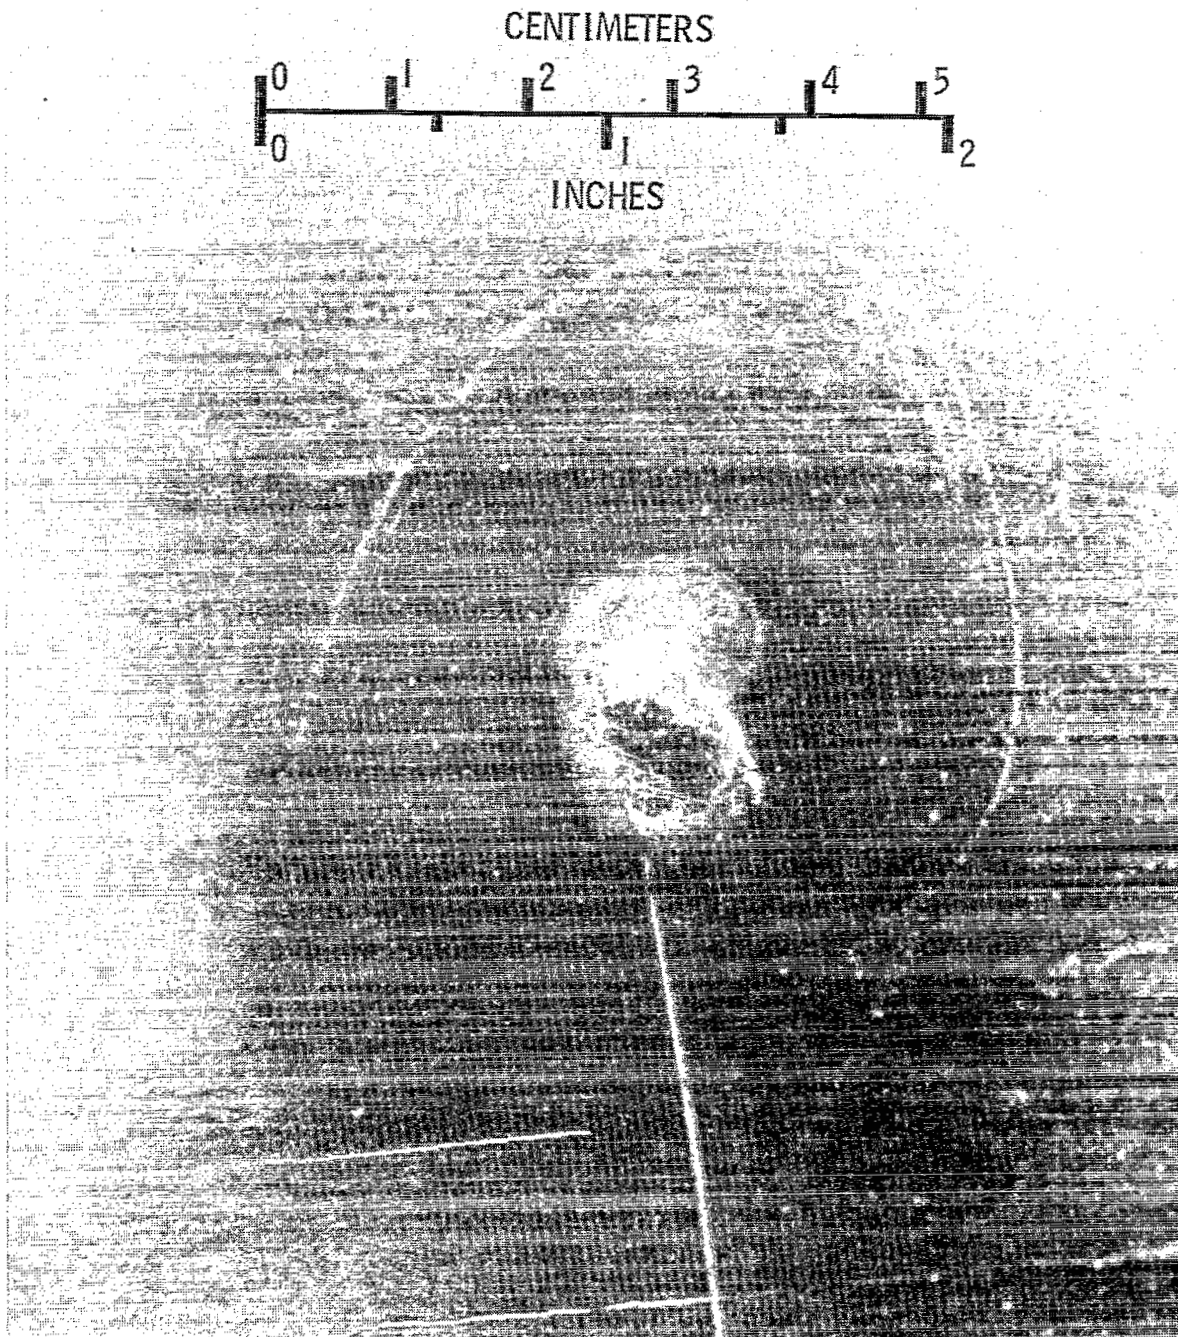
L-82-193

(b) Rivet head on left side of radome.

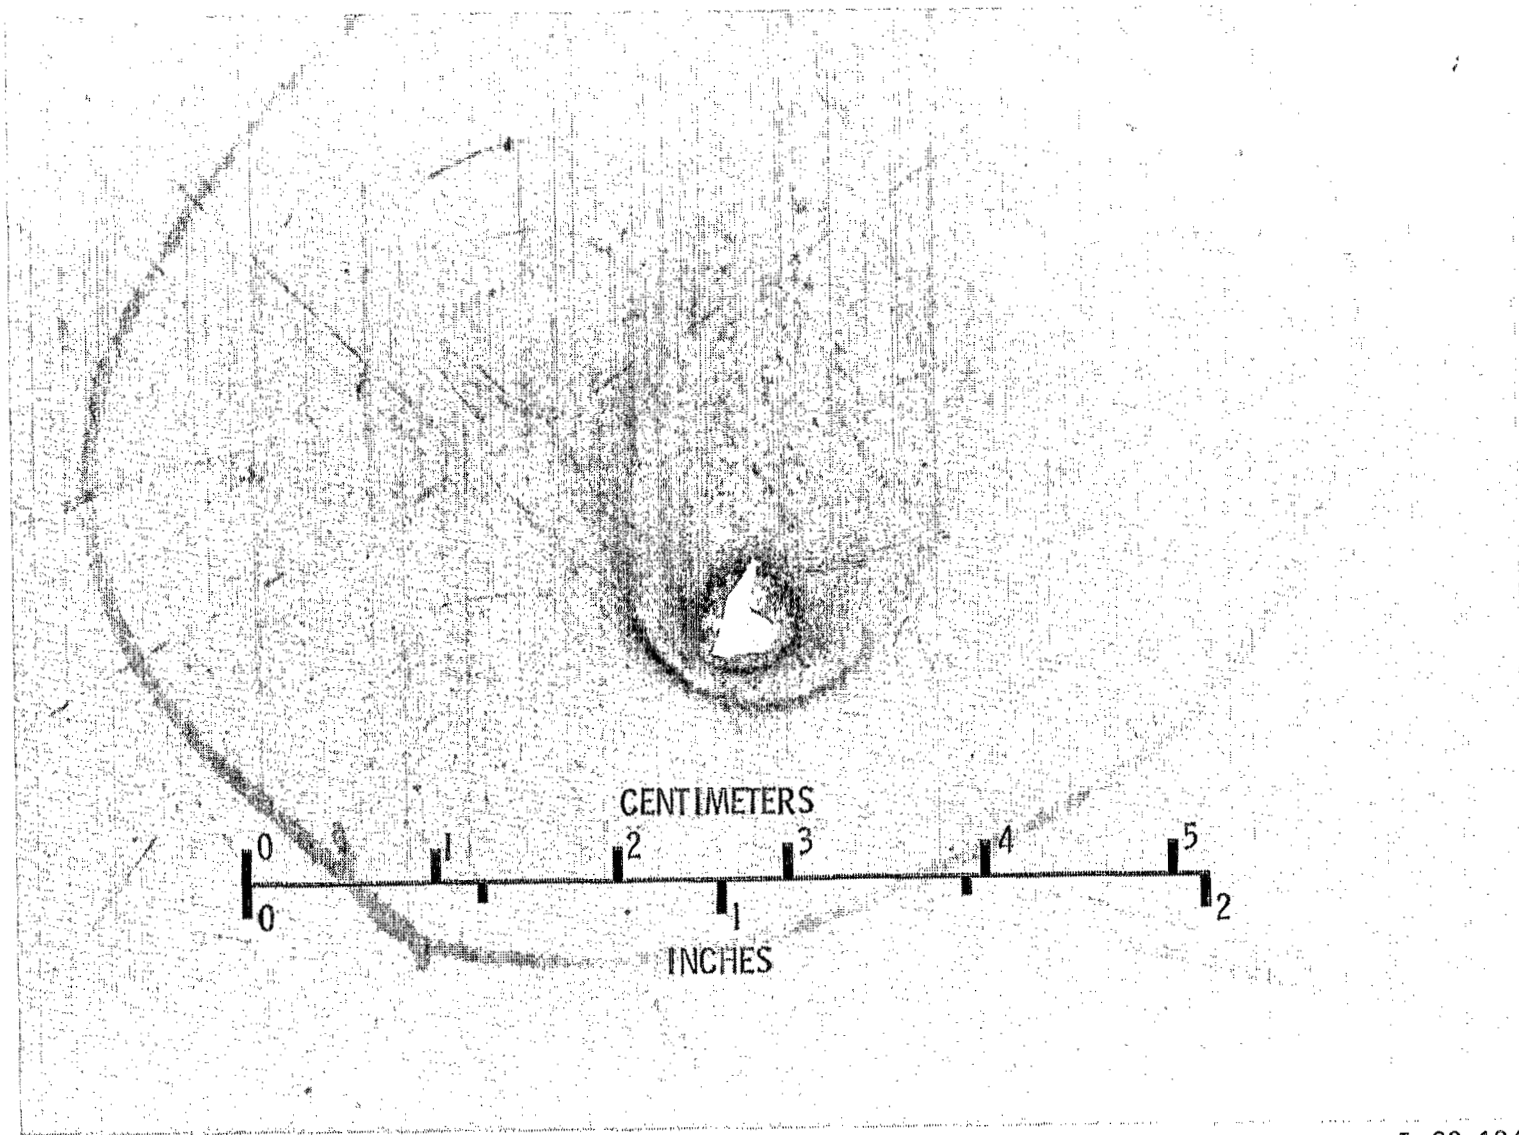
L-82-194

(c) Lightning attachment point on top of left wing.

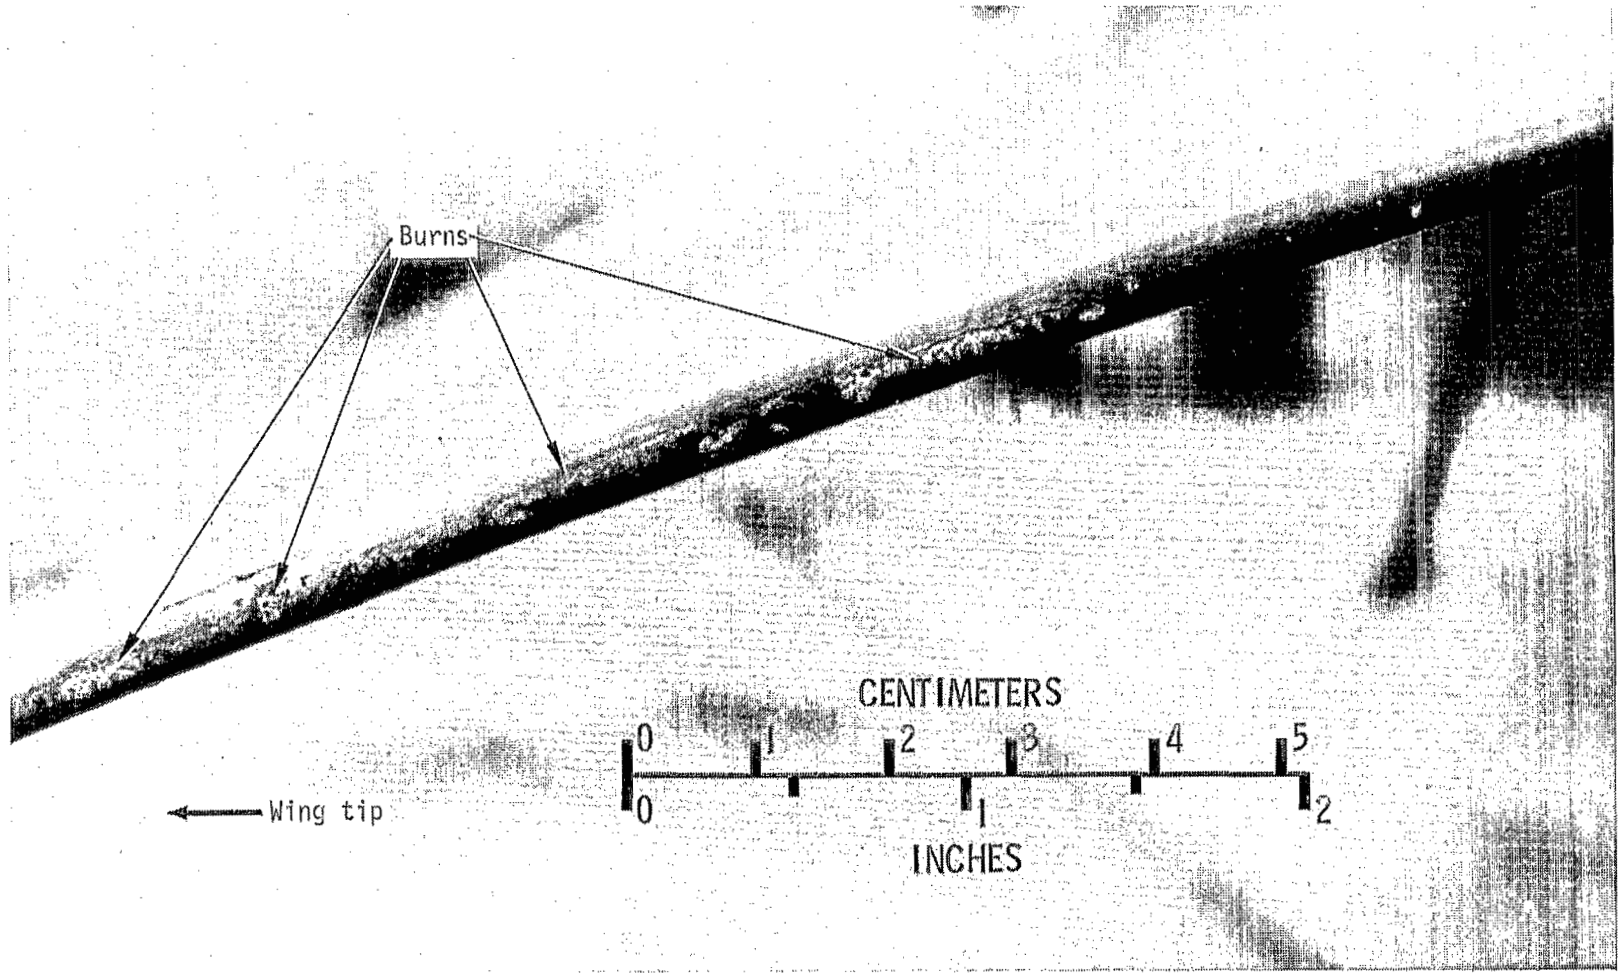
L-82-195

(d) Trailing edge of left wing, just inboard of tip.

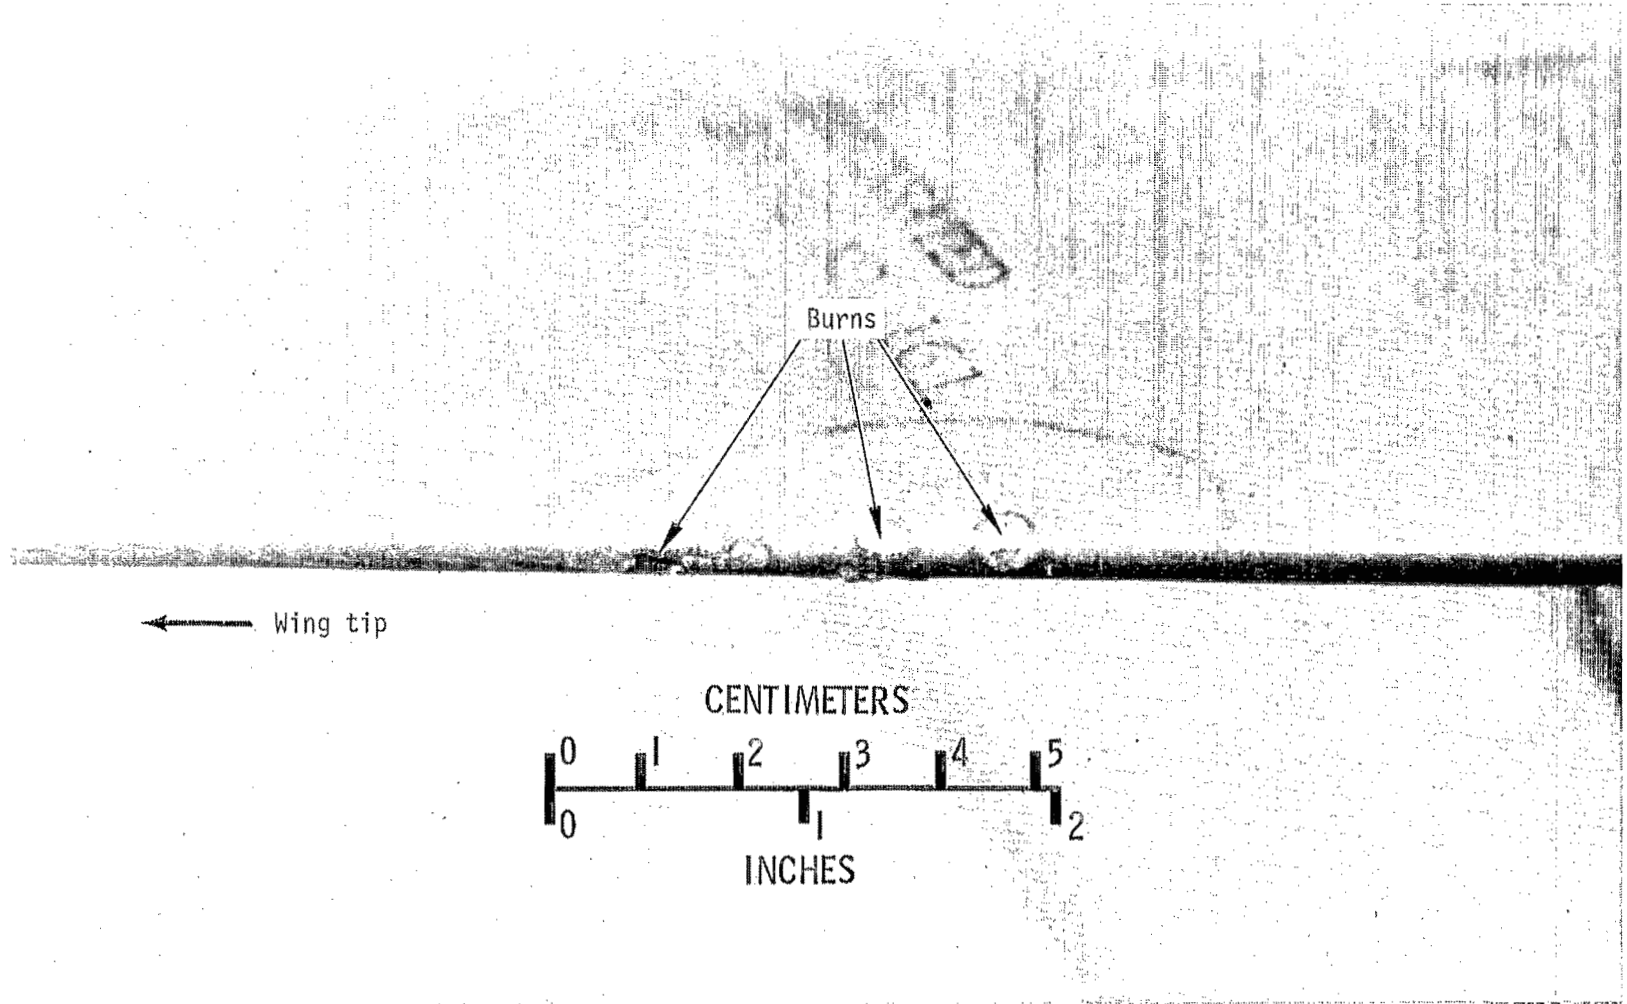
L-82-196

(e) Trailing edge of left wing, slightly inboard of view in figure 4(d).

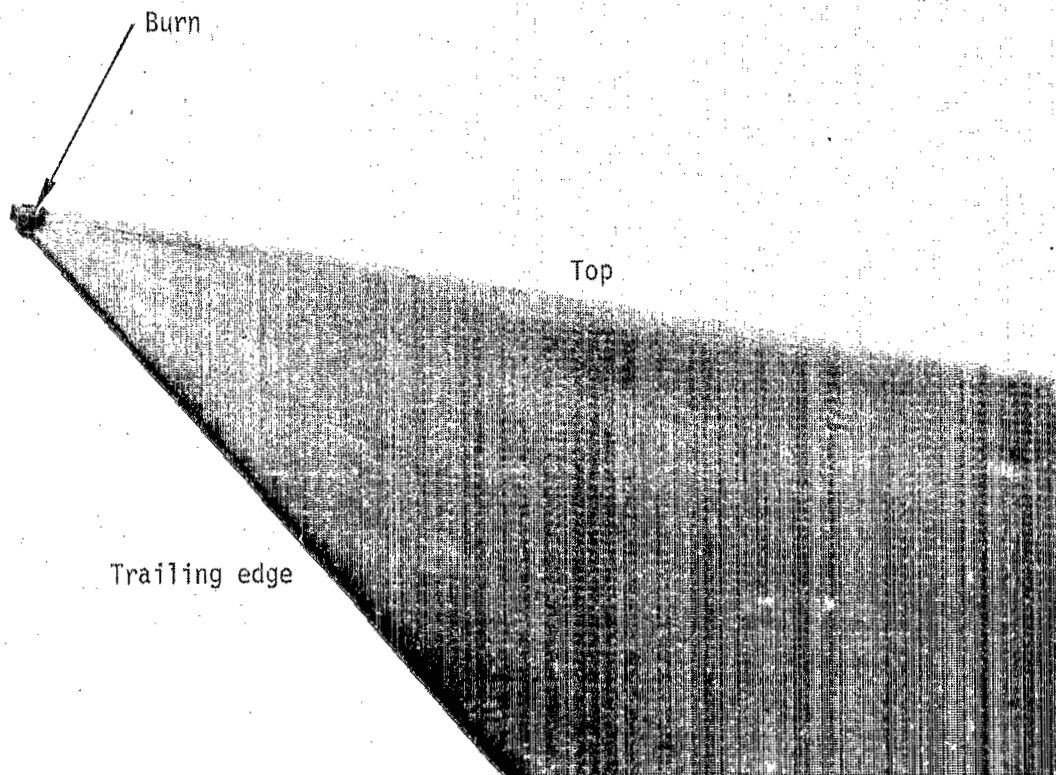
L-82-197

(f) Tip of vertical-fin cap, looking towards left wing tip.

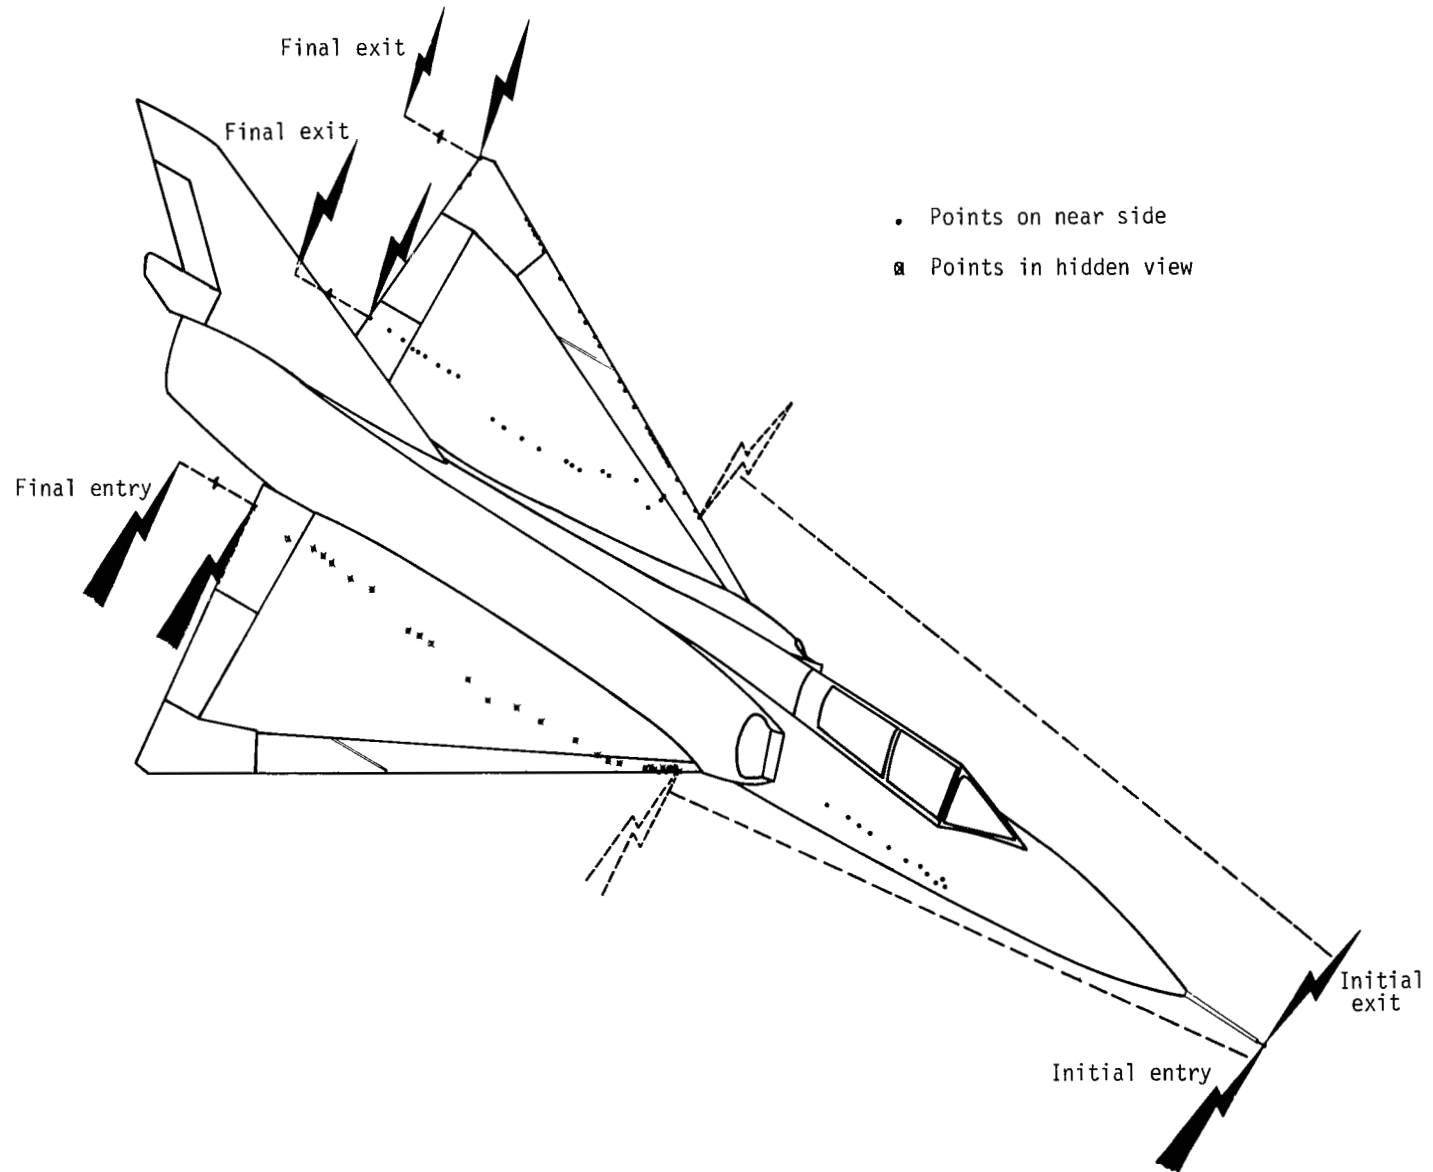
Figure 8.- Lightning attachment points for strike 2, flight 80-019, June 17, 1980.

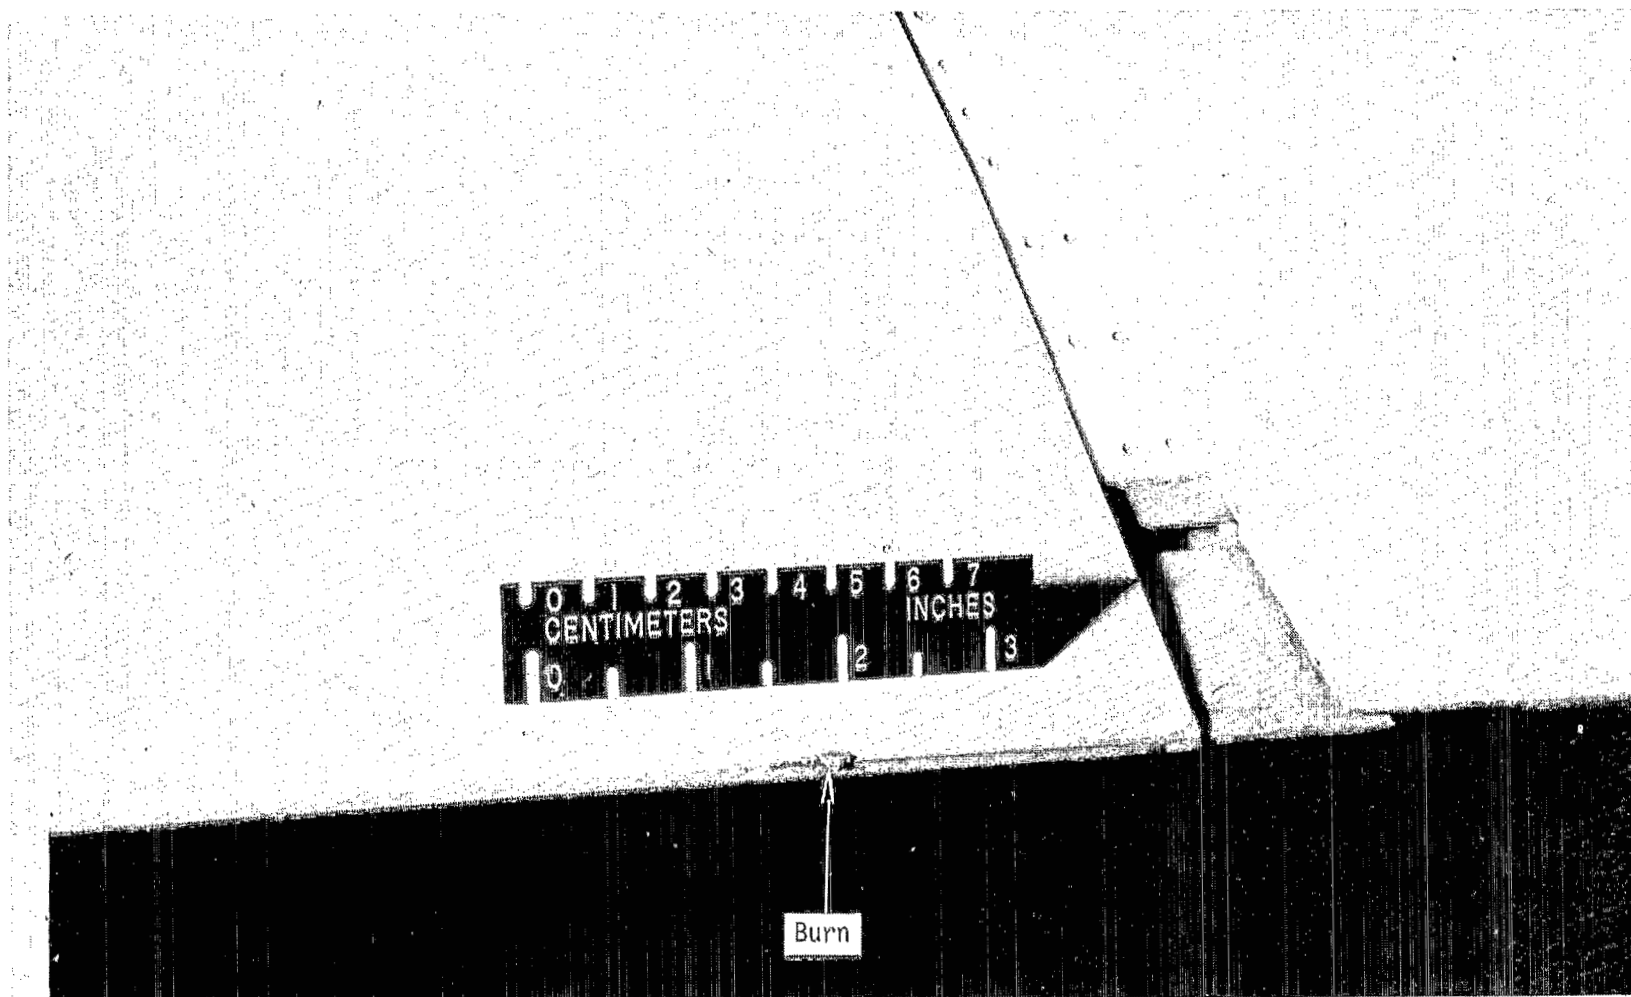
L-80-5356.1

(b) Trailing edge of left elevon.

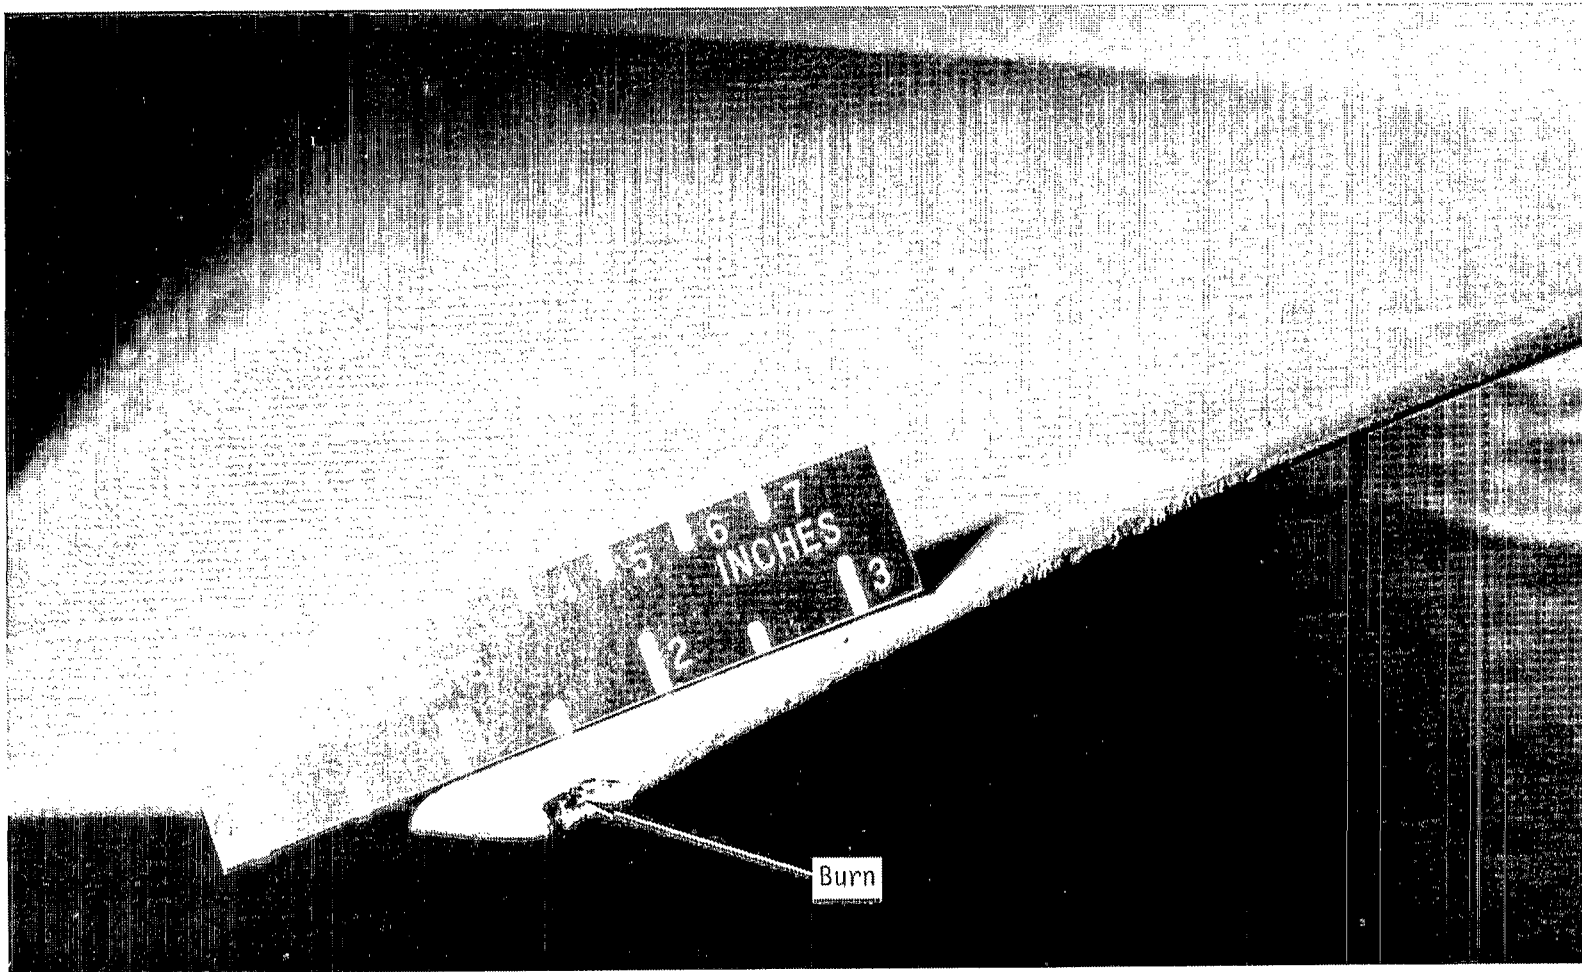
L-80-5354.1

(c) Left wing tip.

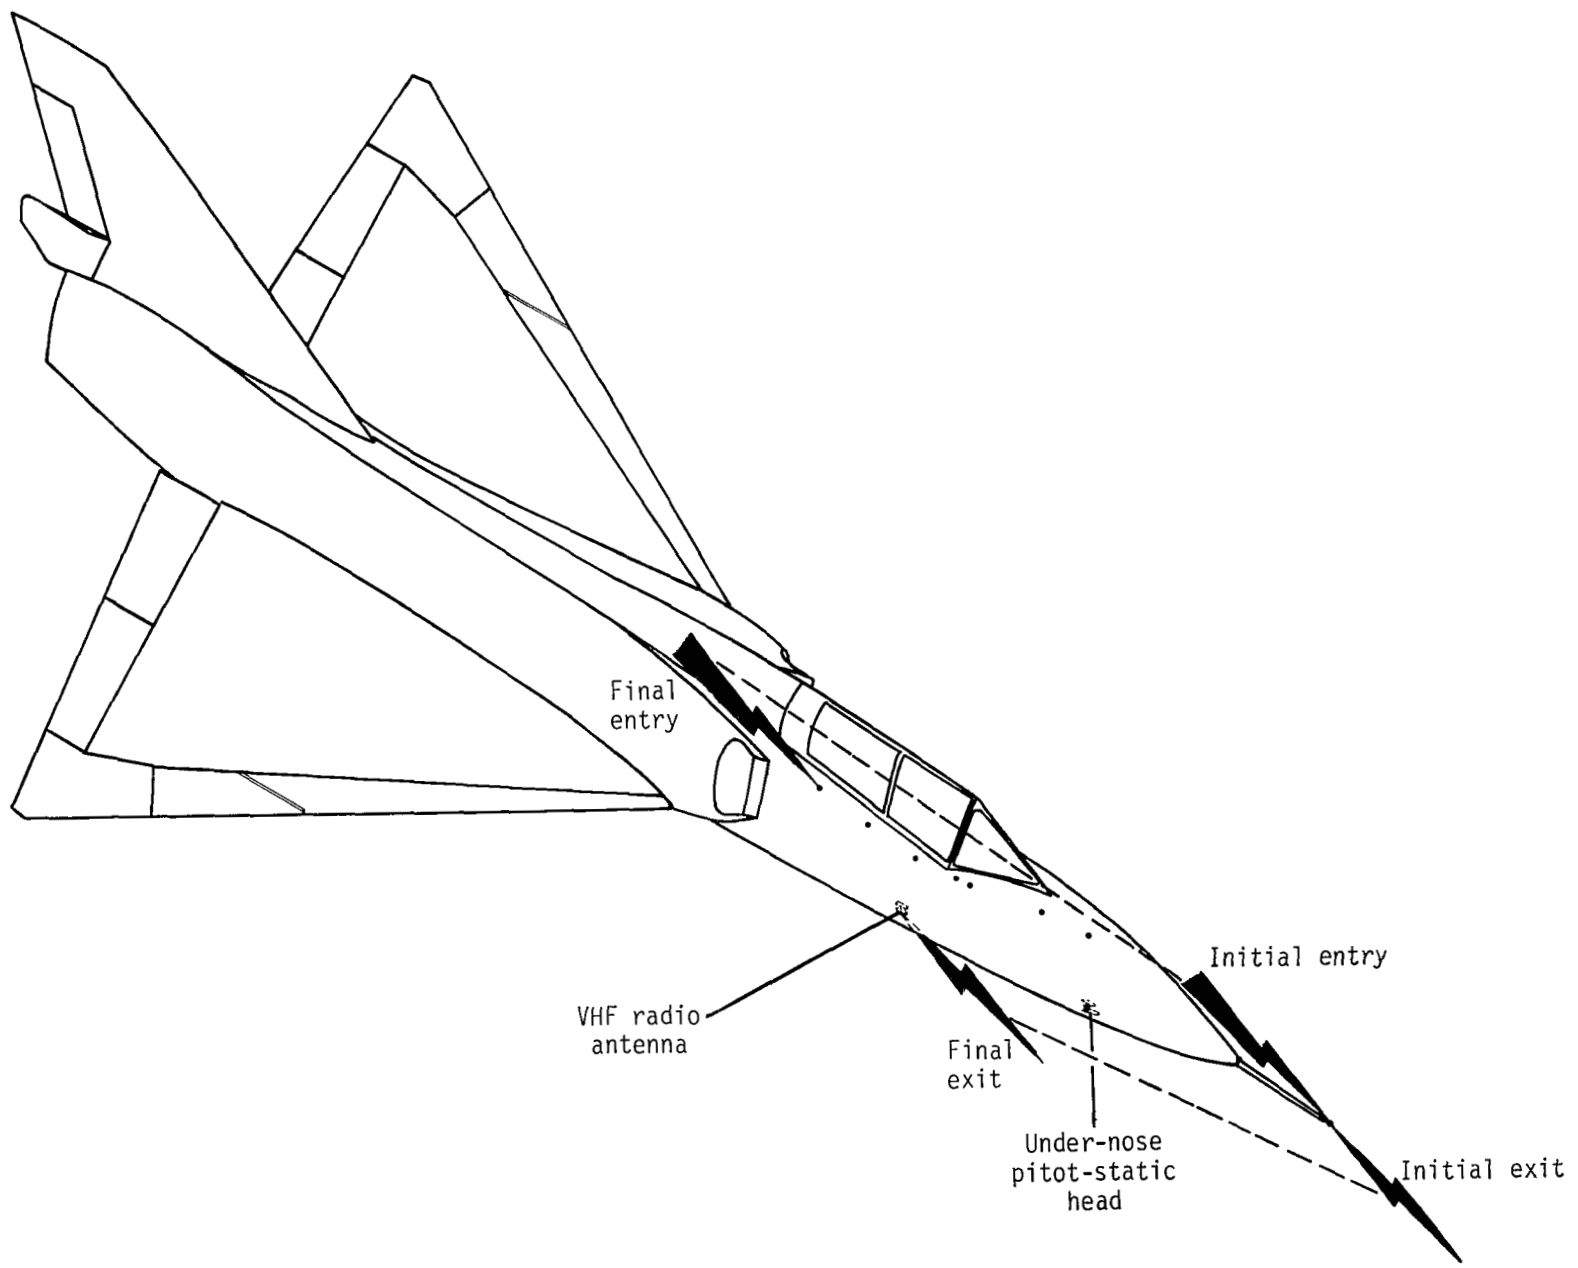
Those points believed to have been caused by strike 3 are shown in figure 11. These points included those found on the under-nose pitot-static head and on the VHF radio antenna on the bottom of the fuselage beneath the cockpit. The resulting lightning scenario is shown in figure 12. The initial entry and exit points occurred on the nose boom, with the entry point sweeping back along the fuselage just below the right canopy rail and the exit point sweeping underneath the fuselage to the two probes under the nose. The channel was oriented from upper right to lower left.

Figure 11.- Lightning attachment points for strike 3, flight 80-019, June 17, 1980.

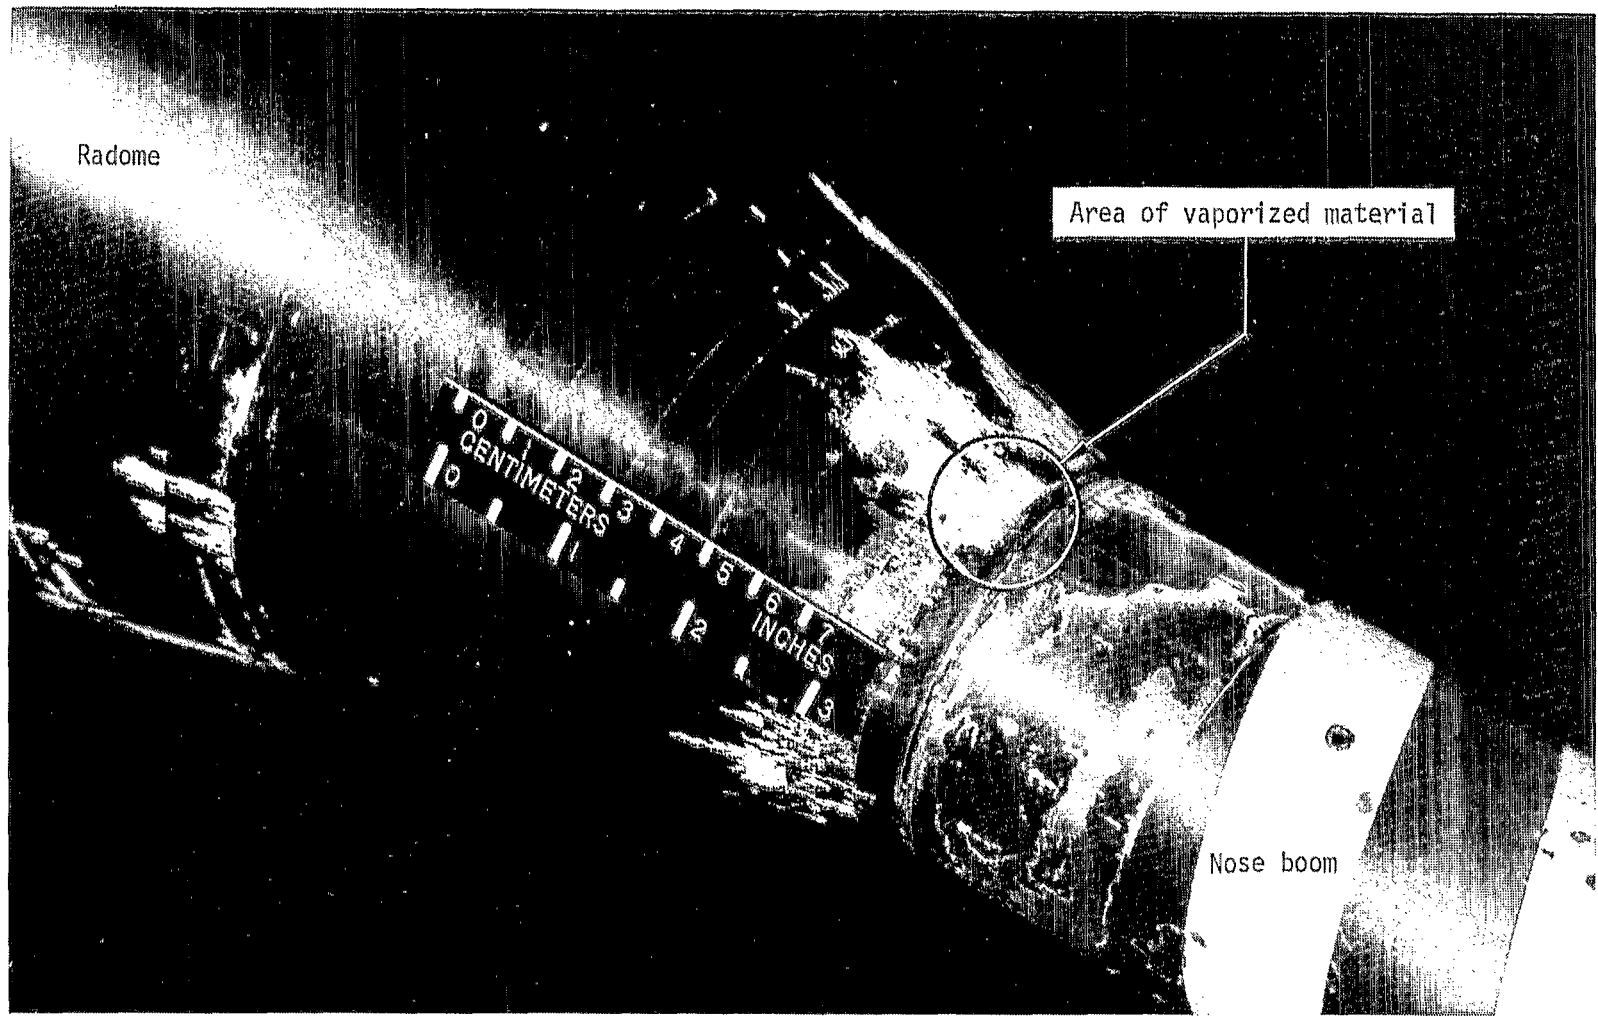
L-80-5357.1

Photographs of the attachment points at the junction between the metal nose boom and the fiberglass radome and at the VHF radio antenna are presented in figures 13(a) and 13(b). The radome damage consisted of a vaporized area about 2.0 cm (0.8 in.) in diameter just aft of the nose-boom fitting. No puncture occurred, however. The VHF radio antenna (fig. 13(b)) had a burn mark on the leading edge and a burn on the side of the antenna 4.1 cm (1.6 in.) aft of the leading edge. The thermal discoloration on the black paint is visible. (The extensive erosion of the black paint along the leading edge was caused by rain.)

(a) Nose-boom/radome junction.

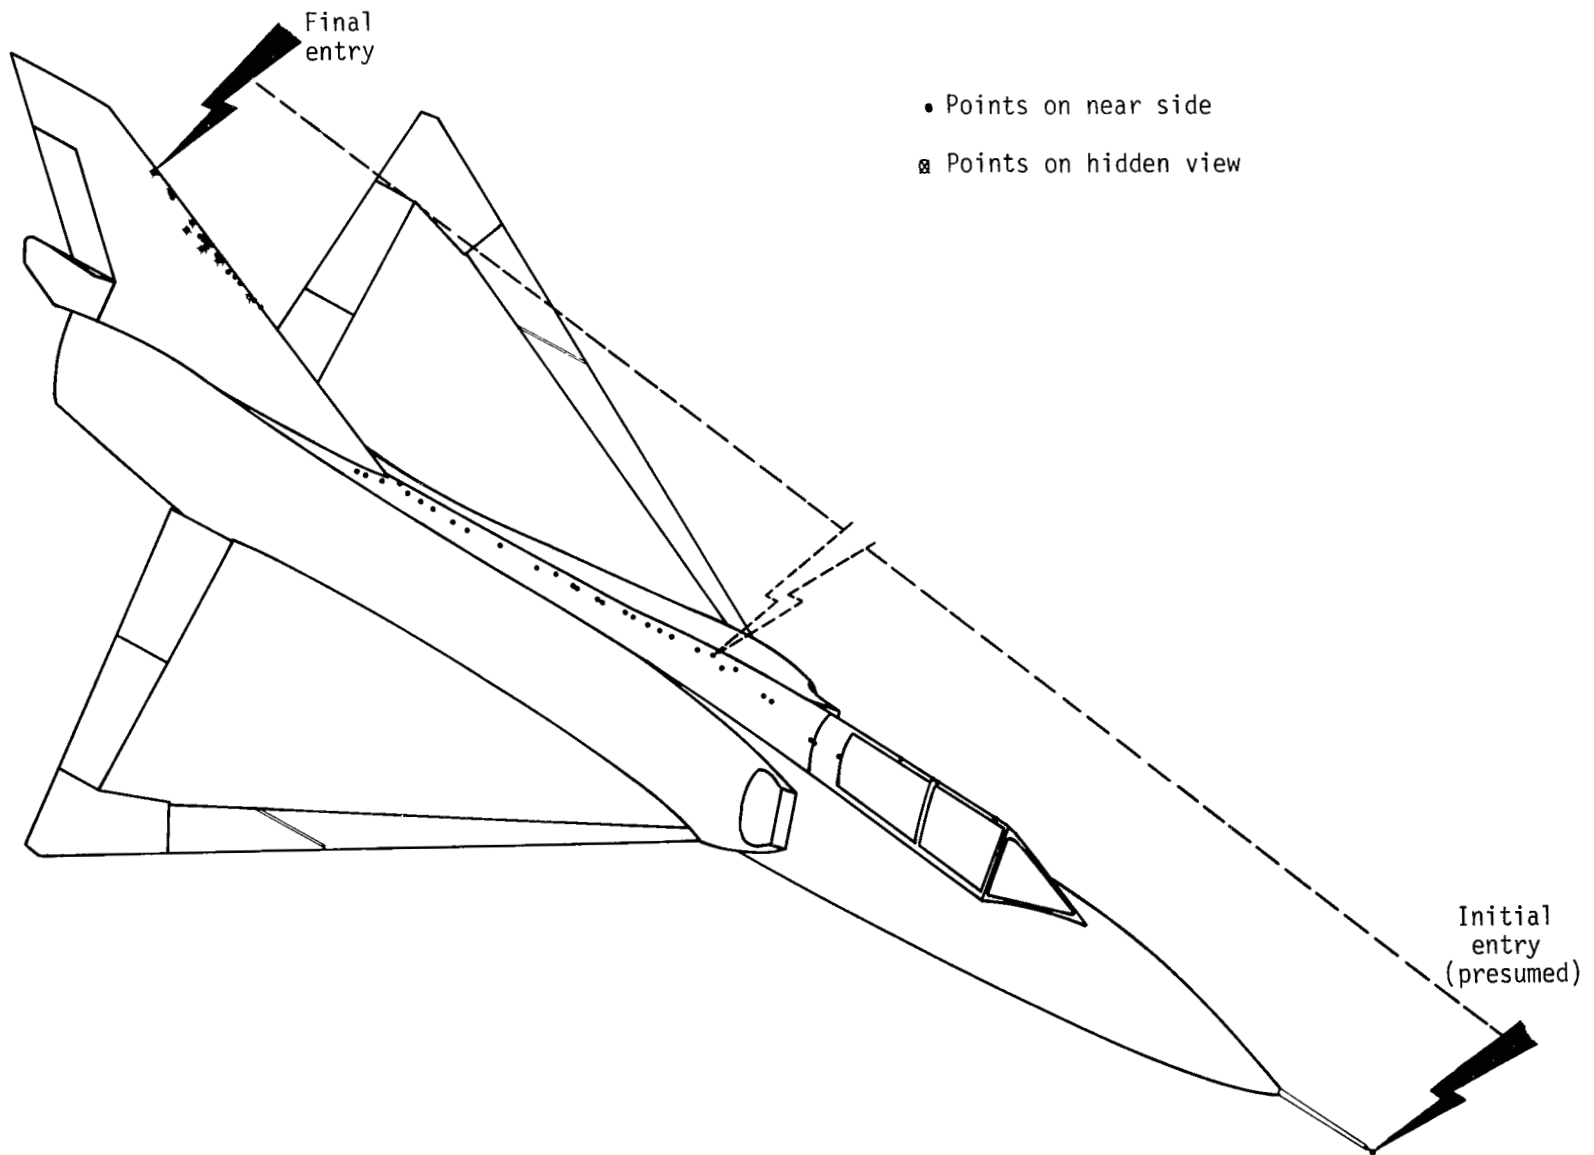
Figure 17.- Lightning attachment points for strike 4, flight 80-029, Aug. 12, 1980.
(No exit points found.)
