**NASA
Technical
Paper
2087**

December 1982

Lightning Attachment Patterns and Flight Conditions for Storm Hazards '80

Bruce D. Fisher,
Gerald L. Keyser, Jr.,
and Perry L. Deal

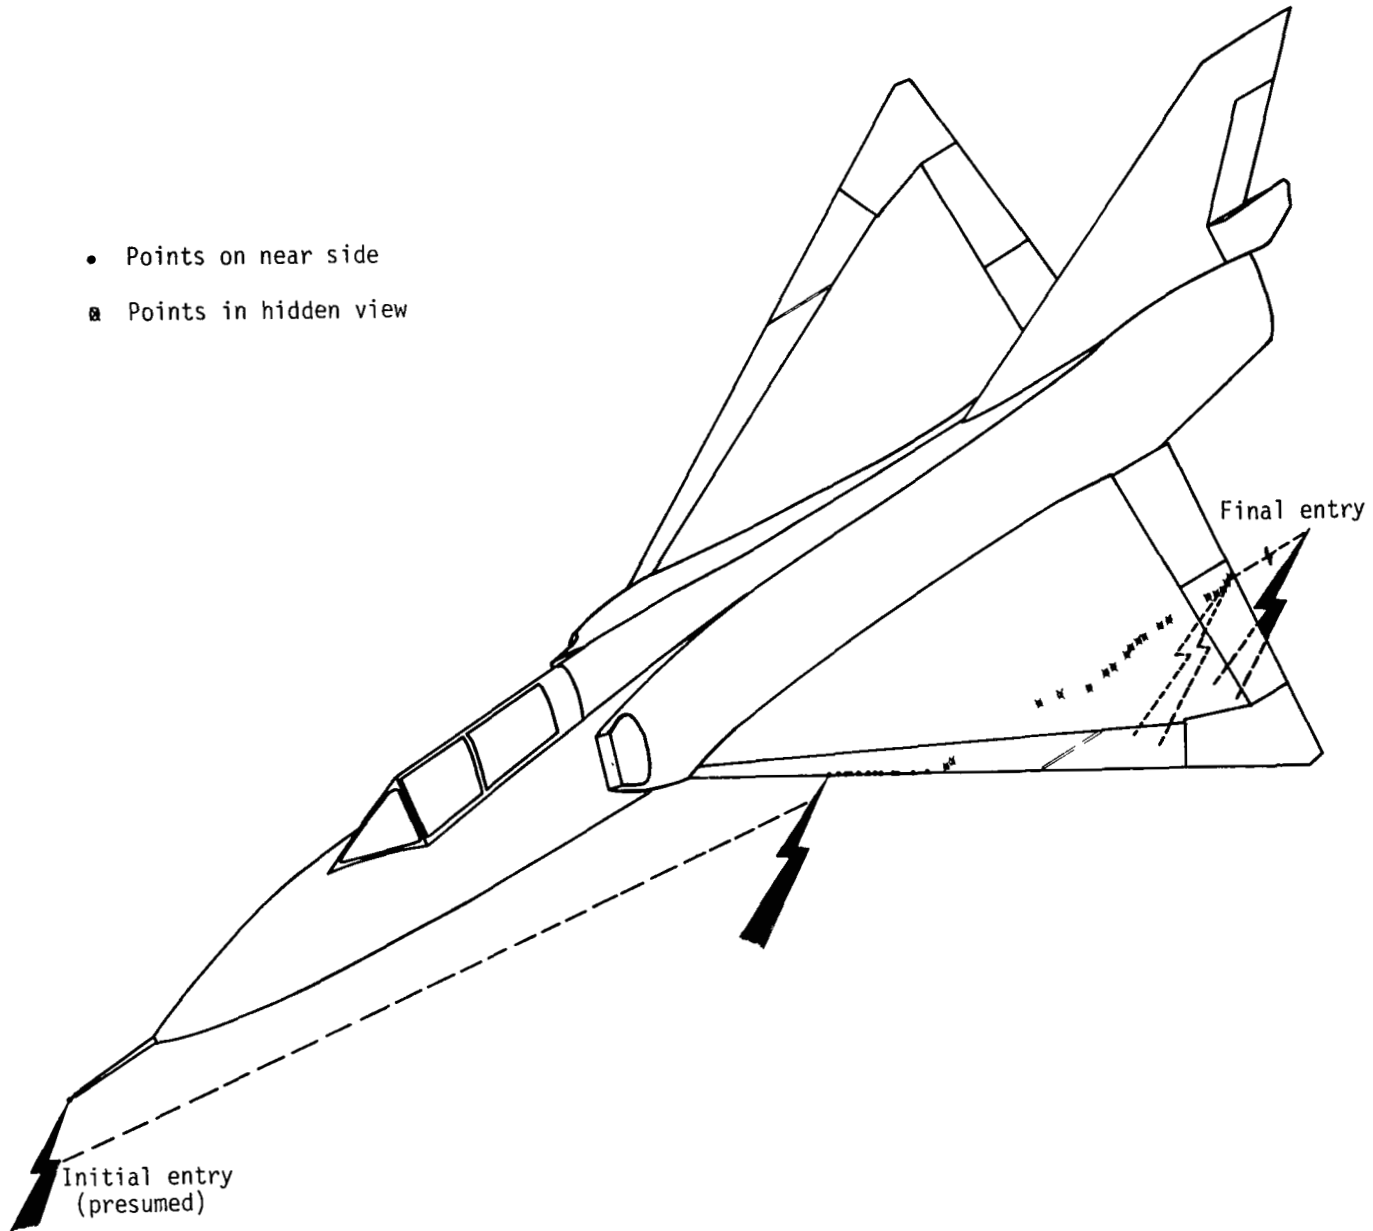
The lightning strike attachment points and the lightning strike scenario for strike 5 are given in figures 19 and 20. No exit point could be identified for this strike. Although no entry point could be found on the nose boom, the initial entry point probably occurred here because of the geometry of the points and the pilot's comments. As the airplane moved forward, the entry point jumped back to the leading edge of the left wing and to the underside of the wing across the midspan area. The entry channel hung onto the trailing edge of the left elevon until the flash was over. The geometry of the points indicates the flash struck the airplane from below and to the left. This was the second strike occurring during 1980 in which the flash swept back across the midspan of the wing with no upstream attracting point. The flash would normally be expected to sweep back along the wing leading edge to the wing tip. (See ref. 34.)

Figure 19.- Lightning attachment points for strike 5, flight 80-036, Sept. 1, 1980.
(No exit points found.)

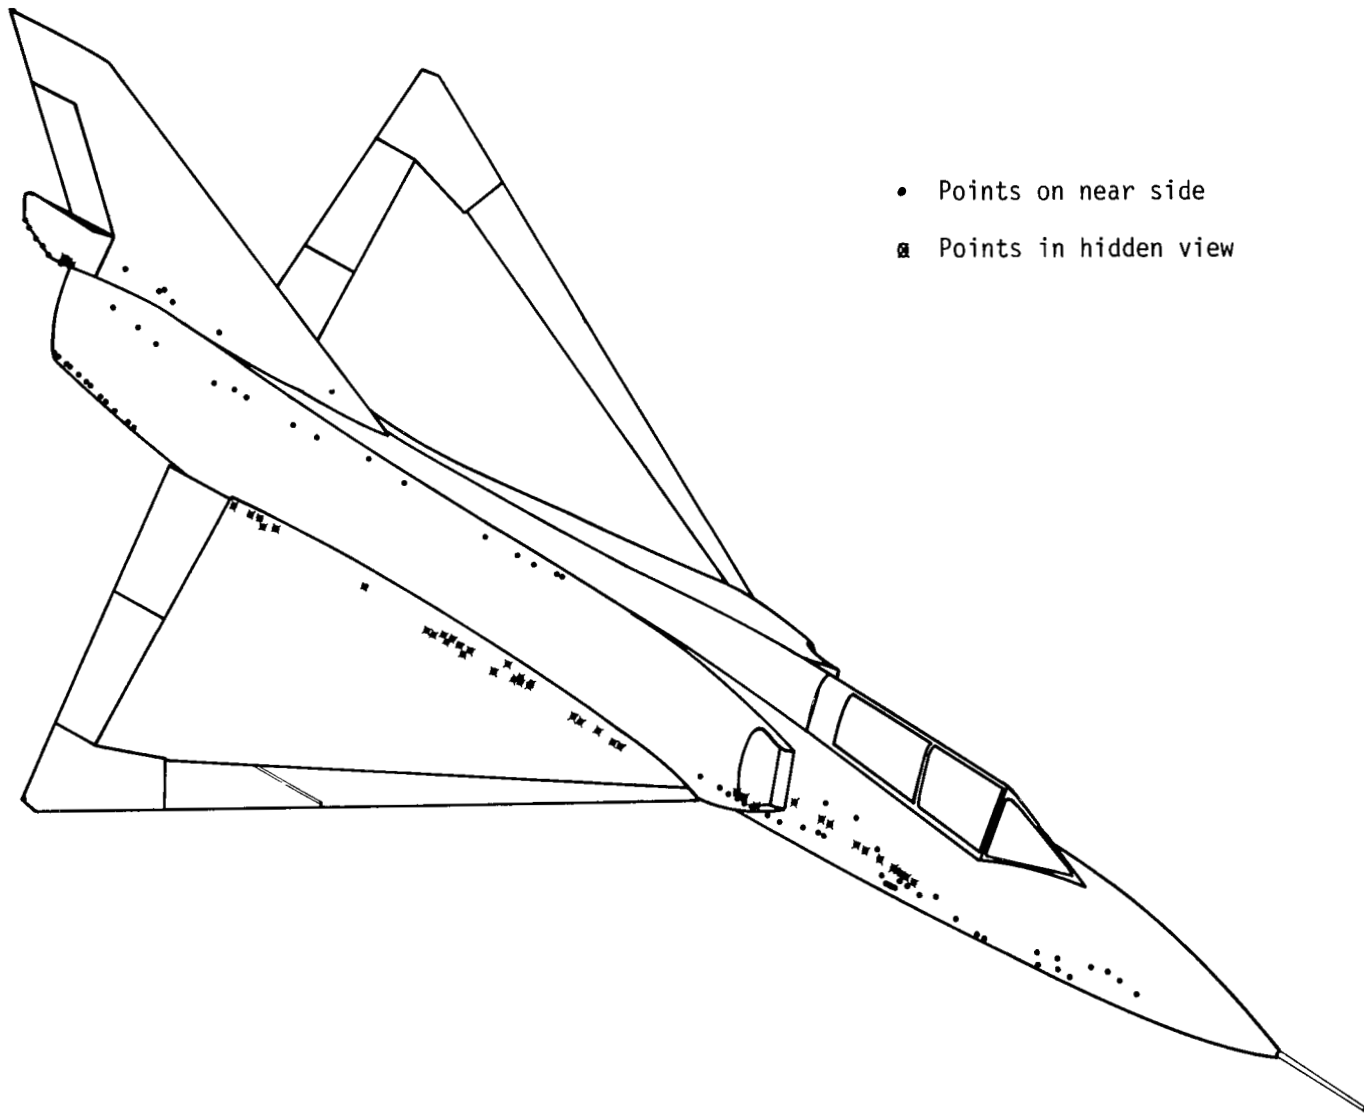
Figure 21.- Lightning attachment points for strikes 6 to 10, flight 80-038,
Sept. 3, 1980.

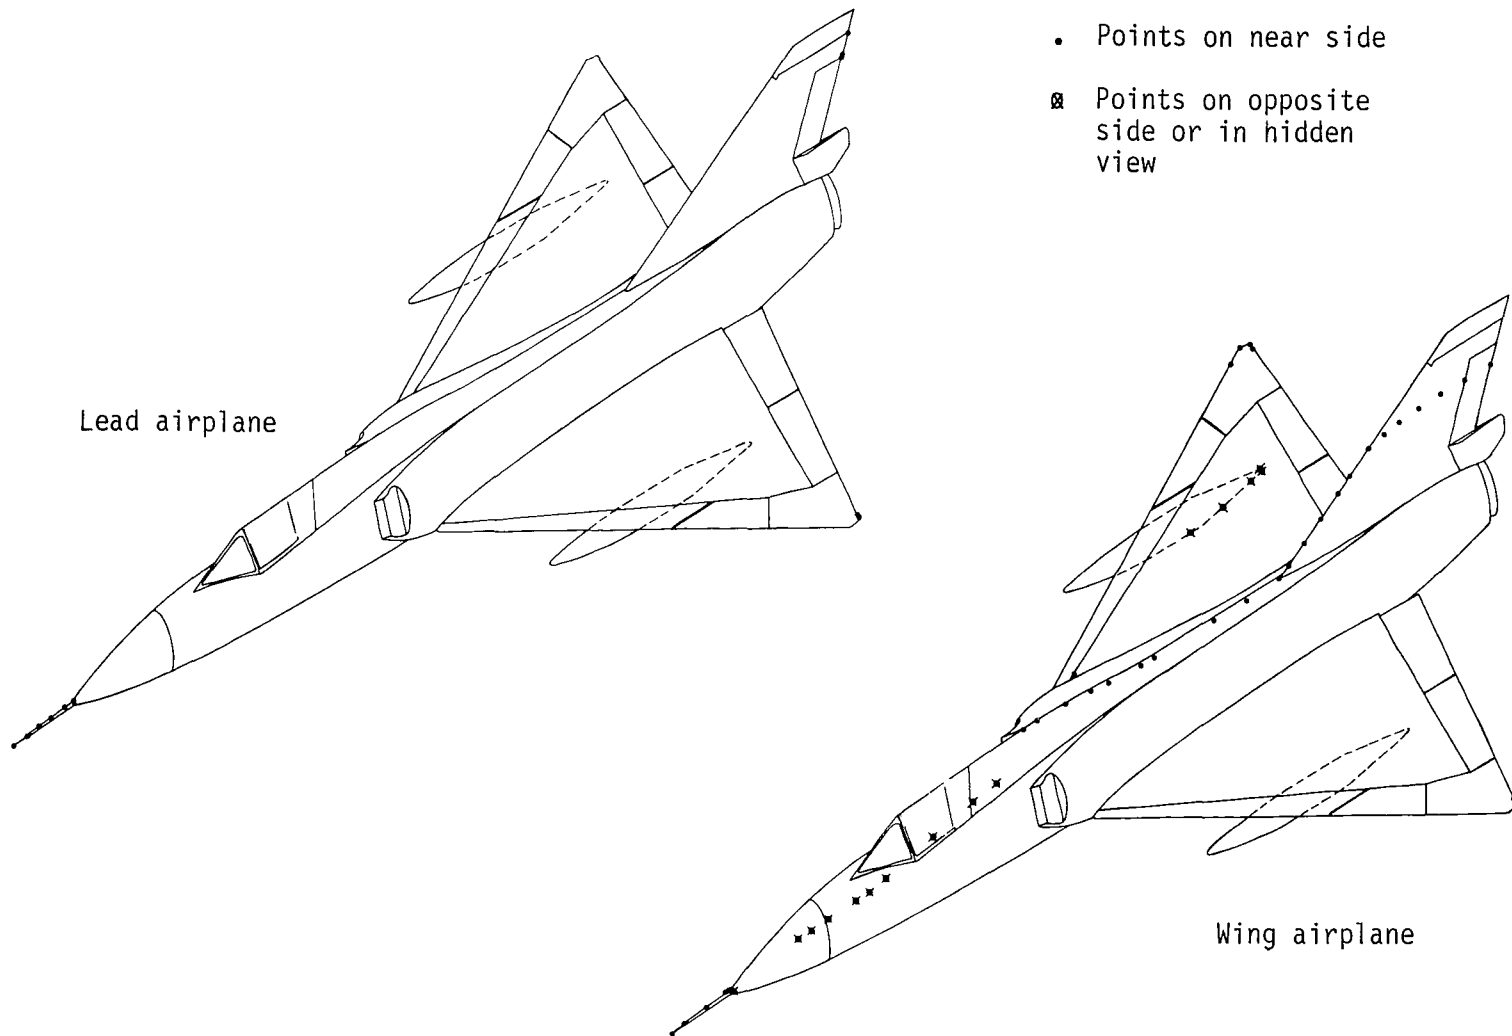
The lightning attachment points found on the two airplanes following the pair of strikes are shown in figure 26. The following lightning damage was found on the lead

airplane: burn marks on the pitot head and along the nose boom; weld-like marks at the fore and aft seams of the glycol ring on the nose boom; evaporated material from the fiberglass radome just aft of the metal nose-boom adapter; considerable erosion on left wing tip; and burns at the top and bottom of the vertical-fin cap at the trailing edge. On the wing airplane, the lightning attachment points were at the following locations: along the nose boom; several at the boom-radome juncture; two points on the right side of the radome several centimeters (inches) aft of the metal boom adapter; one on the right side of the radome high and ahead of the mounting ring; one on the load ring seam; both latches on the right-side nose door and two in between the latches; one on the seam under the windshield; one in the middle of the star in the emblem; numerous along the top of the fuselage; numerous along the leading edge of the vertical fin; several along the left side of the vertical fin; one large burn on the trailing edge of the rudder; one on the top of the right wing near the fuselage juncture; two on the bottom of the end of the right pylon tank and two on the back of the tank; and two on the left wing tip and three on the right wing tip.

Figure 26.- Lightning attachment points found on two USAF F-106A airplanes following a pair of lightning strikes to the formation.

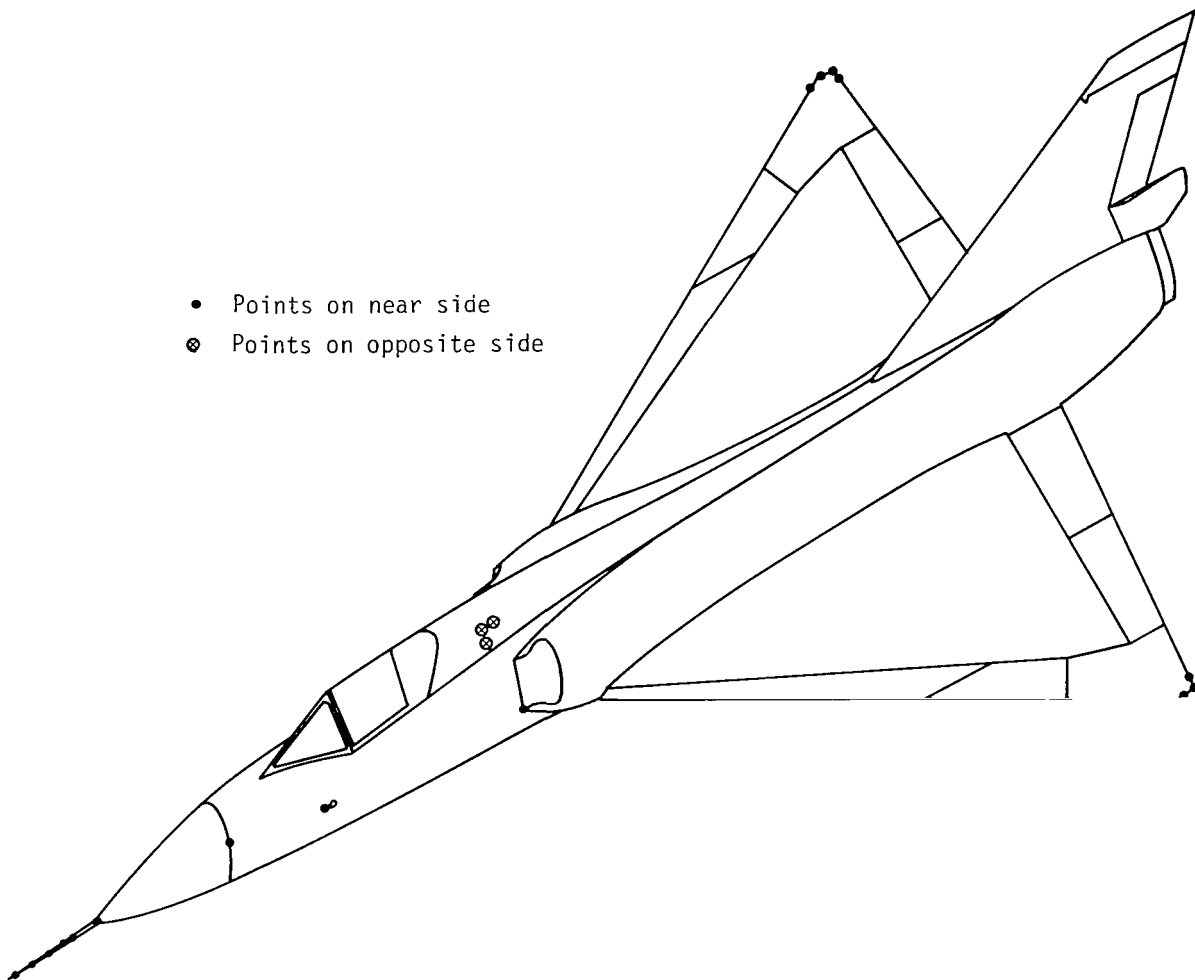
The lightning attachment points found on the airplane are shown in figure 29. The geometry of the points indicates the airplane was struck twice during the flight, with the points ascribed to each strike shown in figures 30 and 31.

Figure 29.- Lightning attachment points found on USAF F-106A airplane following multiple strikes.
