737 GRAPHITE COMPOSITE FLIGHT SPOILER FLIGHT SERVICE EVALUATION

SEVENTH ANNUAL REPORT
MAY 1980 THROUGH APRIL 1981

Prepared under Contract NAS1-11668 by
BOEING COMMERCIAL AIRPLANE COMPANY
FEBRUARY 1982

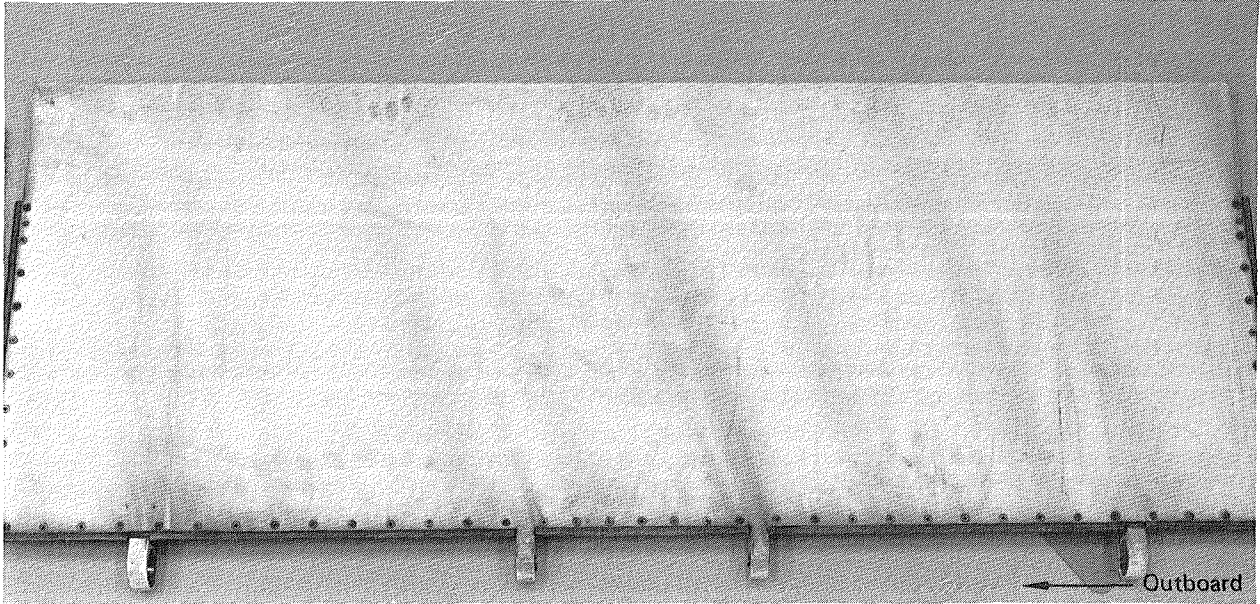
Following selection for test, the units were photographed. Figures 2 and 3 show the upper and lower surface of spoiler S/N 0059. The discrepancies on this unit are shown in figures 4 through 6. Figure 4 shows some minor corrosion of one of the -23 aluminum doublers. Figure 5 shows an exfoliation corrosion blister at one spar to center hinge fitting splice, and figure 6 shows a similar exfoliation corrosion blister at the opposite side.

Figure 2. Upper Surface of Spoiler S/N 0059 After 6 Years of Service

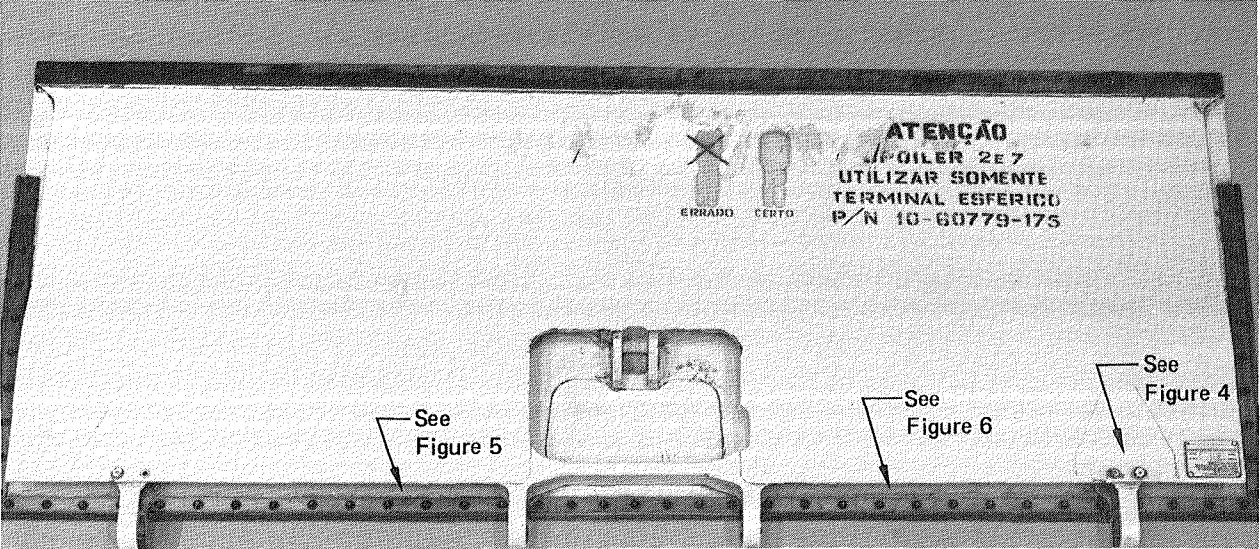
Figure 3. Lower Surface of Spoiler S/N 0059 After 6 Years of Service

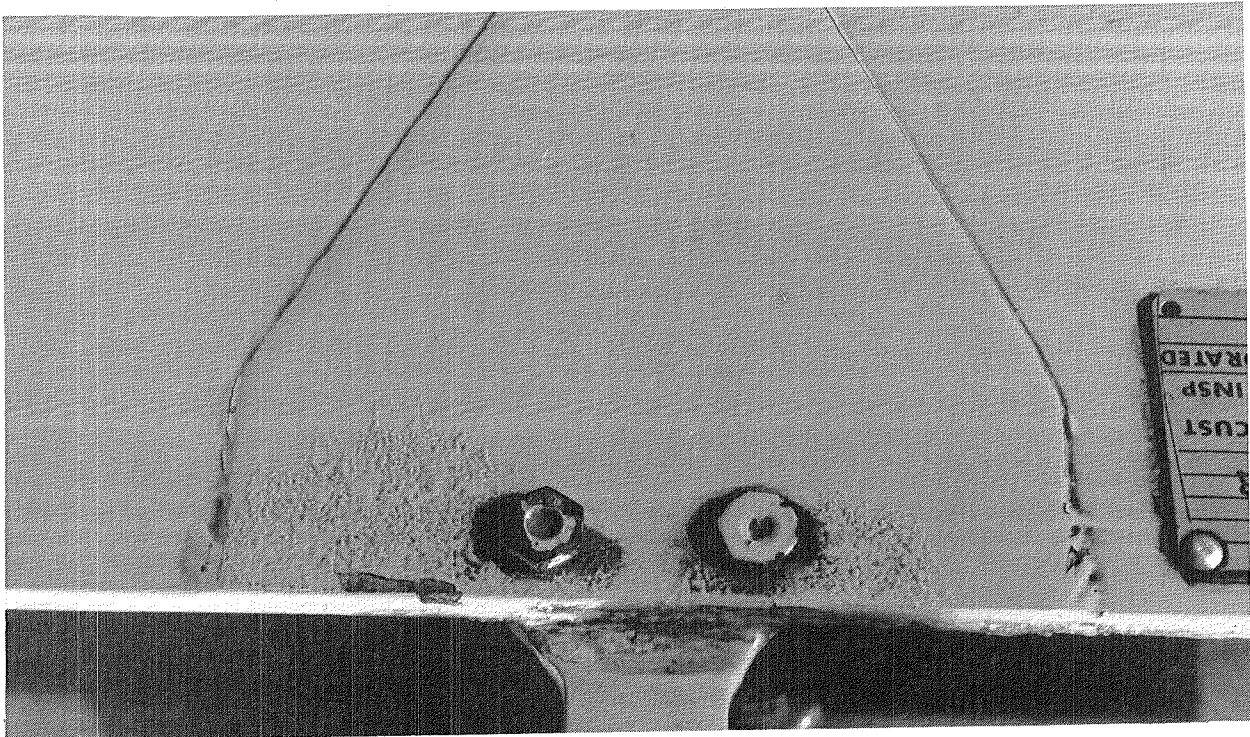
Figure 4. Minor Doubler Corrosion on S/N 0059

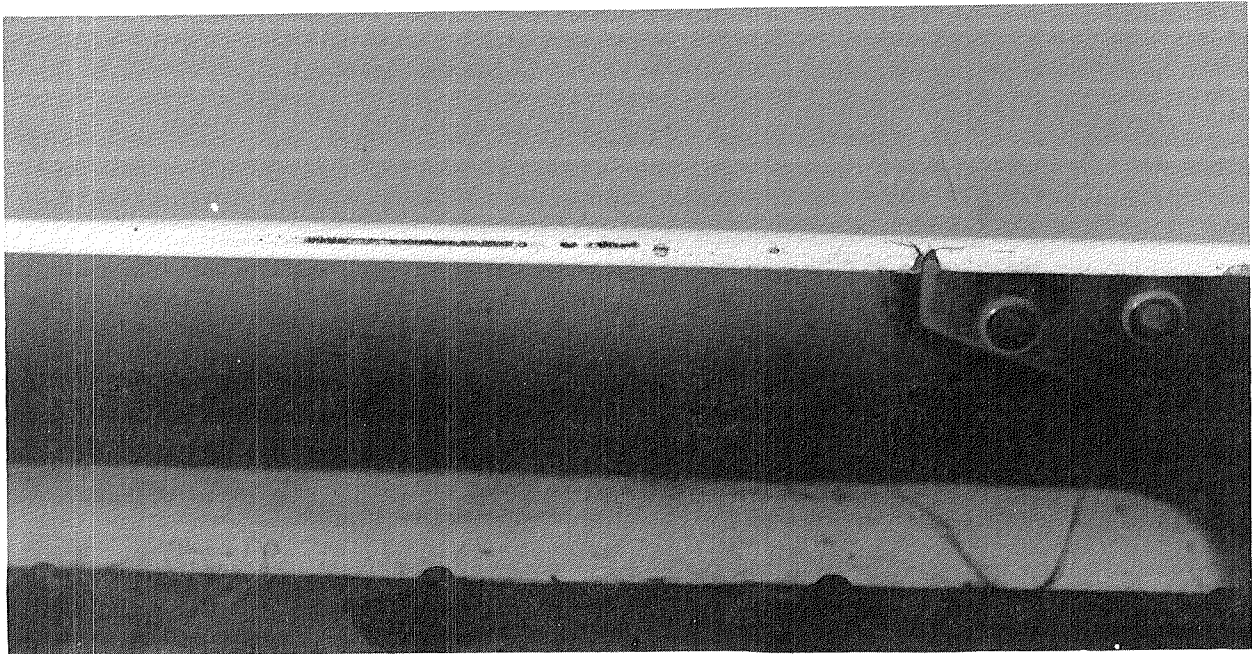
Figure 5. Exfoliation Corrosion at Outboard Spar to Center Hinge Fitting Splice on S/N 0059

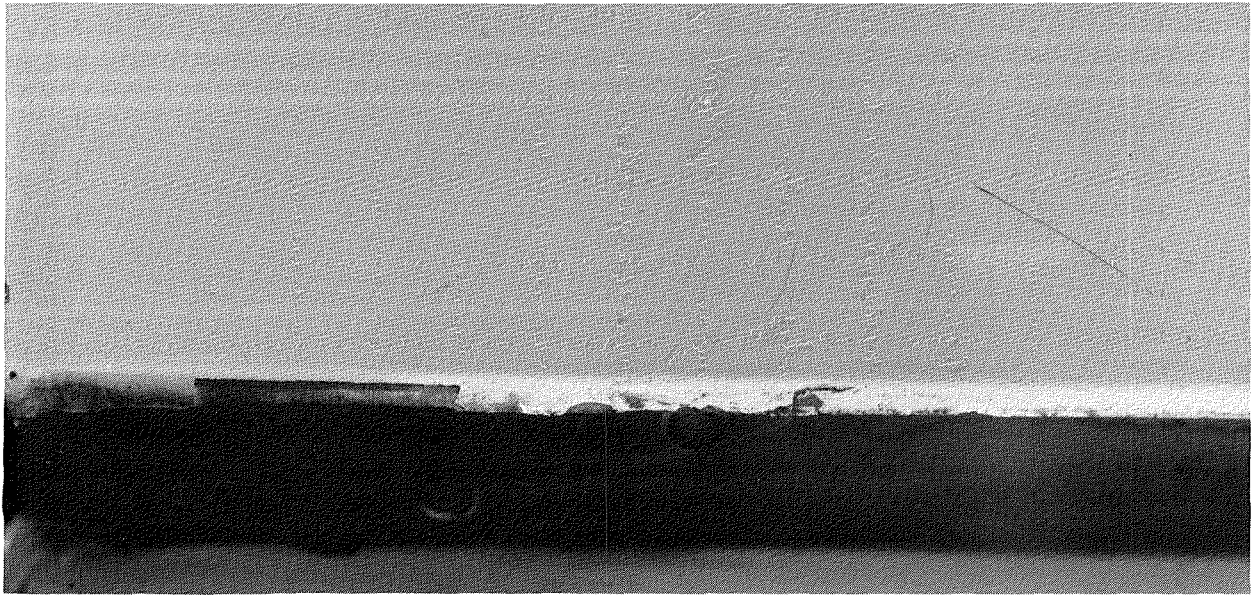
Figure 6. Exfoliation Corrosion at Inboard Spar to Center Hinge Fitting Splice on S/N 0059

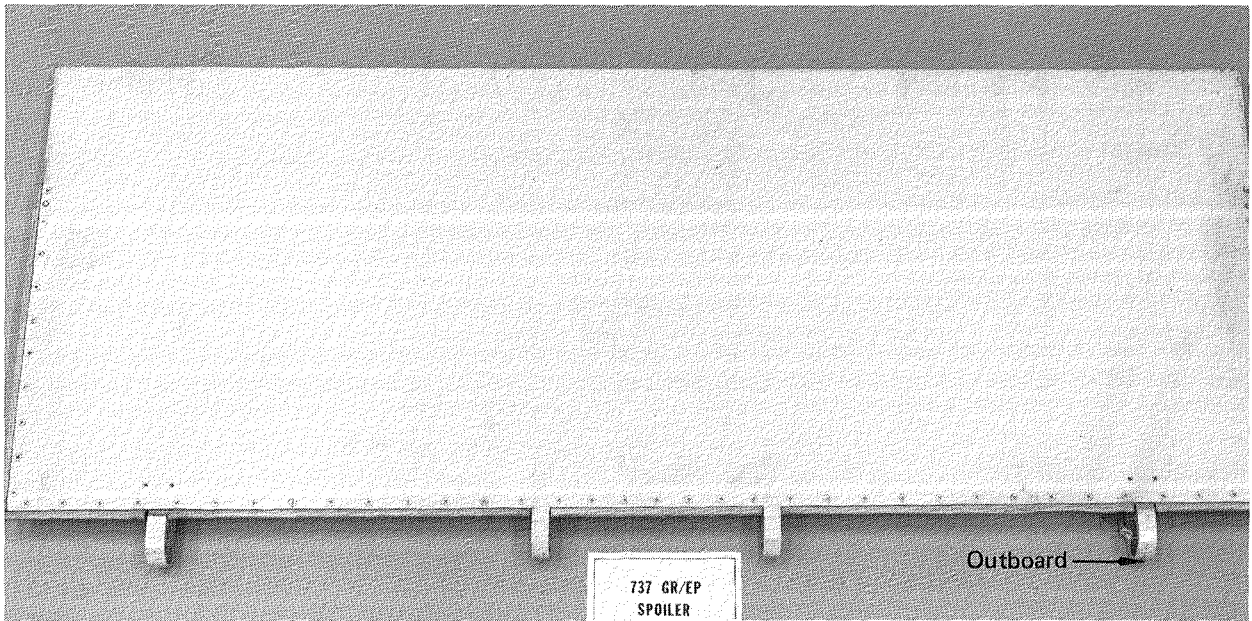
Figures 7 and 8 are photographs of the upper and lower surfaces, respectively, of spoiler S/N 0049. Earlier minor doubler corrosion and flap rubbing had been dressed down and repainted by the airline. Discrepancies for this unit are shown in figures 9 through 12. Figure 9 shows an edge crack resulting from an exfoliation corrosion condition from the outboard spar to center hinge fitting splice. Figures 10 through 12 show the opposite splice in detail. The area had undergone a repair for exfoliation corrosion, but the problem redeveloped during additional service. The repair finish is relatively coarse, because this is not an aerodynamic surface. Figures 11 and 12 show in detail the corrosion blister and edge crack.

Figure 7. Upper Surface of Spoiler S/N 0049 After 7 Years of Service

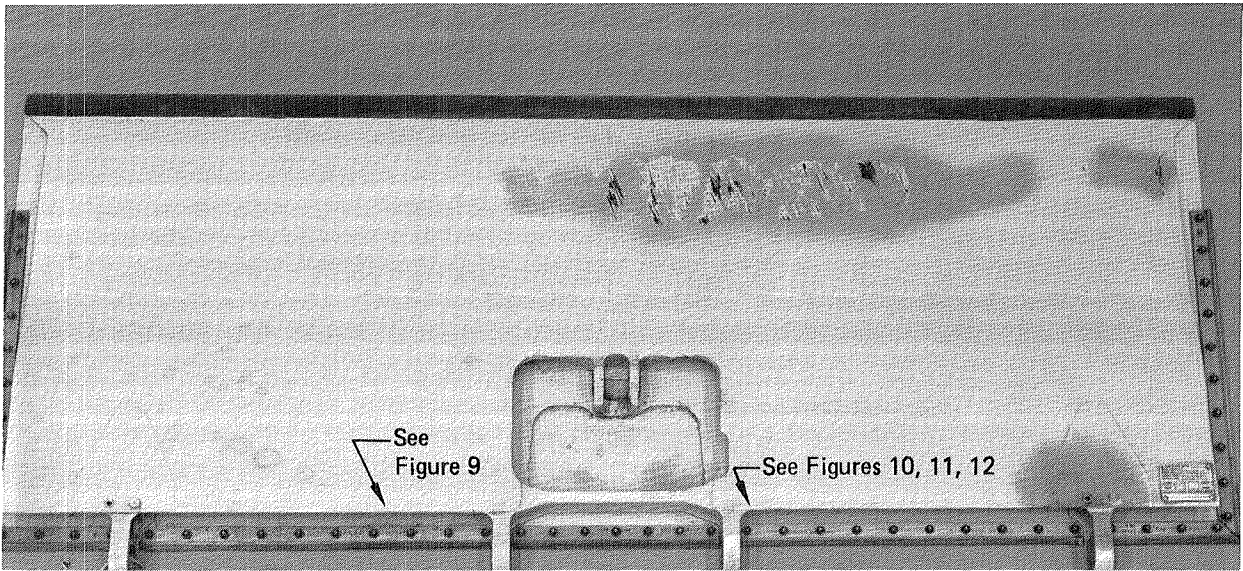
Figure 8. Lower Surface of Spoiler S/N 0049 After 7 Years of Service

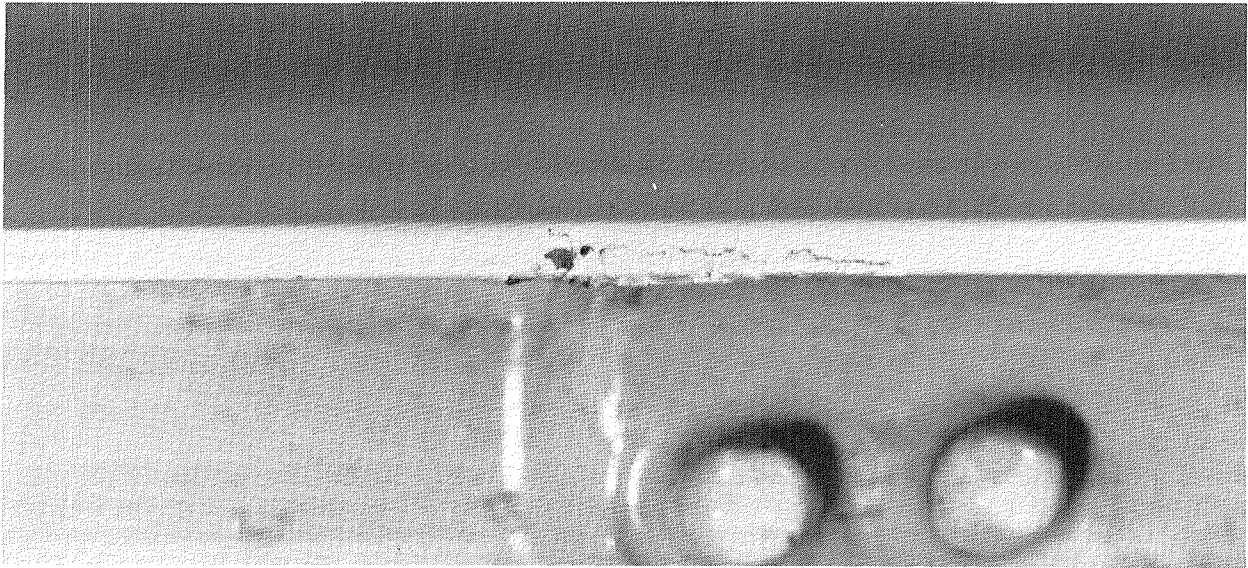
Figure 9. Exfoliation Corrosion at Outboard Spar to Center Hinge Fitting Splice on S/N 0049

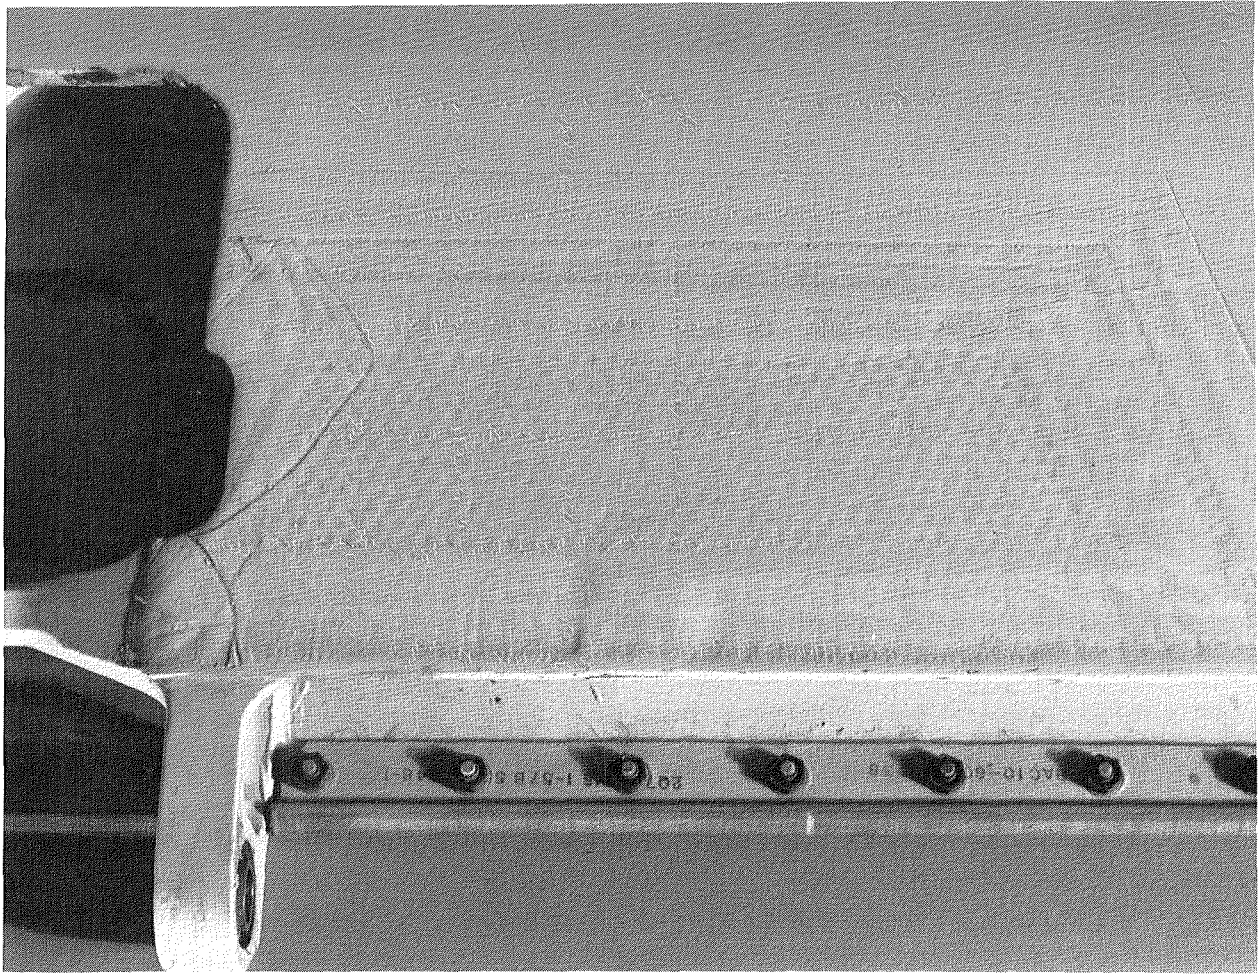
Figure 10. Previous Repair Detail and Exfoliation Corrosion at Inboard Spar to Center Hinge Fitting Splice on S/N 0049

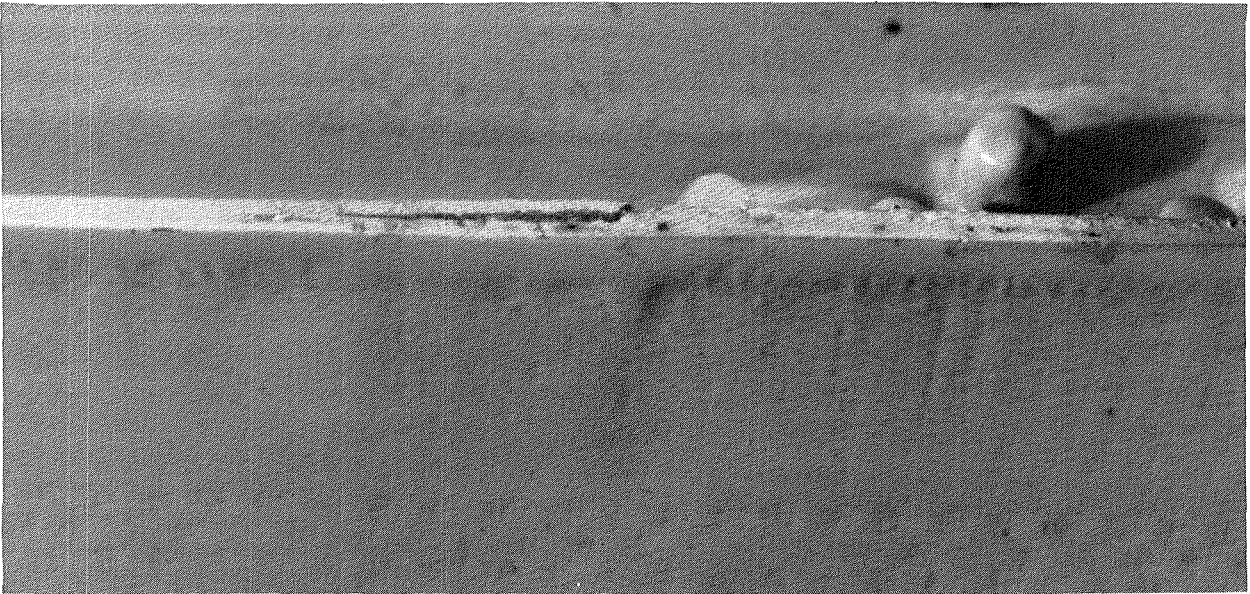
Figure 11. Exfoliation Corrosion at Inboard Spar to Center Hinge Fitting Splice on S/N 0049

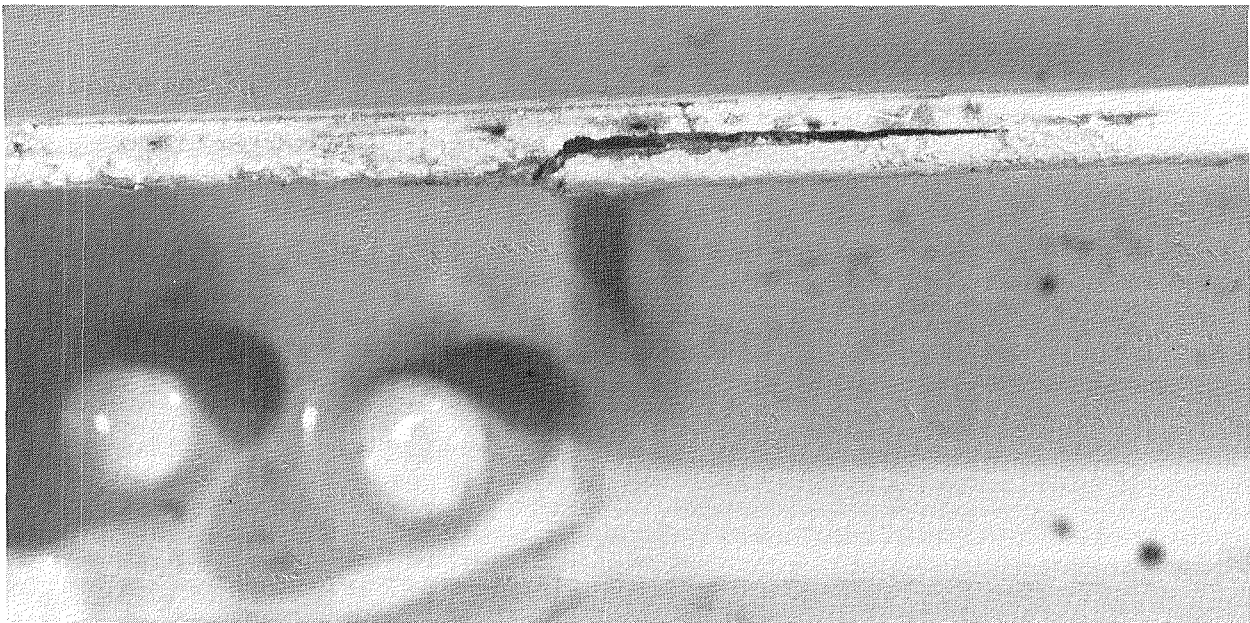
Figure 12. Exfoliation Corrosion at Inboard Spar to Center Hinge Fitting Splice on S/N 0049

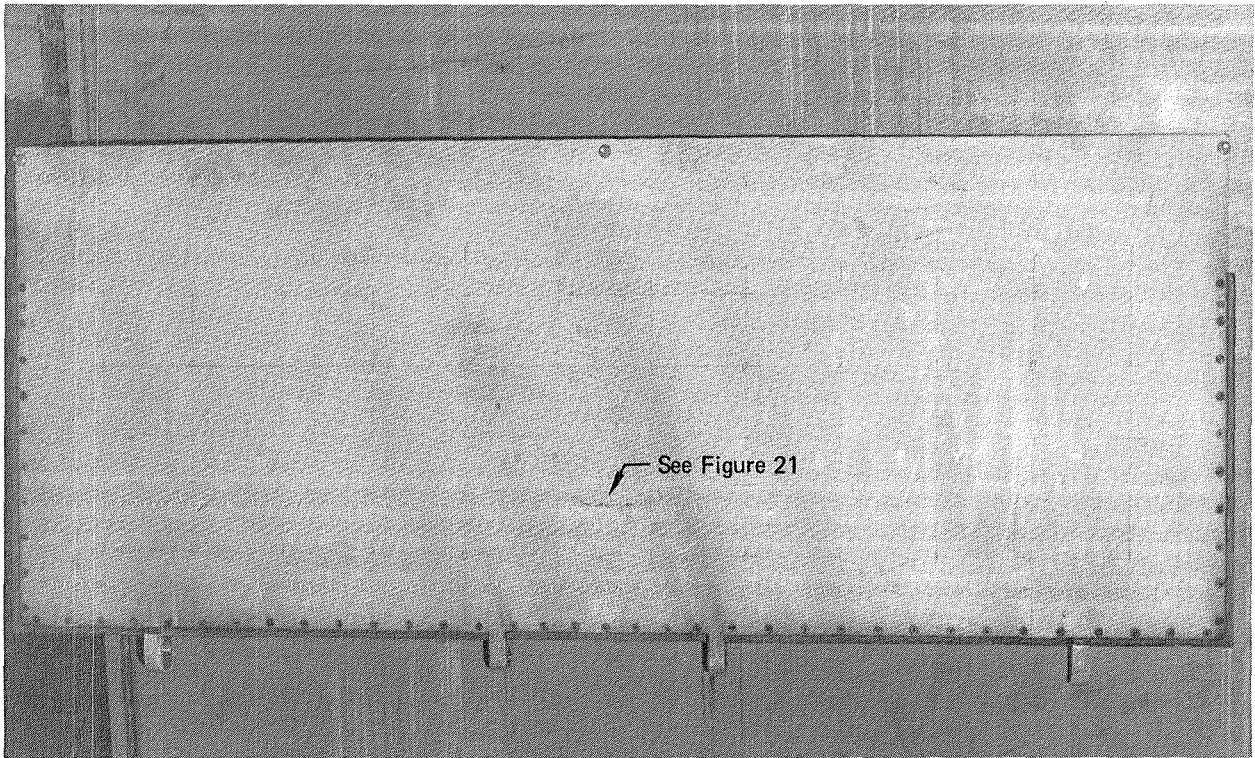
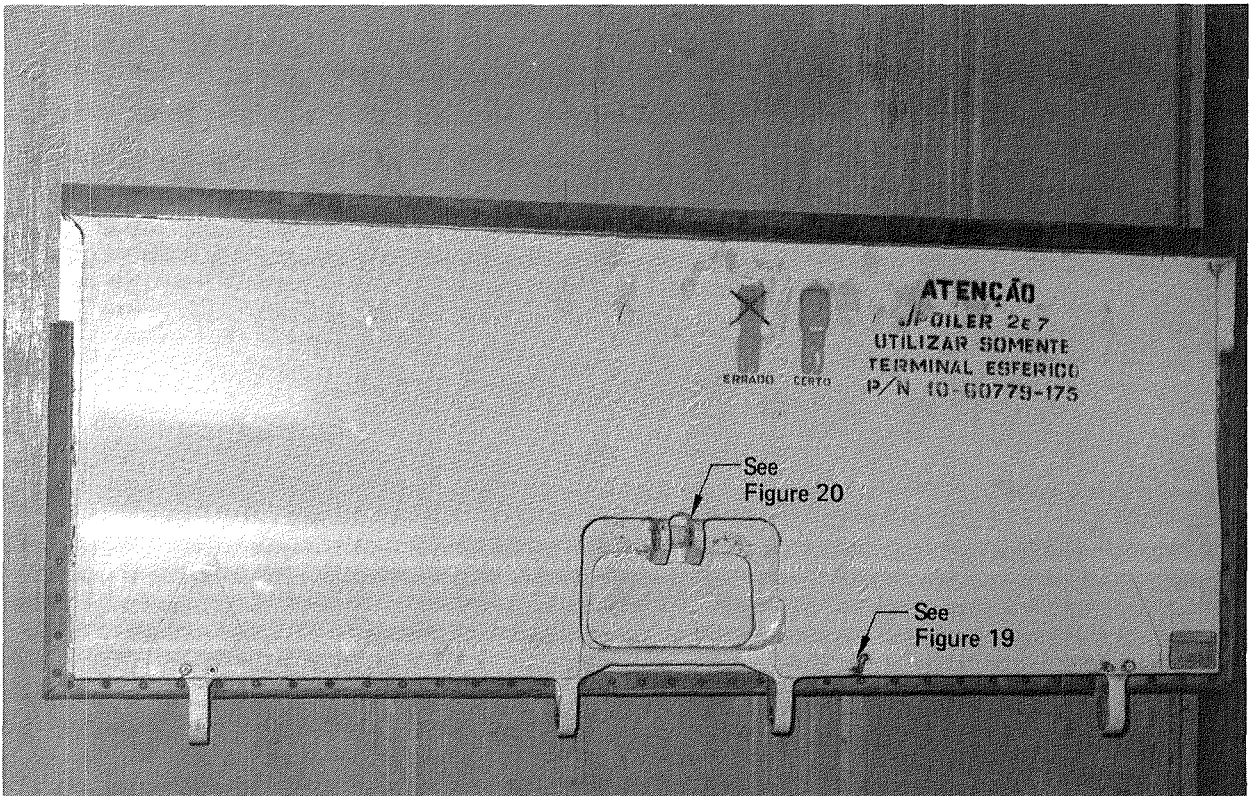
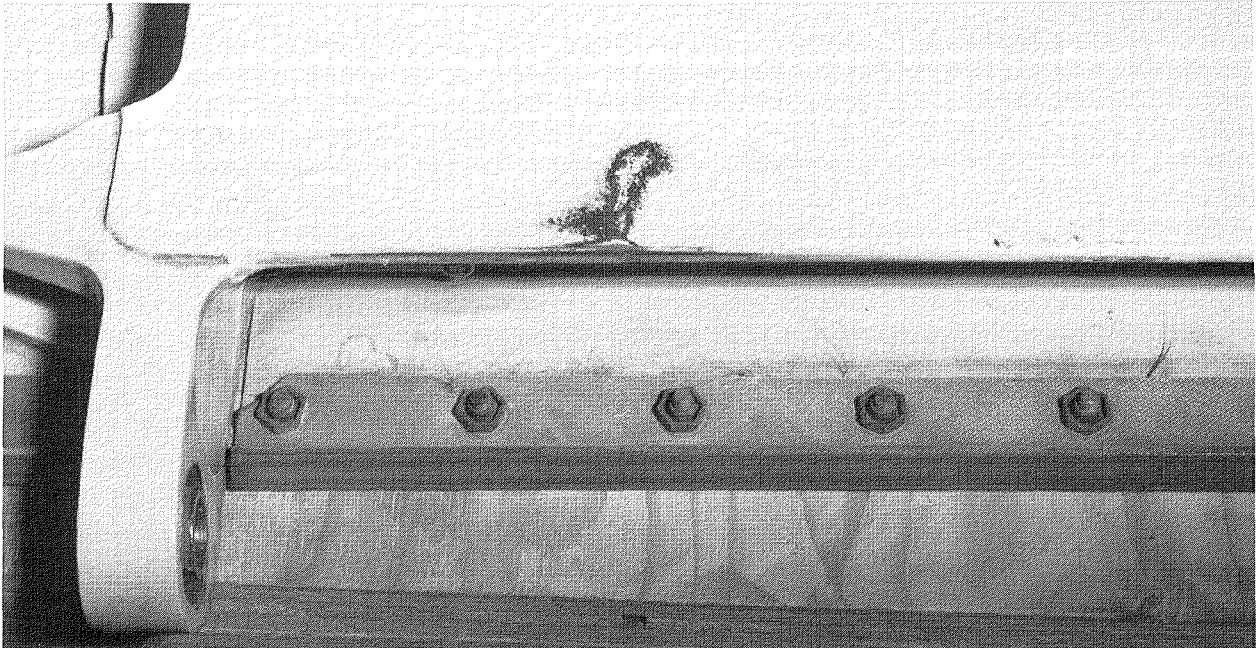
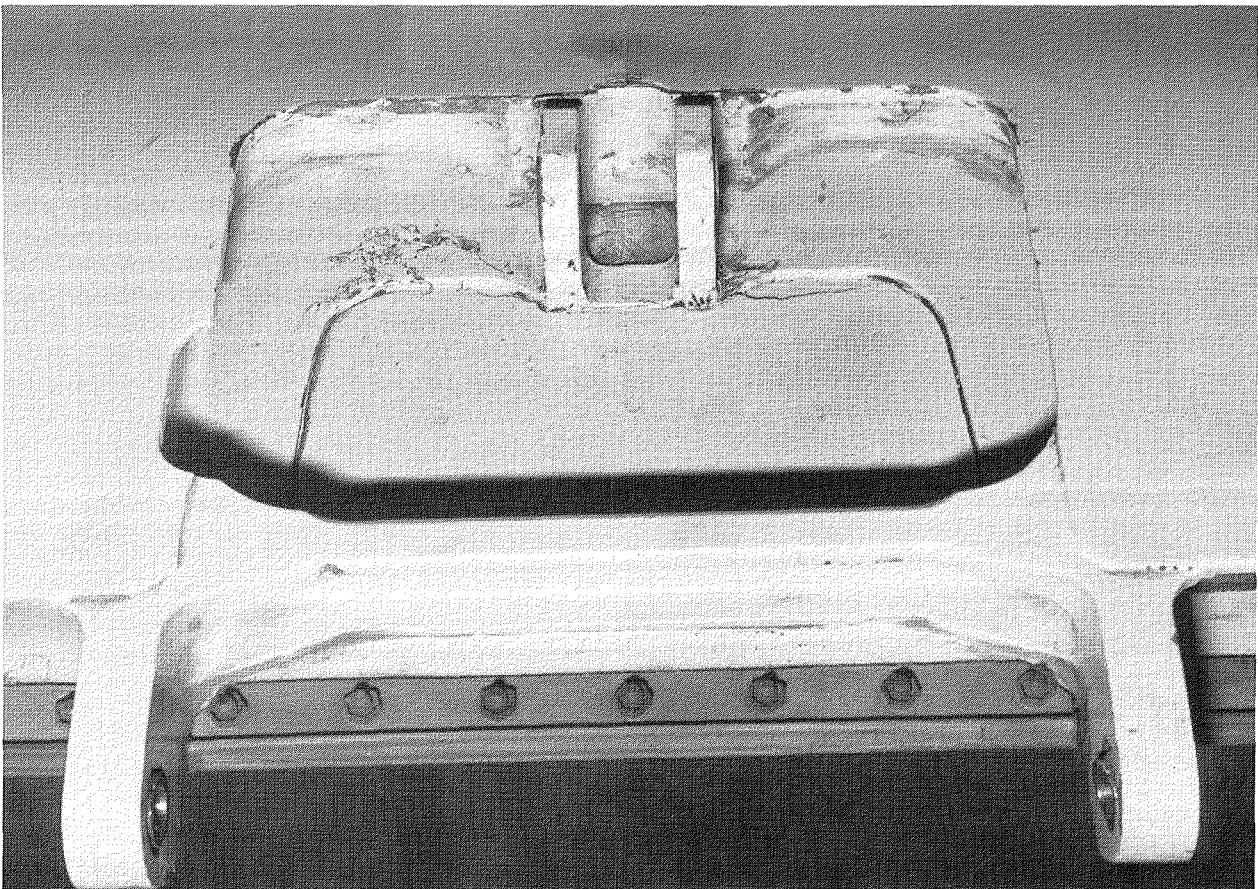
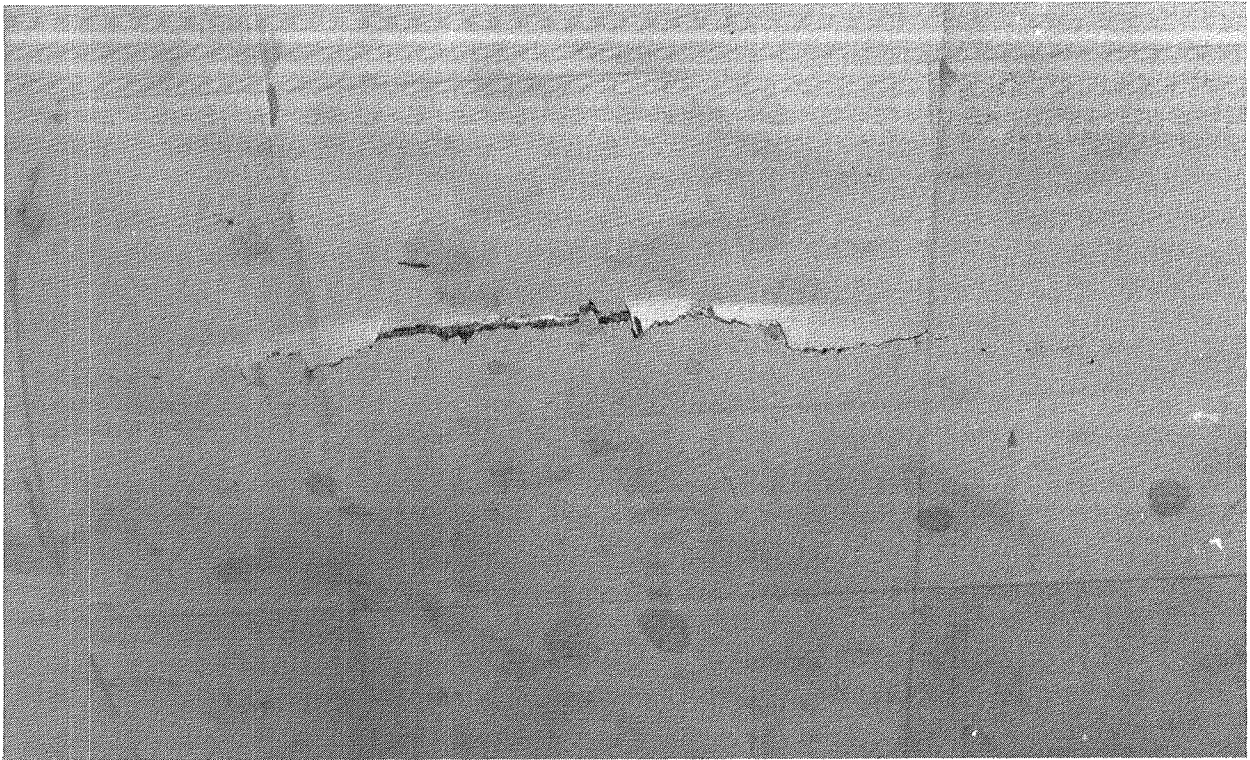
Figures 17 through 27 are photographs of the spoiler panels after testing. On both units, the exfoliation corrosion blisters locate the failure by allowing the compression-loaded lower skin to buckle at the blister location. As expected, these defects did not significantly reduce residual panel strength or stiffness.

Figure 17. Upper Surface of Spoiler S/N 0059 Following Residual Strength Test

Figure 18. Lower Surface of Spoiler S/N 0059 Following Residual Strength Test

Figure 19. Detail at Exfoliation Corrosion Location of Spoiler S/N 0059 Following Residual Strength Test

Figure 20. Detail at Actuator Fitting of Spoiler S/N 0059 Following Residual Strength Test

Figure 21. Upper Surface Over Actuator Fitting of Spoiler S/N 0059 Following Residual Strength Test

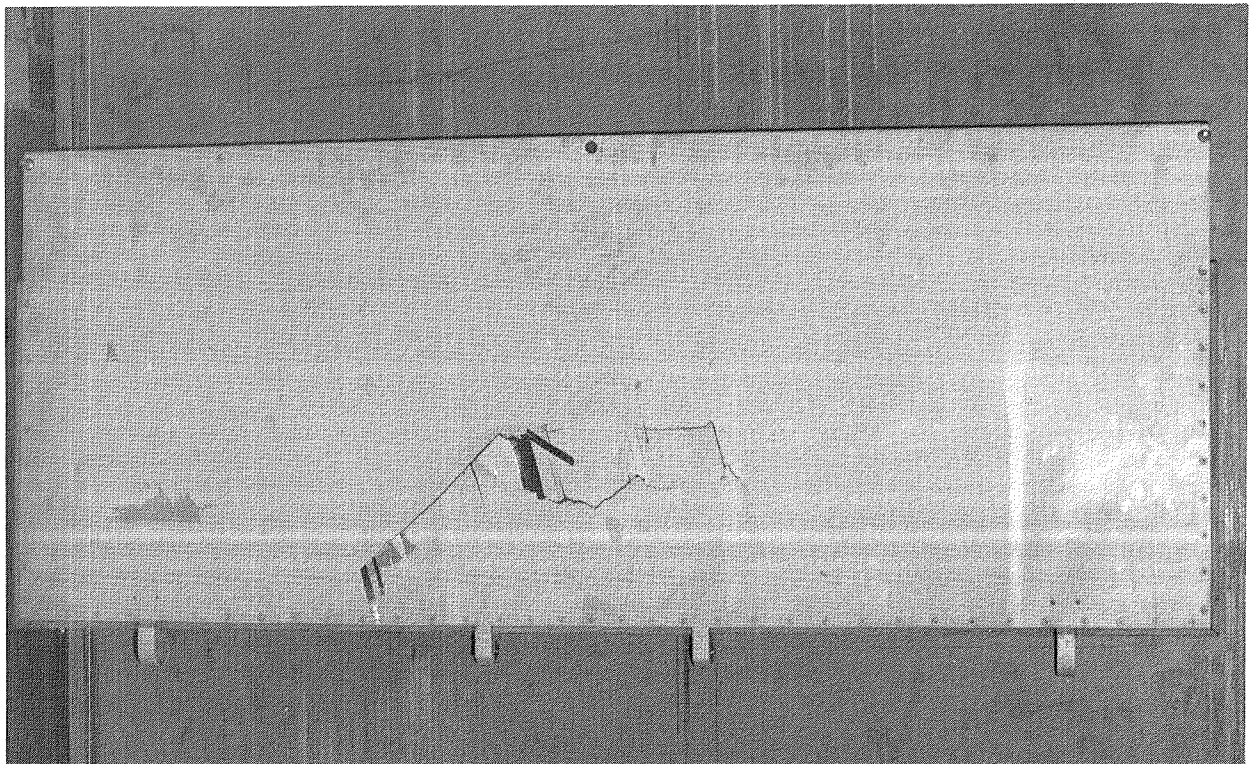
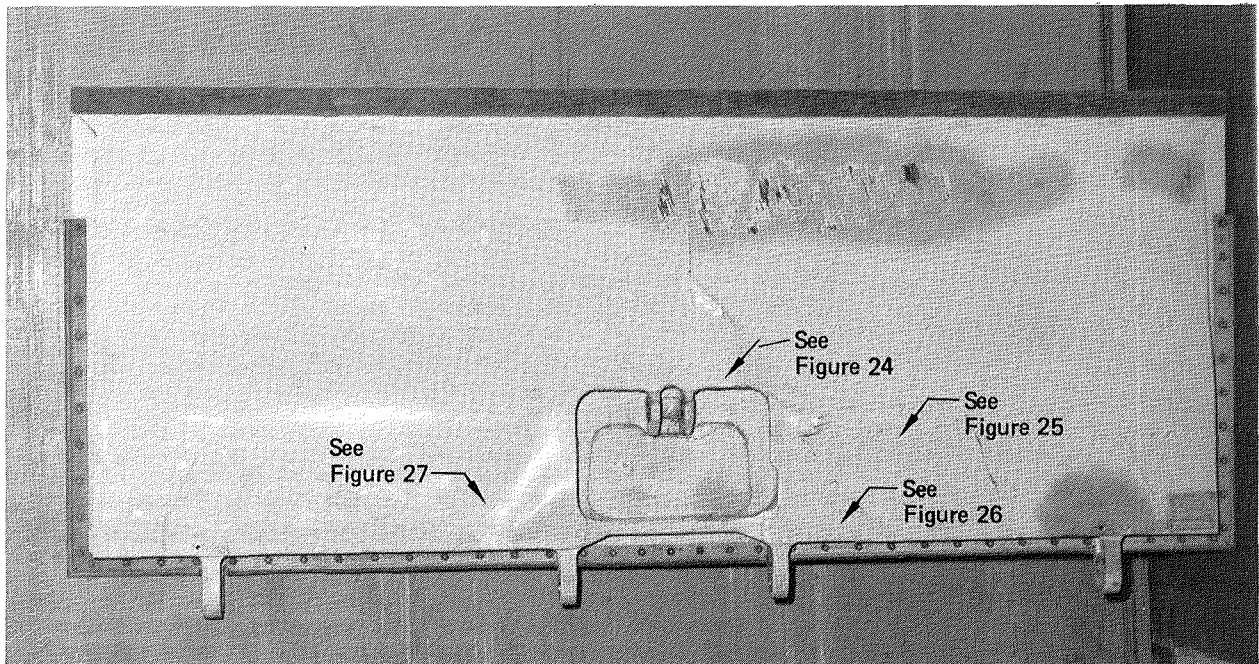
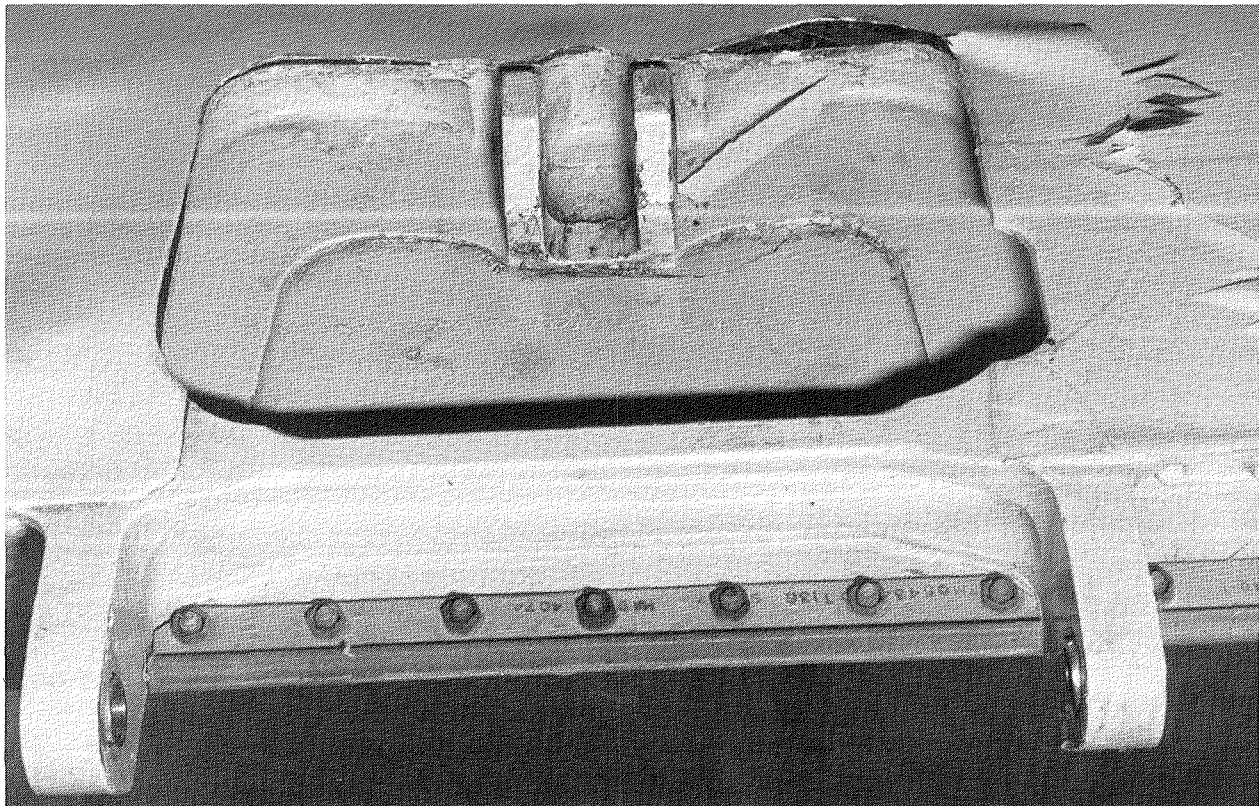
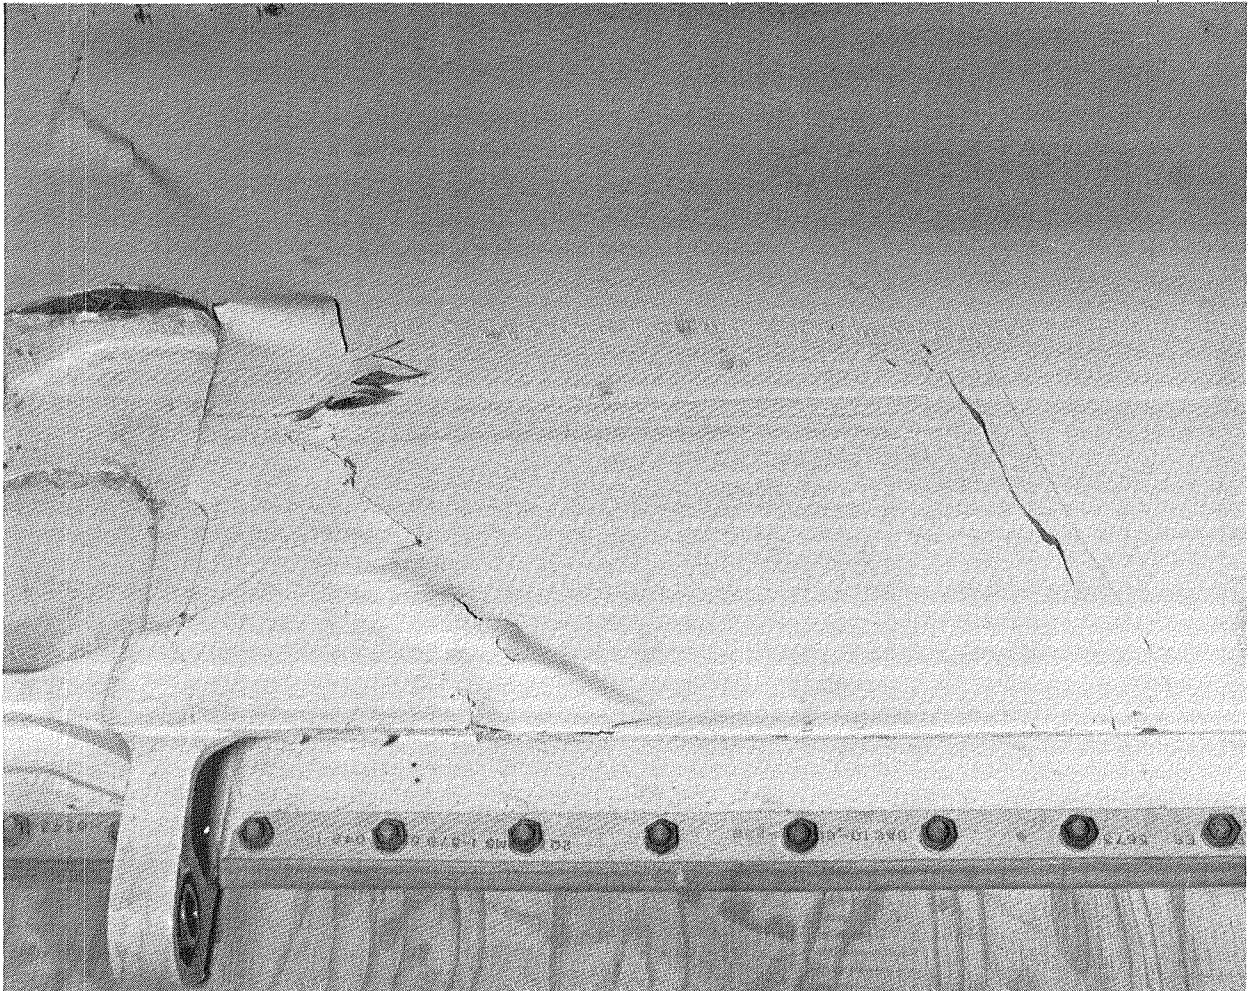
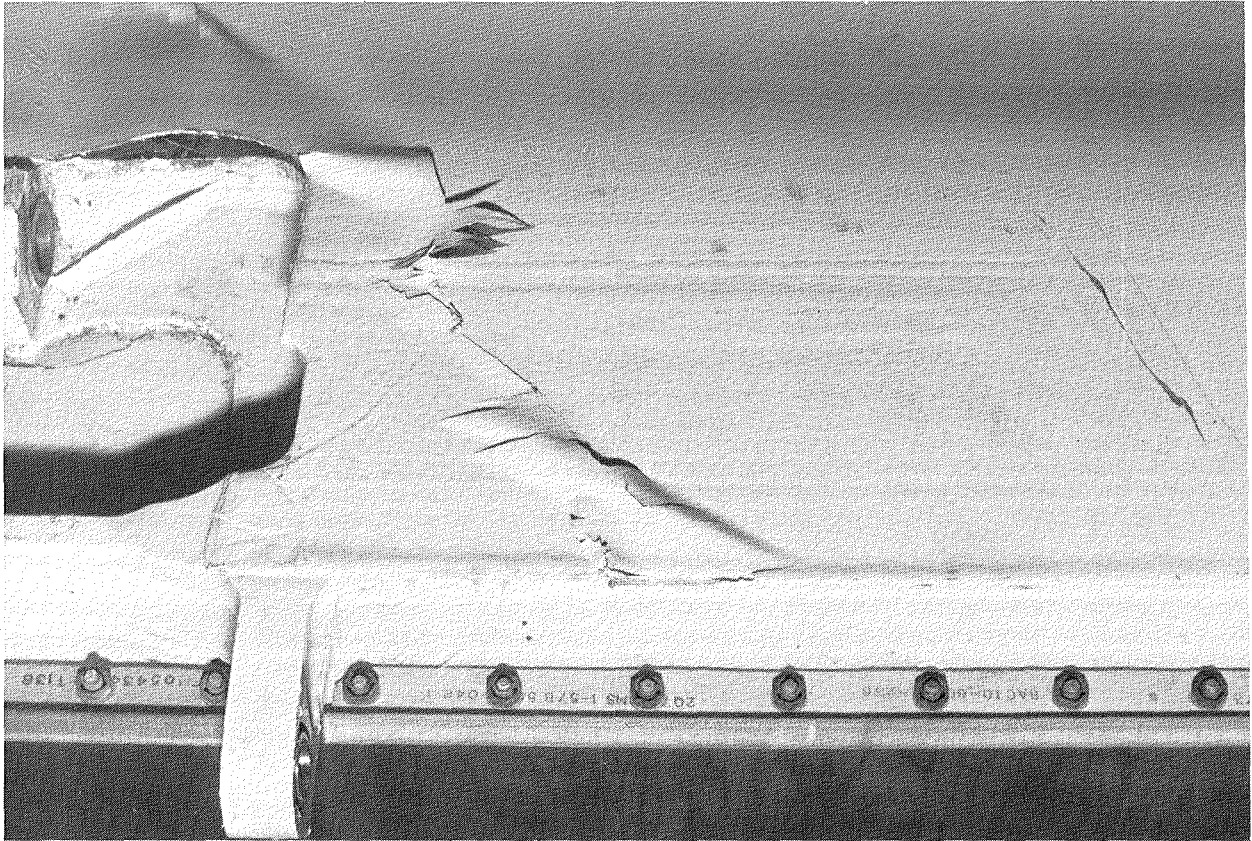
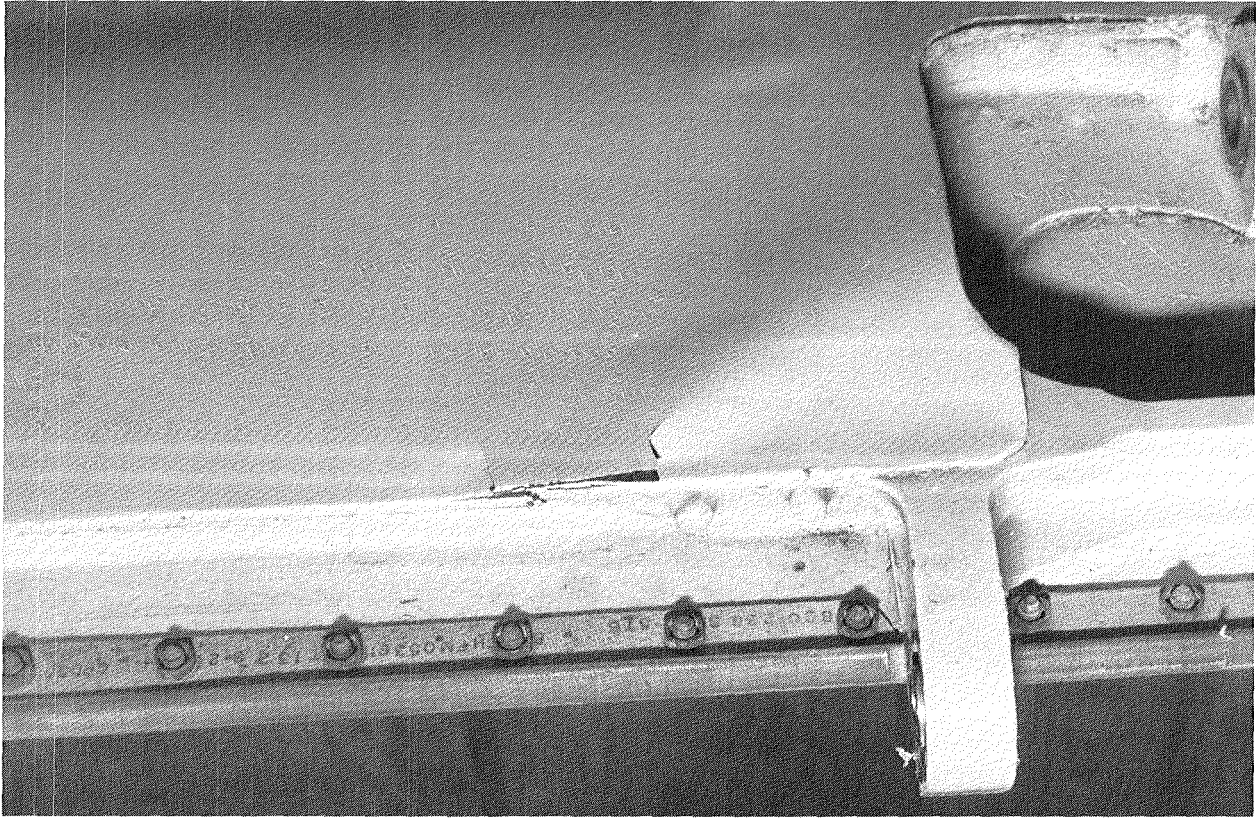
Figure 22. Upper Surface of Spoiler S/N 0049 Following Residual Strength Test

Figure 23. Lower Surface of Spoiler S/N 0049 Following Residual Strength Test

Figure 24. Lower Surface Detail at Actuator Fitting of Spoiler S/N 0049 Following Residual Strength Test

Figure 25. Lower Surface Detail at Exfoliation Corrosion Location of Spoiler S/N 0049 Following Residual Strength Test

Figure 26. Lower Surface Detail at Exfoliation Corrosion Location of Spoiler S/N 0049 Following Residual Strength Test

Figure 27. Lower Surface Detail at Exfoliation Corrosion Location of Spoiler S/N 0049 Following Residual Strength Test

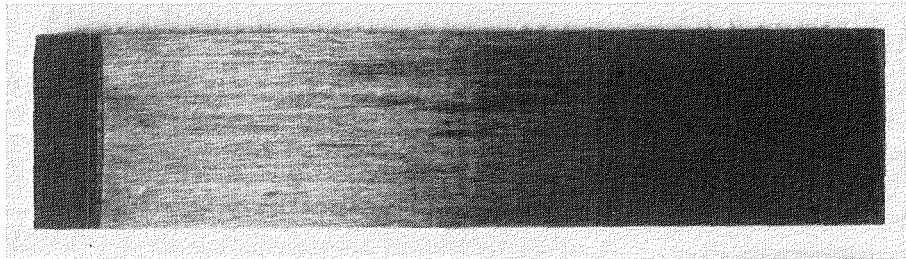
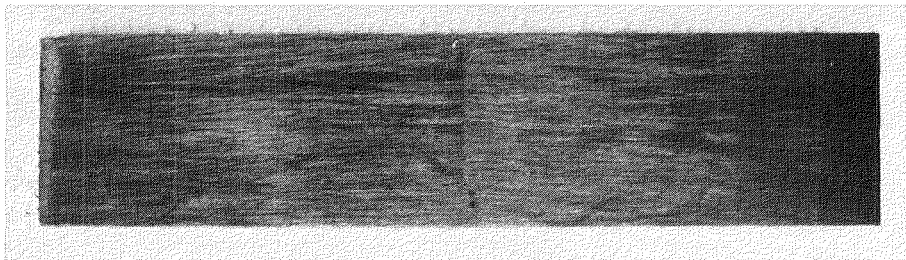
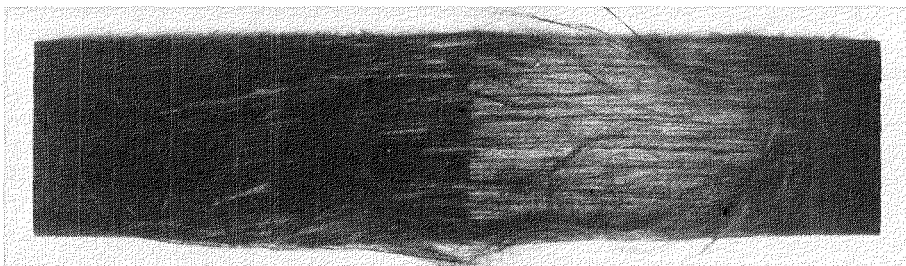
Figure 28. Effect of Ultraviolet Radiation on Graphite-Epoxy After 7 Years of Outdoor Exposure

Ultraviolet radiation can change the chemical structure of epoxy and, therefore, has a degrading effect on the matrix of fiber-reinforced epoxy laminates. Photographs were made of three specimens representing each of the material systems as shown in figure 28. A comparison of the three indicates that T300-2544 is most susceptible to the degrading effect of ultraviolet exposure. The degradation is, however, superficial and does not appear to affect the strength of the material. To observe this effect more closely, a scanning electron microscope was used to photograph an AS-3501 specimen, shown in figure 29. The photomicrographs compare a specimen with no exposure with a specimen with 5 years of exposure. The individual fibers can be seen in the 5-year specimen after the surface layer of epoxy was leached away. It should be noted that a coating of polyurethane aircraft paint will protect the material from ultraviolet degradation.
