737 GRAPHITE COMPOSITE FLIGHT SPOILER FLIGHT SERVICE EVALUATION

SEVENTH ANNUAL REPORT
MAY 1980 THROUGH APRIL 1981

Prepared under Contract NAS1-11668 by
BOEING COMMERCIAL AIRPLANE COMPANY
FEBRUARY 1982

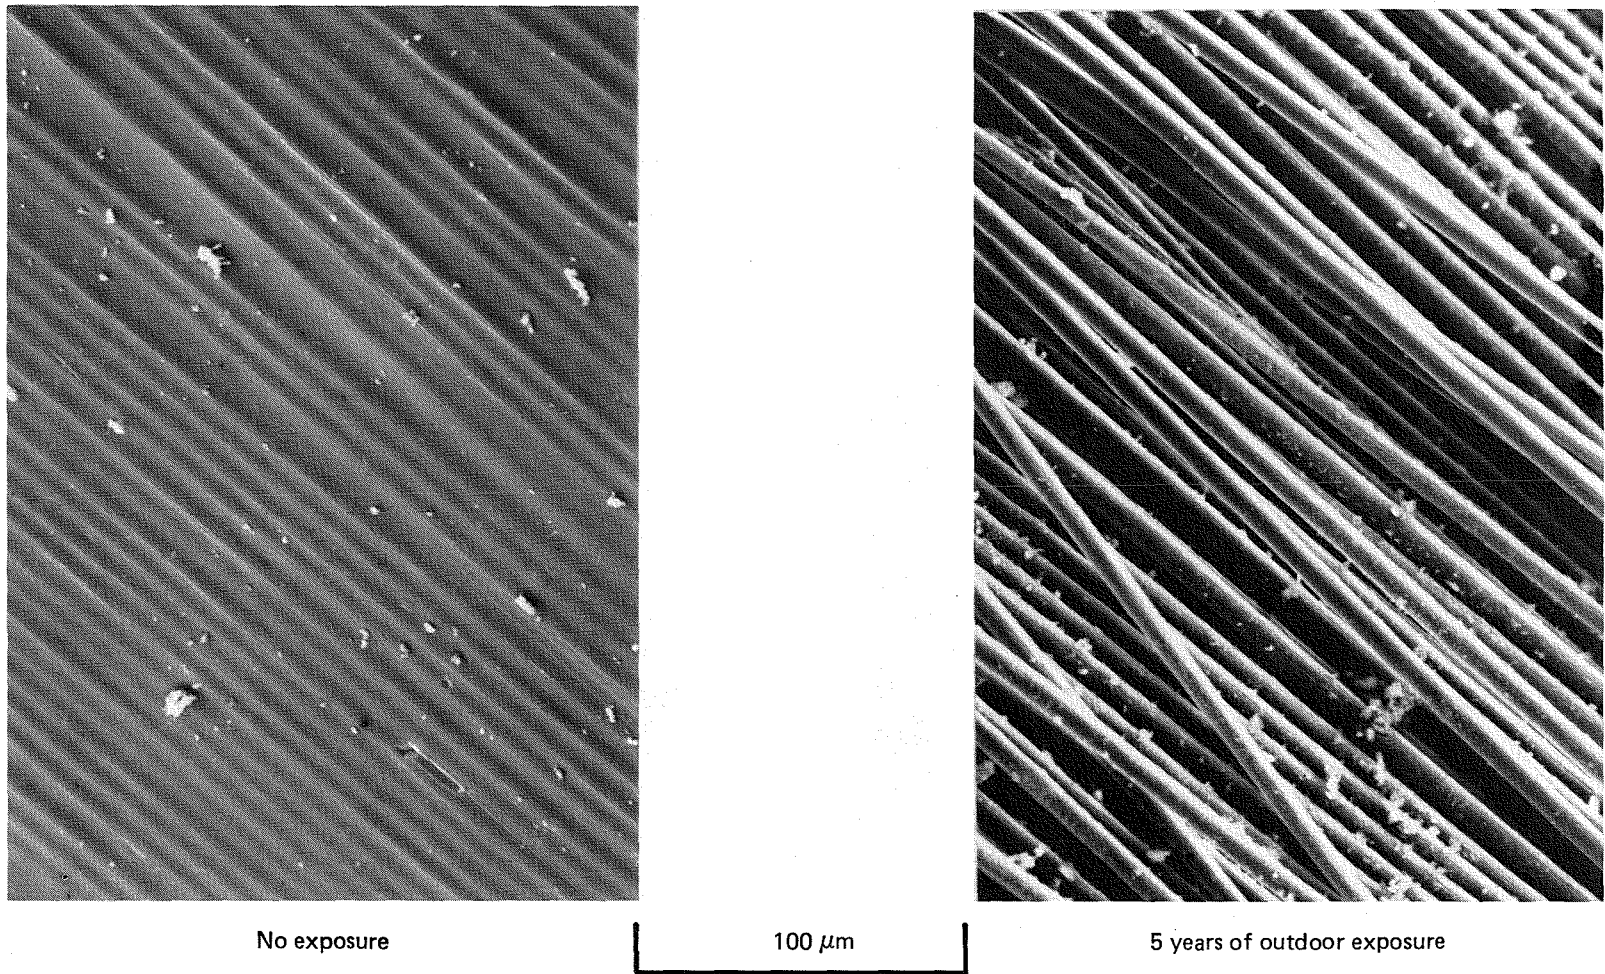
Ultraviolet radiation can change the chemical structure of epoxy and, therefore, has a degrading effect on the matrix of fiber-reinforced epoxy laminates. Photographs were made of three specimens representing each of the material systems as shown in figure 28. A comparison of the three indicates that T300-2544 is most susceptible to the degrading effect of ultraviolet exposure. The degradation is, however, superficial and does not appear to affect the strength of the material. To observe this effect more closely, a scanning electron microscope was used to photograph an AS-3501 specimen, shown in figure 29. The photomicrographs compare a specimen with no exposure with a specimen with 5 years of exposure. The individual fibers can be seen in the 5-year specimen after the surface layer of epoxy was leached away. It should be noted that a coating of polyurethane aircraft paint will protect the material from ultraviolet degradation.

Figure 29. Surface Degradation of AS-3501 Graphite-Epoxy
