Failure Analysis of a Tool Steel Torque Shaft

John R. Reagan
National Aeronautics and Space Administration
Lewis Research Center

Prepared for
Conference on Deformation, Fracture, Wear, and
Nondestructive Evaluation of Materials
sponsored by American Physical Society
and National Bureau of Standards
New Orleans, Louisiana, November 23-24, 1981

FAILURE ANALYSIS OF A TOOL STEEL TORQUE SHAFT

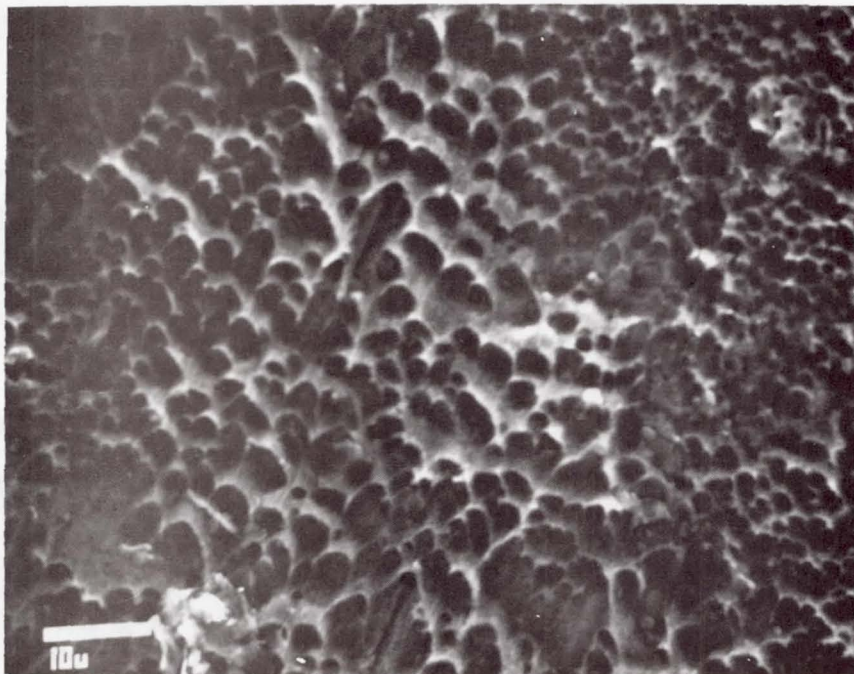
1. The shaft was Zyglo inspected for evidence of cracking.
 - There was no evidence of any flaw being present outside the actual fracture.
 - There was a secondary crack on the fracture surface.
2. A portion of the fracture was placed in the S.E.M. for examination.
 - All areas surveyed showed micro-void coalescence which is indicative of ductile failure. Figure 2.
3. A chemical analysis of the shaft was conducted.
 - The results showed the material to be S-7 tool steel. There was a rather high residual nickel content (0.22 percent), which is not regarded as significant to the failure.
4. Hardness tests were conducted.
 - The shaft hardness was RC 56-57.

The failure of the number one and number three specimens were indistinguishable from the actual failure surface. The surfaces were compared under the Scanning Electron Microscope (S.E.M.) and found to be predominately microvoid coalescence structures identical to the actual failure.

Figure 2. - SEM micrograph at 1.5 KX showing microvoid coalescence.
