(NASA-CR-164742) LIGHTNING PROTECTION SYSTEM FOR SPACE SHUTTLE Final Report
 (Planning Research Corp.) 154 p
 HC A08/MF A01

LIGHTNING PROTECTION SYSTEM FOR SPACE SHUTTLE

PREPARED BY
 PLANNING RESEARCH CORPORATION
 Systems Services Company
 for
 DESIGN ENGINEERING
 JOHN F. KENNEDY SPACE CENTER, NASA

August 1977

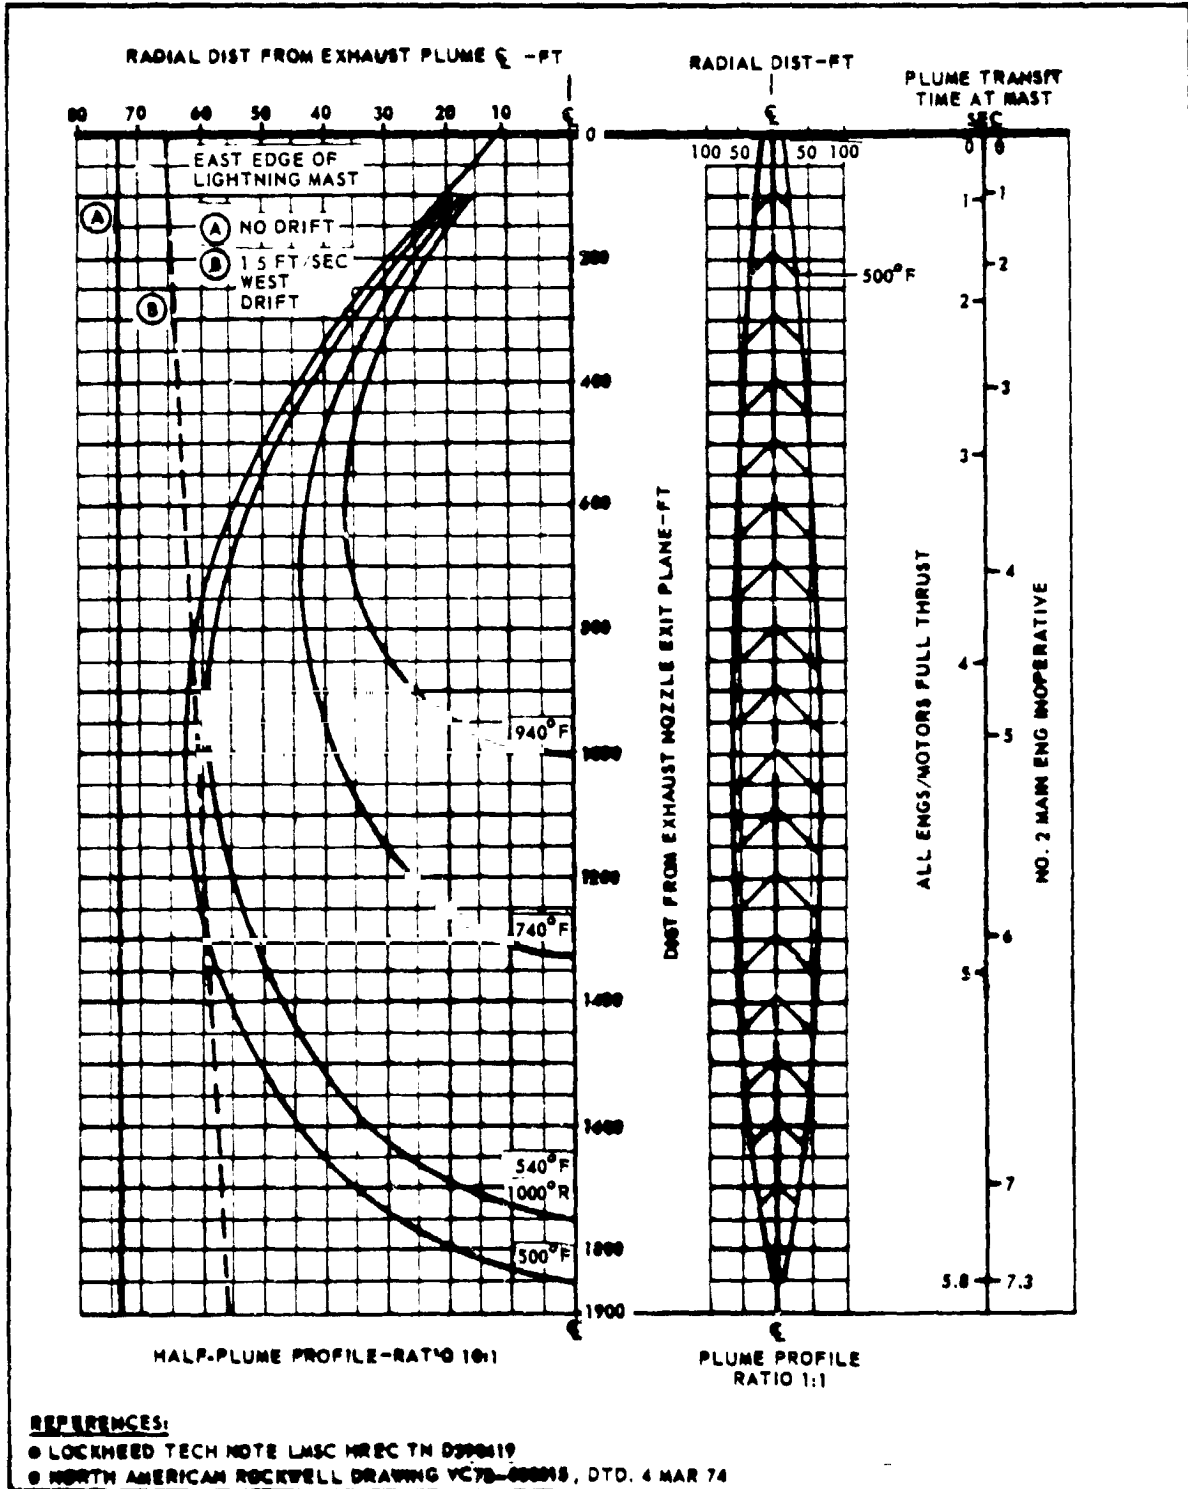
Figure 2-6. Isothermic Profile of a Single Shuttle Solid Rocket Booster Exhaust Plume Showing Projected Flame Impingement on Lightning Mast

Using the aforementioned factors and nominal launch conditions, it is calculated that the Shuttle lightning mast and support structure will experience a minimum of 87 Btu/ft² total radiated heat from the single SRB exhaust plume nearest the SSAT (15 Btu/ft²-s x 5.8 s). Nominal launch conditions are defined as a no-wind, sea-level standard day, with all Space Shuttle propulsion units operating at full thrust. Note that this calculation does not consider the total radiated heat of the combined SRB and main engine plumes, nor the probable increased cross section of the combined plume caused by interaction of gases within the five individual plumes.

Other factors that will significantly increase the level of radiated heat on the lightning mast are: an easterly wind, causing the vehicle to drift towards the mast; the loss of a main engine after liftoff, which would increase mast exposure time to the exhaust plume; and any outward cant to the SRB exhaust plume trajectory, a condition that could envelop the SSAT and lightning mast in flame.

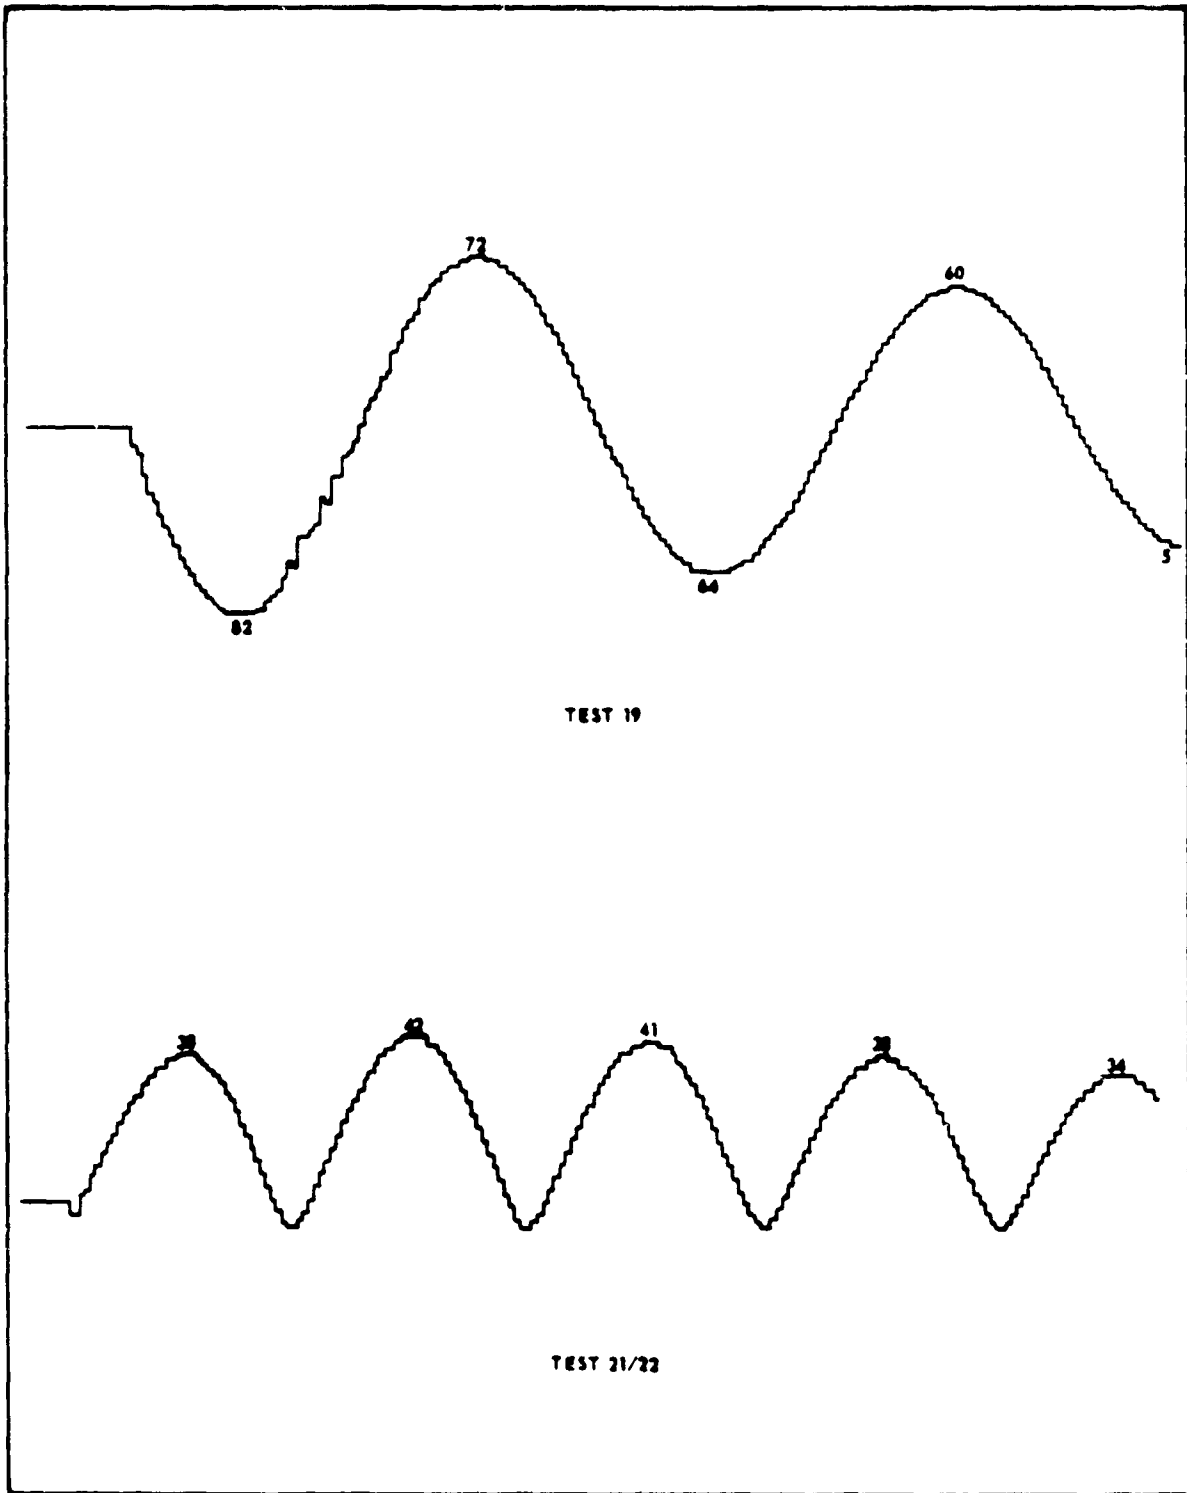
Figure 3-21. Compactor-Acquired Oscillatory Waveforms. Waveform at Top Was Hard-Wired to the Compactor. Bottom Waveform Shows Amplitude Distortion Introduced by Fiber-Optic Coupling.

sensor hard-wired to the compactor. Fiber-optic coupling, used for the waveform shown at the bottom of figure 3-21, introduced an amplitude distortion and polarity was also lost.

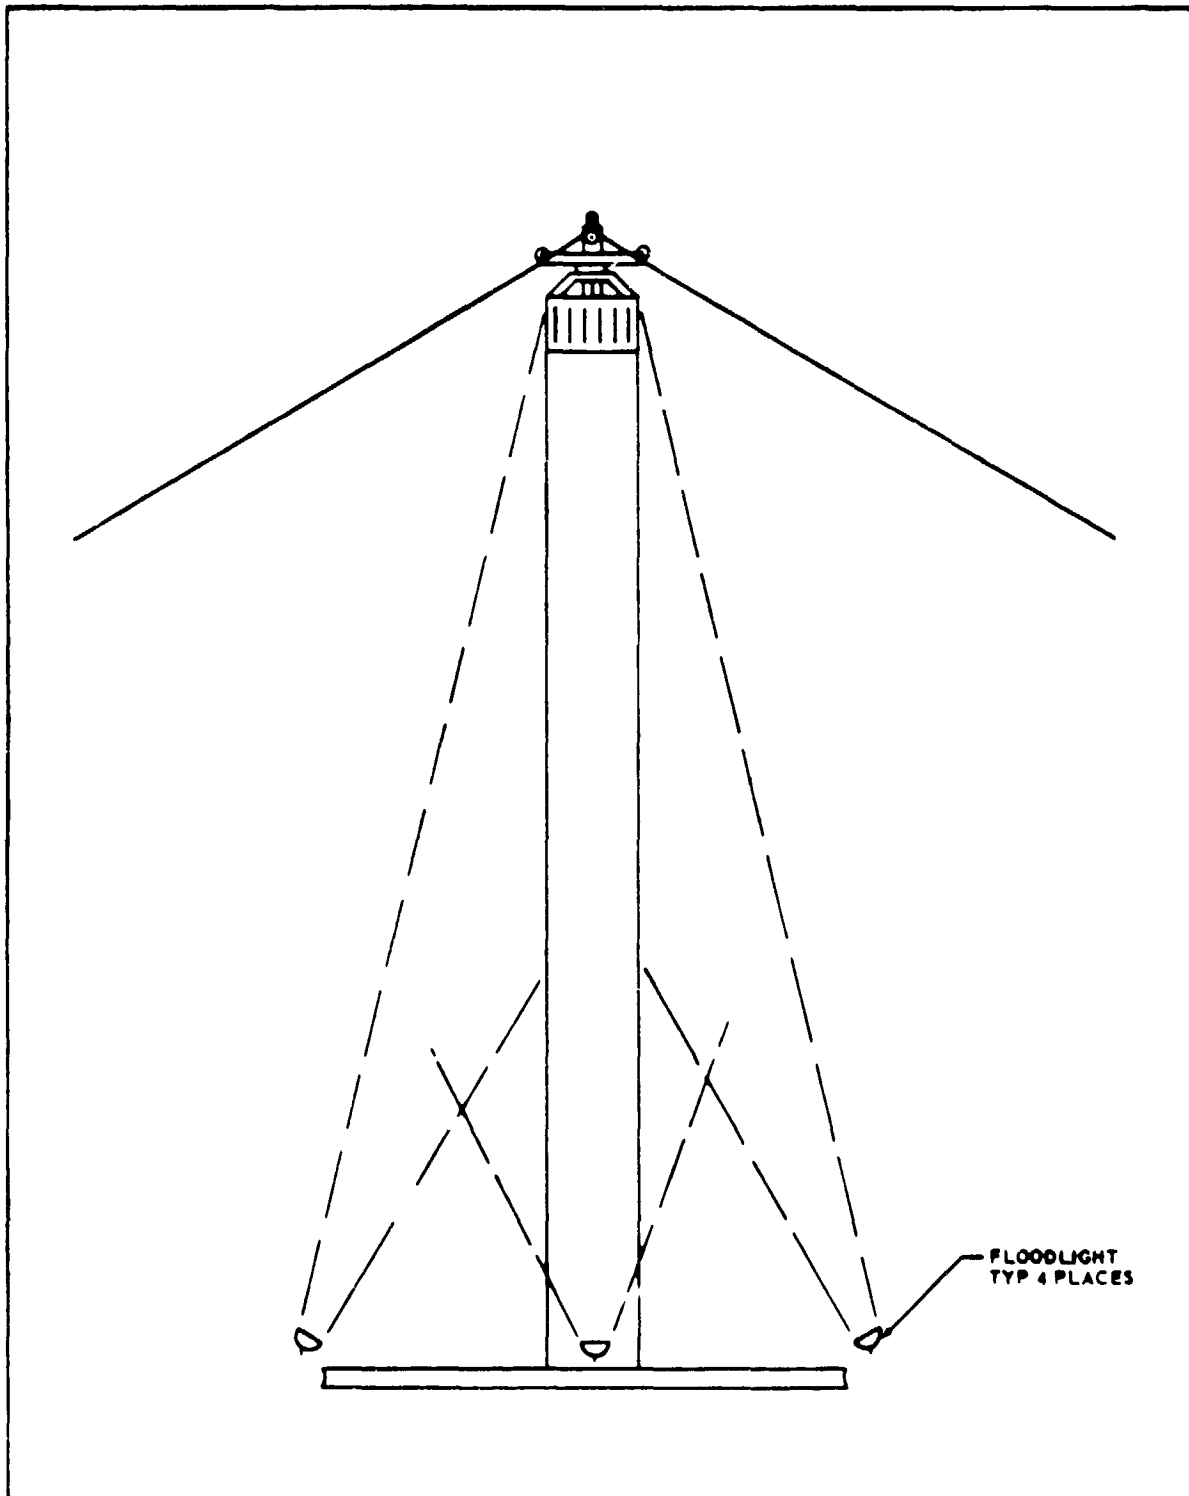
The glass lens was cracked on one of the floodlights used to illuminate the mast. This damage may have been incurred prior to launch; breakage from lamp heating has been a problem.

Figure 3-35. Floodlight Obstruction Lighting for ASTP Lightning Mast

system proved satisfactory for the short-term program and, except for occasional replacement of cracked lenses, maintenance requirements were minimal. Two of the floodlights were used for illumination of the lower portion of the mast while two lighted the top portion. The lights were equidistantly placed around the base and met the general requirements of FAA AC 70/7460-1C for nonstandard obstruction lighting (except that paragraph 15.f of the FAA circular recommends an average illumination of 15 footcandles over the top one-third of the installation). The proposed system for the Shuttle lightning mast would use four explosion-proof searchlight projectors with dual auto-switching lamp bulbs and would be actuated by redundant sky-viewing light sensors. A remote malfunction monitoring system, as prescribed in paragraph 15.h of AC 70/7460-1C, would be incorporated.
