# NASA TECHNICAL MEMORANDUM

NASA TM-82428

## FRACTURE ANALYSIS OF HPOTP BEARING BALLS

May 1981

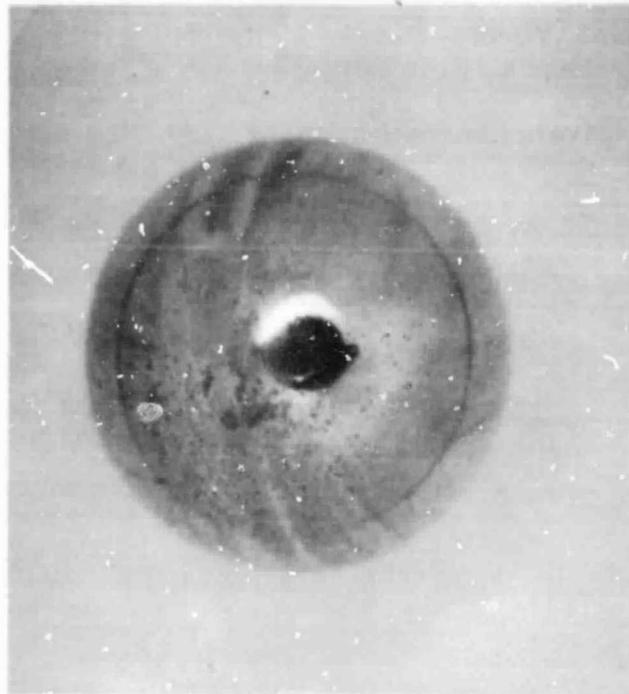
A total of four HPOTP No. 3 bearing balls were examined, two with spalls and two without. The origin and surface characteristics of these balls are given in Table 1. Ball No. 1 showed no visible surface cracks or spalls but had visible wear tracks and numerous shallow pits (Fig. 1). In order to determine if the ball had any subsurface cracks, a nondestructive evaluation technique was used. In this technique, the ball was placed in an eddy current probe operating at 500 KHz and tested. A subsurface flaw was detected. The flaw was located on the wear tracks. Subsequent to the eddy probe examination, the ball was mounted in epoxy and sectioned parallel to the wear track, using a diamond cut-off device. The cross section was polished, etched in Vilella's reagent [4] and examined under an

FIGURE 1. Photomicrograph of Ball No. 1 from HPOTP 2502, Engine 0008. Note the pits and wear tracks. The black dot was used to minimize glare. Photomicrographs of sections of this ball are given in Figures 2, 3, and 4.

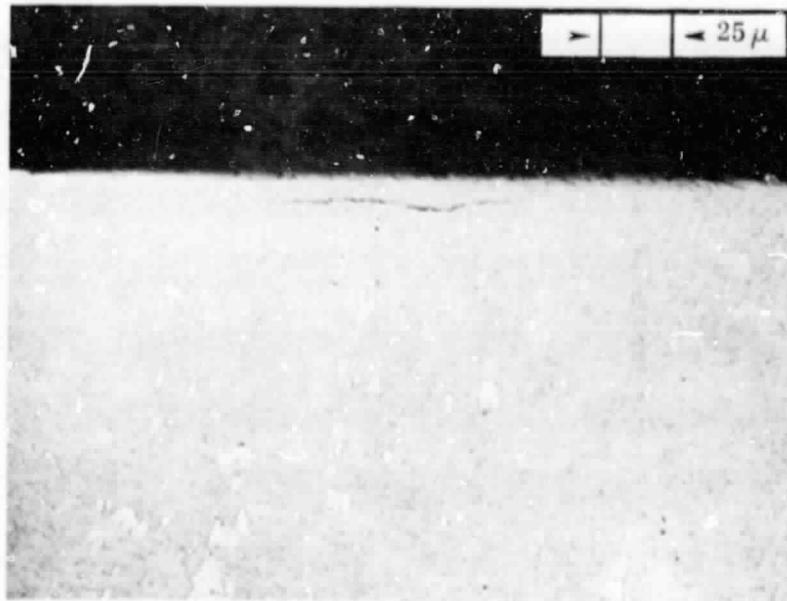
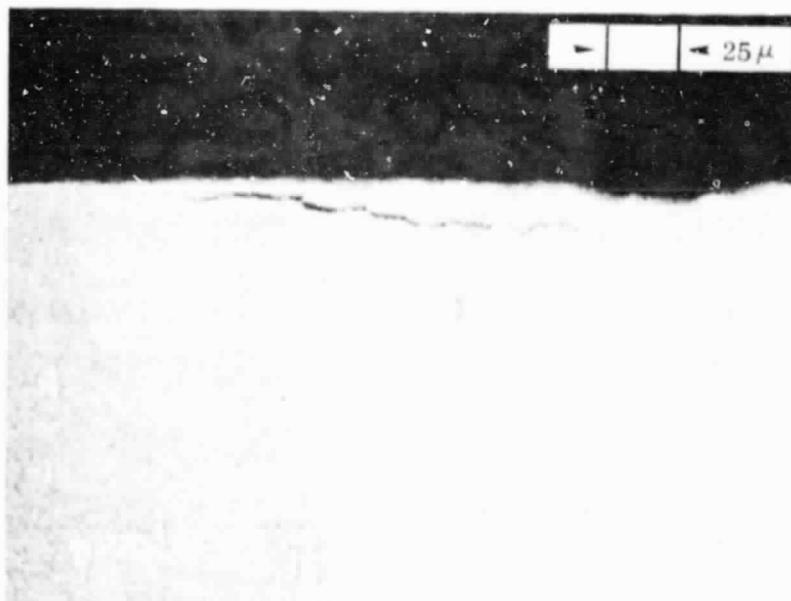
Photomicrographs of cracks in ball No. 1 are presented in Figures 2 through 4. Figure 2 shows two photomicrographs of a subsurface crack at two different positions. The position 2 is 0.25 mm (0.010 in.) from position 1. This crack was correctly located by the eddy probe. Figures 3 and 4 show different types of surface cracks present in the ball. It should be noted that all these cracks are very shallow, less than .025 mm (0.001 in.) deep. They appear to meet the surface at relatively small angles (approximately 20°).

It is significant that the subsurface crack in ball No. 1 (Fig. 2) was correctly located by the eddy probe technique. This result shows that it is possible to determine the subsurface cracks in balls without having to section them. Hence eddy current probe technique may be used to nondestructively identify balls having subsurface flaws existing at the time of manufacture or subsequently induced in operation.

It is also significant that the subsurface crack was actually located under the wear track. This location is to be expected because the bearing material under the wear track is subjected to cyclic stresses. According to the Palmgren theory [5] fatigue cracks initiate under stress at locations of maximum shear stress which is usually subsurface, typically 0.075 to 0.203 mm (0.003 to 0.008 in.), depending on the magnitude of Hertzian stress [3]. Under conditions of pure rolling, high stresses initiate fatigue cracks at deep locations. With the addition of frictional or sliding forces, planes of maximum shear stress move closer to the surface [6]. Sliding forces of sufficient magnitude can cause cracks to originate at the surface and significantly reduce bearing life. The cracks in Figure 3 appear to be surface initiated. The cracks shown in Figure 4 are in advanced stages and it is difficult to tell their origin. Interestingly, all cracks in this ball were very shallow, less than 0.001 in. from the surface. This result suggests two possible mechanisms of cracking: (1) Hertzian stresses are very low such that crack initiation occurs at very shallow depths; (2) Hertzian stresses are high but the coefficient of friction is also high such that the plane of maximum shear stress is very close to the surface. The author favors the latter mechanism because, if the Hertzian stresses were indeed low, the bearing life would have been very long (hundreds of hours). However, the ball in question had seen only 1904 sec of operation in the turbopump (7) and subsurface crack initiation is not expected in such a short time period under normal loading conditions. On the other hand, surface cracks are expected to occur in a short time under abnormally high loading conditions in combination with poor lubrication (high coefficient of friction). Therefore, it appears that the cracks in this ball were initiated under conditions of high stresses and high coefficient of friction. The high coefficient of friction was probably due to the failure of teflon transfer film lubrication. If this hypothesis is correct, it should be possible to increase the life of this bearing by improving lubrication.

Figure 2. Subsurface crack in HPOTP 2502 bearing ball from Engine 0008. Crack depth approximately 0.075 to 0.203 mm (0.0003 to 0.0008 in.)

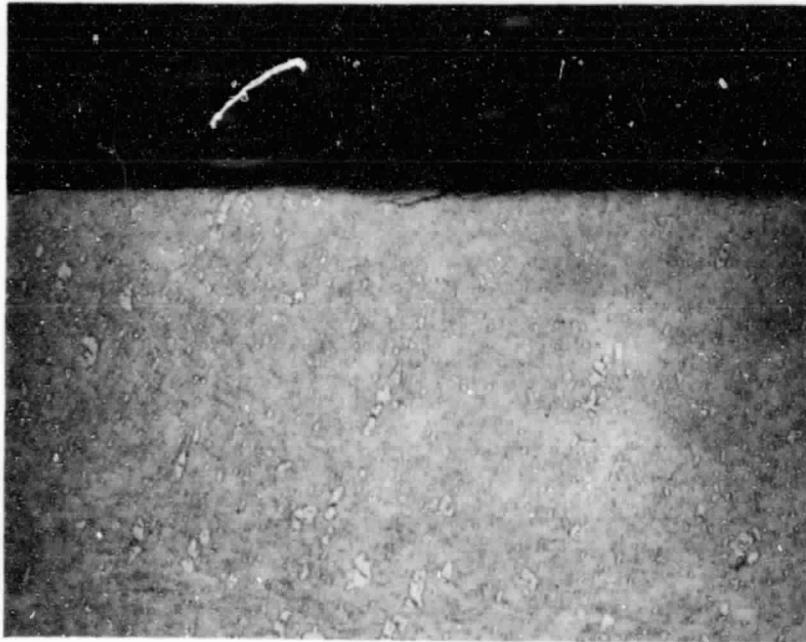
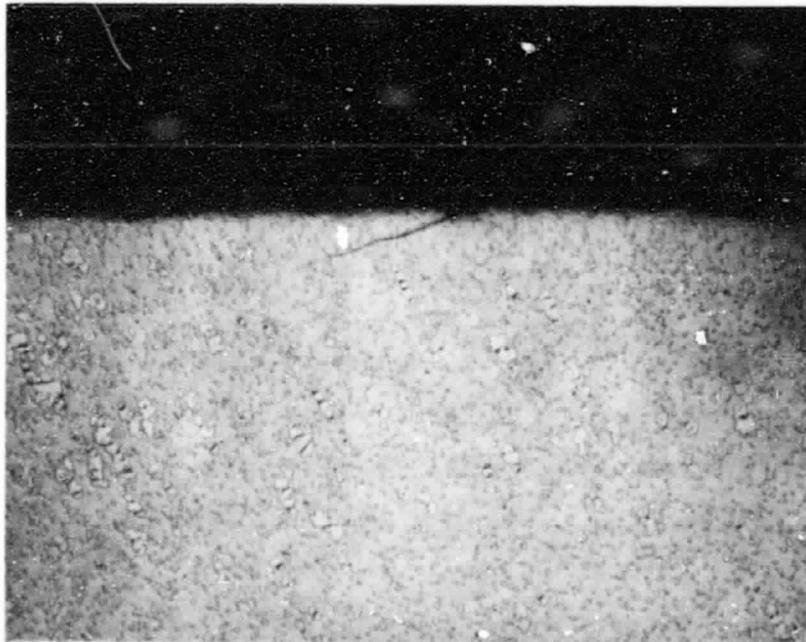
Figure 3. Surface cracks in HPOTP 2502 bearing ball from Engine 0008.

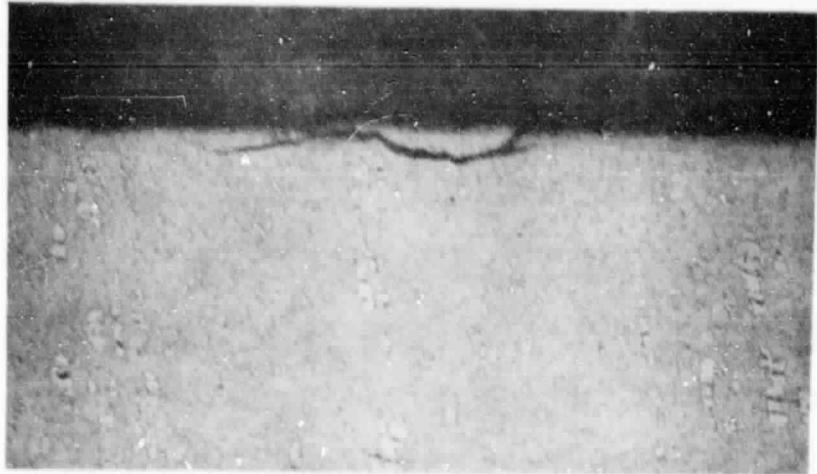
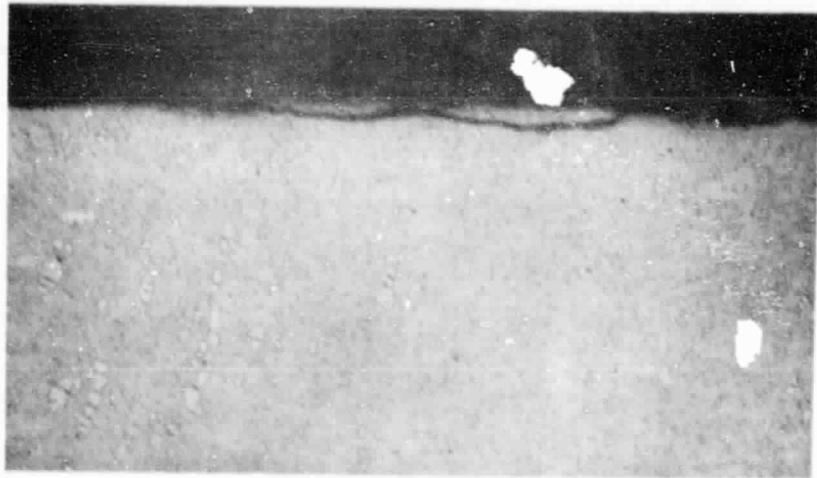
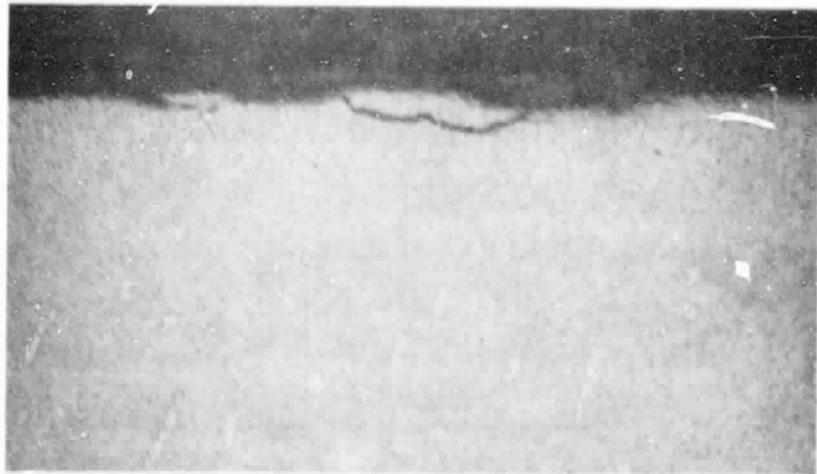
Figure 4. Surface cracks in HPOTP 2502 bearing ball from Engine 0008.

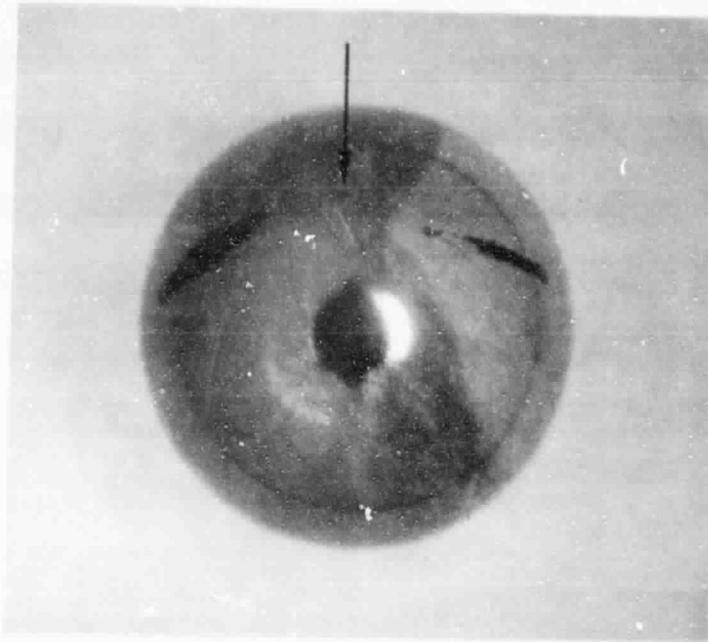
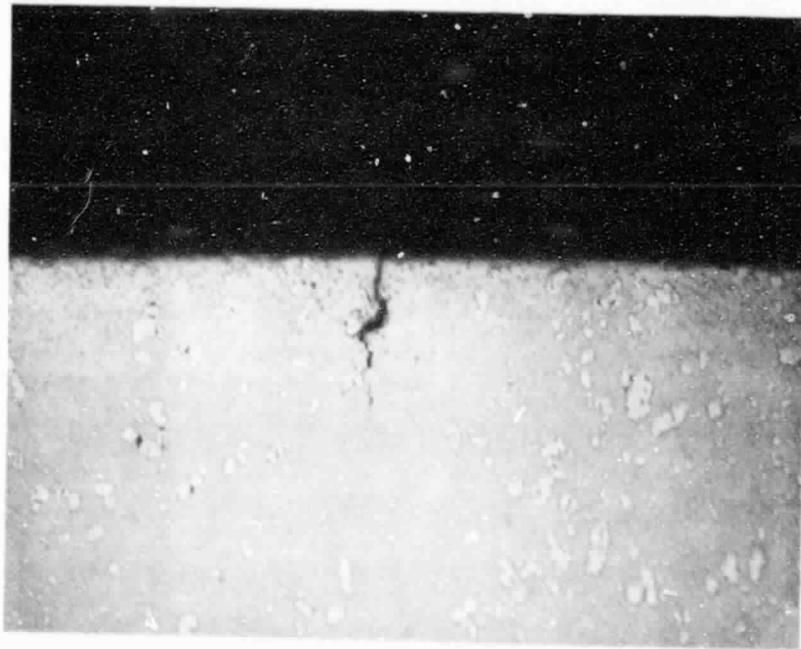
The crack in ball No. 2 (Fig. 5) appears to propagate nearly perpendicular to the surface. The reason for this kind of crack is not well understood. It is possible that this was a preexisting crack.

Figure 5. (A) Photograph of ball No. 2 from HPOTP 9008, Engine 2004. Note the surface crack. (B) Photomicrograph of section of ball through the crack. Crack depth approximately 0.05 mm (0.002 in.).

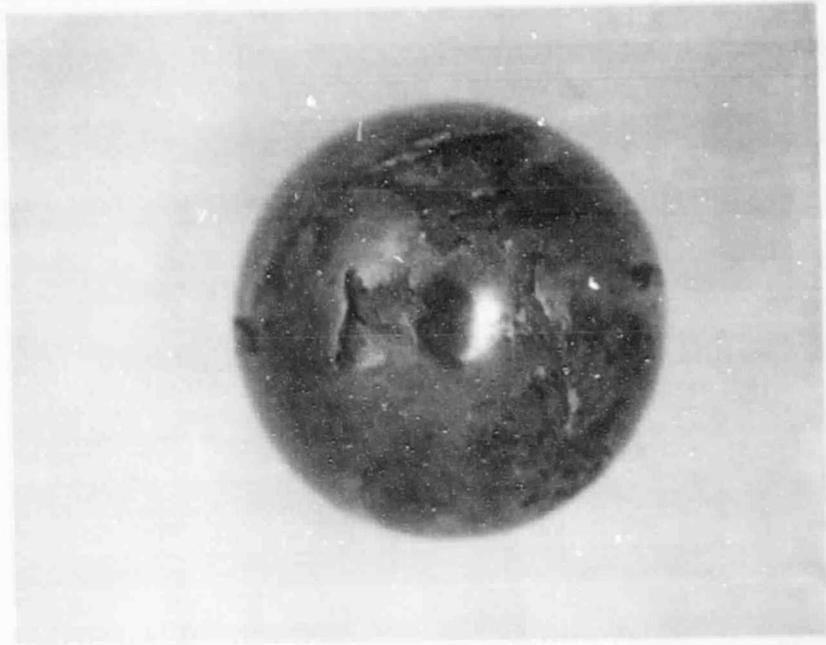
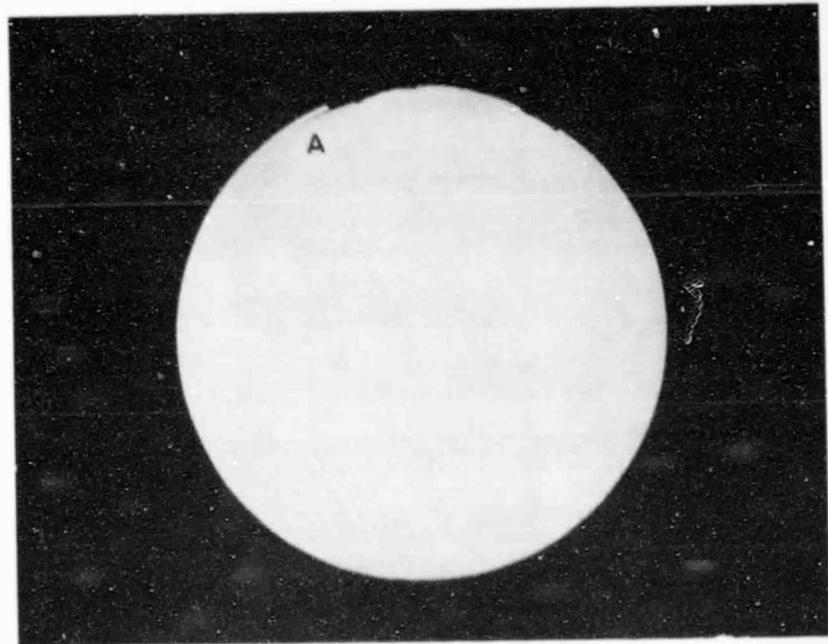
Figure 6. (A) Photomicrograph of ball No. 3 from HPOTP 9008, Engine 2502. (B) Cross section of the ball at top. Photomicrographs of this ball are shown in Figures 7 through 11.

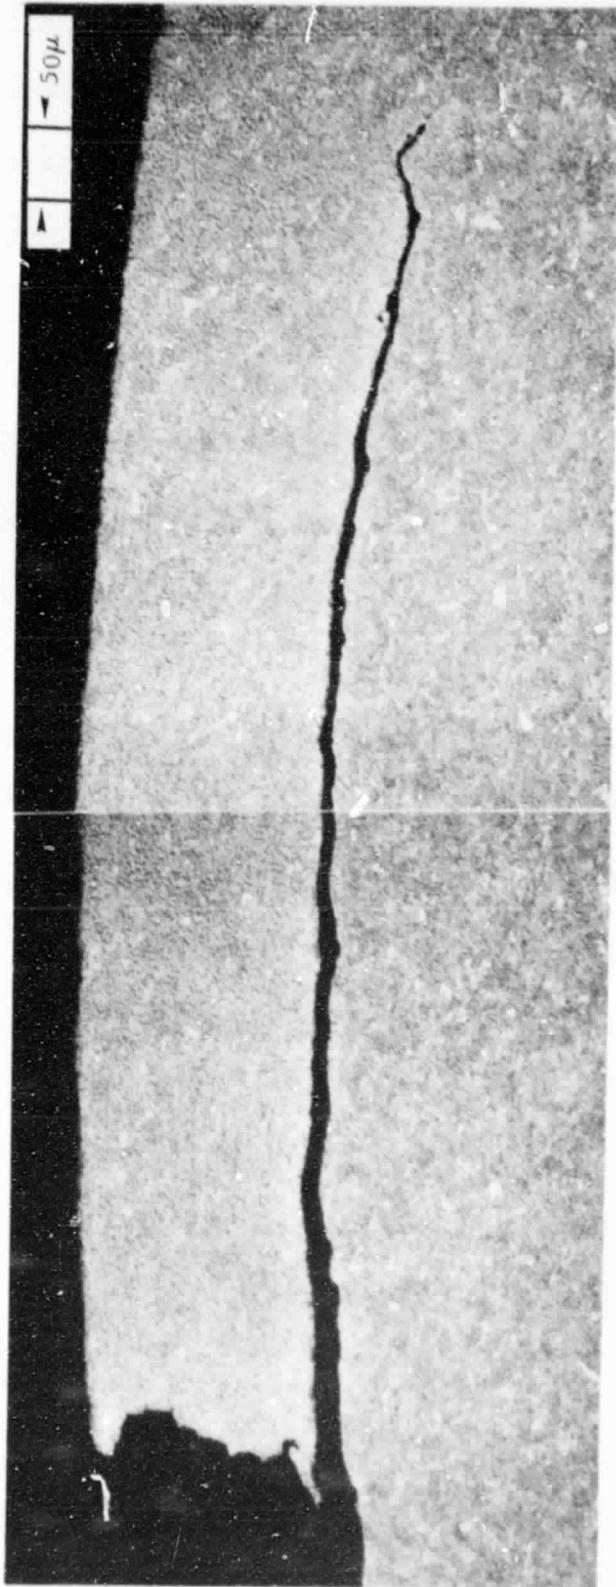
The crack in ball No. 3 (Fig. 7) appears to run parallel to the ball surface and is approximately 0.18 mm (0.007 in.) deep. The fracture at the spalled edge is nearly perpendicular to the surface. This crack configuration is consistent with a subsurface crack initiated under high Hertzian stresses,  $>3.8$  GPa (550 ksi) [3]. The crack in Figure 8, on the other hand, appears to have initiated at a shallow spall (at the upper right hand corner of the Figure), and propagated inward at an increasing angle. Figure 9 shows a more advanced stage of spalling in which some material from the surface has been removed and cracks have propagated deeper inside. The deep crack has two branches at right angles and both appear to be at approximately  $45^\circ$  to the surface. This type of crack pattern could be a result of concentrated loading [8]. Another example of a  $45^\circ$  crack pattern is shown in Figure 15. Here again, the crack appears to have originated at a shallow spall and propagated inwards at an increasing angle. The branches are at  $90^\circ$  to each other and at  $45^\circ$  to the surface.

Figure 7. Crack in spalled ball from HPOTP 9008 bearing in Engine 2502 (area A in Figure 6).

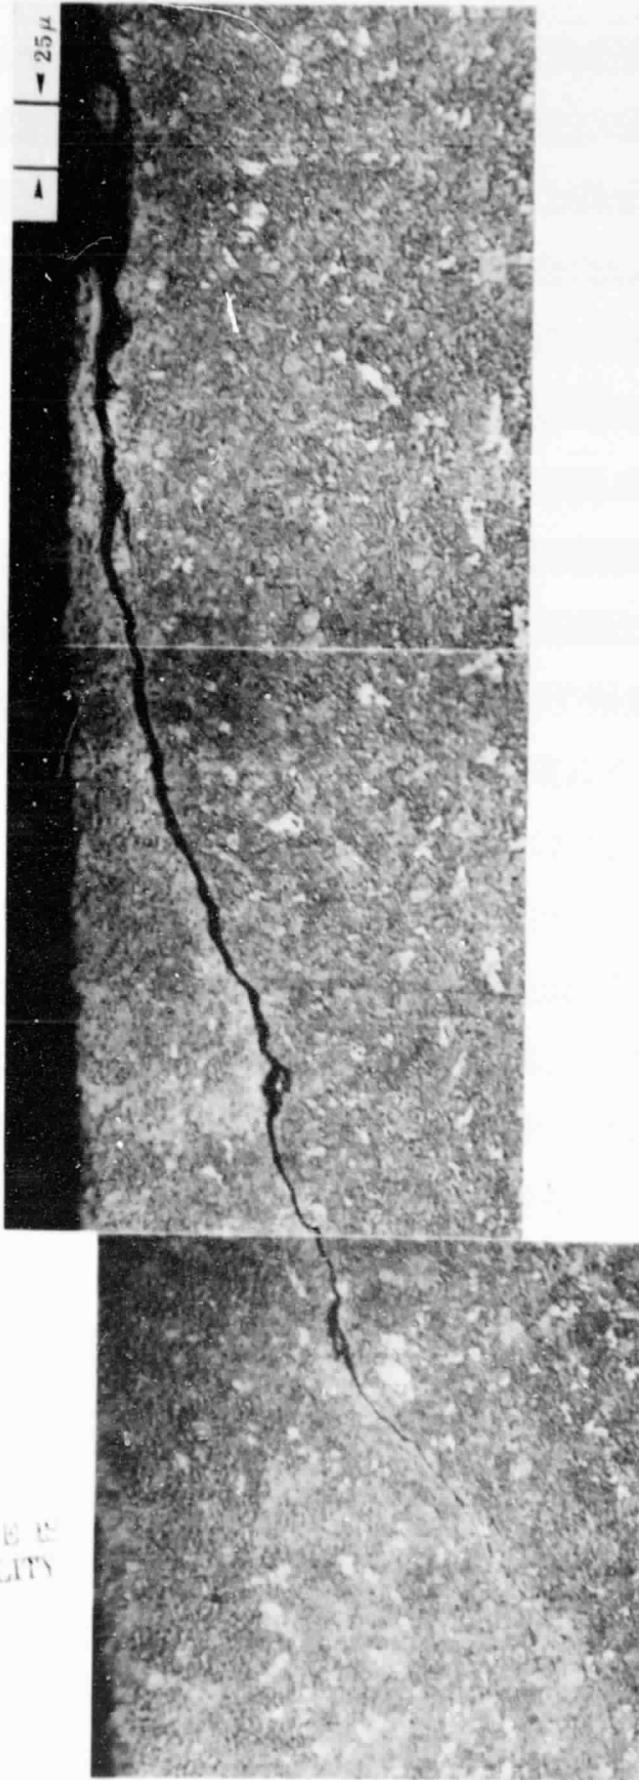
Figure 8. Shallow surface crack in spalled ball from HPOTP 9008 bearing in Engine 2502. Crack depth approximately 0.18 mm (0.007 in.).

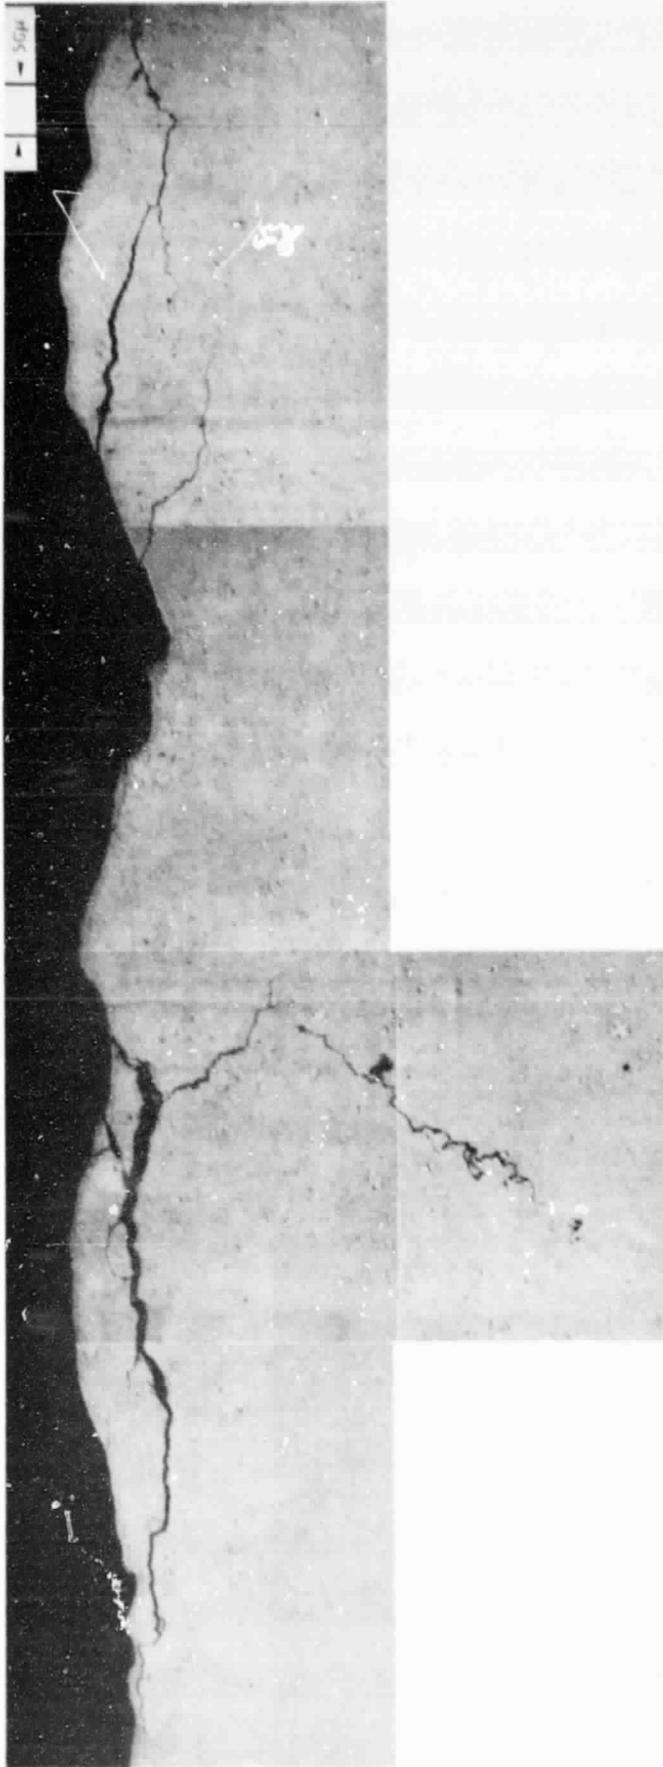
Figure 9. Cracks in spalled ball from HPOTP 9008 bearing in Engine 2502.

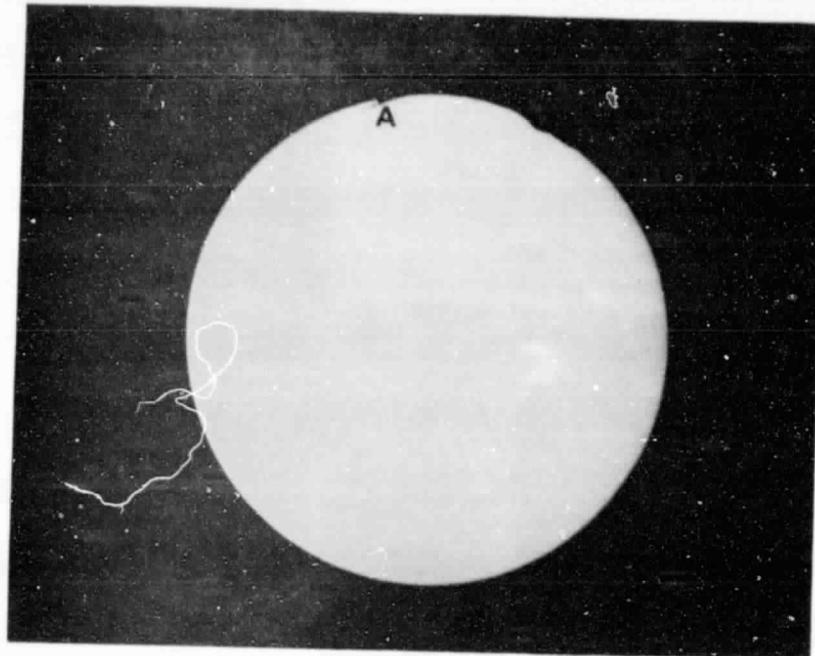
Figure 10. Cross section of spalled ball from HPOTP 9008 bearing in engine 2502. Crack in area A is shown in Figure 11. Original magnitude 5X.

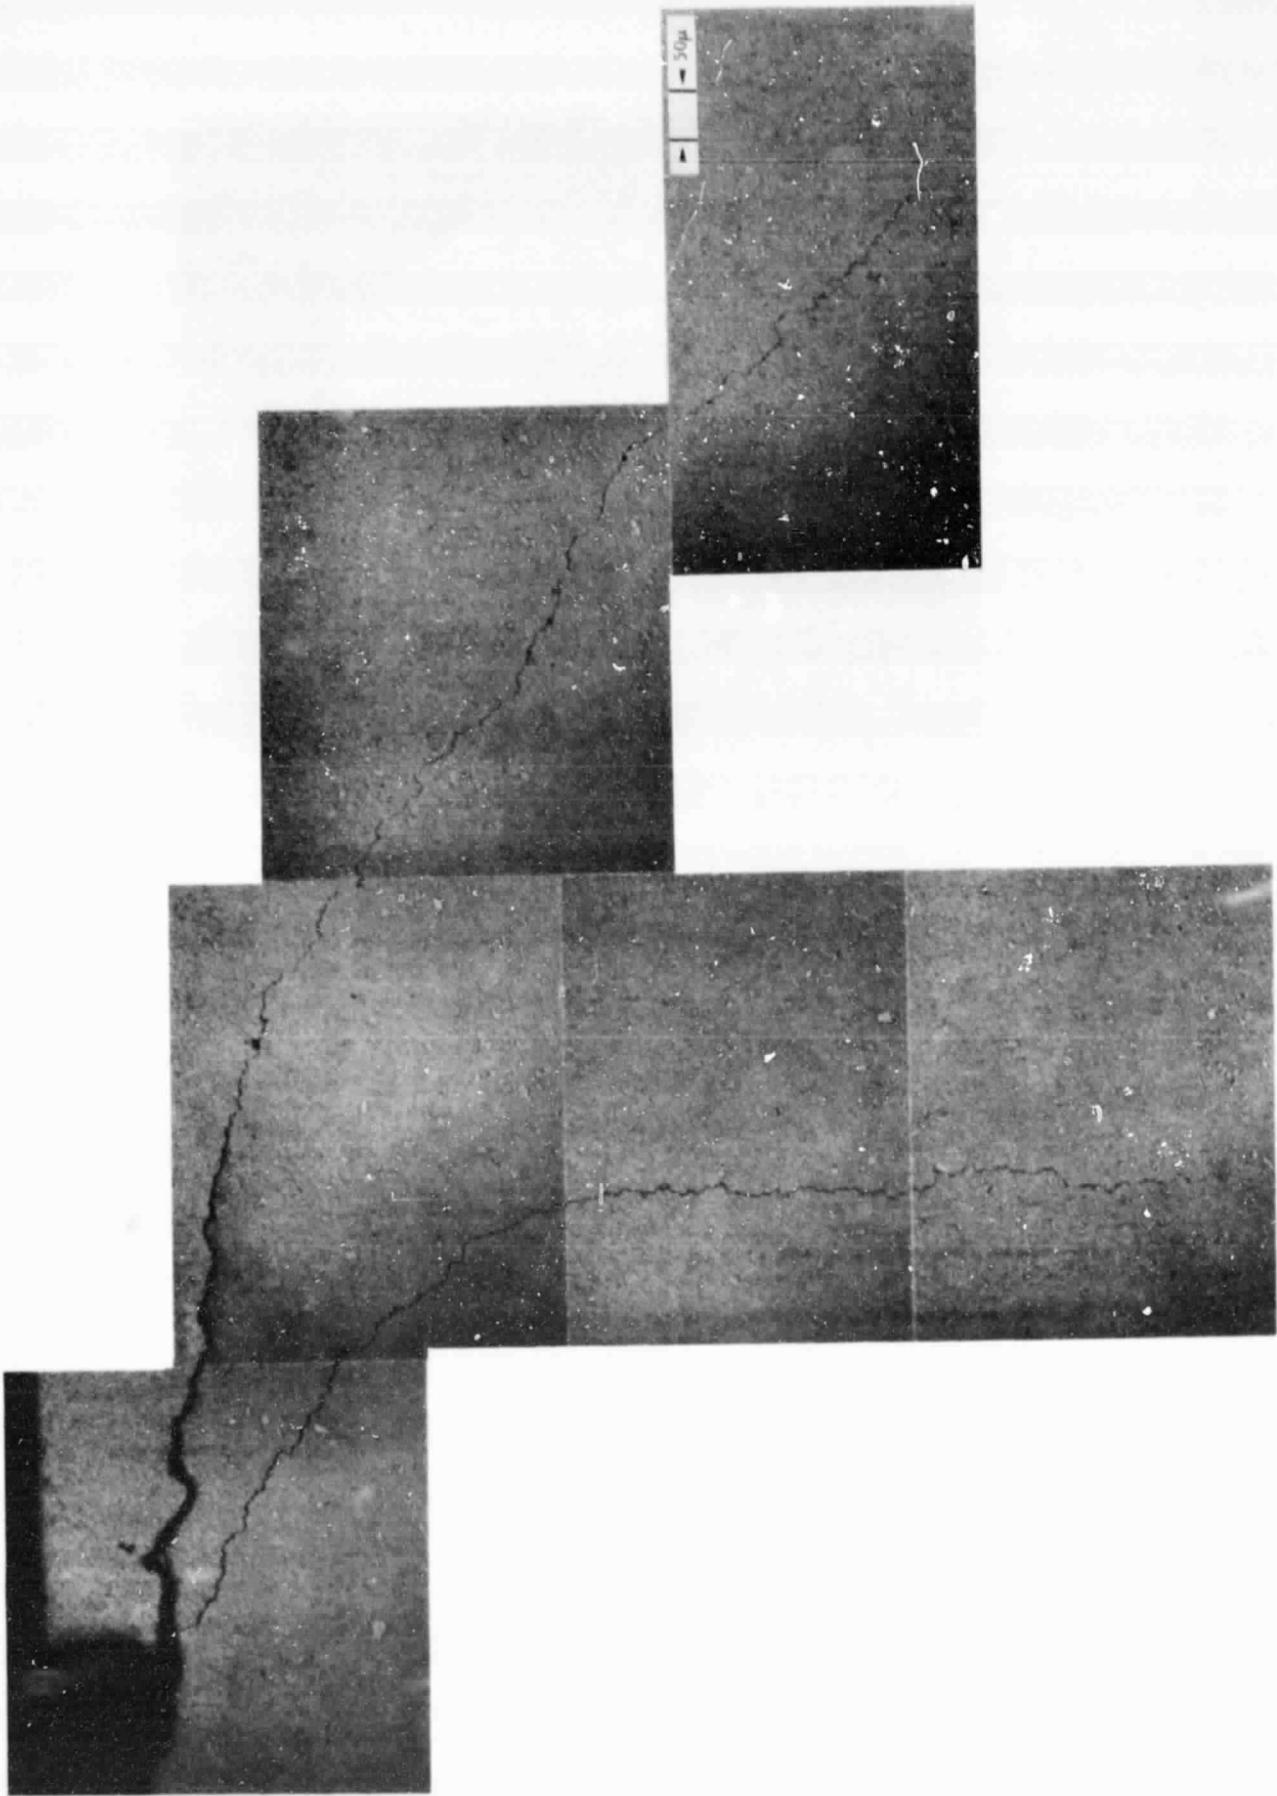
Examples of very deep cracks are given in Figure 11, 13, and 14 (balls No. 3 and No. 4). All these cracks appear to have originated in heavily spalled areas. The crack propagation patterns seem to follow the shear trajectories predicted by a stress model based on concentrated loading [8]. Further analytical work is needed to accurately predict the crack propagation patterns. TEM photomicrographs of a carbon replica of the fractured surface of the crack in Figure 13 are shown in Figure 16. This figure shows striations that are typical of crack growth by fatigue mode. The striation spacing is approximately  $0.03 \mu$ . This spacing corresponds to approximately 75,000 cycles for the crack to grow to a length of 2.3 mm (0.090 in.). This result translates into approximately 15,000 revolutions or 30 sec of running time for the HPOTP at 30,000 rpm. The actual running time is difficult to predict and might be longer than the estimated 30 seconds, but the result suggests that crack propagation could occur in a relatively short time.

Figure 11. Deep cracks in spalled ball from HPOTP 9008 bearing in Engine 2502 (area A in Figure 10).

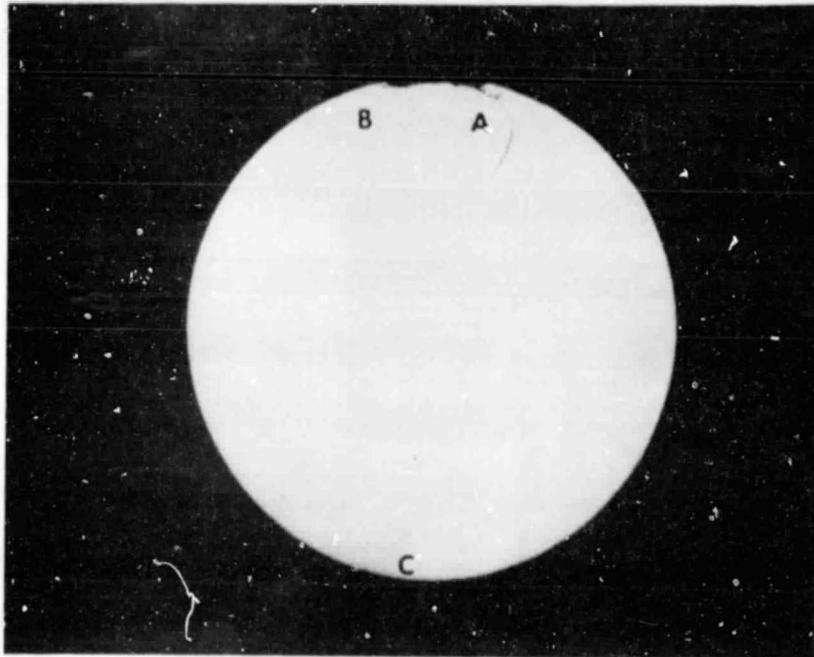
Figure 12 is a cross section of ball No. 4 from HPOTP 9008, No. 3 bearing from engine 2004. A deep crack, nearly 2.3 mm (0.090 in.) deep, is visible at area A. Figure 13 is a high magnification photomicrograph of a crack at area A in Figure 12. Figure 14 is a photomicrograph of a crack at area B in Figure 12. Figure 15 is a photomicrograph of a shallow crack in area C, (Fig. 12) away from the heavily spalled areas A and B. This crack appears to have originated at a shallow spall and then propagated inwards at a continuously increasing angle. Extensive branching has occurred with cracks meeting at approximately 90°. The cracks appear to be oriented at 45° to the surface. Significance of these angles is discussed in the next section.

Figure 12. Cross section of spalled ball No. 4 from HPOTP 9008 bearing from Engine 2004. Cracks in areas A, B and C are shown in Figures 13, 14, and 15 respectively. Original magnification 5X.

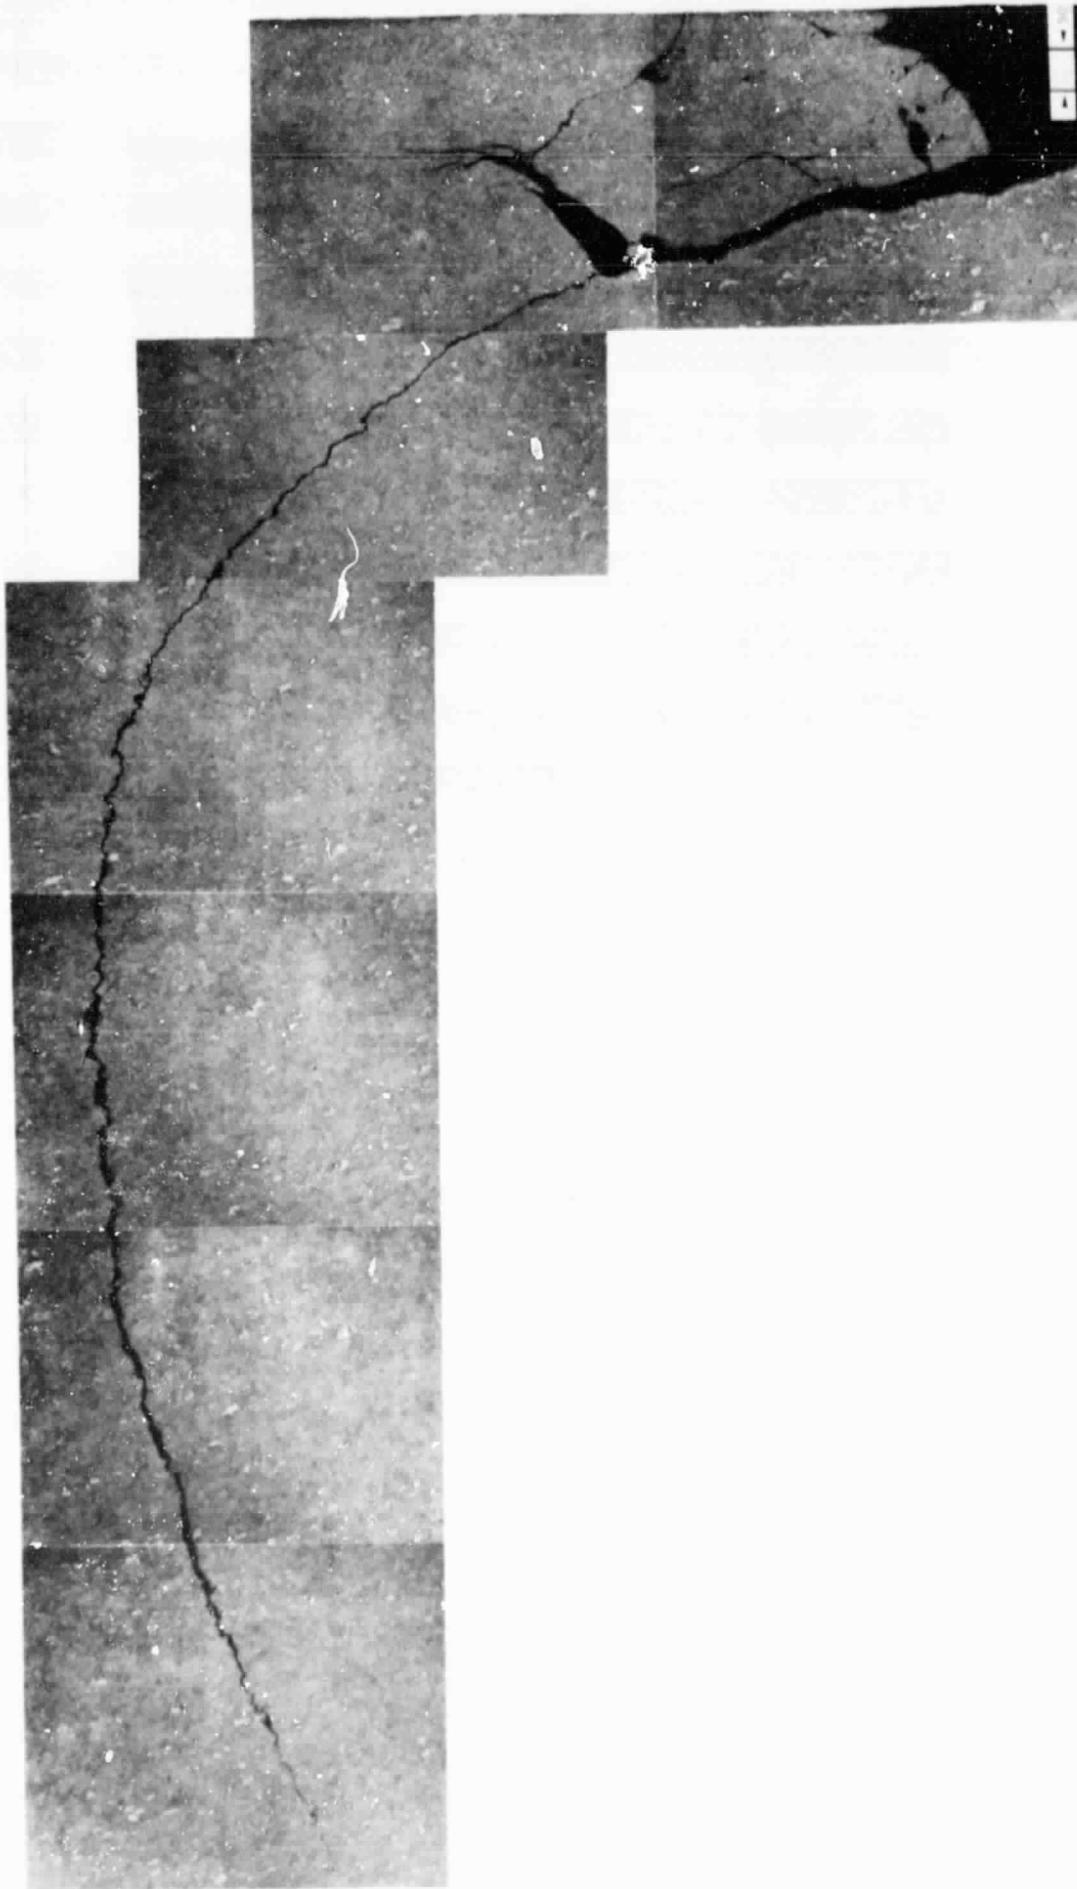
Figure 13. Deep crack in HPOTP 9008 bearing ball from Engine 2004. Crack depth approximately 2.3 mm (0.090 in.) (area A in Figure 12).

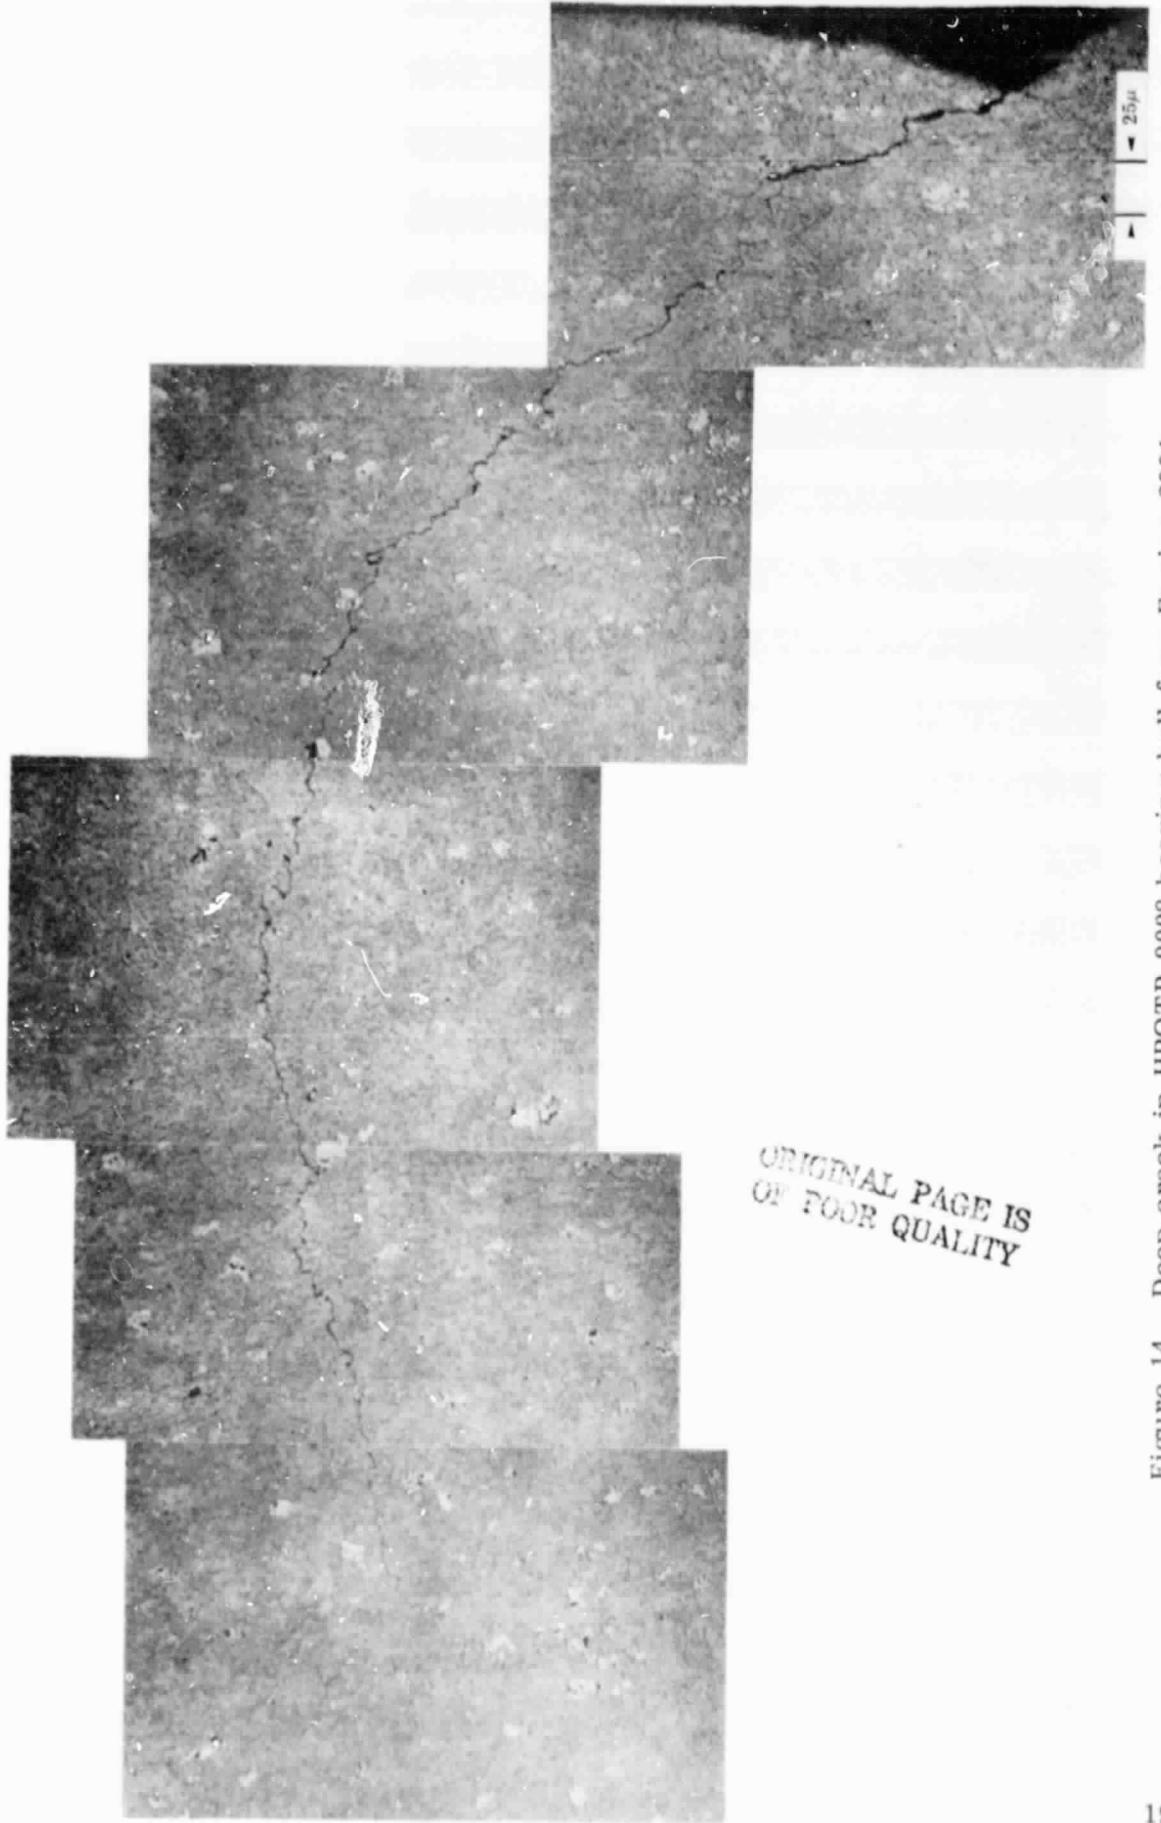
Figure 14. Deep crack in HPOTP 9008 bearing ball from Engine 2004. Crack depth approximately 0.76 mm (0.030 in.) (area B in Figure 12).

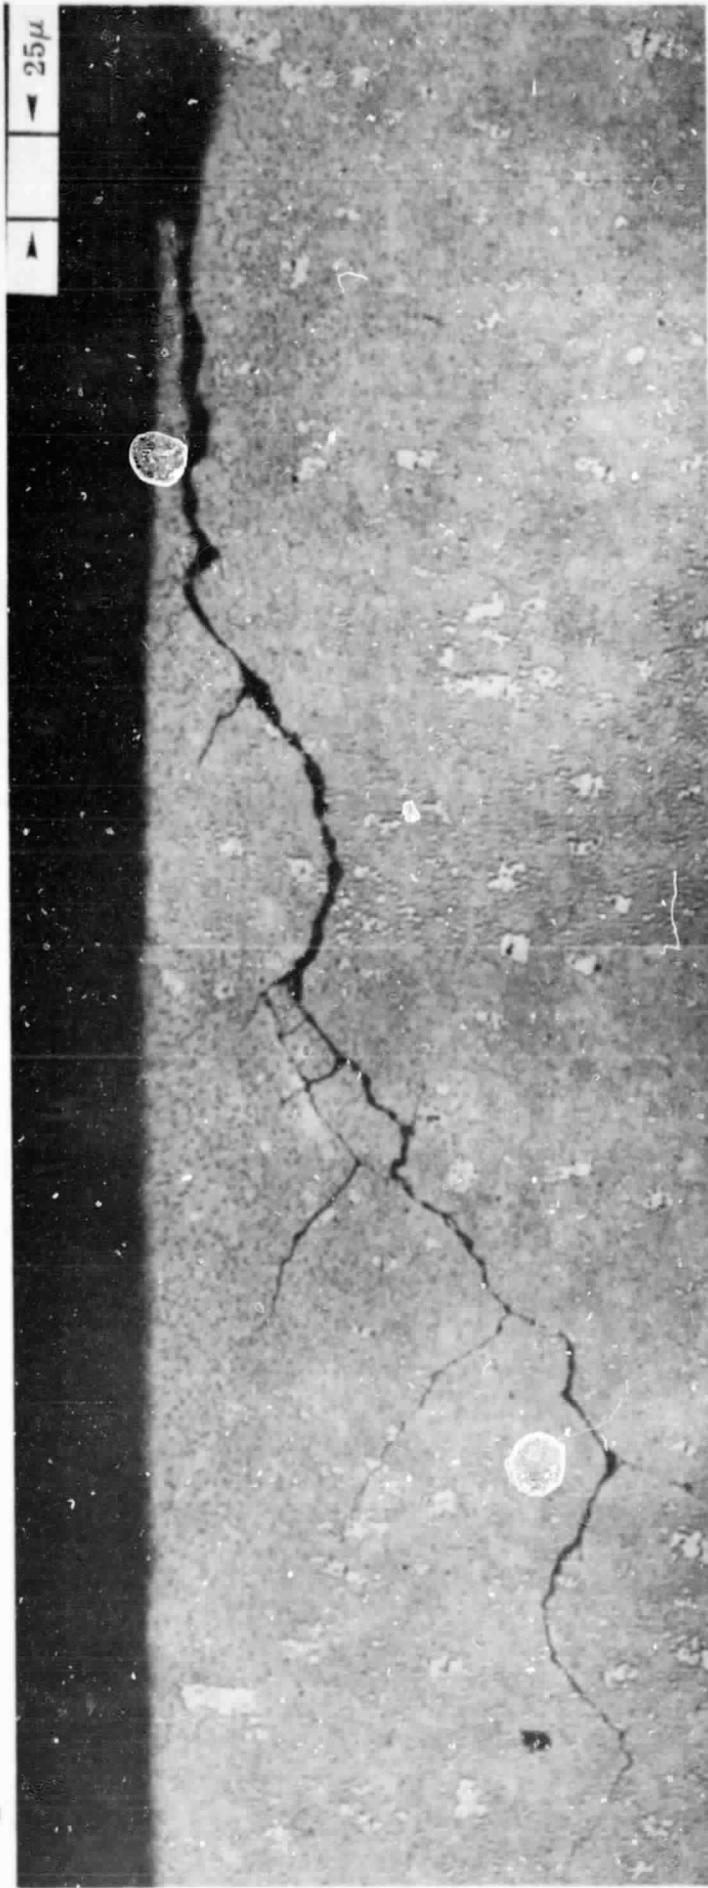
Figure 15. Shallow crack in HPOTP 9008 bearing ball from Engine 2004.  
Crack depth approximately 0.13 mm (0.005 in.) (area C in Figure 12).

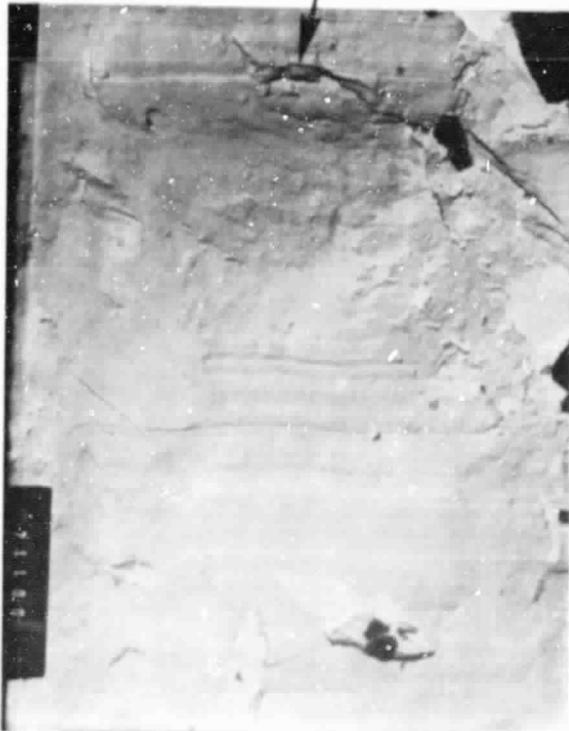
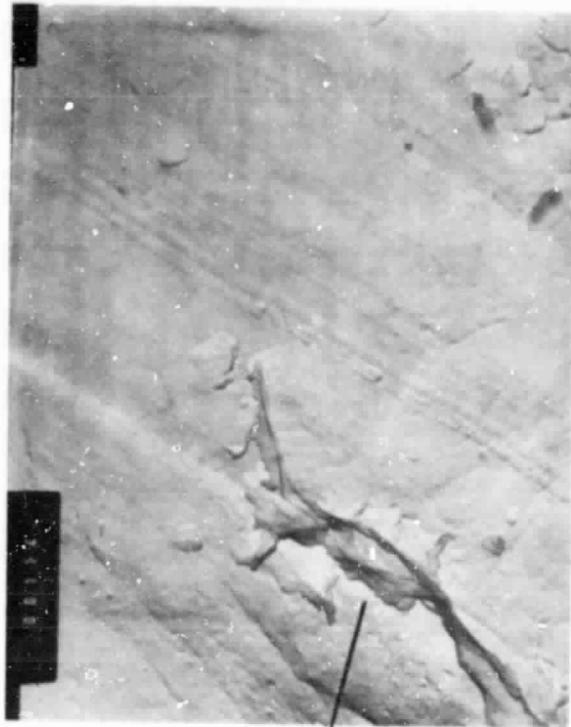
The crack A in Figure 12 was opened and the fractured surface was carbon replicated for examination in the transmission electron microscope. Two TEM photomicrographs of the fractured surface are shown in Figure 16. Parallel lines, resembling fatigue striations, are observed. Such striations were observed in different parts of the fractured surface.

Figure 16. TEM photomicrographs of fractured surface in HPOTP 9008 bearing ball from engine 2004. (Fractured surface from crack A in Figure 12).
