NASA TM-82424

LOX/GOX RELATED FAILURES DURING
SPACE SHUTTLE MAIN ENGINE DEVELOPMENT

By C. E. Cataldo
Materials & Processes Laboratory

May 1981

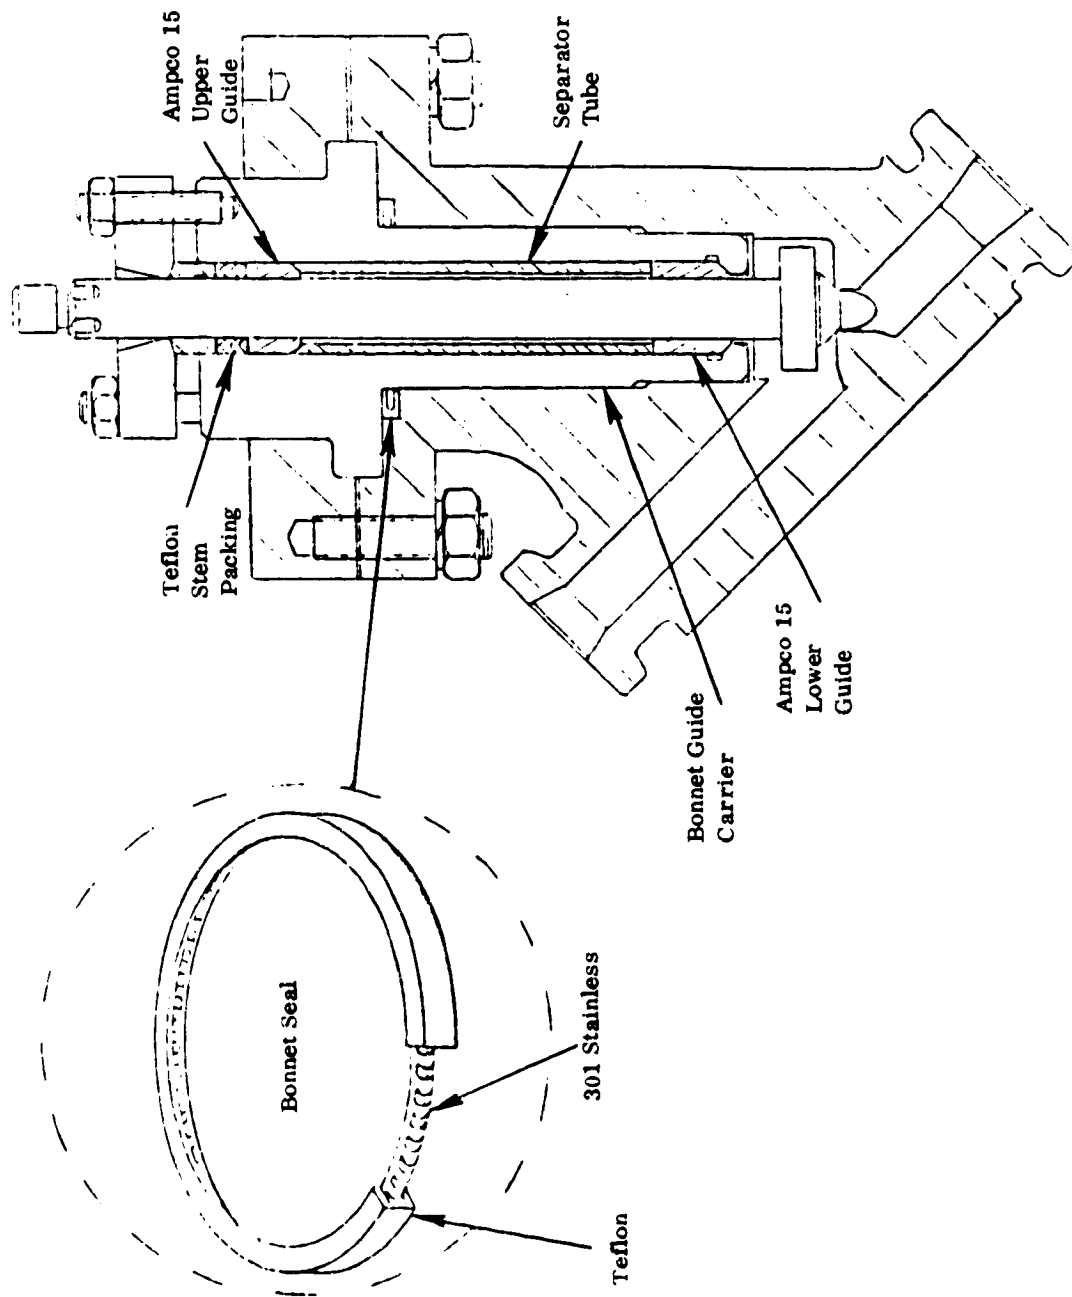
Figure 3. Coca 4B oxidizer P/B F/M lox bleed.

located on a stub line to the main flow line. A schematic of this valve and associated components and materials is shown in Figure 3. This particular valve was found to have a burned bonnet seal (Teflon). There was no evidence of significant prior contamination. Note that the valve was installed such that lox/gox pressure was over the ball. The downstream valves were reversed, with the low pressure under the ball; thus, protecting the stem packing and seals from exposure to lox while in the closed position.

It was concluded that primary velocities and surges in the unprimed stub bleed line, caused by main line surges, could have resulted in pressures of 20,000 psi and velocities of 400 ft/sec. This would have resulted in high temperatures, generated by adiabatic gox compression in the stub line. Temperatures on the order of 1220°F were calculated because of this effect. The ignition temperature of Teflon at 3060 psi is approximately 850°F. The Teflon seal was a static bonnet seal (Rayco) of TFE Teflon with an internal spring, used between the cap and body of the valve. The spring and seal were burned; no other damage occurred to the valve. No other cause, other than adiabatic compression, was found to explain the Teflon ignition.

The explosion and major assembly damage were not attributed to the Teflon ignition in the valve but to surges and overpressure in the system. The Teflon ignition was caused by the pressure surge because of erratic main lox valve opening, and the installation of the valve such that the Teflon was exposed to the surge pressure.

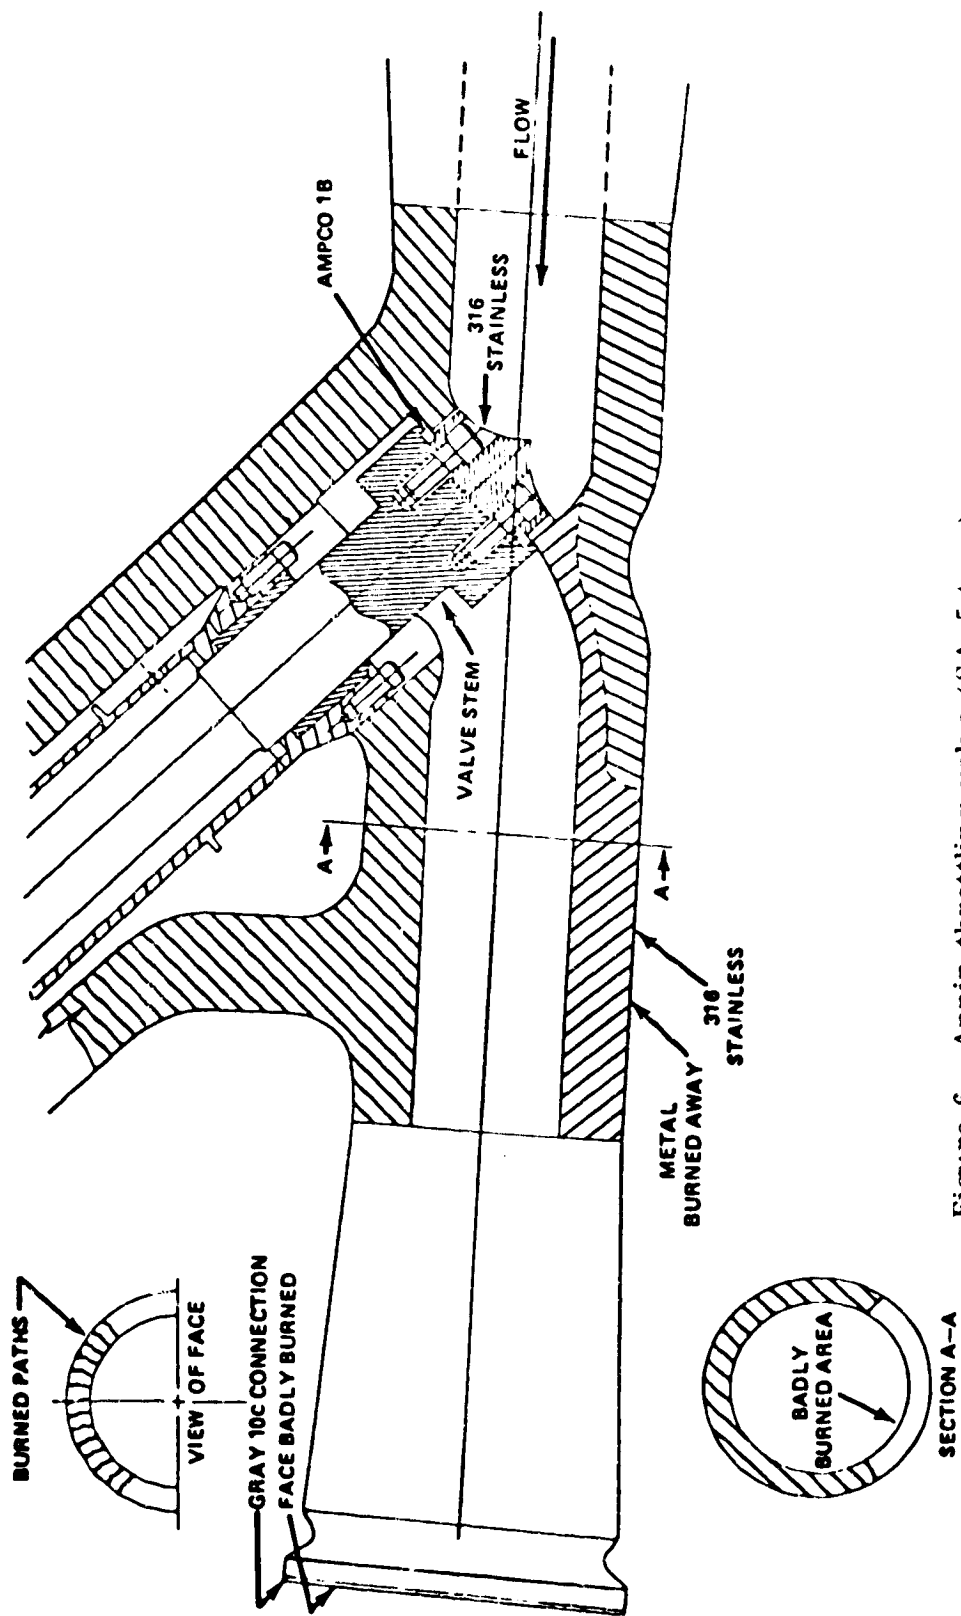
Figure 6. Annin throttling valve (SA 5 type).

A simplified schematic of the test hardware is shown in Figure 4. The test set up and annotations as to post test observations are shown in Figure 5. Extensive burning occurred in the SA-5 Annin Throttling valve, as illustrated in Figures 6 and 7. Also, damage was observed in a flowmeter (LA-71). The meter lost two adjacent rotor blades; a retaining ring was dislodged; and two anti-rotation pins were missing (Fig. 8 and 9).

The 6-in. Annin valve was of typical construction and was used as a throttling valve with a fail open mode. The poppet shaft seals were on the low pressure side of the valve. The valve body material was 316 CRES and the lip seal of the valve was an integral part of the body. The poppet material was also 316 CRES, containing an AMPCO aluminum bronze seal ring which mated against the 316 body for sealing. The poppet shaft rode in an aluminum bronze bushing and was sealed by a battery of Teflon chevron seals in the shank.

- 1) The flowmeter was redesigned to minimize the risk of blade breakage and loss of pins and retainer rings due to mechanical vibrations.
- 2) Revised procedures were implemented in the operation of throttling valves. The procedures were developed to minimize valve position changes during high lox flow conditions; cavitation conditions were avoided; and additional screens were employed to intercept foreign particles.

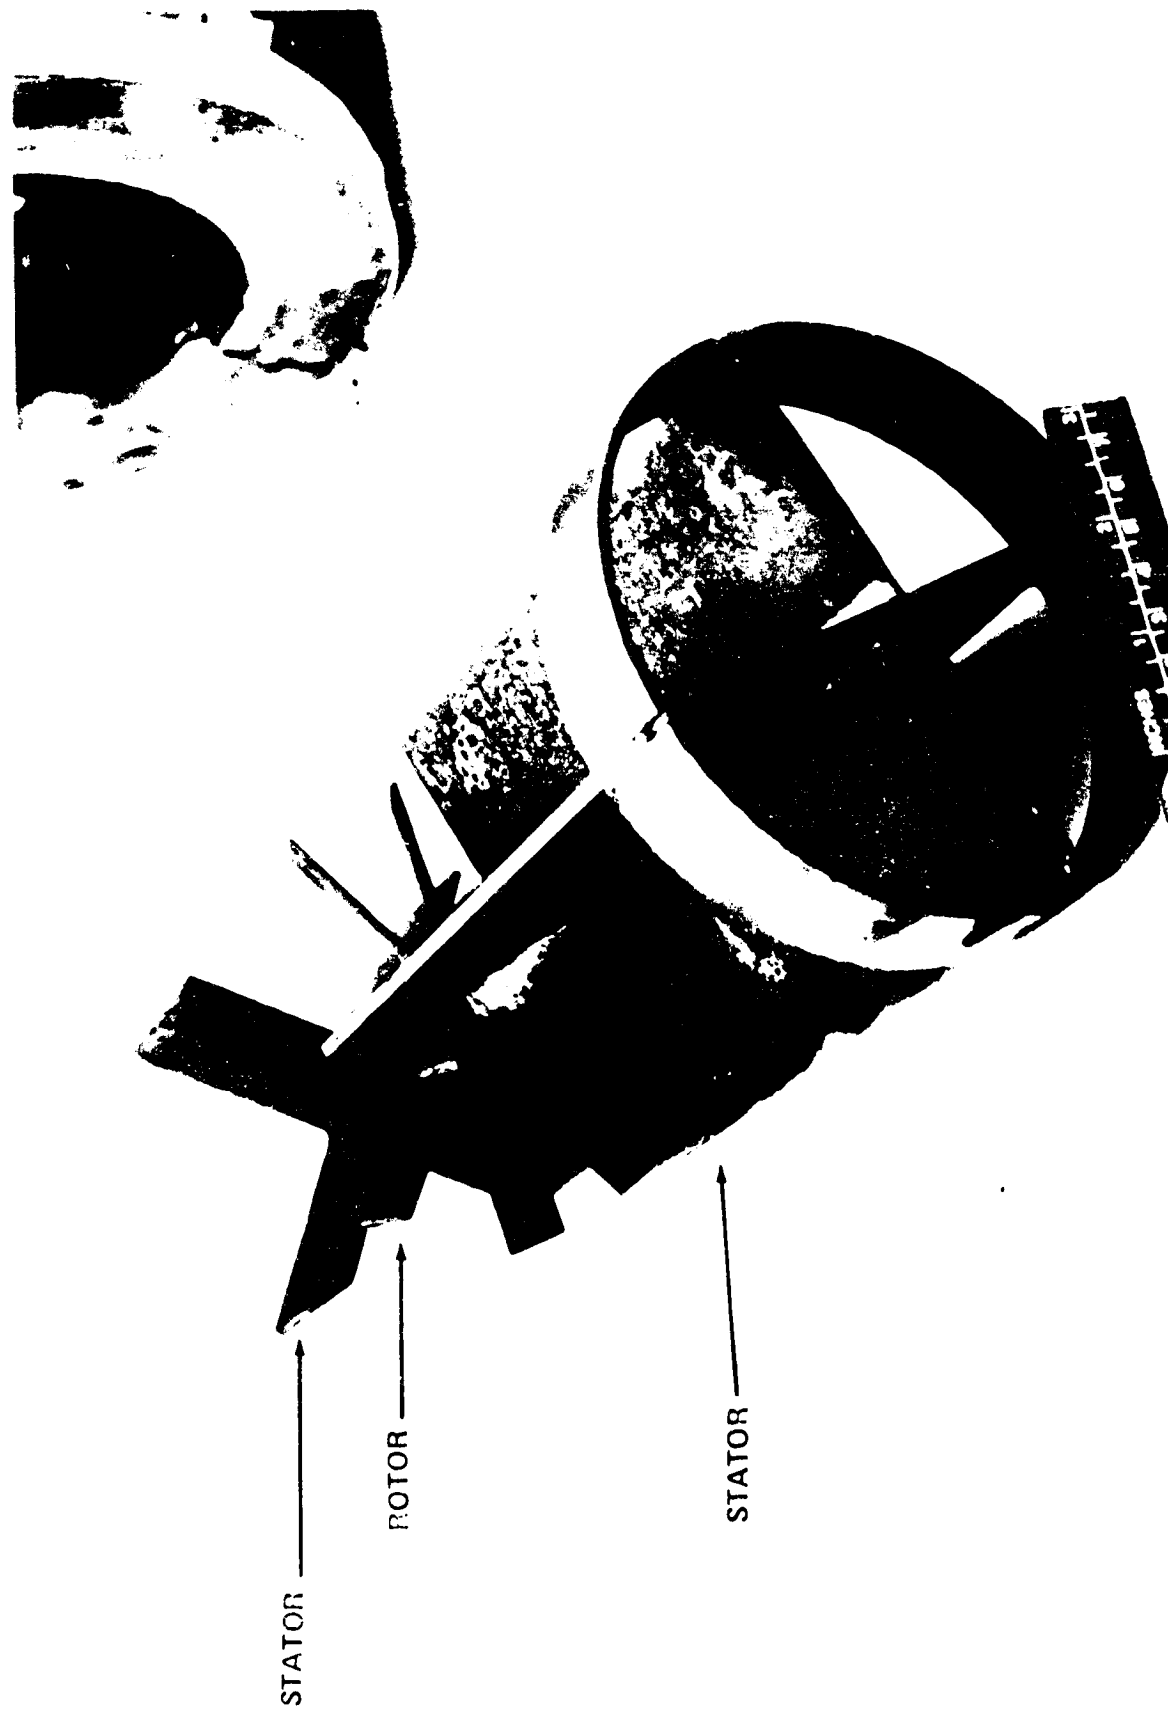
Figure 8. Coca 1A facility flowmeter LA71 - post test.

The 6-in. diameter flowmeter, made by Flow Technology, Inc., Tempe, Arizona, was of 1970 vintage and had been previously used in development testing (16 tests and 413 sec test time). The ten blade rotor was SAE 9310 steel, nickel plated. Most other parts were 302 and 304 CRES. Following the failure, two adjacent blades were missing; the 308 CRES anti-rotation pins were missing; the 440C CRES rotor bearing was free, but rough running; and the Sprialoc ring, which held the flow straighteners in place, was out of its groove and bent over the downstream vanes. Analysis of the rotor blades showed them to be AMS 6260 aircraft quality 9310 steel, with a hardness of RB 93-96. Some globular oxides and sulfides were evident in the microstructure, and the material showed a typical air melted structure. Failure in both blades initiated at the leading face. The leading failed blade had numerous scratches from sanding and a portion of the fractured edge followed a large scratch. The fractures were primarily cleavage type, and were found to be identical to samples broken in the laboratory by bending LN₂ soaked specimens. Some other blades on the rotor were slightly undercut at the root; the second fractured blade was 0.0001 out of spec; and part of the fracture ran through this area (Fig. 10). Stress calculations on the blade showed that the combined torque load on the blade and a load calculated from the impact of a loose anti-rotation pin would approach the yield strength of the alloy.

The accident investigation board concluded that the probable cause of the accident was the loss of blades from the LA 71 facility flowmeter and subsequent ignition from the impact of the blades with downstream components, probably the SA-5 valve. It was also concluded that this valve operated with a cavitation condition just downstream of the throat. This condition would tend to propagate burning once ignition occurred. The resulting internal fire would restrict flow from the HPOTP causing excessive pressures in the ducting, loss of flow in the preburner pump, subsequent

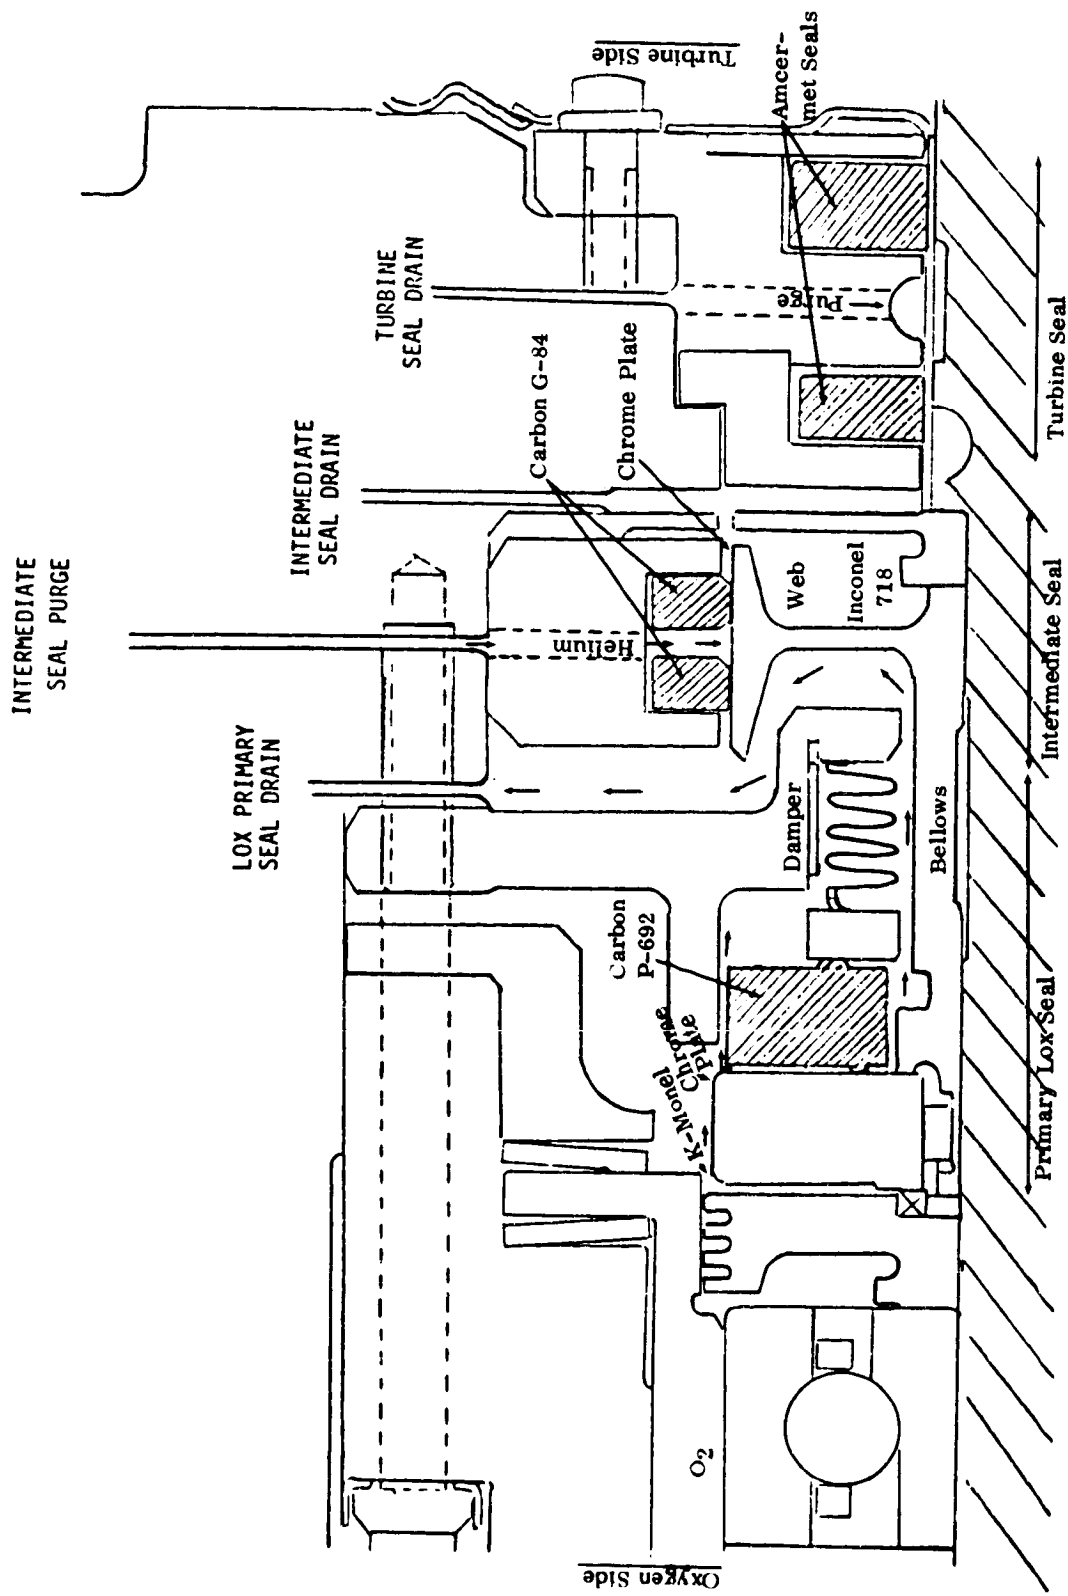
Figure 15. Configuration of the primary seal area of the HPOTP and the associated materials of construction.

- 1) Loss of hydrodynamic lift in the primary lox seal, causing rubbing of a carbon seal against a stainless steel mating ring, creating frictional heat and ignition of the carbon composite. Figure 15 illustrates the configuration of the primary seal area of the HPOTP, and the associated materials of construction.
- 2) Primary oxidizer seal bellows (Inco 718) weld failure, allowing oxygen leakage.
- 3) Ignition of the interface of the bellows and its vibration damper as a result of friction.
- 4) Contamination in the seal cavity.
- 5) Hot gas leakage past the intermediate seal into the primary seal area.
- 6) Vibration of the carbon seal against the mating ring.

Since no direct cause could be identified, design changes of major importance were implemented to correct all deficiencies defined. A new primary seal concept was employed using a labyrinth concept, and the carbon seal concept was eliminated.

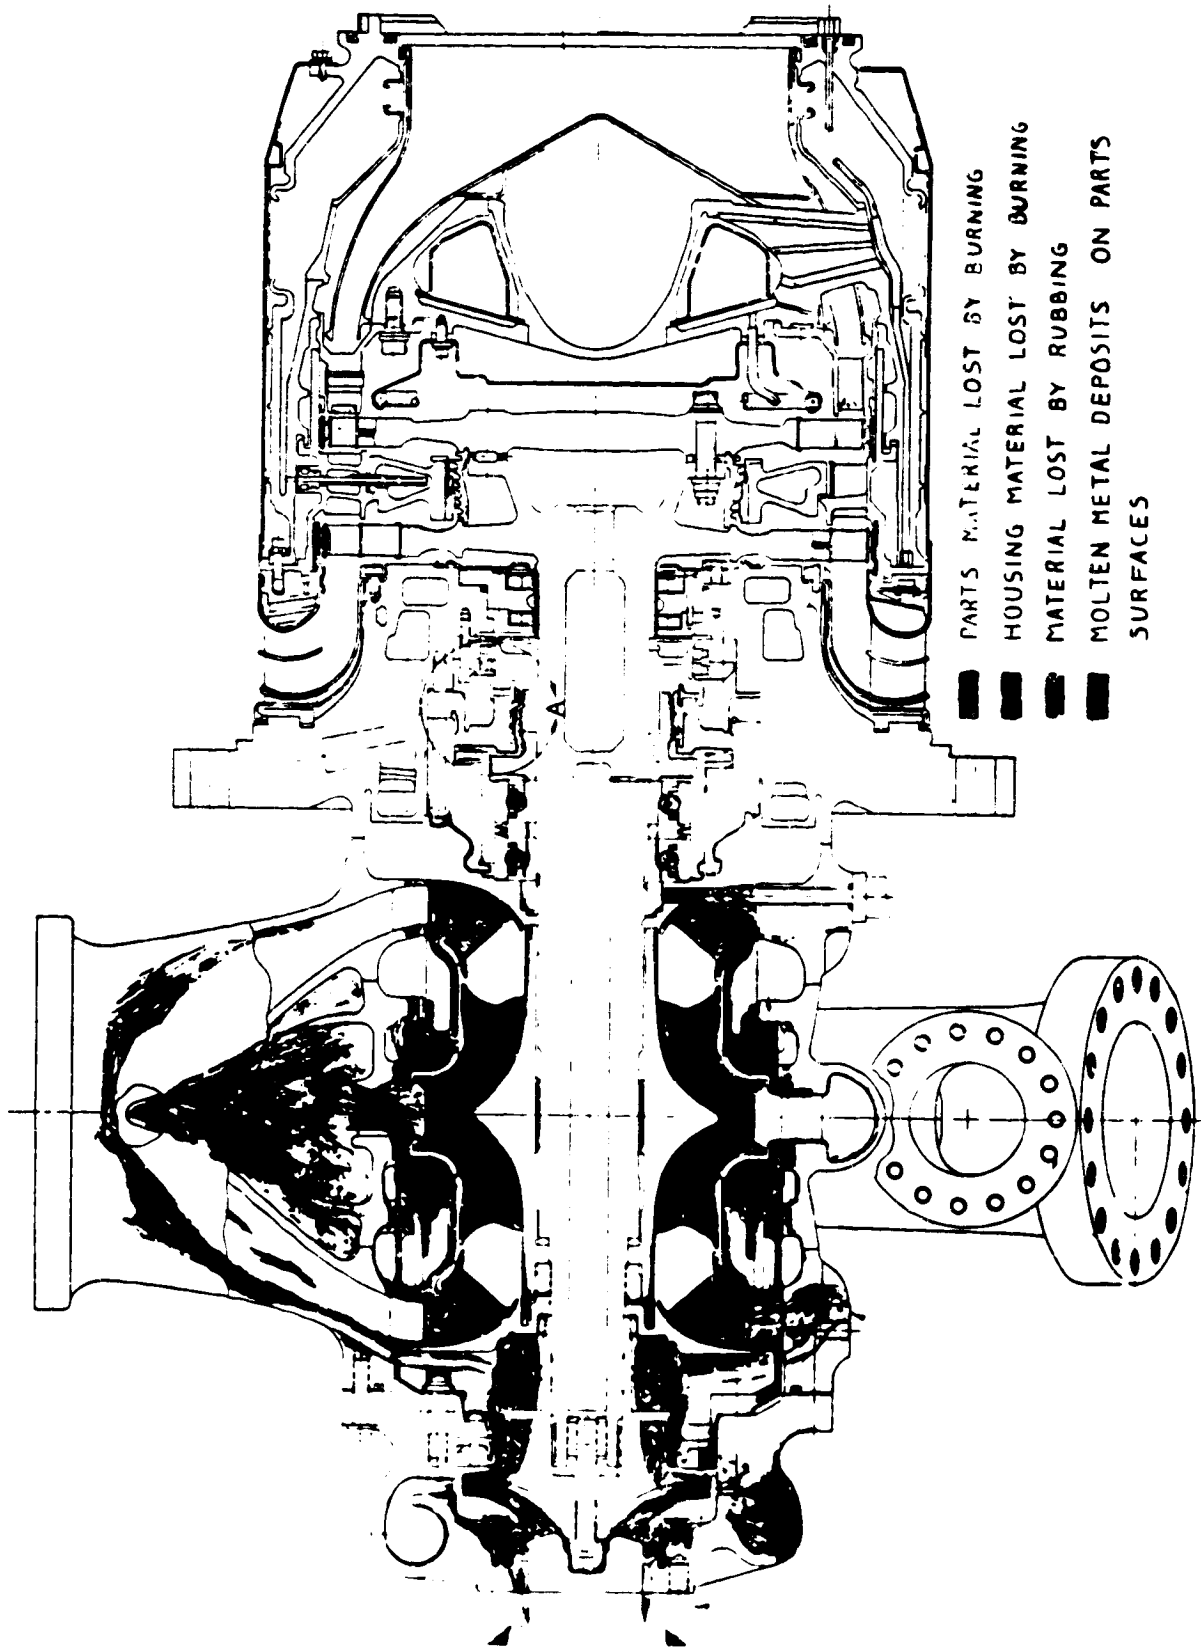
Figure 21. Cross-sectional drawing of high-pressure oxidizer turbopump after fire showing area of damage.

The investigating board concluded that the failure was caused by a bearing failure in the HPOTP. A load imbalance of the four bearings apparently occurred because of liquid oxygen coolant flow characteristics. The flow was such that the axial and radial loads on the pump end pair of bearings were not shared, but were concentrated on the inboard bearing. Also, the inboard turbine end bearing was not cooled adequately to provide satisfactory bearing life. The board also found inadequacies in the pump rotor balancing that needed more improvement. A cross-sectional view of the HPOTP is shown in Figure 20. A sketch of the HPOTP is shown in Figure 21 showing the principal areas of damage.

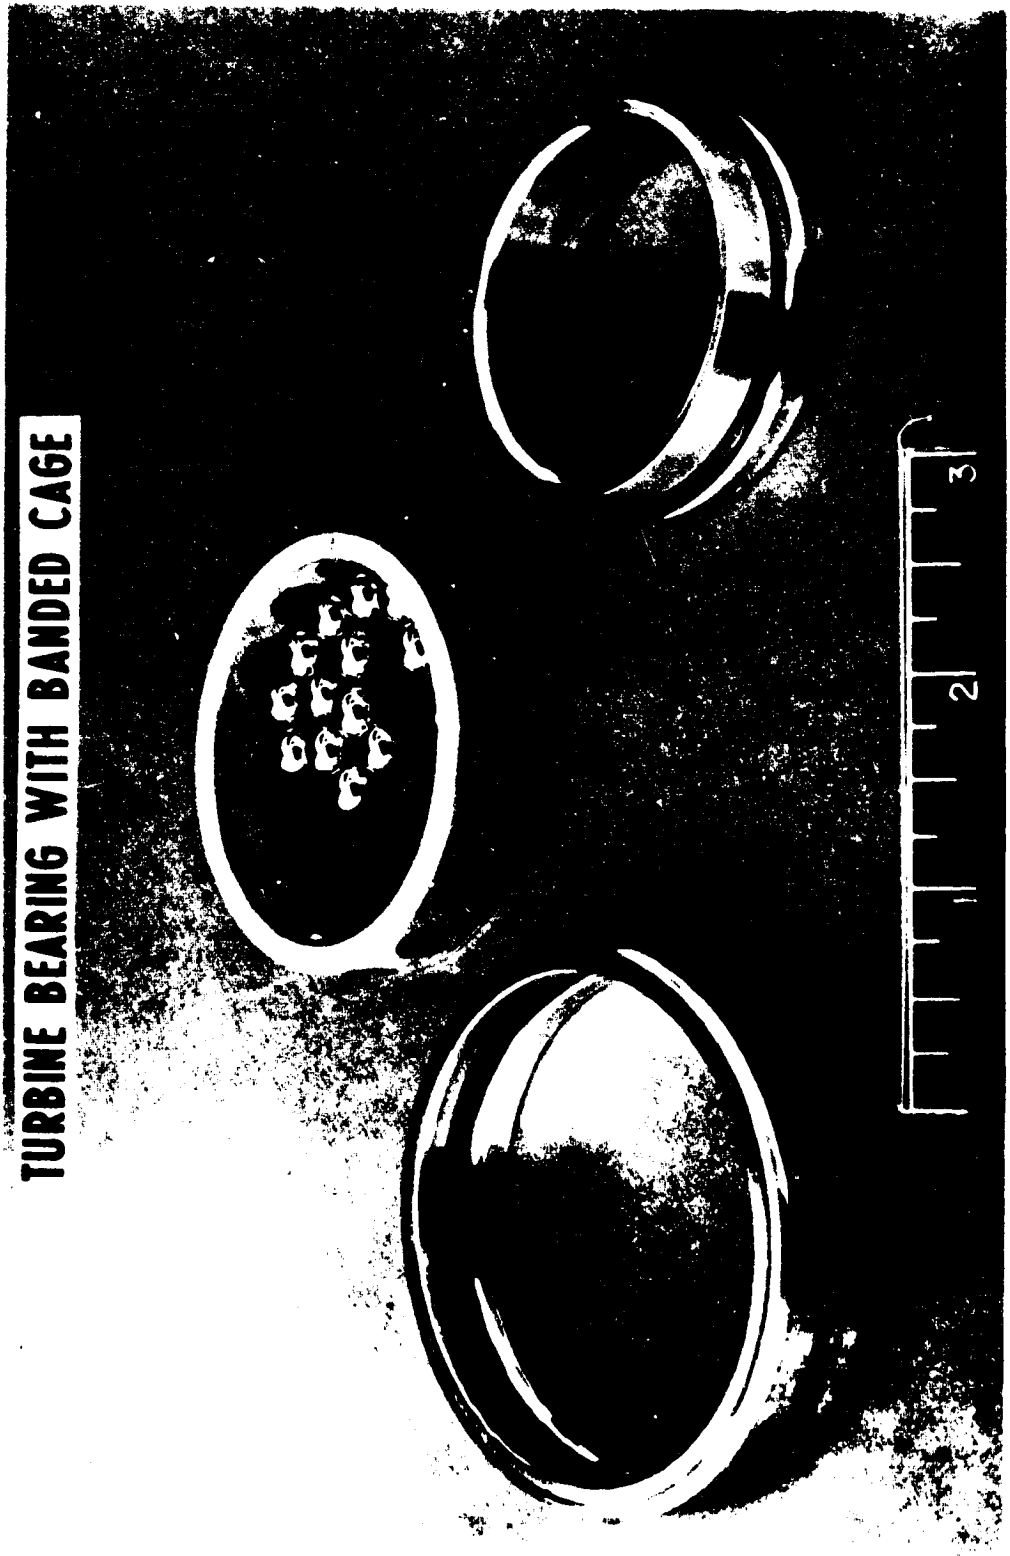
Figure 22. HPOTP bearings.

6. HPOTP Bearings - (Material 440C Balls and Races, Figure 22). All bearings (Nos. 1 and 2 on the pump end and Nos. 3 and 4 on the turbine end) were burned and essentially destroyed except for parts of the inner and outer races. All balls were missing and assumed destroyed.

by fire. Examination of the remaining races indicated moderate to heavy synchronous radial loads and non-uniform wear, indicating an unbalanced condition. It appeared that the worst fire damage occurred between the two sets of bearings, in the inducer area, and was more severe on the No. 2 bearing side.

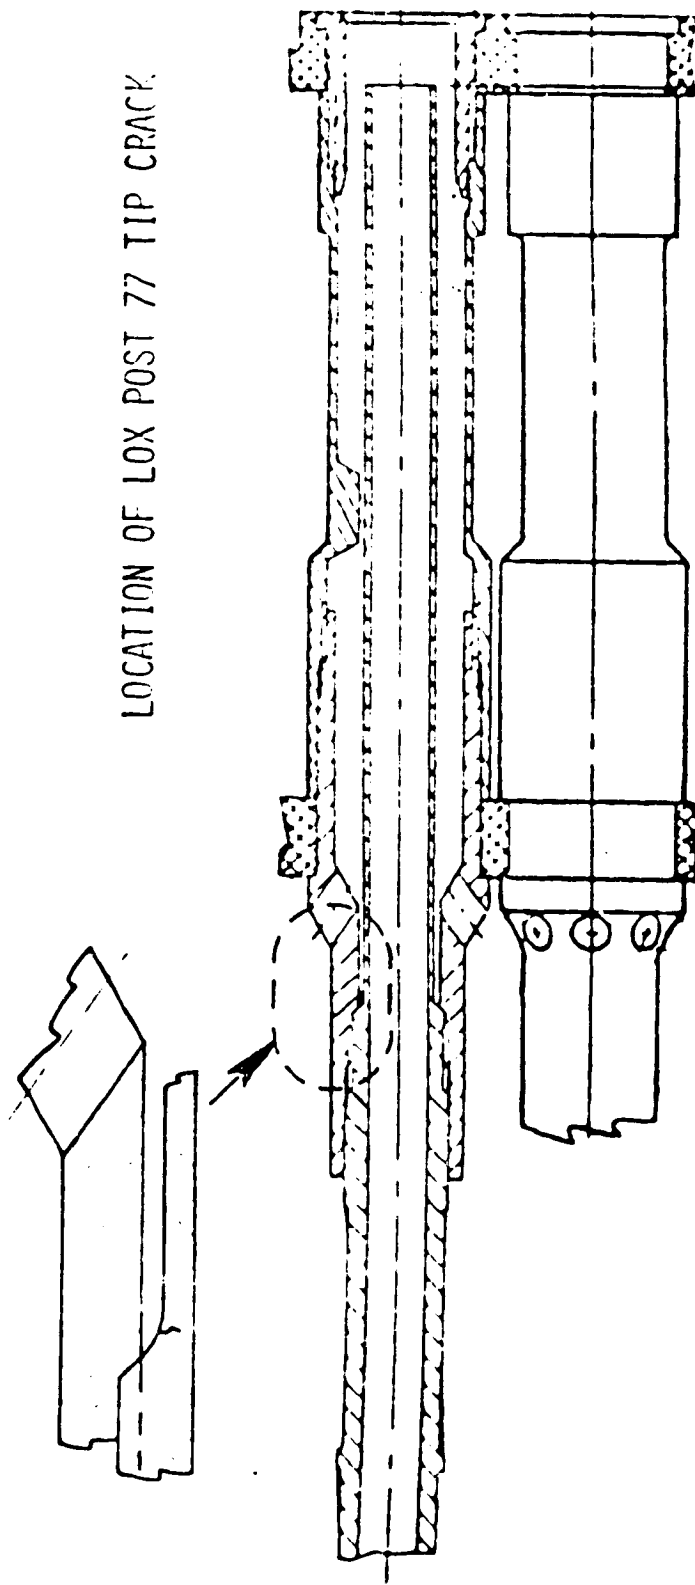
Figure 24. Main injector 0002, lox post failure.

Post-test examination revealed a crack in the radius of a lox post, and several lox posts were bent, up to 1/4-in. in line with the outside hot gas transfer ducts. Some damage was observed on 18 lox posts and retainers. Cracks were found in the interpropellant plate.

The investigation of this failure concluded that the crack in the tip of lox post No. 77 (in No. 13 outer row) was caused by high cycle fatigue. This particular crack was not a through crack; it had progressed 0.010 through a 0.020 in. wall. The bent posts were caused by high temperature, high velocity, hot gas impingement. The lox posts were made from 316L CRES and apparently lacked sufficient high temperature strength to be structurally adequate. The Inconel 718 interpropellant plates were cracked parallel to the post axis and the cracks were attributed to low cycle thermal fatigue. One other post (post 8, row 12) was found to have failed at the friction weld, on the 316L side, by hot tensile failure, primarily because of overheating after the burning began. Early in the development program, the lox posts were made from HS-188, and no bending or cracking was encountered during testing. The 316L posts were used after the first three injectors, since the structural and thermal analysis showed them to be adequate, and considerable difficulties had been experienced in manufacturing the HS-188 units. The high loads and temperature effects and subsequent bending of the 316L posts had not been anticipated.

Laboratory studies made in support of the failure investigation further defined the lox post vibration frequencies and mode shapes. Dynamic and structural models were made to simulate the failure mode. Vortex flow models were made and studied. It was concluded that the lox posts in line with the outer gas ducts failed first because of higher dynamic forces and higher temperatures. Thermal bending of the post caused increased tip loading. Vibration was most severe in the outer row of the posts. Consequently, several modifications were made to the main injector, including the incorporation of larger propellant face plate nuts, and better GH_2 cooling of the lox posts by using larger GH_2 orifices.
