NASA Contractor Report 166159

Study of Aircraft Crashworthiness for Fire Protection

**A. Cominsky, et al
Douglas Aircraft Company
McDonnell Douglas Corporation
Long Beach, California 90846**

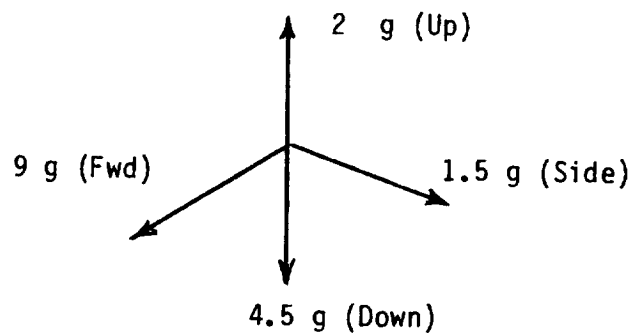
ACCIDENT 2-19

Seat Failures

There were 8 known passenger seat failures. Only one of these seat frames was found. All the legs of the seat were fractured. The entire seat showed a lateral deformation to the left. They were designed for
