CERAMIC APPLICATIONS IN TURBINE ENGINES

Progress Report for 1 July 1979 to 31 December 1979

Detroit Diesel Allison Division
General Motors Corporation

May 1980

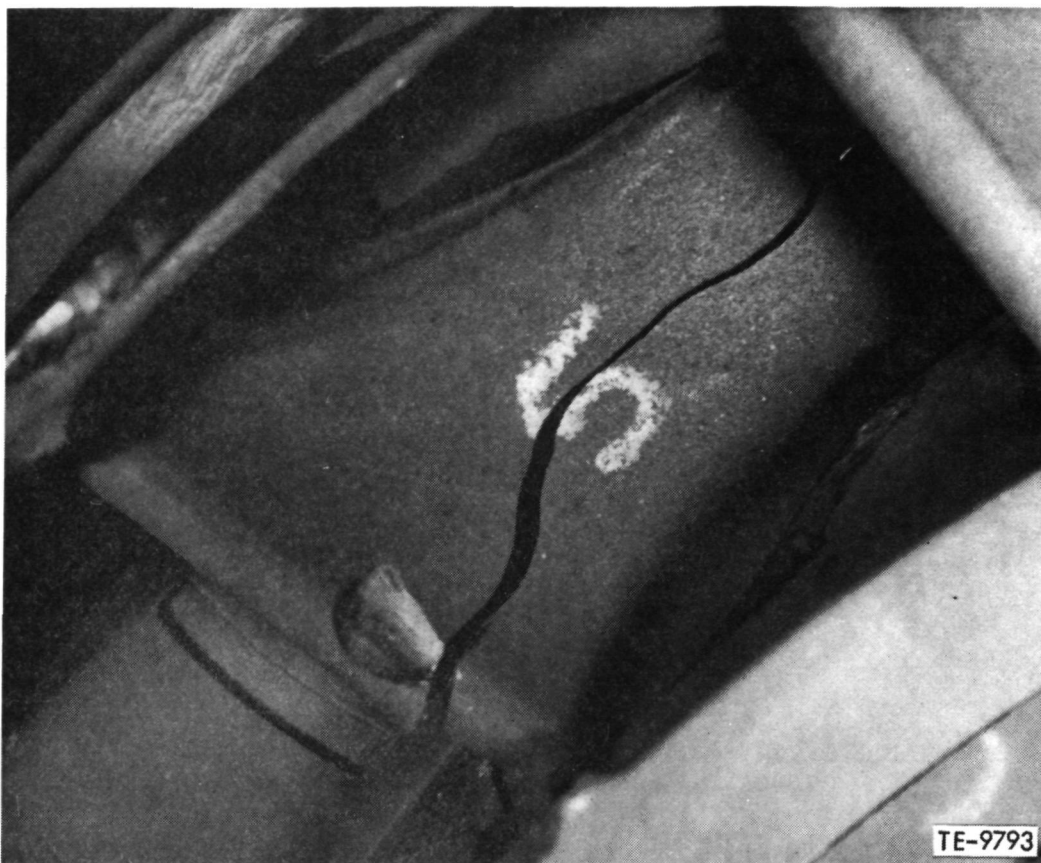
Figure 5. Failed silicon carbide vane.

Test 2 consisted of 128 hours of truck cycle durability, which was interrupted after four hours of testing by a failed silicon carbide vane (Figure 5). The failed vane was a first generation silicon carbide vane which had accumulated 1211 hours of engine testing. Engineering and Materials Research failure analyses have not conclusively determined the reason for failure. No evidence

of flaws or other material defects was found and no indication of load input from surrounding metal parts was evident on the failed vane. However, signs indicate that the plenum (which directs the burner outlet gas into the gasifier nozzle assembly) may have shifted position into the vane row at the location of the failed vane. The broken vane was replaced, the plenum shifting problem was resolved, and testing was continued without additional incidents.

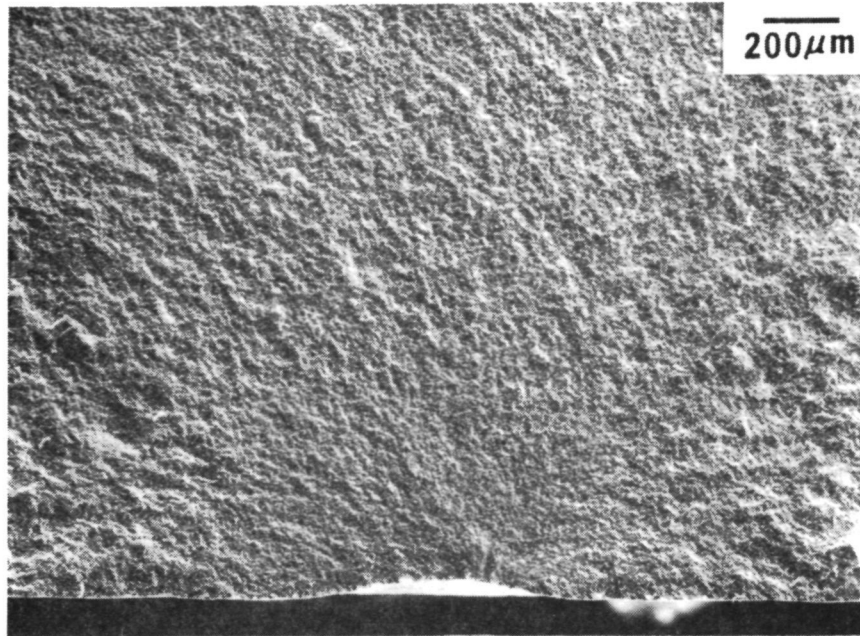
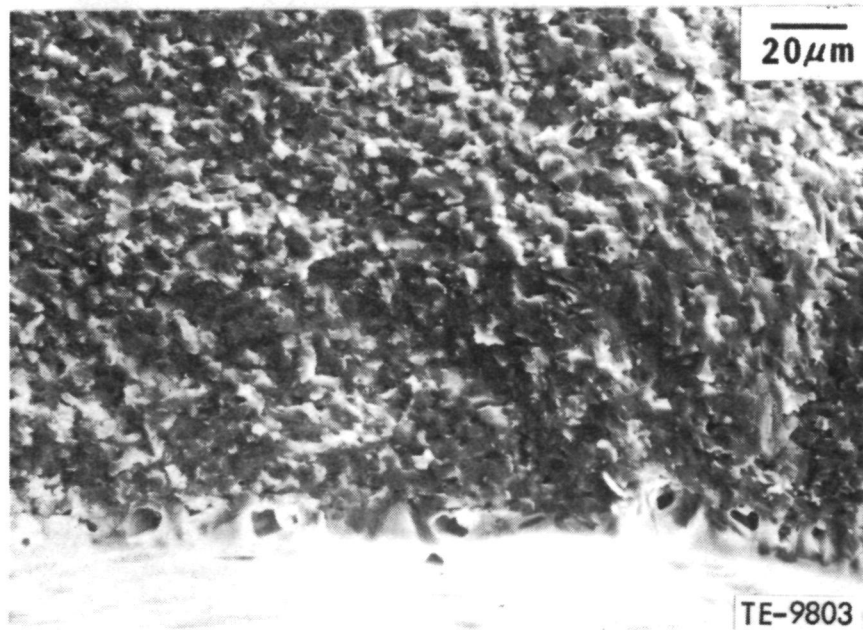
Figure 14. Fracture surface of slip-cast, oxidized Pure Carbon RB SiC showing glassy puddle at failure origin.

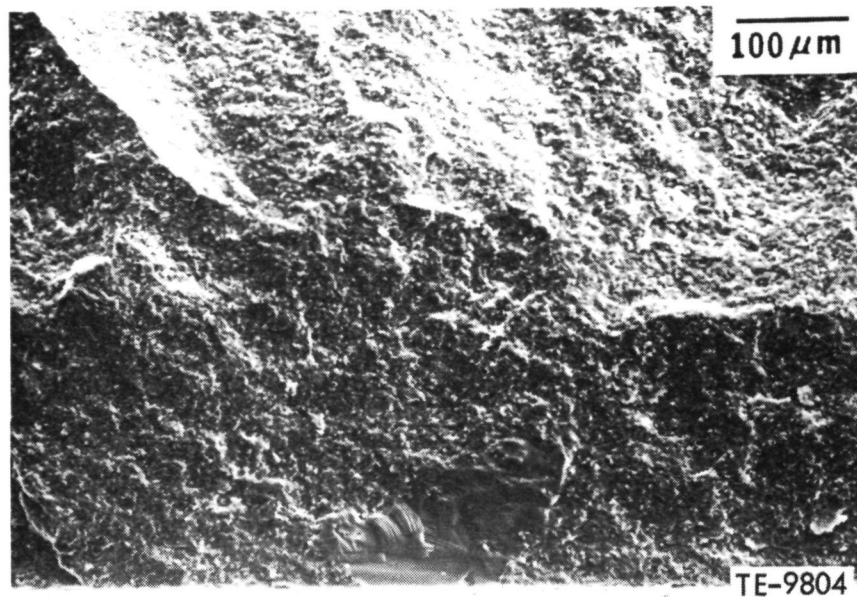
Figure 15. Photomicrograph of fracture surface of slip-cast, oxidized Pure Carbon RB SiC showing large grain at failure origin.

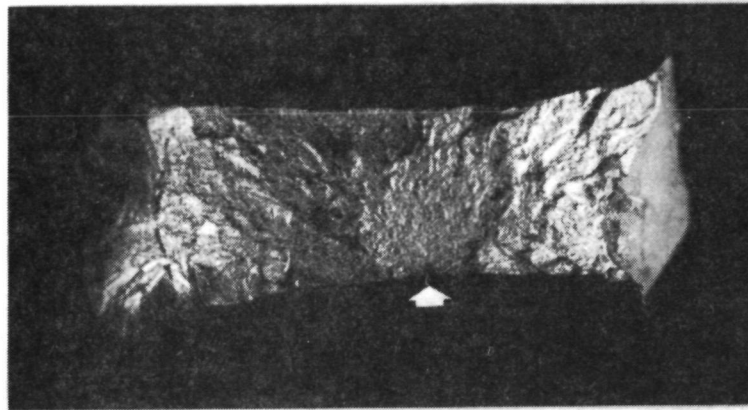
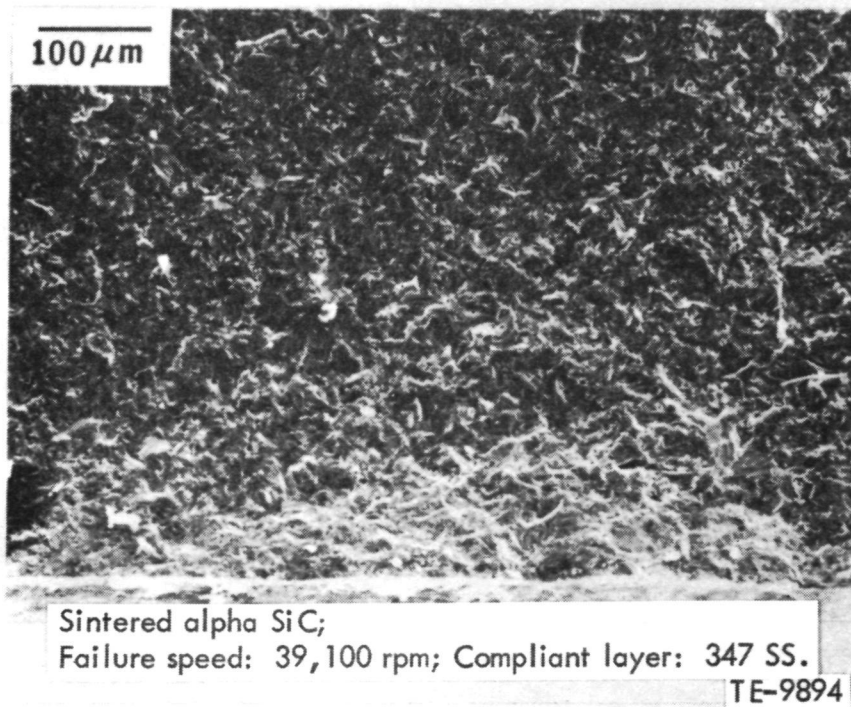
Figure 80. Spin coupon No. 22.

- o Coupon No. 22 failed at 39 100 rpm, using a 347 stainless steel compliant layer (Figure 80). The primary failure origin, indicated by arrow, is in a zone of high predicted stress (near the peak stress location), and no major flaw was found at this origin. Presumably, the fracture at the surface was a result of machining damage.

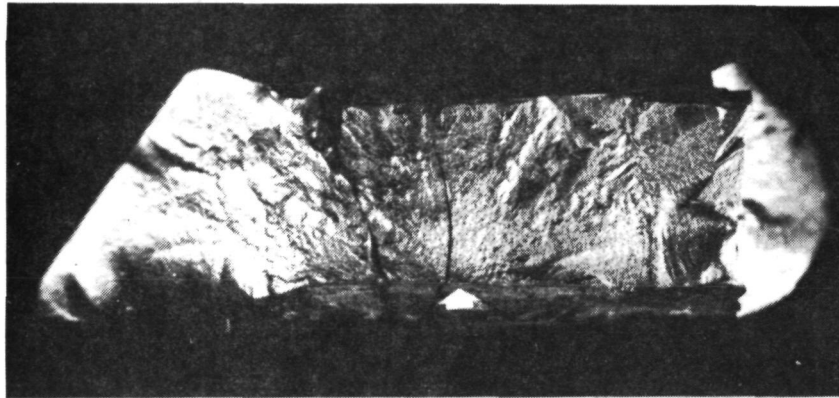
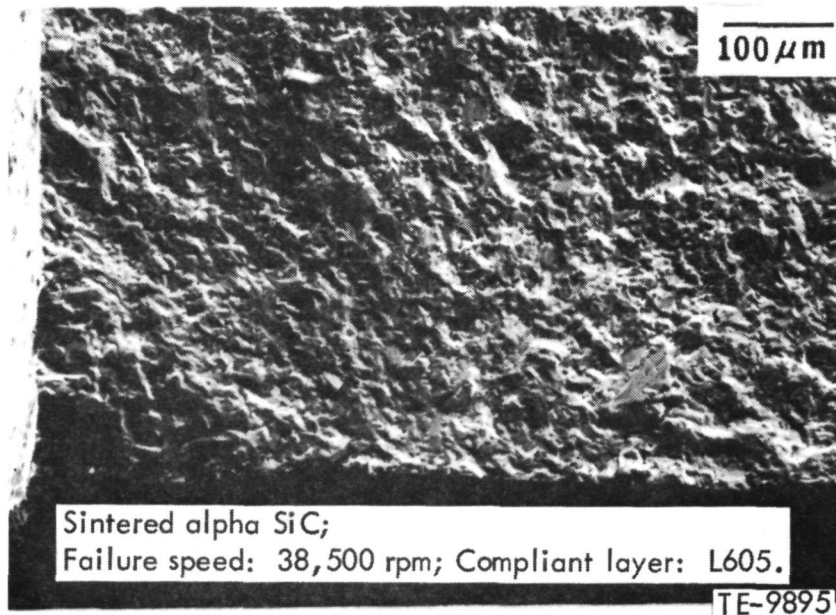
Figure 81. Spin coupon No. 23.

- o Coupon No. 23 failed at 38 500 rpm, using L605 material as the compliant layer (Figure 81). The primary failure originated at the surface in a zone of high stress near the peak stress location but, again, no flaw could be found.
- o Coupon No. 25 failed at 41 750 rpm, using an IN-600 material compliant layer (Figure 82). Primary failure originated at a rounded pore located at the predicted peak stress location. This pore is typical of those which control strength in material qualification test bars that were cut from billets along with the spin coupons.

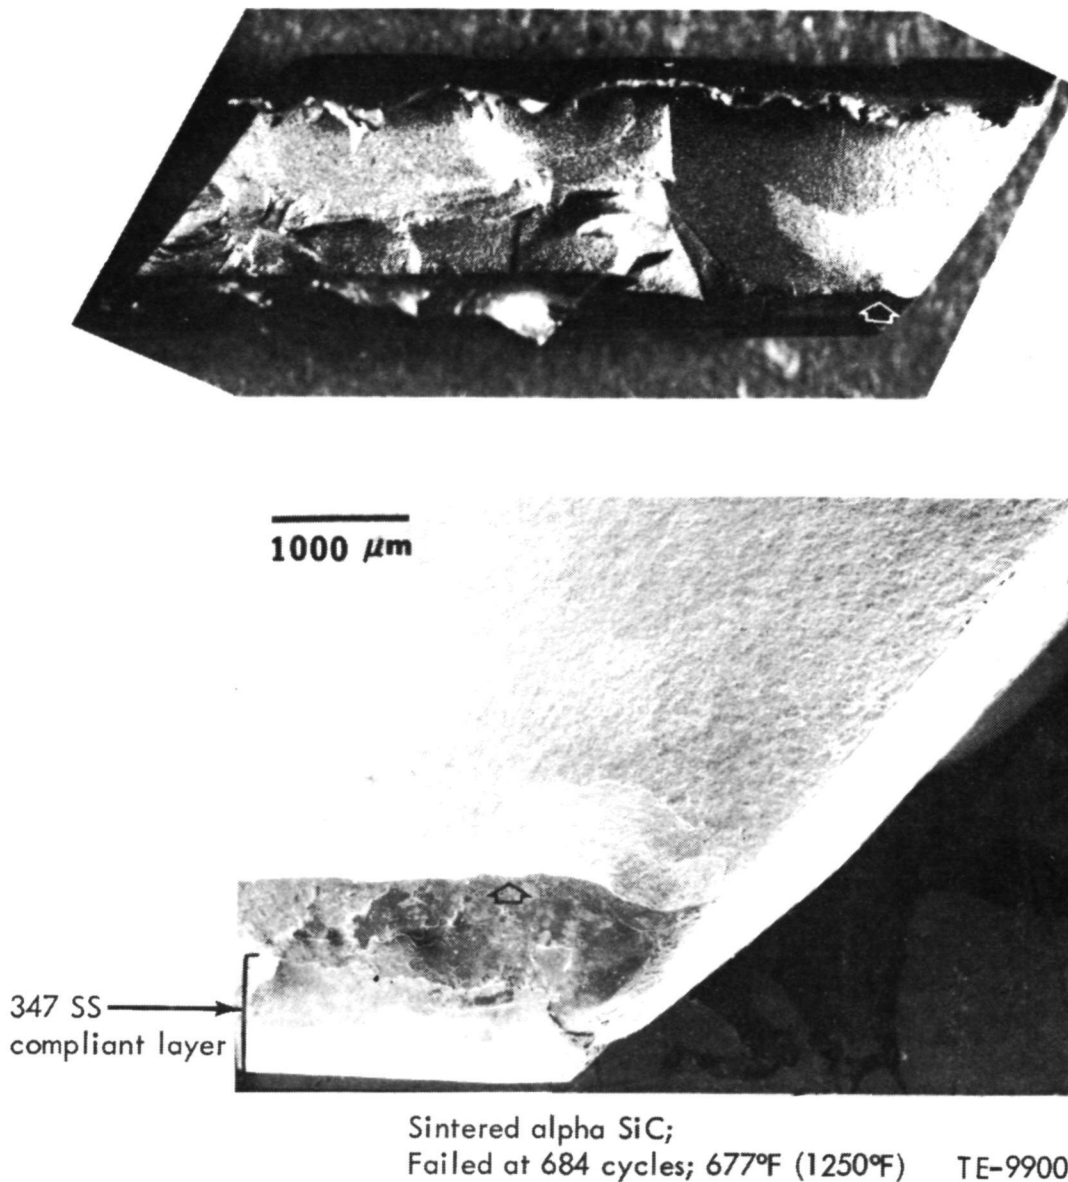
Figure 86. Spin coupon No. 20.

Closer examination of the failed spin coupon No. 20 reveals the relationship between compliant layer thin-out position and coupon fracture origin (Figure 86). Failure originated at a point of local contact between test disk and ceramic coupon. Multiple horizontal cracks, shown in Figure 87, are located at the failure origin and are typical of high Hertzian stress failures in brittle materials.

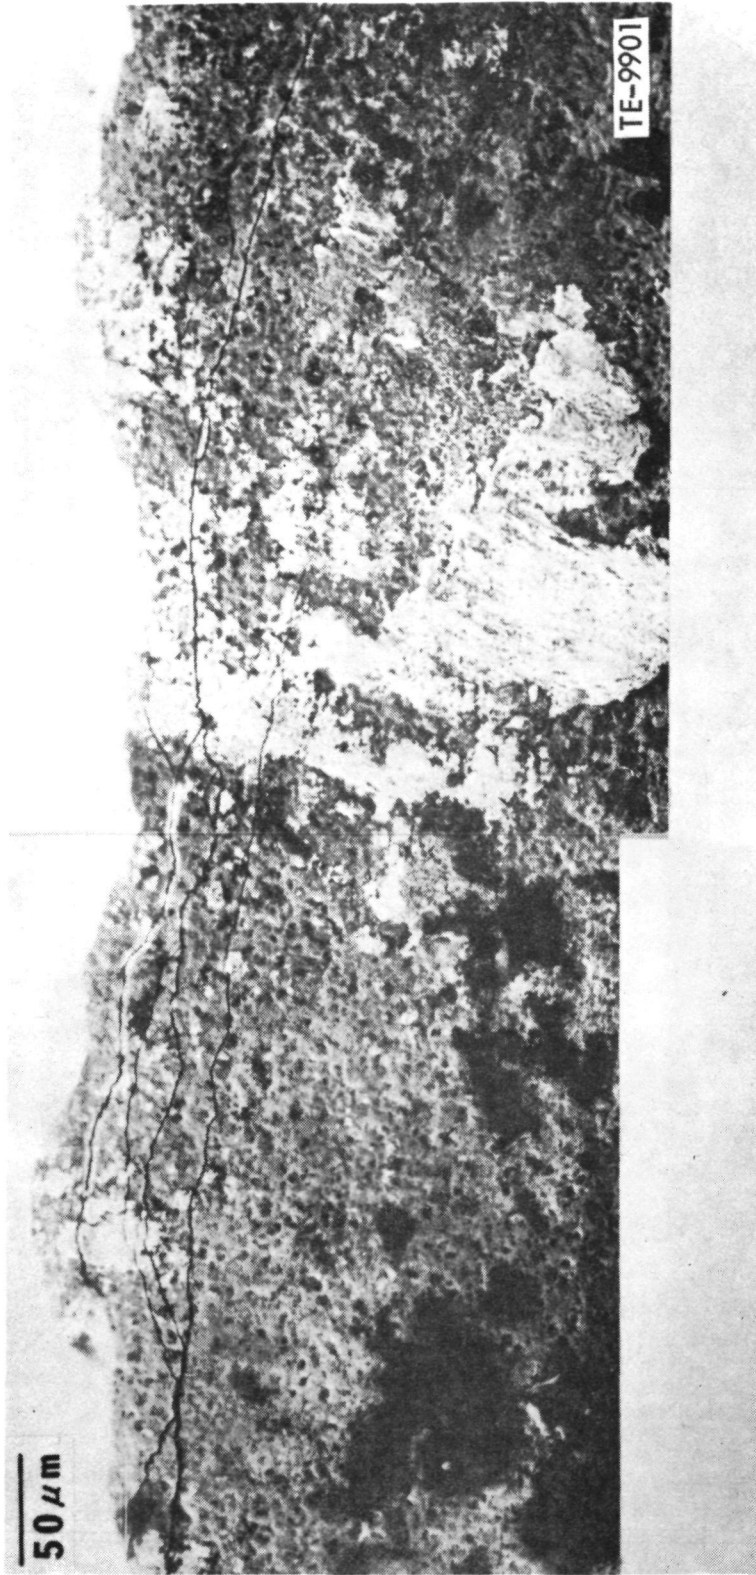
Figure 87. Multicrack at peak stress area in spin coupon No. 20.

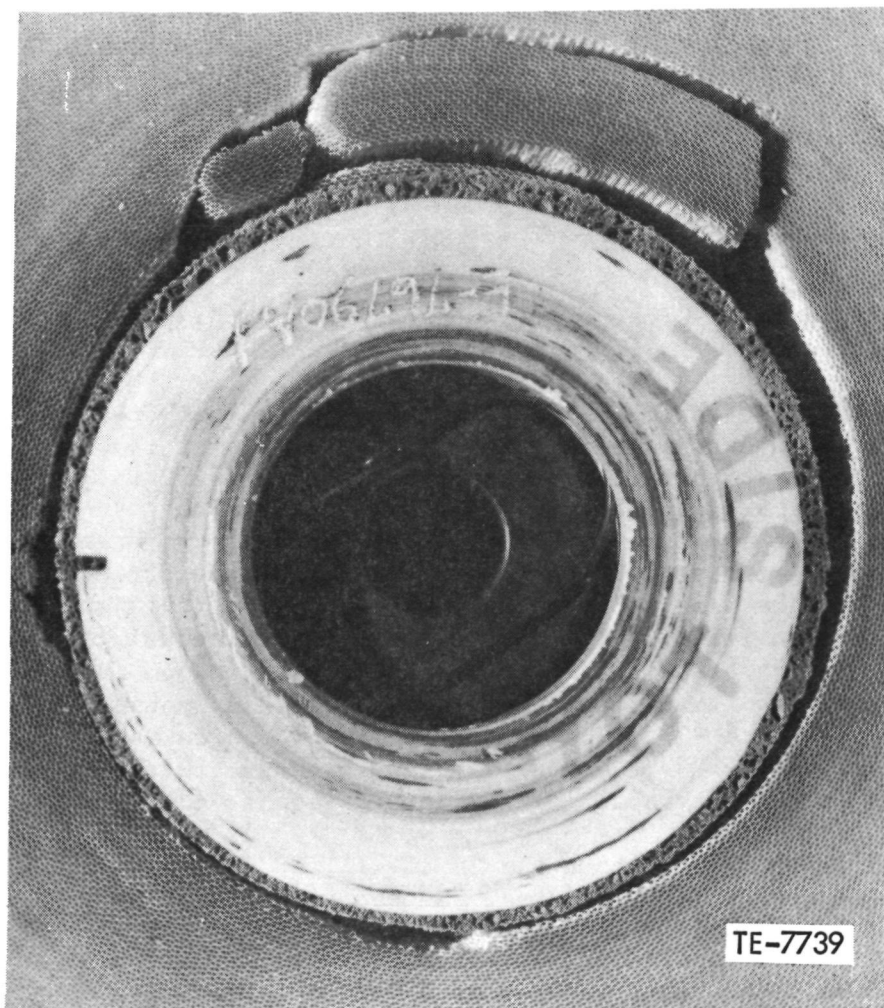
The two disks which were completely broken in the regenerator rig had each run about 5 hours at lower speeds and failed after about 45 minutes at 100% engine speed conditions. The 100% speed represents the maximum pressure and torque but not the maximum temperature encountered by a disk. At the radii where these failures occurred, stress analysis shows that pressure loads are by far the dominant stress producer. Consequently, a 30% overpressure proof test has been incorporated into the hot rig test of each set of seals and disks.

Figure 91. Regenerator disk hub failure encountered during hot rig running.

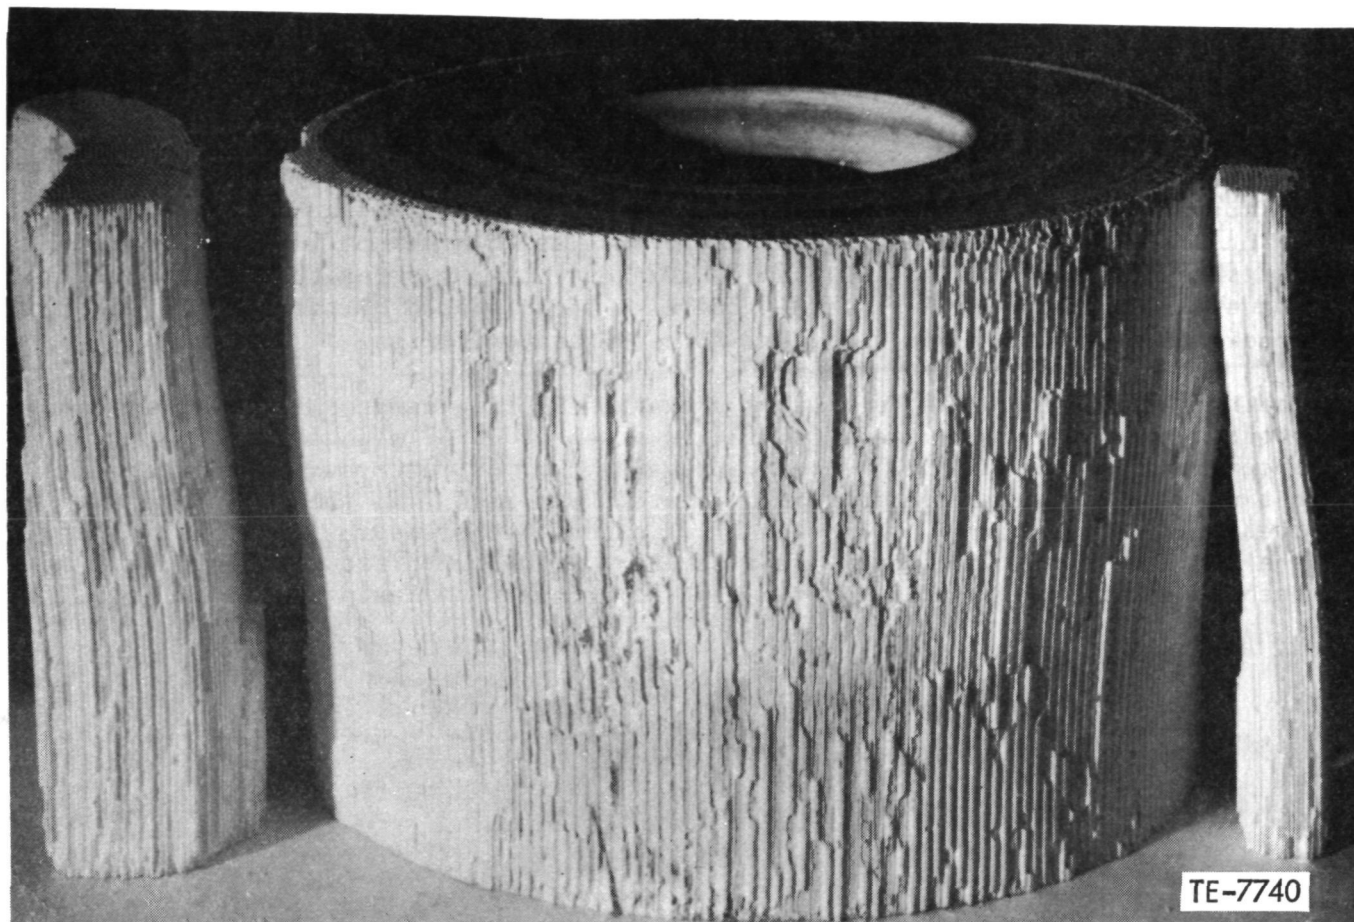
Figure 92. Close-up of hub showing unusual passage slant.

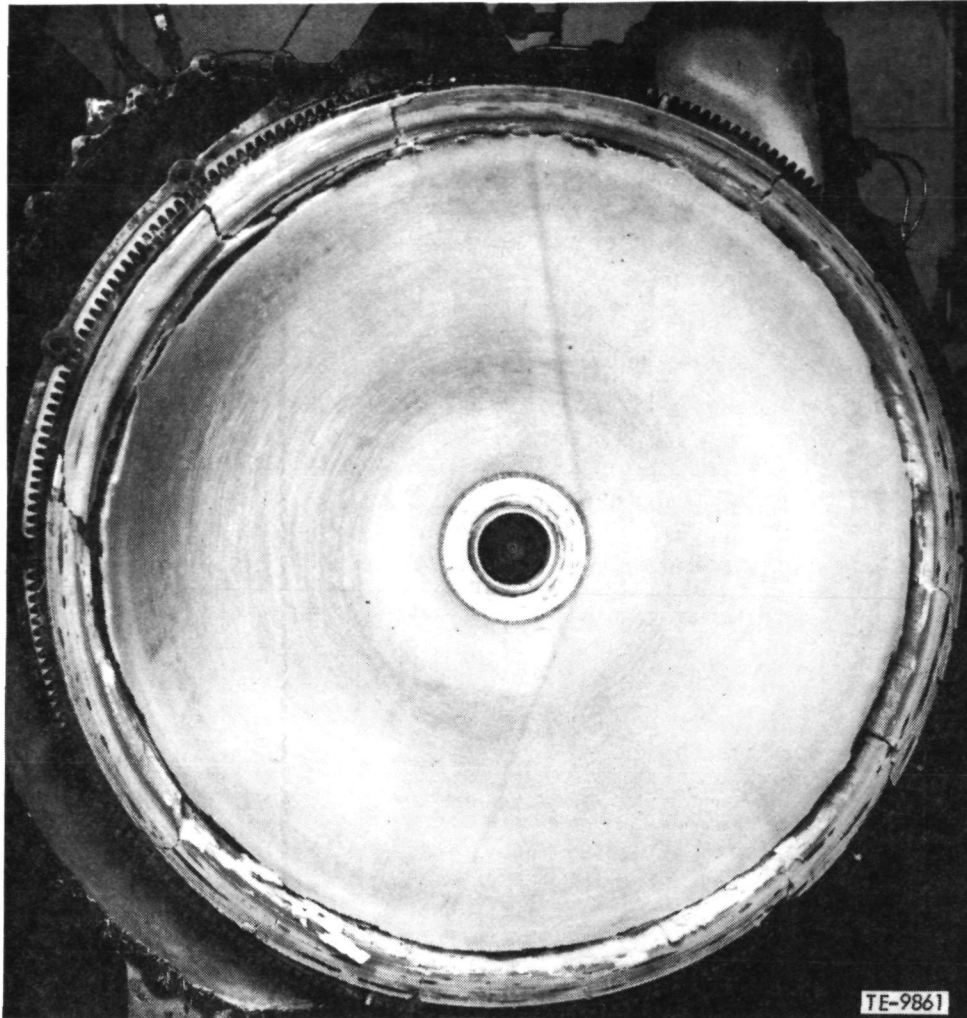
The second disk failed at about the 28-cm (11 in.) radius, as shown in Figure 93. This disk also had the abnormal "S" shaped passages and consequent separator distortion; however, it was milder near the failure area than elsewhere and not judged to be responsible for the failure. Correlation of matrix strength and wall thickness demonstrated that this failure was the result of thin separators. Regression coefficients show a very strong dependency of

Figure 93. Failed ceramic regenerator disk (DOE transit coach project).

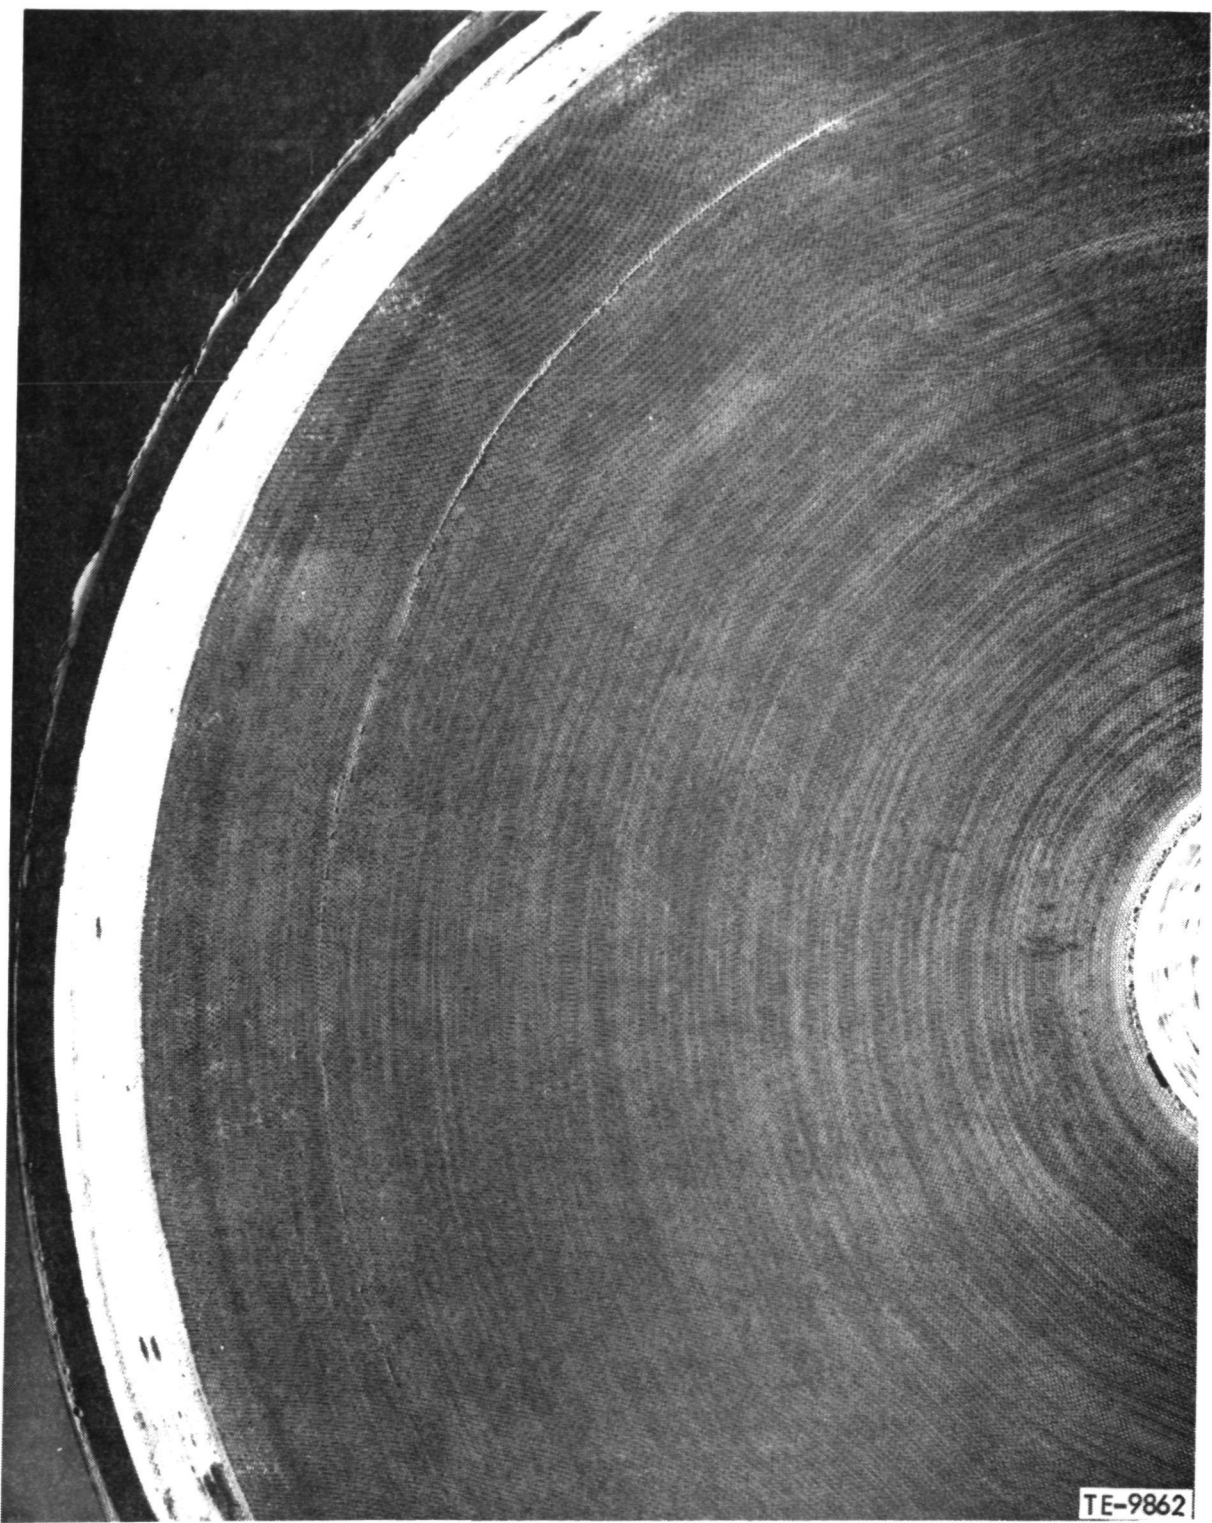
Figure 94. Cracked ceramic regenerator disk (DOE transit coach project).

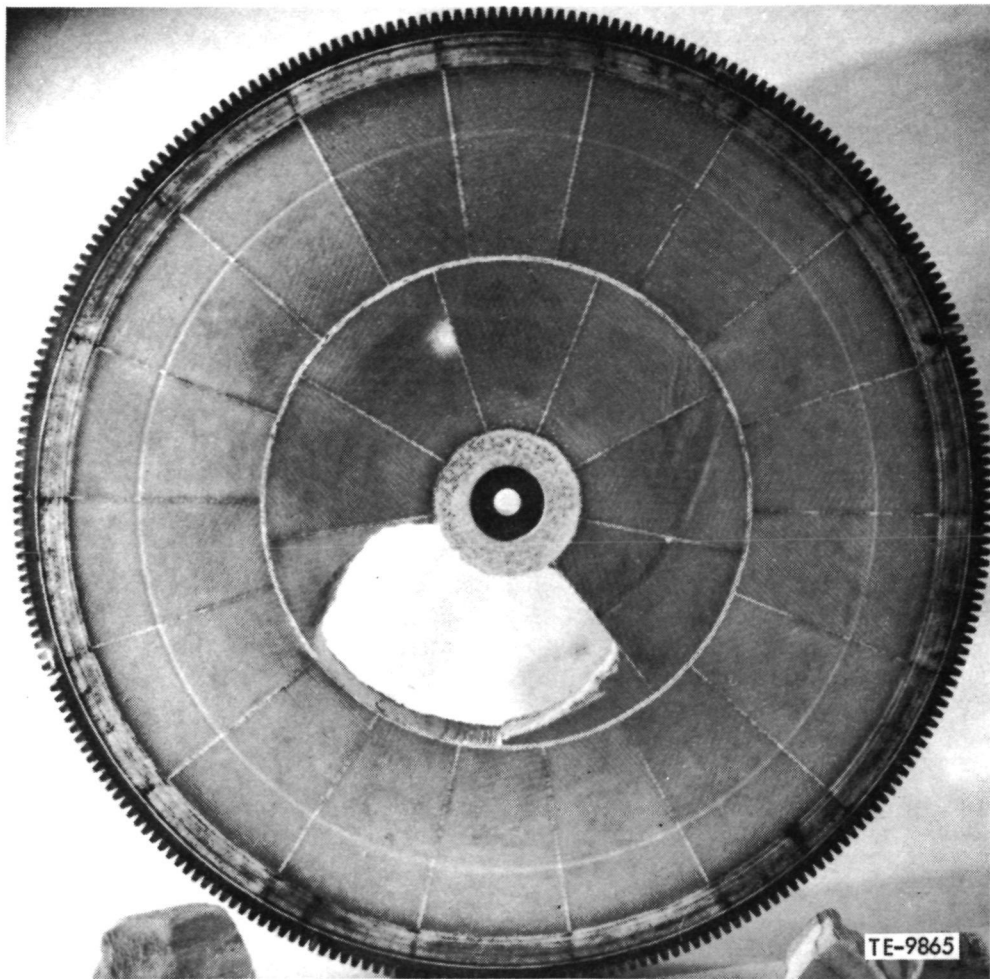
Figure 96. Failed NGK regenerator disk after 3.17 hours of rig testing.
