NASA-CR-159562
VOLUME 2 OF 2
AIRESEARCH 21-2063-E

MATERIALS FOR ADVANCED TURBINE ENGINES

PROJECT COMPLETION REPORT
PROJECT 1

LOW-COST DIRECTIONALLY-SOLIDIFIED
TURBINE BLADES

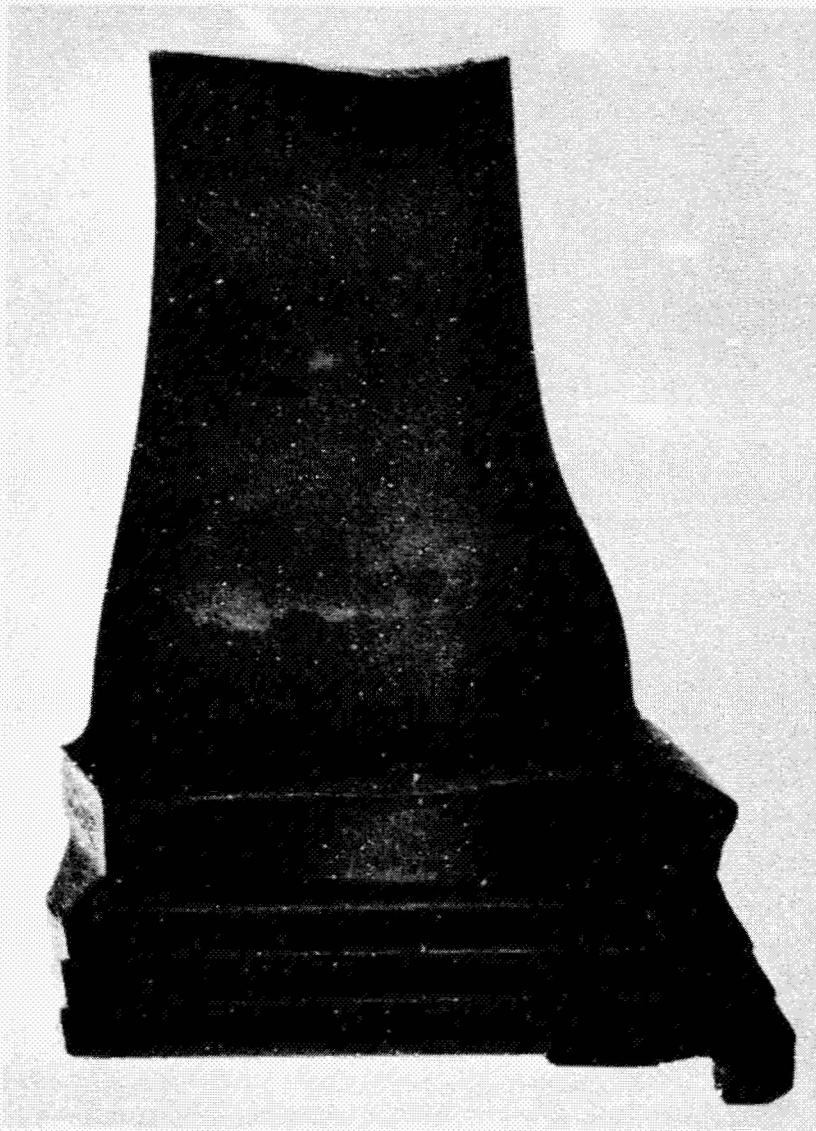
The tip-rub experience during the performance run removed approximately 0.015 cm (0.006 inch) from the tips of the tested blades. After disassembly and inspection of the engine, the rubbed blade tips were deburred to eliminate any sharp corners. No attempt was made to recoat the local areas near the rub zone

Figure 5. MATE DS Turbine Blade After Tip-Rub

prior to further testing. All new blades that were substituted into the disk were trimmed an equivalent amount to provide a uniform rotor-tip diameter. The wheel was assembled, balanced, and then installed in the engine. New shroud segments were procured with their chords trimmed 0.025 cm (0.010 inch) to allow for the additional circumferential thermal growths.

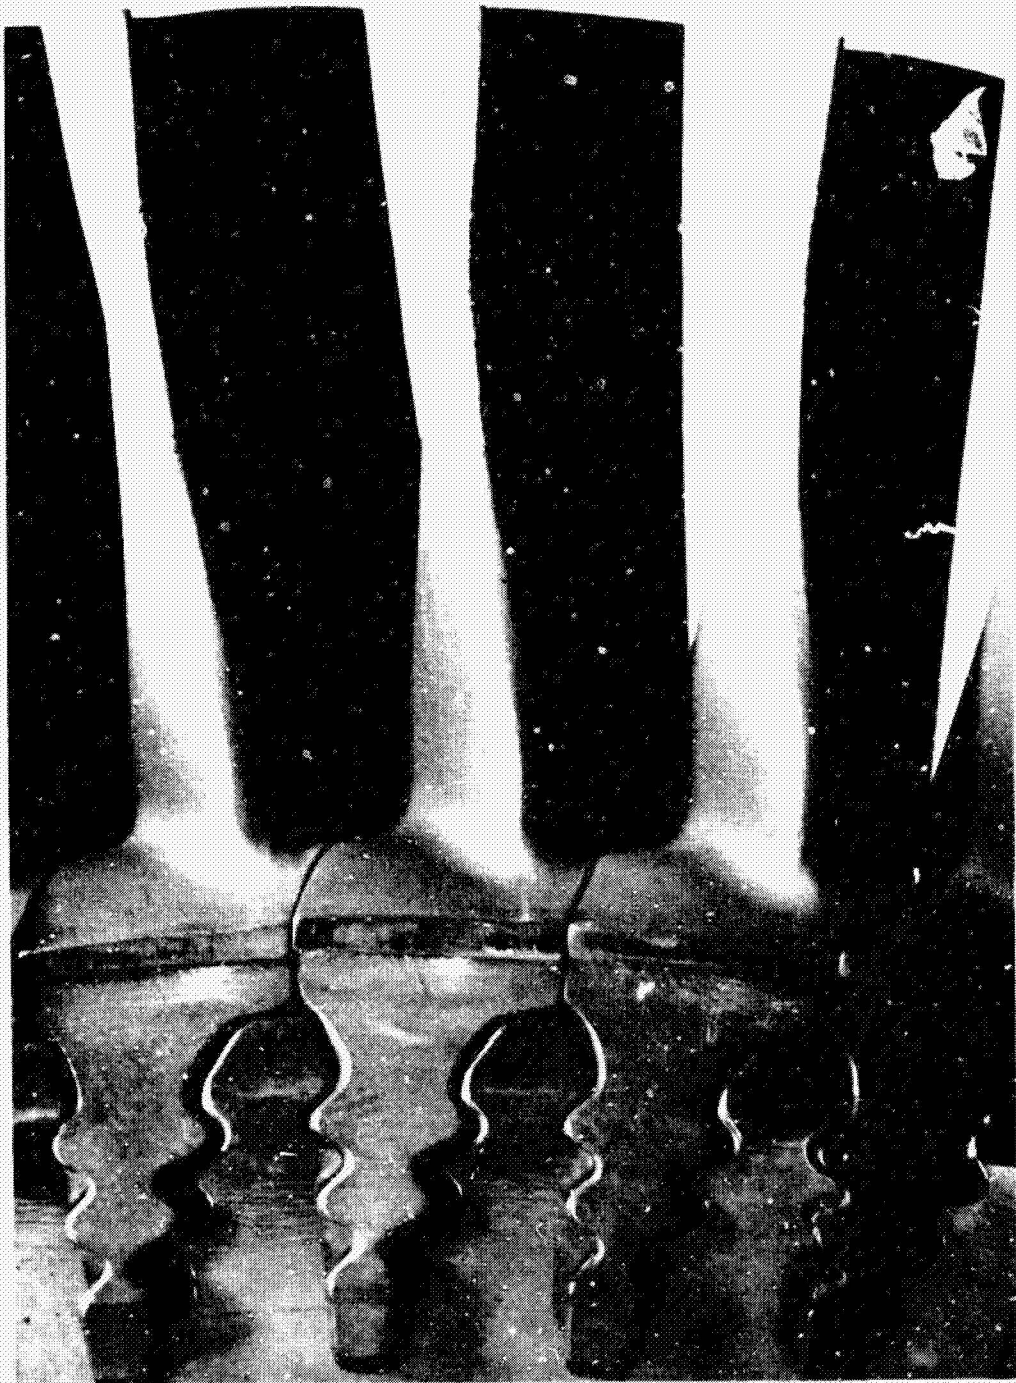
The third 50-hour test, designed to provide a limited evaluation of the low-cycle-fatigue capability of the DS blade, is shown in Figure 3. No significant engine testing problems were encountered during this test, and engine performance was consistent with previous testing. The post-test inspection revealed that there were no blades with any indication of distress. Figures 8 and 9 present photographs of typical leading and trailing edges of the blades tested for the entire 150 hours. The results of the metallurgical evaluation of the DS blades are presented in the Post-Test Evaluation section of this report.

Figure 8. Leading-Edge View of Typical Blades Subjected to the Entire 150 Hours of Endurance Testing

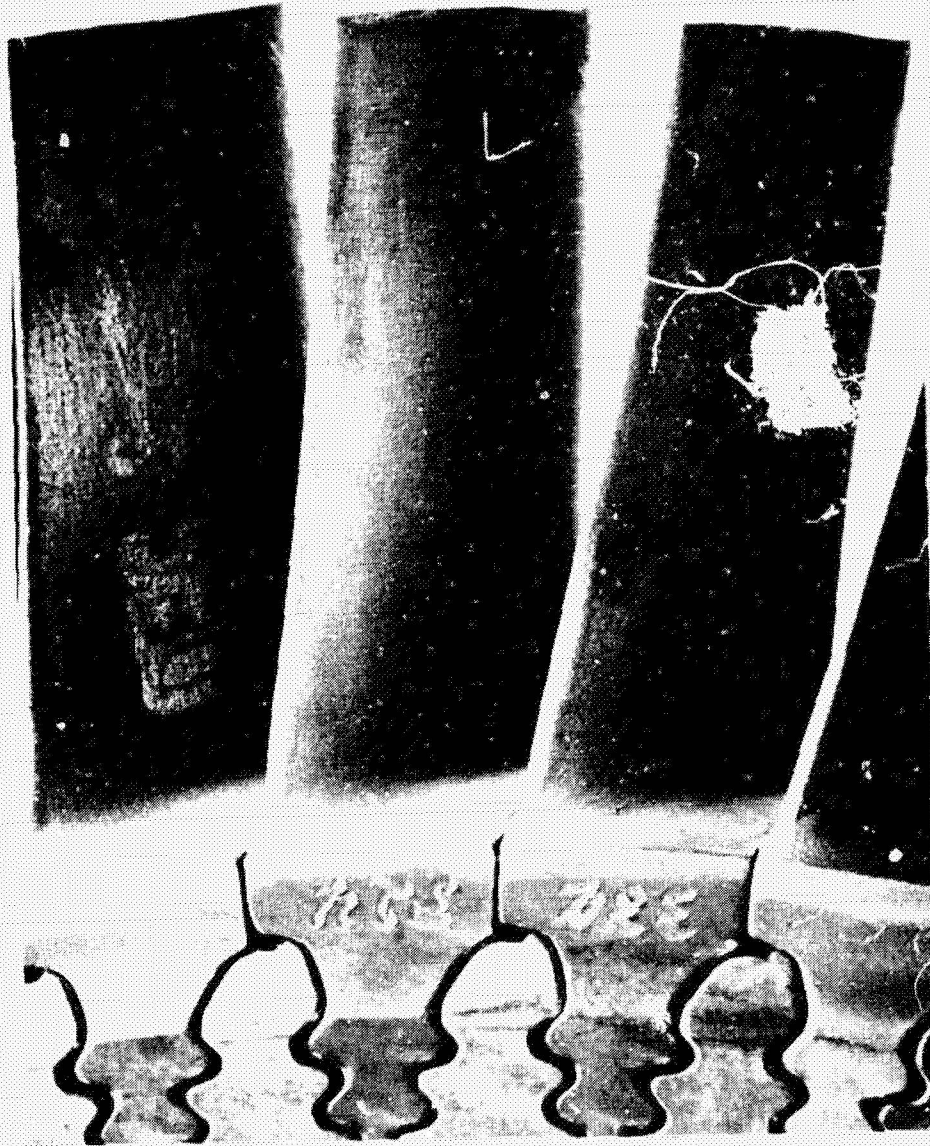
Figure 9. Trailing-Edge View of Typical Blades Subjected to the Entire 150 Hours of Endurance Testing

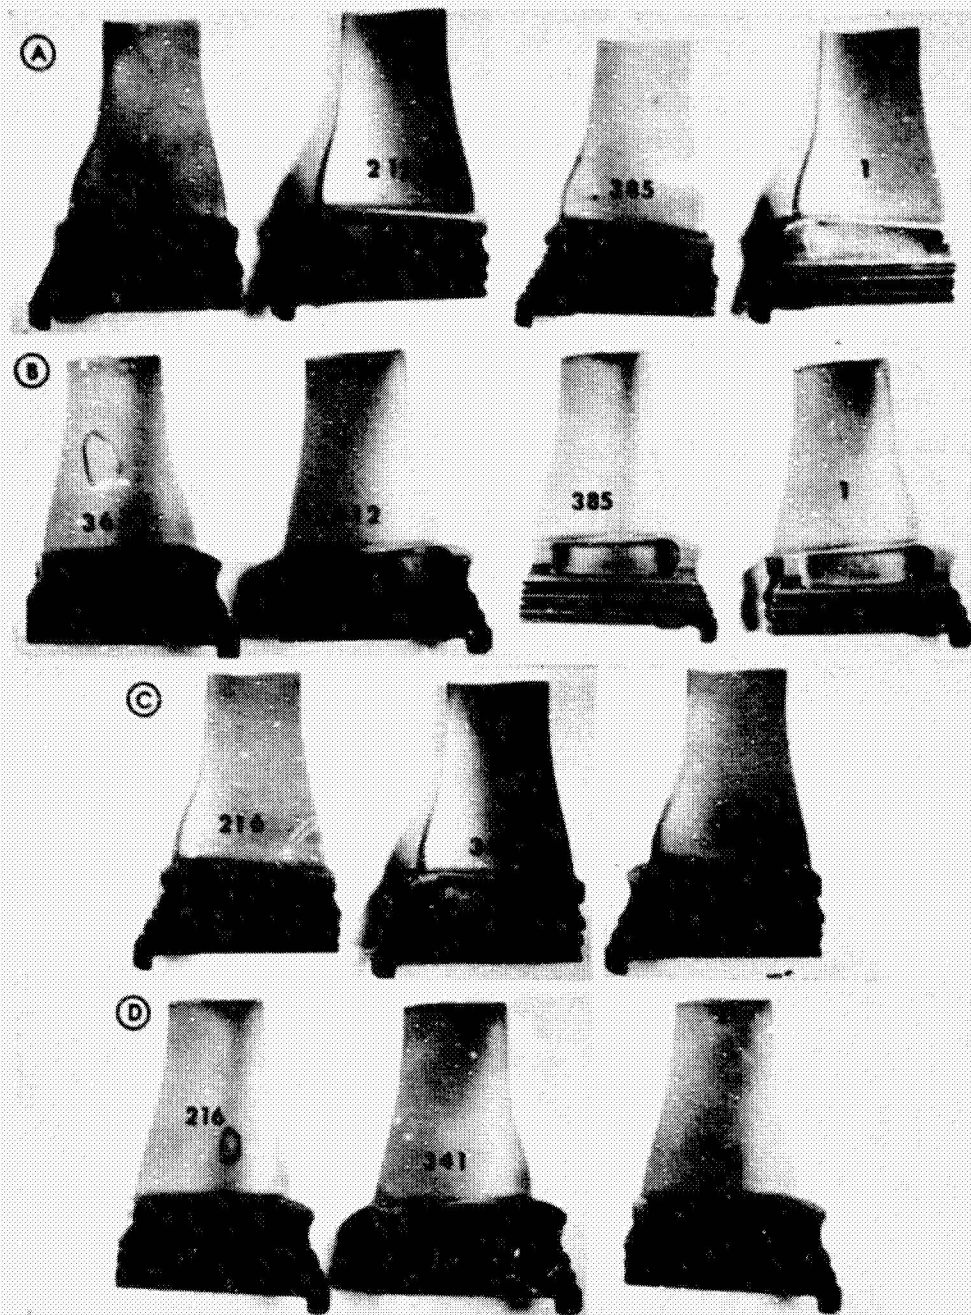
The serial numbers and the alloys of the blades selected for metallurgical evaluation are listed in Table III. Figure 10 depicts the seven blades selected for detailed examination after the third 50-hour test. The mark on the suction side of the blade S/N 367 identifies the area in which a 0.025-cm (0.010-inch) long coating crack was found. Inspection of this indication by binocular microscope at 40X magnification showed it to be a shallow crack within the coating and of no significance.

Figure 10. TFE731 MATE HP Turbine Blades After Engine Testing. The Numbers Denote the Blade Serial Numbers. Photos (A) and (C) Show the Pressure Side of the Blades, and Photos (B) and (D) Show the Suction Side (Mag.: 1X)

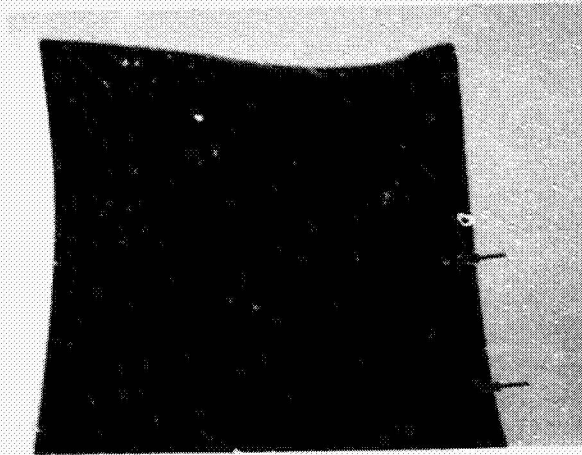
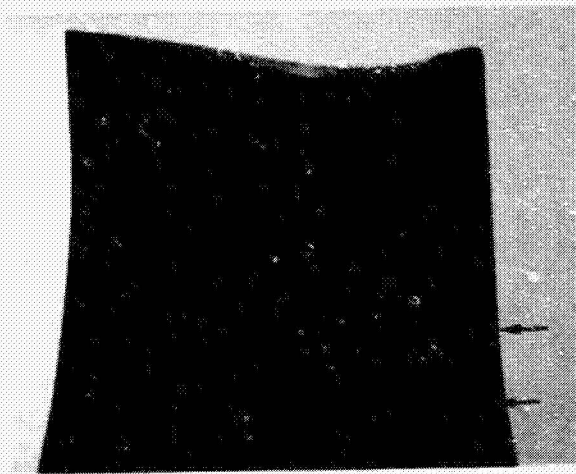
Although no extraneous deposits were found on any blades after the first 50-hour test segment, small white spots were noticed on all blades after the second and third test segments. These spots are shown in Photographs A and B of Figure 11. Figure 12 shows the areas sectioned to assess the microstructures of the seven blades and evaluate the small white spots.

Figure 11. Photomicrographs Showing Blade-Tip Rub Areas and the White Deposit on Blade Leading Edges. (a) MAR-M 200+Hf Blade S/N 13. (b) MAR-M 247 Blade S/N 341. The Arrows Indicate the White Deposit on the Leading Edges

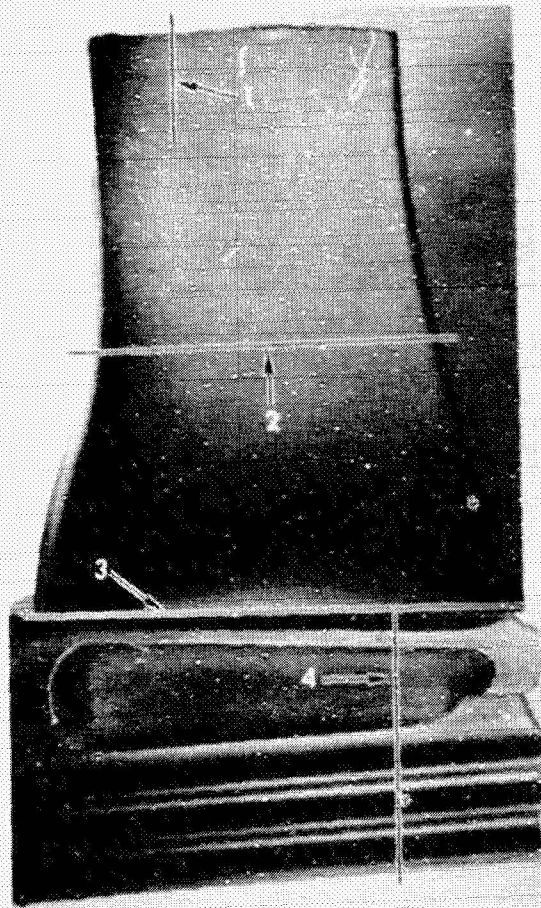
Figure 12. The Pressure Side of MAR-M 247 Blade S/N 341 Showing Microsection Locations. The Arrows Denote Sections: 1 - Blade-Tip Rub Area; 2 - Midspan; 3 - Airfoil Base; and 4 - Platform and Dovetail

Coating-thickness measurements were made at airfoil cross-sections located as shown on Figure 12. Ten measurements per section were collected and averaged, with the results reported in Table IV. All measured thicknesses were within the coating specification tolerance of 0.0025 to 0.005 cm (0.001 to 0.002 inch).

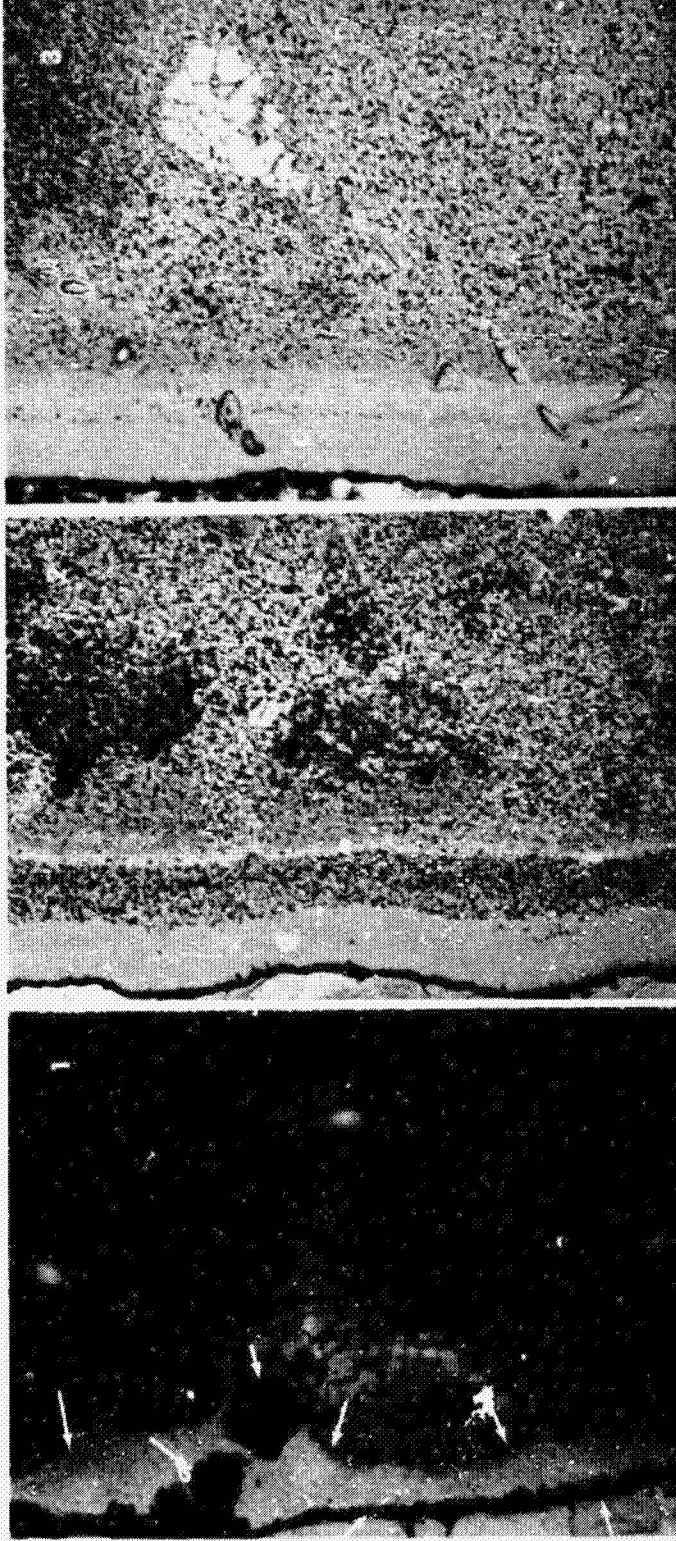
Figures 13 and 14 present typical microstructures of the DS blades--blade S/N 341 (MAR-M-247) and blade S/N 13 (MAR-M 200 +Hf), respectively. These blades suffered tip-rub damage during the performance test but were tested for the full 150 hours. As anticipated, oxidation and alloy depletion occurred at the tip where the coating was removed during the tip-rub, but other areas of the blades showed normal alloy and coating microstructures. More eutectic is evident in the MAR-M 200+Hf blade than the MAR-M 247 blade--probably due to the higher hafnium content of MAR-M 200+Hf alloy. Figure 15 presents the mid-span structure of four other engine-tested blades, both the alloy and coating structures are normal.

Figure 13. Representative Photomicrographs of MAR-M 247 Blade S/N 341. The Numbers Denote Sections Indicated in Figure 12. Section 1 is Through the Tip-Rub Damage Area Shows Alloy Depletion and the Oxidation; Section 2 Through the Mid-Span and Section 3 Through the Airfoil Base Show Normal Alloy and Coating Structures. The Letter C denotes Coating (Etchant: Oxalic Acid) (Mag.: 500X)

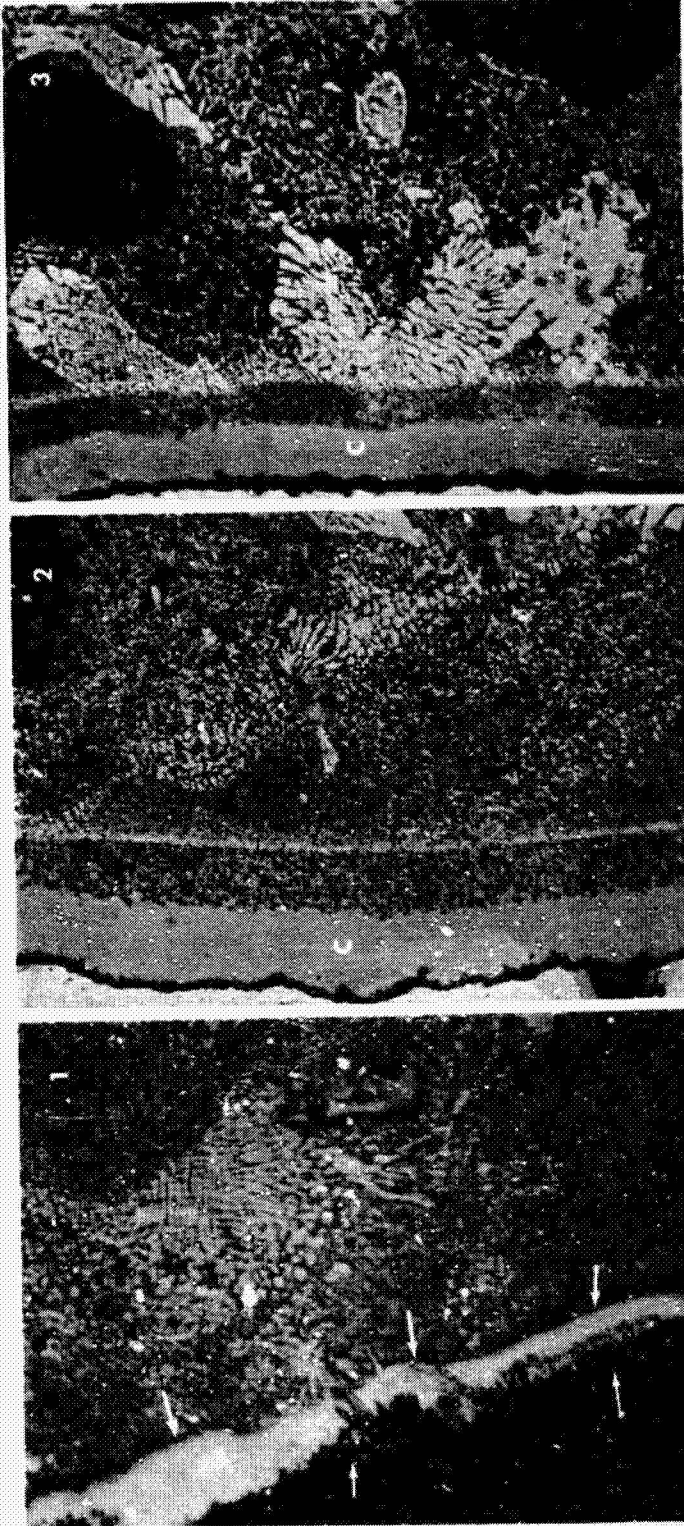
Figure 14. Representative Photomicrographs of DS MAR-M 200+Hf Blade S/N 13. The Numbers Denote Sections Indicated in Figure 12. Section 1 is Through the Tip-Rub Damage Area Shows Alloy Depletion and Oxidation; Section 2 Through the Mid-Span and Section 3 Through the Airfoil Base Show Normal Alloy and Coating Structures. The Letter C Denotes Coating (Etchant: Oxalic Acid) (Mag.: 500X)

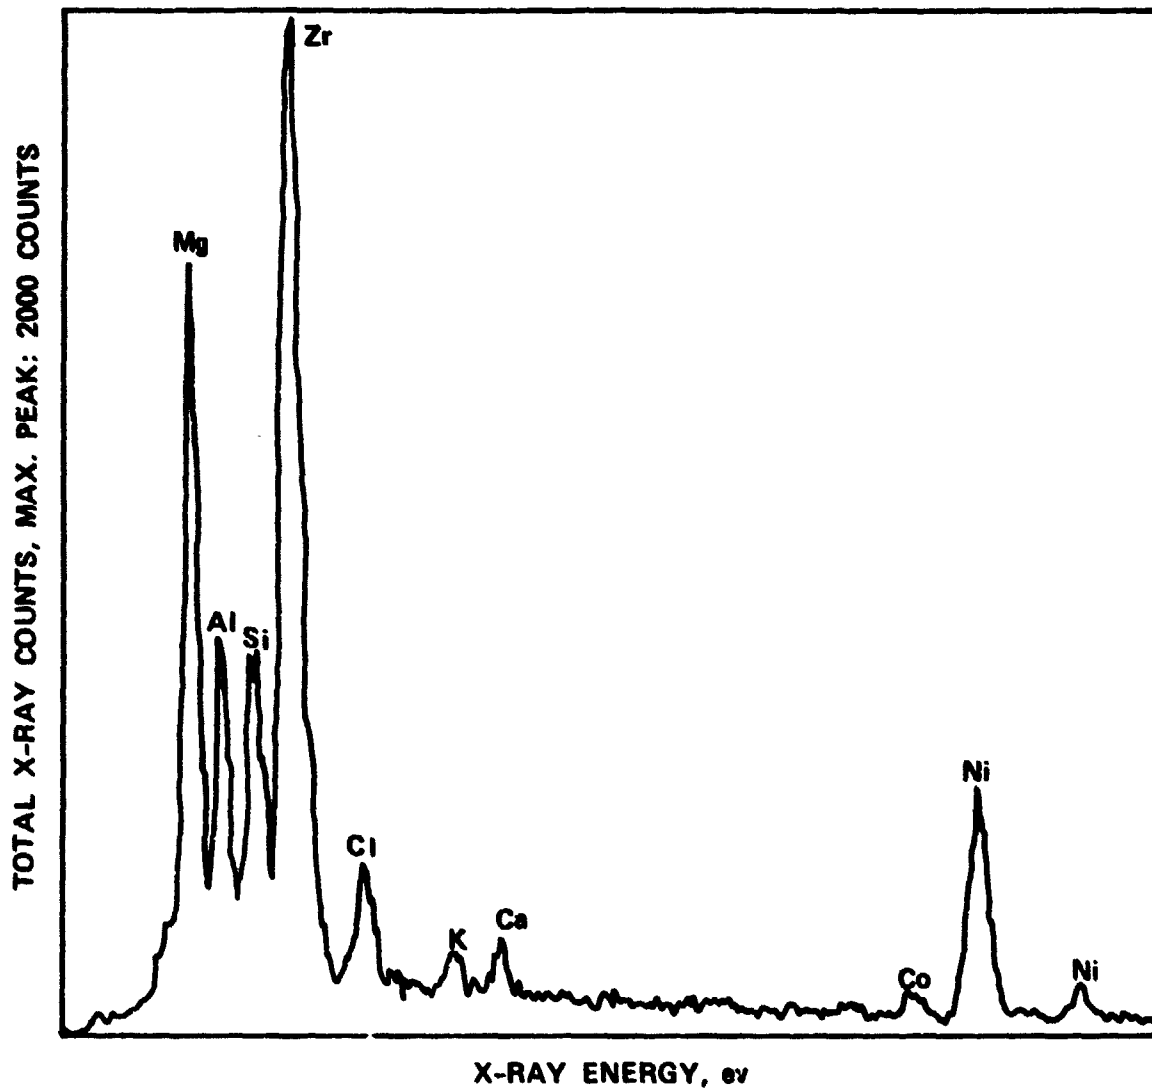
SEM Energy Dispersive Analysis by X-ray (EDAX) of the white deposit on the leading edges of blades S/N 13 and 341, indicated that the spots were high in zirconium and magnesium (see Figure 16). An investigation revealed that the test engine utilized a plasma-sprayed, magnesia-stabilized zirconia thermal-barrier coating on the transition liner immediately forward of the high-pressure turbine. This coating had spalled in spots during the engine testing, and some material was deposited on the blade leading edges.

Figure 16. EDAX Analysis of the White Deposit on the Leading Edges of Blades S/N 13 and 341 as Shown in Figure 11
