NASA CR-159867

ENGINE DIAGNOSTICS PROGRAM CF6-50 ENGINE PERFORMANCE DETERIORATION

General Electric Company
Aircraft Engine Business Group
Evendale, Ohio 45215

November 1980

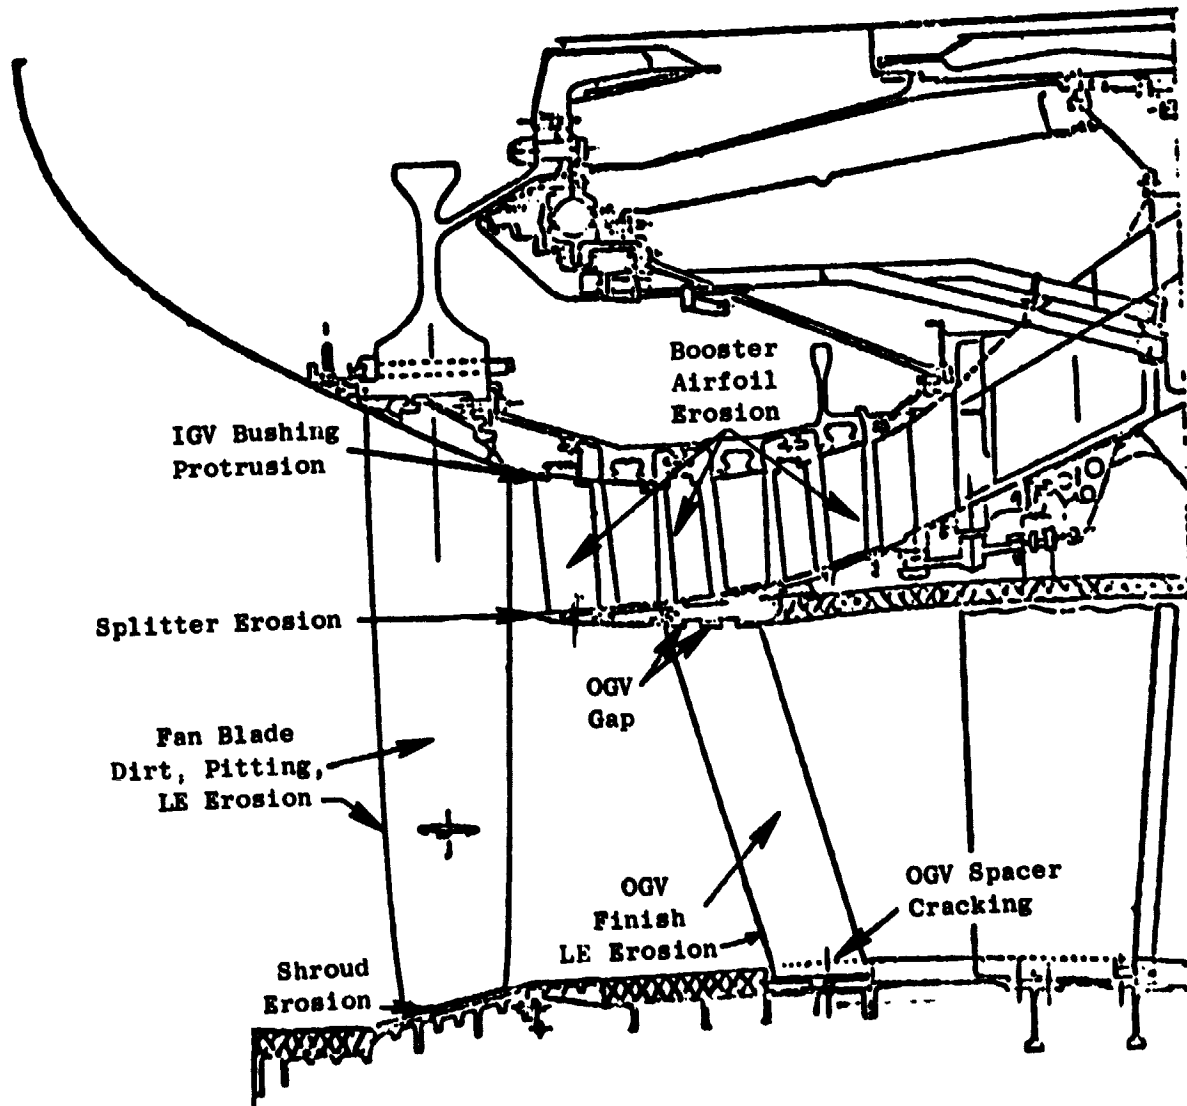
Figure 4-37. CF6-50 Deterioration Modes - Fan Section.

Clearances between the fan blade tip and shroud are set to achieve a minimum of 0.175 inch with a maximum allowable average of 0.201 inch. The minimum clearance is designed to prevent blade tip rubs while the average clearance, which considers blade tip and shroud runouts, is designated for fan performance reasons. Measurements from engines removed from revenue service indicated that the average clearance was 0.213 inch which compares with the production new engine average of 0.193 inch. Part of this clearance increase is attributed to the airline shop maintenance practice of controlling only the minimum clearance since clearance measurements are required only when replacing the fan rotor or fan casing. Any underminimum clearances observed during engine buildup are opened by local grinding of the shroud which results in an increased average clearance. The method of measuring clearances is to use a dial gage with two pins that locate the correct axial plane for the measurements. Because pins are used, the tendency is to measure the high point on

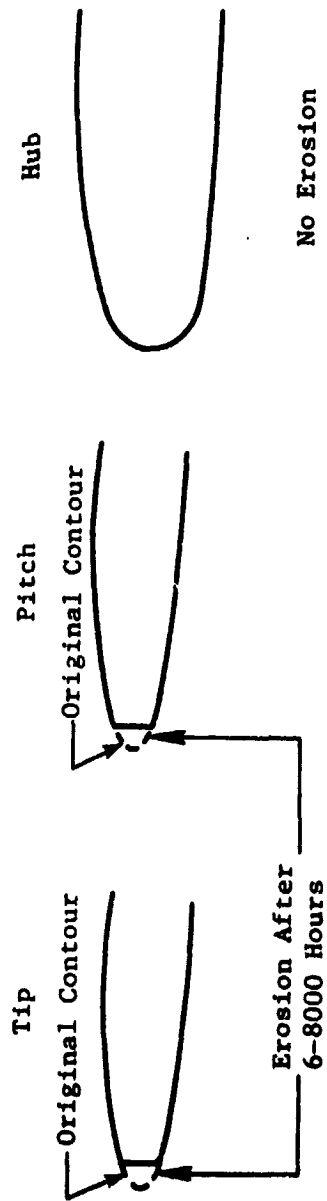
Figure 4-42. Erosion Pattern on Stage 1 Fan Blade.

The shape of the fan blade leading edge is extremely important for optimum performance. Erosion of the leading edge in 6,000 to 8,000 hours of engine operation has been observed to be a significant deterioration mode (Figure 4-42). While it is difficult to analytically assess the performance effects

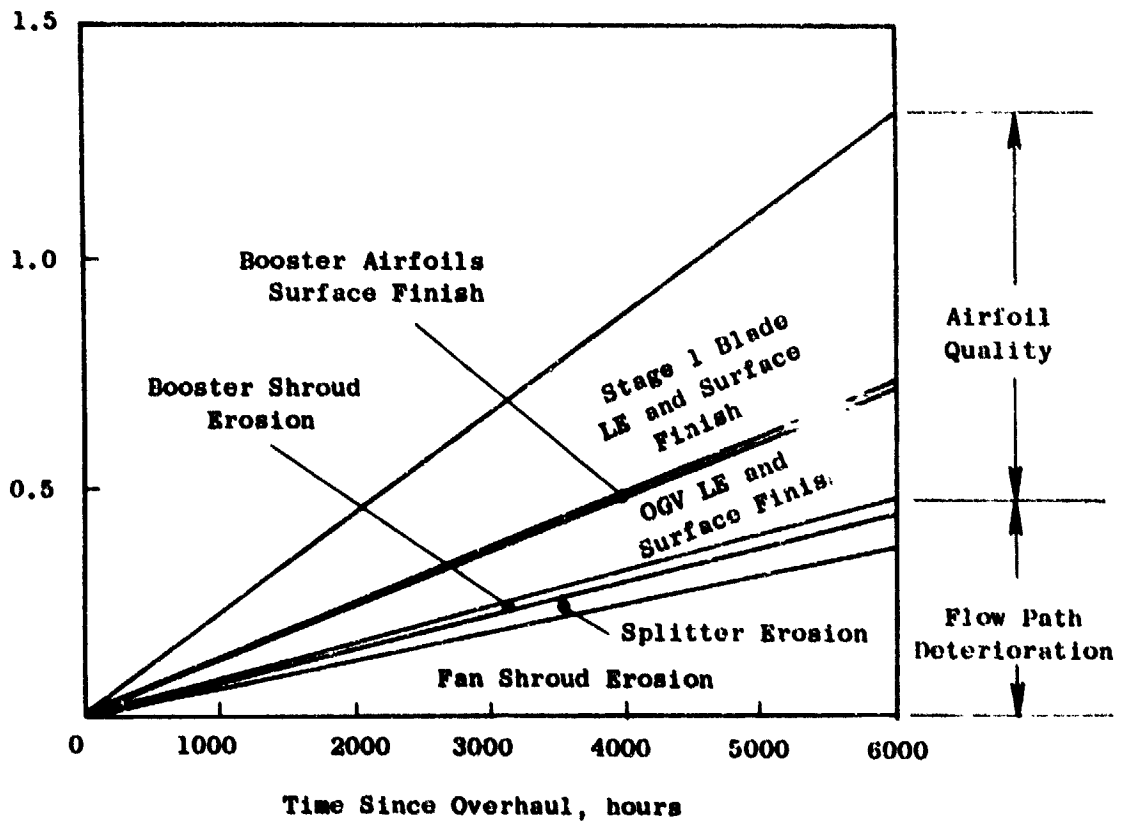
Figure 4-43. Fan Section - Estimated Deterioration Characteristics at 6000 Hours.

Fan Blade	<u>Δ SFC at Cruise, percent</u>
Tip Clearance	0.38
Leading Edge Contour	0.44
Surface Roughness	0.03
Dirt Accumulation	0.12
Splitter Leading Edge	0.07
Bypass OGV	
Leading Edge	0.06
Roughness	0.18
Booster	
Tip Clearance	0.03
Surface Roughness	0.01
Net	1.32%

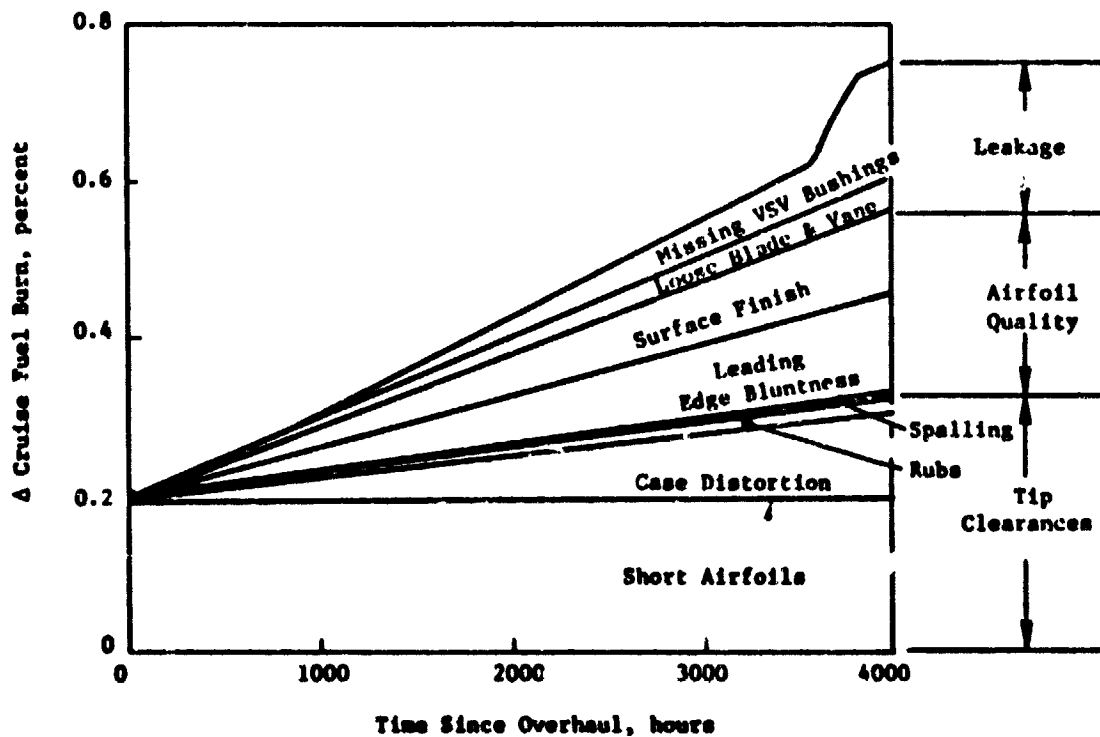
Figure 4-60. HP Compressor Section - Estimated Deterioration Characteristics at 4000 Hours.

The estimated rate of deterioration for each damage mechanism isolated during this study is presented in Figure 4-60. The short airfoil effect is shown as a constant loss since the deterioration occurs during engine refurbishment and not during revenue service.

Δ SFC at Cruise (percent)
Increase in Airfoil Tip Clearances	0.33
Airfoil Leading Edge Bluntness	0.11
Airfoil Finish Degradation	0.11
Casing and Spool Coating Degradation	0.01
Variable Vane Leakage	0.15
Loose Blade and Vane Losses	0.04
Net	0.75

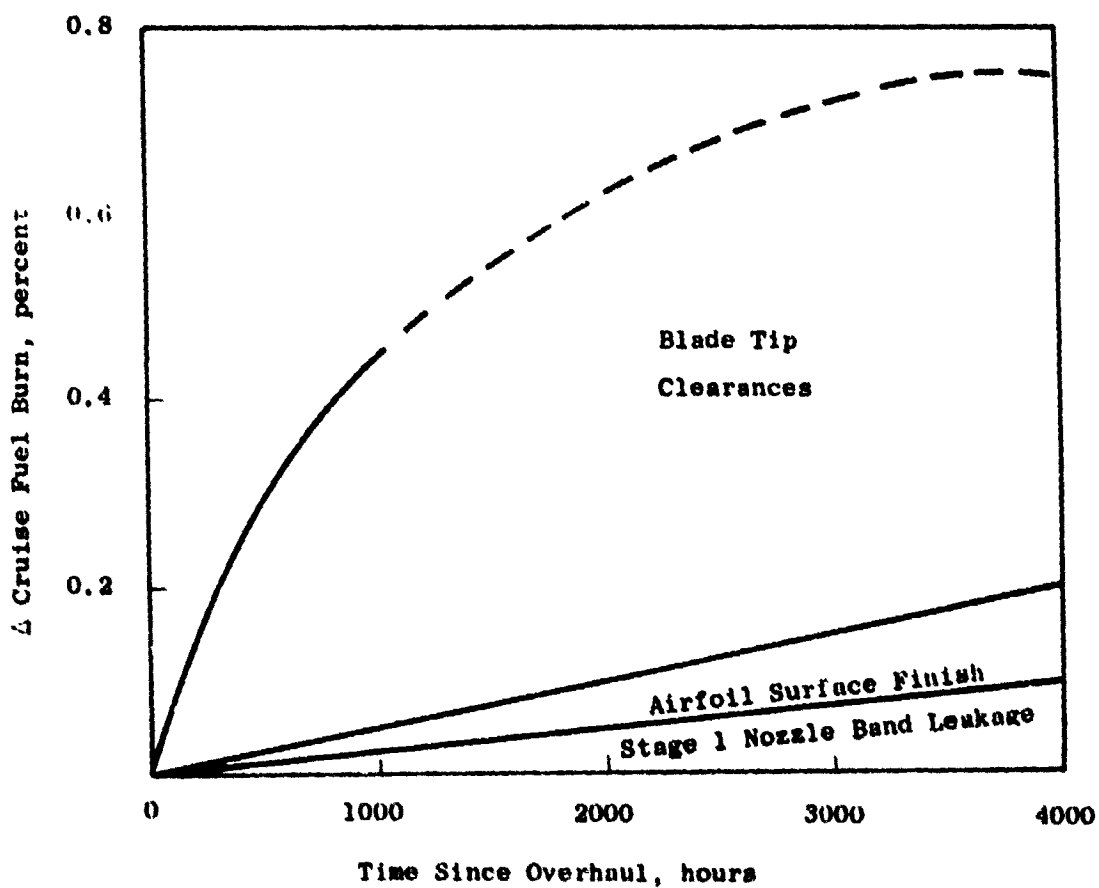
Figure 4-79. HP Turbine Section - Estimated Deterioration Characteristics.

The best estimate for the deterioration rate for each damage mechanism is presented in Figure 4-79. A dotted line is shown for the tip clearance effect after approximately 1,000 hours. This is intended to represent an "unknown" condition; but as previously discussed, is expected to occur during one or two rub events rather than being time-dependent.

<u>Δ SFC at Cruise, %</u>
Increase in Blade Tip Clearances - Stage 1	0.42
Stage 2	0.13
Stage 1 Nozzle Band Leakage	0.10
Surface Finish Degradation	0.10
Net	<u>0.75</u>

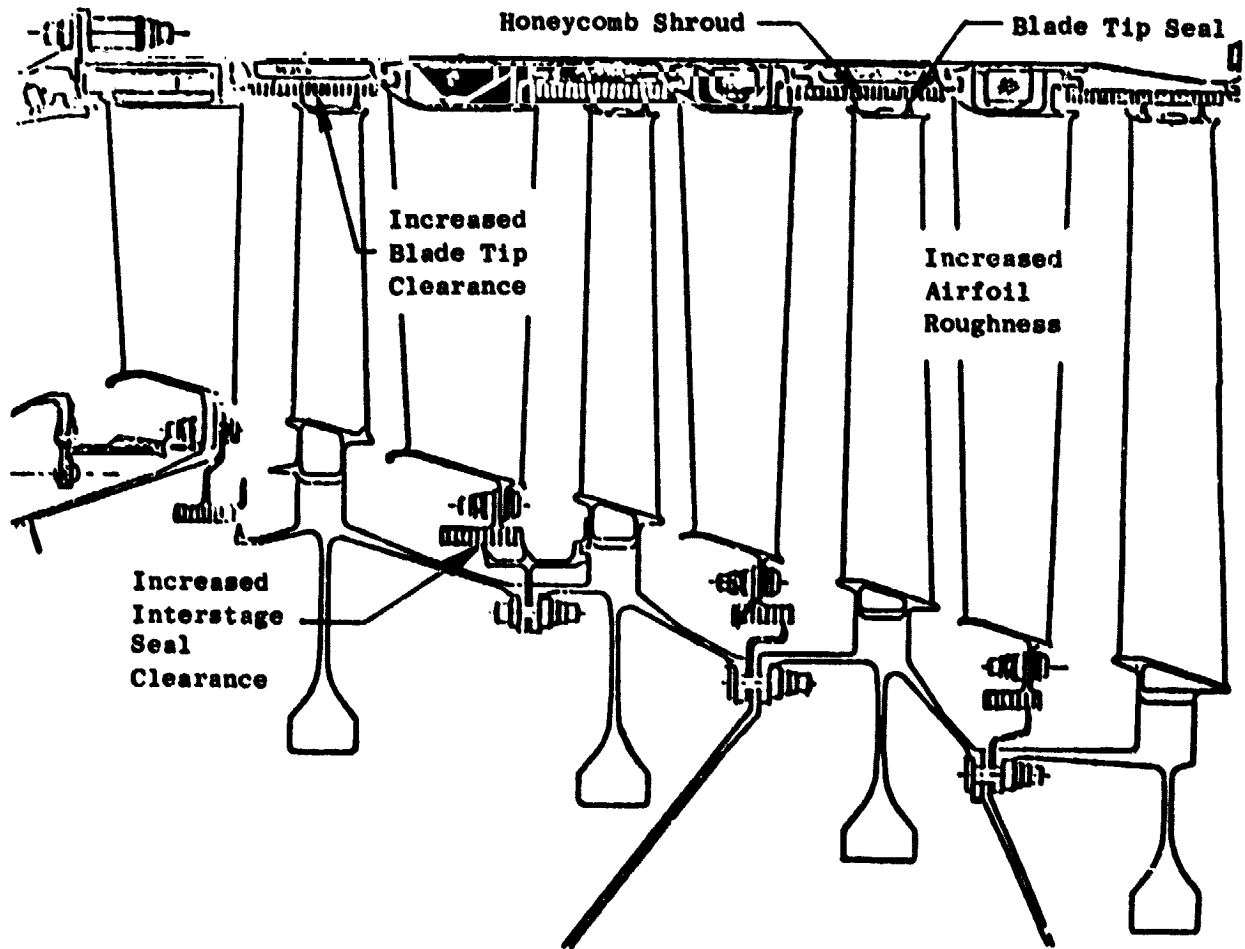
Figure 4-80. CF6-50 LP Turbine Section Deterioration Modes.

The calculated performance effects from these rubs are shown in Figures 4-81 and 4-82. The estimated increase of 0.035 inch in blade tip/shroud clearance is equivalent to a 0.43 percent loss in LPT efficiency while the 0.040-inch increase in interstage seal clearance is equivalent to a 0.32 percent loss in LPT efficiency for the typical parts with 5,000 hours. This 0.75 percent loss in LPT efficiency results in a 0.52 percent increase in cruise fuel burn which is equivalent to 0.41 percent after 4,000 hours.

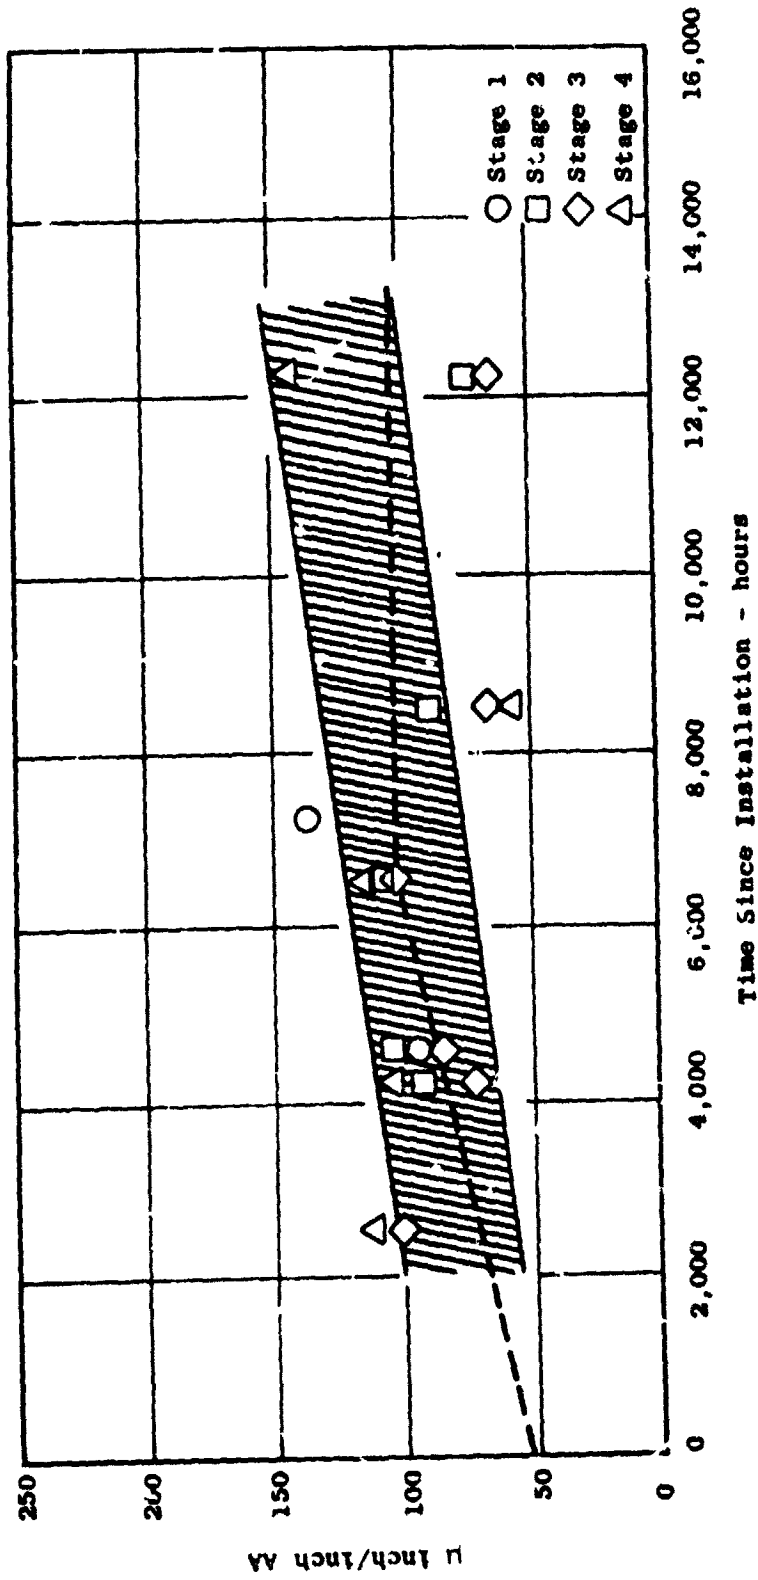
Figure 4-83. Degradation of IP Turbine Vane Surface Finish (Convex Side).

Deposits which degrade the surface finish were also noted for the higher temperature corrosion, but an additional and more lasting effect is also experienced. These deposits contain much larger amounts of sulfates which, while molten, remove the normal protective oxide scales formed on the surface of the metal thus destroying the metal's normal resistance to oxidation. The protective oxide scales do not reform as long as the sulfates' deposits remain on the surface. The loss of the protective oxide scales produces accelerated oxidation of the parent metal which also degrades the surface finish. These deposits can be removed using normal cleaning procedures, but the surface condition when there is parent metal attack is not restored by cleaning alone. The higher temperature corrosion is more likely to be experienced in the Stage 1 and 2 parts, since their metal temperatures are in the optimum range to produce this condition. However, experience to date indicates both types of conditions tend to overlap, and the distinction by stage in the LPT is less obvious. Most airfoil surfaces reviewed as part of this program have conformed to the lower rate of surface roughness increase as shown in Figures 4-83 and 4-84. Many of those have revealed corrosion in the sense of metallurgical attack, but this condition has not yet led to dramatic increases in surface roughness. In general, surface roughness effects are small, and the dashed lines shown in Figures 4-83 and 4-84 are the best estimates for average conditions. It also appears from these data that surface roughness continues to increase to 6,000 to 7,000 hours, and then remains relatively constant. Using the performance derivatives presented in Figures 4-85 and 4-86, average surface roughness changes of 32μ in./in. AA for the vanes and 50μ in./in. AA for the blades after 5,000 hours result in an approximate 0.07 percent decrease in LPT efficiency and a 0.03 percent increase in cruise sfc after 4,000 hours.

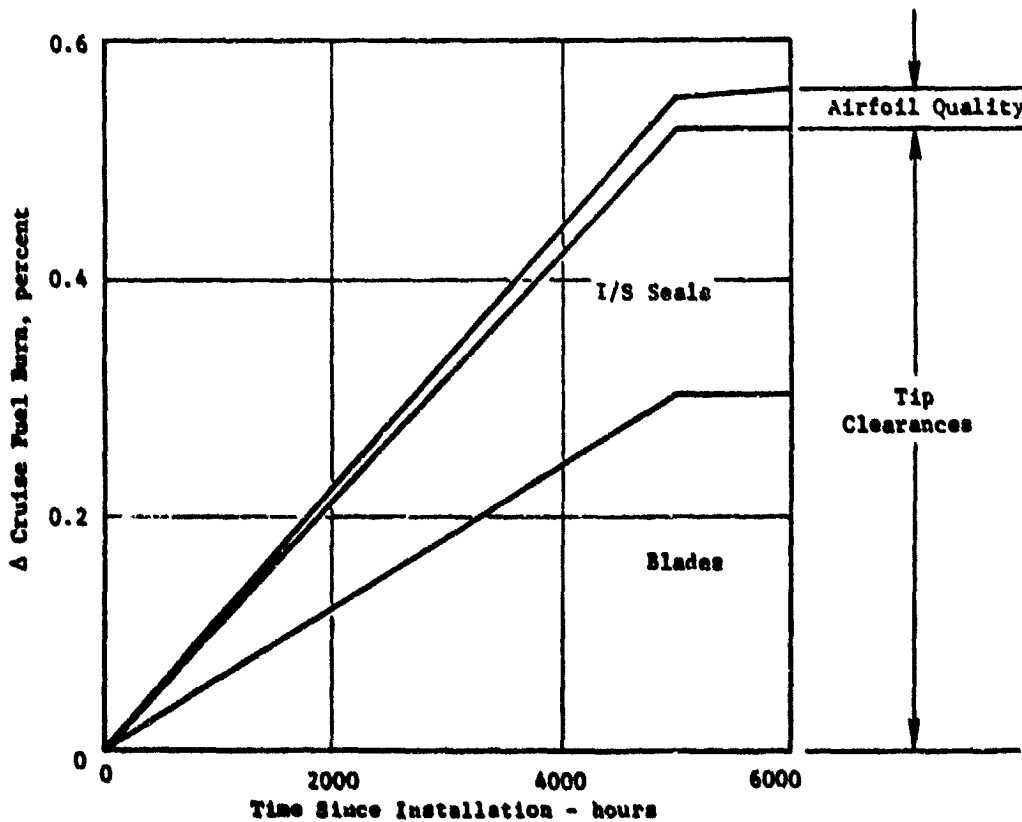
Figure 4-87. LPT Section - Estimated Deterioration Characteristics at 6000 Hours.

<u>Δ SFC ° Cruise, %</u>
Increase in Blade Tip Clearances	0.24
Increase in Interstage Seal Clearances	0.17
Surface Finish Degradation	0.03
Net	<u>0.44</u>
