CF6-6D ENGINE PERFORMANCE DETERIORATION

GENERAL ELECTRIC COMPANY
AIRCRAFT ENGINE GROUP
CINCINNATI, OHIO 45215

(NASA-CR-159786) CF6-6D ENGINE PERFORMANCE
DETERIORATION (General Electric Co.) 286 p
HC A13/MF A01 CSCL 21E

1. Report No. NASA CR159786		2. Government Accession No.		3. Recipient's Catalog No.	
4. Title and Subtitle CF6-6D Engine Performance Deterioration				5. Report Date January 1980

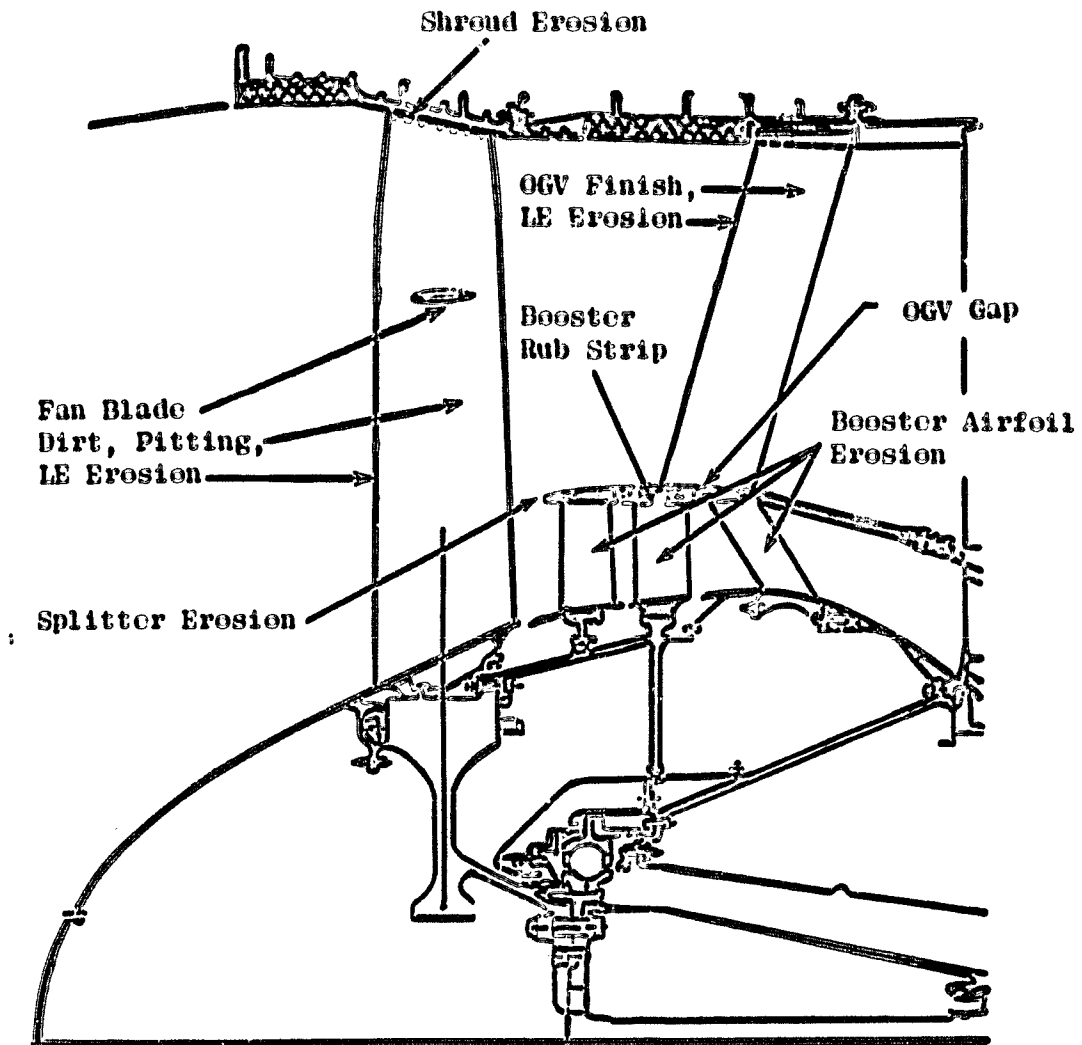
Figure 4-21. Fan and Booster Areas of Deterioration.

Removal of the rub strip material over the rotor resulted in a 0.185 inch clearance increase. This clearance increase results in a loss of 1.33 percent in booster efficiency or a 0.19 percent loss in cruise fuel burn efficiency.

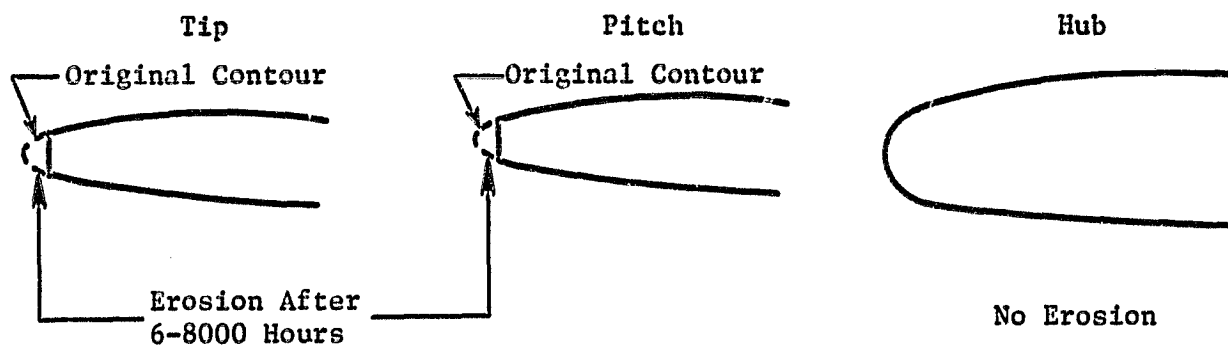
Fan Blade Leading Edge - The physical condition and shape of the fan blade leading edge is extremely important for optimum performance. Erosion of the leading edge in 6000 to 8000 hours of engine operation has been observed to be a significant deterioration mode. This erosion tends to blunt the edge as shown in Figure 4-24. While it is difficult to analytically assess the performance effects of changes to the fan blade leading edge shape, factory and field experience have permitted a reasonable assessment. Based on visual observation, the performance degradation due to fan blade leading edge bluntness was assessed at 0.71 percent fan efficiency or 0.38 percent cruise fuel burn.

Figure 4-24. Results of Erosion on Fan Blade Leading Edge.

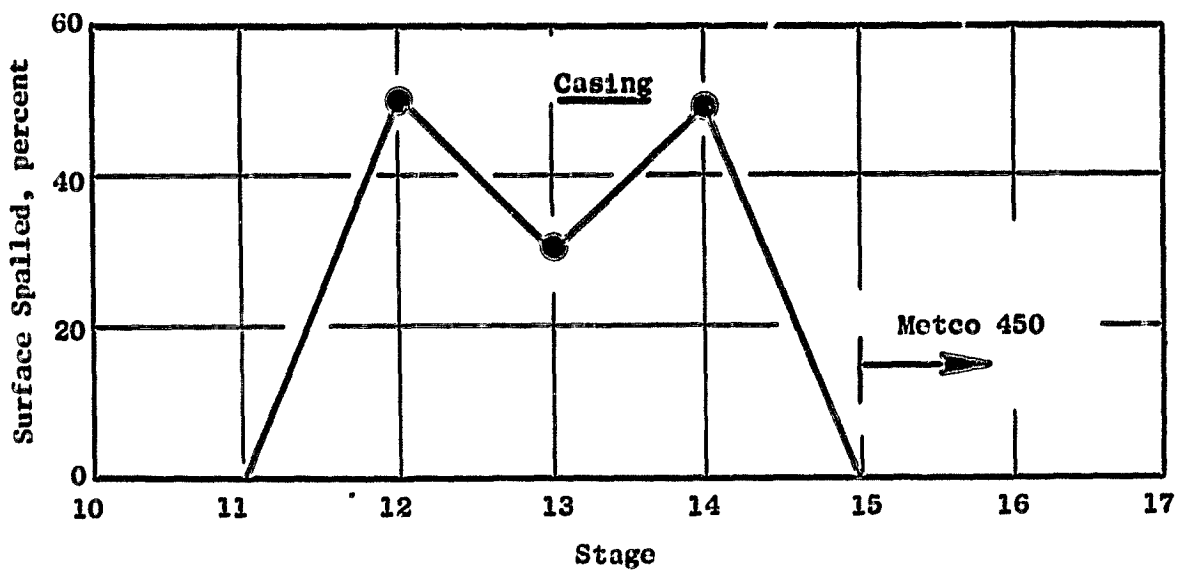
Figure 4-29. CF6-6 High Pressure Compressor - Abradable Aluminum Rub Coating Spalling Deterioration at 6000 Hours.

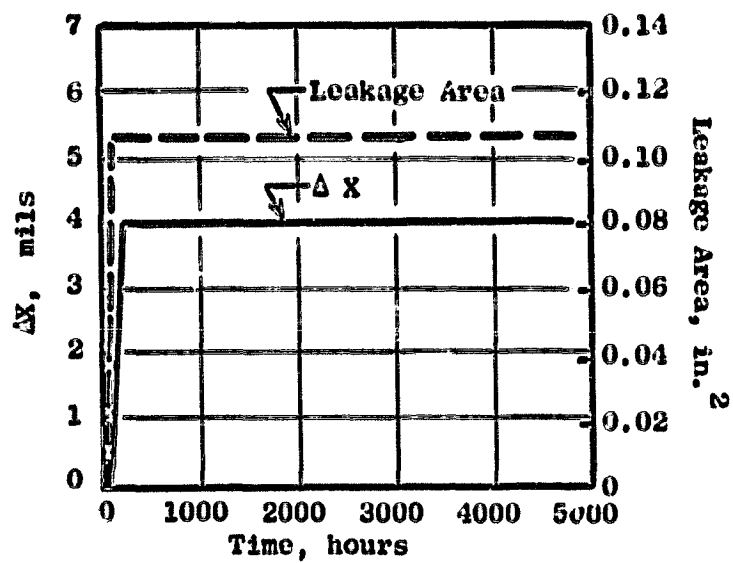
Figure 4-39. Stage 1 HPT Nozzle Vane Outer Band Distortion.
