CF6-6D ENGINE SHORT-TERM PERFORMANCE DETERIORATION

W.H. Kramer, J.E. Paas,
J.J. Smith, and R.H. Wulf

GENERAL ELECTRIC COMPANY
AIRCRAFT ENGINE GROUP
CINCINNATI, OHIO 45215

NASA Lewis Research Center
Contract NAS3-20631

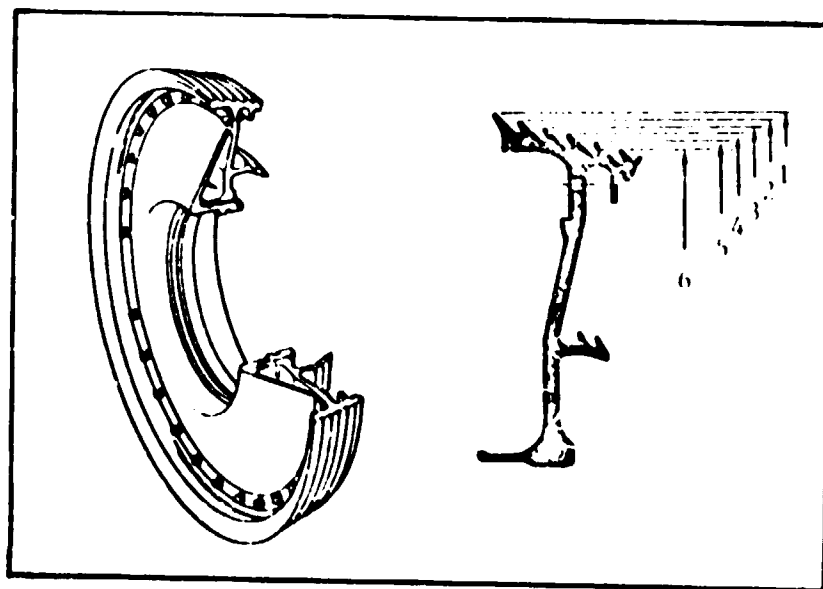
A visual inspection revealed no discrepancies. Diameter and runout measurements of each of the CDP seal teeth, Figure B-5, were made and the results are shown in Table B-VI. (NOTE: The twelve o'clock position was arbitrarily chosen, and all measurements are relative to that point.) Calculations of the rotating seal to stationary seal (Table B-IX later in this report) clearances, as shown in Table B-VII indicated no measurable change from production nominal clearances.

Figure B-5. Forward CDP Seal, Rotating.

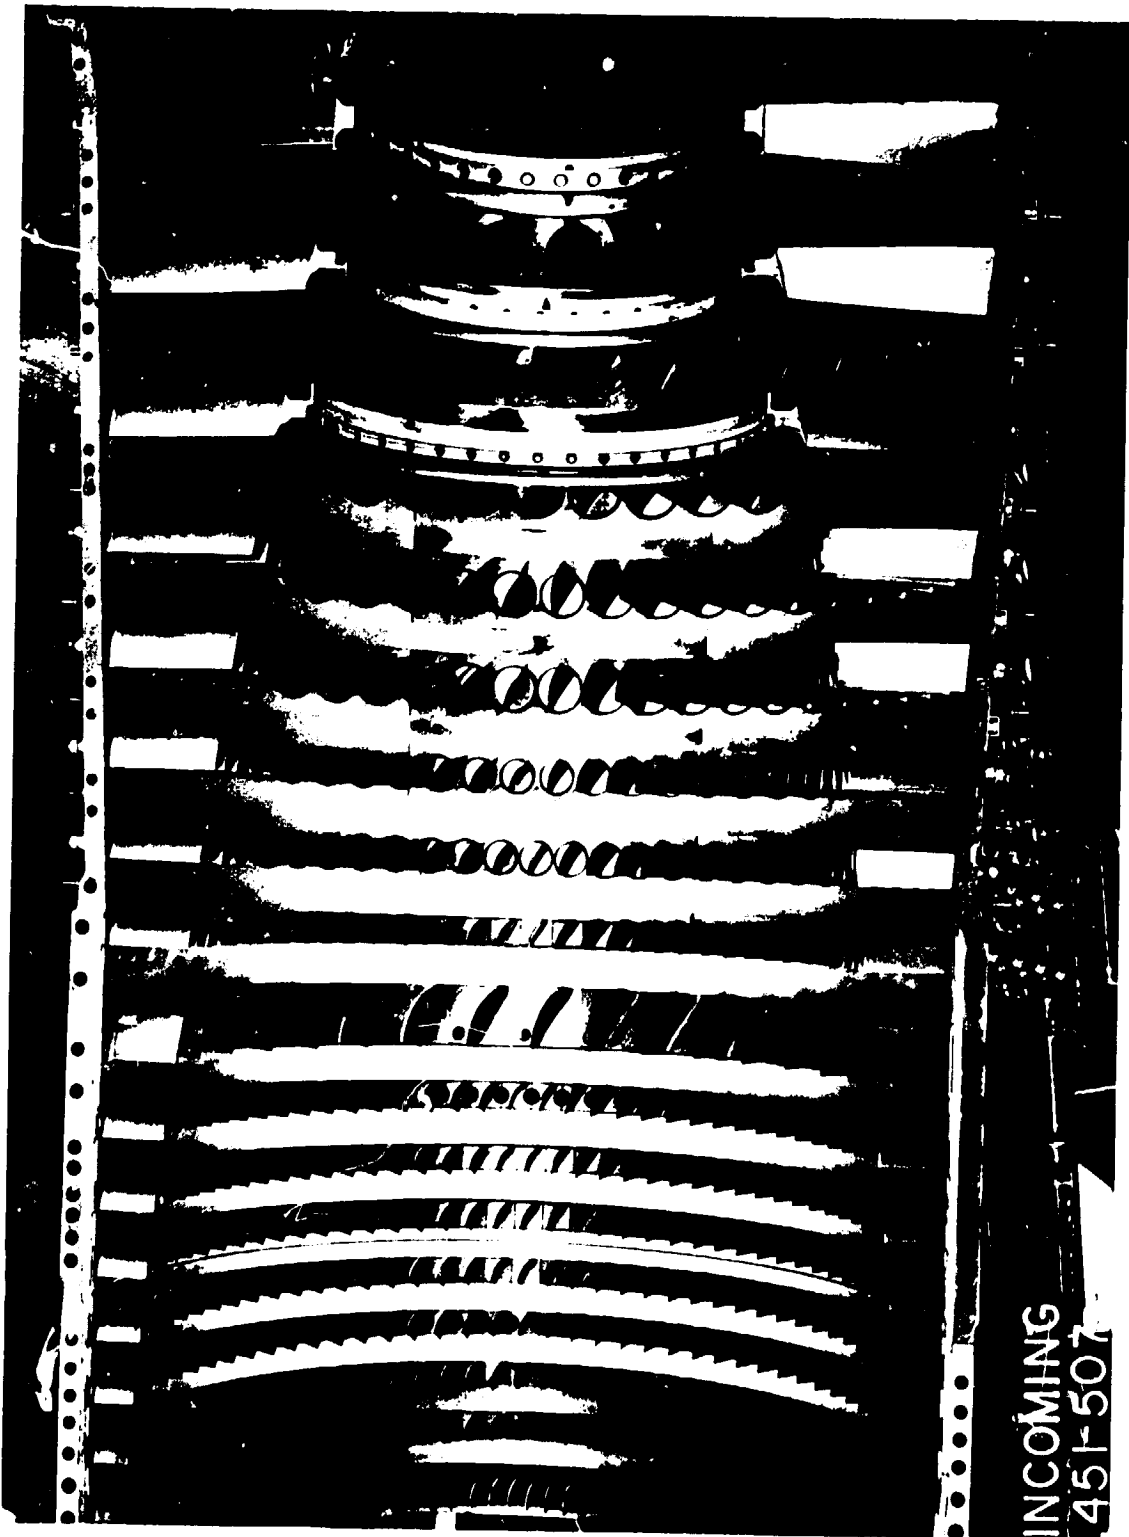
Figure B-6. High Pressure Compressor Stator Assembly - Rubs and Chipped Coating.

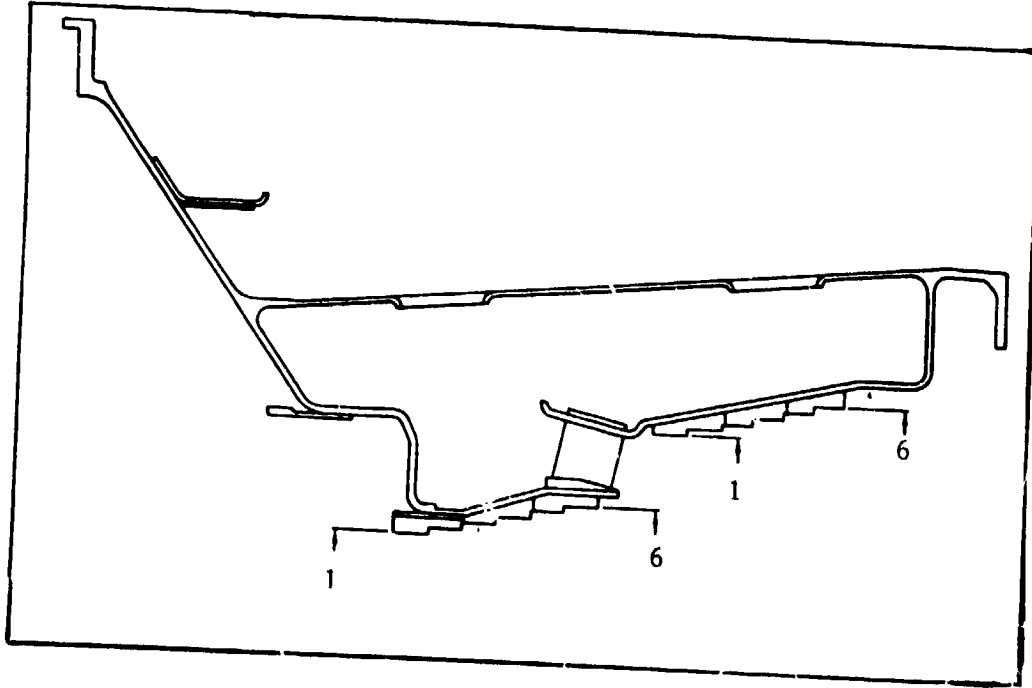
A visual inspection of the No. 4B pressure balance seal, Figure B-9, showed it to be in excellent condition with only very slight rubs located at approximately the six o'clock position. Dimensional inspections consisting of measurements of eight equally spaced diameters were made on each land of each of the aft seals. This seal structure provides the stationary seal surface for both the aft CDP seal and balance piston seal. These measurements are presented in Tables B-X and B-XI, while the inspection data for the rotating seals are presented in Tables B-XXIX and B-XXX in Section B.3.3 of this report. The resultant clearances are shown in Tables B-XII and B-XIII. Note that the 0.010 inch average clearance of the aft CDP seal is the nominal value for stackup of production/new hardware. The balance piston seal was within 0.0005 inch of its nominal stackup of 0.010 inch.

Figure B-9. No. 4B Pressure Balance Seal (Mini-Nozzle).

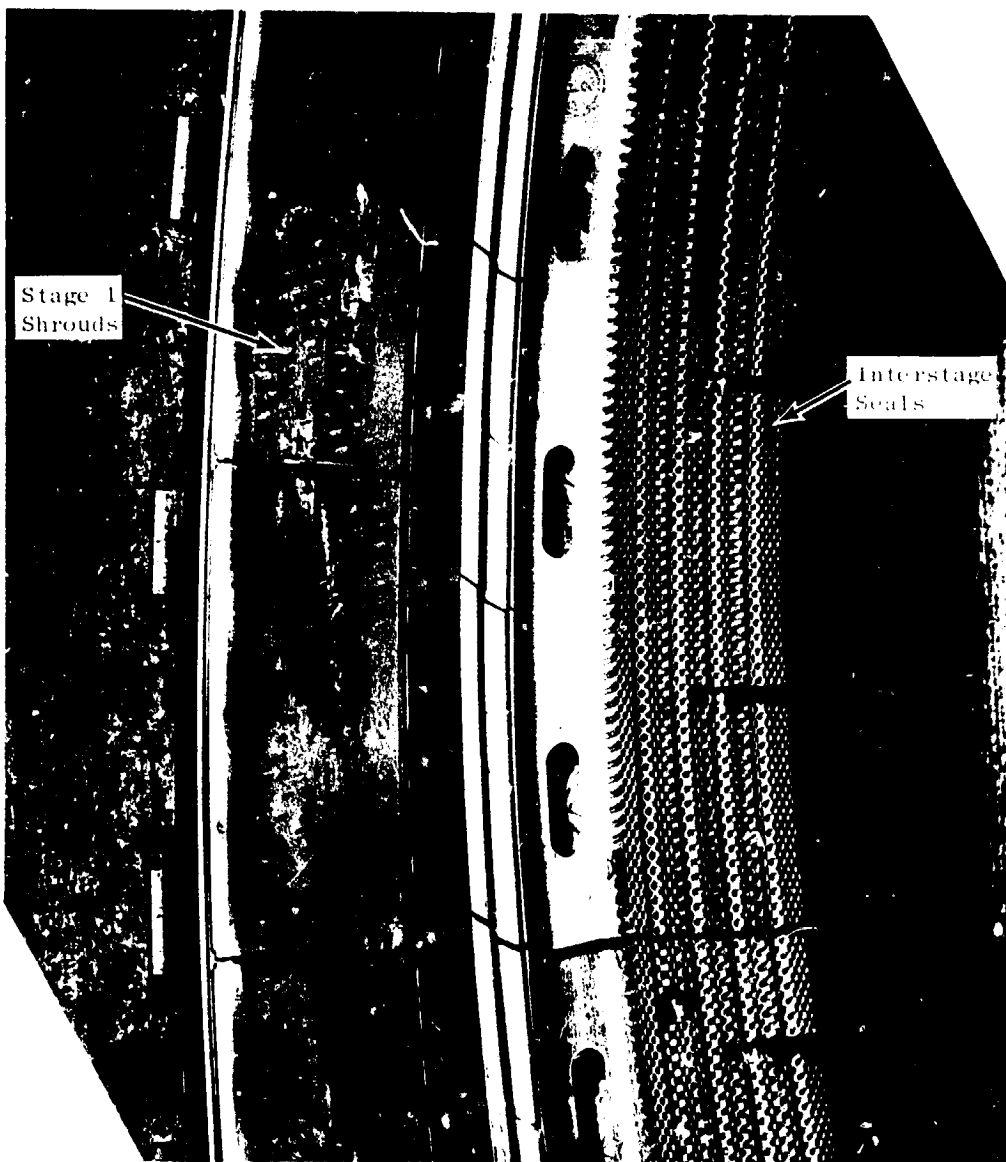
Figure B-14. Stage 1 HPT Shroud - Rub.

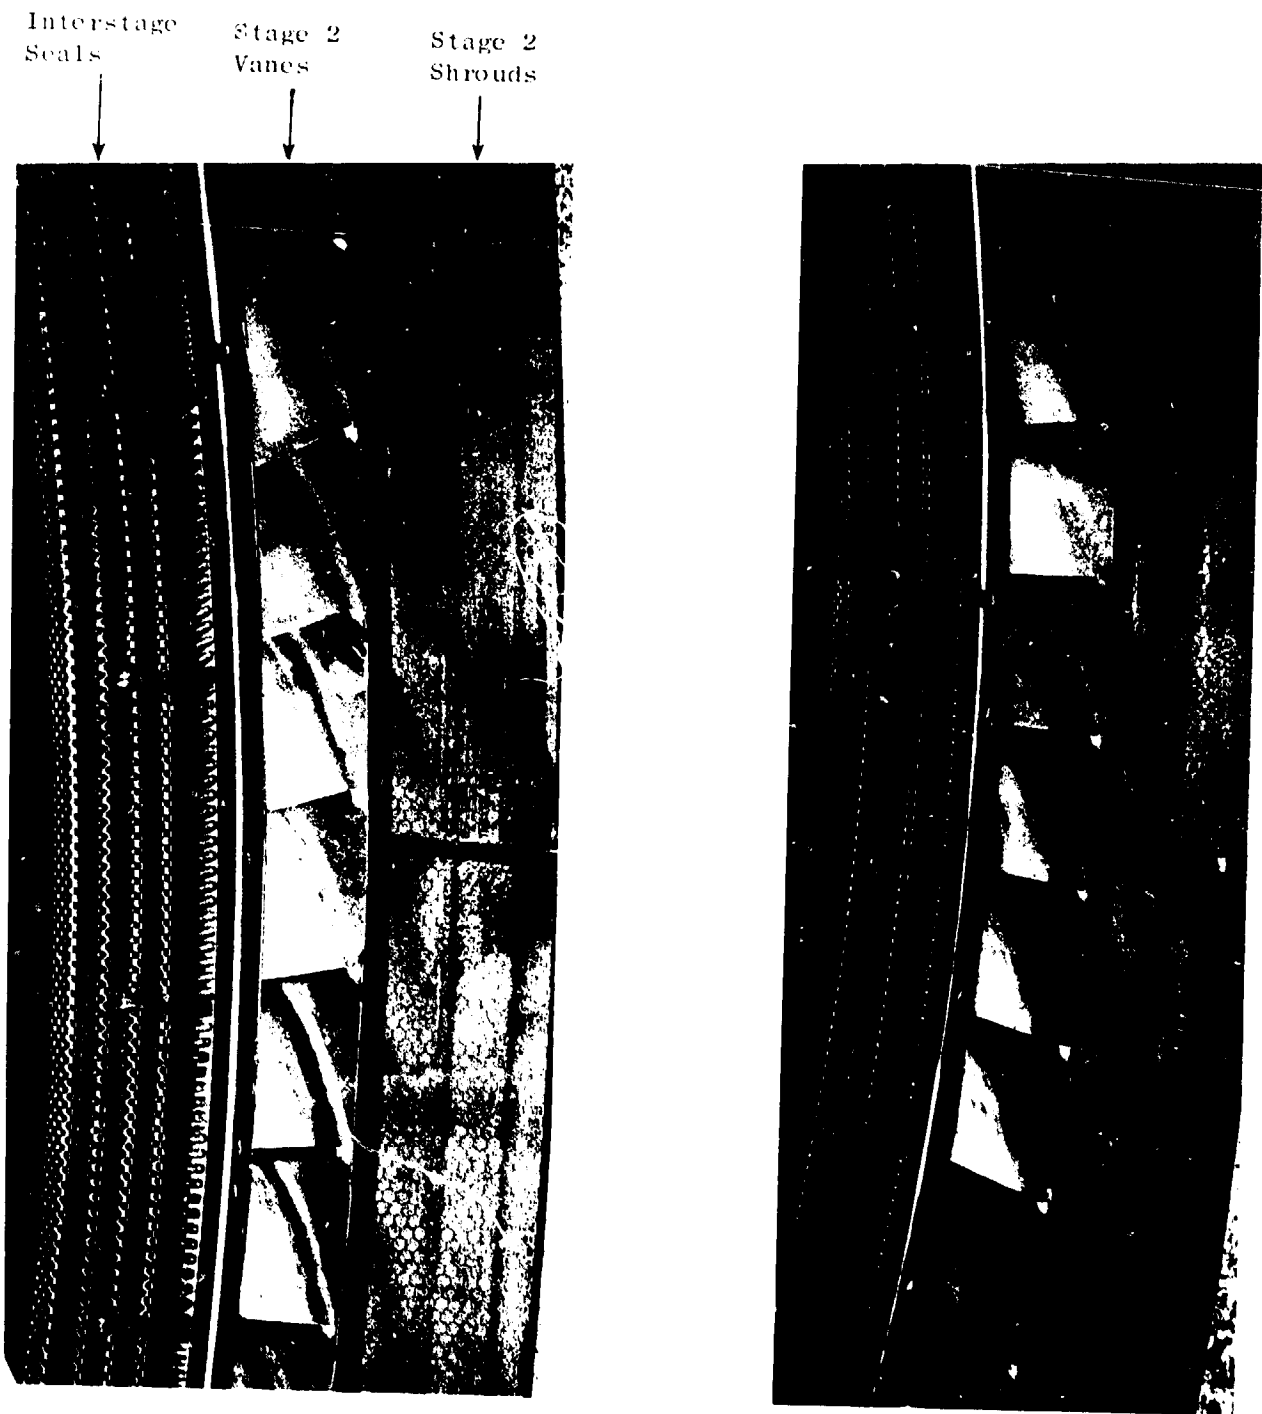
Figure B-15. Stage 2 HPTN Assembly - Typical Stage 2 Shroud Rubs.

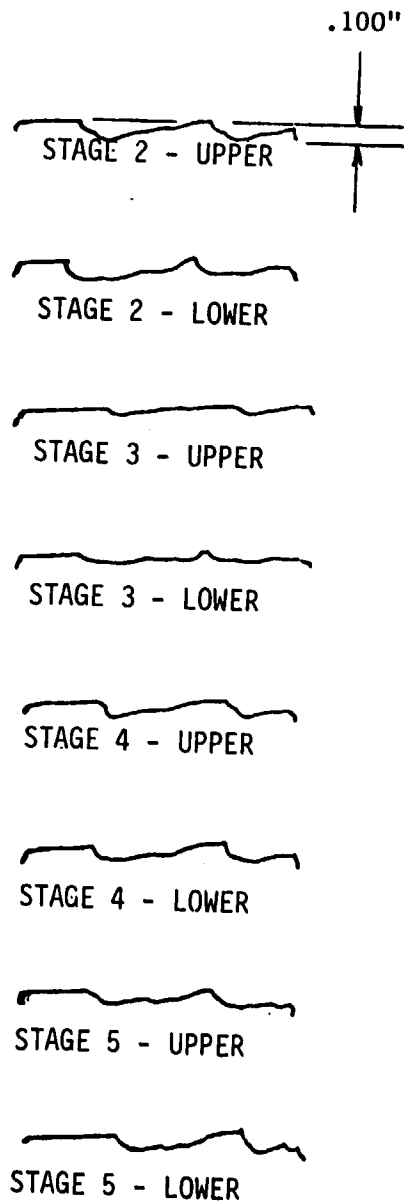
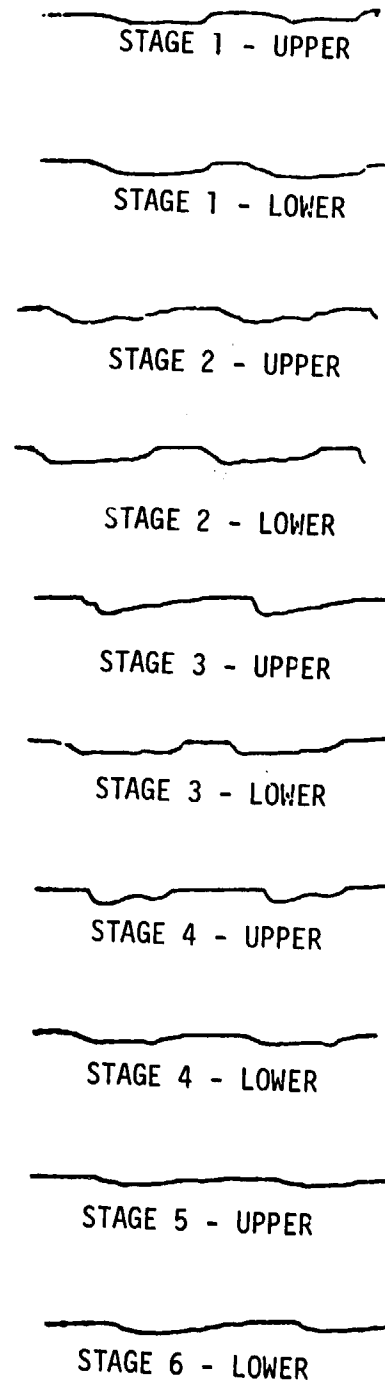
Figure B-31. LPTS Shroud and Interstage Seal Rub Impressions.

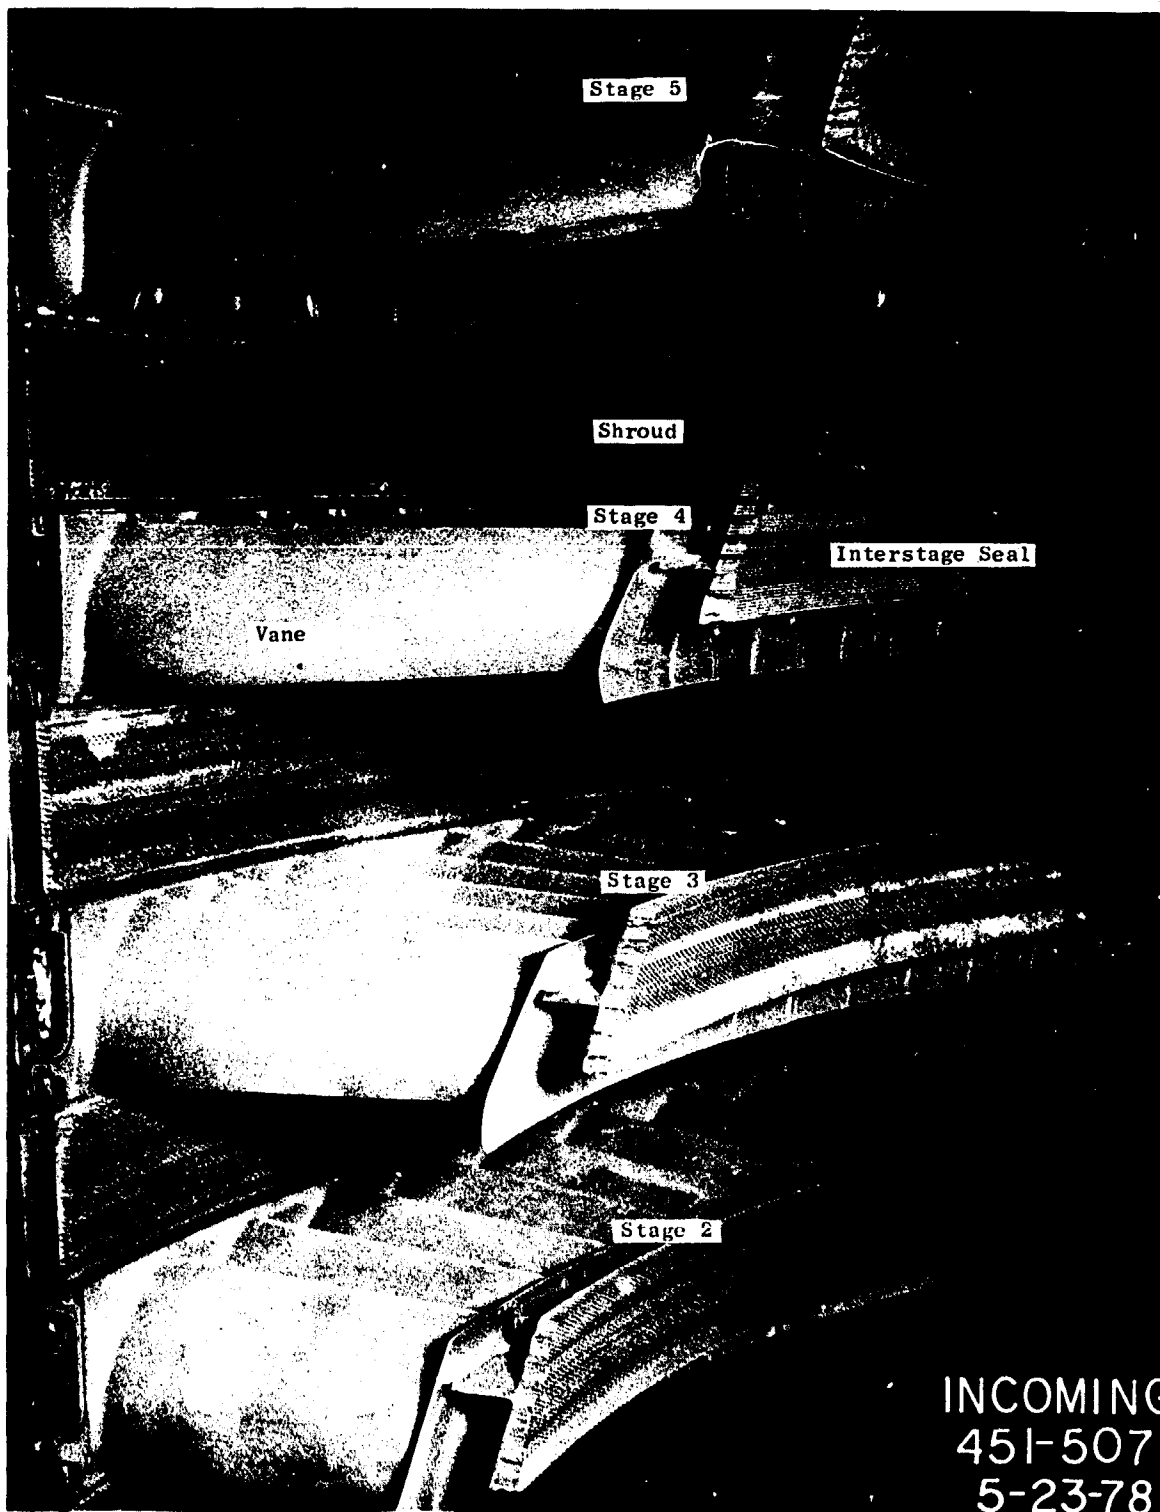
Figure B-32. Low Pressure Turbine Stator Assembly - View of Shroud and Seal Rubs.
