NASA Technical Memorandum 81421

ENDURANCE AND FAILURE
 CHARACTERISTICS OF MODIFIED
 VASCO X-2, CBS 600 AND
 AISI 9310 SPUR GEARS

Dennis P. Townsend and E. V. Zaretsky
 Lewis Research Center
 Cleveland, Ohio

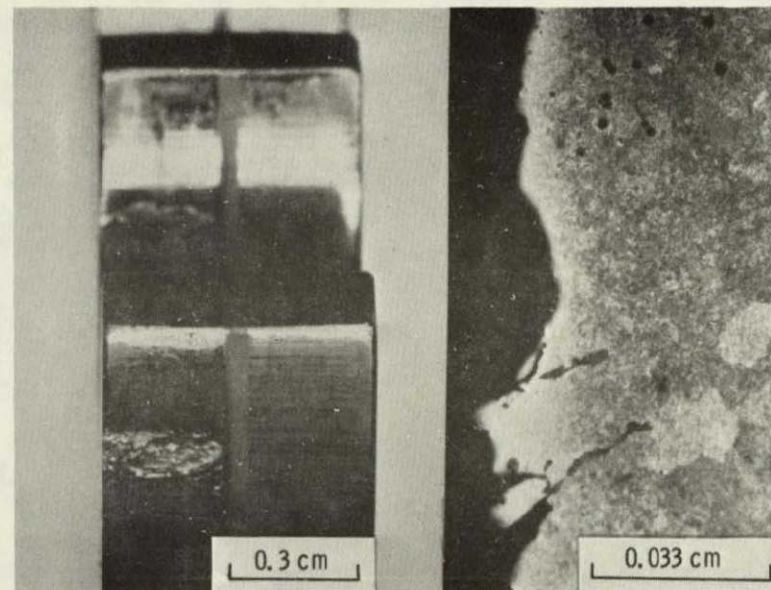
Pitting fatigue life results for the gears made from the CVM AISI 9310 material are shown in Fig. 4(a). The 10- and 50-percent lives were 24×10^6 and 54×10^6 stress cycles (40 and 90 hr), respectively. The failure index (i. e., the number of fatigue failures out of the number of sets tested) was 30 out of 30. A typical fatigue spall that occurs near the pitch line is shown in Fig. 5. This spall is similar to those observed in the rolling-element fatigue tests shown in Fig. 6. The pitch-line pitting is the result of high subsurface shearing stress which develops subsurface cracks. The subsurface originating cracks propagate into a crack net work which results in a fatigue spall that is slightly below the pitch line where the sliding condition is more severe.

(a) FATIGUE SPALL.

(b) CROSS SECTION OF SPALL.

Figure 5. - Representative fatigue spall of test gear material CVM AISI 9310 steel. Speed, 10 000 rpm; lubricant, synthetic paraffinic oil with additive package.

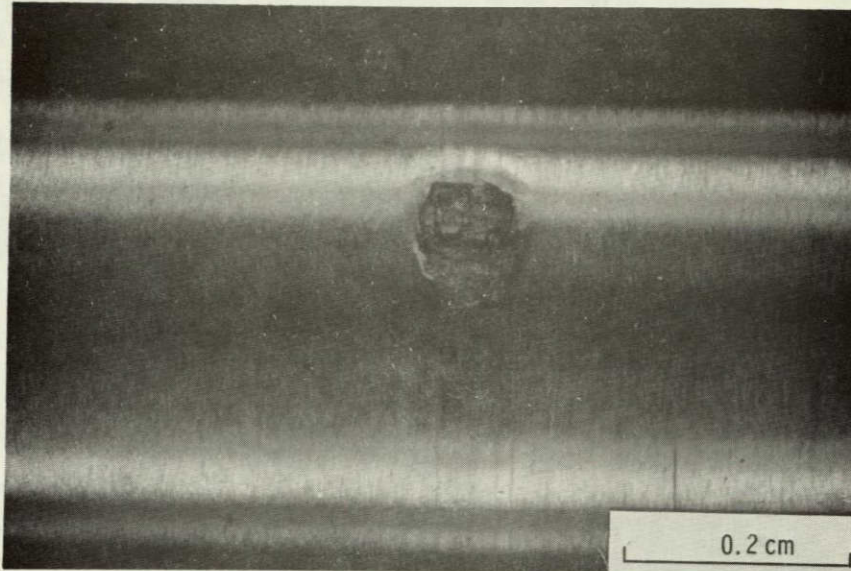
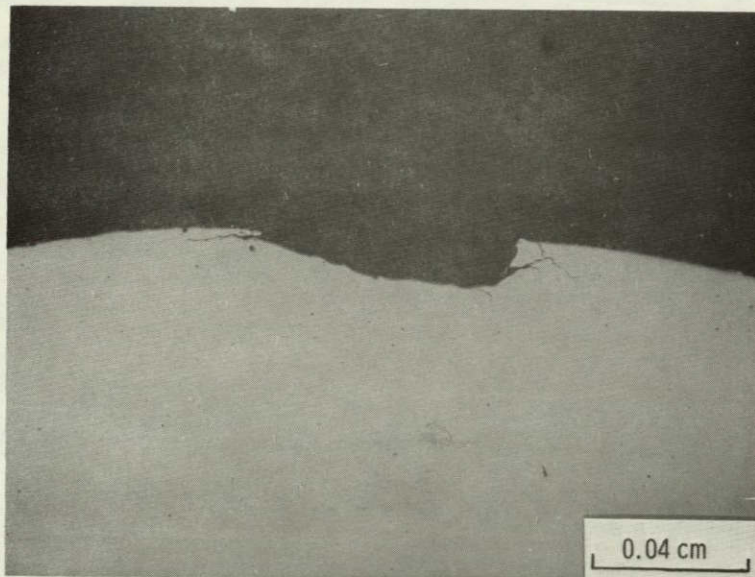
Table 7. These data were analyzed according to the methods of [12]. The spalling fatigue failure for CBS 600 shown in Fig. 6 is typical of all three materials.

Figure 6. - Typical rolling-element fatigue failure in CBS 600.

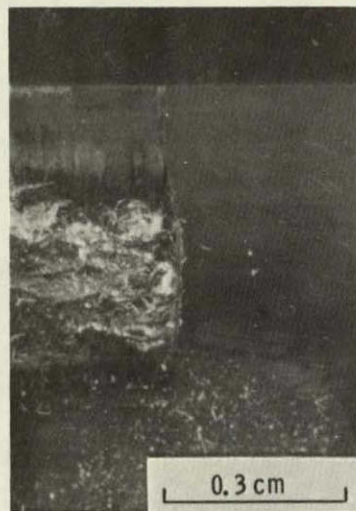
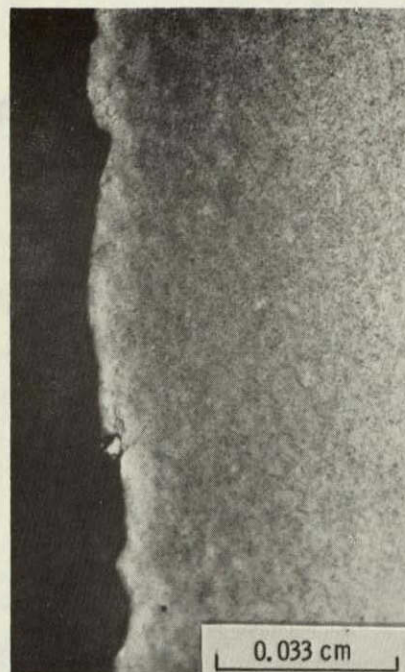
One of the fatigue spalls on the CBS 600 gears is shown in Fig. 7(a). A cross section of this fatigue spall is shown in Fig. 7(b). The two gears with pitting failures were run for 6 hours after spalling had occurred. A single tooth bending fracture occurred on each of the gears as a result of the overrun. A fractured tooth is shown in Fig. 8. AISI 9310 gears that were overrun did not fracture.

(a) FATIGUE SPALL.

(b) CROSS SECTION OF SPALL.

Figure 7. - Typical pitch-line fatigue spall of CBS 600 test gear. Speed, 10 000 rpm; lubricant, synthetic paraffinic oil with additive package.

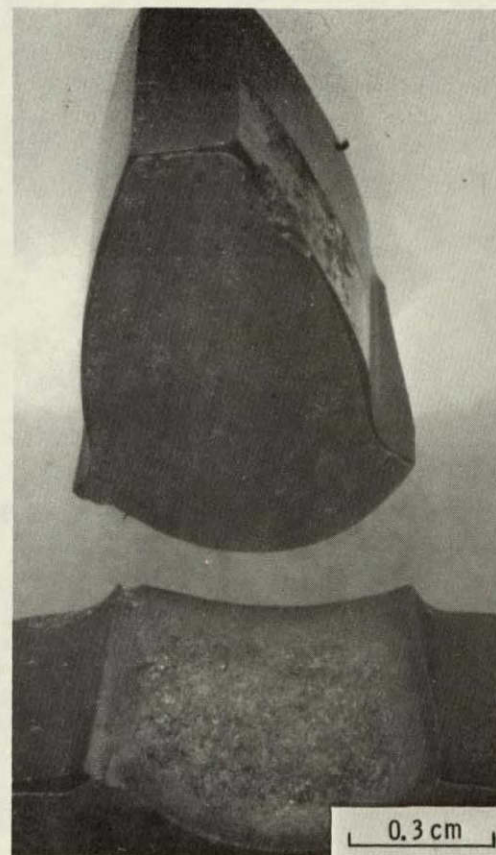
Reference [2] reports good fracture toughness for the CBS 600 material. There are three factors which may have contributed to tooth fracture after pitting occurred on the gear teeth as reported herein. First, the resultant core hardness of Rockwell C 45 is excessive for the CBS 600 and, therefore, makes the material more brittle. Second, the case grain structure has large carbides from a slight amount of excess carbon. This condition would tend to promote bending-type fatigue failure. Third, there was an excessive case depth of 1.47 millimeters (0.058 in.) instead of the desired 0.76 millimeter (0.030 in.). All of these factors can and should be controlled. However, lower amounts of carbon, a lower core hardness, and a lower case depth may not by themselves assure an absence of bending failure when

Figure 8. - Typical tooth bending fracture on CBS 600 after running with a fatigue spall; speed, 10 000 rpm; lubricant, synthetic paraffinic oil with additive package.

accompanied by surface pitting. Additional research must be undertaken to assure that tooth fracture can be eliminated with reasonable heat-treat procedures.

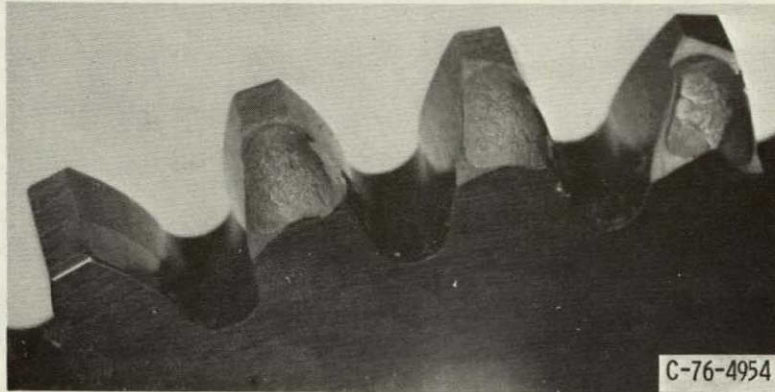
Four pairs of modified Vasco X-2 gears having the NASA heat treat specification which were carburized on all sides were tested. Several fracture failures occurred, in a short time on each pair of gears tested. Failure was by tooth fracture at the tips of the teeth as shown in Fig. 9.

The modified Vasco X-2 material is somewhat low in fracture toughness even with carefully controlled carburization [13, 14]. Low fracture toughness may result in material fracture under adverse stress conditions. The CBS 600 material has a higher fracture toughness than the modified Vasco X-2 material [2]. However, this material also has the potential to fracture under adverse stress conditions. For both materials it is necessary to exercise very stringent quality control during heat treatment. Unless the prescribed heat treat method is closely

Figure 9. - Typical fracture of modified Vasco X-2 gear teeth with NASA specified heat treatment carburized on all sides.

4. Case carburization of all the gear surfaces for the modified Vasco X-2 gears resulted in fracture at the tips of the gears. However, carburization of the gear flanks only using a carefully controlled heat-treat procedure, eliminates this failure mode.

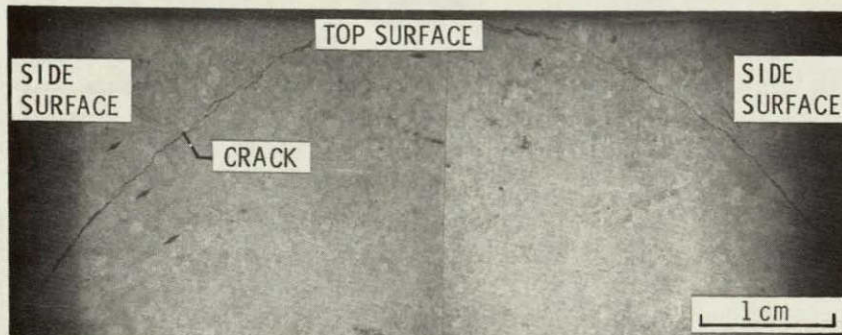
Two unfailed teeth on a single failed gear were cross-sectioned across the width of the tooth and across the profile. A cross section of the tooth width is shown in Fig. 10(a). The section revealed cracks around the corners of the tooth. Test gears that had not been run were sectioned and similar cracks were found as shown in Fig. 10(b). Because the gears had not been run, it was evident that the cracks developed during heat treatment. It was theorized that the cracks were caused by expansion of the carburized surface that produced excessive tensile stresses in the core material. All subsequent gears tested did not have the sides and end of the gear teeth carburized.

(a) CROSS SECTION OF UNFAILED GEAR TOOTH FROM FAILED MODIFIED VASCO X-2 GEAR SHOWING CRACK AT EACH CORNER OF TOOTH.

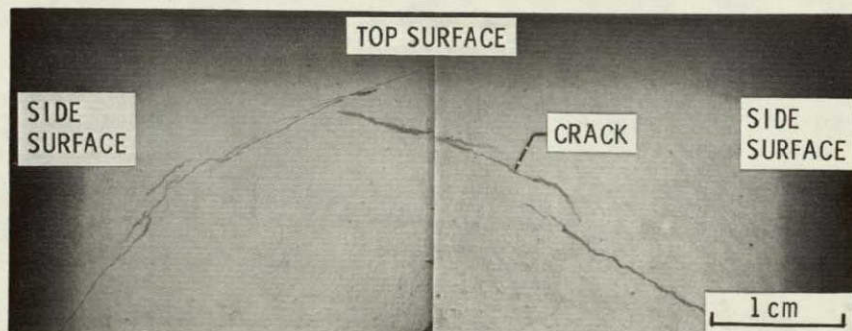
(b) CROSS SECTION OF GEAR TOOTH FROM UNRUN MODIFIED VASCO X-2 GEAR SHOWING CRACK.

Figure 10. - Cross section of unfailed and unrun modified Vasco X-2 gear teeth heat treated to NASA specification and carburized on all sides.

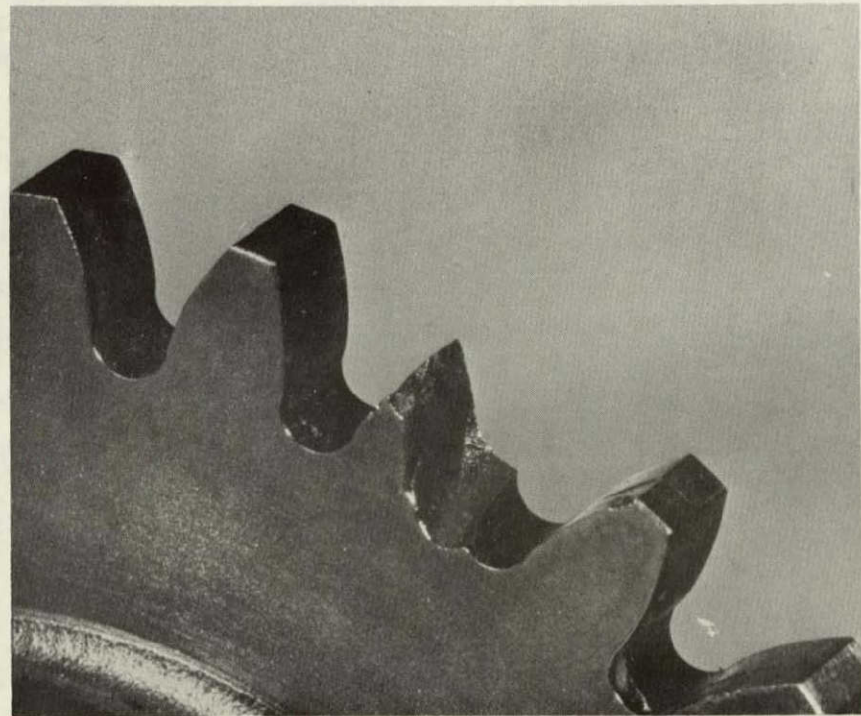
The pitting fatigue life results for the three lots of gears made from the modified Vasco X-2 are shown in Fig. 11. A statistical comparison was made between the gear tooth pitting fatigue life of the three lots of modified Vasco X-2 gears and the CVM AISI 9310 and is summarized in Table 6. The difference between the pitting fatigue life of the AISI 9310 gears and modified Vasco X-2 lot D having the Boeing Vertol heat treatment gears is statistically insignificant with a confidence number of 80 percent. Lots B and C having the NASA and Curtis-Wright heat treatments, respectively, had statistically lower lives than the AISI 9310 gears. In addition, lot B had fracture failures of several of the gears concurrent with the pitting fatigue failure. A representative fracture failure is shown in Fig. 12.

Figure 12. - Gear tooth fracture through a fatigue spall of NASA heat treated modified Vasco X-2, maximum Hertz stress, 1.71×10^9 N/m² (248 000 psi) speed, 10 000 rpm.

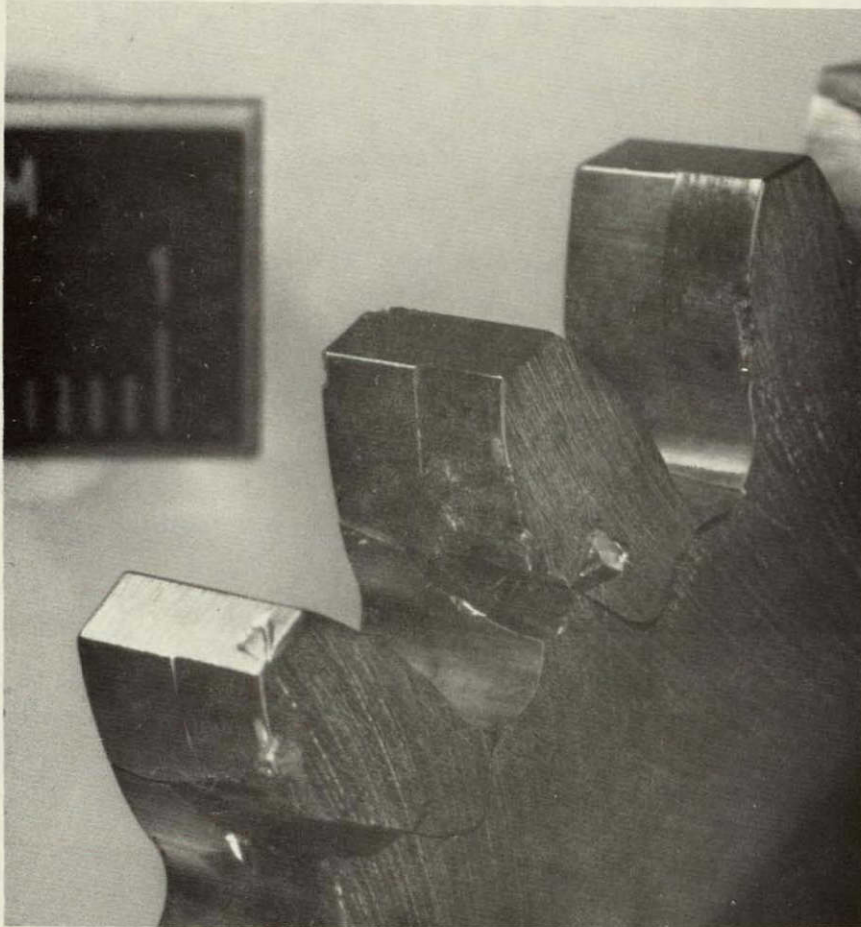
Of the 12 failed tests of modified Vasco X-2 lot D, five gear sets were deliberately overrun for 8, 10, 16, 30, and 60 hours after the surface fatigue spall had formed. Only one gear subsequently failed by fracture of the teeth after 8 hours (4.8×10^6 stress cycles) in the overrun condition. The fractures portion of the gear is shown in Fig. 13. As in the previous instances for the other heat treat methods, the spall acted as the nucleus of the fracture failure. However, based upon the other overrun tests, the Boeing Vertol heat treat procedure resulted in modified Vasco X-2 gears less susceptible to fracture failure.

Figure 13. - Gear tooth fracture through a fatigue spall of Boeing vertol heat treated modified Vasco X-2, maximum Hertz stress, $1.71 \times 10^9 \text{ N/m}^2$ (248 000 psi) speed, 10 000 rpm.
