NASA Technical Paper 1481

# Light Airplane Crash Tests at Three Pitch Angles

Victor L. Vaughan, Jr., and Emilio Alfaro-Bou

NOVEMBER 1979

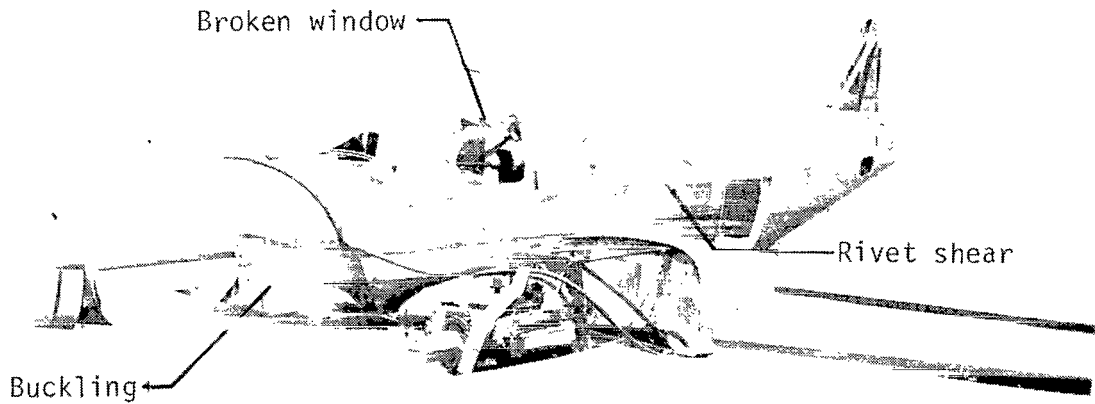
(a) Pitch-down test specimen.

Pitch-down test.— The photograph of the test specimen for the pitch-down test (fig. 12(a)) shows extensive buckling damage to the lower part of the fuselage from the nose to the fire wall, which was the primary impact area. The separation of the skin at the lower edge of the windows on the port side was caused by rivet-shear failure during the slam down or second impact. The window breakage also occurred at this time; however, the pilot's head impacting the window 0.165 sec into the crash (fig. 11(a)) may have contributed to side-window breakage.

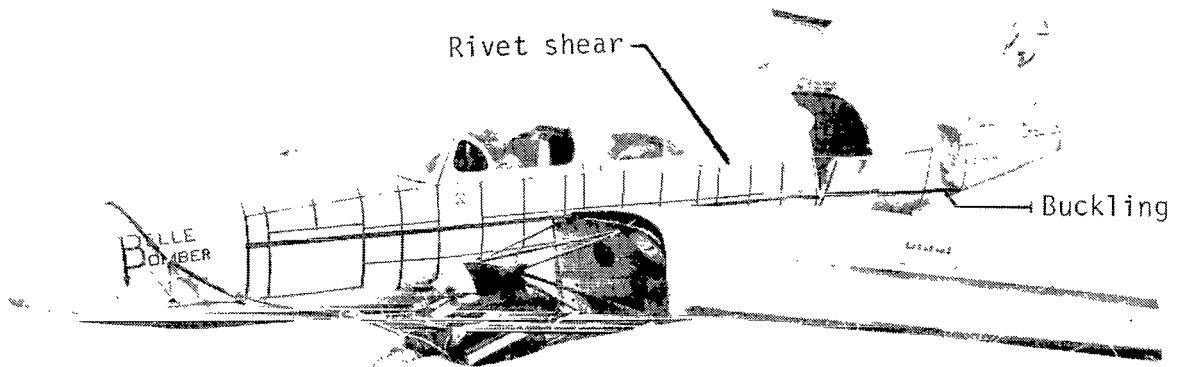
(b) Flat test specimen.

Flat test.- The photograph of the test specimen for the flat test (fig. 12(b)) shows only skin wrinkles in the forward section of the airplane specimen. The initial contact of the fuselage with the ground was in the vicinity of the door. The transverse expansion of the fuselage caused separation of the skin under the windows, as in the pitch-down test, but the degree of separation was less. More severe lower fuselage damage was sustained in the vicinity of the third window and extended rearward through the baggage compartment aft of the door (fig. 14). Separation of the skin along the bottom of the windows on the starboard side of the fuselage is shown in figure 14(a). As in the pitch-down test, the port side sustained more rivet-shear damage along the windows than the starboard side, thus supporting the conclusion that the door opening weakened the fuselage on the port side. In this test, the door opened immediately after the first ground contact.

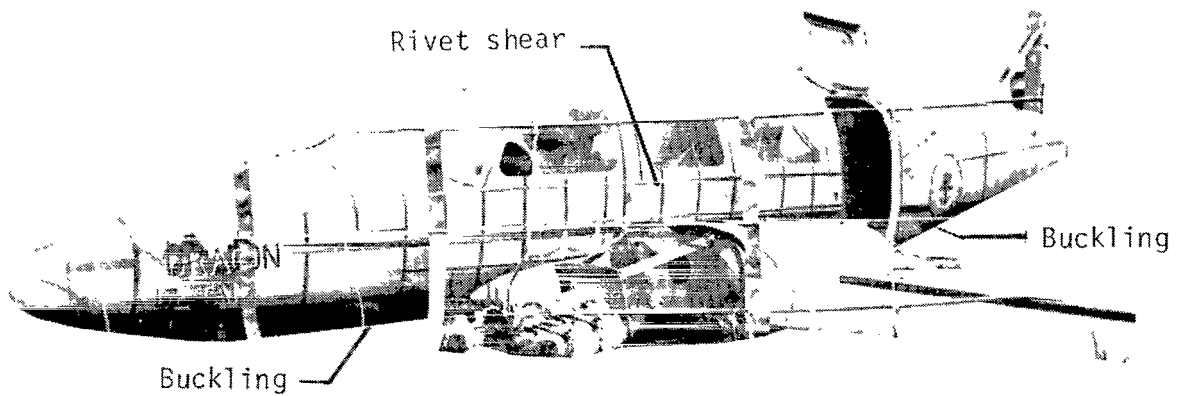
(c) Pitch-up test specimen.

Pitch-up test.- The photograph of the test specimen for the pitch-up test (fig. 12(c)) shows very little damage to the port side of the specimen. Small wrinkles or buckling can be noted at the nose near the fire wall and aft of the door. Separation of the skin under the windows due to rivet shear is shown in figure 15(a), but was not nearly as severe as in the pitch-down and flat tests. The primary impact occurred along the aft fuselage section at the baggage compartment. The separation and buckling of the skin on the bottom of the fuselage at the frame forming the aft edge of the door was a result of the tensile loading in the bottom of the specimen as the aft end of the specimen contacted the ground. Separation of the skin on the starboard side of the specimen is shown in figure 15(b). The door opened immediately after initial ground contact as it did in the flat test.

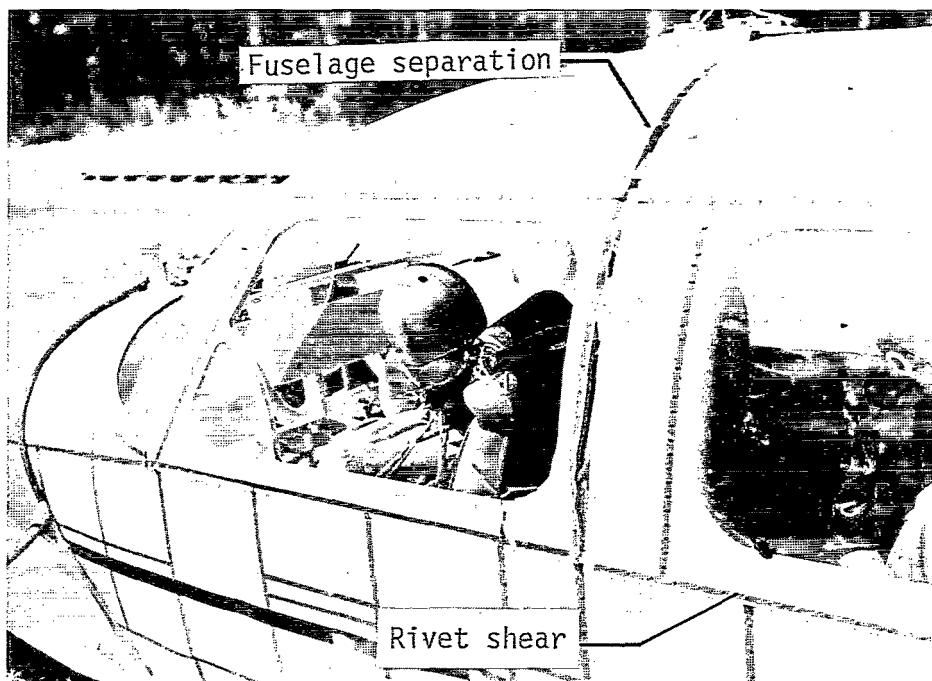
L-74-2632.1

A close-up view of the window section of the specimen is presented in figure 13(a). The separation in the fuselage at the frame just aft of the pilot is directly over the main wing spar that passes through the fuselage. This separation occurred as the specimen tail reached its lowest position during downward rotation, which caused the top of the fuselage to go into tensile loading, thus shearing the rivets that attach the skin to the frame.

(a) Separation of fuselage on port side of fuselage.

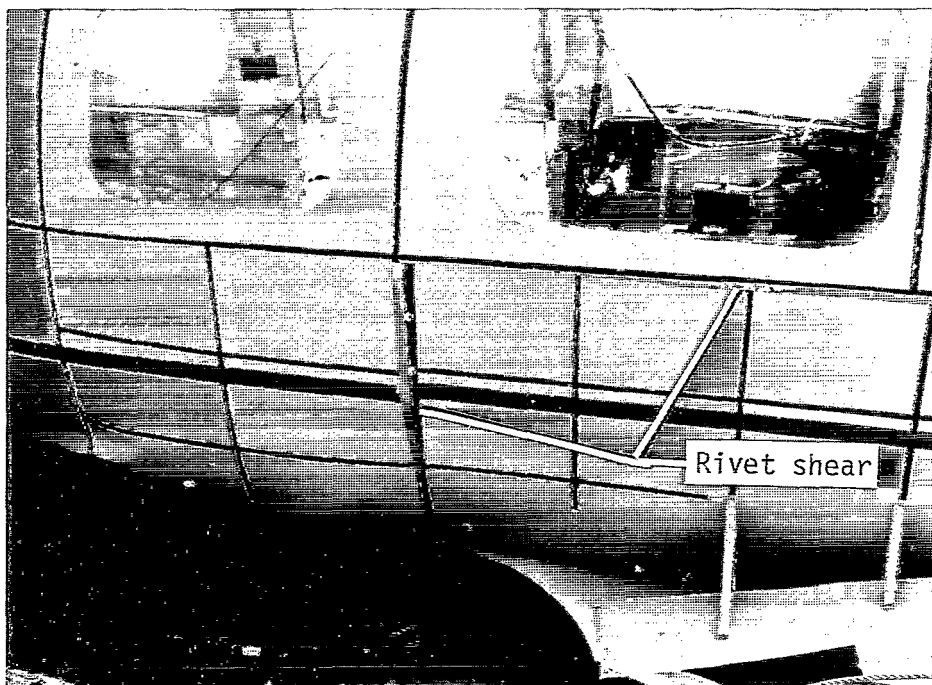
L-74-2622.1

Figure 13(b) shows the rivet-shear failure under the windows on the starboard side of the fuselage. This type failure also occurred in the lower section of the fuselage on the starboard side at the frame forming the leading edge of the door on the opposite side. The greatest rivet-shear damage occurred on the port side of the fuselage (fig. 11(a) and fig. 13).

The large door opening on the port side breaks the continuity of the fuselage structure to make it more susceptible to structural buckling during the crash. During the second impact, this port-side weakness led to tensile loading of the starboard side, which sheared the rivets that fasten the skin to the frame (fig. 13(b)). The small yaw angle of  $1^{\circ}$  at initial ground contact may have been a contributing factor in the more severe damage on the port side. The door opened on second impact and did not contribute to the strength of the structure on that side of the fuselage.

(b) Separation of cabin on starboard side of fuselage.

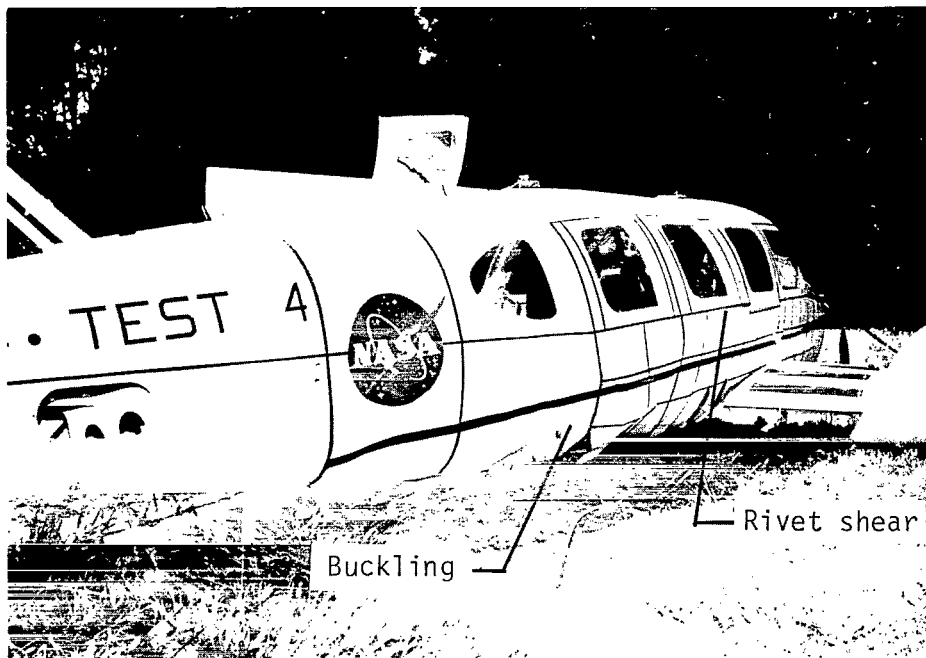
L-74-8081.1

(a) Aft section damage on starboard side of fuselage.

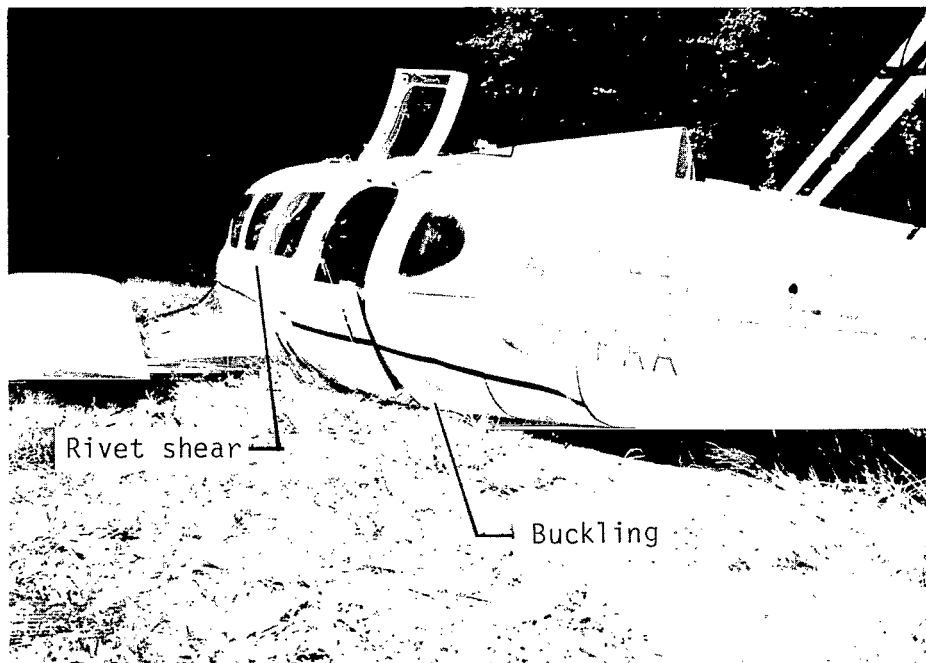
L-74-8073.1

(b) Aft section damage on port side of fuselage.

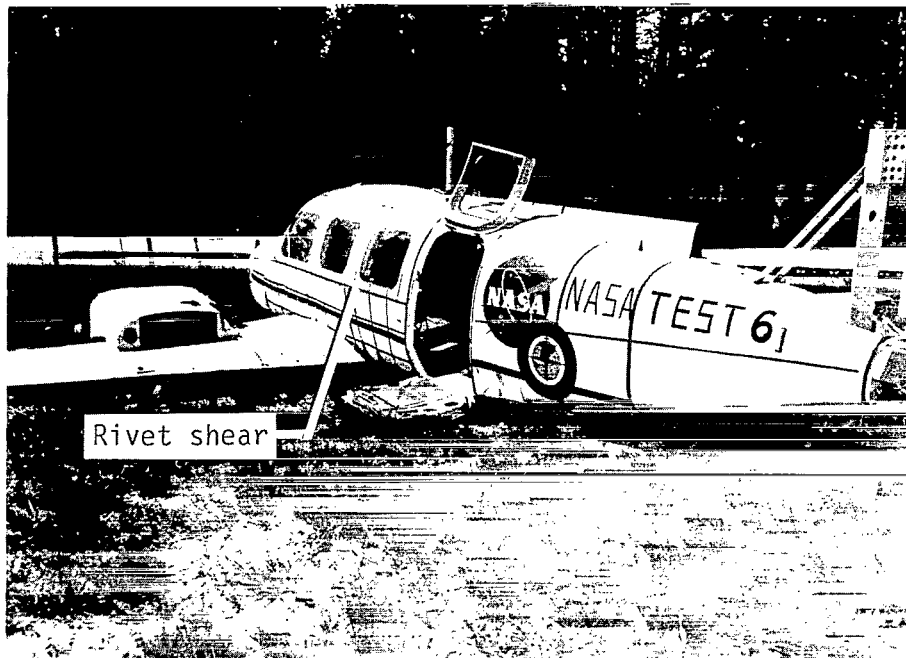
L-75-3755.1

(a) Aft section damage on port side of fuselage.

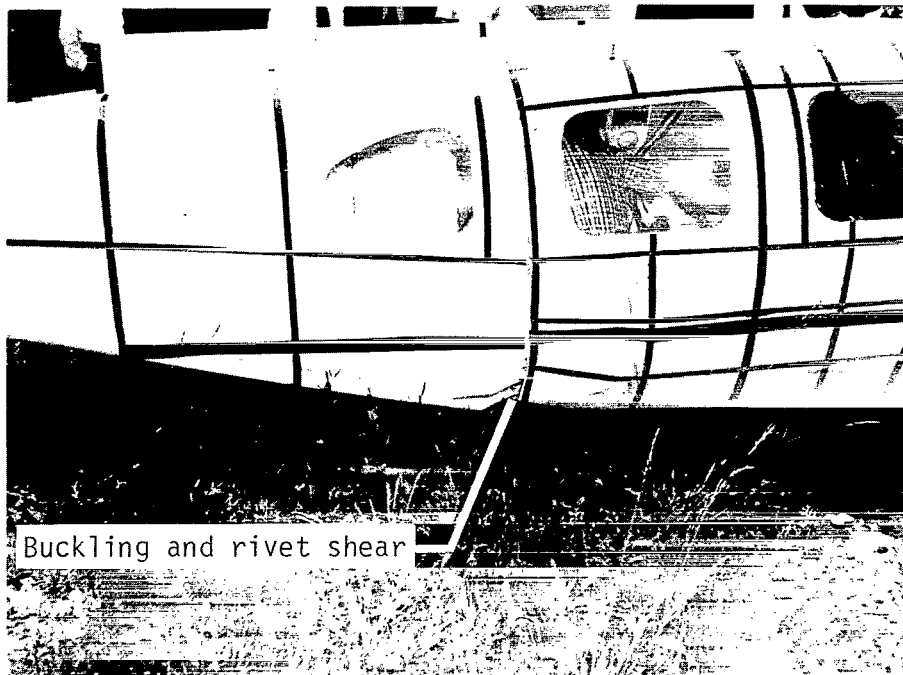
L-75-3749.1

(b) Aft section damage on starboard side of fuselage.

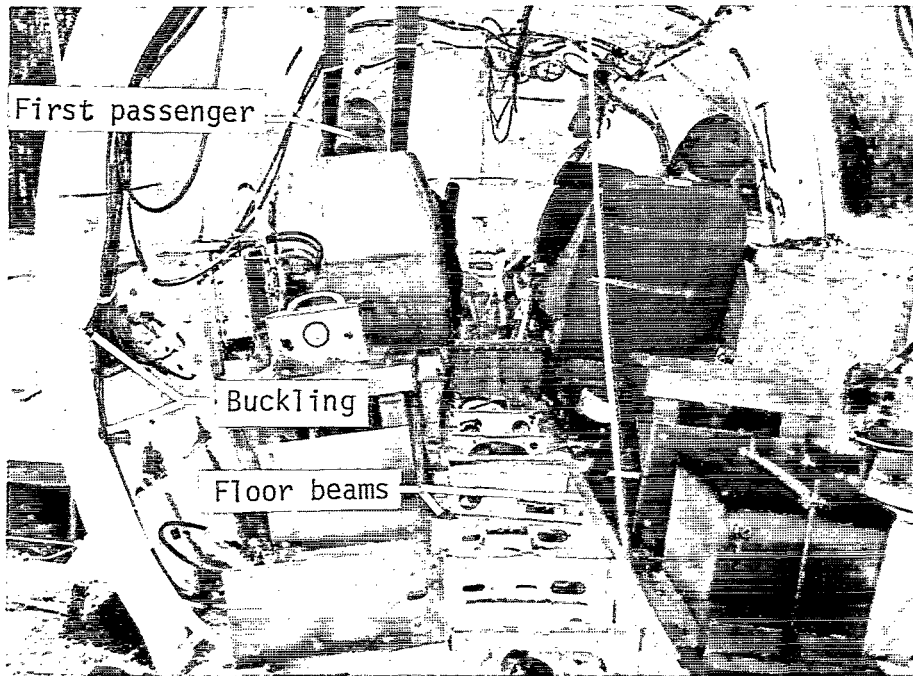
I-74-2642.1

Pitch-down test.- The photograph from the pitch-down test (fig. 16(a)) was taken from the aft end of the fuselage looking forward. The intrusion of the floor structure into the cabin is shown by the outward rotated position of the seats. Because of the circular shape of the bottom of the fuselage, the out-

board floor structures were bent down around the two longitudinal floor beams which made first ground contact. Consequently the seats, dummies, and all items outboard of the floor beams rotated outward.

This rotation, together with the counterclockwise rotation of the pilot's body around the restraint strap crossing the left shoulder (fig. 9(a)), was responsible for the pilot's head impacting the side window, contributing to window breakage. The buckles in the door frame resulted from the transverse expansion of the fuselage during impact. The photograph taken from the pilot's position looking rearward (fig. 16(b)) shows only small buckles in the cross members between the floor beams and very little evidence of any damage in the aft section of the fuselage due to impact.

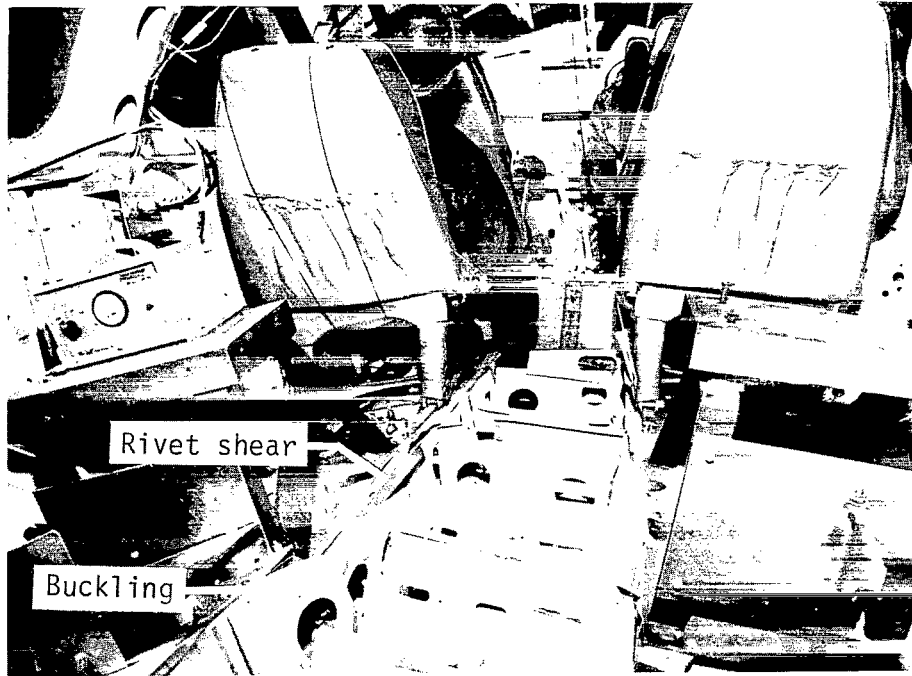
L-74-8078.1

Flat test.- The photograph from the flat test (fig. 17(a)) was taken from the aft end of the fuselage looking forward. The outboard rotated position of the seats is much more pronounced than in the pitch-down test. The floor structure was pushed upward, with buckling and rivet-shear failures throughout the floor area. The longitudinal floor beams, which are fabricated from flat stock and extrusions riveted together, separated along the rivet lines. The photograph taken looking through the doorway at the structural damage in the vicinity of the fuselage where first ground contact occurred (fig. 17(b)) indicated that the floor structural damage was extensive and included buckling, rivet-shear failure, breaking, and tearing of the structure. This damage area extended back to the frame of the baggage compartment farthest aft, as shown in figure 17(c). The photograph (fig. 17(d)) shows a break in the main wing spar near the center of the fuselage.

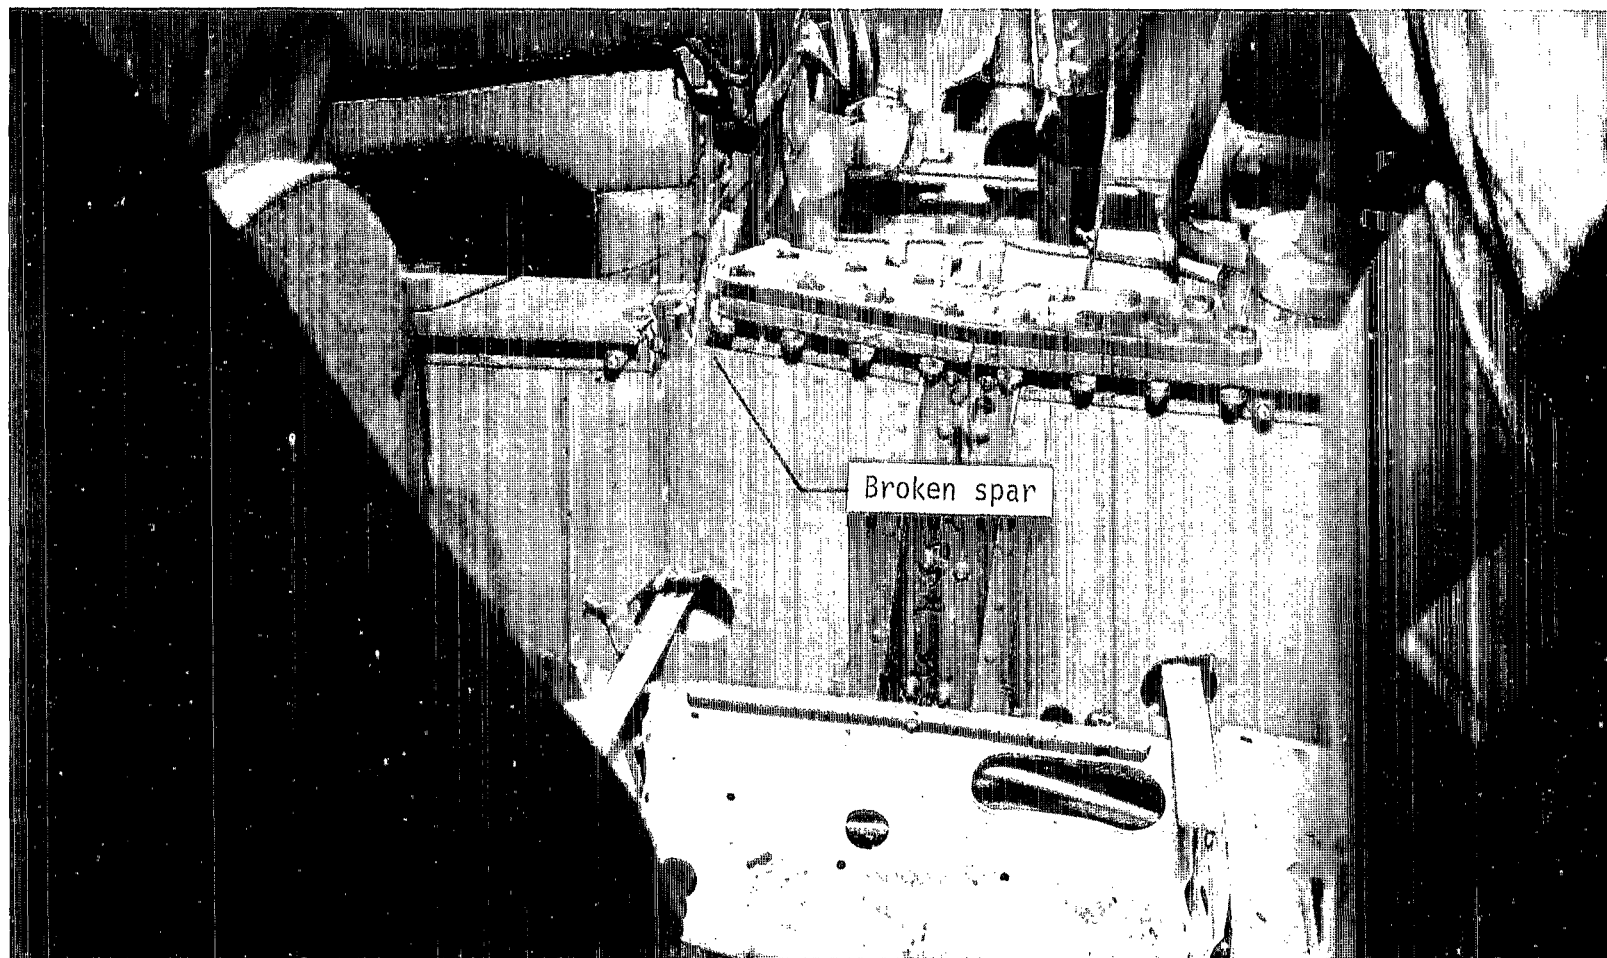
L-74-8075.1

(d) View of broken main wing spar.

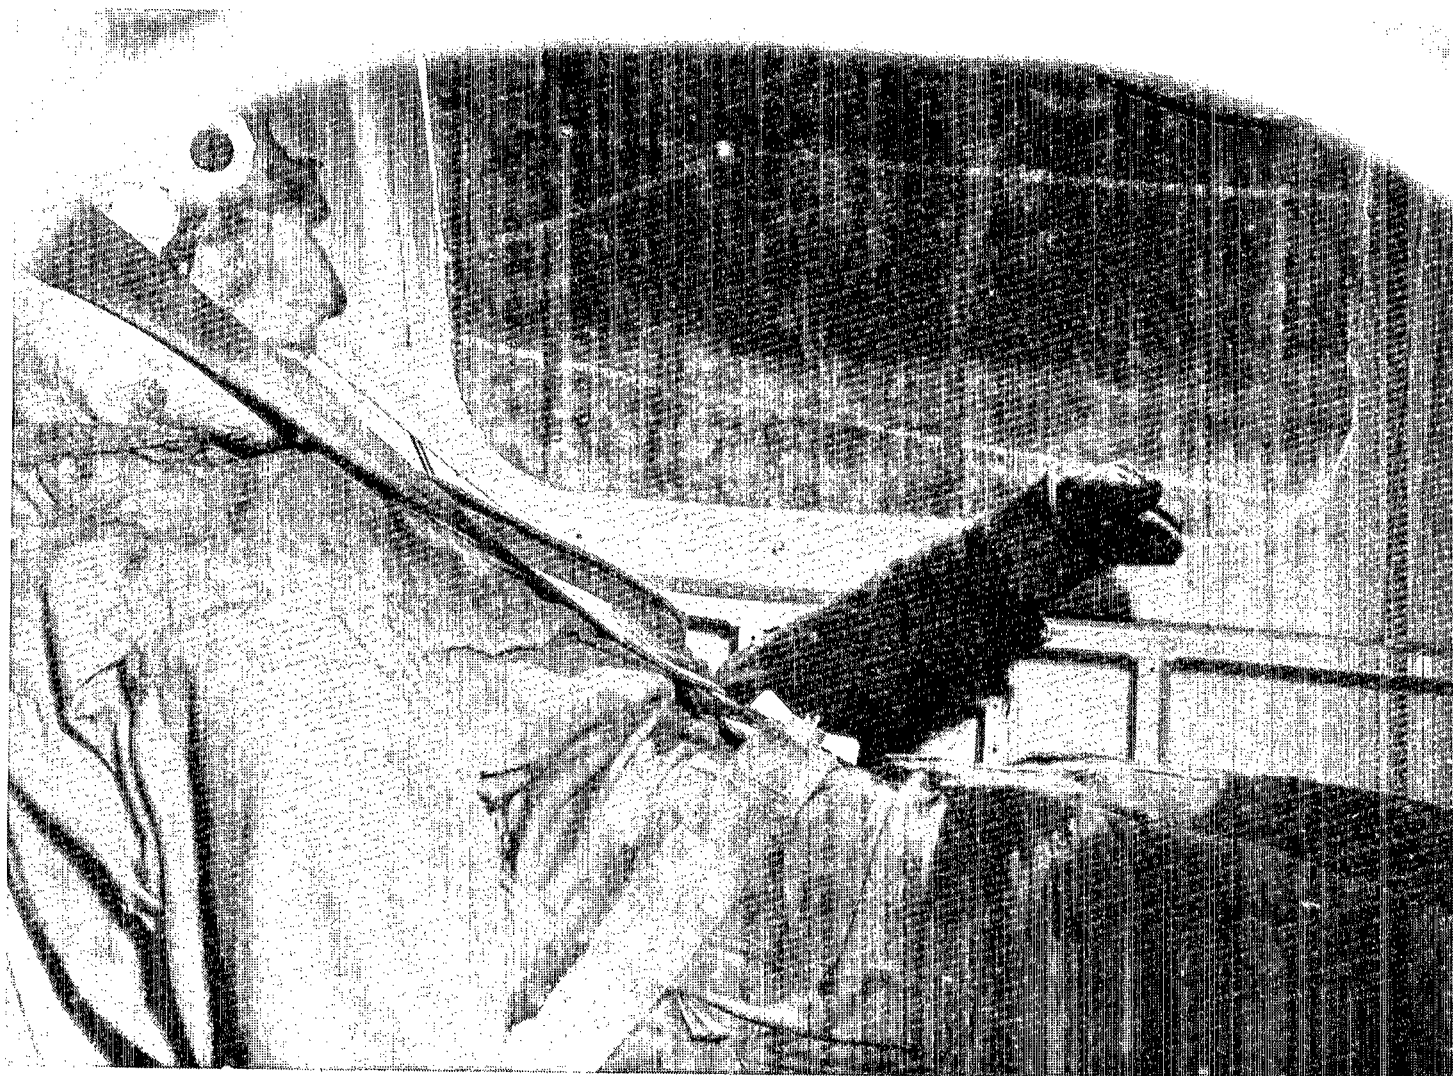
L-75-3751

Figure 24.- Submarined position of first-passenger dummy in pitch-up test specimen.

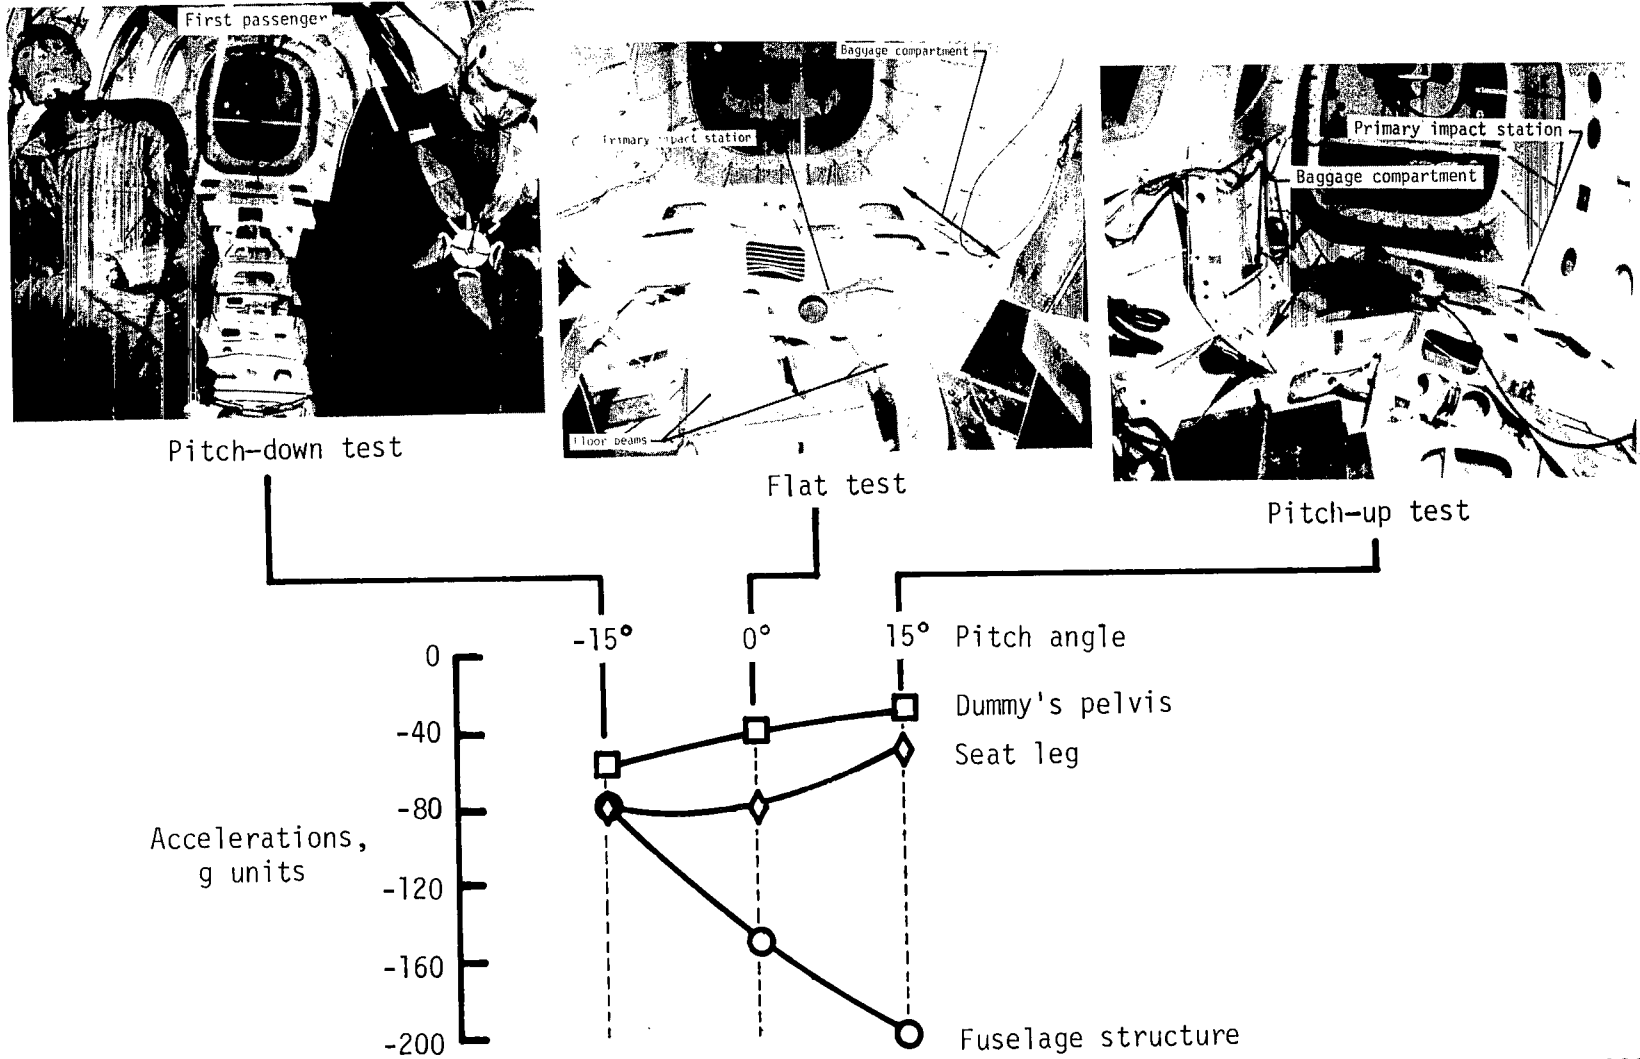
The difference in physical damage to the passenger compartments that accompanied these accelerations is presented by the photographs in figure 25. The damage increased from the pitch-down to pitch-up tests. The peak accelerations in the pelvic region of the first-passenger dummy decreased from -55g, to -40g, to -30g for the pitch-down, flat, and pitch-up tests, respectively. As the fuselage structural damage increased, peak pelvic accelerations in the first-passenger dummy decreased.
