NASA Technical Paper 1477

# Light Airplane Crash Tests at Three Roll Angles

Claude B. Castle and Emilio Alfaro-Bou

OCTOBER 1979

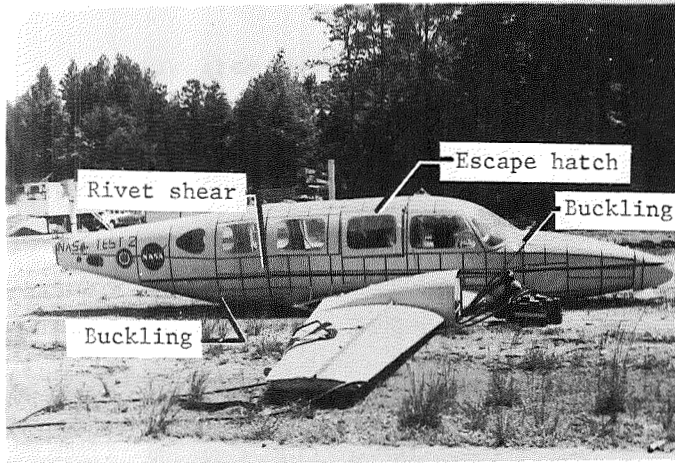
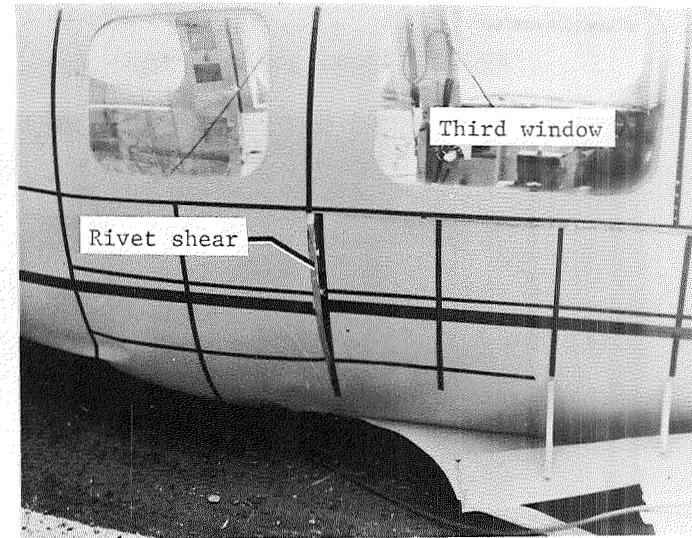
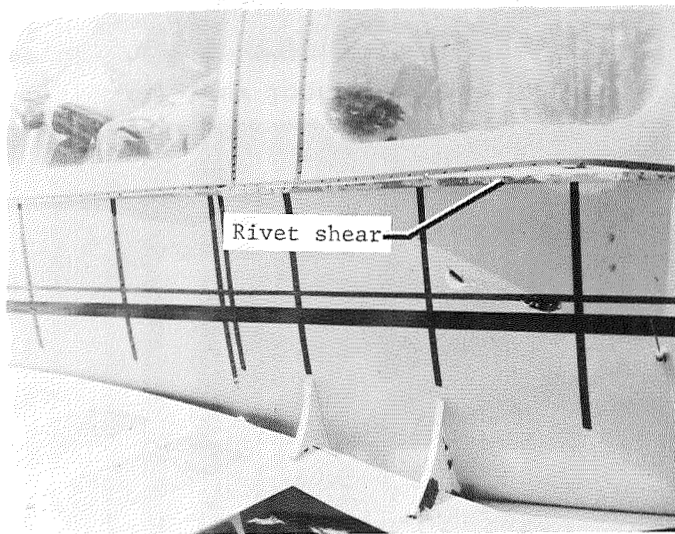
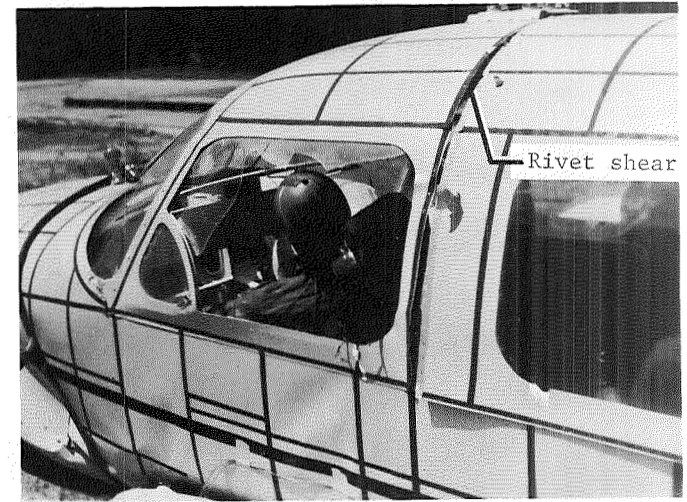
The exterior damage to the airplane for the 0° roll test is shown in figure 10. As seen in the overall view of the right side (fig. 10(a)), buckling occurred in the nose section, at the fire wall, and along the bottom of the fuselage. Rivet shear failure is evident aft from the escape hatch along the window ledge and downward at the rear of the third window. (See figs. 10(a) and 10(b).) Also, rivet failure is shown under the first-passenger window (fig. 10(c)) and across the top of the fuselage aft of the pilot and copilot seats (fig. 10(d)). The breakage of the pilot's windshield and side window occurred because of deformation of the forward cabin section (fig. 10(d)).

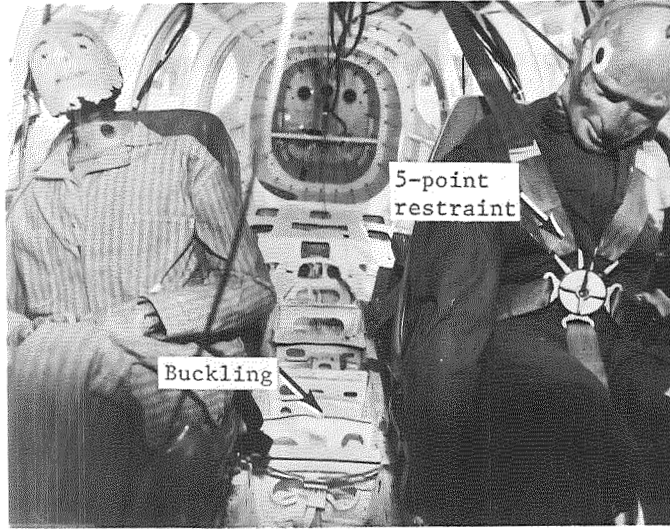
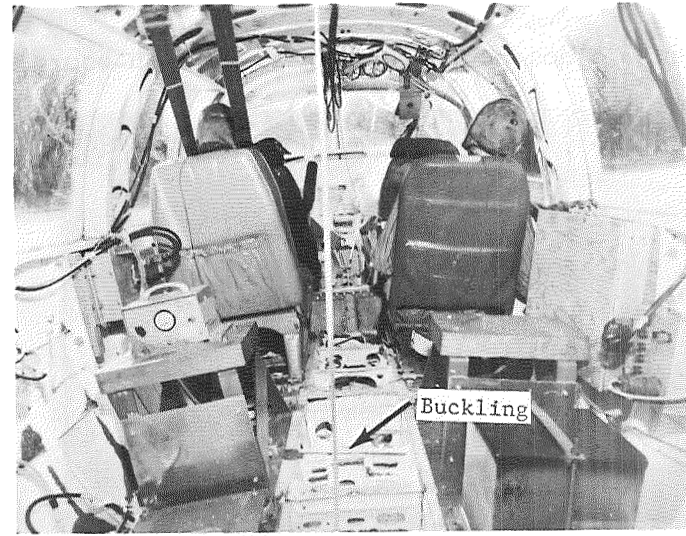
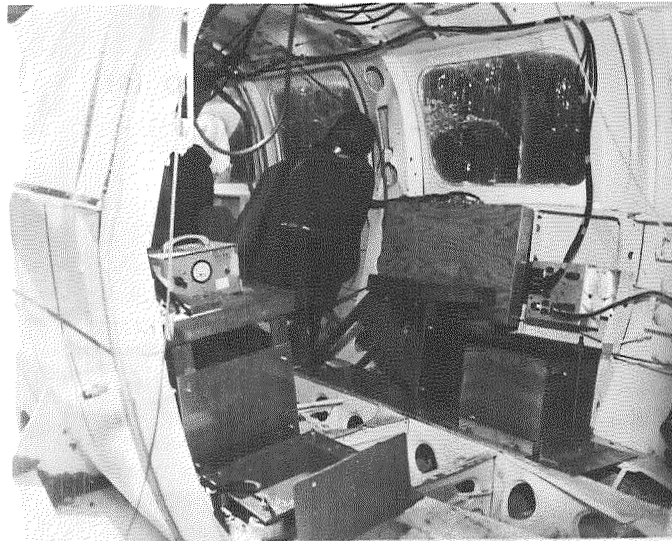
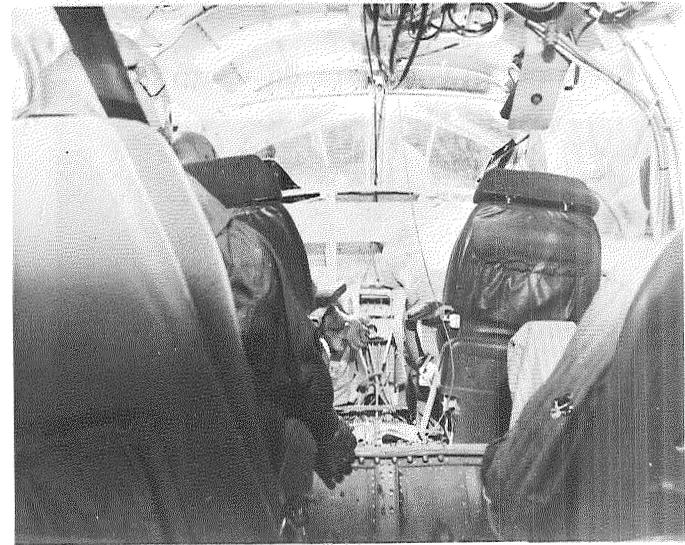
Figure 11.- Interior damage to 0° test.

Damage to the cabin interior is shown in the four photographs of figure 11. The first photograph (fig. 11(a)) is a view looking aft from the cockpit, where buckling can be seen in the stiffeners which tie together the two main floor beams. Also shown is the five-point restraint worn by the first-passenger dummy. Figure 11(b) is a view looking forward from the tail section and again shows the main floor beams and the buckled stiffeners. The apparent upward movement of the floor section is shown by the outward rotation of the seats. The four photographs of figure 11 also show the layout of seats, dummies, additional masses, instrumentation equipment, and moderate interior damage.

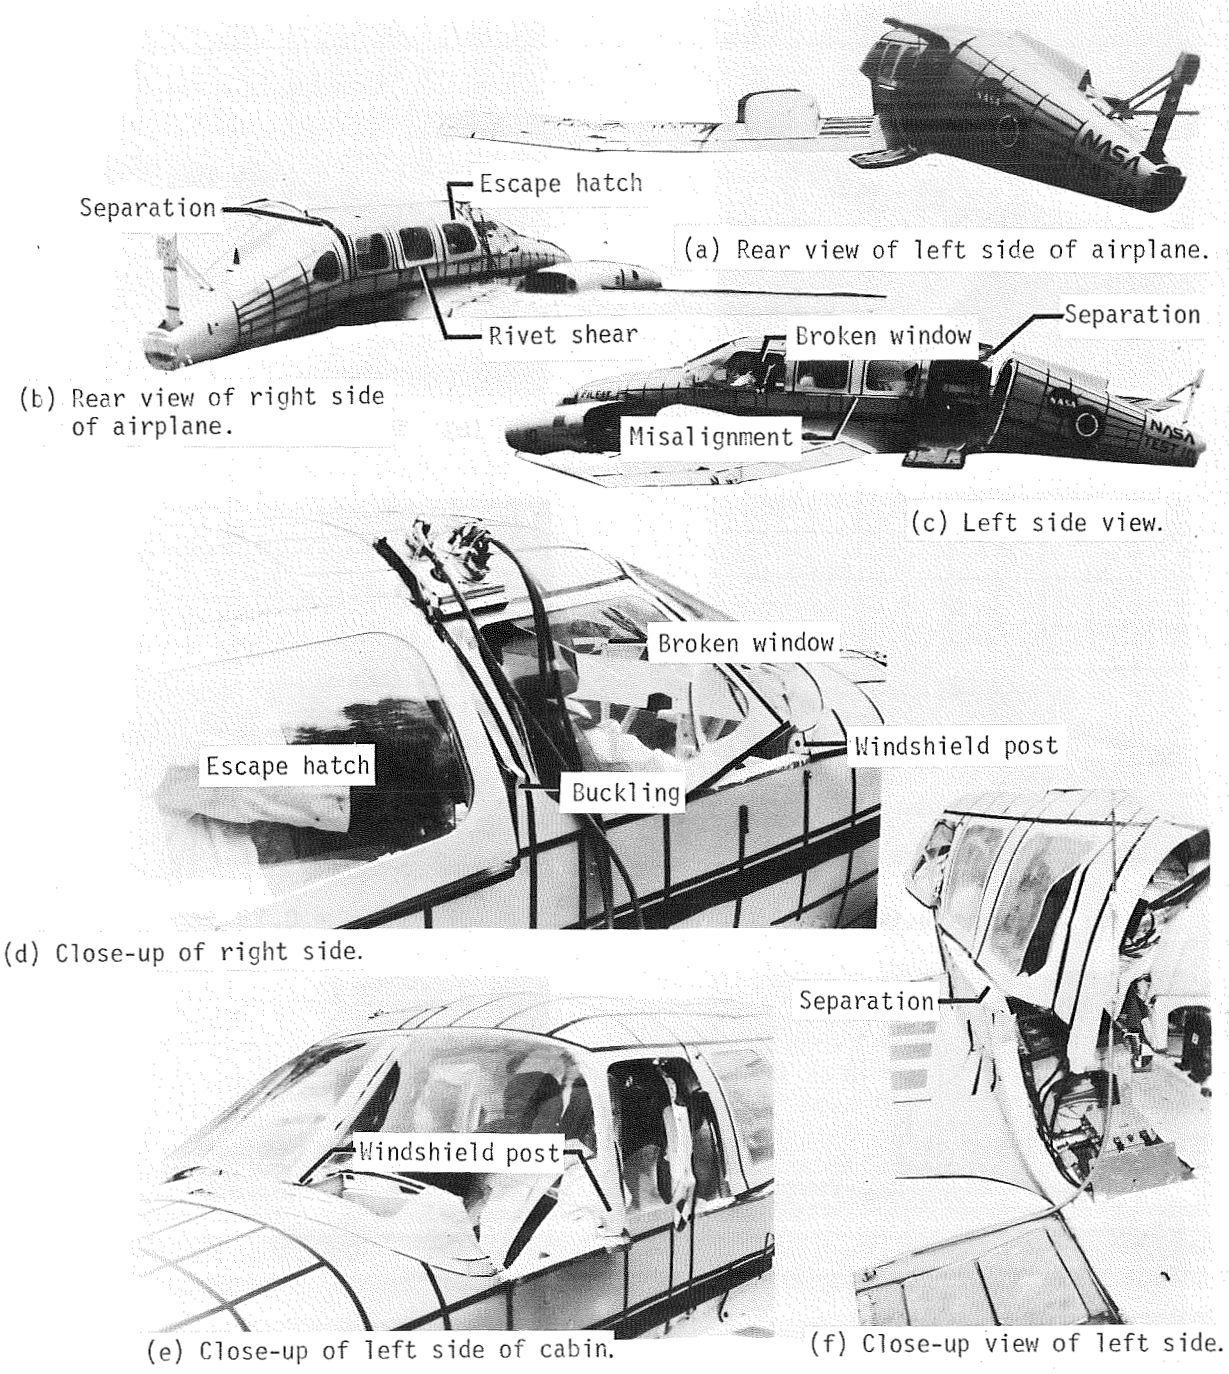
Figure 13.- Exterior damage to -15° test.

The exterior damage resulting from the impact is shown in figure 13. The rear view of the left side in figure 13(a) shows structural damage to the top surface of the wing at about one-third of the wing semispan from the tip. The rear view of the right side in figure 13(b) shows the tail-section separation and loose emergency escape hatch with rivet shear and sheet metal separation under the window frame in the vicinity of the second-passenger seat. A full view of the left side of the test airplane in figure 13(c) shows the damaged wing, cabin and tail separation, broken windows, and the misalignment of the top portion of the cabin. A close-up view (fig. 13(d)) of the right side of the cabin and cockpit areas shows the loosened escape hatch, buckling of the skin, broken copilot side window, and separation and deformation of the windshield corner post. Figures 13(e) and 13(f) show more clearly the damage at the base of the windshield and left side. The deformation across the top of the cabin (fig. 13(e)) and the subfloor crushing did not significantly reduce the livable volume inside the cabin area.

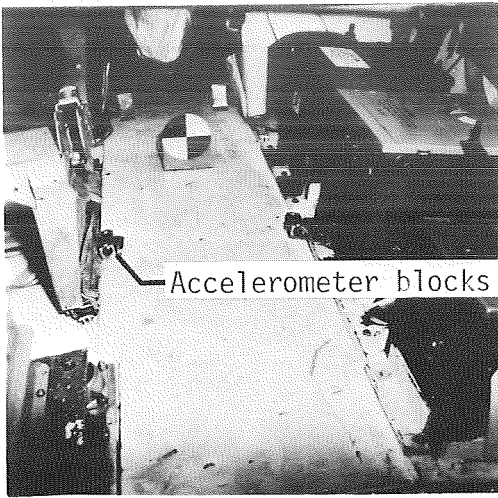
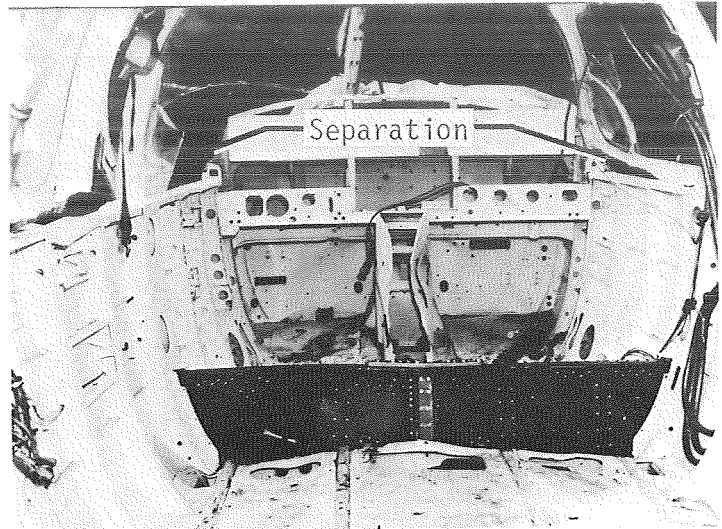
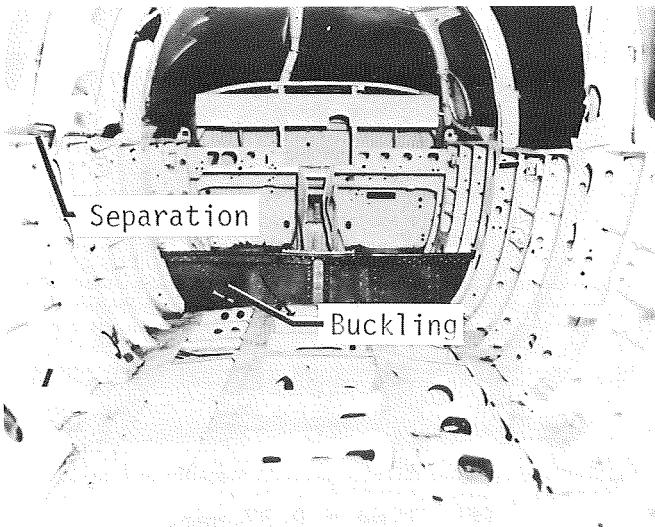
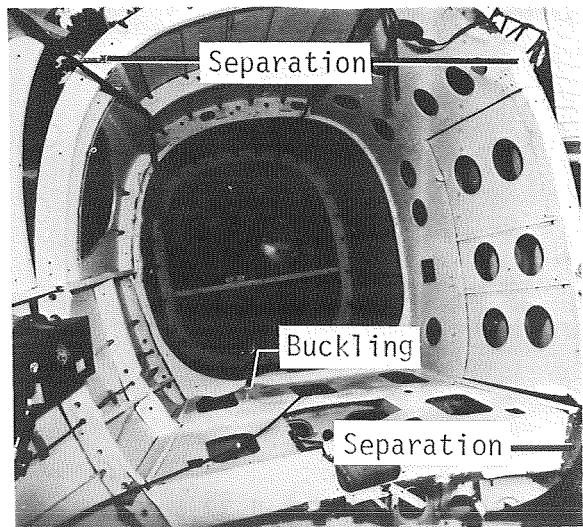
Figure 14.- Interior damage to -15° test.

The damage done to the airplane interior in the  $-15^{\circ}$  roll test is shown in figure 14. A view looking forward in the cabin area (fig. 14(a)) shows only a slight apparently upward movement of the center floor area, as can be determined by the outward rotation of the accelerometer blocks. Figure 14(b) shows the forward cabin and cockpit area with fixtures removed. Also evident are slight apparently upward movement of the cabin floor center section and the separation of the cabin along the window ledge. The buckled left main spar near the main spar splice can be seen in figure 14(c), which is a top view of the main spar inside the cabin. A view of the floor support with small amounts of buckling of the cross-support structures is shown in figure 14(d). The torn and separated tail section shown in figure 14(e), in a view aft of the door, shows the effects of tail slapdown during impact.

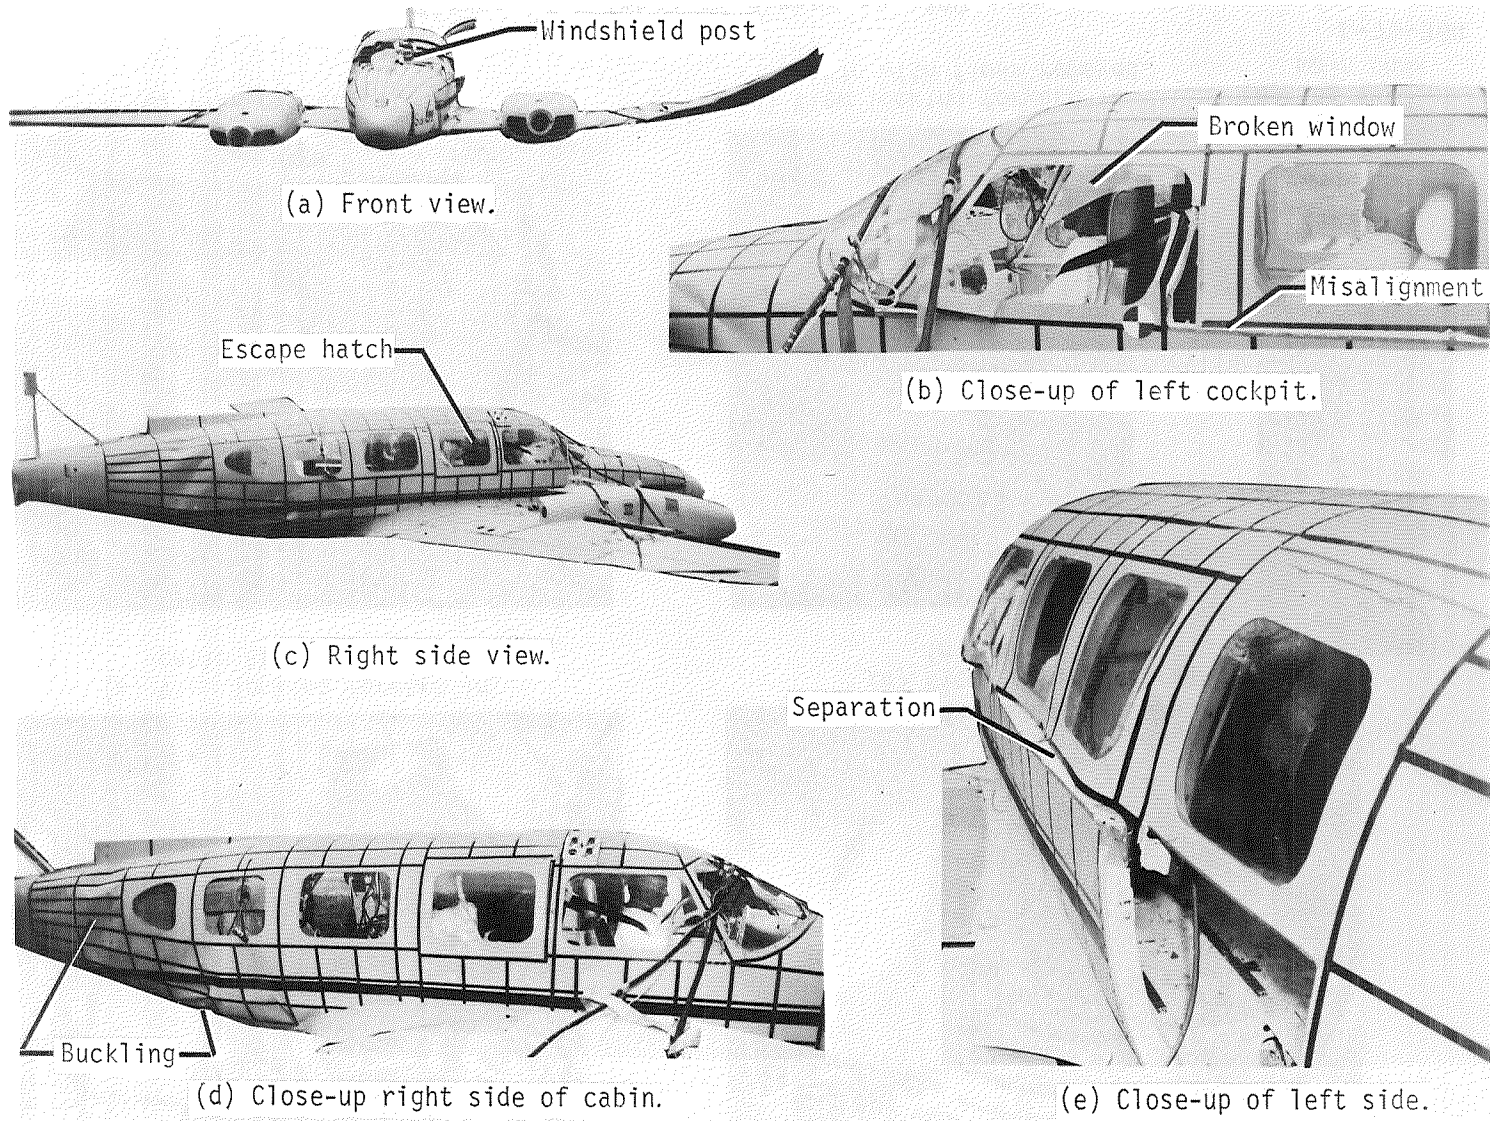
Figure 16.- Exterior damage to -30° test.

The exterior damage to this airplane is shown in figure 16. An overall front view of the airplane in figure 16(a) shows the upward deformation of the left wing and the left and center windshield posts separated at their lower fuselage attachments. The separation of the posts was caused by the tensile load on the top portion of the cabin during tail slapdown. Evidence of the tensile load can be seen in figure 16(b) by the misalignment of the black vertical skin lines (reference lines) between the pilot and first-passenger dummies. In the right side views (figs. 16(c) and 16(d)) skin buckling is shown in the aft portion of the fuselage. A rear view of the left side of the airplane (fig. 16(e)) shows separation of the cabin along the window ledge and misalignment of the painted lines of the underlying airframe sections.

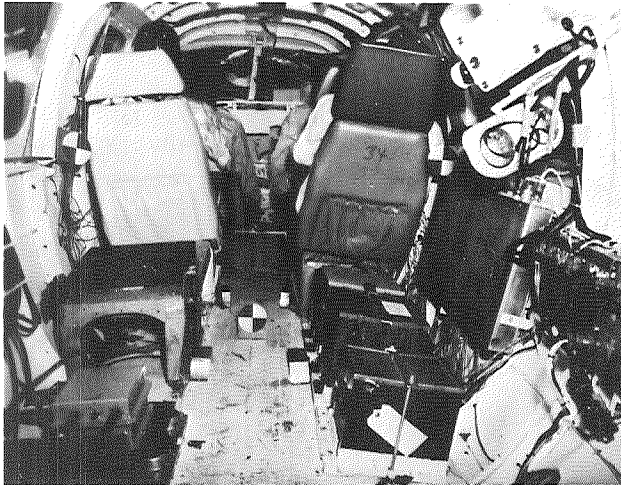
Figure 17.- Interior damage to -30° test.

The interior cabin damage in the  $-30^{\circ}$  roll test is shown in figure 17. A view looking forward in the cabin section (fig. 17(a)) shows only a slight apparent rise in the center portion of the floor manifested by the outward rotation of the seats. A view of the rear section of the airplane (fig. 17(b)) shows only minor fuselage separation along the lower portion of the fuselage. The windshield post, pilot side window, and copilot windshield were broken and are shown in figure 17(c); also shown is a slight buckling of the main spar. Damage to the cross members between the floor beams is shown in figure 17(d). Damage to the main spar is shown in a top view in figure 17(e).

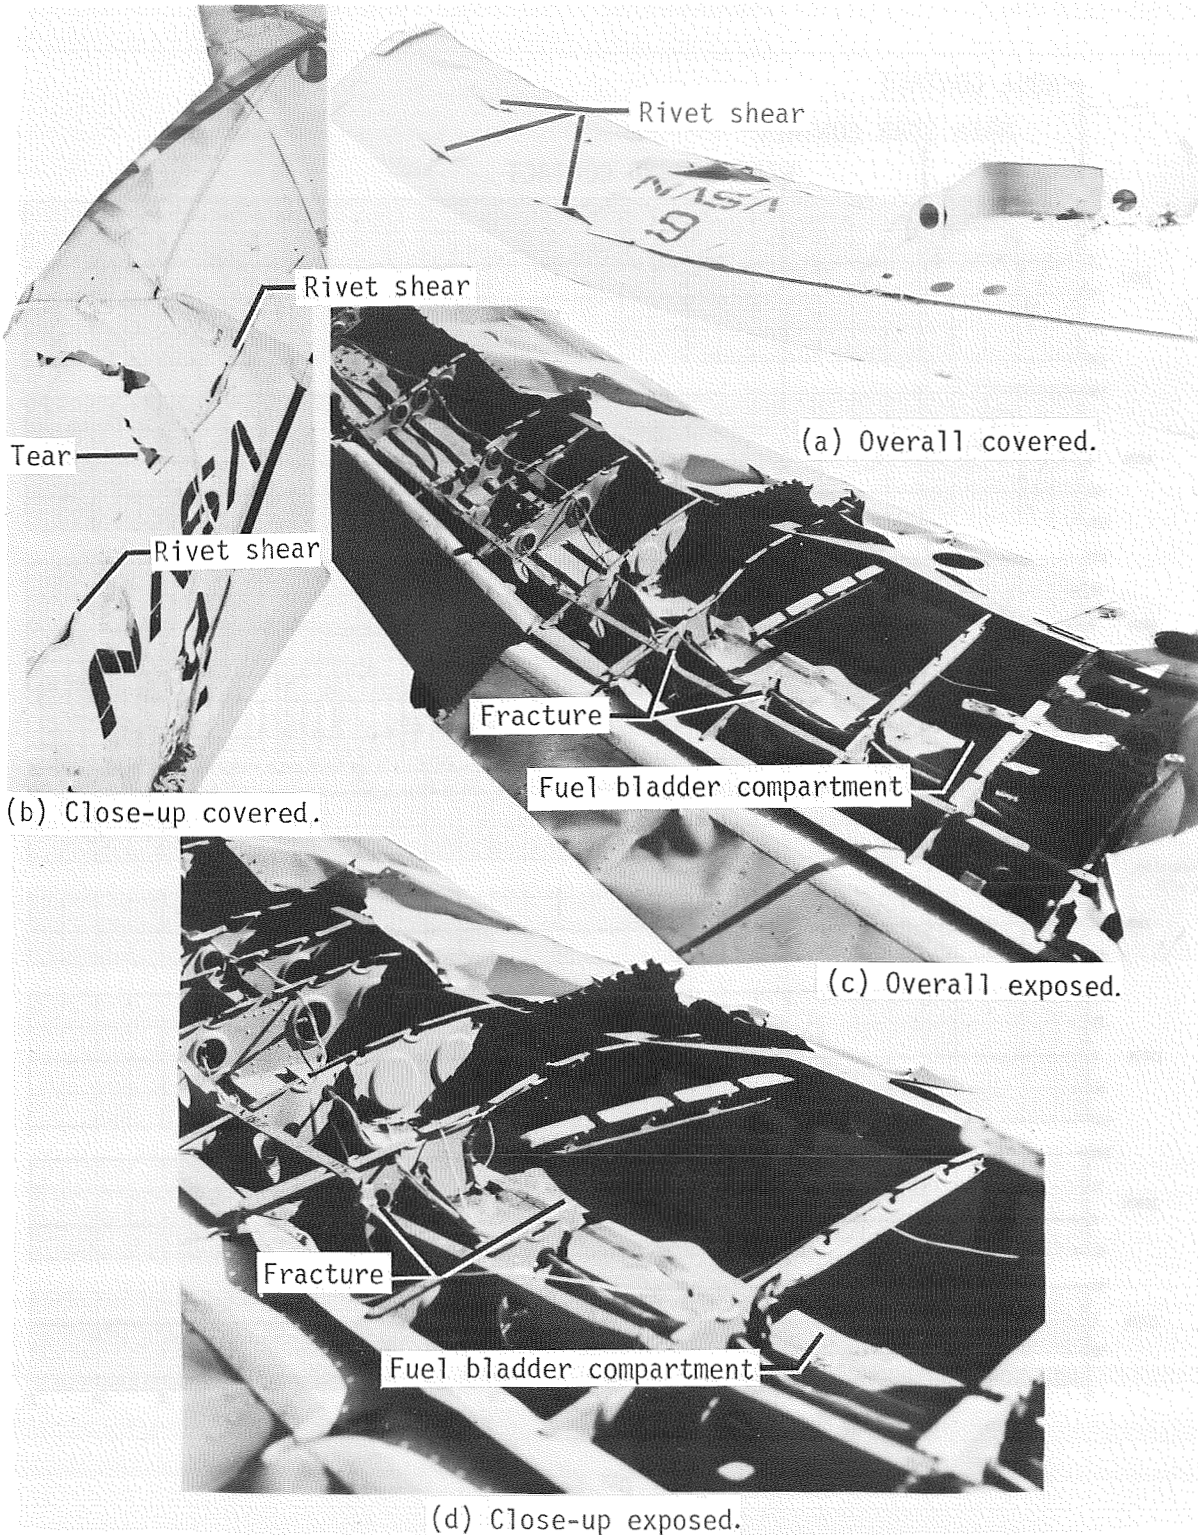
Figure 18.- Damage to left wing in  $-30^{\circ}$  test.

The left wing in the  $-30^{\circ}$  roll test is shown in figure 18 with skin damage evident on the top surface (fig. 18(a)) and with skin tears and rivet shear shown in the close-up (fig. 18(b)). A section of the damaged wing with the upper skin removed is shown in figures 18(c) and 18(d). Rib and rear spar fracture is evident in the close-up view (fig. 18(d)) in the vicinity of the outboard fuel bladder. The broken rib sections punctured the fuel bladder in several places.
