**737 GRAPHITE COMPOSITE FLIGHT SPOILER
FLIGHT SERVICE EVALUATION**

**BOEING COMMERCIAL AIRPLANE COMPANY
SEATTLE, WA**

AUG 78

737 GRAPHITE COMPOSITE FLIGHT SPOILER FLIGHT SERVICE EVALUATION

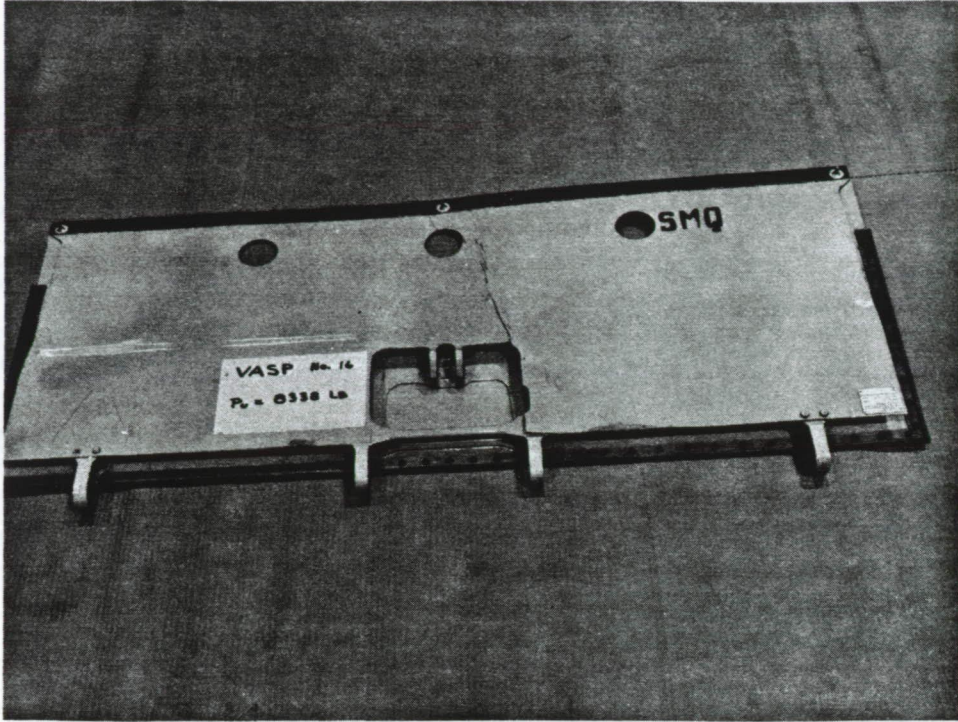
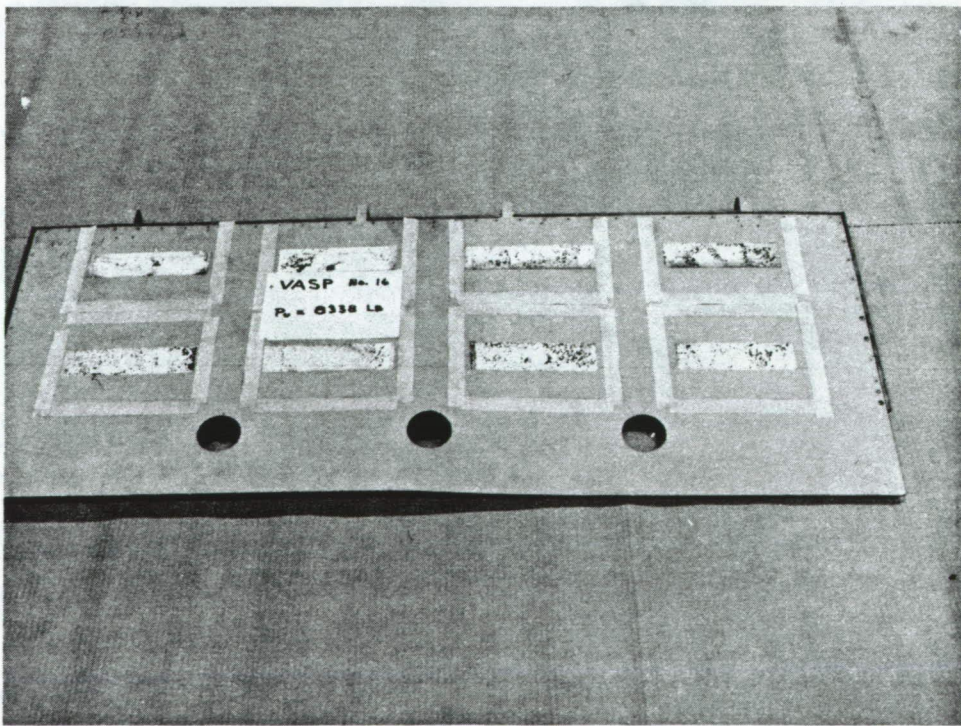
Figure 2.—Spoiler S/N 0016 Static Test

Additional core corrosion investigations conducted during this reporting period followed the previous technique of visual examination of the static test specimens subsequent to testing. Two of the specimens (S/N 0016 and 0107), were sectioned similar to spoiler S/N 0054 in ref. 1. Both panels were completely free of any evidence of corrosion in the honeycomb core.

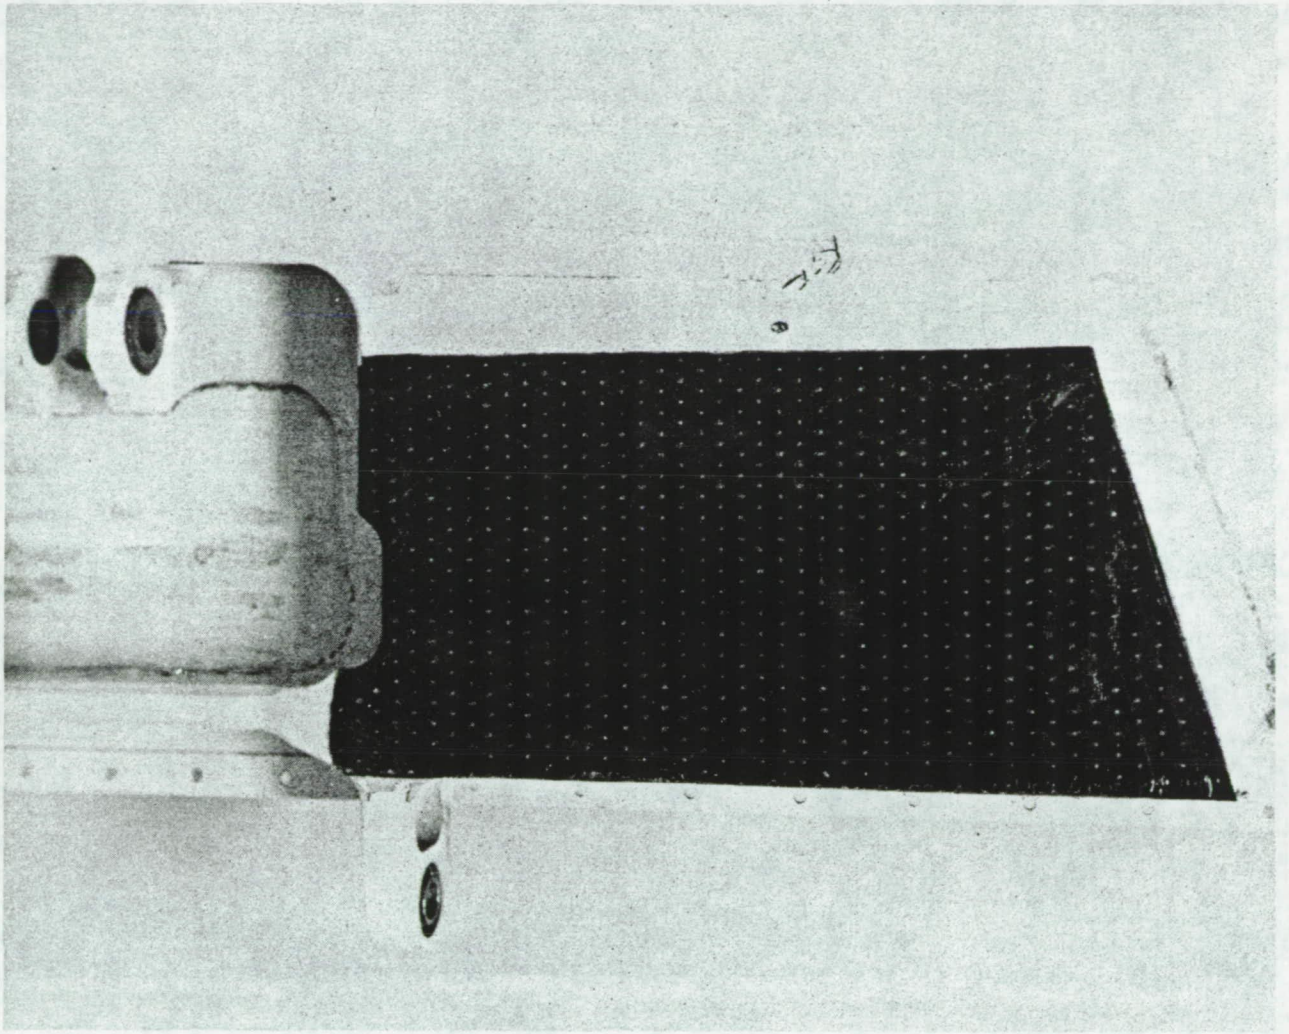
Figure 12.—Completed Repair on Aloha's S/N 0049

During the current reporting period, only four panels were removed from the service evaluation for corrosion of all types. One of these was attributable to the external doubler corrosion reported previously in ref. 3. The other three panels contained exfoliation corrosion in the spar chord extrusion, evidenced in a similar fashion to the corrosion reported in ref. 1 on spoiler S/N 0049 from Aloha.

The external doubler corrosion problem on S/N 0049 was repaired by Boeing and returned for further flight service. The repair processing of the exfoliation corrosion condition is discussed in detail under "Repairs."

In reference 1, spoiler panel S/N 0049 was reported as being in the repair process. The repair, which included dressing out the corrosion and re-processing the spar surface, was successfully accomplished on this panel, as well as on panel S/N 0009 (previously reported in ref. 2). This successful repair process is being followed by similar processing of those panels withdrawn from service during the present reporting period. Figure 12 shows the completed repair on S/N 0049 prior to surface refinishing. Not only was S/N 0009 refurbished with a spar repair in the manner of S/N 0049, but this panel also required repair of the three core samples removed as a portion of the core-sampling technique development in 1976. (Figure 13 shows both the cored trailing edge and a partially completed spar repair). Having successfully repaired the spar, the core-sample repair was then undertaken to return S/N 0009 to flight-worthy status.

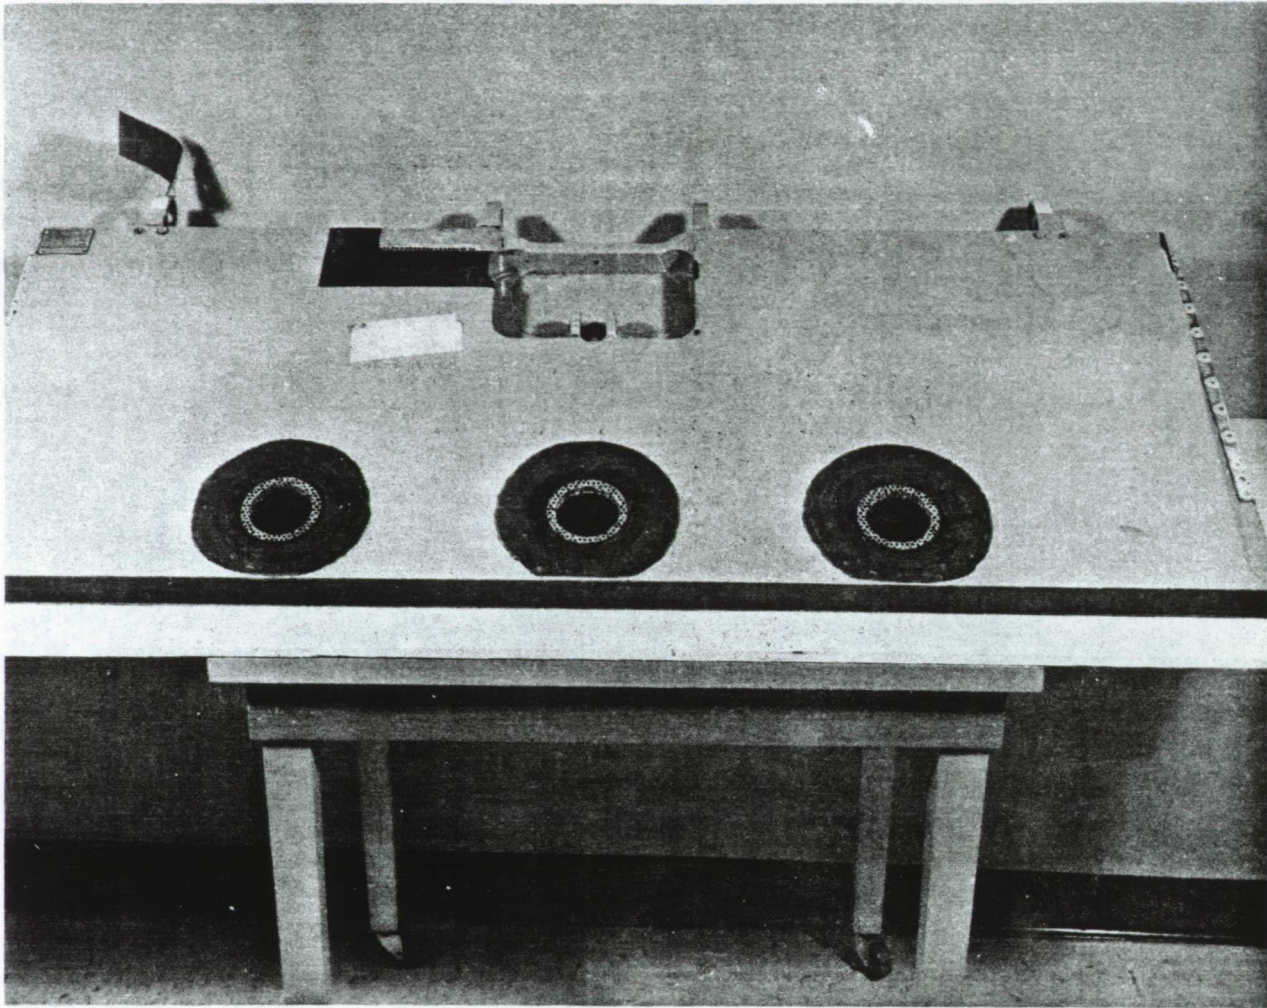
Figure 13.—Spoiler S/N 0009 Prepared for Repair

Two panels (S/N 0009 and 0050), previously withdrawn from the program, are undergoing repair and will be returned to service following successful completion of the repair process.
