NASA Technical Memorandum 79227

THE EROSION/CORROSION OF SMALL
SUPERALLOY TURBINE ROTORS
OPERATING IN THE EFFLUENT
OF A PFB COAL COMBUSTOR

G. R. Zellars, S. M. Benford,
A. P. Rowe, and C. E. Lowell
Lewis Research Center
Cleveland, Ohio

Prepared for the
Advanced Materials for Alternate Fuel Capable
Directly Fired Heat Engines Conference
cosponsored by the United States Department of Energy
and the Electric Power Research Institute
Castine, Maine, July 30 - August 3, 1979

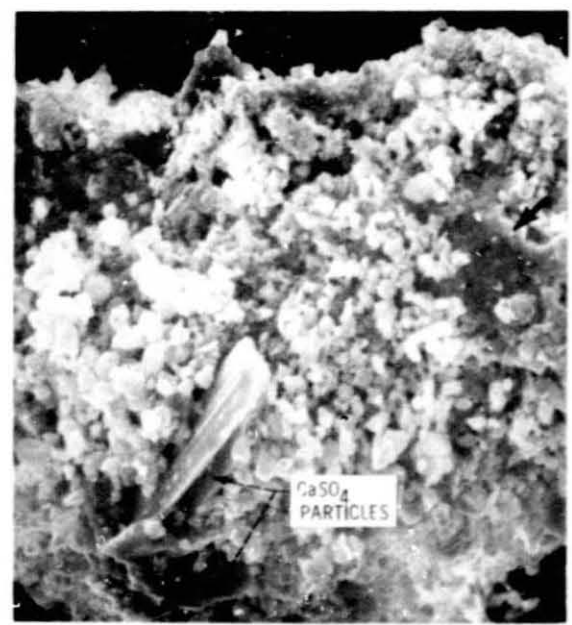
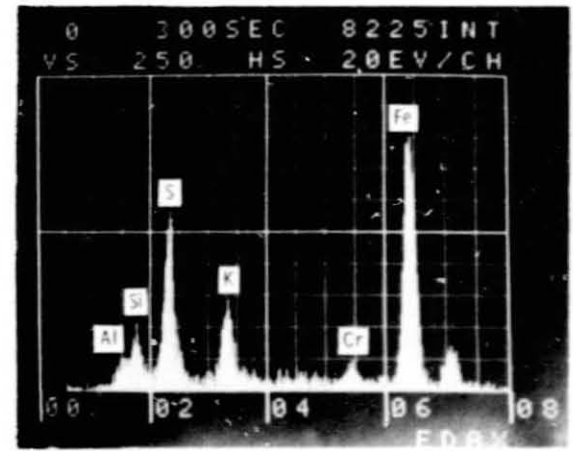
Figure 8 shows solids particles adhering to chromium oxide scraped from the pressure side of an R4 blade. The oxide may be from the surface or may have been deposited, perhaps after erosive removal from another blade or surfaces upstream. The solids particles are generally fluffy with varying Al-Si, K, Ca, and Fe content. The presence of sulfur is often accompanied by K and Fe, suggesting the presence of alkali metal-iron trisulfates. The smooth, dark appearance of these regions may indicate previous melting. Large CaSO₄ crystals imbedded on the oxide are representative of highly erosive species.

Figure 8. - Solids particles adhering to chromium oxide.

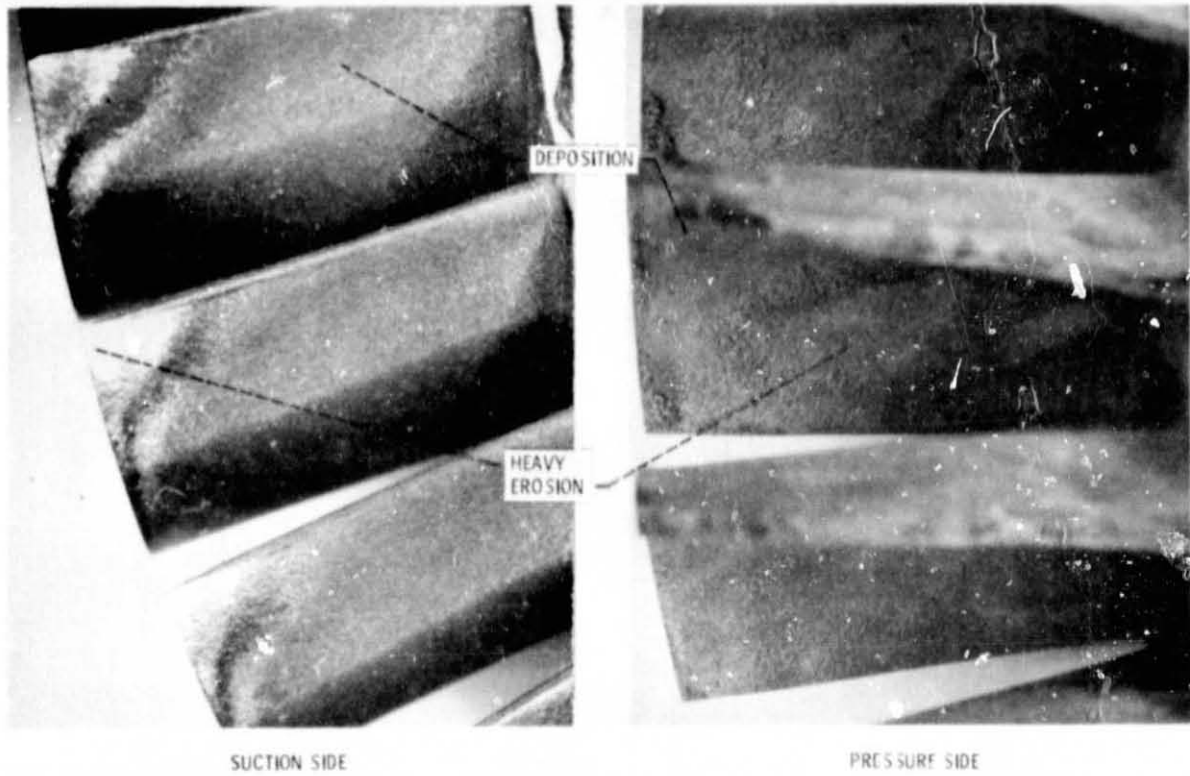
ROTOR 3, Pa COAL/LIME STONE

Average surface materials loss on the Alloy 713 LC rotor (R3) was 0.1 mm (4 mils) and the loss rate was about 0.6 u/hr (0.024 mil/hr). Leading edge to trailing edge losses were comparable. Figure 9 shows the erosion and deposition pattern on an R3 blade. After rebounding from the leading edge, some heavy particles appear to impact on the pressure side of the blade above as they are thrown radially outward, finally impacting a third time on the trailing edge tip. The rippled appearance of erosion on the pressure side (Figure 10) is evidence of impact at the maximum erosion angle (≈ 30 degrees) (5). Average erosion loss rates projected from small-scale turbine tests are likely to be conservative because of the higher probability of multiple impact with smaller blade separations. A larger centrifugal force in small radius rotors also enhances erosion near the tip. Deposition occurred on areas surrounding the heavy particle path primarily on the suction side.

Figure 9. - Erosion of alloy 713 LC exposed at 260 m/sec, 690° C, 164 hours. Solids loading = 600 ppm (0.3 gr/SCF).

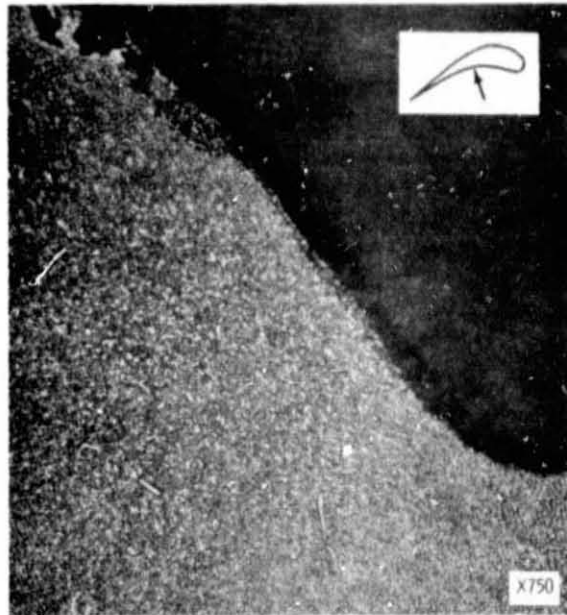
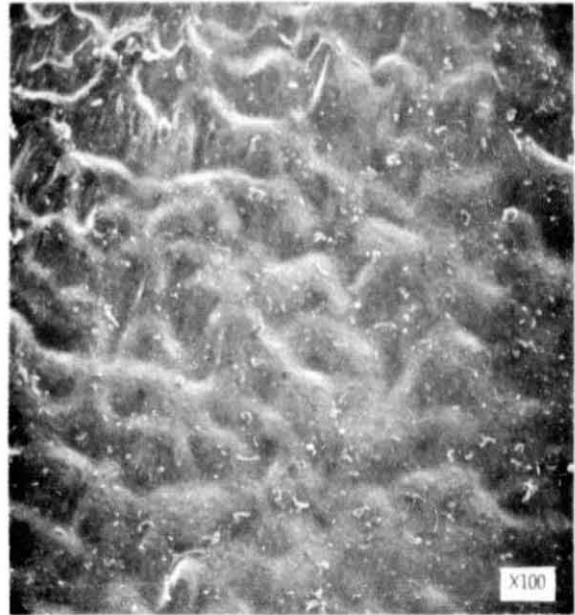
Figure 10. - Rippled appearance of pressure side erosion on alloy 713 LC (R3).

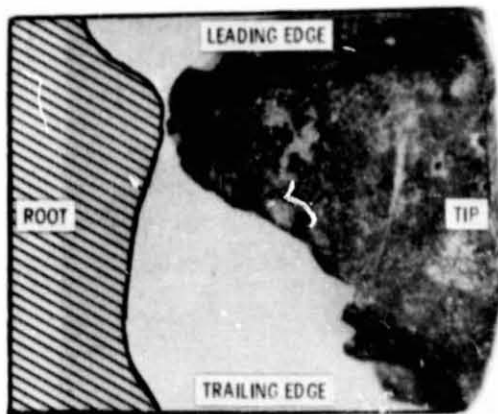
ROTOR 4, OHIO COAL/DOLLOMITE

R4 was terminated by complete loss of the blades after 13 hours. Erosion damage had severely weakened the structure of the blades, and examination of the blade fragments revealed that many were joined to the root at a single point near the leading edge (Figure 11) prior to failure. Average surface loss, estimated from blade fragments, was 0.25 mm (10 mils) and the loss rate was 18 u/hr (0.7 mil/hr). The location of sites of heavy metal loss is consistent with the leading edge notch and teardrop shaped pressure side erosion observed on R3 blades. After 12 hours at nearly the same high solids loading, R5 blades had lost only the trailing edge tip section. Average surface loss (0.1 u, 4 mils) and erosion rates (6.5 u/hr, 0.3 mil/hr) were less than half as great as R4 losses.

Figure 11. - Erosion of IN 792 + Hf blades at 330 m/sec, 780° C, 12-13 hours. Solids loading, ≈ 2700 ppm (1.5 gr/SCF).

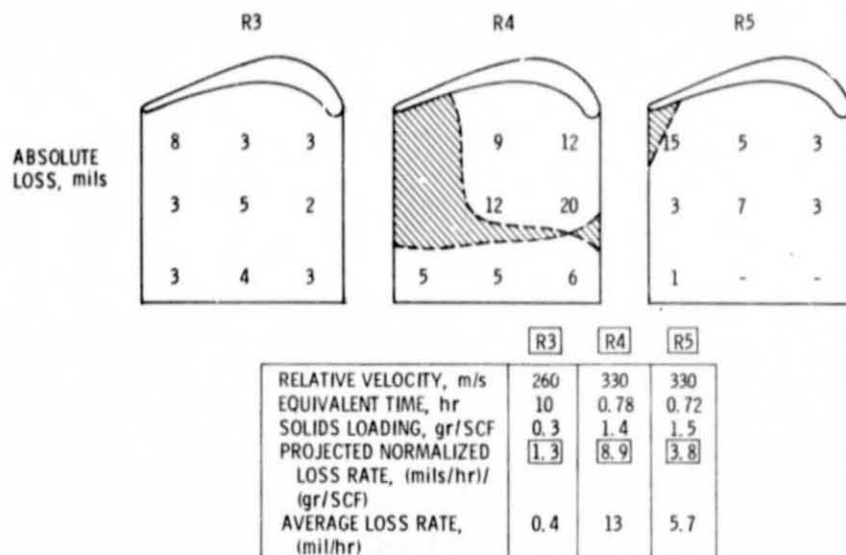
A comparison of surface loss rates projected for full admission is shown in Figure 12. At 6% partial admission, the exposure times are equivalent to 10 hours for R3 and about 0.75 hours for R4 and R5. In these times, the average loss rate ranged from 10 to 300 u/hr (0.4 to 12 mil/hr). Both R3 and R5 rotors were exposed to limestone sorbent effluent. The normalized erosion rate of R5 (45 cm/yr/1000 ppm, 3.8 (mils/hr)/(gr/SCF)) is three times greater than that of R3 (15 cm/yr/1000 ppm, 1.3 (mils/hr)/(gr/SCF)). If erosion varies as the cube of velocity, the erosion rate should be only twice as great at the higher velocity. The additional factor may reflect a larger proportion of heavy particles at higher solids loading, a slight difference in particle composition, or a difference in the erosion resistance of the oxide or metallic surfaces.

Figure 12. - Projected surface erosion loss rate at full admission.

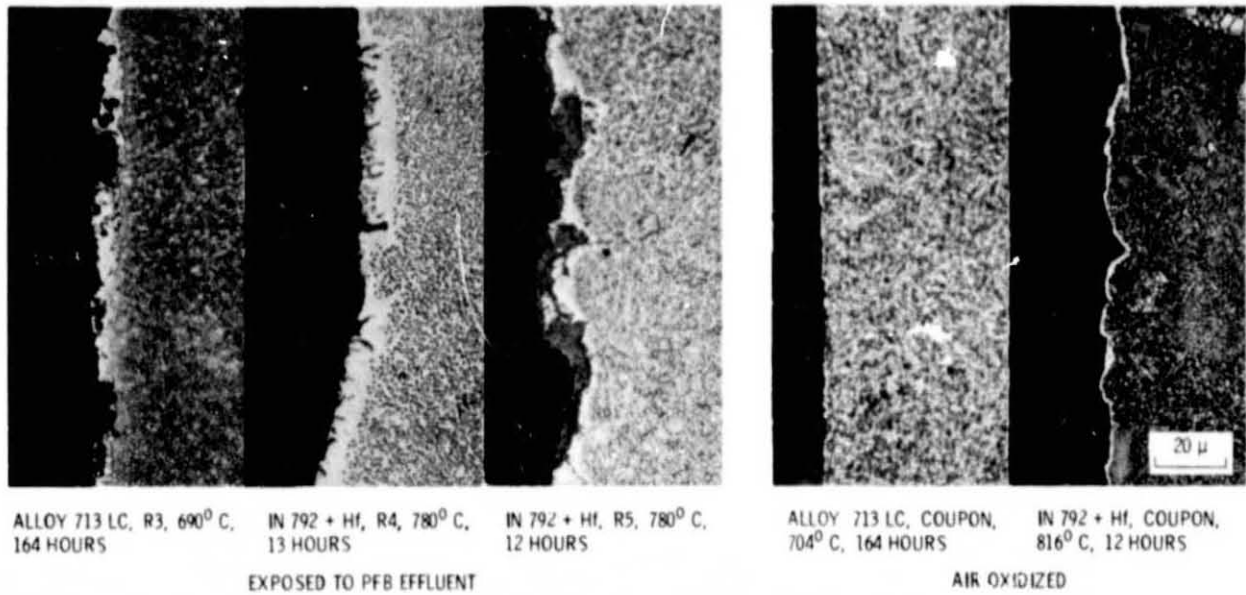
Figure 13. - Suction side oxidation compared with furnace oxidized coupons.

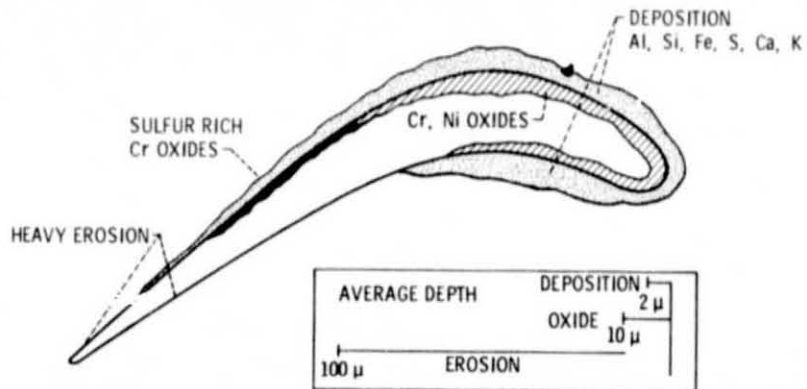
The oxidation pattern of an Alloy 713 LC blade, exposed for 164 hours at 690 C, is shown in Figure 14. Oxide affected layers of about 10 μ are seen on most of the suction side beneath 1-2 μ deposition layers. The average erosion depth is an order of magnitude greater than the average oxidation affected depth. Oxides on the suction side are typically rich in chromium (Figure 15) and may be protective unless erosively damaged by brittle cracking (Figure 16).

Figure 14. - Erosion/corrosion schematic of an alloy 713 LC blade; tip section (R3).

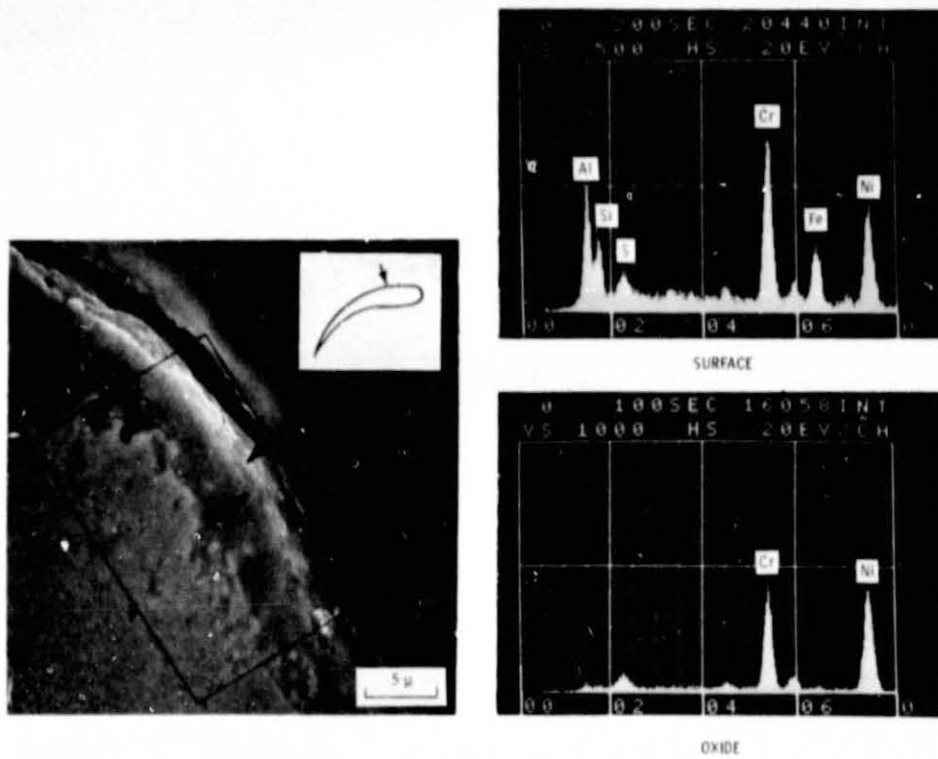
Figure 15. - Chromium-rich oxide on alloy 713 LC blade, exposed at 690^o C for 164 hours (R3). Erosion rate, 0.6 μ/hr (0.024 mil/hr).

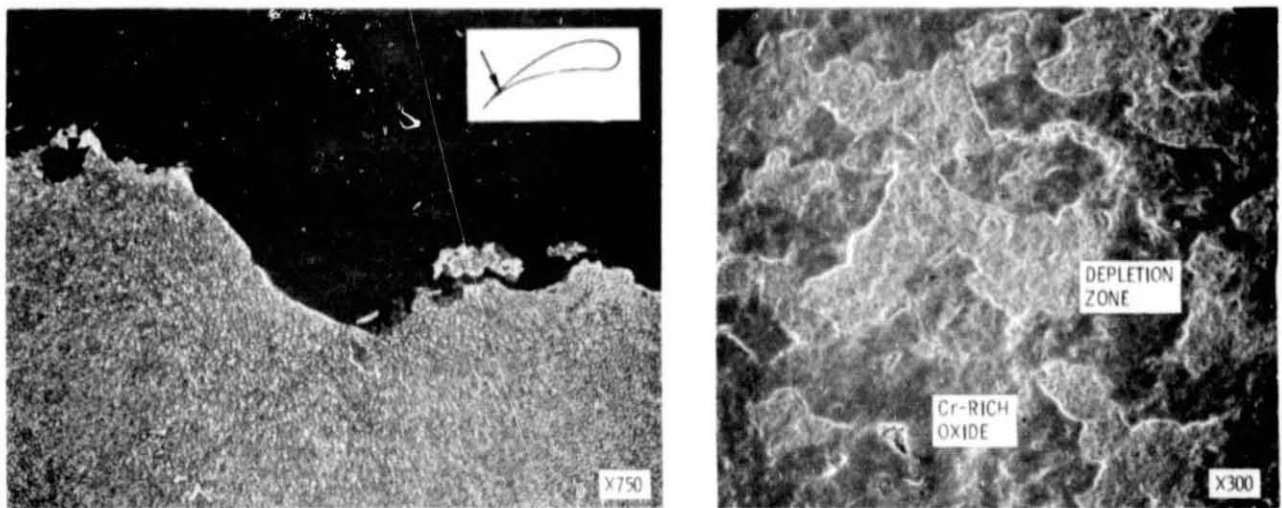
Figure 16. - Erosion of protective oxide layers in transition zones on alloy 713 LC (R3).

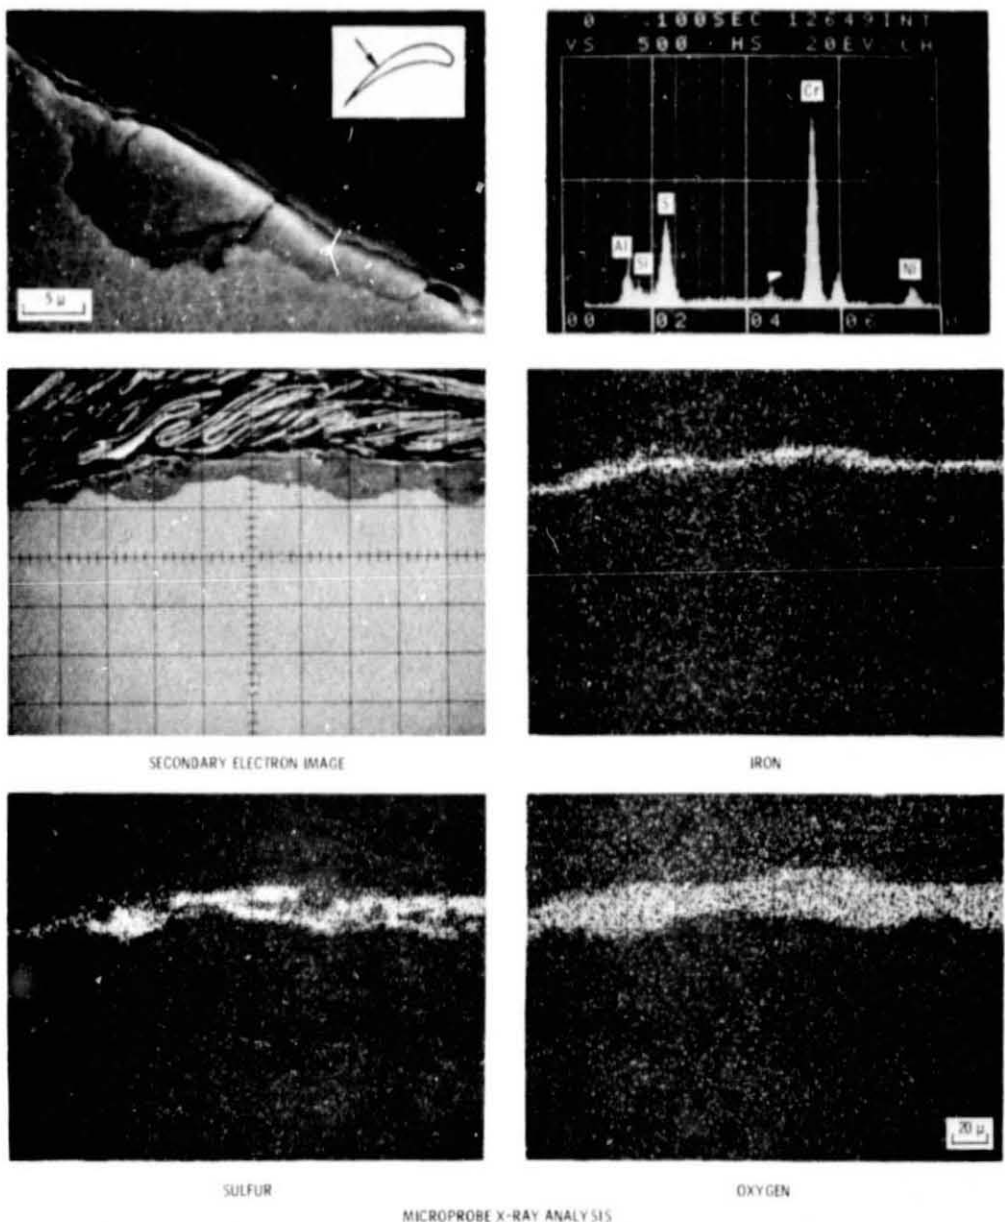
Figure 17. - Sulfur-rich chrome oxide on suction side of an alloy 713 LC blade, exposed at 690° C for 164 hours (R3).

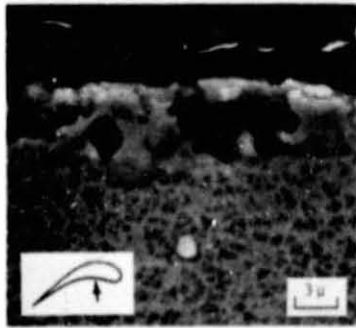
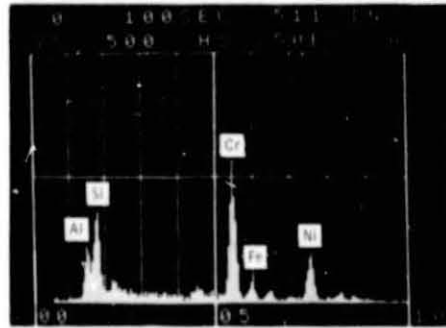
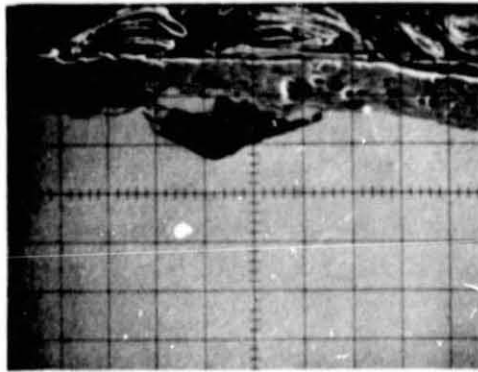
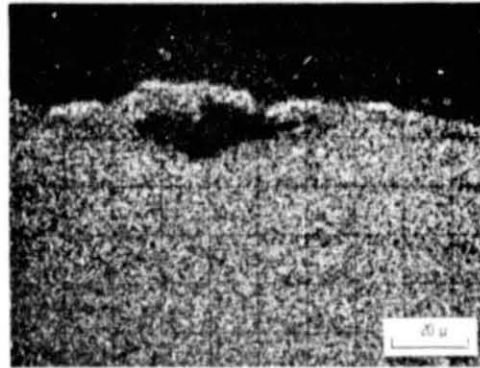
On the pressure side, oxide growth is irregular and deposition is heavy ($\approx 10\mu$). In some areas, Cr oxides are mixed with deposition materials in the absence of visible depletion zones (Figure 18). This buildup may be primarily composed of rebound particles from the leading edge of another blade. The formation of heavy deposits may also be protective against erosion, but heavy deposits do not necessarily enhance oxide or sulfide growth.

Figure 18. - Heavy pressure side deposition on alloy 713 LC blade (R3).

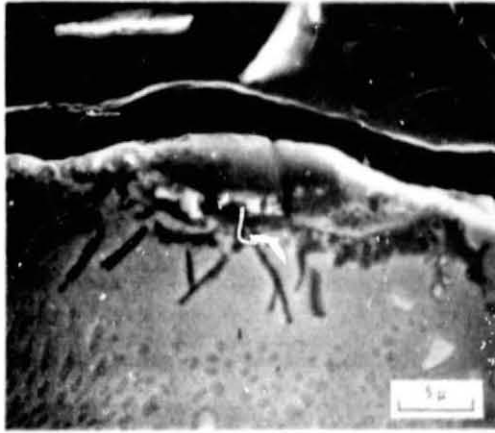
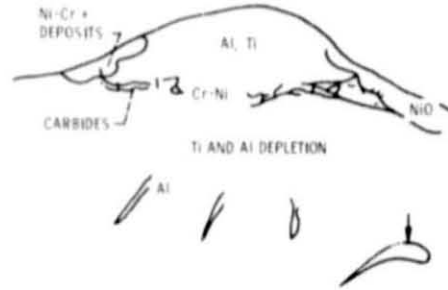
Oxides on heavily eroded R4 (IN792+Hf) blades, exposed for 13 hours at 780 C, were limited to projecting aluminum and titanium oxide nuclei with substrate oxide streamers in broad ($\approx 10\mu$) depletion zones (Figure 19). Remnants of Cr and Ni rich oxides surrounding the nuclei or knobs suggest an oxide evolution picture in which harder subsurface aluminum oxide deposits either remain after surface oxides are eroded away or form in exposed depletion zones. Aluminum rich knobs seen on the pressure side of an R4 blade (Figure 20) may correspond to similar knobs observed on previous Lewis wedge bar tests with IN792. Deposition materials form a wake behind the knobs. Since the erosion rate of these blades was extremely high, the presence of highly localized aluminum oxide deposits does not appear to diminish the erosion rate. The relatively rapid formation of subsurface oxides after erosive removal of protective oxide elements may, in itself, be a materials problem at lower loadings.

Figure 19. - Aluminum and titanium rich oxide on IN 792 + HT blade, exposed at 780° C for 13 hours (R4). Erosion rate, 18 μ/hr (0.7 mil/hrs).

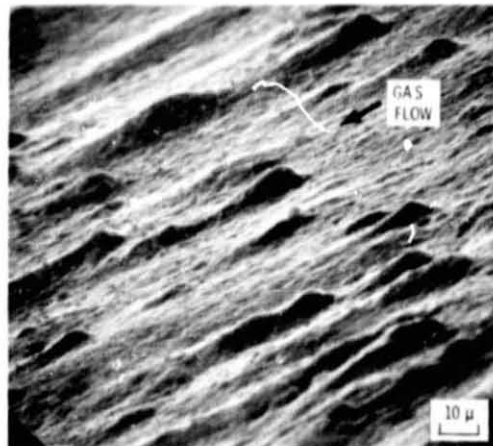
Figure 20. - Aluminum-rich knobs on pressure side of an IN 792 + HT blade (R4).

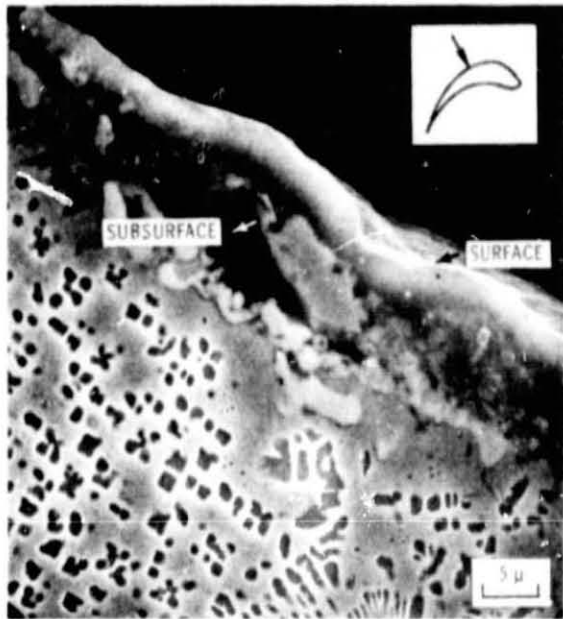
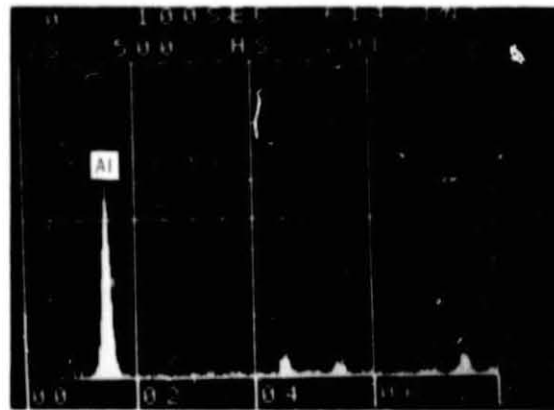
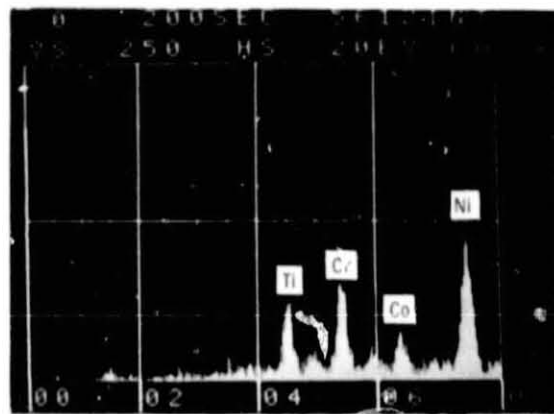
R5 blades (IN792+Hf), also exposed at 780 C for 12 hours, contained a somewhat more protective oxide layer on the suction side. Aluminum rich deposits formed beneath chrome and titanium rich overlayers (Figure 21). The apparent presence of Hf and Ti carbides imbedded in mixed oxides on both R4 (Figure 22) and R5 blades suggest that carburization may also occur in the primarily oxidizing PFB effluent under deposition layers (10). The carbides are often seen rimming an oxide region.

Figure 21. - Aluminum, chromium, and titanium rich oxides on IN-792 + Hf blade, exposed at 790°C for 12 hours (R5). Erosion rate, 8.5 μ/hr (0.32 mil/hr).

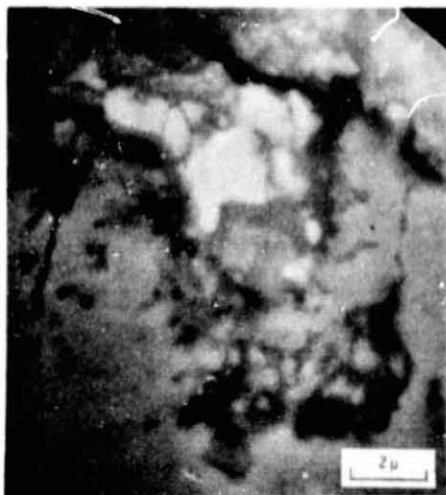
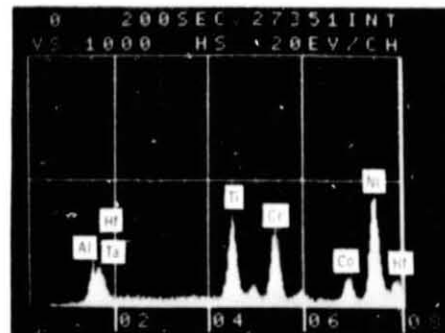
OXIDES AND CARBIDES

Figure 22. - Carbides imbedded in mixed oxides on IN-792 + Hf blade (R4).
