NASA-CR-135447

DEFINITION OF MUTUALLY OPTIMUM NDI
AND PROOF TEST CRITERIA FOR
2219 ALUMINUM PRESSURE VESSELS

VOLUME III APPLICATIONS TO RAIL DEFECT EVALUATION

MARTIN MARIETTA CORPORATION

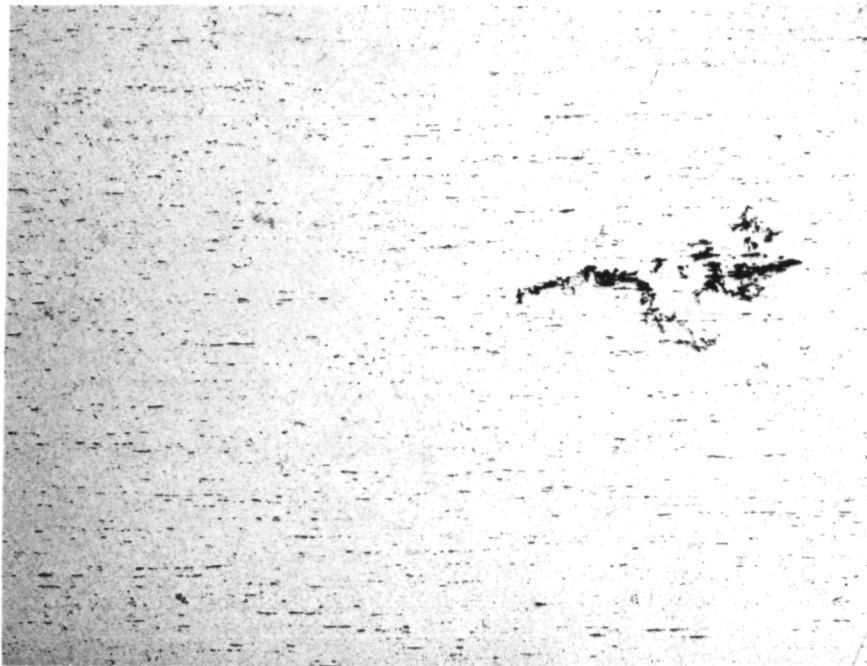
Figure 2. - Longitudinal section through rail obtained from DOT.

Ultrasonic C-scanning using conventional pulse-echo techniques was performed on the as-received first series of rails to locate the defects that required removal from service and to determine the detectability of transverse fissures. The high level of inclusions in the steel produced so many defect indications that operators, unaccustomed to evaluating this type of material, had difficulty establishing the locations of the transverse fissures. The ultrasonic inspection was repeated several times to verify that the indications were due to inclusions. Sectioning and macro-etching confirmed the high level of inclusions. Figure 2 shows such a section.

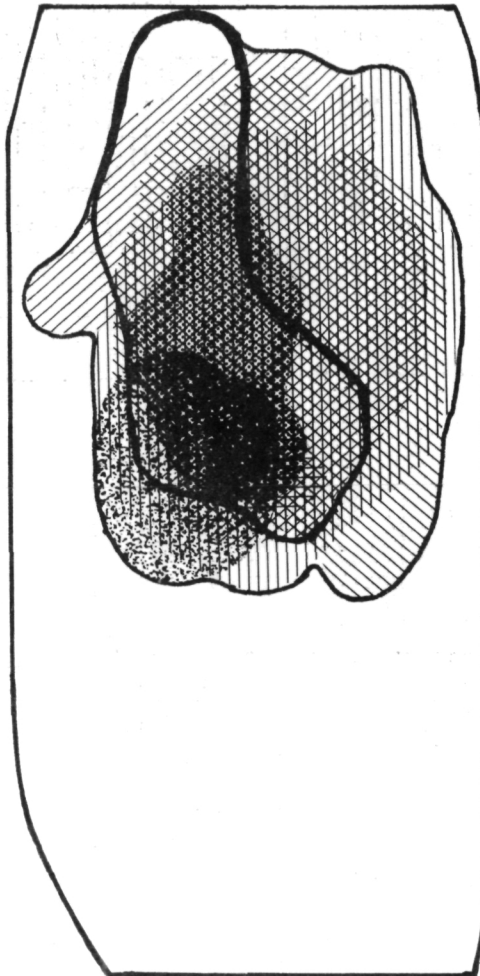
Figure 9. - Characterization of defect in rail 65 obtained by multiple pulse-echo scans.

Rail 65 was inspected in six directions, representing traverses from left to right and right to left (two directions) for each of the three surfaces (head and each side). Figure 6 shows the scans obtained by traversing the head in each direction. Note the significant difference in size and shape of the defect indications. Similarly, figures 7 and 8 show the scans for each side face. One trace was duplicated on the next day and was found to agree quite well with the previous result. Such scans had to be adjusted for the angle of transmission of the signal through the metal. By doing so and making a composite of the seven scans (six directions plus one repeat), the representation of the defect shown in figure 9 was obtained. Experience has shown that a better correlation with actual defect size was obtained by incorporating a correction for beam width. Figure 10 illustrates the reduction in size of the indicated defect by half- and full-beam-width correction and compares actual defect size and shape.

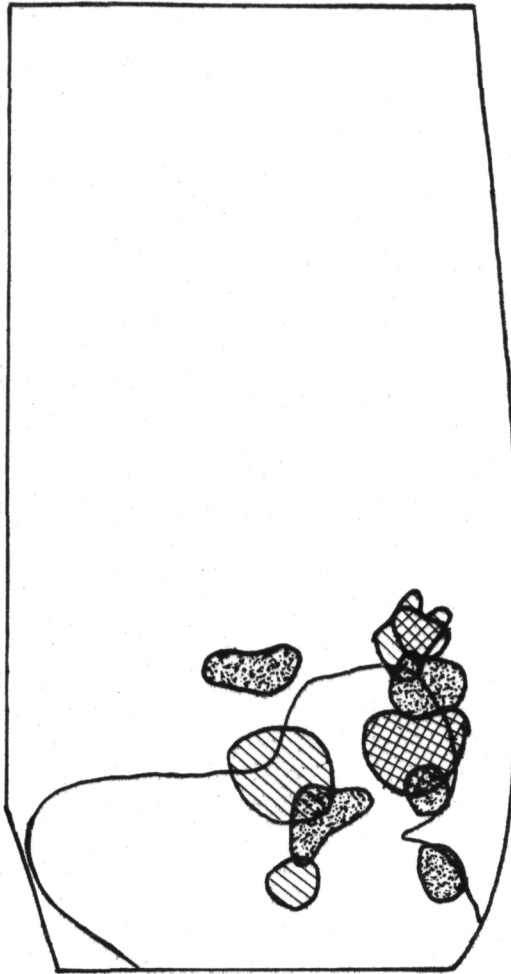
Figure 11. - Characterization of defect in rail 64
obtained by multiple pulse-echo scans.

Rail 64 was similarly evaluated. Two scans failed to show evidence of a defect. Three scans revealed small defect indications and one revealed a large indication. Figure 11 shows the composite of the various scans. Note the significant difference in the size and location of individual indications. The large dotted image was obtained from a top-surface traverse. The top-surface traverse in the opposite direction did not produce any reflection. Traverses from the side surfaces produced small indications grouped together, which suggested that defect characterization might be influenced by detail fracture.* Side-surface

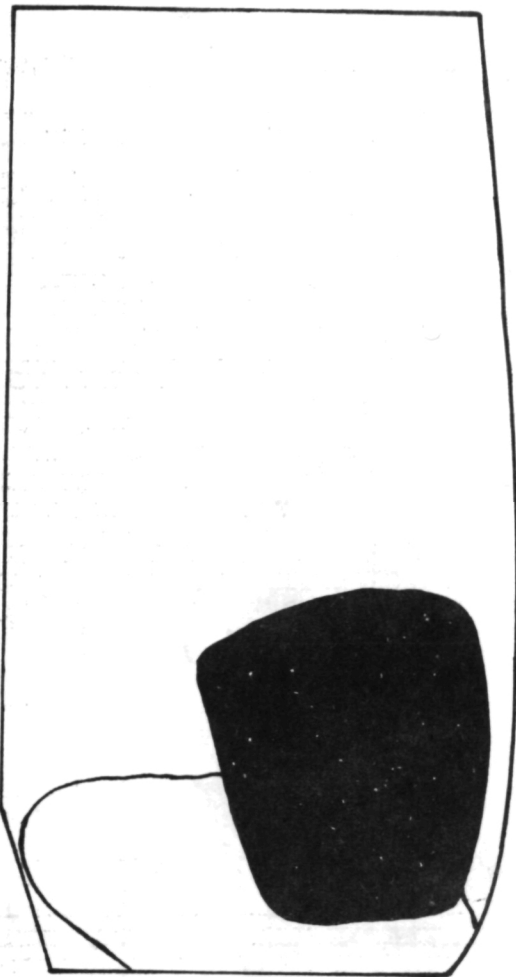
Figure 12. - Characterization of transverse portion of defect in rail 64.

traverses characterized the transverse portion of the defect. Figure 12 illustrates the envelope suggested by the transverse portion.

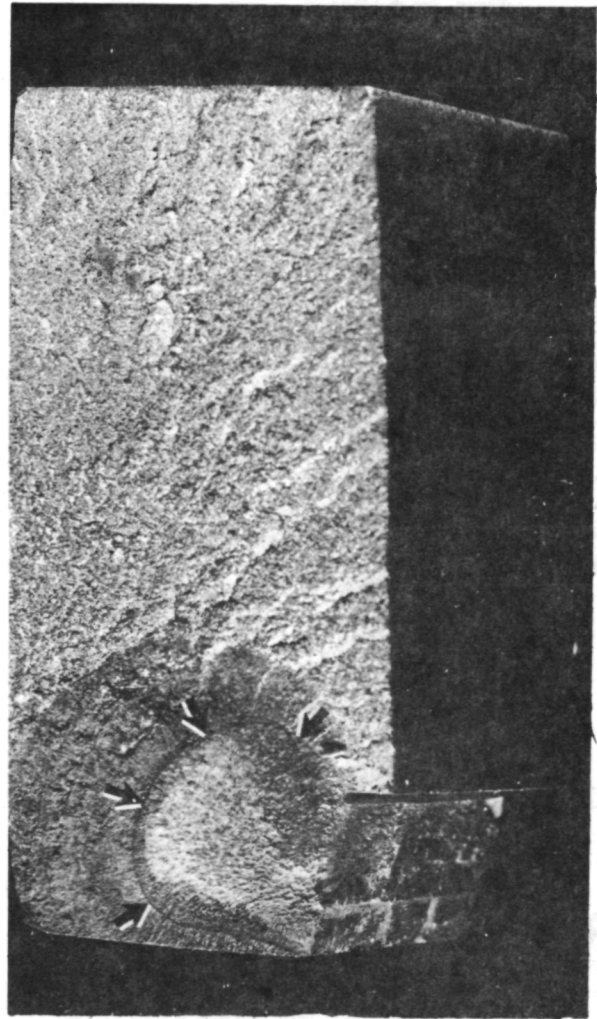
Figure 13. - Fracture surface of rail 64.

Opening the defect confirmed that initiation was in the longitudinal direction and that, during propagation, it rotated to the transverse orientation. Figure 13 shows the fracture surface.

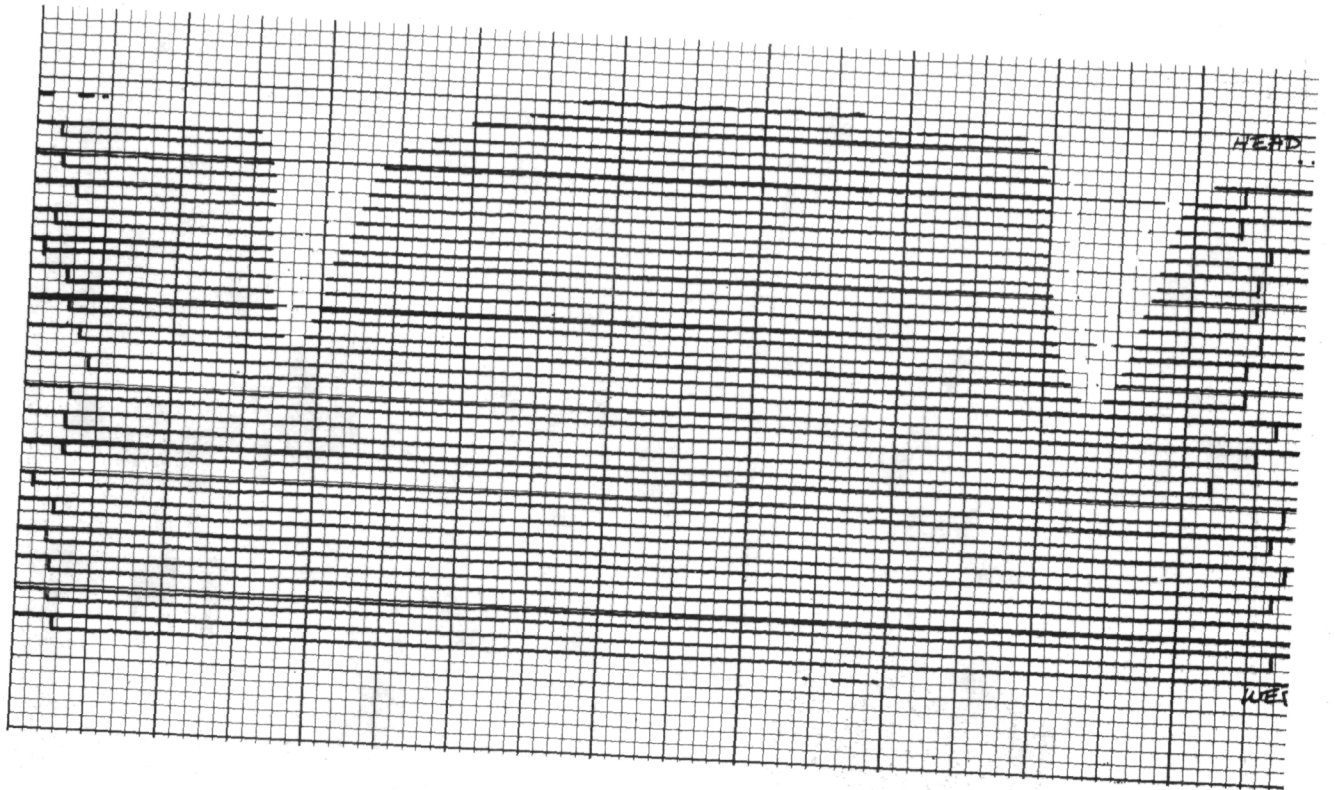
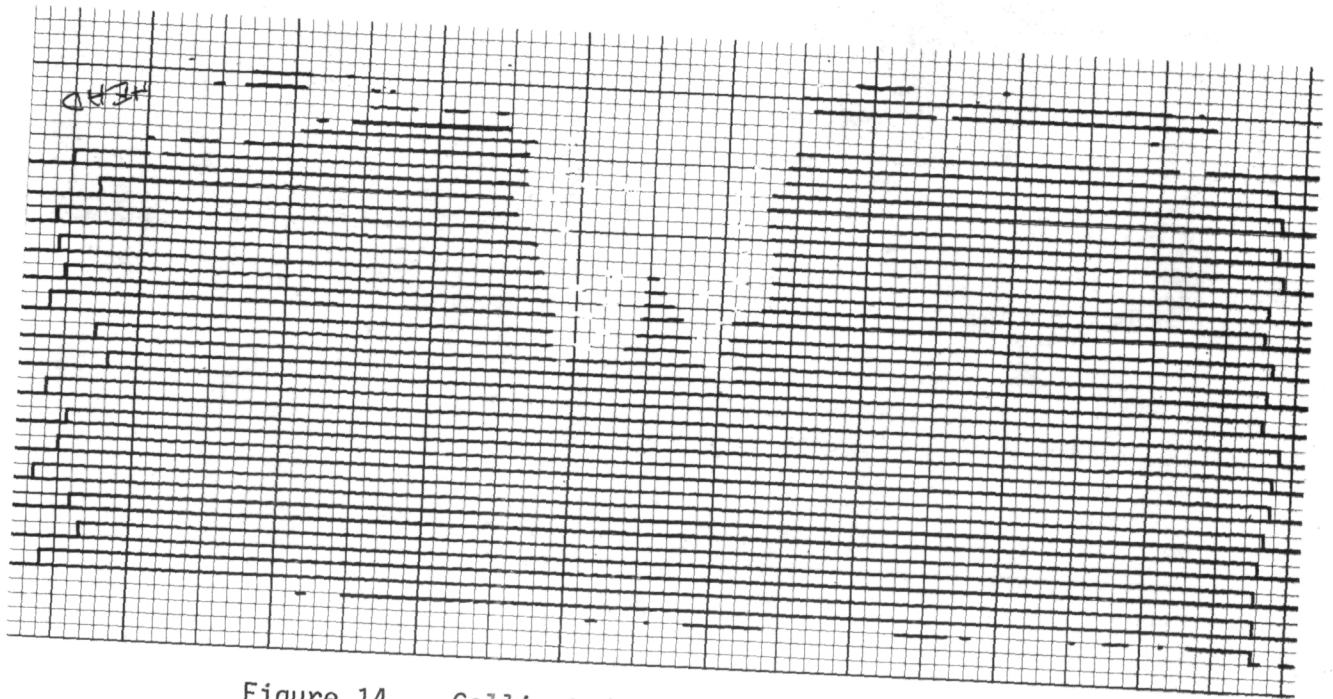
Figure 14. - Collimated pitch-catch data for rail 64 in as-received condition.

Figure 14 illustrates actual rail 64 data evaluated from each side. The trace from one side shows two indications of the defect widely spaced; the trace from the other side shows the indications to be overlapping.* This observation indicated that the defect was quite close to one side. Further study of the figure showed that the defect was near the head. The dissimilarity in size of the two indications suggested an orientation that is not normal to the surface.

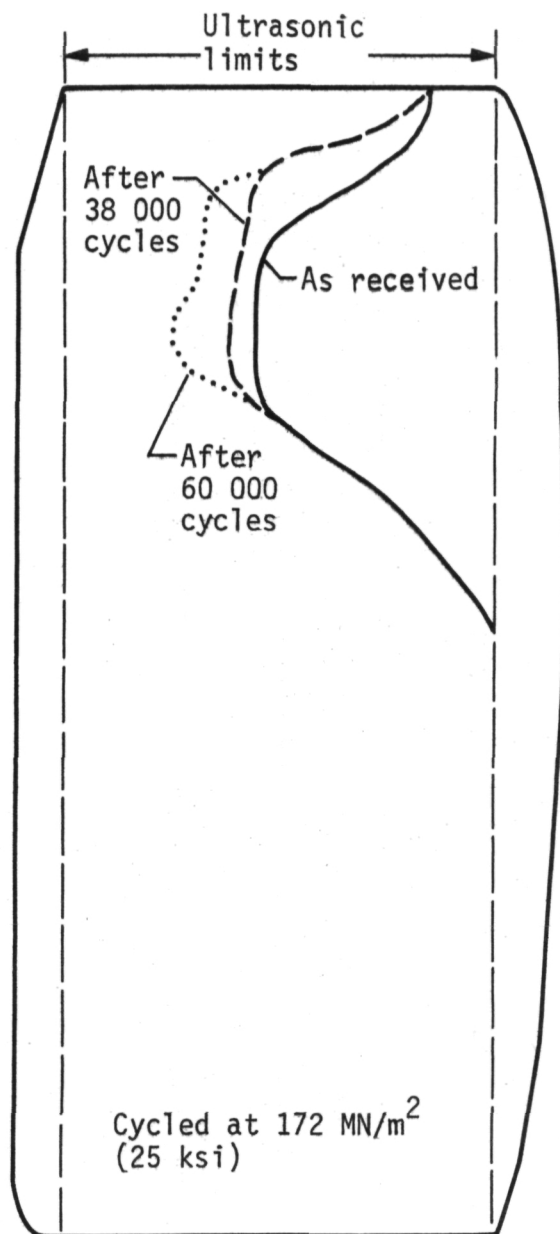
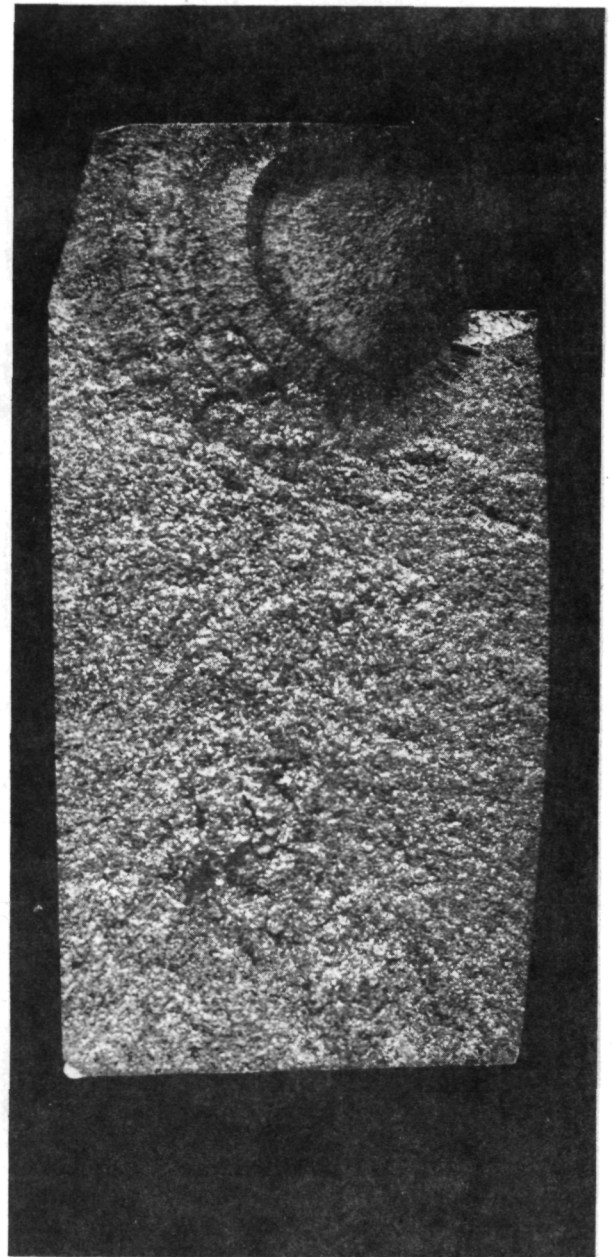
Figure 16. Pitch-catch flaw map and fractograph of rail 64.

To enlarge the defect, the specimen was then subjected to a series of cyclic loadings at 172 MN/m^2 (20 ksi). After each cyclic loading, the rail section was reinspected. The growth band was marked by cycling at a lower stress to produce a small growth band of different appearance. The marking cycle was 5000 reversals at a stress of 138 MN/m^2 (20 ksi). Five growth and inspection sequences were performed. Figure 15 is an ultrasonic record after cycling in which depth growth was apparent. For additional clarity, ink blots have been removed, and a flaw map of these data transformed to true shape. Figure 16 shows a fracture-face photograph.

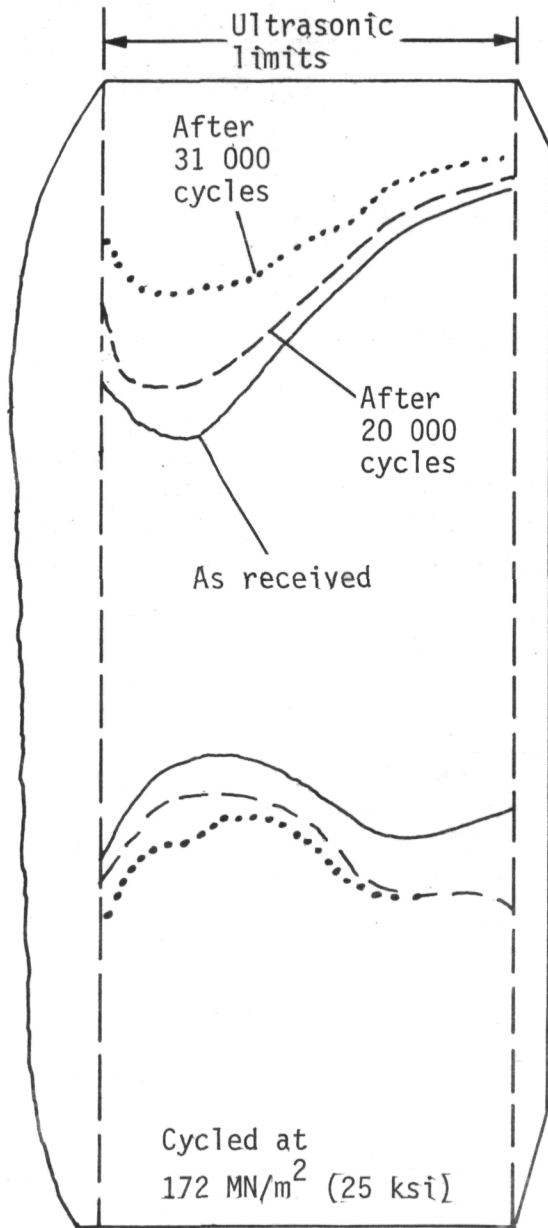
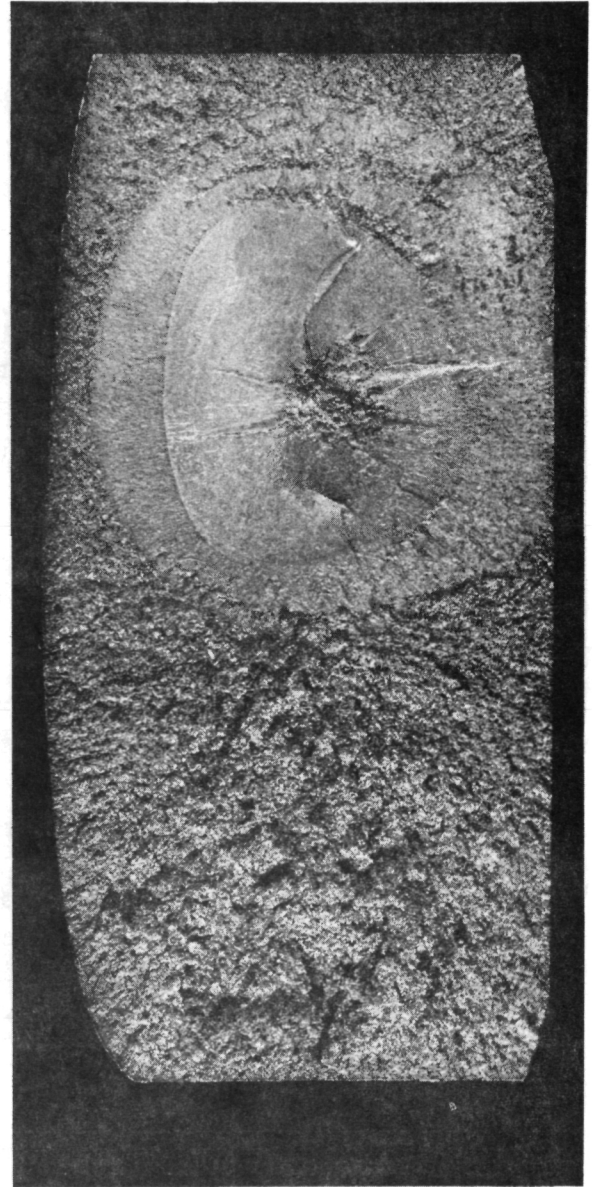
Figure 18. - Pitch-catch flaw map and fractograph of rail 65.

through the entire section from head to web. The traces also suggest an hourglass shape for the defect. The fractograph in figure 18 shows the defect to be totally embedded; a flaw map constructed from the data is also shown.

The results of this part of the evaluation show that, although crack growth could be tracked, the ability to map the entire cross section was limited. It appeared that only the central portion could be adequately monitored. As the head and web surfaces were approached, the ultrasonic signal did not validly represent the defect shape.

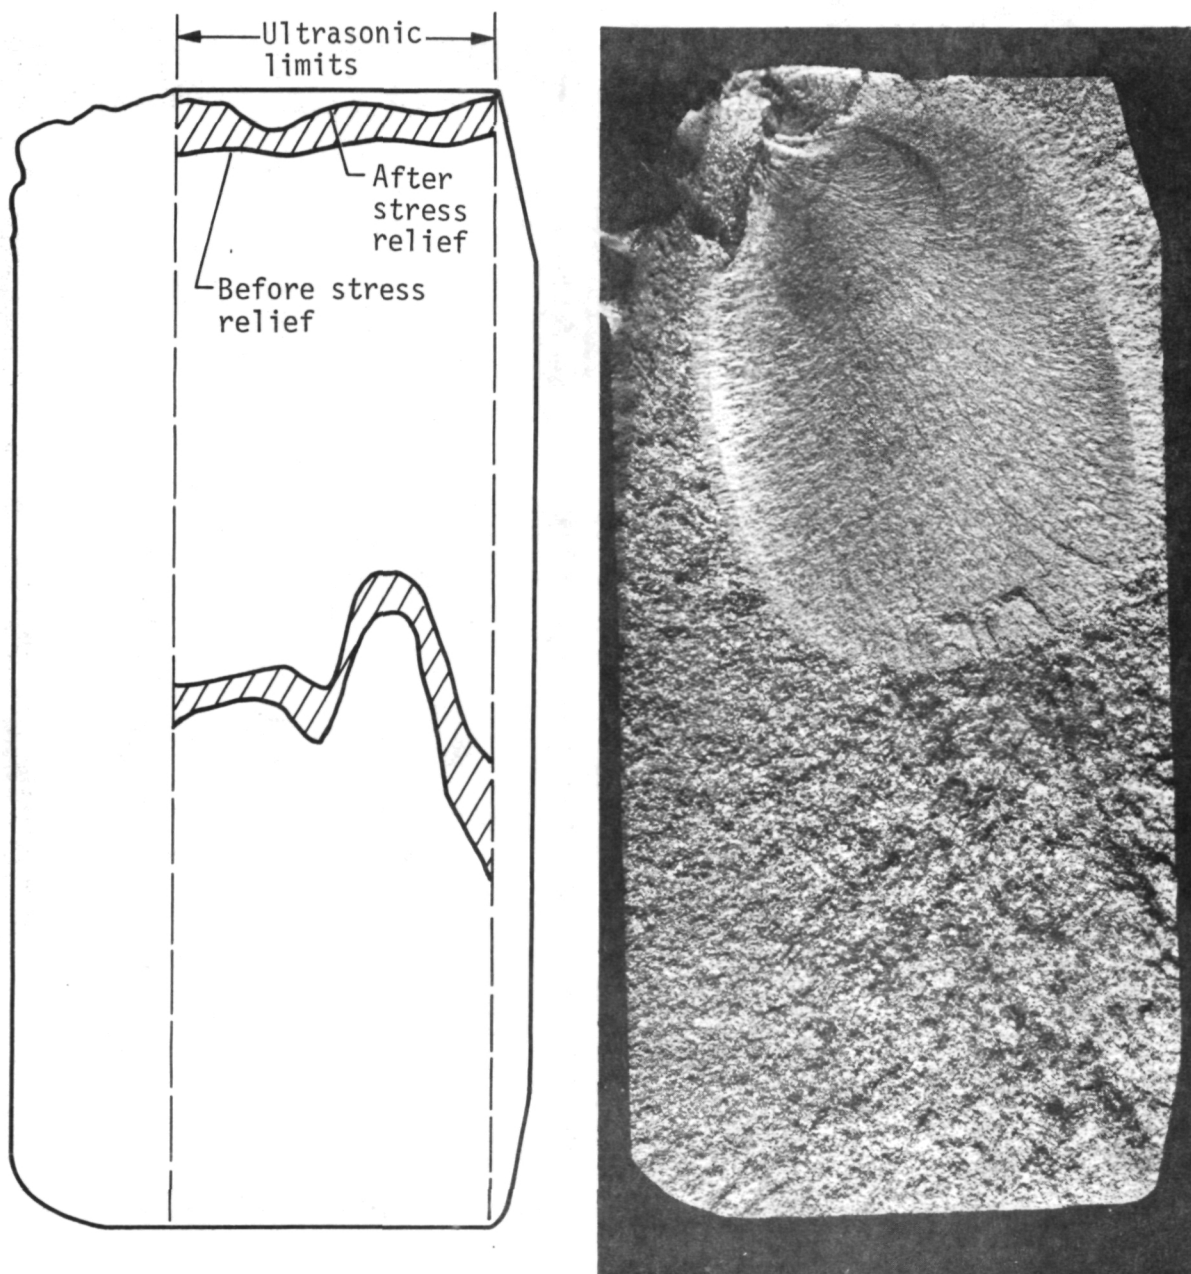
Figure 19. - Pitch-catch flaw map and fractograph of rail 1.

The second series of rails (1 through 6) was evaluated using the ultrasonic pitch-catch technique. Rail 1 was ultrasonically inspected, then stress relieved at 538 C (1000°F) for 2 hours and reinspected. Ultrasonic inspection indicated that the defect extended from close to one surface to approximately halfway across the width; the defect was shown to be at least 2 cm (0.8 in.) high. Figure 19 shows a fractograph of the defect and the flaw map drawn before opening. Stress relieving had little effect on the appearance of the defect.

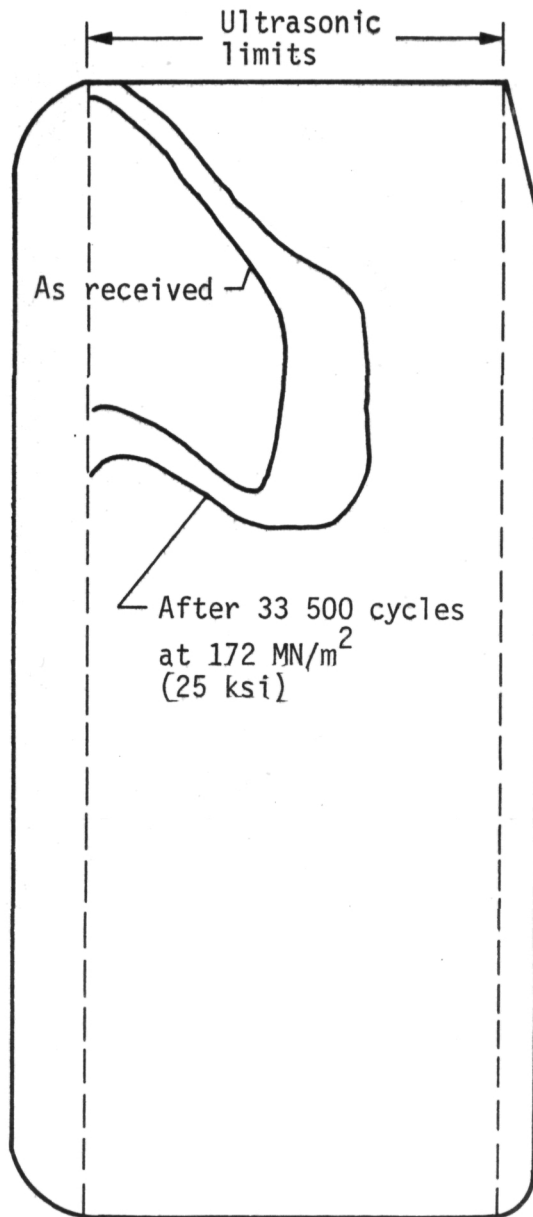
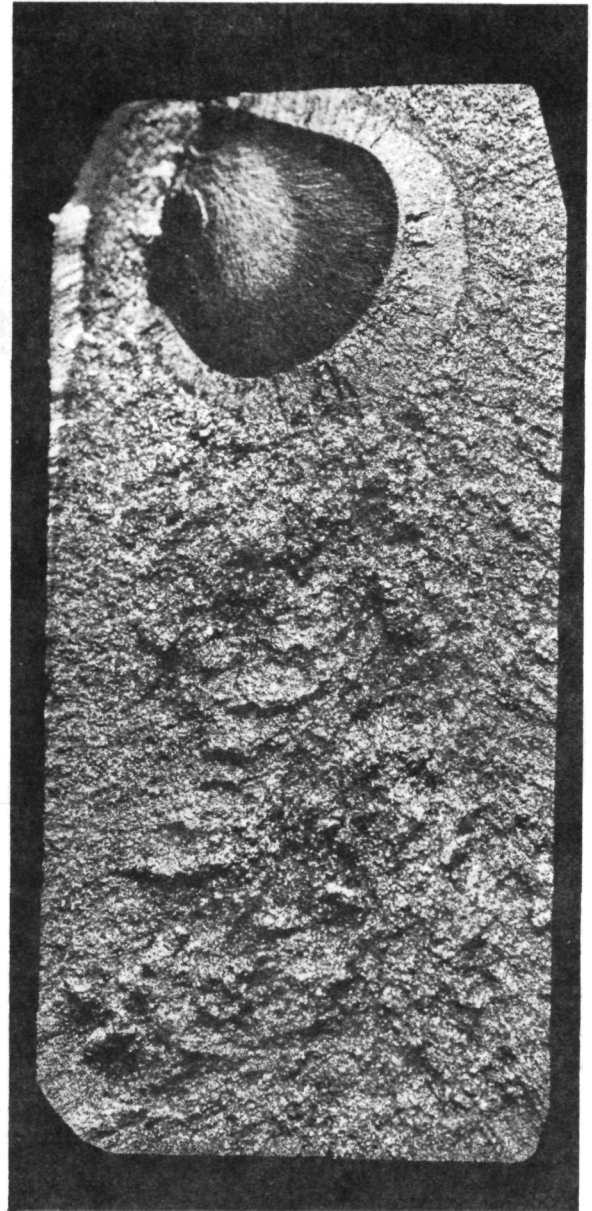
Figure 20. - Pitch-catch flaw map and fractograph of rail 2.

Rail 2 was inspected, cycled, and reinspected. Agreement between the flaw map and fractograph was relatively good, as shown in figure 20.

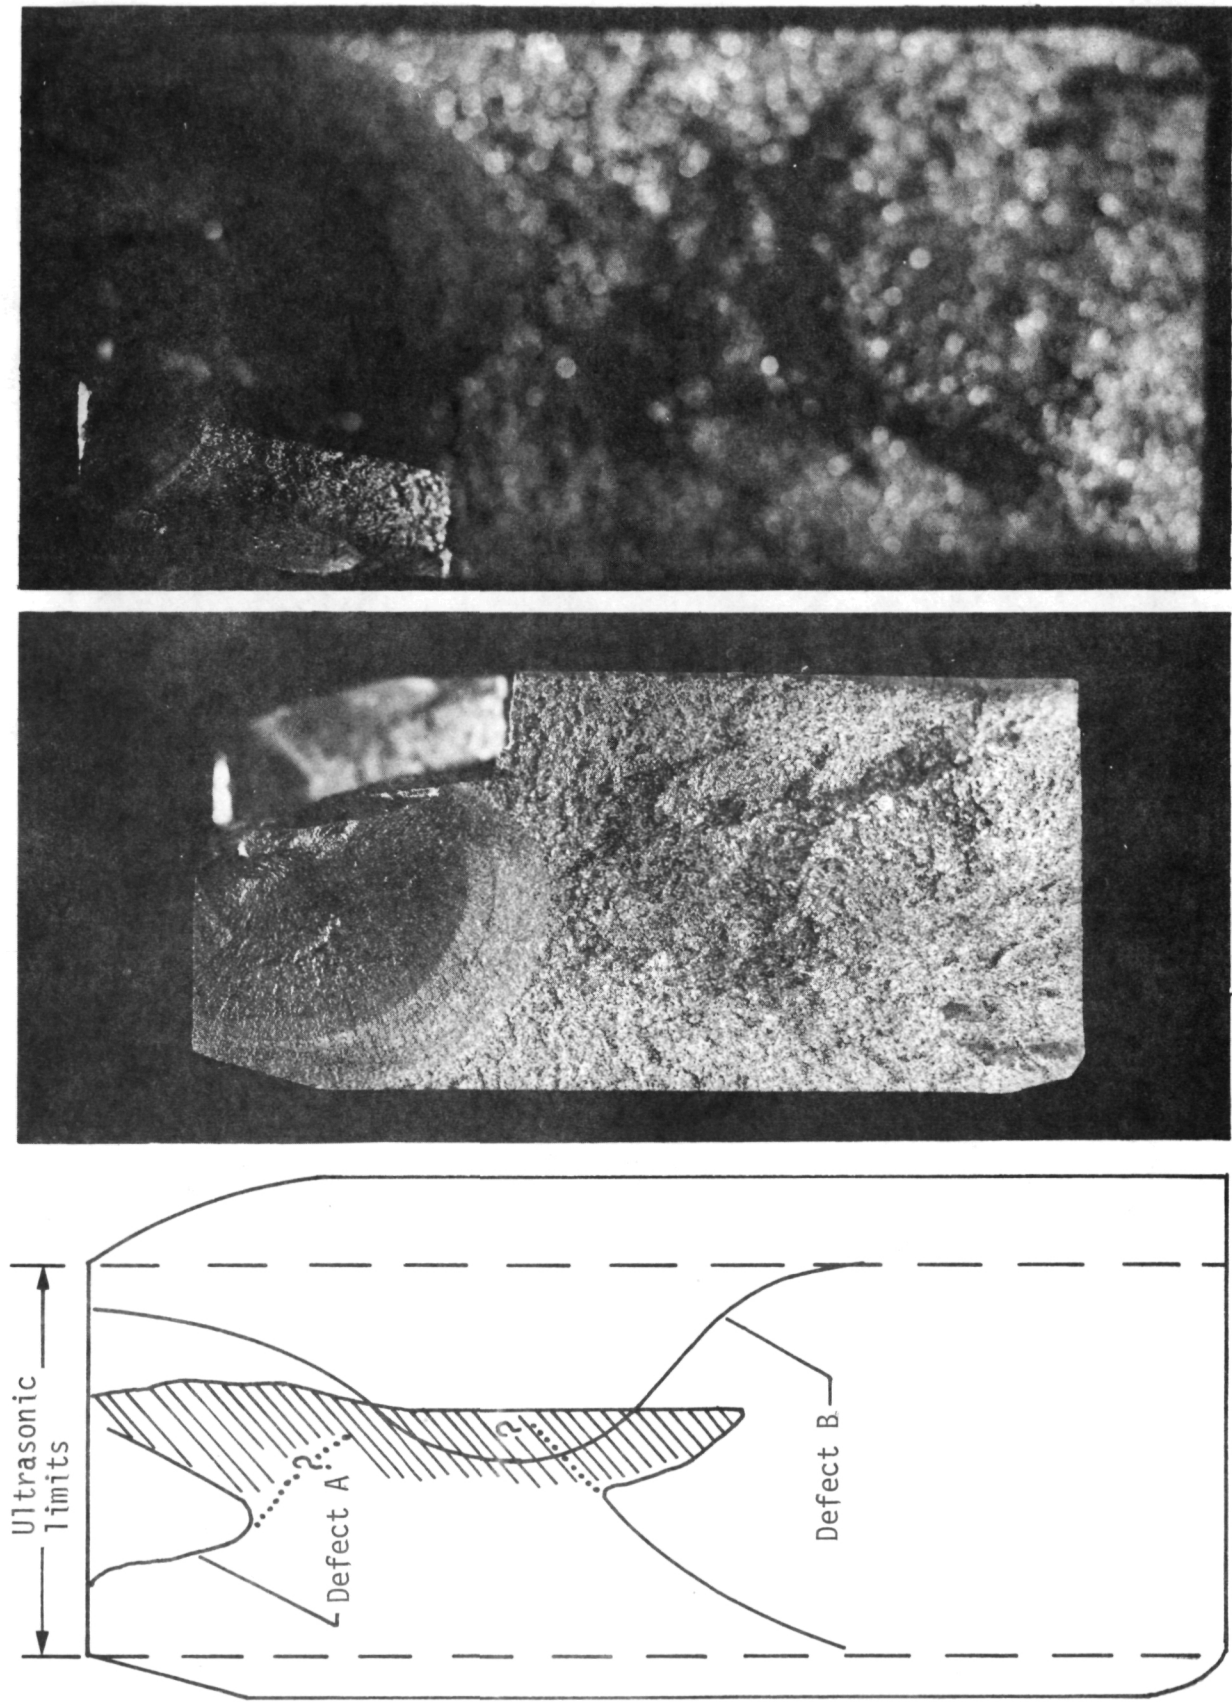
Figure 21. - Pitch-catch flaw map and fractographs of rail 3.

Rail 3 showed a large defect indication. Actually, two defects in close proximity were noted. The flaw maps indicated large defects of irregular shape. We surmised that part of the indication resulted from a detail fracture oriented so that it partially

blocked the ultrasonic signal. Figure 21 shows the flaw map and views of the two transverse fracture faces. The flaw map identifies defects A and B. Defect A narrowed as it extended into the center of the rail, then suddenly widened. The widening was probably caused by detection of the detail portion of the fracture and is shaded in the flaw map. As anticipated, the detail portion of the defect was skewed and would mask the ultrasonic signal. Figure 22 is a photo of the two defects in rail 3 showing their relative proximity.

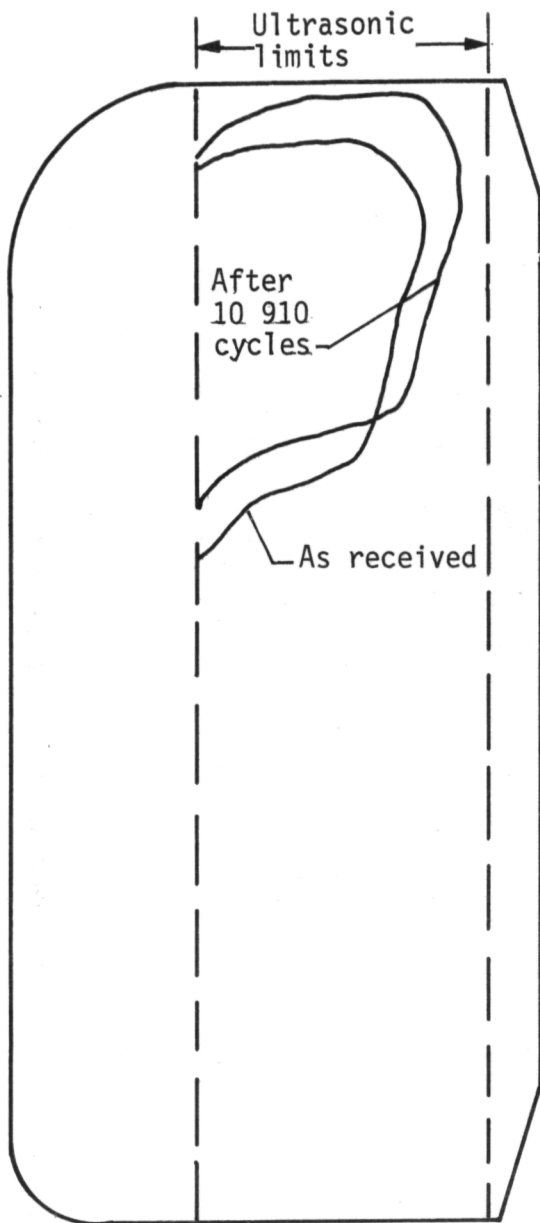
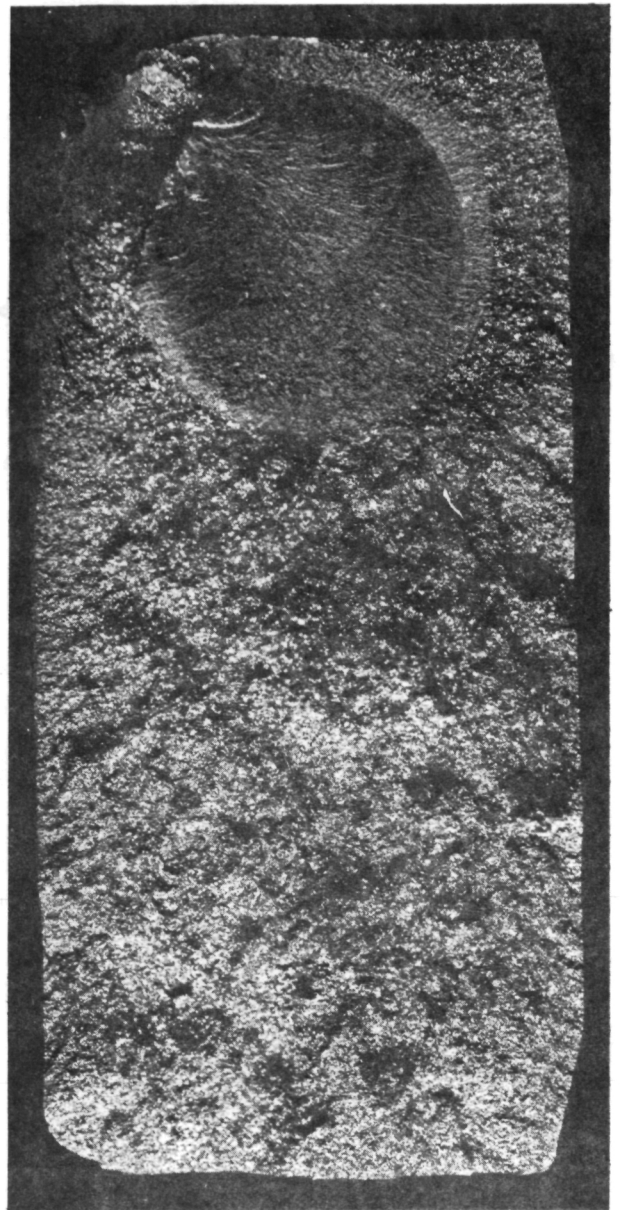
Figure 23. - Pitch-catch flaw map and fractograph of rail 4.

Rail 4 was inspected, stress relieved, inspected, then cycled and reinspected. Stress relieving did not produce significant changes in flaw character. Figure 23 shows the flaw map and fractograph.

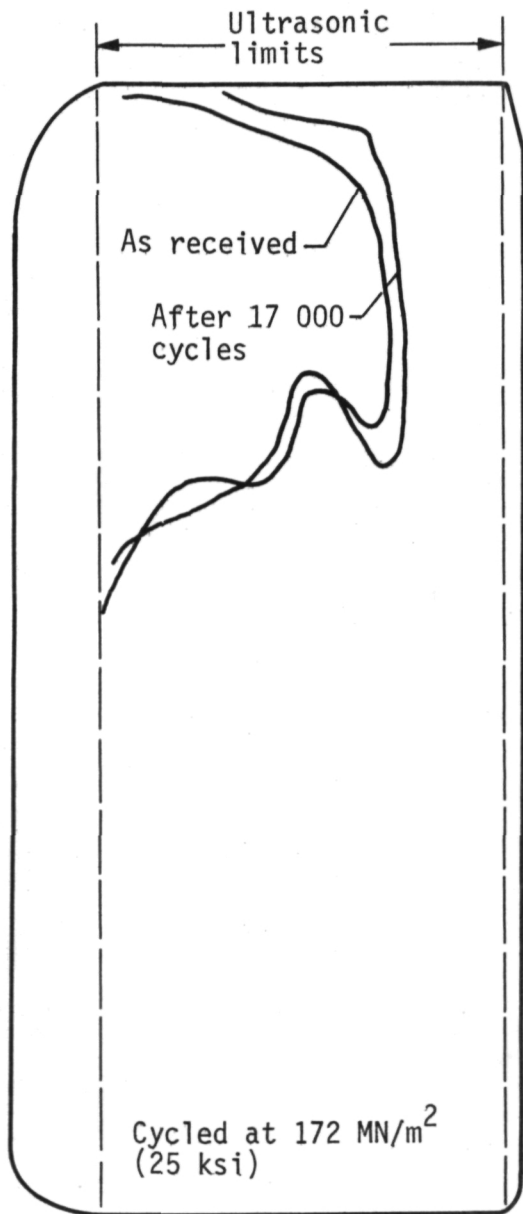
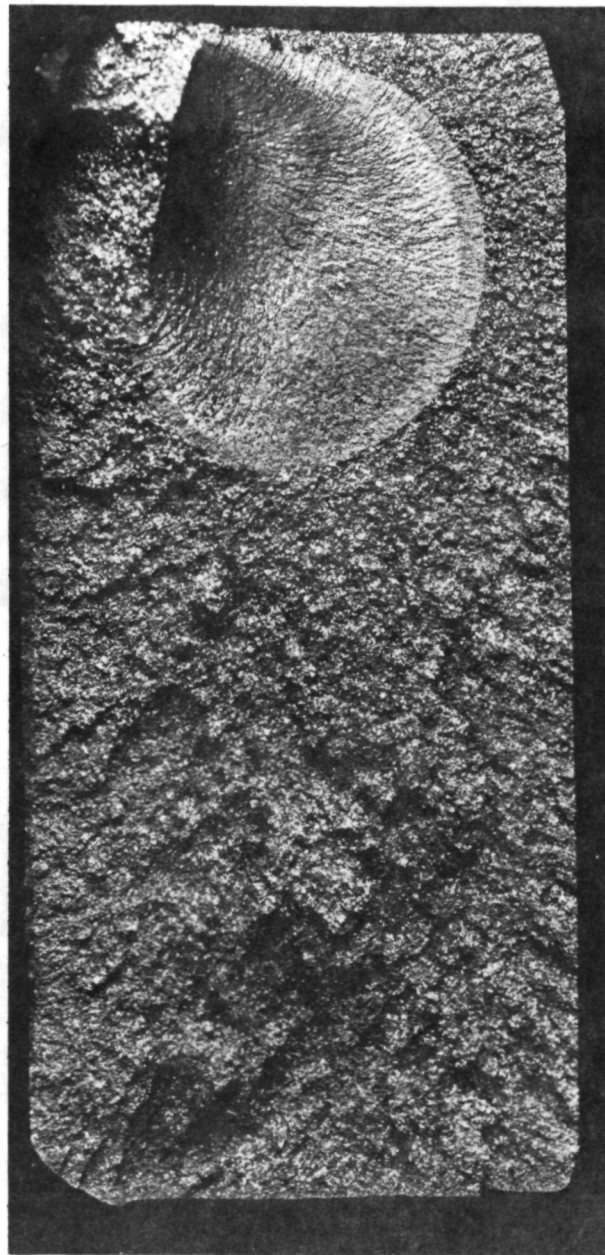
Figure 24. - Pitch-catch flaw map and fractograph of rail 5.

Rails 5 and 6 were inspected, cycled, and reinspected. As shown in figures 24 and 25, agreement between the flaw map and fractograph was reasonably good.
