NASA Technical Memorandum 79112

SOME EFFECTS OF CYCLIC INDUCED
DEFORMATION IN ROCKET THRUST CHAMBERS

N. P. Hannum, R. J. Quentmeyer, and H. J. Kasper
Lewis Research Center
Cleveland, Ohio

TECHNICAL PAPER to be presented at the
Conference on Advanced Technology for Future Space Systems
sponsored by the American Institute of Aeronautics and Astronautics
Hampton, Virginia, May 8-11, 1979

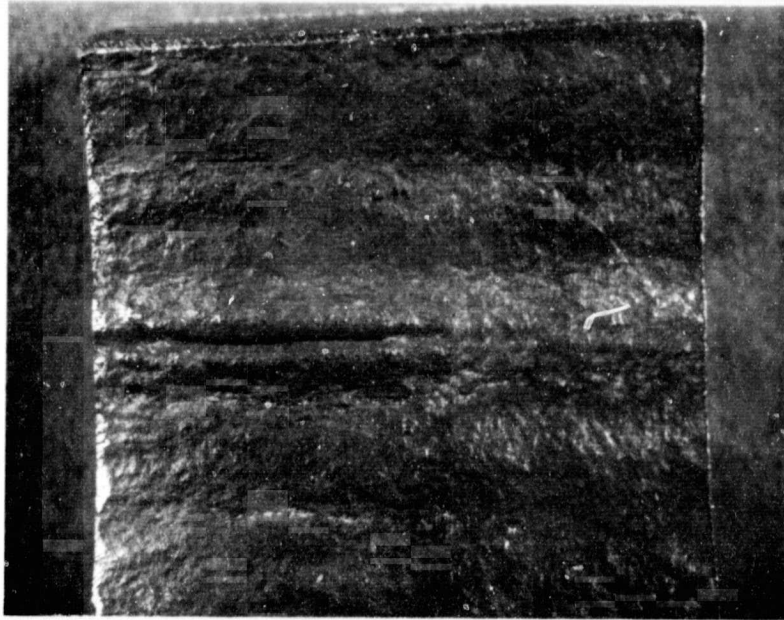
The failures are generally characterized by a thinning and bulging of the hot gas wall. Also, there was a roughening of the hot gas side wall, especially in the throat region of the thrust chamber. Figure 3(a) is a view of the hot gas side wall showing the general surface roughening for OFHC copper chamber S/N 74. A 3.5 cm (1.4 in.) long crack at the center line of a coolant channel can also be seen. The roughening was more severe with the OFHC copper than with the Narloy-Z and heat treated Amzirc. The roughening was more severe in the throat region where the temperature was higher than at other locations in the combustion chamber.

(a) VIEW OF THE HOT GAS WALL SHOWING A TYPICAL CRACK THROUGH THE WALL JUST UP STREAM OF THE THROAT.

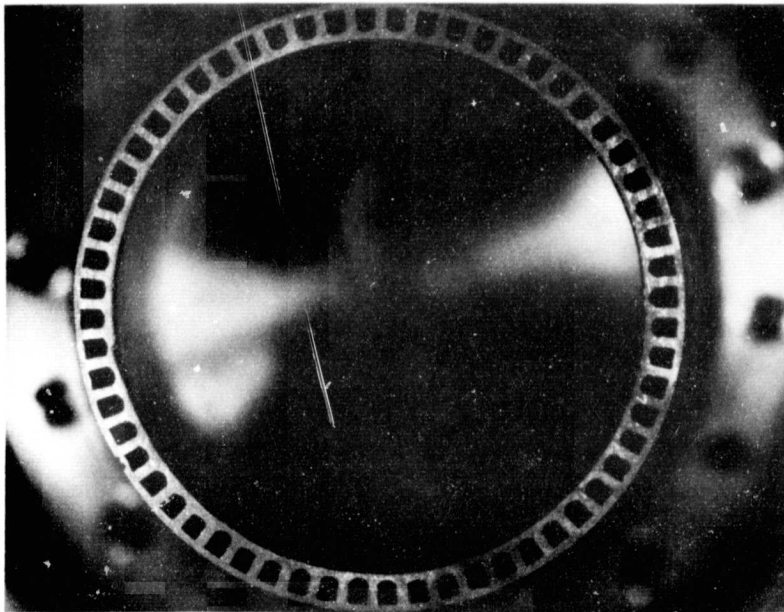
A cross section, at the throat, of an entire thrust chamber is shown in Fig. 3(b). This is the OFHC copper chamber S/N 74 which had the low stiffness closeout described in the Apparatus section. The fiberglass portion of the closeout has been removed. It can be seen in Fig. 3(b) that the deformation is not the same in each of the 60 coolant channels. The circumferential location of the most severe deformation seems to be random, that is, not related to injector patterns, cooling manifolds, or fabrication anomalies that are within the drawing specifications.

(b) CROSS SECTIONAL VIEW TAKEN IN THE THROAT PLANE SHOWING THE 60 COOLING CHANNELS AND THE ELECTROFORMED CLOSEOUT.

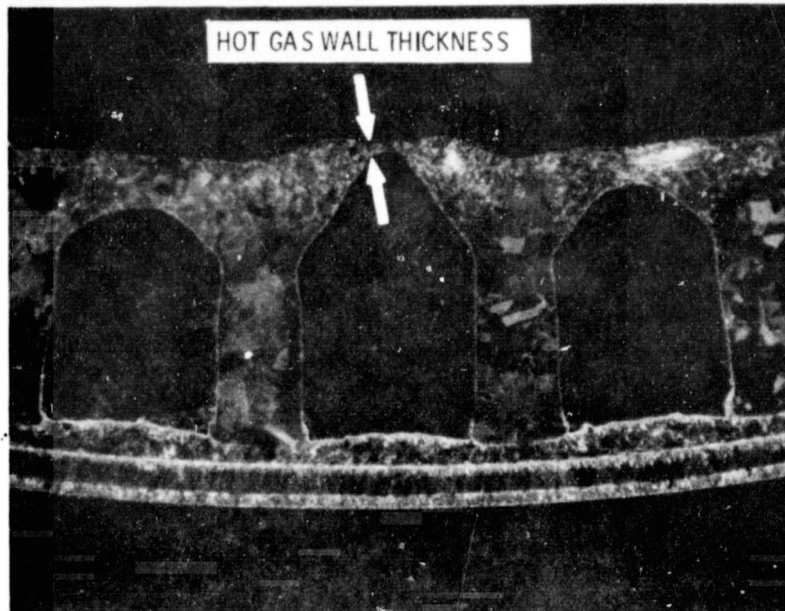
(a) OFHC COPPER THRUST CHAMBER S/N 75.

Cross section views of the failure sites for two different materials are shown in Fig. 4. The failed coolant channel is characterized by a "dog house" shape and a bulge of the hot gas wall toward the centerline of the thrust chamber. Conservation of the wall material was assumed since no hot gas surface melt or erosion was observed. The hot gas wall must thin, therefore, to accommodate the bulge. Because of the progressive thinning, the bulge on the hot gas wall tends to form two bumps per cooling channel. It can be seen in Fig. 4(a) that the bulging and thinning that occurred with the OFHC copper material was much greater than with the

Narloy-Z (Fig. 4(b)). The failure sites for the other thrust chambers not shown also had the "dog house" shape. Although all materials deformed similarly, an important difference is evident between the two failure sites shown in Fig. 4. In addition to the thinning of the hot gas wall, a necking of the material in a small region on each side of the failure site occurred with the OFHC copper. This is a typical appearance of a tensile failure with a ductile material. Tensile failures were observed in Ref. 4 for OFHC copper, heat treated Amzirc, and Narloy-Z. The failure mechanism was described as stress rupture. In the present work the failure site shown for Narloy-Z in Fig. 4(b) does not show necking of the material adjacent to the crack. Therefore, the visual evidence in the present work supports the Ref. 4 contention of a tensile stress failure mechanism only with OFHC copper. The failure sites for the Narloy-Z and heat treated Amzirc in the present work are different than observed in Ref. 4 because there is no evidence of necking adjacent to the crack with these materials.

Some metallographic observations were made for the material at the failure sites. It appears that some recrystallization has occurred in the hot gas wall of the OFHC copper chamber S/N 75 (Fig. 4(a)). No recrystallization was observed for the other materials. When hardness surveys were taken across sections similar to those shown in Fig. 4, it was found that hardness adjacent to the failure site was different from hardness away from the failure site (near the electroformed closeout). If it is assumed that the liner material away from the failure site remained in the pretest condition, then a change in hardness occurred at the failure site for all liner materials during cyclic testing. A tabulation at hardness measurements for each chamber are shown in Table I. The as fabricated hardness with OFHC copper was R_B 12-15. At the failure sites there was softening to R_B 0-9. In contrast the heat treated Amzirc and Narloy-Z hardened as cycles were accumulated. Heat treated Amzirc hardened from R_B 10 to R_B 15, Narloy-Z chamber S/N 140 hardened from R_B 33 to R_B 57. Narloy-Z chamber S/N 150 hardened from R_B 45 to R_B 60. An observation can be made that both Narloy-Z chambers failed at about the same hardness, but the one that hardened more (R_B 33 to 57) had longer life (301 compared to 154 cycles). The reasons for these differences in material behavior is not understood.

A rapid increase in the hot gas wall deformation can be seen in Fig. 6(a) just before failure with the OFHC copper. At the onset of failure the material no longer ratchets linearly but becomes unstable and rapidly deforms (thins) until a tensile stress failure occurs. This was seen visually in

the cross section photograph (Fig. 4(a)) as local necking of the material adjacent to the crack. The rapid deformation and thinning may have occurred in the final cycle or progressively during the last nine cycles.

As noted in Ref. 4 and as can be seen in Fig. 4(a) of the present work the visual evidence supports the contention of tensile stress failure with OFHC copper. For a tensile stress failure to occur, the ultimate stress for the material must be exceeded at some point in the cycle. The exact point in the cycle when failure occurred is not known since both the stress in the wall and the ultimate stress of the material are changing with time. The stress is nominally the same for all three materials for the same wall thickness and would increase as the wall thickness decreases. Therefore, it is assumed that a wall thickness of approximately 0.475 mm (0.0187 in.) corresponds to a stress in the wall equal to the ultimate stress value of OFHC copper. The result is a tensile stress failure. However, since the published data for heat treated Amzirc and Narloy-Z indicate that the ultimate stress is greater than OFHC copper at similar temperature conditions, the level of stress in a wall 0.475 mm (0.0187 in.) would not produce a tensile stress failure in these stronger materials. Figure 7 shows that these stronger materials possibly failed at stress levels even less than the OFHC copper since the final wall thickness was greater than with OFHC copper. The implication is that the failure mechanism for the heat treated Amzirc and Narloy-Z thrust chambers in the present work is more complicated than simple tensile stress failure.

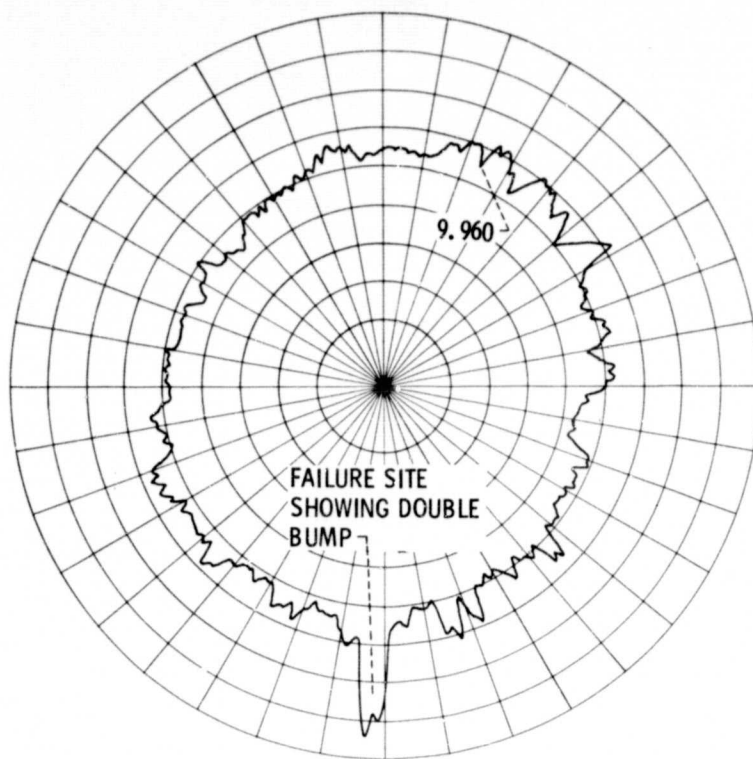
The hot gas side wall deformation was measured nondestructively. Polar plots were made for each of the thrust chambers to document the post test hot gas wall deformation. A typical plot is presented in Fig. 5(a). It can be seen in the figure that the failure site and one or two other channels exhibit the double bump characteristic (each cooling channel covers a 6° arc). The deformation at the failure site is much greater than at other locations in the thrust chamber. This was true for all materials. The deformation data from these polar plots are tabulated in Table I. Deformation at the failure site was defined as the distance from the valley (at approx. the rib center line) to the largest peak. The data tabulated was for the

(a) POST FAILURE DATA AFTER 193 CYCLES.

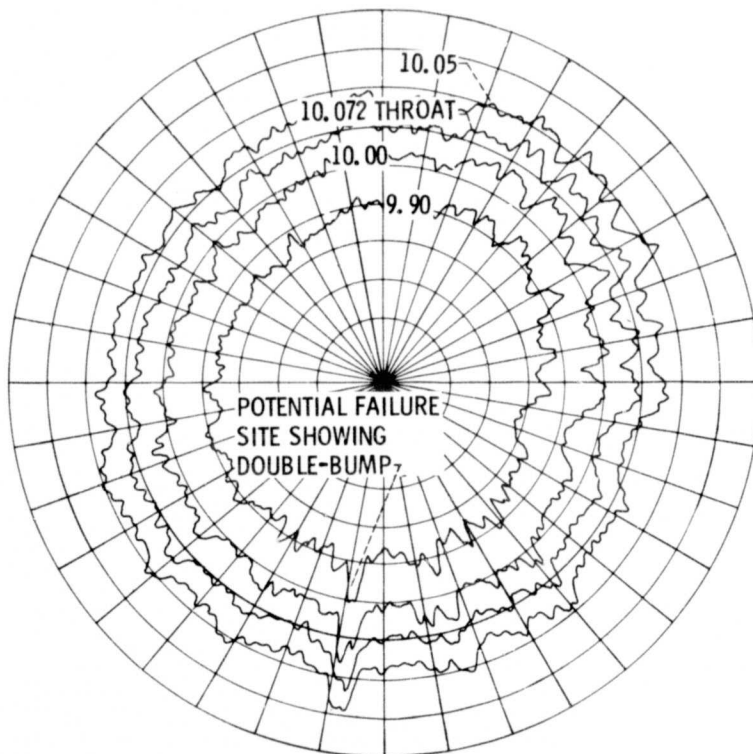
Since the method for measuring deformation was nondestructive, it was also employed to obtain deformation data of intermediate life points. Two variations of the nondestructive method were used. First, the 360° plots previously described could be made at various axial locations, but that required removing the chambers from the thrust stand. Second, it was found that after the most highly deformed area had been located, data could be taken from plaster casts of the area. These intermediate life data are also recorded in Table I. An example of intermediate life hot gas wall deformation data is shown in Fig. 5(b) for OFHC copper chamber S/N 74 after 124 cycles. The polar plots were made at various axial stations in the vicinity of the most highly deformed area. The potential failure site can readily be identified even though the failure did not occur for another 69 cycles. The double-bump characteristic is also evident. As can be seen from Table I there was good agreement between deformation data using the two methods for OFHC copper chamber S/N 74 at 124 cycles. The 360° plots indicated a deformation of 0.173 mm (0.0068 in.) and the plaster cast method indicated 0.155 mm (0.0061 in.).

(b) INTERMEDIATE LIFE DATA AFTER 124 CYCLES.

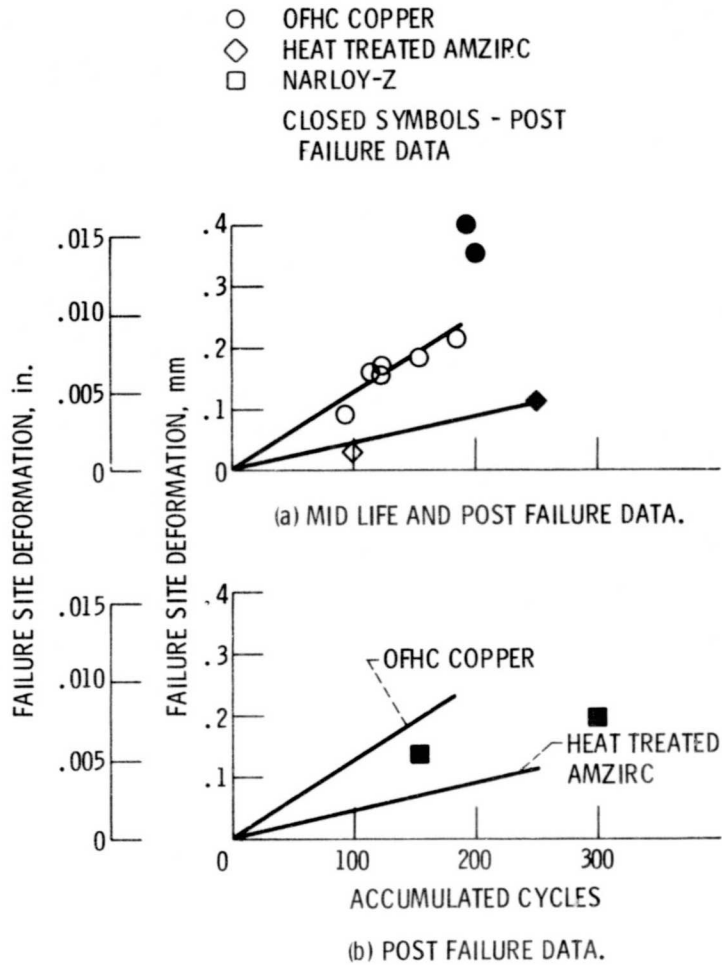
The failure site deformation data for the two OFHC copper chambers (S/N 74 and 75) and for the heat treated Amzirc chamber (S/N 82) are presented in Fig. 6(a) as functions of accumulated cycles. Where available, data using both nondestructive methods, that is, from plaster cast segments and full 360° plots are shown. The closed symbols are the post failure points and represent an average of the nondestructive and the post failure photographic data. Even as the deformation becomes large the failure site bulges out into the chamber in a nearly linear manner as cycles are accumulated. Reference 5 has characterized the failure mechanism as a ratcheting type process. The slope of the deformation histories presented in Fig. 6 could be considered a ratcheting rate. The ratcheting rate for the OFHC copper is nearly 3 times greater than the heat treated Amzirc. As noted in APPARATUS the stiffness of the structural jacket for the OFHC thrust chambers was less than the other chambers. It is reported in Ref. 6 that the low stiffness structure reduced the strain range approximately 10% compared to the thick nickel structure. Consequently, if the OFHC copper chambers had been fabricated with the same stiffness the trend would be toward increasing the ratcheting rate for the OFHC copper.

The ratchet rate curve for the heat treated Amzirc is not as well defined as the OFHC copper. A linear curve was drawn using the origin and the single mid life data point. This curve was extrapolated to 250 cycles. Since the post failure data are close to this linear ratchet rate curve the indication was that the material does not become unstable and rapidly deform at the onset of failure. As was stated earlier, the cross section photographs of the heat treated Amzirc and the Narloy-Z failure sites did not indicate local necking of the material adjacent to the crack. The post failure deformation data for the two Narloy-Z thrust chambers are shown in Fig. 6(b) along with the deformation histories for the OFHC copper and heat treated Amzirc chambers presented above. A single deformation rate curve could be used for both Narloy-Z chambers, but with failure occurring at different points.

Figure 6. - Failure site deformation as a function of accumulated cycles.

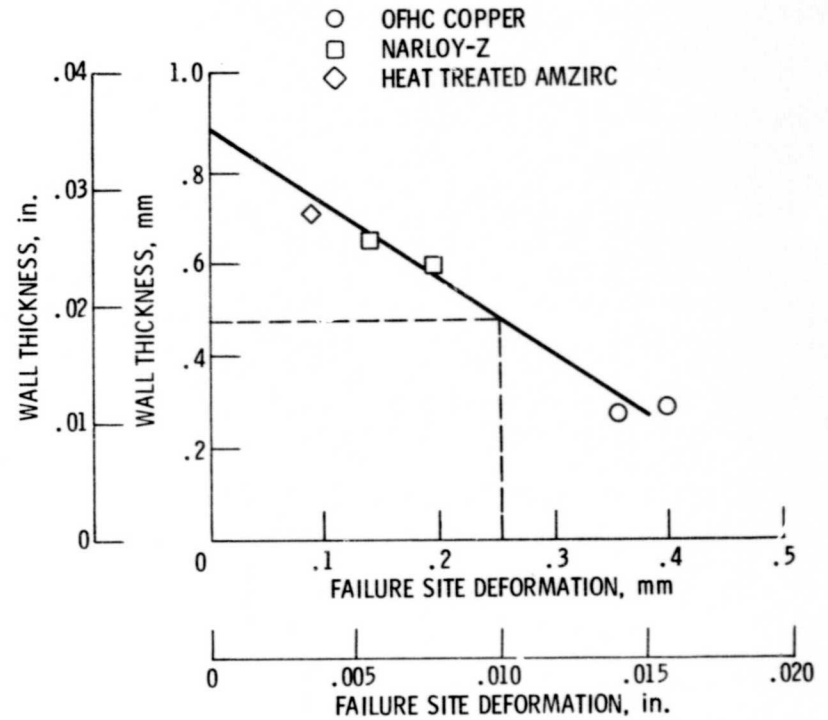
Figure 7 shows the final failure site deformation versus the final failure site hot gas wall thickness for three different thrust chamber materials. The data were obtained by measuring cross section photographs. The definition of deformation was the same as used with the polar plots (Fig. 5). The wall thickness was measured as indicated in Fig. 4. As shown in Fig. 7 the wall thickness versus deformation data are correlated by a straight line which extrapolates to the original wall thickness of 0.889 mm (0.035 in.) for zero deformation. Although this correlation was made from post failure data it is assumed that the correlation is also valid at intermediate life. Use of this correlation provides a means for determining wall thickness at intermediate life points from measurements of hot gas wall deformation.

For example, the use of the correlation between hot gas wall deformation and thinning made it possible to estimate the wall thickness for the OFHC copper at the onset of failure. By extrapolating the OFHC ratcheting rate curve (Fig. 6(a)) to 200 cycles it can be seen that at the onset of failure the deformation was approximately 0.25 mm (0.010 in.). From Fig. 7 it can be seen that 0.25 mm (0.010 in.) deformation corresponds to a wall thickness of 0.475 mm (0.0187 in.).

Figure 7. - Relationship of failure site deformation to coolant channel wall thickness for three different thrust chamber liner materials.
