NASA-CR-159486
PWA-5615-3

STRAIN GAGE SYSTEM EVALUATION PROGRAM
FINAL REPORT

UNITED TECHNOLOGIES CORPORATION
PRATT & WHITNEY AIRCRAFT GROUP
COMMERCIAL PRODUCTS DIVISION

March 1979

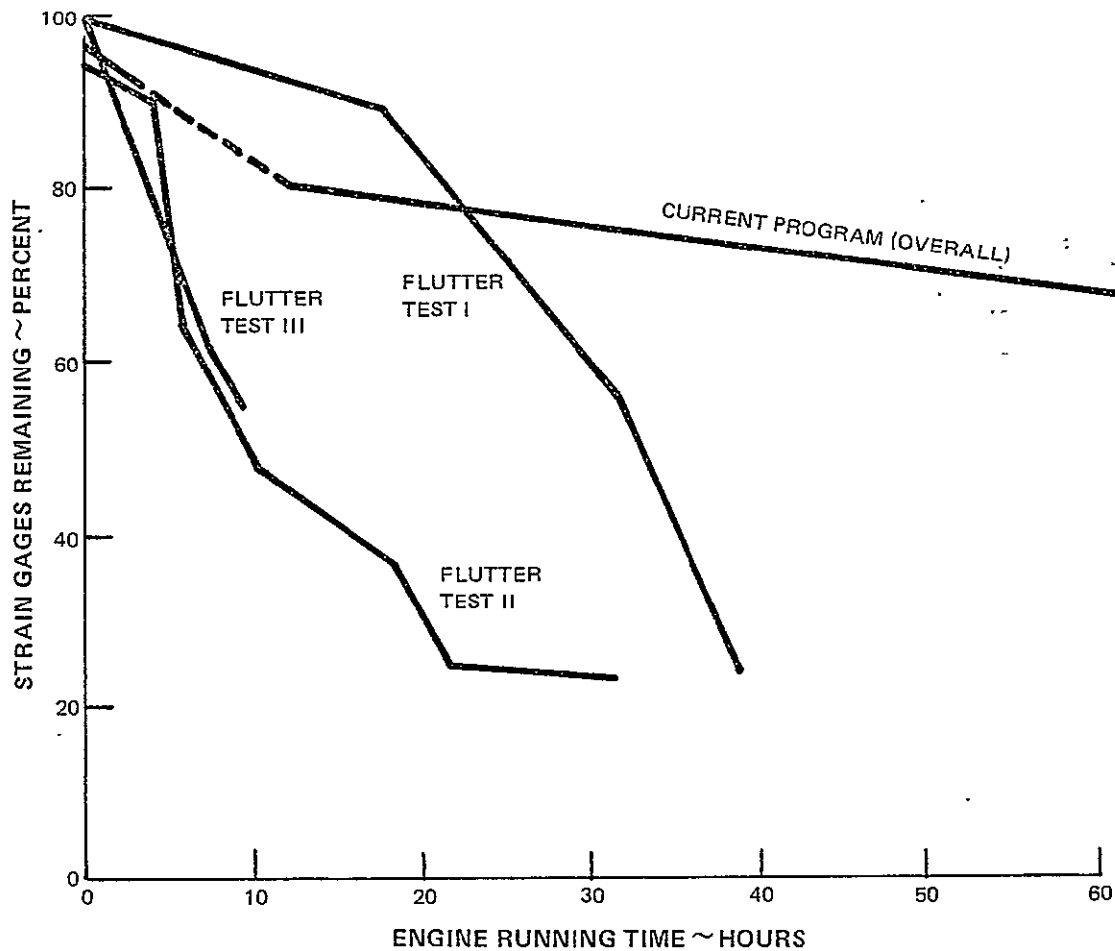
Figure 12 shows the strain gage system failure rate during engine testing together with the strain gage failure rate results for previous testing of this same engine type at NASA in flutter programs. As shown, a number of failures occurred during the first ten hours of testing, after which the failure rate was substantially slower. The initial higher failure rate is believed to be the result of poor jump formation. Unfortunately, most of these failures occurred during the time that the gages were not being monitored;

Figure 12 Strain Gage System Failure Rates for the Current Program and Previous Tests of the Same Engine Type

therefore, it is not known if the failures resulted from a single event or if they were spread throughout the first ten hours of engine running. However, no event is evident from the engine running logs that might be suspected of causing multiple gage system failures.

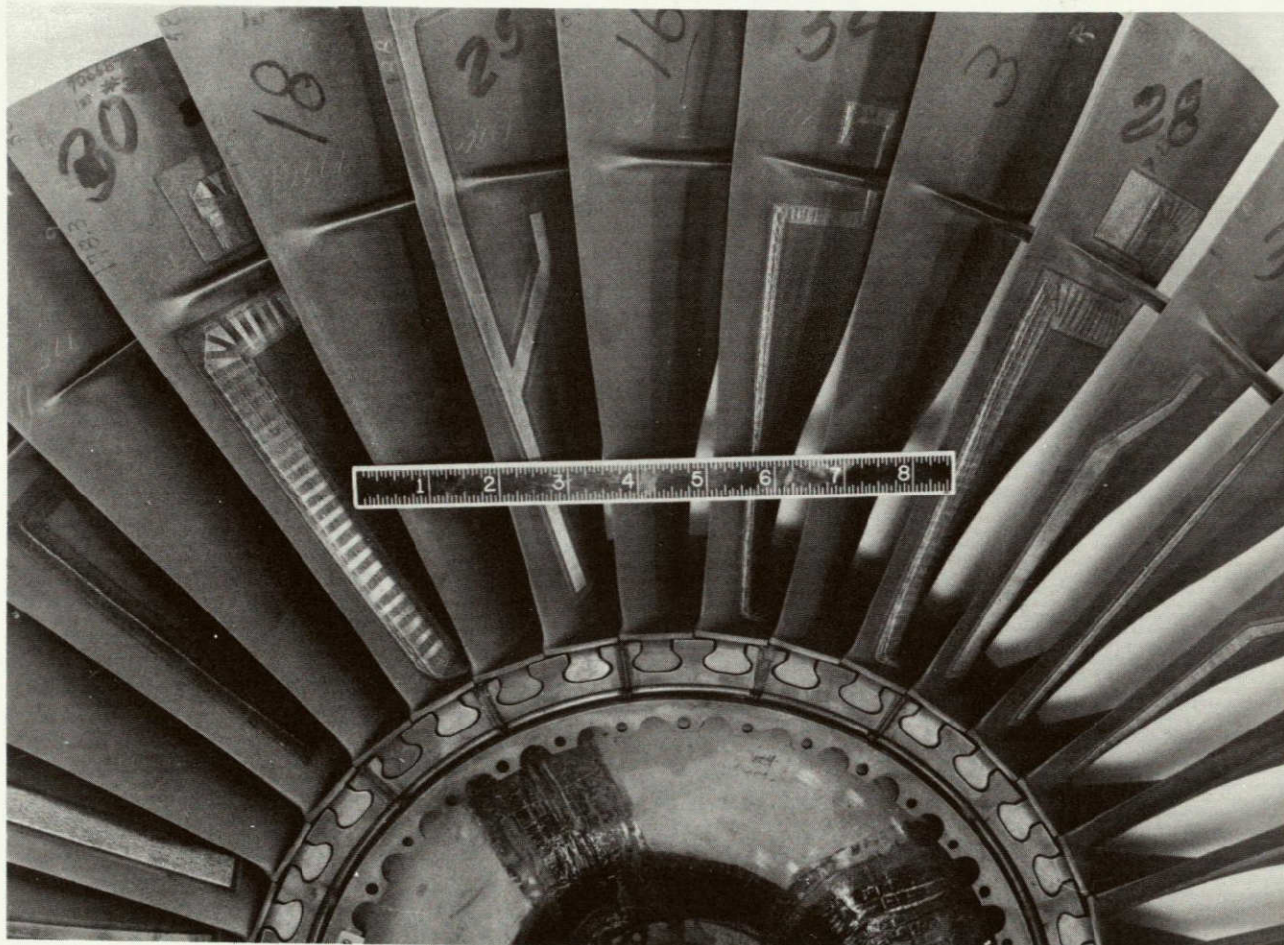
Figure A-2 Section of First Stage Instrumented Blade Assembly After Testing - Convex Side

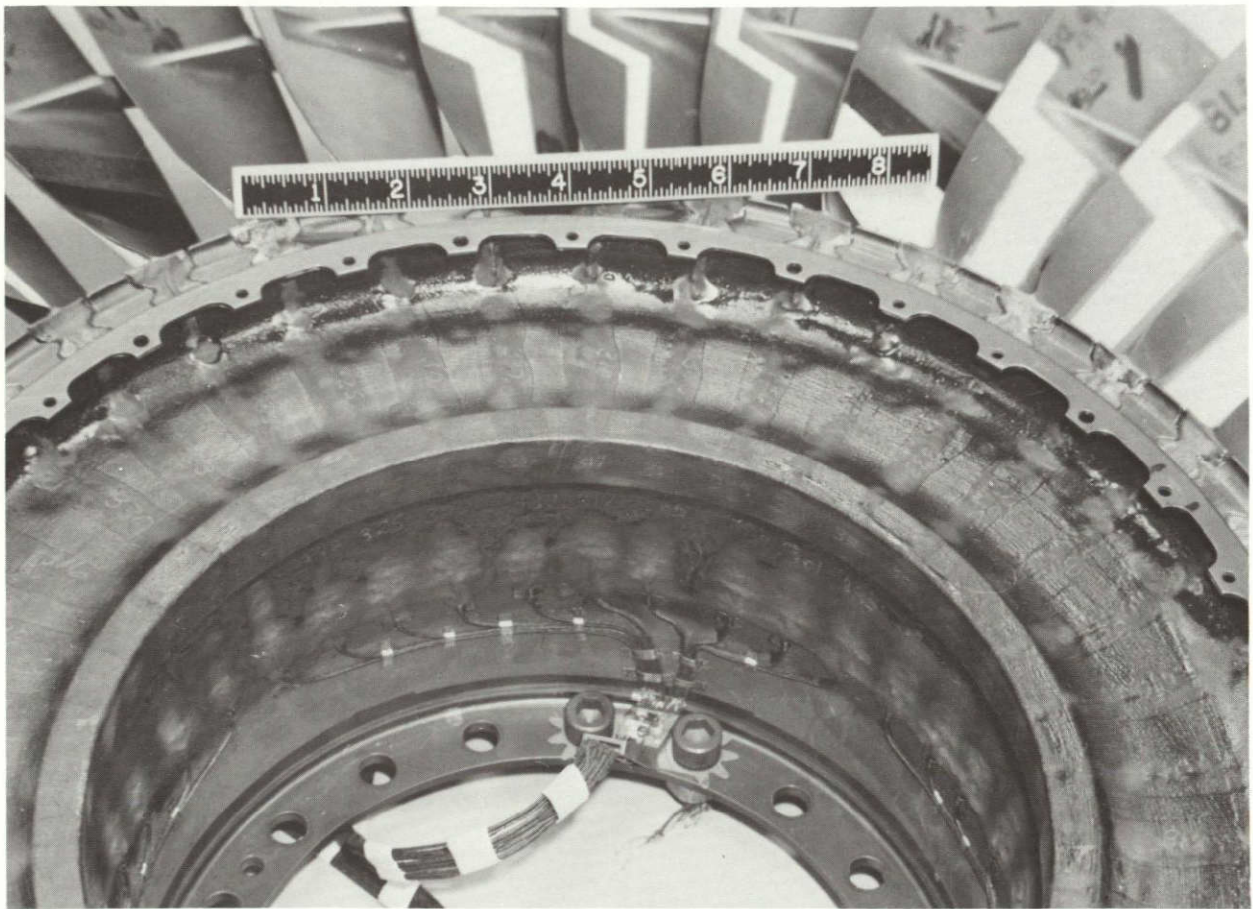
Figure A-5 Section of Third Stage Instrumented Blade Assembly After
Testing - Concave Side

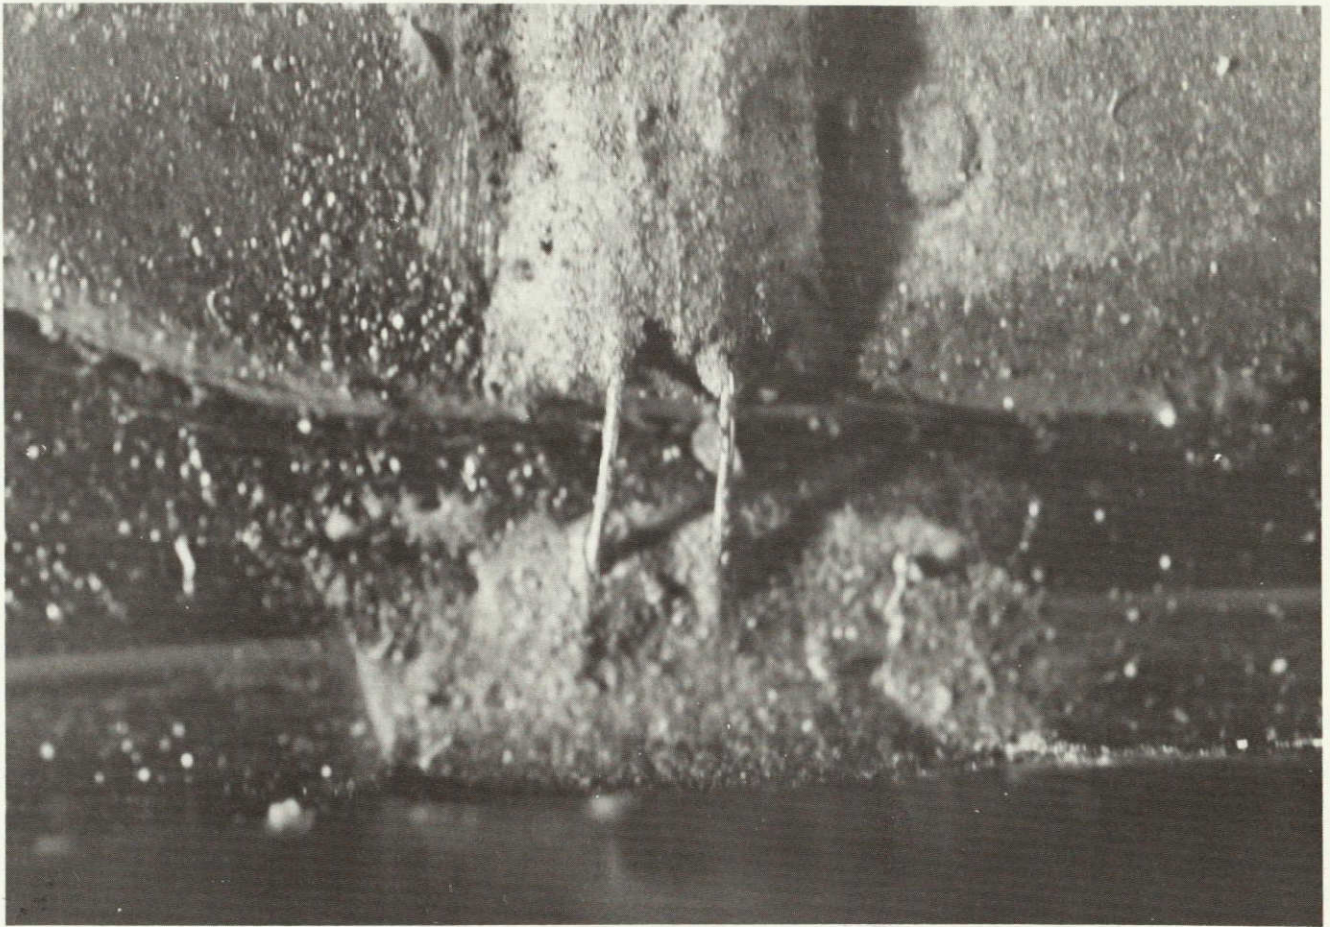
Figure A-36 Third Stage Blade to Disk Jump With Good 36 Gage Chromel
P Wires (78-444-0340-D)

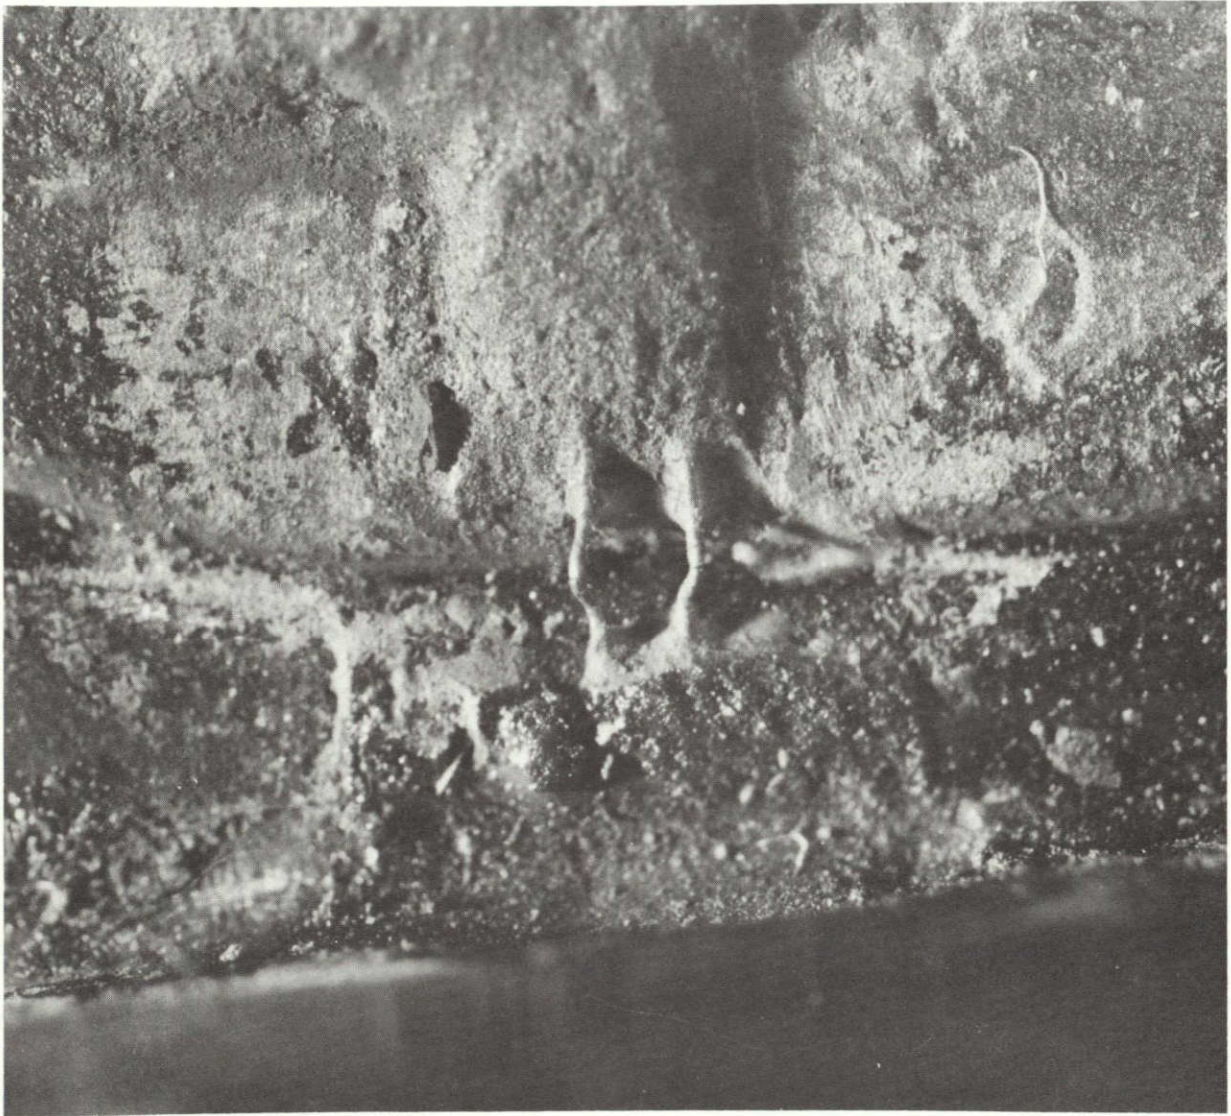
Jump failures were primarily attributed to the inadvertent coating of bare wire jumps with the epoxy cement used to secure the leadwires, and to the unexpected wicking of this cement by the asbestos-insulated jumps, reducing their flexibility.

Figure A-37 Third Stage Blade to Disk Jump With Broken 36 Gage Chromel P Wires (78-444-0340-A)
