**EVALUATION OF SHUTTLE TURBOPUMP BEARINGS**

By K. D. Dufrane and J. W. Kannel  
Battelle Columbus Laboratories  
505 King Avenue  
Columbus, Ohio 43201

Final Report

November 22, 1978

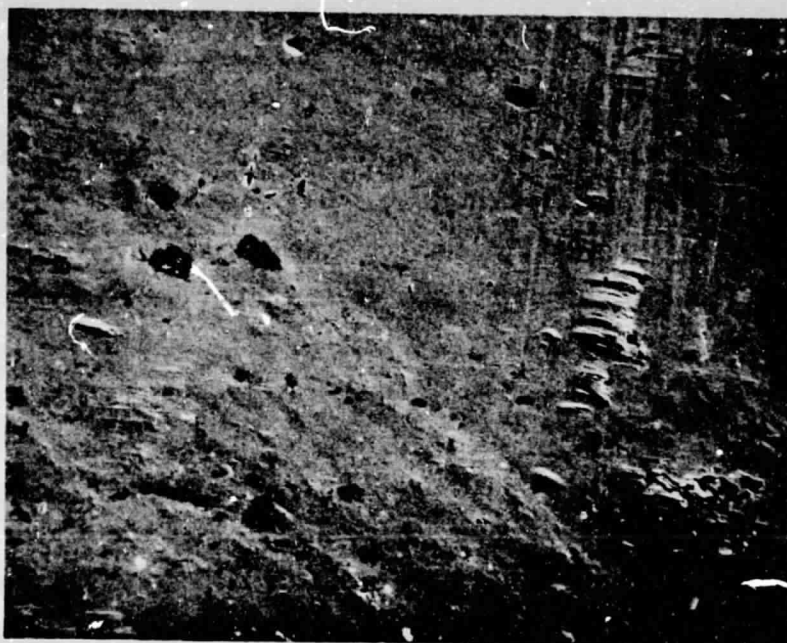
All of the contact paths also had numerous indentations caused by hard debris. The dents were defined by angular sides often reaching sharp points at the bottoms of the depressions. Such dents are typically caused by minerals, such as  $\text{SiO}_2$ , or small carbides. The requirement is that the indenting material be harder than the bearing race. A typical area on the inner race of bearing 8492669 is shown in Figure 1. Numerous small debris dents are visible on the generally featureless ball contact path.

FIGURE 1. SCANNING ELECTRON MICROSCOPE VIEW OF  
INNER RACE OF BEARING 8492669.

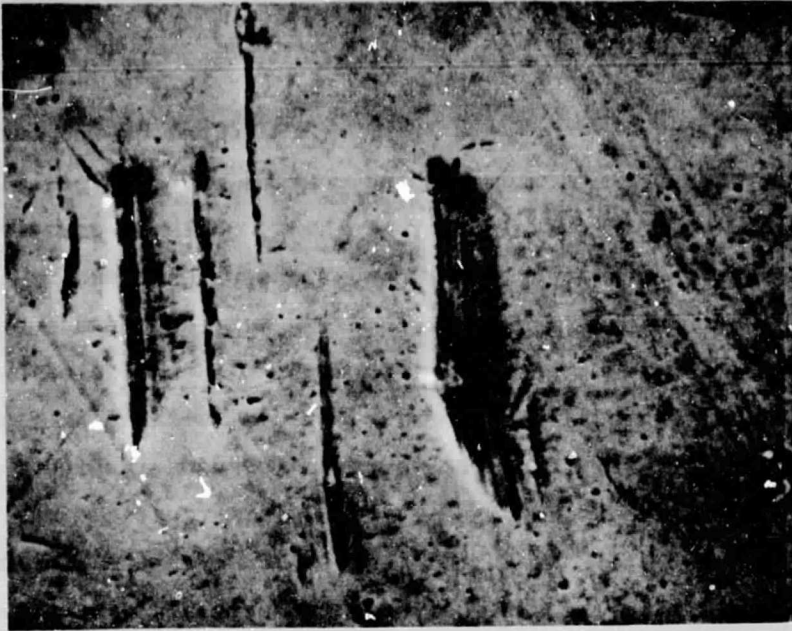
Inspection of the balls showed that they all had a tendency toward banding, which would be expected because of the significant axial load applied to angular-contact bearings. However, the bands were faint and on multiple axes. This indicates that the balls had been unloaded during portions of their orbit in the bearing or that the overall bearing loading had varied significantly during operation. The bands were defined mostly by debris dents of various sizes and a fine frosting of the original ball finish through wear. A typical area showing elongated dents on a ball from bearing 8517901 is shown on Figure 3a.

a. Elongated Dents.

FIGURE 3. DAMAGED AREAS OBSERVED ON BALL  
FROM BEARING 8517901.

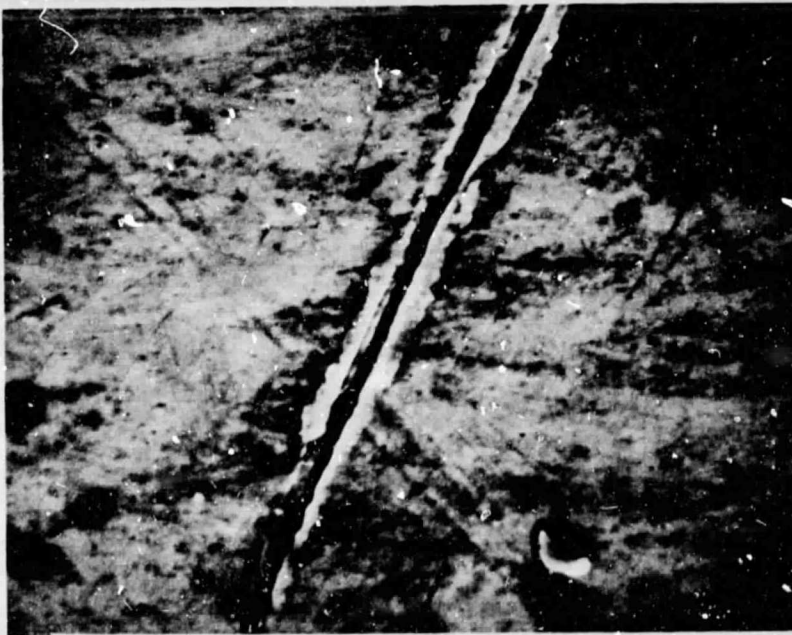
Most of the balls also had continuous small-circle scars on their surfaces, such as shown in Figure 3b. These are normally assumed to be caused by sliding contact with debris embedded in the retainer. If the balls continue to rotate about the same axis, such scars never contact the race, and therefore, are not of significance. However, when operating conditions change the axis of rotation, the scars can be placed in contact with the race and thereby contribute to torque variations (roughness). The flattened material at the edges of the scar in Figure 3b indicate that this portion of the ball had rolled through the race contact area after the scar was formed.

b. Portion of Continuous Small-Circle Scar.

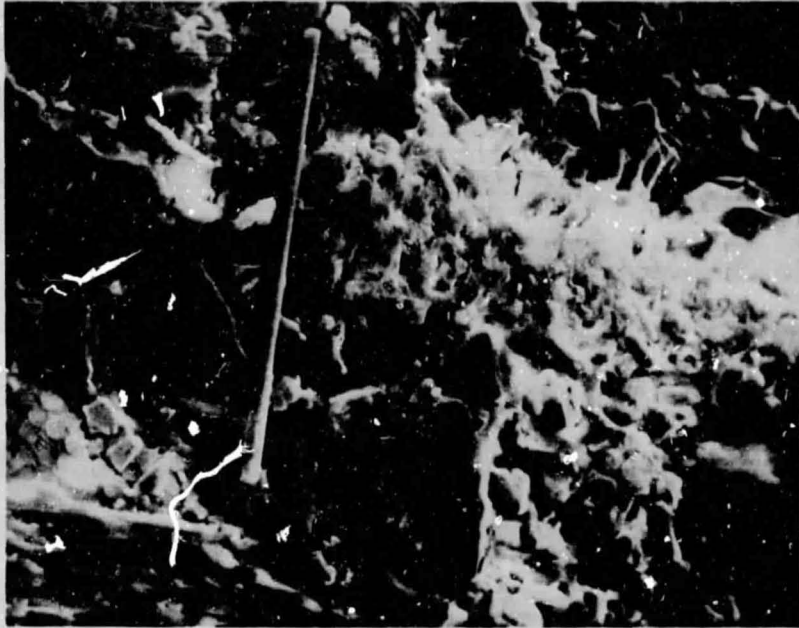
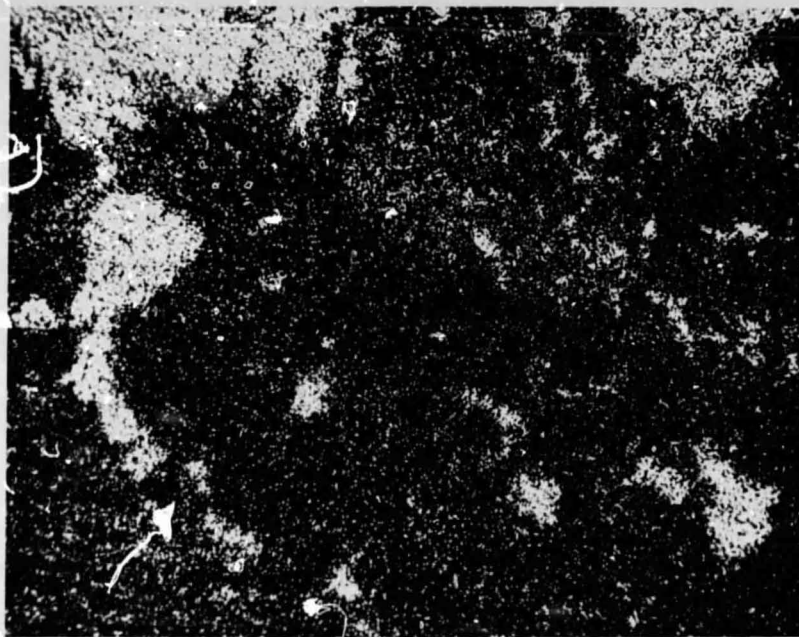
Several of the ball pockets and guiding surfaces had embedded metallic debris observable by low-power optical microscopy. An example of the debris observed in an SEM on the retainer of bearing 849674 is shown in Figure 4a. The X-ray fluorescence pattern of this area for iron is shown in Figure 4b, which identifies the metallic debris in Figure 4a. A similar pattern was developed for chromium, which suggests that the debris is most likely a steel alloy, such as the bearing race steel itself. Since some of the metallic particles protruded from the surfaces of the ball pockets, they may have been responsible for wear scars on the balls.

a. Debris.

b. X-ray Scan for Iron.

FIGURE 4. SEM OBSERVATION OF METALLIC DEBRIS IN  
BALL POCKET OF 8492674 BEARING RETAINER.

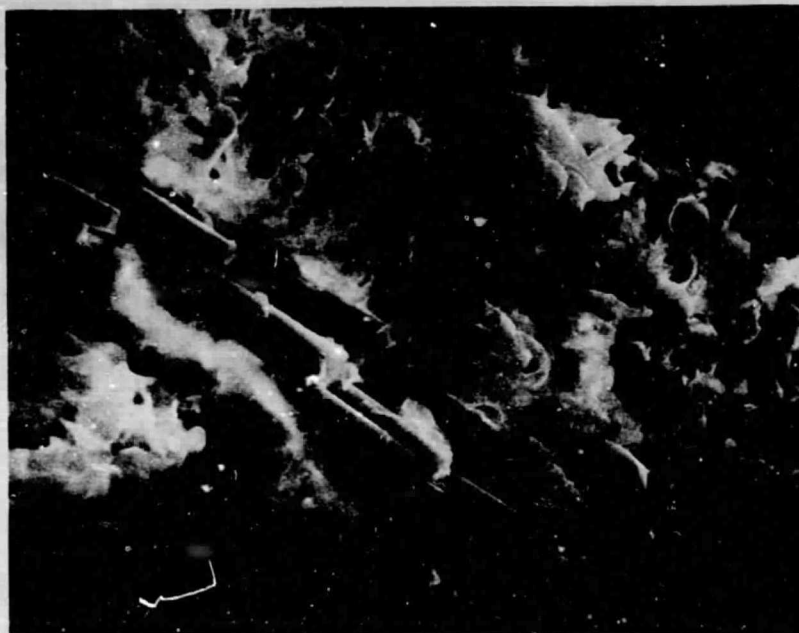
The rod-shaped particle in Figure 4a is a segment of the glass fiber reinforcing used in the retainer. A view of the fibers in another portion of a ball pocket on the retainer from bearing 8492674 is shown in Figure 5. The TFE is visible between the fibers and was often present as the loosely attached particles seen in Figure 5. Since the ball pockets are machined normal to the lay direction of the fibers, the intersection with the ends of the fibers is expected. On a microscale these present a rough surface for the balls and probably are responsible for the mild frosted appearance of the ball surfaces.

FIGURE 5. ENDS OF GLASS FIBERS IN BALL POCKET OF SEPARATOR  
FROM BEARING 8492674.

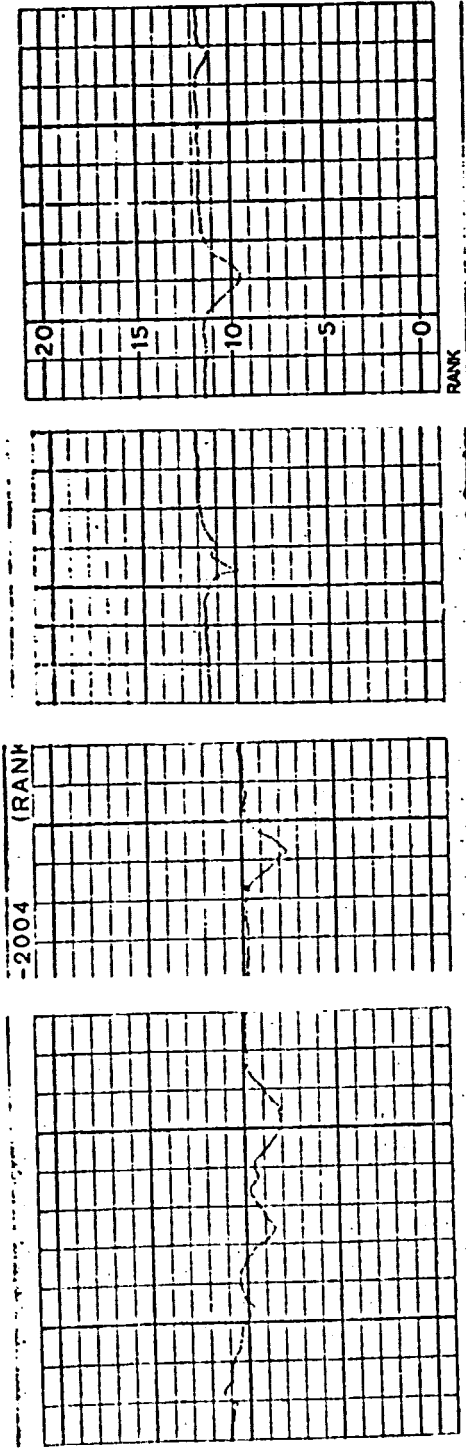
Figure 7a shows profiles of the minor-circle scratches on a ball from bearing 8517901. Scratch depths up to  $1\ \mu\text{m}$  (40 microinches) were measured. Although debris embedded in the ball pockets is generally assumed to cause such scratches, a second possible source may be the result of the sliding/rolling contact on the chamfer of the inner races during periods of very high inner-race contact angles. To explore this possibility, traces of the chamfer corners were made at the same magnification as was used on the balls, shown in Figure 7b and 7c. The radii at the tips of the chamfer corners are seen to match the radii of many of the ball scratches and could, therefore, have caused these scratches. The few scratches with sharper radii were caused by sliding against a sharper object, which was probably embedded debris.

a. Scratches in Ball from Bearing 8517901.

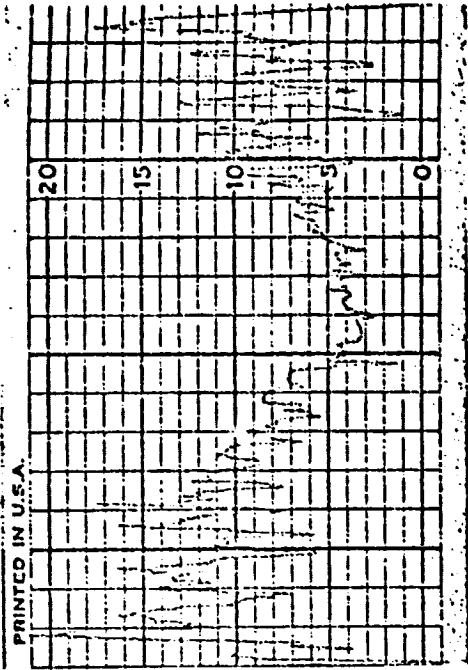
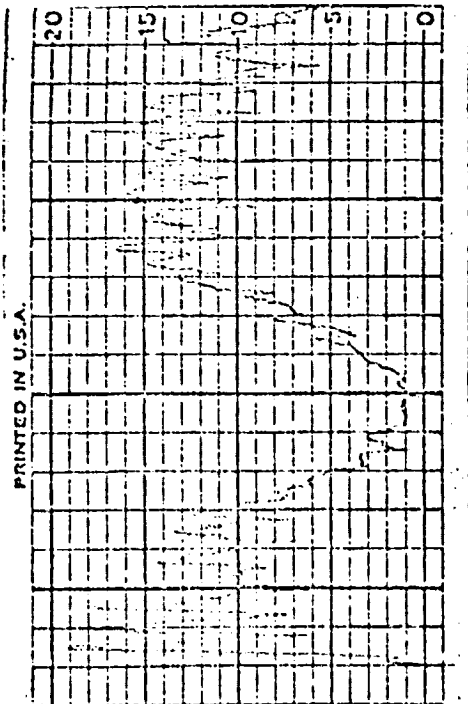
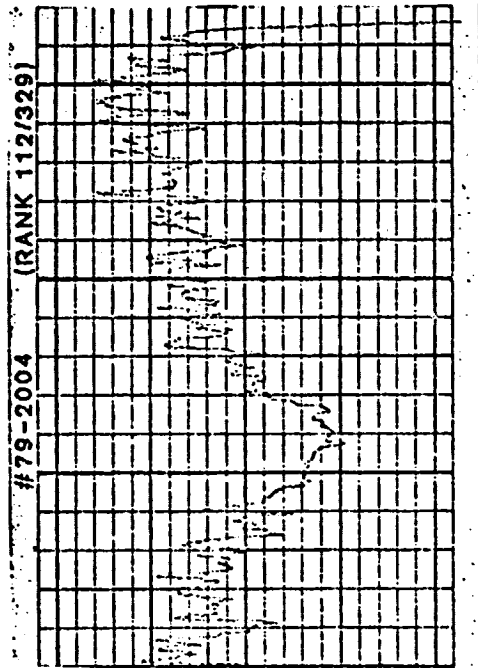
In Figures 8 and 9, the Talysurf was used to measure the extent of retainer wear at the ball-and outer-race contact areas. In figure 8, ball pocket wear depths of approximately 23 to  $38\ \mu\text{m}$  (900 to 1500 microinches) were measured on the three retainers provided. The wear on the outer guiding surfaces was less, as seen in Figure 9. Only the peaks of the wrapped structure were worn off in the right portion of the trace where the retainer contacted the race. A wear depth of approximately  $13\ \mu\text{m}$  (500 microinches) was measured. Since the lubrication of the bearing is assumed to result from wear transfer of the TFE in the retainer, wear such as that measured is desirable.

FIGURE 8. PROFILES OF MAXIMUM WEAR AREAS OF RETAINER BALL POCKETS. MAGNIFICATIONS, MINOR DIVISIONS, VERTICAL: 2.5  $\mu$ m (100 microinch) HORIZONTAL: 0.25 mm (.010 inch)

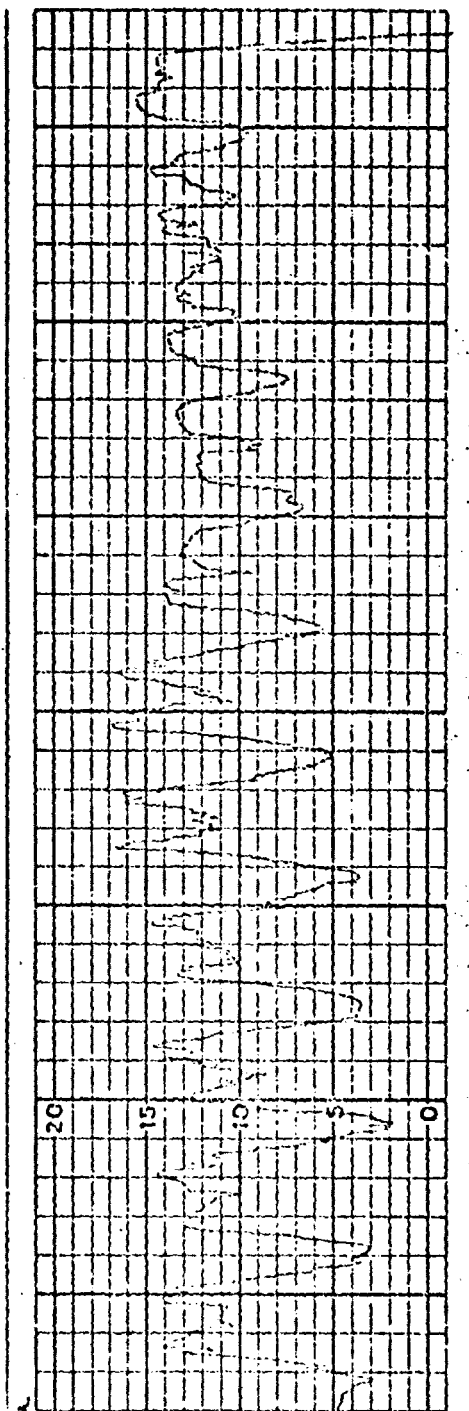
FIGURE 9. WEAR OF RETAINERS ON OUTER DIAMETER FROM SLIDING CONTACT WITH RACE.  
MAGNIFICATIONS, MINOR DIVISIONS, VERTICAL: 2.5  $\mu$ m (100 microinch)  
HORIZONTAL: 0.25 mm (.010 inch)

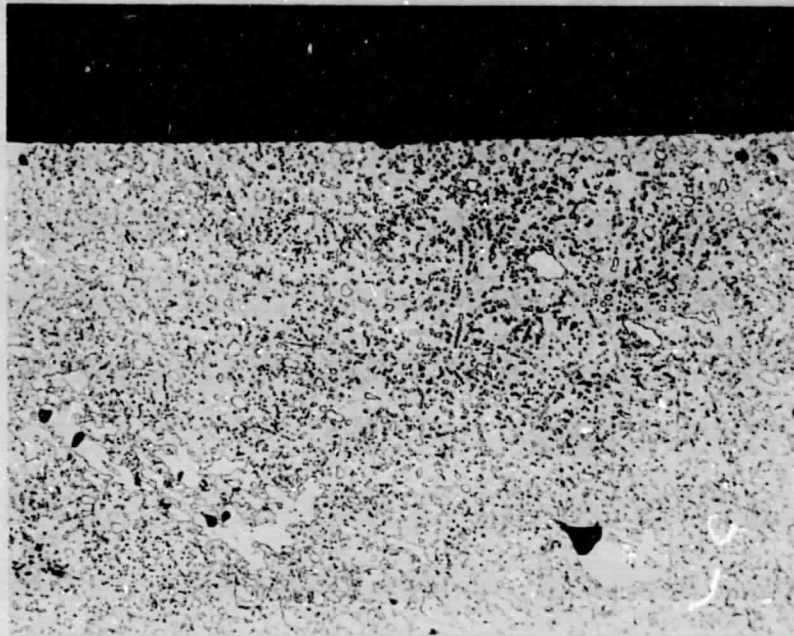
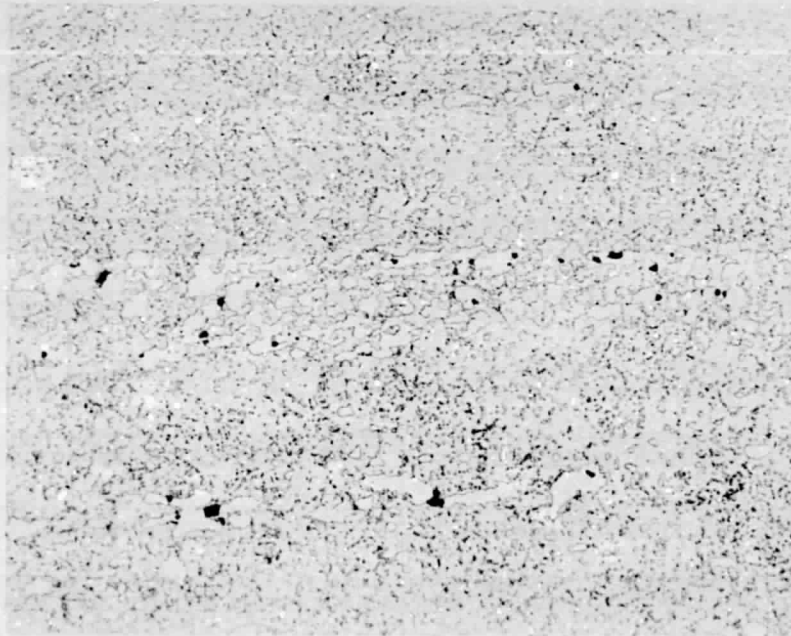
Metallurgical sections were prepared of a race from each bearing to examine the microstructure. A typical area of two bearings is shown in Figure 10. In Figure 10a, taken at the surface, a debris dent was intersected and is visible at the upper surface. The general microstructures are typical of 440C bearing steel, and no evidence of cracking, decarburization, retained austenite, or finishing damage was noted. Hardness readings taken on each of the races are presented in Table 1.

a. Bearing 8492674 Inner Race, with Dent on Surface.

b. Bearing 8492674 Outer Race.

FIGURE 10. TYPICAL BEARING STEEL MICROSTRUCTURE.

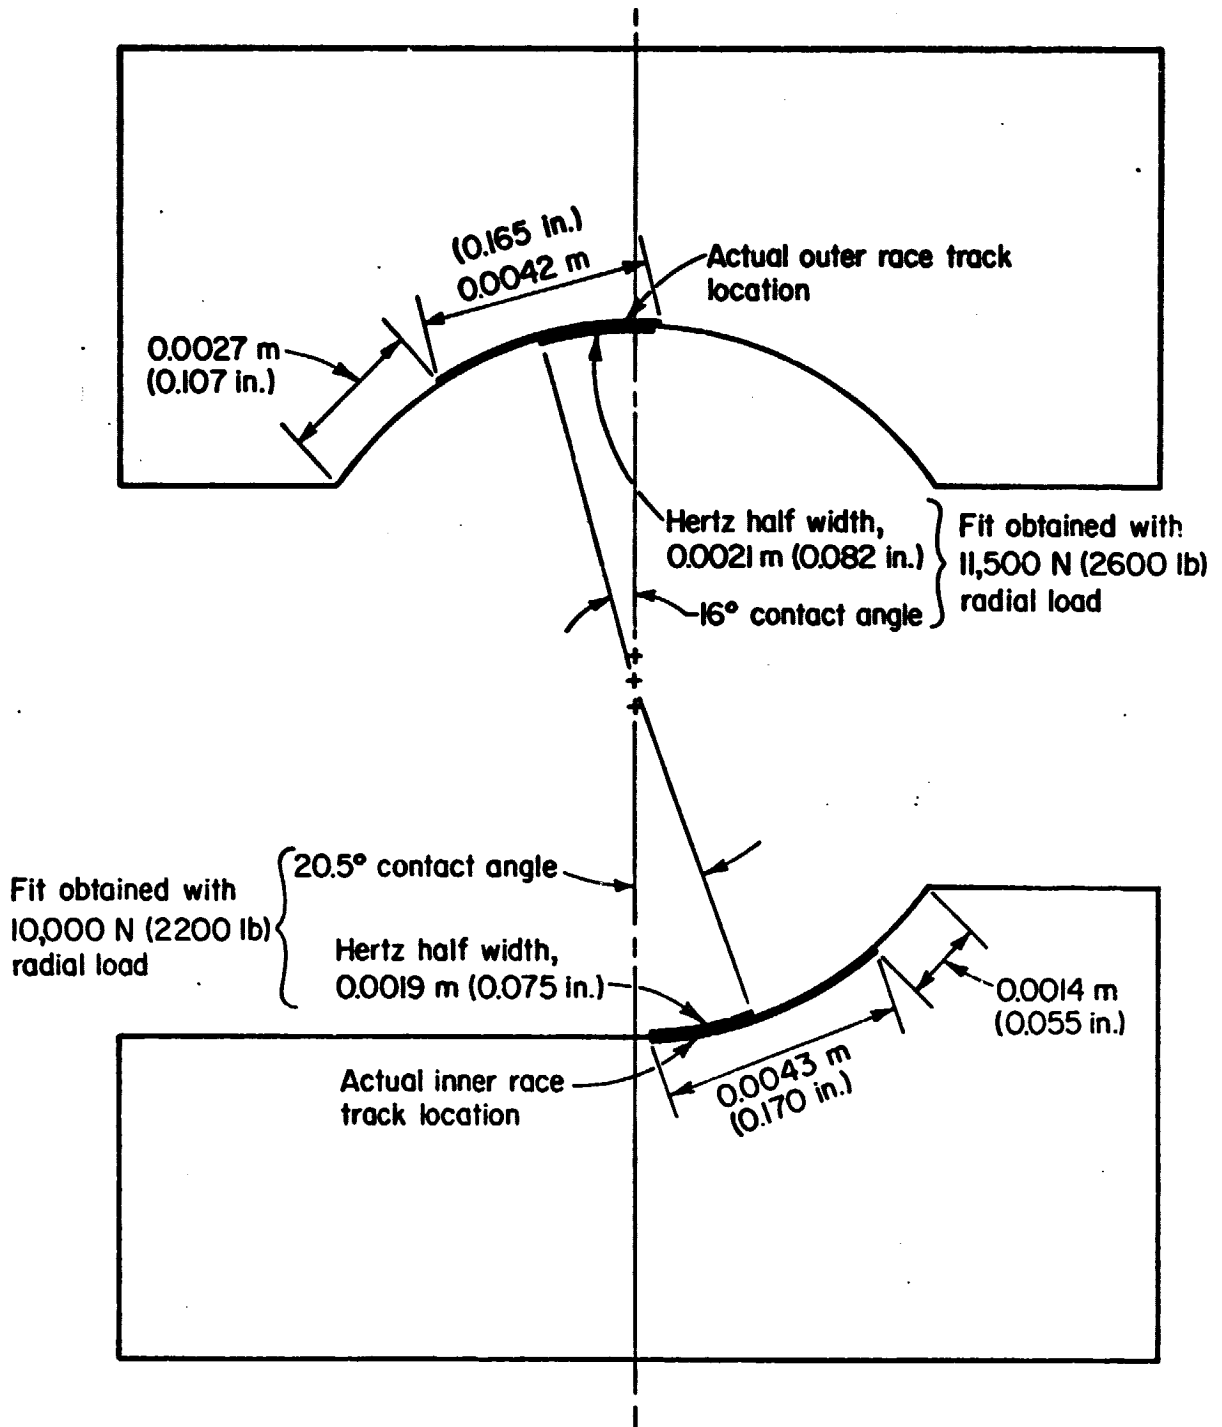
Measurements were made of the location and width of the ball contact paths on the pump bearing races supplied by NASA, by using an optical microscope. The results are shown in Table 3. Using these measurements and the graphs presented in Figures 11 through 14, an estimation was made of the maximum radial load applied to each bearing race. Axial loads were assumed of 2900N (650 lbs) on the type 7522 bearings and 3800N (850 lbs) on the type 7955 bearings. An example of the procedure is shown in Figure 17, which is based on a scale drawing of the bearing races in their nominal position during operation. By graphical iteration, the load was chosen for each race that gave the best simultaneous fit of contact angle and Hertz half width for the extreme edge of the ball contact path (maximum radial load position). The maximum radial loads obtained for each bearing race are presented in Table 3.

FIGURE 17. LOCATION OF ACTUAL BALL CONTACT PATHS ON BEARING 8517901 SHOWING FIT OF CONTACT ANGLES AND HERTZ HALF WIDTHS OBTAINED FROM FIGURES 12 and 14.
