NASA Technical Memorandum 79040

HIGH VELOCITY BURNER RIG OXIDATION
AND THERMAL FATIGUE BEHAVIOR OF
Si₃N₄- AND SiC-BASE CERAMICS TO 1370° C

William A. Sanders and James R. Johnston
Lewis Research Center
Cleveland, Ohio

November 1978

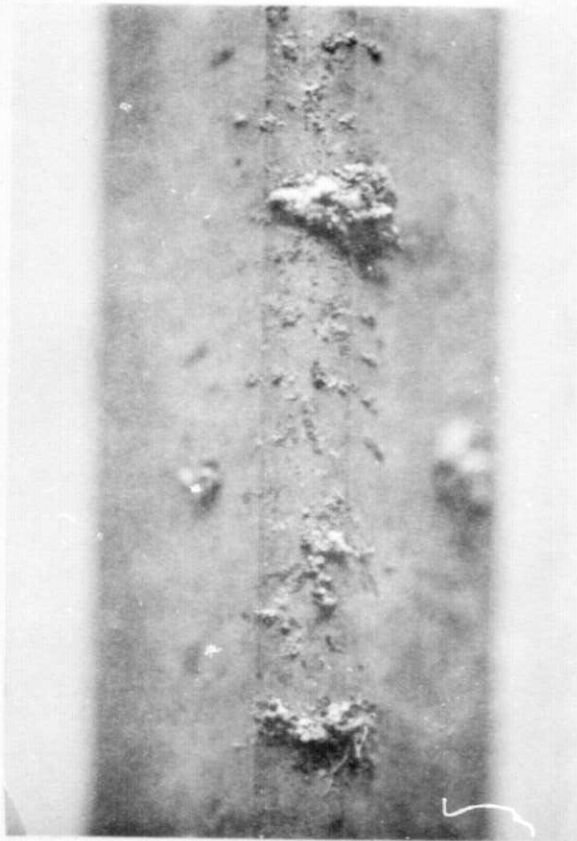
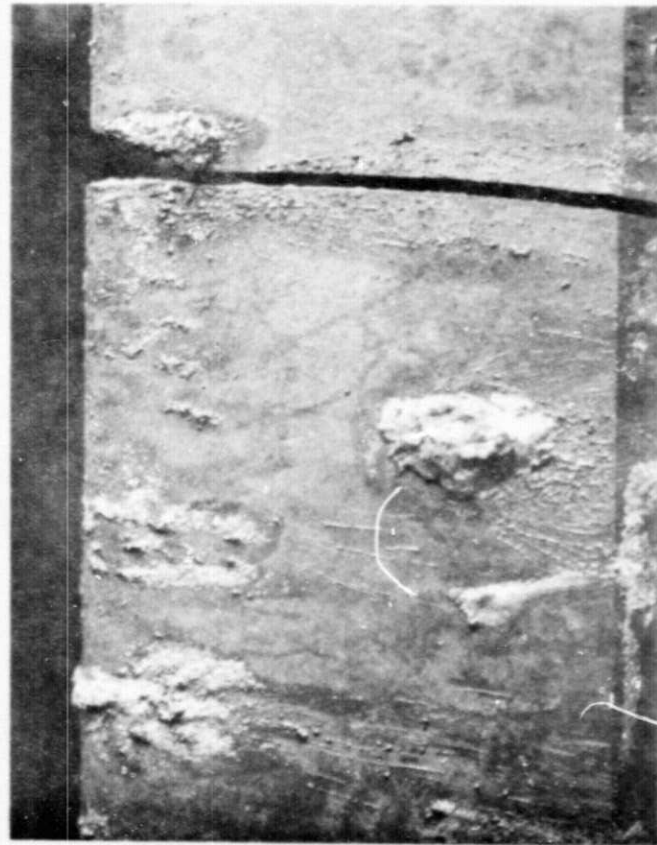
Figure 13. - Norton NC-435 siliconized SiC batch 3 vane hot zone leading edge after 1205⁰ C exposure in Mach 1 burner rig. Cycle: 12 minutes at 1205⁰ C, 3 minute still air cool. X10.

We reason this flaw to be a partial void containing some silicate oxidation product which may well be cracked. Evidence for the heavy exudation of molten material can be seen in figure 13 which shows a front view and a side view of the hot zone leading edge of the Batch 3 NC-435 vane. The front view shows a particularly heavy buildup noted at the 125 cycle inspection. The side view shows the pieced-together vane which failed at the heavy buildup during the 126th cycle cooling. Glassy oxide streaks and buildups can also be noted. Figure 13(a) can likewise be compared with figure 12(b) for noting the coincidence of the failure point and the heavy buildup. We suggest that the Batch 3 NC-435 vane had high near-surface concentrations of silicon, iron, and aluminum resulting in eutectic formation and "sweating out" of the molten eutectic during burner rig exposure. Based on vane appearance in figure 12, such presumed deleterious near-surface concentrations of silicon, iron, and aluminum were considerably less for the Batch 1 NC-435 vane and very slight for the Batch 2 NC-435 vane. This batch ranking, 3-1-2, based upon degree of sweat-out differs from a batch ranking, 2-3-1, based upon highest to lowest concentration of metallic impurities (iron and aluminum, major), given in table II. Apparently, for the metallic impurity levels 0.68, 0.58, and 0.49 percent, chemical inhomogeneties within the vane can override the effects of overall impurity level.

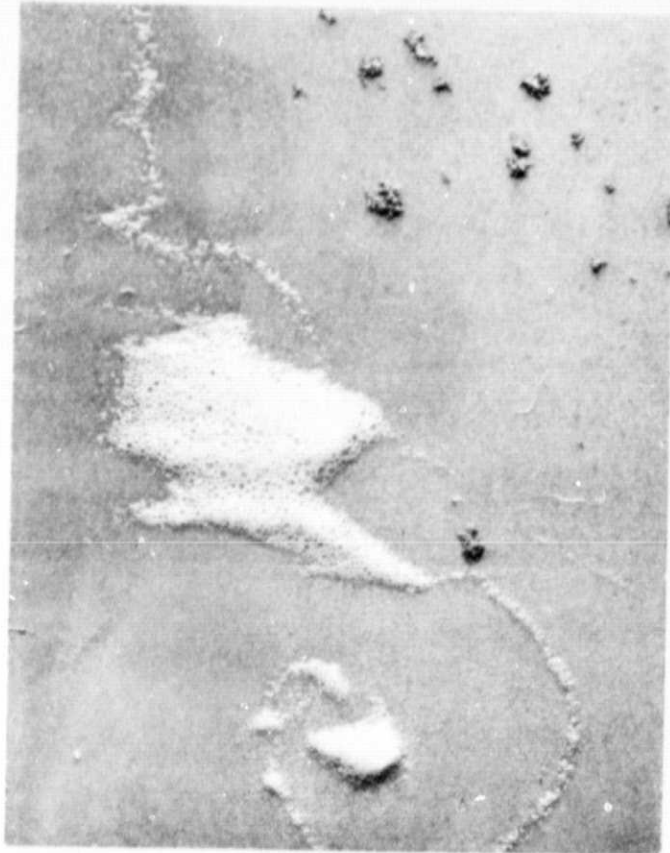
Figure 15. - Norton NC-435 siliconized SiC batch 3 vane after 1260⁰ C exposure for 125 cycles in Mach 1 burner rig. Cycle: 12 minutes at test temperature, 3 minutes still air cool.

at 1205° C. The photos in figure 15 show the Batch 3 vane after 125 cycle exposure at 1260° C. In addition to the clusters of bead-like particles, there was a large collection of frothy oxide on the vane major flat surface which had been swept back from the leading edge by the Mach 1 hot gas stream.
