NASA Technical Paper 1343

Lubrication and Failure Mechanisms of Molybdenum Disulfide Films

I - Effect of Atmosphere

Robert L. Fusaro

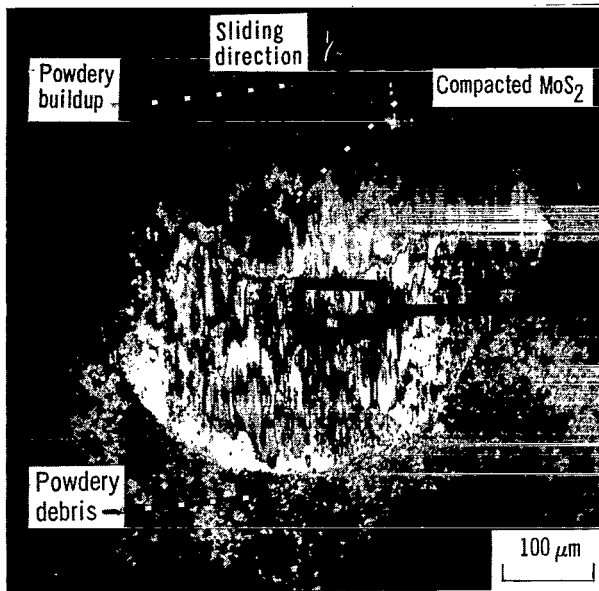
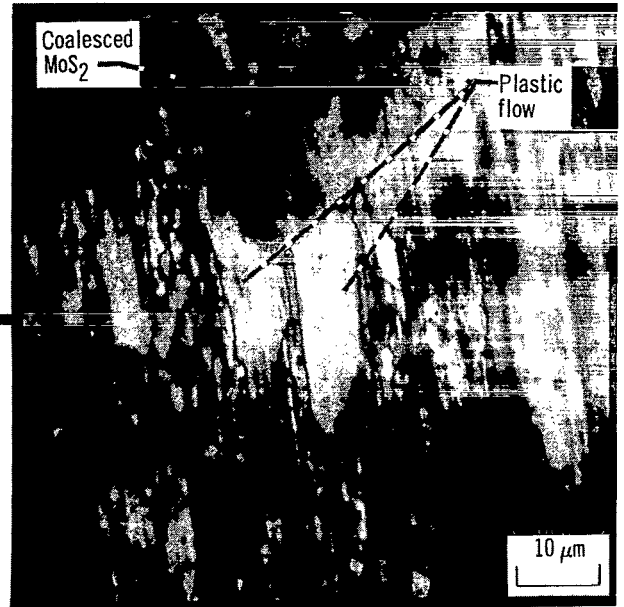
(a) Rider wear scar.

Figure 5. - Photomicrographs of rider wear scar and MoS₂ film wear track after 1 kilocycle of sliding (run-in) in moist air (10 000-ppm H₂O) at 25° C.

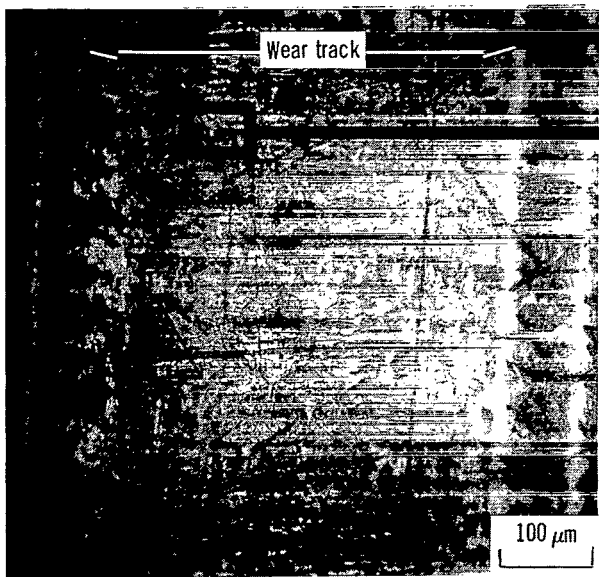
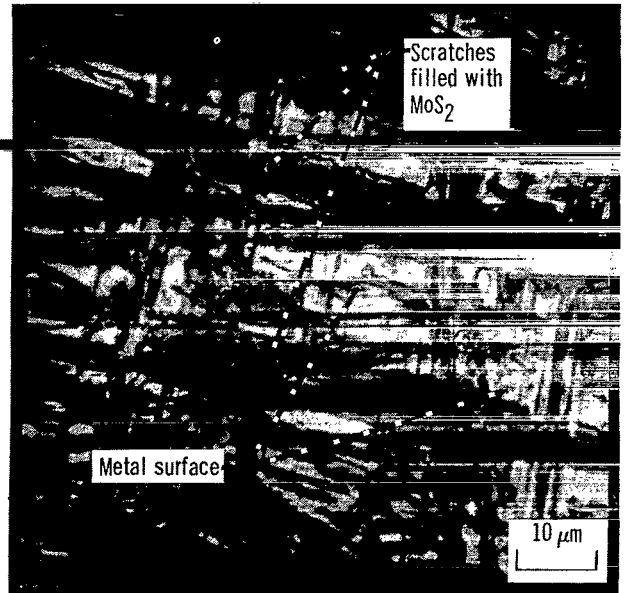
(b) MoS₂ film wear track.

The wear track on the rubbed MoS₂ film is shown in figure 5(b) after 1 kilocycle of sliding. In the center of the wear track, most of the original film had been plowed away and what remained was compacted MoS₂ in the sanded scratches. The MoS₂ tended to flow from the scratches in very thin films across the flat metallic plateaus between the scratches.

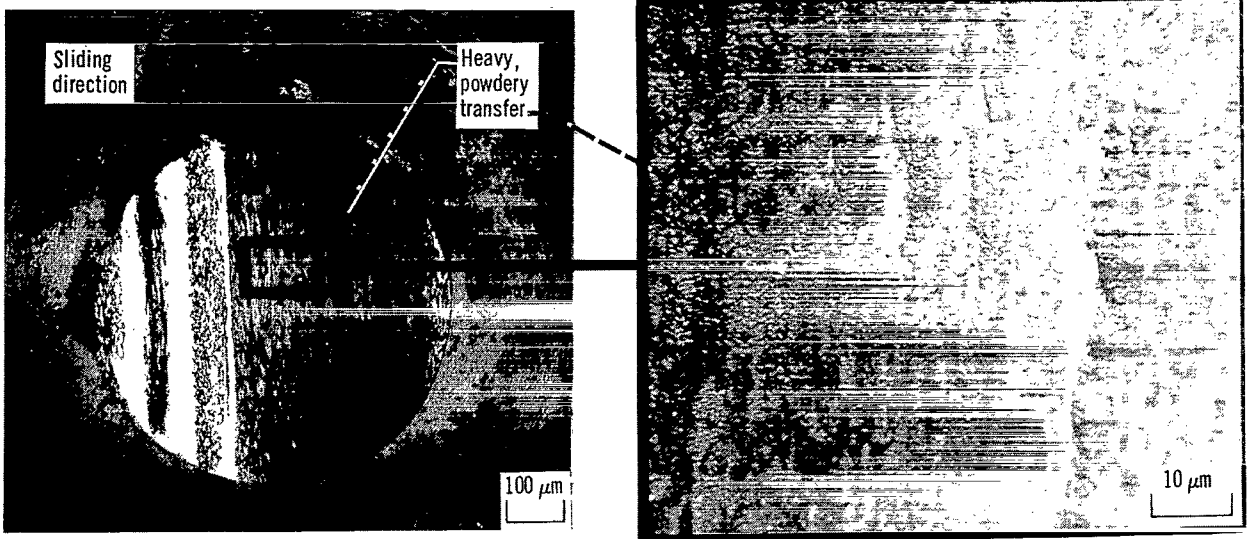
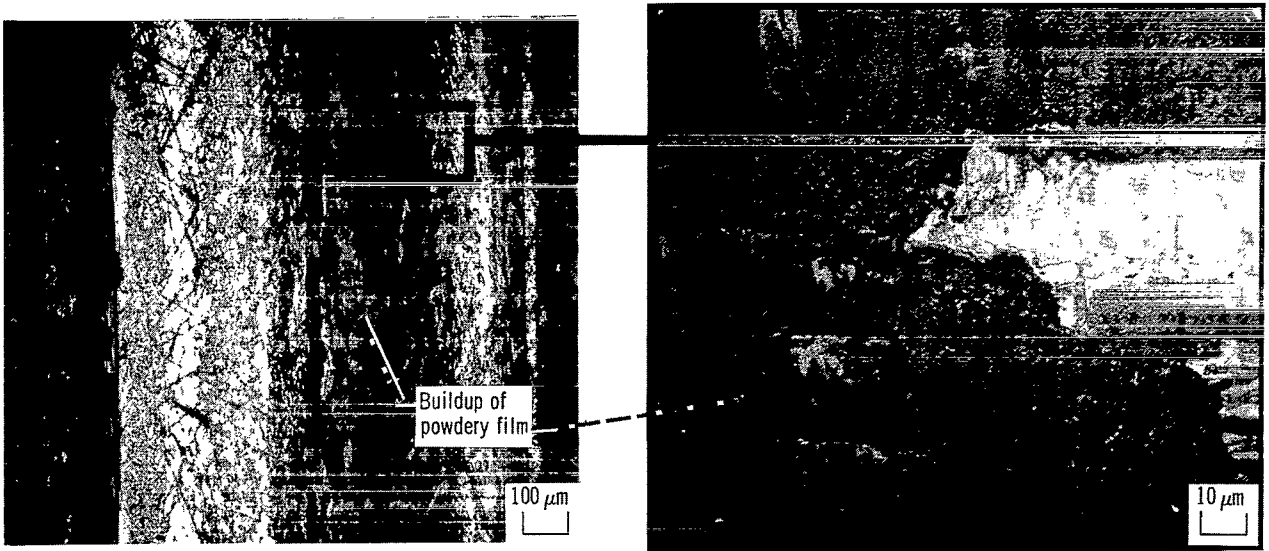
After 10 kilocycles of sliding (fig. 7), failure occurred (a friction coefficient of 0.30). No smooth, coalesced MoS₂ films were found on either the rider or the wear track. Instead, a heavy, rippled powdery film was found on both rider and disk sliding surfaces. Significantly, failure was marked by the buildup of a heavy transfer film on both surfaces, and no galling was evident on either surface.

Figure 7. - Photomicrographs of rider wear scar and MoS₂ film wear track after tailure (10 kilocycles of sliding) in moist air (10 000-ppm H₂O) at 25°C.

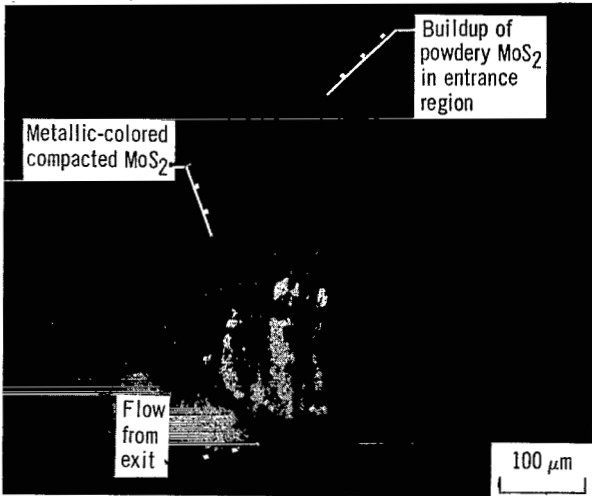
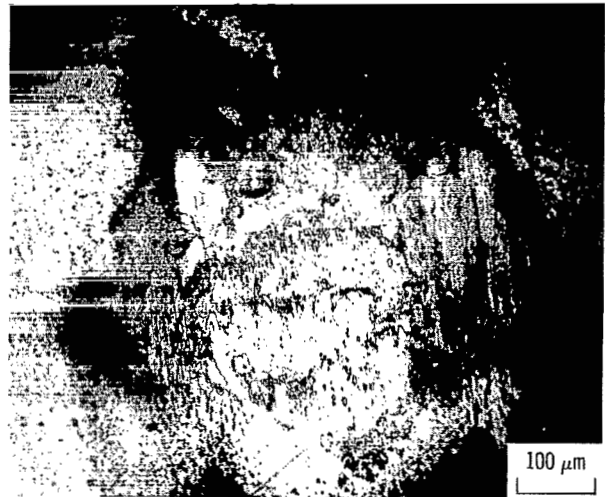
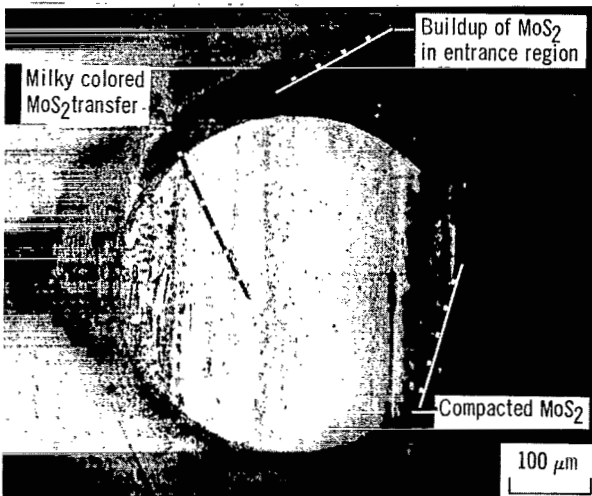
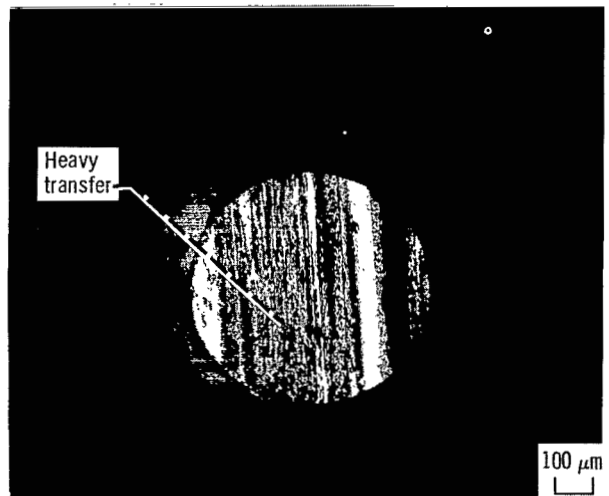
Figure 8. - Photomicrographs of rider wear progression and film transfer formation in dry air (<20-ppm H₂O).

films could be determined. Figure 8 shows photomicrographs of rider wear and transfer films after 1, 15, 60, and 100 kilocycles of sliding in dry air. Figure 9 shows higher magnification photographs of the transfer films shown in figure 8.

After 1 kilocycle of sliding, transfer to the rider was like that in moist air; that is, the transfer film was fairly heavy. After continued sliding in dry air, the transfer film became considerably thinner (figs. 8(a) and 9(a)). After 15 kilocycles of sliding (figs. 8(b) and 9(b)) the heavy transfer film of MoS_2 had disappeared and layer-like flow of MoS_2 through the contact was occurring. After 60 kilocycles of sliding (figs. 8(c) and 9(c)), no layer-like flow was visible in the center of the rider scar. As the MoS_2 moved into the contact zone (flat area), it was sheared thinner and thinner. Interference fringes are visible in this region, but in the actual contact region the MoS_2 was sheared too thin for interference fringes to occur and the transfer was milky colored (figs. 8(c) and 9(c)).

At failure (figs. 8(d) and 9(d)), the transfer film resembled that in moist air; that is, it was heavy, rippled, and coarse. This film still possesses flow properties (fig. 9(d)).

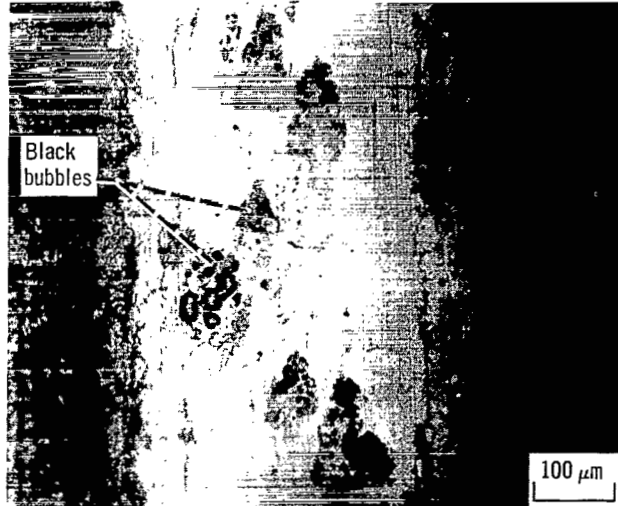
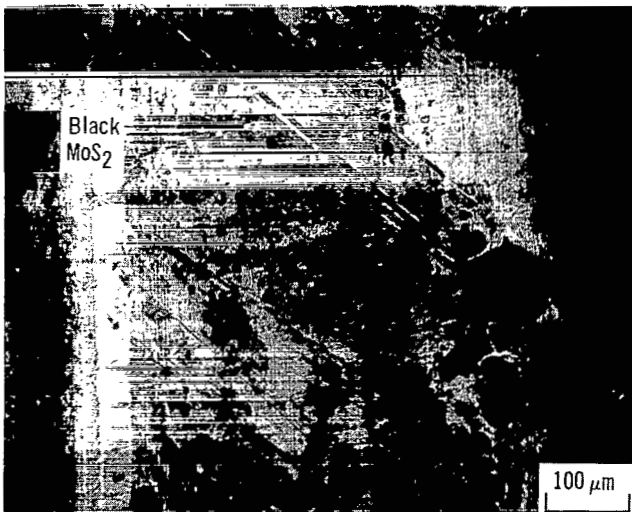
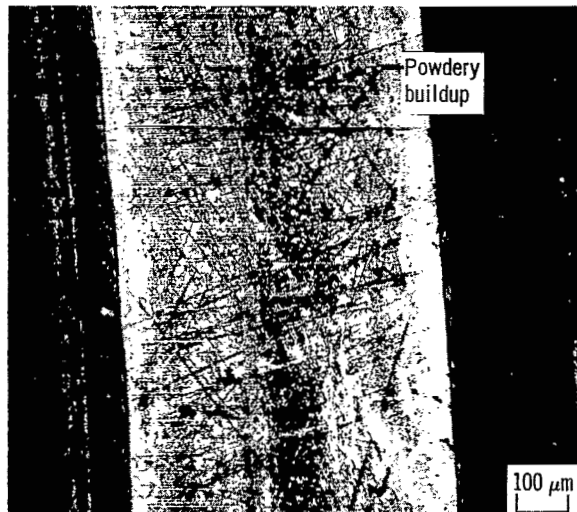
Figure 10. - Photomicrographs of MoS₂ film wear progression in dry air (<20-ppm H₂O).

Figure 10 shows photomicrographs of MoS_2 film wear progression in dry air, and figure 11 shows higher magnification photomicrographs of interesting features within those films at the same sliding intervals. The MoS_2 film on the wear track formed in dry air covered the surface more continuously and had a greater metallic luster than did the wear track films formed in moist air. After 1 kilocycle of sliding (figs. 10(a) and 11(a)), the MoS_2 films had become black in areas, and as sliding continued the number of these areas increased. Where the film was thicker, the black areas took the form of bubbles (figs. 10(b) and 11(b)) and as sliding continued the number increased (fig. 10(c)). At failure (100 kilocycles of sliding), a powdery material built up on the wear track as in moist air (figs. 10(d) and 11(d)). Thus the transformation of MoS_2 occurred in dry air as well as in moist air; however, the rate was much slower in dry air.

In dry air and dry argon, the friction coefficients for most of the tests were less than 0.02. In moist air, the lowest friction coefficient was 0.08. Optical observations of the sliding surfaces indicate that friction was higher in moist air because of the rapid transformation of MoS_2 , which affected the film-forming properties. After 1 kilocycle of sliding, the film was not nearly as continuous in moist air (fig. 5(b)) as in dry air (fig. 10(a)). There was thus more metallic contact and higher friction.

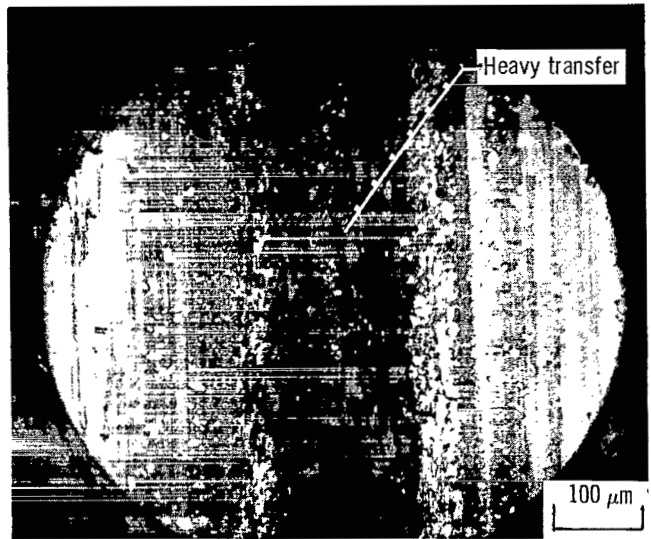
Figure 12. - Photomicrographs of rider wear progression and film transfer formation in dry argon (<20-ppm H₂O).

Experiments like those conducted in dry and moist air were conducted in dry argon (<20-ppm H_2O) so that the effect of oxidation on the lubrication and failure mechanisms of MoS_2 films could be determined. Figure 12 shows photomicrographs of rider wear scars after 1, 60, 700, and 1860 kilocycles of sliding. Rider transfer characteristics in dry argon were not markedly different than those in dry air. However, the test in dry argon lasted considerably longer.

The amount of MoS_2 transferred to the rider did not affect the friction coefficient. Figures 8 and 12 show varying degrees of MoS_2 transfer to the rider scar, but figure 3 shows that this did not affect the friction coefficient. Only when the transfer became powdery (transformed MoS_2 and or powdery metallic debris), was the friction observed to increase (figs. 8(d), 9(d), 12(d), and 13(d)).

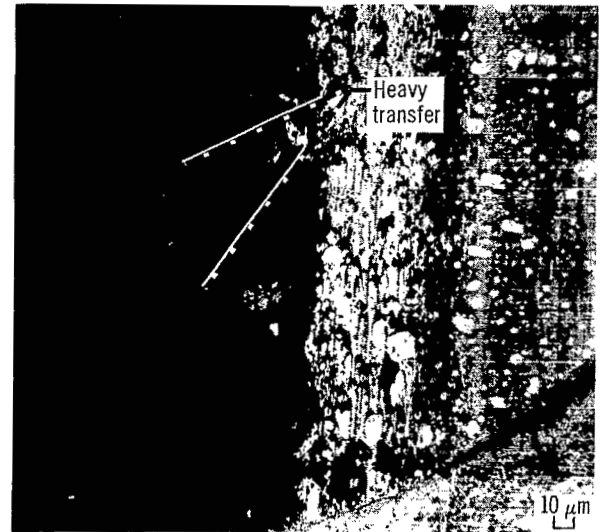
Figure 13. - Higher magnification photomicrographs of rider transfer films shown in figure 12.

Figure 13 shows higher-magnification photomicrographs of the rider wear scars for these sliding intervals. As in dry air, the MoS_2 tended to buildup in the rider entrance and then was sheared thinner and thinner as it passed through the contact region and also

with sliding time. In figure 13(c), MoS_2 is shown flowing from the exit of the rider scar. In figure 13(d), the buildup of a heavy transfer film at failure is shown.

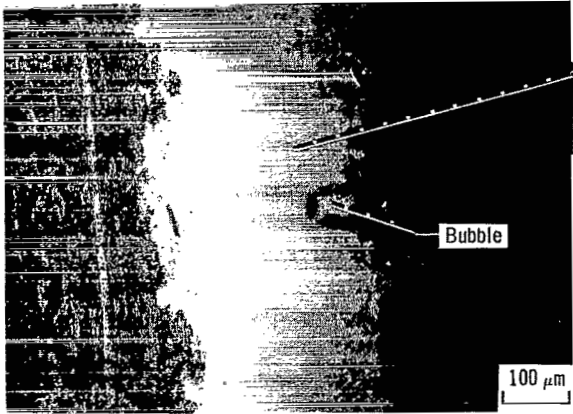
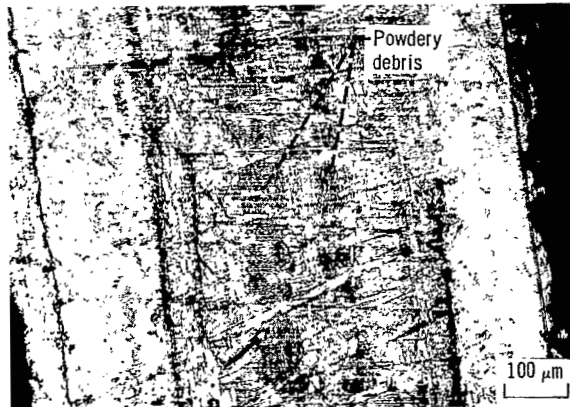
Figure 14. - Photomicrographs of MoS₂ film wear progression in dry argon (<20-ppm H₂O).

Little evidence of MoS_2 transformation in dry argon was found on the rider or in the film wear track. The films were very smooth and had a bright metallic luster. Figures 14 and 15 show photomicrographs of the wear tracks at intervals that correspond to the intervals used for the riders. After 1 kilocycle of sliding (fig. 14(a)), the film on the wear track was smooth and continuous and the metallic substrate was not visible. There were a few bubble-like protrusions at the outer edge of the wear track after 1 kilocycle of sliding (figs. 14(a) and 15(a)). These bubbles could also be found in the center of the wear track at longer sliding intervals (fig. 14(b)). Figure 15(b) shows one of these bubble areas in which the bubbles had cracked and spalled from the surface. These areas of bubbling, cracking, and spalling were localized and most of the track remained smooth and continuous. Since there was no change in color (i. e., the areas remained metallic colored and did not turn black), it is surmised that no transformation of MoS_2 was occurring.

After continued sliding, the spalled areas tended to be self-healing; nevertheless, after long sliding the films started to thin in the center (figs. 14(c) and 15(c)). After 1500 kilocycles of sliding, the friction started to get "rough." At the sides of the wear track the film still had a metallic luster (fig. 14(d)); however, in the middle of the wear track the film looked disrupted. This disrupted area was a buildup of powdery material (fig. 15(d)).
