NASA TM-78201

**ARC TERMINATION CRACKS IN INCONEL 718
AND INCOLOY 903**

By E. Bayless, J. McCaig, and R. Poorman
Materials and Processes Laboratory

October 1978

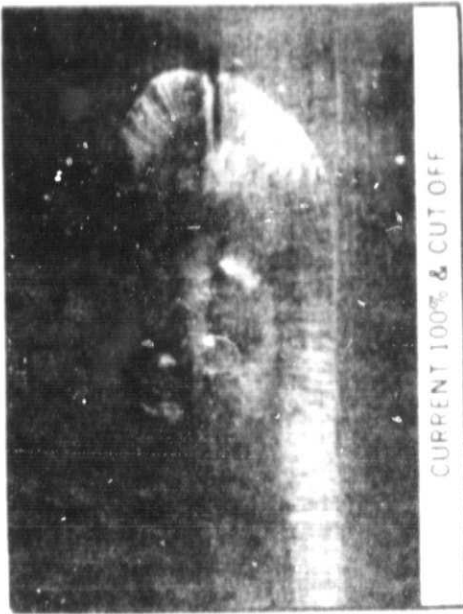
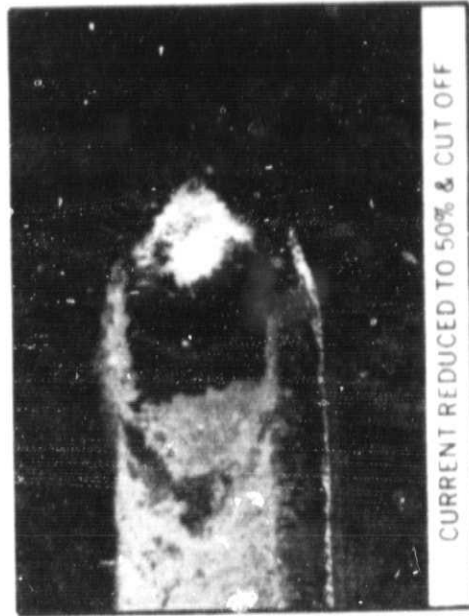
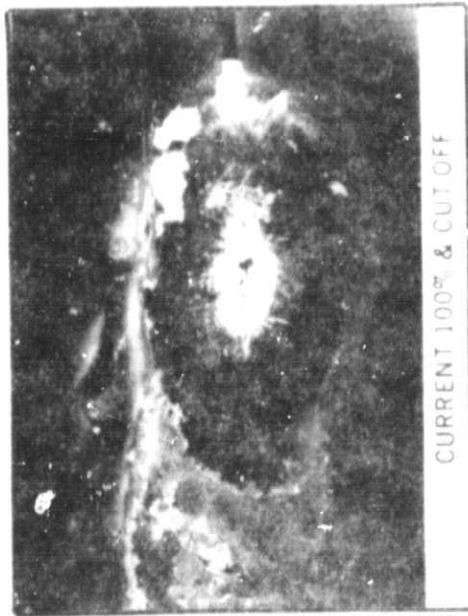
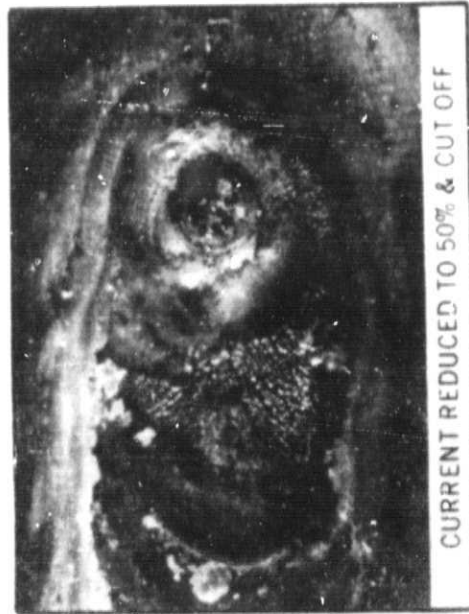
Figure 2. Weld termination in 0.250 in. Inconel 718.

Eight root pass weld beads were made manually with the weld current terminated as rapidly as possible. This technique would simulate an unplanned termination such as loss of power or malfunction of equipment. Seven were similarly made by machine weld operations. All 15 weld terminations had crater cracks and most were very deep, some completely through the weld nugget. A typical termination is shown in Figure 2.

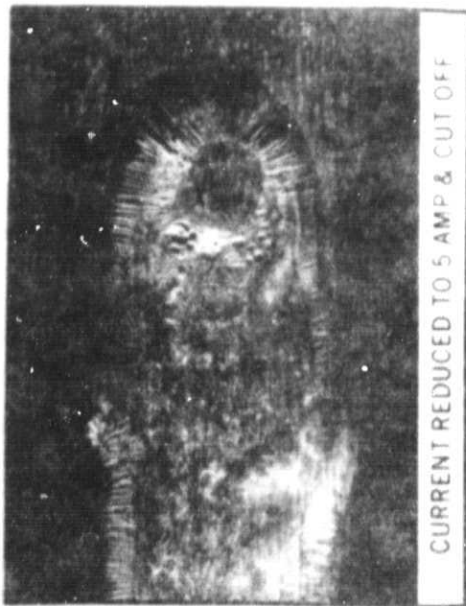
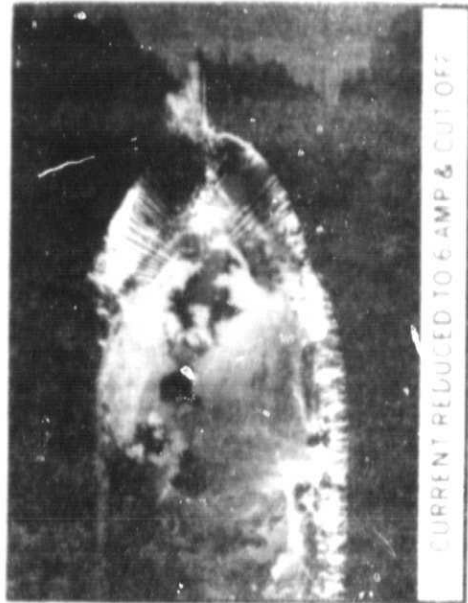
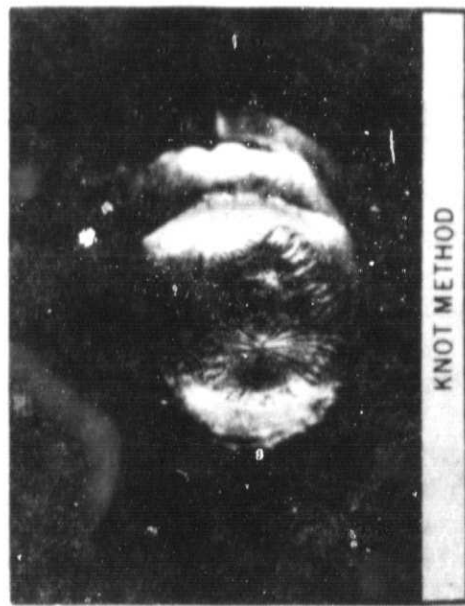
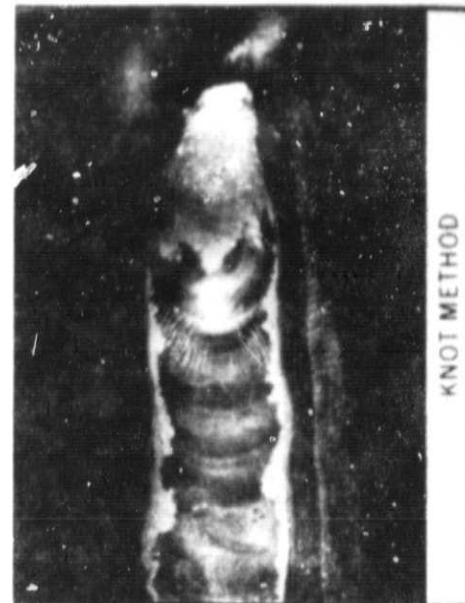
Figure 3. Weld termination in 0.250 in. Inconel 718.

All welds were examined visually, radiographically, and by dye penetrant. A typical termination zone produced by this reduced current technique is shown in Figure 3.

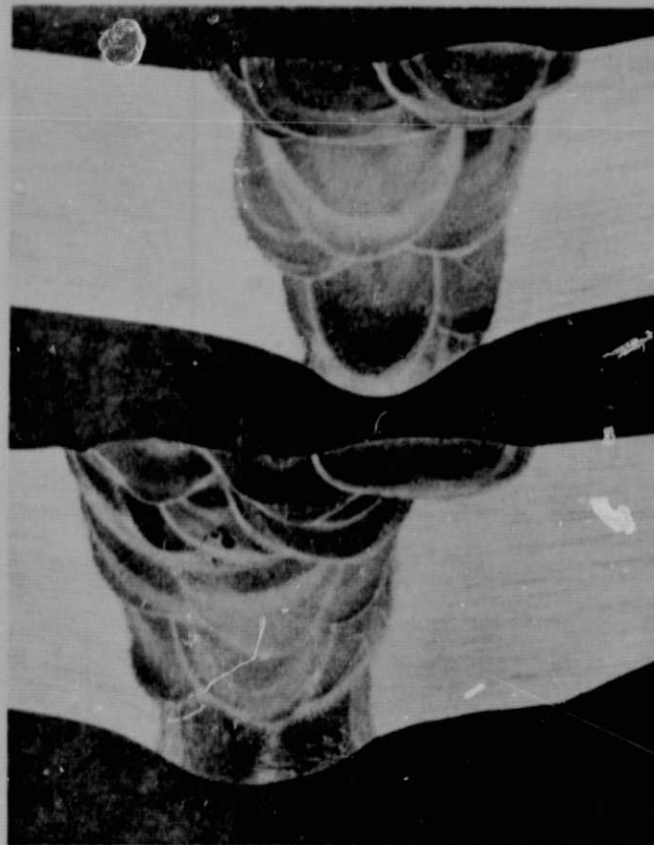
Figure 4. Sections of weld panels 14M (top) and 15M (5X).

Figure 4 shows a cross section of a weld over a crater crack in panels 14M and 15M. The crater cracks were in the penetration pass. Panel 15M shows defects that were found to be a combination of gas porosity and oxide contamination. Figure 5 shows the defects in panel 15M at 50X. The defect near the penetration side of the weld possibly is a result of welding over entrapped dye penetrant.

The practice of welding over cracks is not recommended because of the possibility of not refusing the crack and the likelihood of having porosity and oxide inclusions. When a crack is detected the best practice is to remove the crack mechanically, etch the area, and dye penetrant examine for assurance of removal.

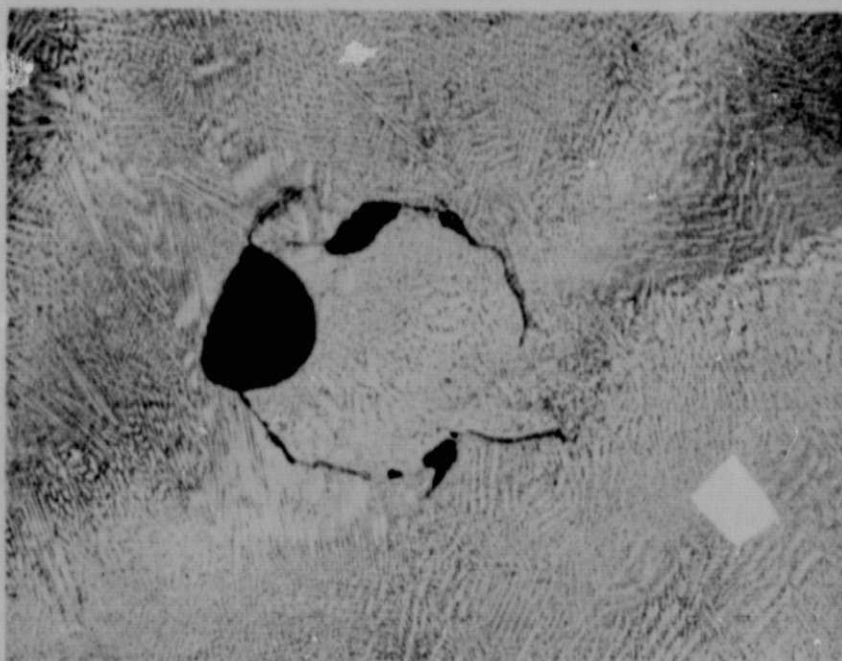
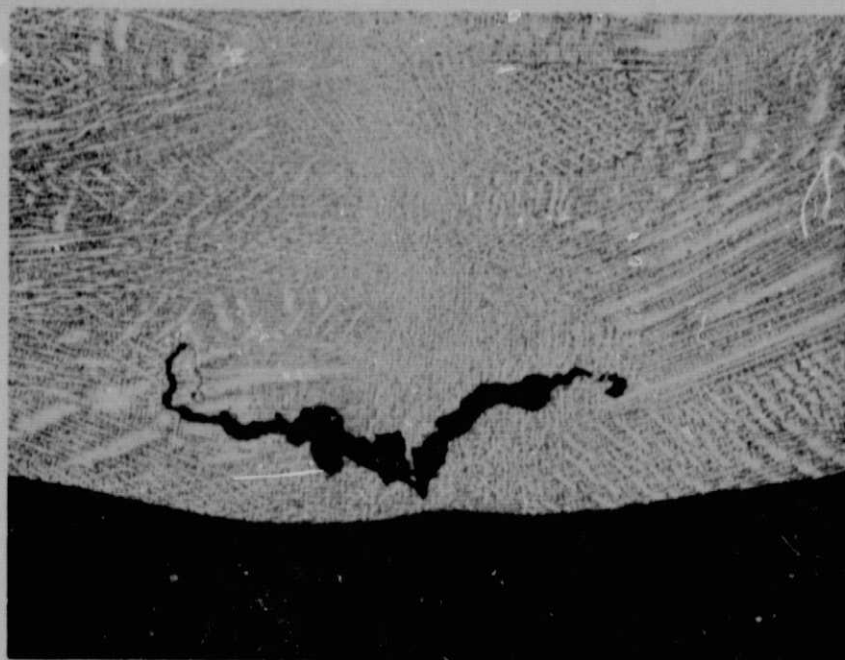
Figure 5. Defects in 15M (50X).

Weld 15M.

Root pass of weld 15M.

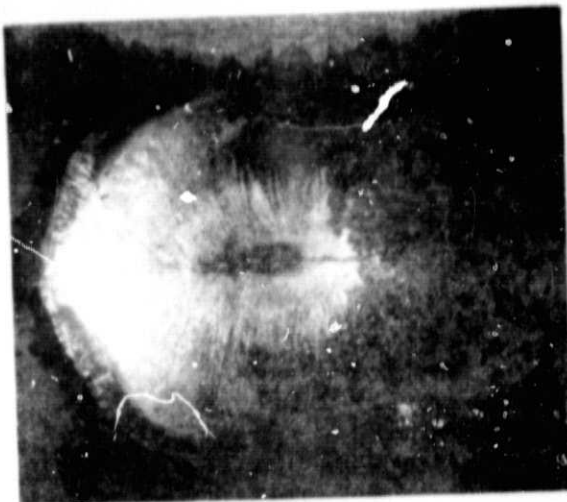
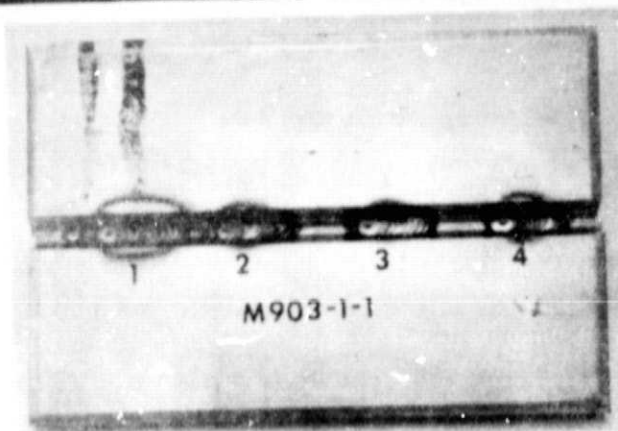
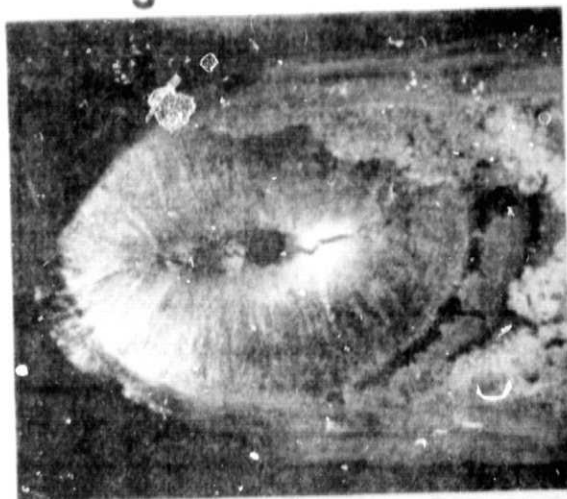
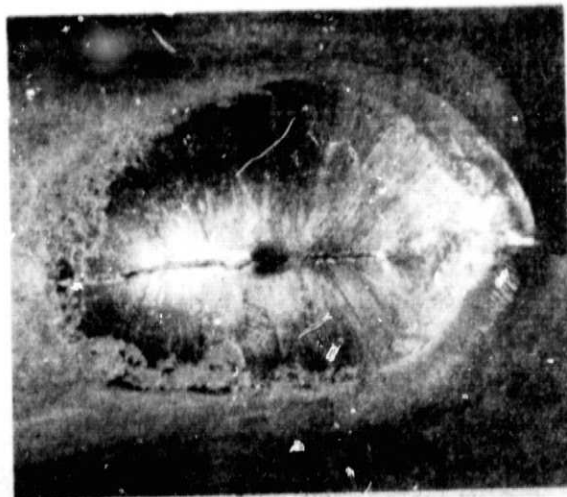
Figure 6. Panel M903-1-1 (welding A 70 and termination A 70).

This phase involved a determination of the crater cracking sensitivity of Incoloy 903 as compared to Inconel 718. Arc terminations were made by arc shutoff at welding current. These also resulted in crater cracks in 100 percent of the terminations. Utilizing the weld buildup technique used on Inconel 718 eliminated the crater cracks in Incoloy 903. Figure 6 shows the defects resulting when the arc is terminated at welding current, and Figure 7 shows the defect free weld buildup technique. The limited amount of investigation on Incoloy 903 did not give us a relative comparison of the crater crack sensitivity of Incoloy 903 and Inconel 718.
