NASA TM-75448

CHEVRON CUTTING--EXPERIMENT WITH NEW
RUNWAY MIXTURES

K. Tyran

Translation of "CHEVRON CUTTING--Versuch mit
neuen Laufflachenmischungen," Swissair, Dept. _____
Technik, Versuchsbericht, Publ. No. 72'758
 Dec. 22, 1977, 20 pages.

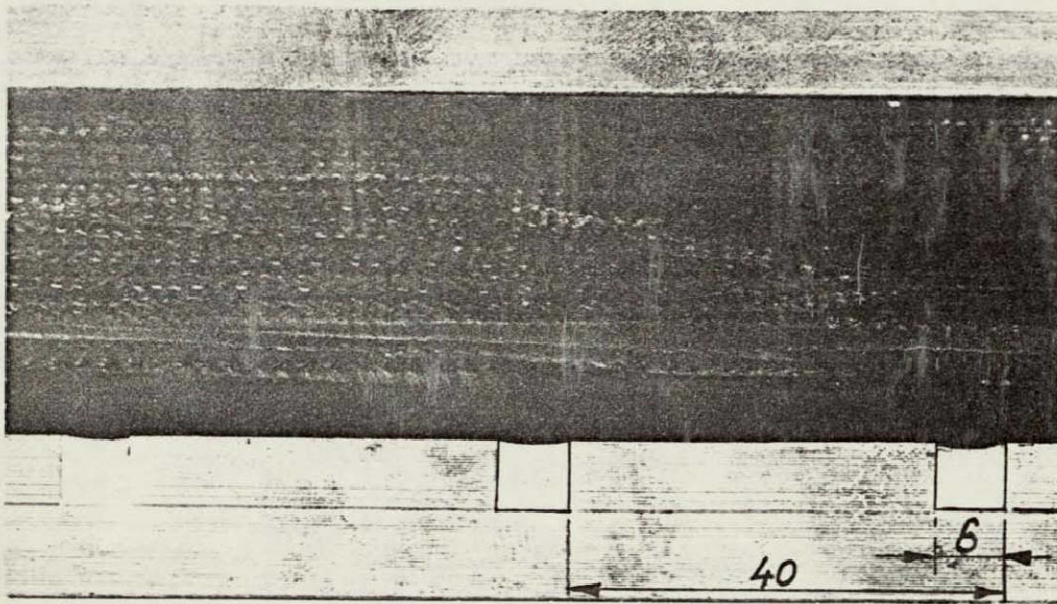
Fig. 2 Runway profile. A B-747 tire with 13.35 kp/cm^2 tire pressure is pressed about 1.4 mm deep into the groove.

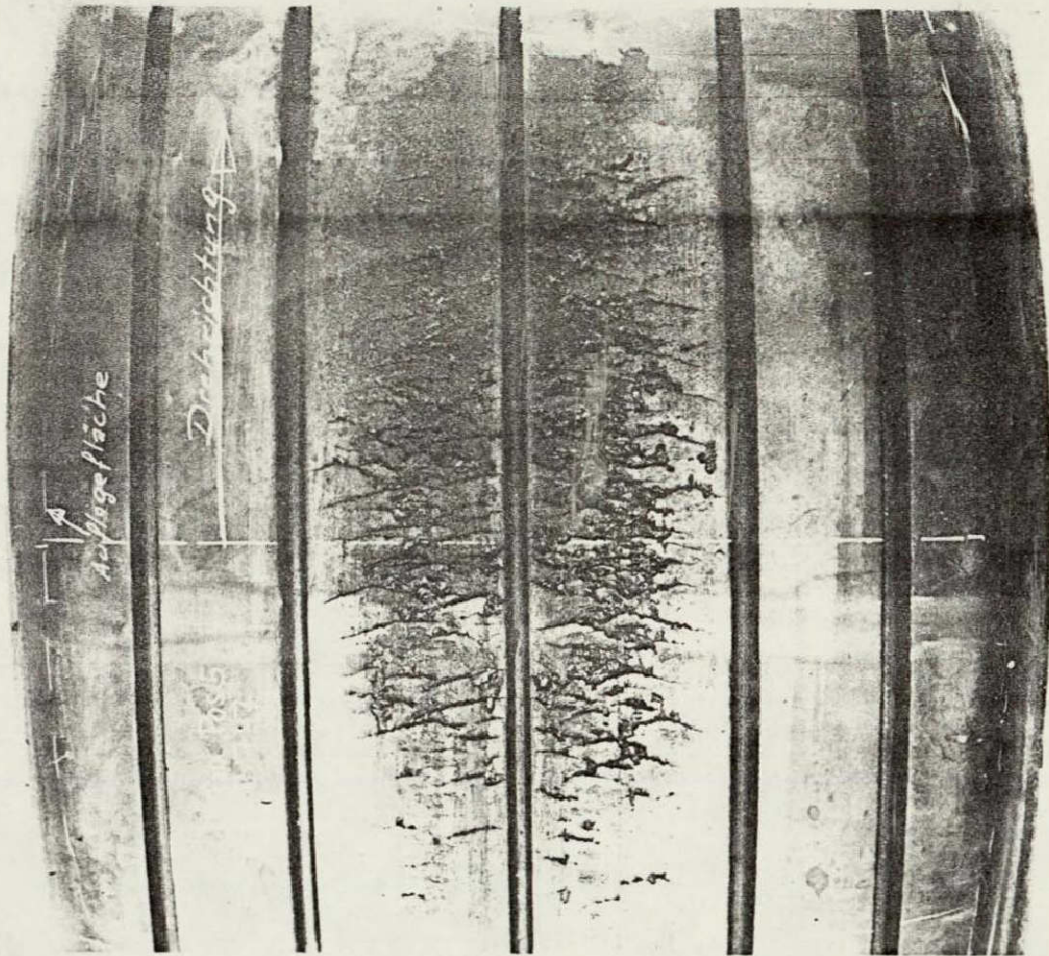
These damages occur upon landing when the stationary tire touches the grooved runway and slides over the groove edges. Chevron Cutting is influenced by tire pressure, touchdown velocity and mass moment of inertia of the wheel (Figs. 1, 2, 3).

Fig. 3 Chevron Cutting occurs at the touchdown surface when the stationary tire glides over the groove edges.

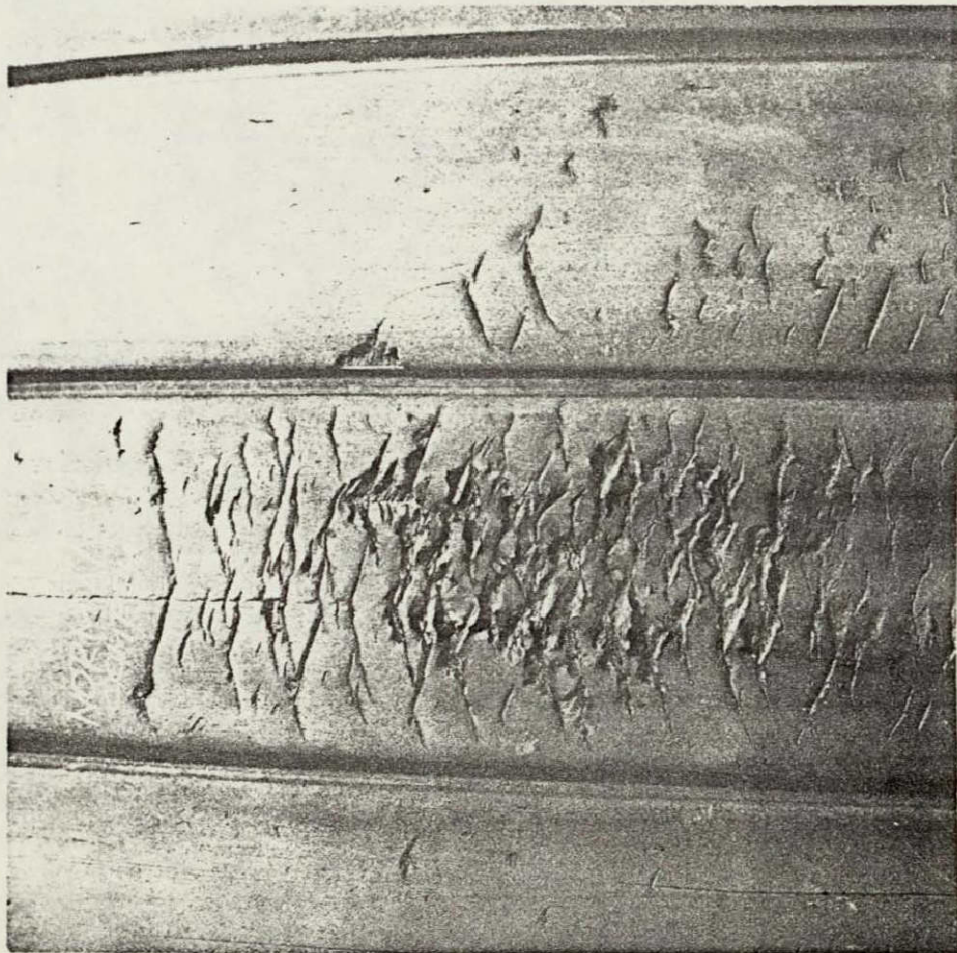
There were no Chevron Cuts on two of the nine test tires. They did appear on the remaining seven test tires but to a much smaller extent than for the previous running surface mixture. The breaks are up to 8 mm long and about 0.8 mm deep. For the previous mixture breaks were as much as 40 mm long and 3-4 mm deep (see Figs. 5, 6, 7 and 8). Two of the tires capped with natural rubber showed better performance with regard to Chevron Cutting than those with the previous running surface mixture.

Fig. 5 THOMPSON--normal mixture with typical Chevron Cuts.

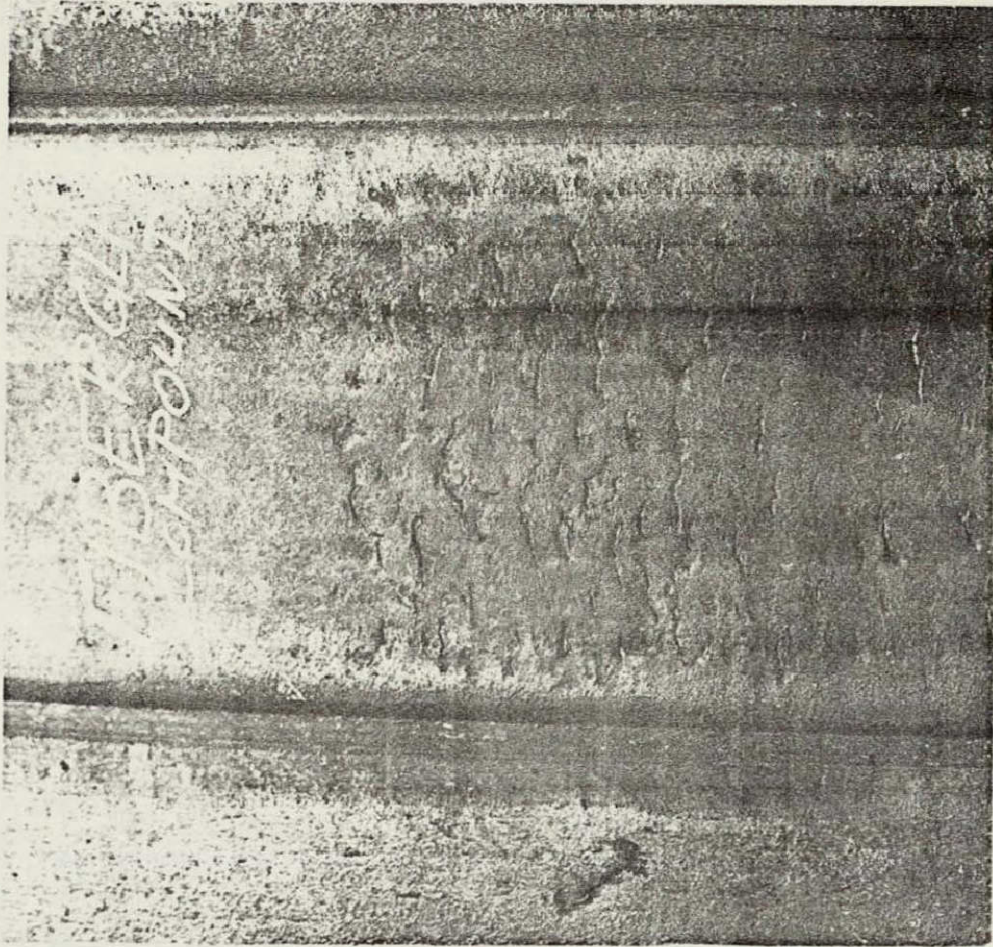
The running surface mixture, which was reinforced with fiberglass, showed remarkable improvement when compared to the previous running surface mixture with regard to susceptibility to "Chevron Cutting."

Fig. 6 THOMPSON--Fiberglass compound with typical Chevron Cuts.

It is suggested that this rubber mixture not be used because of the financial disadvantages involved. Of all

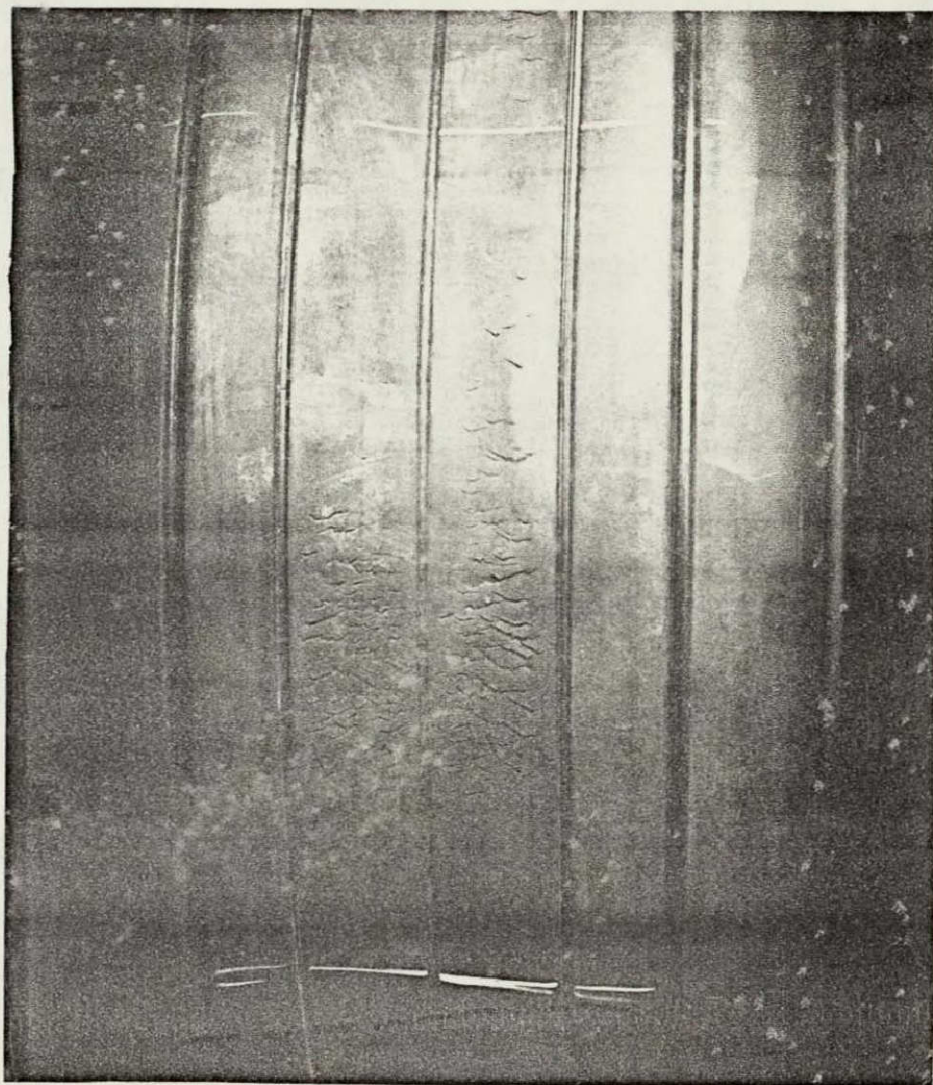
Fig. 9 shows Chevron Cutting on a normal running surface construction. Fig. 10 shows a worn-out "spiral wrap"-tire.

Fig. 9 GOODYEAR--normal construction with typical Chevron Cutting.

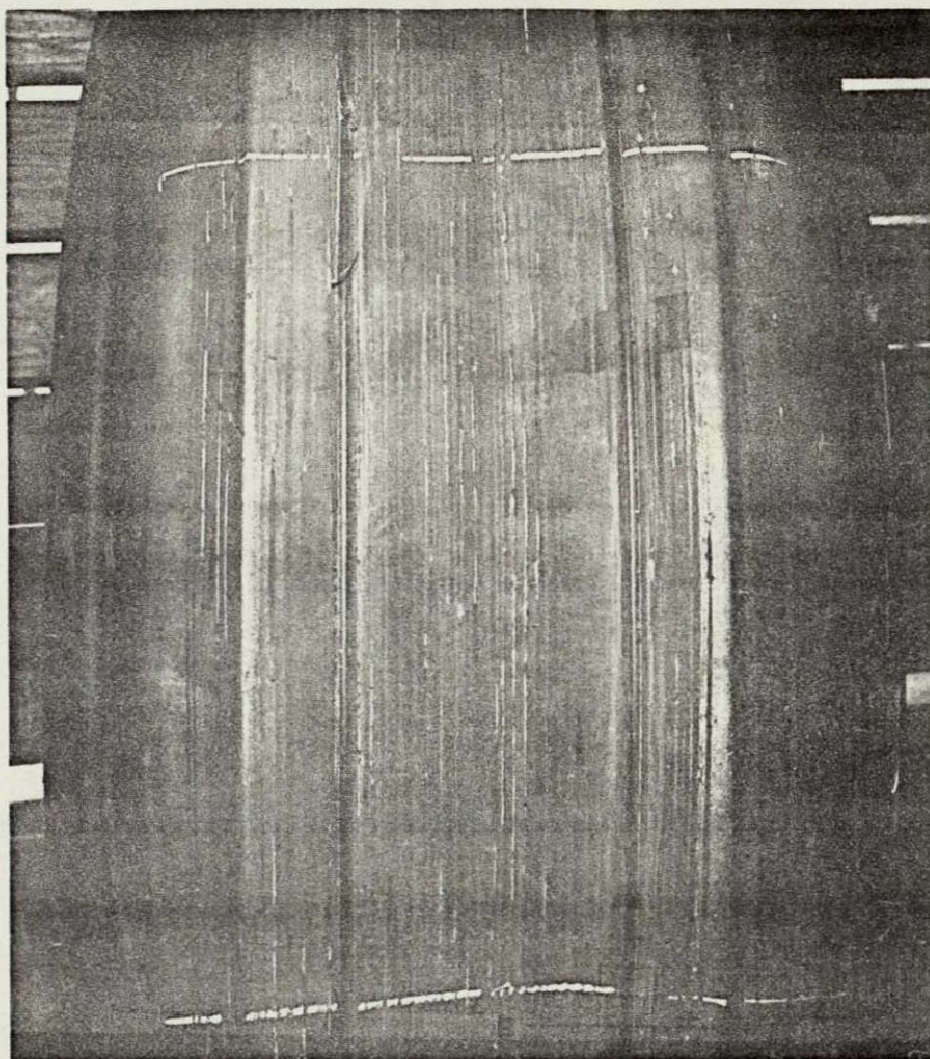
The "spiral wrap" construction of the running surface has shown the best performance of all tested fabrics with regard to Chevron Cutting. No Chevron Cuts appeared on the tires tested.

Fig. 10 "Spiral Wrap" construction, typical appearance of a worn-out tire. No Chevron Cutting appears on this tire.

--Because positive results have been achieved with the spiral wrap tires and no price increases are expected for the moment, it is suggested that this construction be continued for the B-747. After sufficient experience with it the introduction of this construction may be considered for other types of aircraft.

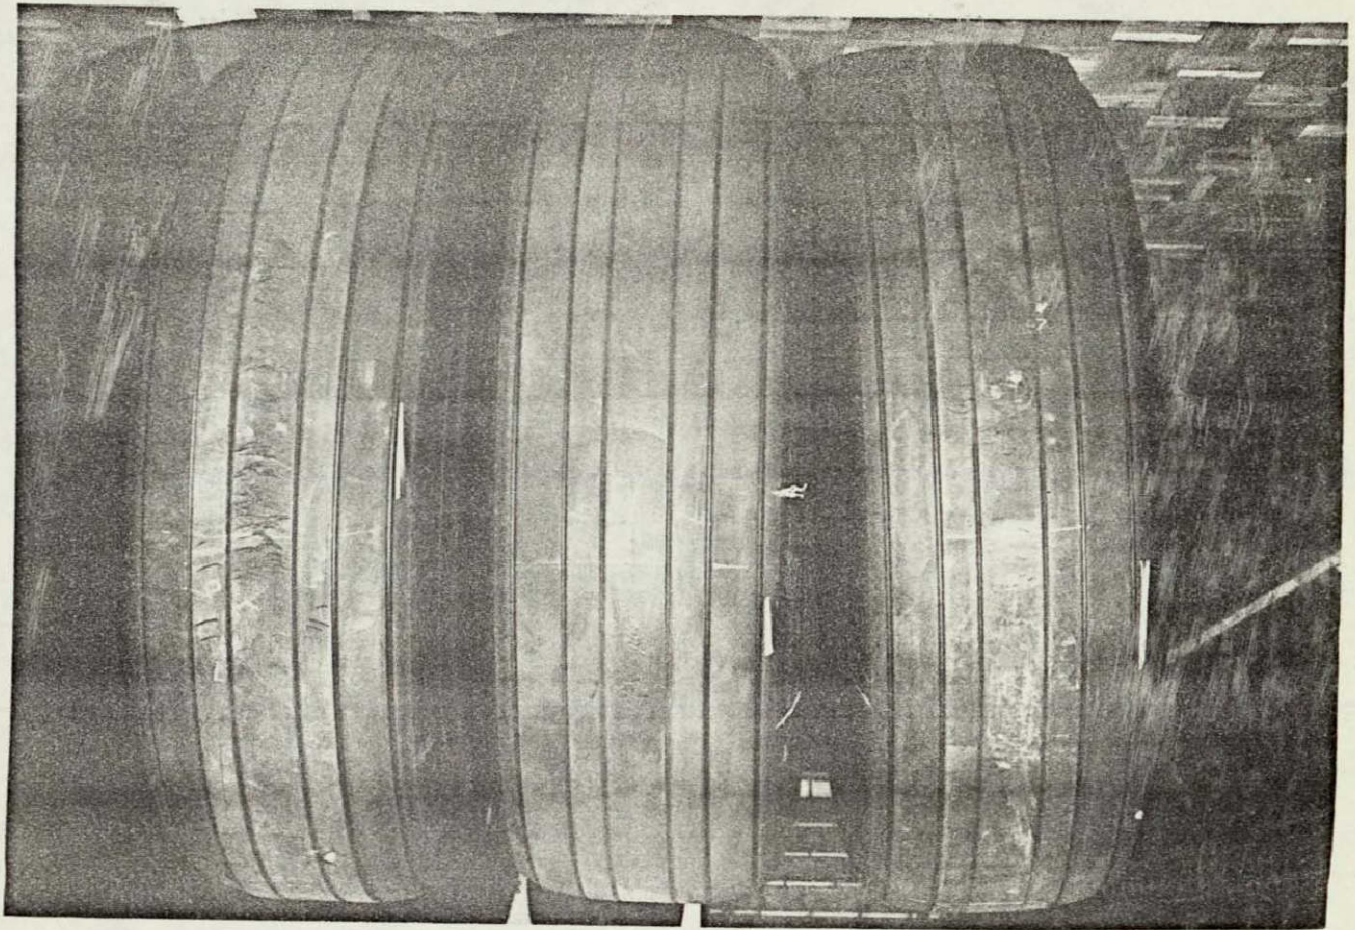
The softer rubber mixture showed no difference from the previous normal running surface mixture with regard to susceptibility to Chevron Cutting. Length and depth of the breaks is also about the same for both mixtures. Figs. 11 and 12 show the extent and Figs. 13 and 14 the characteristic of Chevron Cuts on Mader rubber cappings.

Fig. 11 MAEDER--normal mixture typical appearance of worn-out tires.

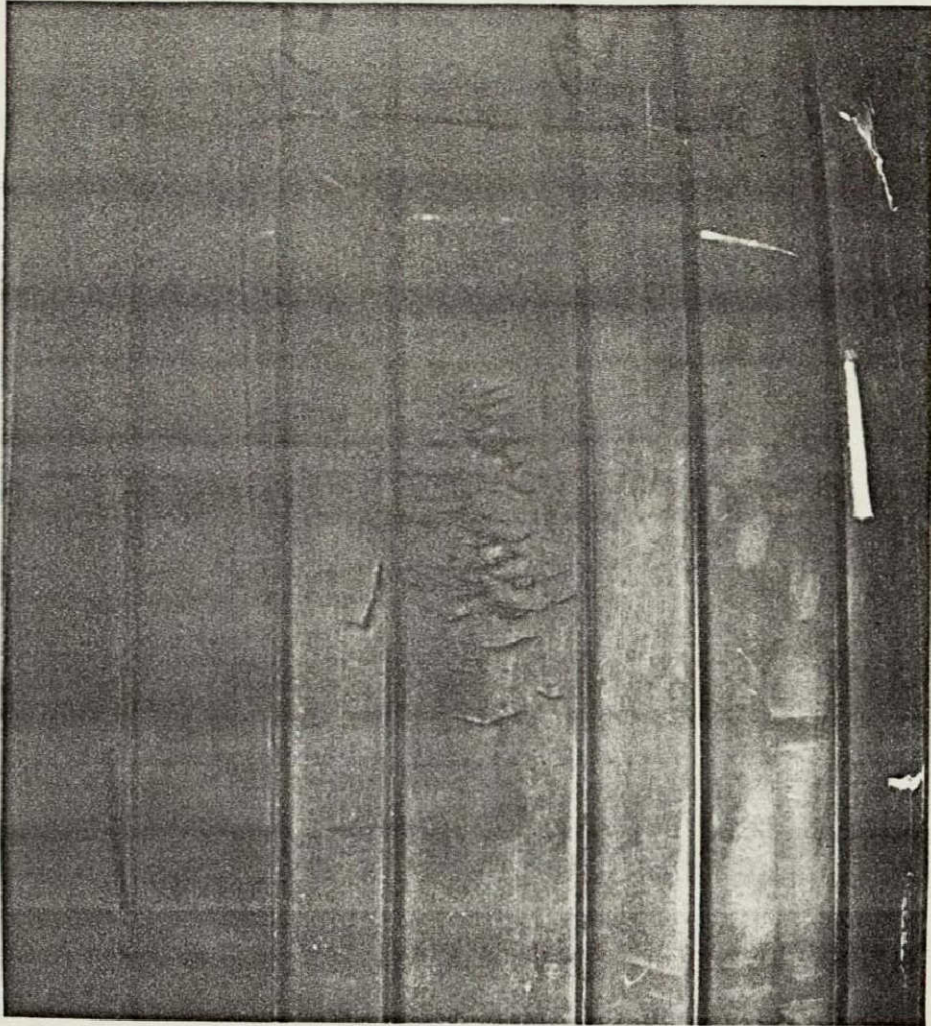
Fig. 13 MAEDER--normal mixture with typical Chevron Cuts.

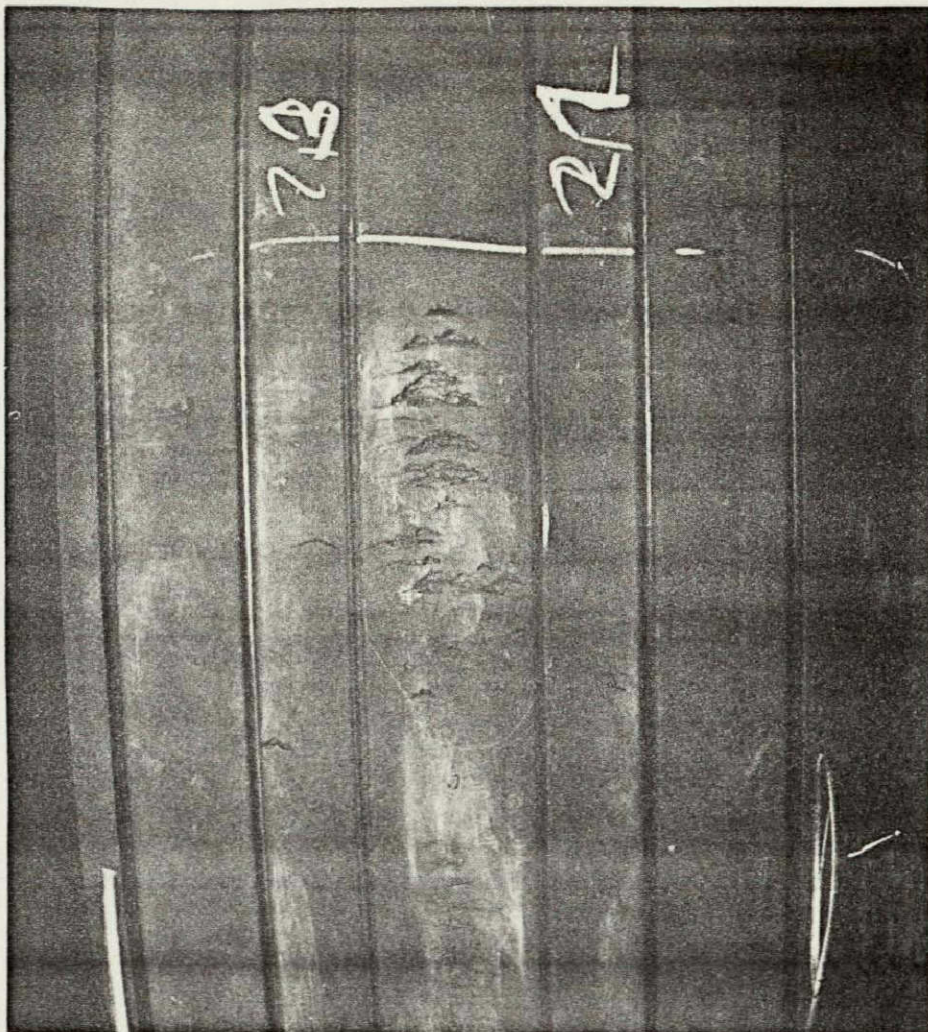
Defects that are caused by Chevron Cutting are relatively harmless. No complete separations from the running surface or blowouts will result. Only breaking off of rubber or rib separations above the reinforcement layers can happen (see Fig. 14).

Fig. 14 MAEDER--soft rubber mixture with typical Chevron Cuts.

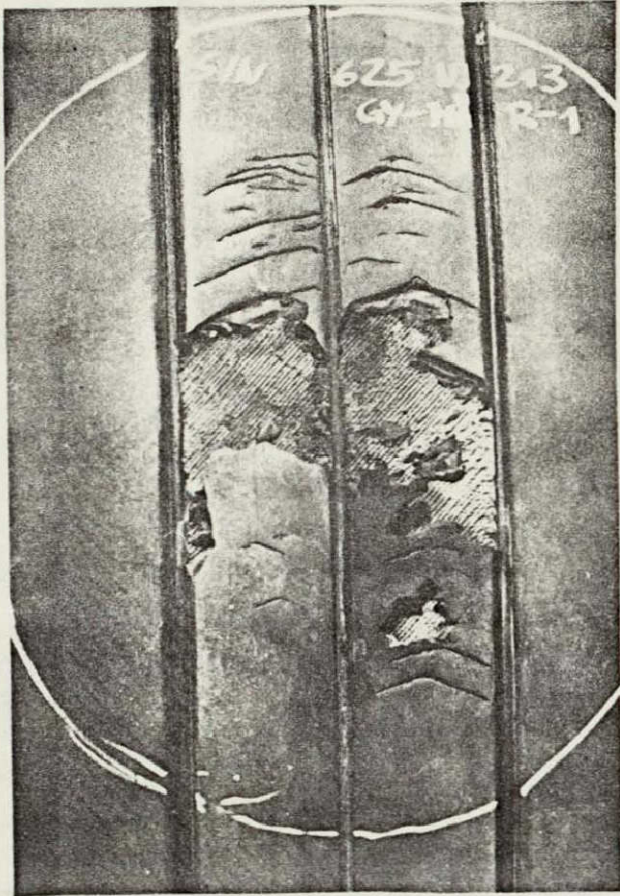
Fig. 16A (DC-10 NLG)

<u>A/C</u>	<u>L-Gear</u>	<u>Fabric</u>	<u>Description of Defect</u>
DC-10-30	NLG	Mader	Rib completely separated
DC-10-30	NLG	Mader	Rib separated by 60 cm (Fig 16C)
DC-10-30	NLG	Mader	Rubber breaking off (Fig. 16A)
B-747	MLG	Kleber	Rubber breaking off (Fig. 16B)

Three defects occurred on DC-10-30 tires that were capped by the Mäder Company (Figs. 16A, 16C). One defect occurred on a new B-747 tire from the Kleber Company (Fig. 16B).

Rubber breakouts caused by Chevron Cutting

--It is suggested that the Mäder Company make some changes in the rib configuration of the rubber mixture on this type of tire since only Mäder-capped DC-10-30 NLG-tires suffered defects from Chevron Cutting.

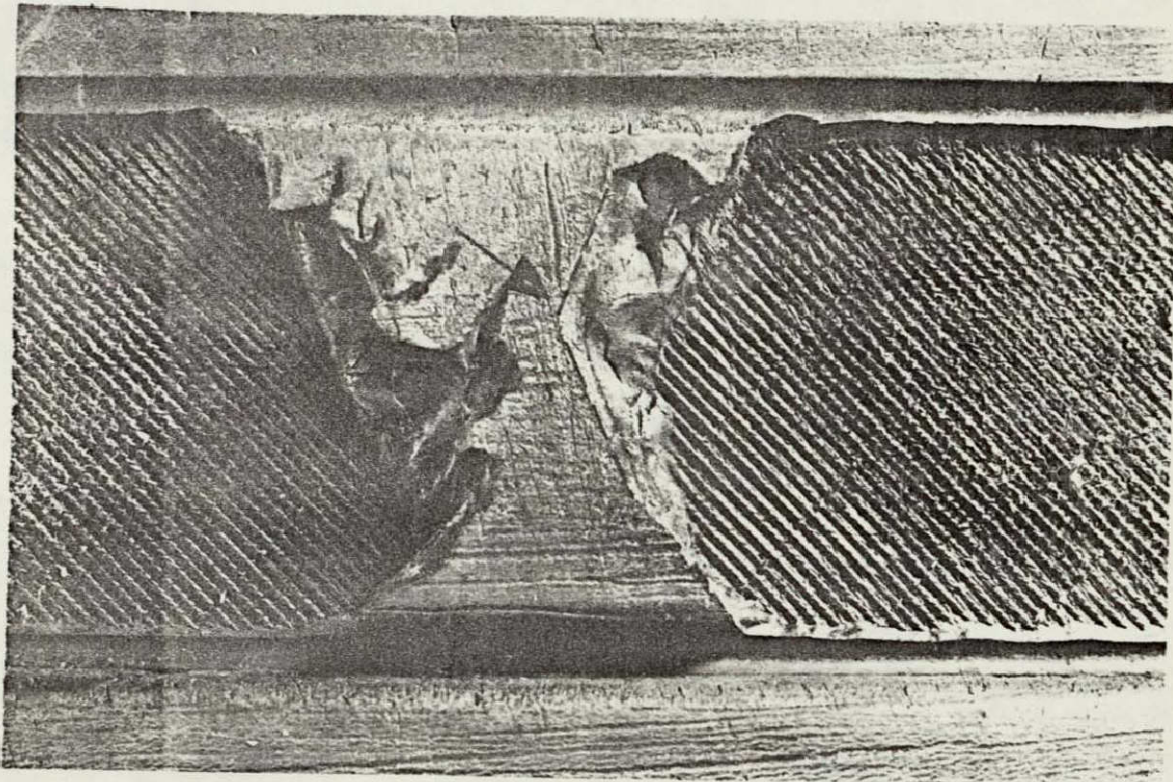
Fig. 16C Chevron Cutting is the point of origin for a rib separation (DC-10 NLG).

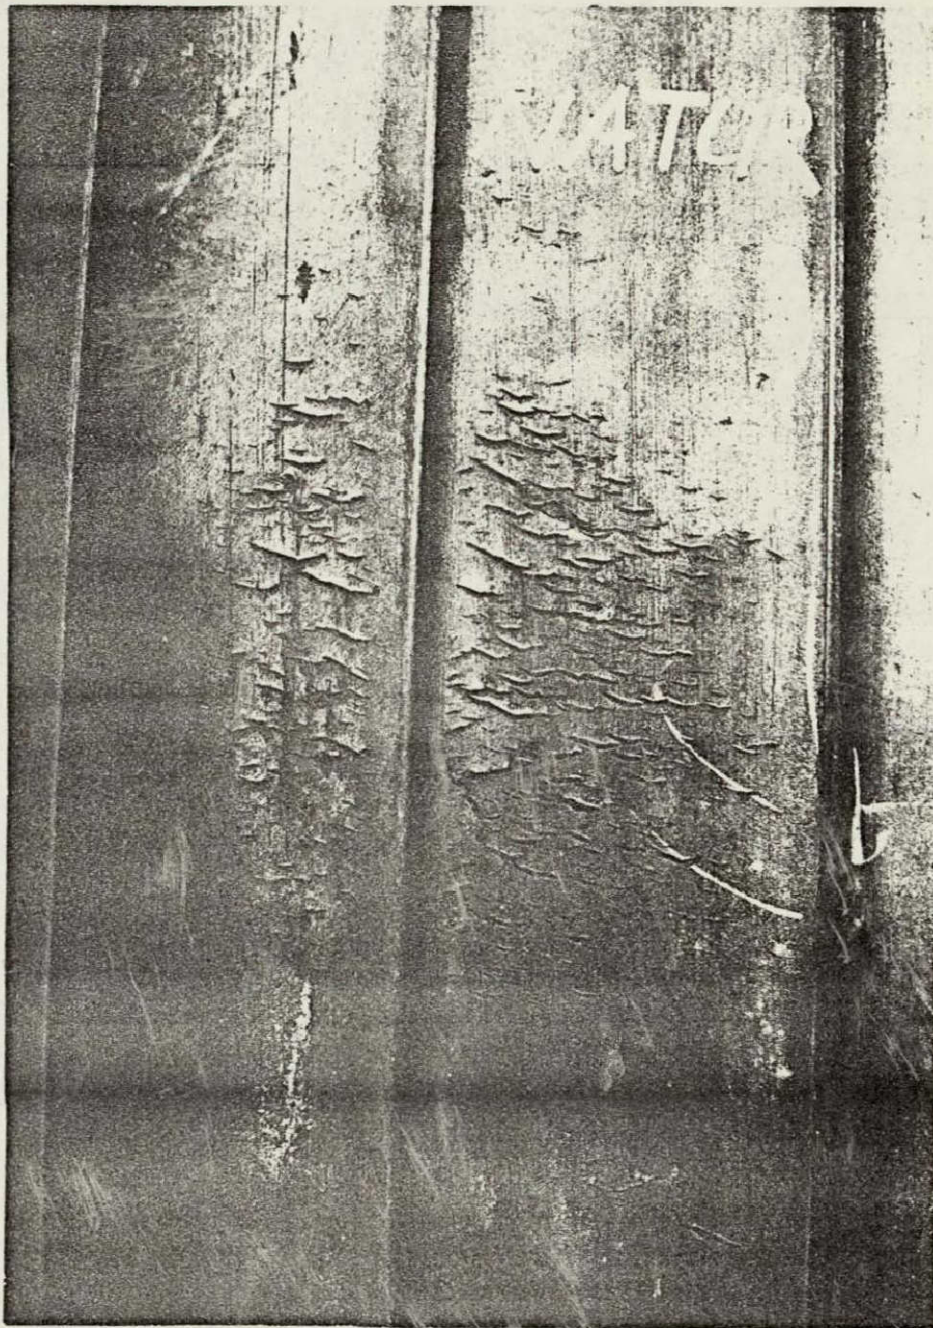
The extent of Chevron Cutting differs for the various rubber capping fabrics according to the different rubber mixtures. It could be observed, for instance, that breaks at the running surfaces are shorter for natural rubber mixtures than for synthetic mixtures (Fig. 15). Chevron Cutting occurs with different intensity at all types of aircraft, resp. tire dimensions.

Fig. 17 THOMPSON--natural rubber mixture mit shorter breaks.

aircraft tires and capping fabrics used the B-747 running surfaces by Thompson are the most seriously affected by Chevron Cutting. It is suggested that this type of tire be capped with natural rubber or some improved rubber mixture, for the time being.
