NASA Technical Paper 1210

Light Airplane Crash Tests
at Three Flight-Path Angles

Claude B. Castle and Emilio Alfaro-Bou

JUNE 1978

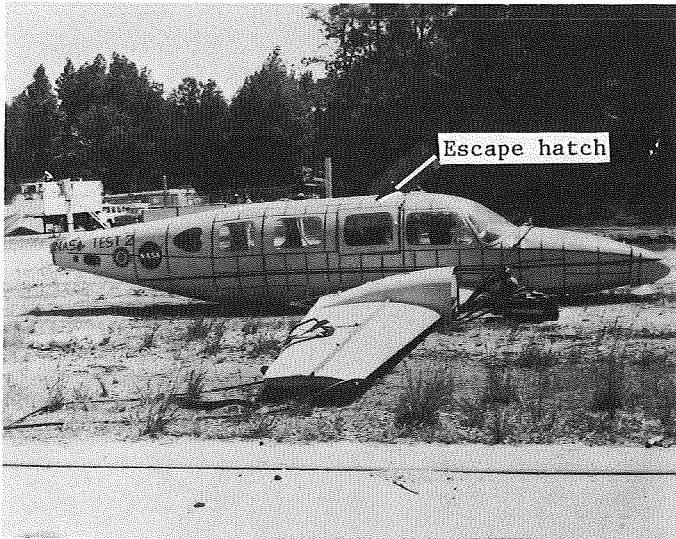
The exterior damage to the -15° test specimen is shown in figure 10. As seen in the overall view of the right side (fig. 10(a)), buckling occurred in the nose section, at the fire wall, and along the bottom of the fuselage. As shown in figures 10(c) and 10(d), there is rivet shear across the top of the fuselage aft of the pilot and copilot. Also, rivet shear is evident aft from the escape hatch along the window ledge and downward at the rear of the third window. (See figs. 10(a) and 10(b).) The breaking of the pilot's windshield and side window was due to deformation of the forward cabin section (fig. 10(a)).

(a) Overall view of right side.

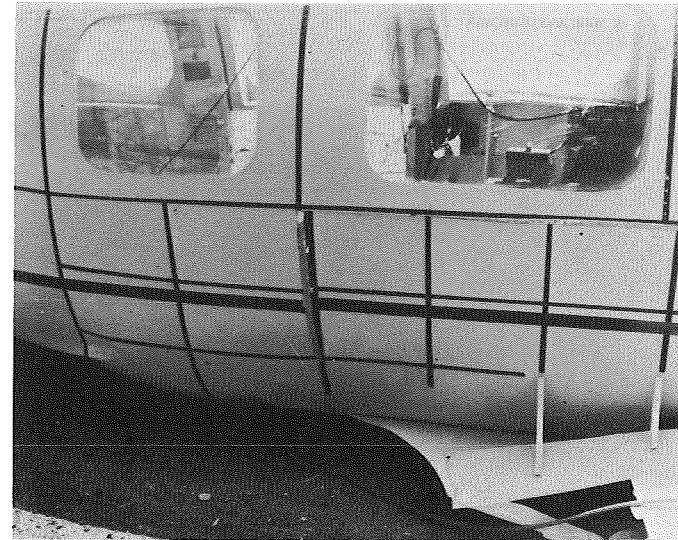
(b) Closeup view of right side.

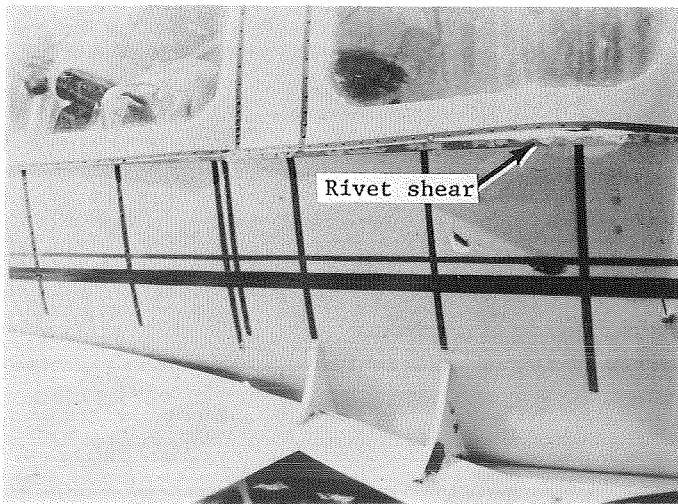
(c) Closeup view of left side.

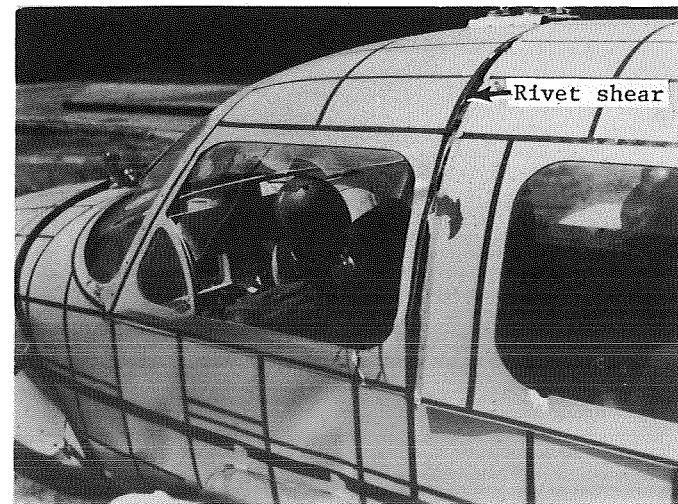
(d) Closeup view of left side and top of fuselage.

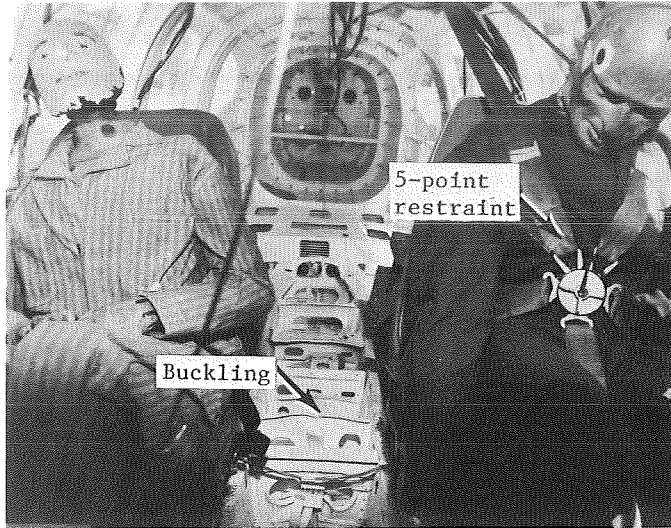
Damage to the cabin interior is shown in the four photographs of figure 11. The first photograph (fig. 11(a)) is a view looking aft from the cockpit where buckling can be seen in the stiffeners which tie together the two main floor beams. Figure 11(b) is a view looking forward from the tail section and again show the main floor beams and the buckled stiffeners. The four photographs of figure 11 also show the layout of seats, dummies, additional masses, and instrumentation equipment. The apparent upward movement of the floor section is shown by the outward rotation of the seats. The view looking through the doorway, figure 11(c), and the view of the cockpit, figure 11(d), show moderate interior damage.

(a) View looking rearward.

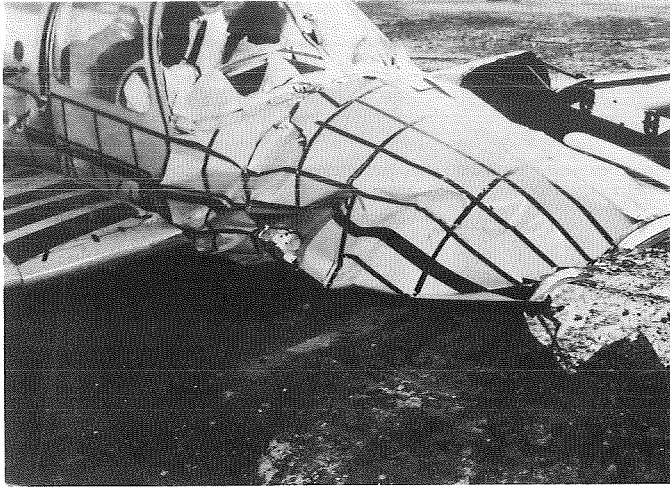
The exterior damage resulting from the crash is shown in figure 13. A view of the right side and nose section shown in figure 13(a) shows severe structural damage to the nose section, broken windshield, rivet shear, and cabin separation in the vicinity of the main spar aft of the pilot and copilot. Figures 13(b) and 13(c) are closeup views of the cabin on the right side, and figure 13(d) is a closeup view on the left side. Due to rivet shear, separation of the airframe occurred on the right side along the vertical edge of the emergency escape hatch (figs. 13(b) and 13(c)) and directly opposite on the left side (fig. 13(d)). There is rivet shear and skin separation across the top of the cabin at the rear of the escape hatch, and there is skin buckling along the roof of the cabin. Figure 13(d) shows the left side of the -30° test specimen and the cabin separation along the window ledge, the broken windows, and the collapsed nose section. The windshield center post was fractured. The deformation, tearing, and buckling of the nose of the test specimen are quite visible. Aft of the fire wall, a livable volume was maintained inside the cabin.

(a) View of right side and nose.

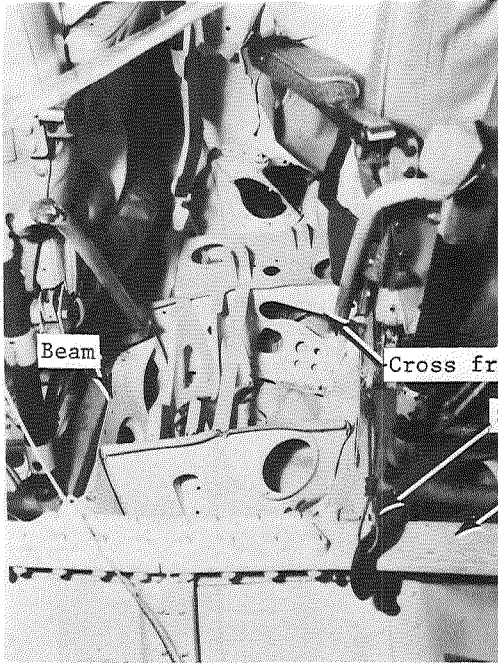
The interior damage to the -30° test specimen is shown in figure 14. The view looking forward from the main spar (fig. 14(a)) shows the upheaval of the floor between the pilot and copilot, with deformed cross-frame and beam-member floor supports. The crew seats remained attached to the floor although the seat support structure on the pilot seat was broken. The steel cable attached to the copilot seat did not contribute to the support of the seat but was a precautionary measure to restrain the seat and dummy had the seat detached from its floor mounts. The separation of the skin along the cross-frame member in back of the main spar is shown in figure 14(b); this view is looking forward at the right side of the test specimen, with the displaced window being the emergency escape hatch. The floor and left side of the airplane in the vicinity of the first passenger are shown in figure 14(c). The floor cross-frame supports are bent but attached, and there are buckles in the cross frame about seat-pan level along the left side. Also shown are the broken passenger window and the separation of the cabin along the window level. Figure 14(d) shows an overall view looking forward from the area behind the door. The third-passenger seat was deformed because of the apparent upward movement of the floor during the tail slapdown. (See fig. 12(h).) The cross-member supports between the two main longitudinal floor beams pulled loose from the left beam (fig. 14). In the first-passenger location, the forward movement of the dummy produced a sufficient load on the shoulder restraint system to cause tearing of the airframe structure supporting the inertial reel.

(a) View of cockpit area.

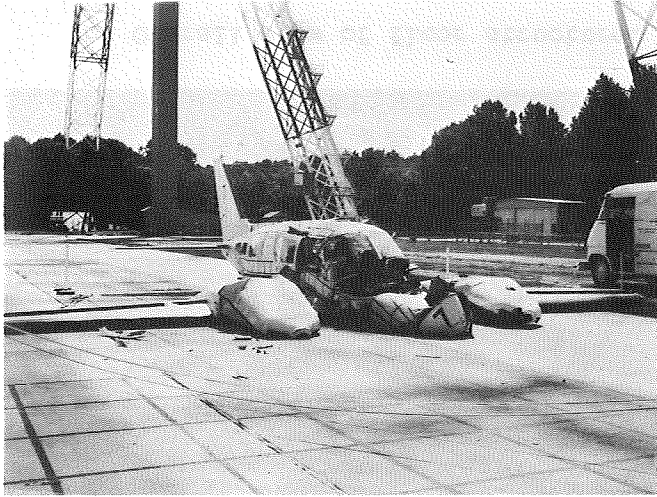
The crash damage to the exterior of the -45° test specimen is shown in figure 16. An overall view of the right front side of the airplane is shown in figure 16(a) which shows the nose demolished, the windshield broken, the windshield post broken both in the center and right side, the damaged nacelle covering, and the crease across the top of the cabin section where inward folding of the roof section has taken place. Figure 16(b) is a closeup view of the right side and shows the wing-to-cabin deformation, the breakaway of the emergency escape hatch, the separation of cabin and nose section at the fire wall, and the fuel leakage. Fuel leakage occurred in both fuel tanks because of the wing structure piercing the fuel bladders. Figure 16(c) shows the cabin section from the left side and shows the fracture of the left windshield post and collapse of the first main-section frame at window level. Also shown is rivet shear along the window ledge and across the top of the cabin. Figure 16(d) is another view of the damaged cabin discussed in the previous figure (fig. 16(c)) and clearly shows the roof crease. Safety glass was used on the left windshield and plexiglass was used on the right windshield. The fragmentation pattern for both sides is shown in figure 16.

(a) Overall view of right front side.

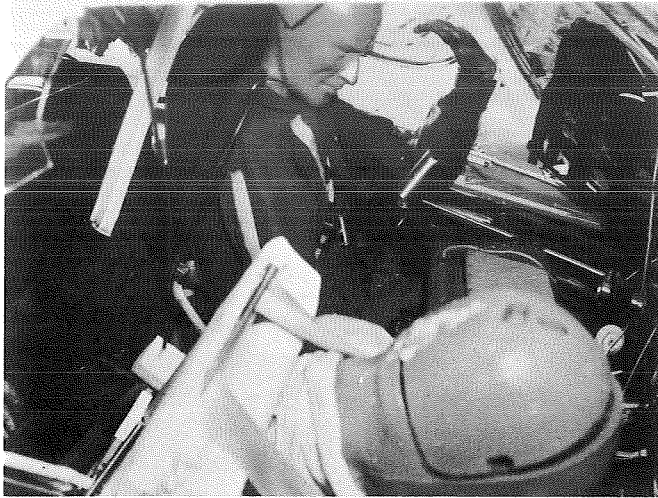
Interior cabin damage to the -45° test specimen is shown in figure 17. A view of the pilot and copilot section of the cabin (fig. 17(a)) shows the instrument panel displaced upward and the control wheel shaft broken, with the control wheel bearing on the pilot's chest. The roof impacted the head rest on the pilot seat to deform it forward, causing the dummy pilot's chin to rest on its chest. The upheaval of the cabin-floor section thrust the dummy copilot forward into the instrument panel. Figure 17(b) shows a view through the cabin door looking at the rear of the third-passenger seat. The forward motion of the third passenger during impact caused the rear seat legs of the third-passenger seat to break loose from the seat rails, as shown. The seat back is broken and the dummy's arm is visible resting in the aisle. Motion-picture coverage of the interior (see film supplement) indicates that the third seat was broken during the second impact.

(a) View of crew and cockpit.

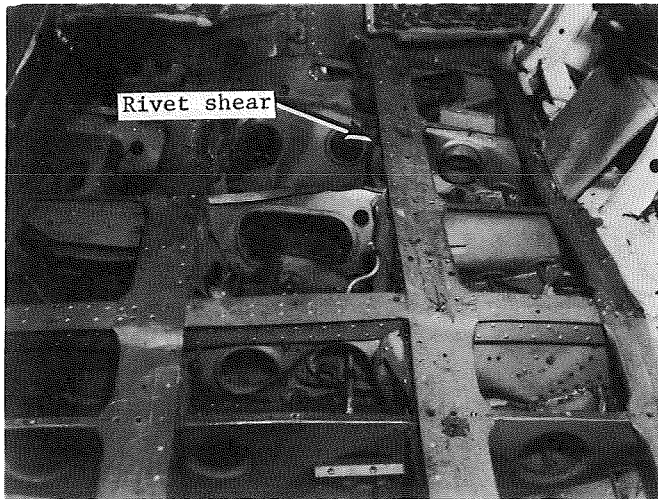
The type of subfloor structural failure can be seen in the overall (fig. 17(c)) and closeup (fig. 17(d)) photographs. In figure 17(c) is shown the rivet shear along the side wall and between the cross sheet-metal frames and the longitudinal floor beams. Tearing of the sheet-metal frames is evident along the entire length of the cabin area. The closeup view (fig. 17(d)) shows the sheared rivets lying on the outer skin and the mangled cross frame structure.

(c) Overall view of floor structure.

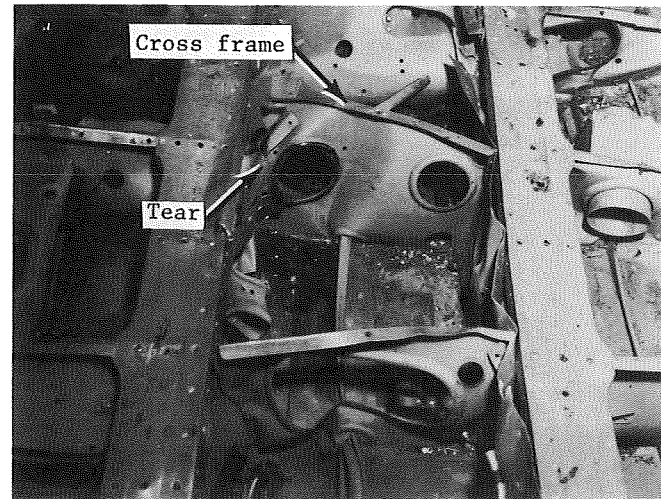
(d) Closeup view of floor structure.
