DOE/NASA TECHNICAL MEMORANDUM

DOE/NASA TM-78163

OWENS-ILLINOIS LIQUID SOLAR COLLECTOR
MATERIALS ASSESSMENT

By R. L. Nichols
Materials and Processes Laboratory

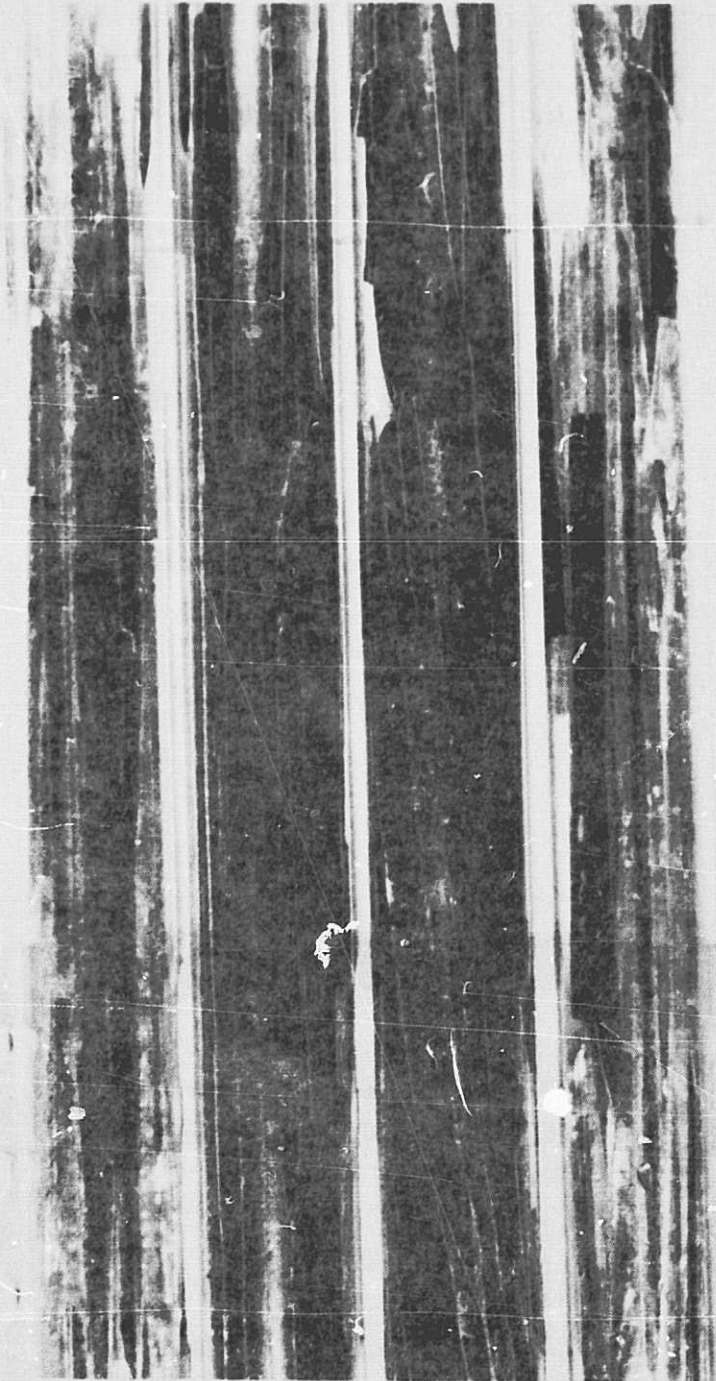
Figure 4. Typical fracture pattern.

The fracture initiation site on any fractured glass appears as a straight, mirror surface surrounded by a distinct, gray-colored area, termed the stippled area. The fracture will then branch and propagate in both axial directions, creating long spiraling slivers of glass. These slivers typically point to the initiation surface. Figure 4 shows a typical fracture pattern created by pressurization of a tube.

Fracture studies of the complete collector tubes which broke during proof testing consistently indicated that the fracture initiated at a defect or scratch on the internal surface of the absorber tube. These defects are attributed to scratches and checks generated during manufacturing and inspection processes. Similar studies on the bare absorber tubes, which were pressure tested to failure, show that the fracture initiation site was consistently on the outside surface of the tube and that, again, an observable defect such as a scratch or check was present at the initiation site.

939-1	937-1	935-1	937-2
415 psi	430 psi	500 psi	305 psi
TOP			BOTTOM

In the case of the bare absorber tubes tested to failure, the fact that these tubes were not subjected to the normal measuring, inspection, and fabrication processes of collector tube manufacture undoubtedly accounts for all initiation sites appearing on the external surface (i. e., the internal surface has not been rubbed or scratched by any jigs or fixtures while the external surface has been subjected to some abuse, producing the scratches, checks, or rubs that are failure initiation sites). In testing complete collector tubes to failure, potential initiation sites on the exterior surface of the absorber tube are inhibited from slow flaw growth to failure by the vacuum in the annular gap between tubes. This moves the initiation site to the interior surface of the absorber tube because the water hydrotest fluid causes the stress corrosion induced slow flaw growth, entirely consistent with the experimental results of flaw growth studies.¹ It is also indicated that the magnitude of the flaws produced on the interior surface of the absorber tube during collector tube manufacture is similar to those on the exterior of the tube. Thus, minimizing the production of these defects on the internal surface would reduce the losses during proof pressure testing.

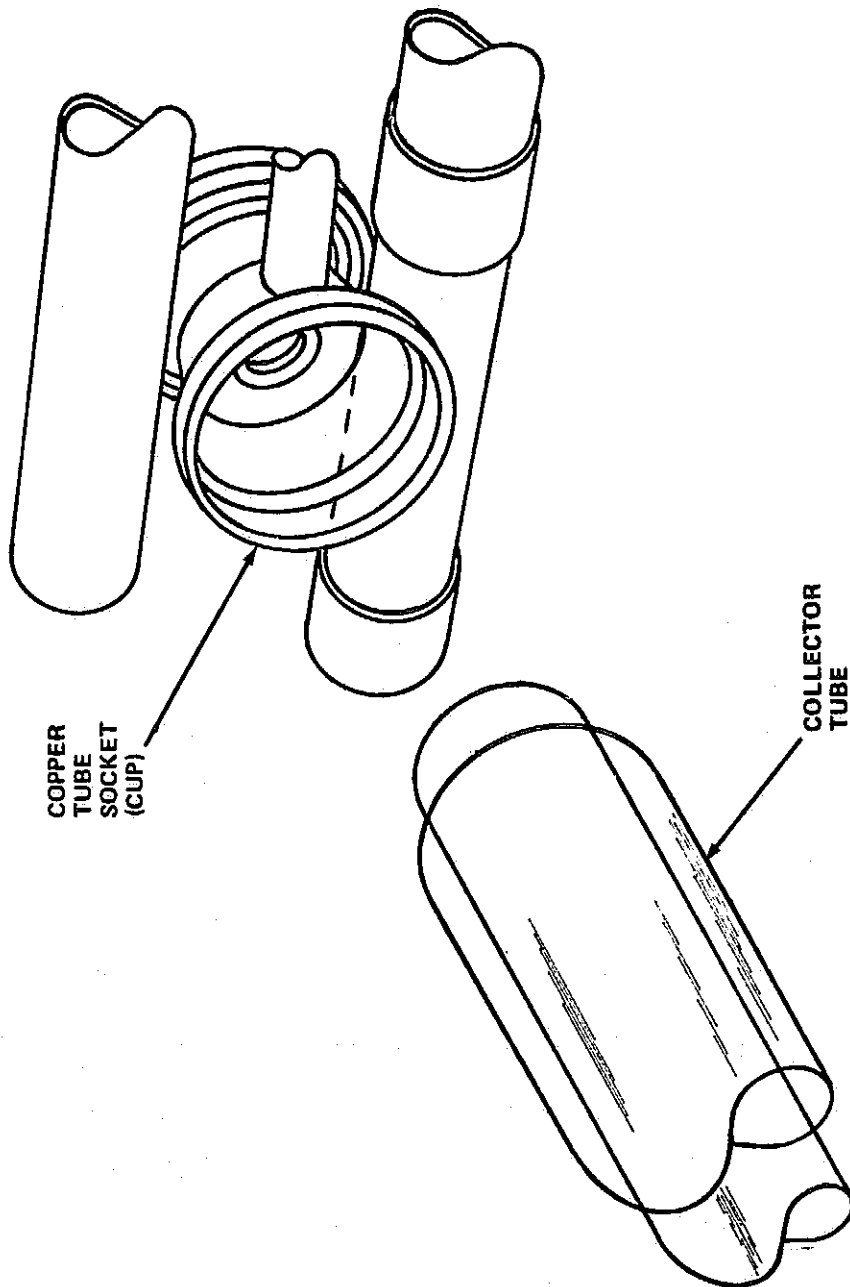
Figure 5. Copper tube socket.

The liquid flow in the collector is channeled from one tube pair to the next by copper tubing and cups shown in Figure 5. These individual components are soldered together with Welco No. 5 solder (95 percent tin, 5 percent silver) which melts at approximately 435°F (224°C). The maximum temperature observed near a soldered component during boilout and stagnation on the solar simulator was 495°F (257°C) at the cups.

Soldering does not appear to be an adequate process for fabricating the cup assemblies. The flow of the solder, due to gravitational force, does not fill the joint as desired; the surface area in the joint is relatively small for a soldered assembly carrying loads; and the melting point of the solder is too low for the temperatures observed in stagnation/boilout.

The solder used to assemble the manifold softens at a temperature very close to those observed during boilout conditions. The components should be brazed together provided the copper is not fully annealed during the process. The optimum manifold system would be one which is a monolithic casting. This would eliminate seal leakage and improve the tolerance achievable on the manifold.

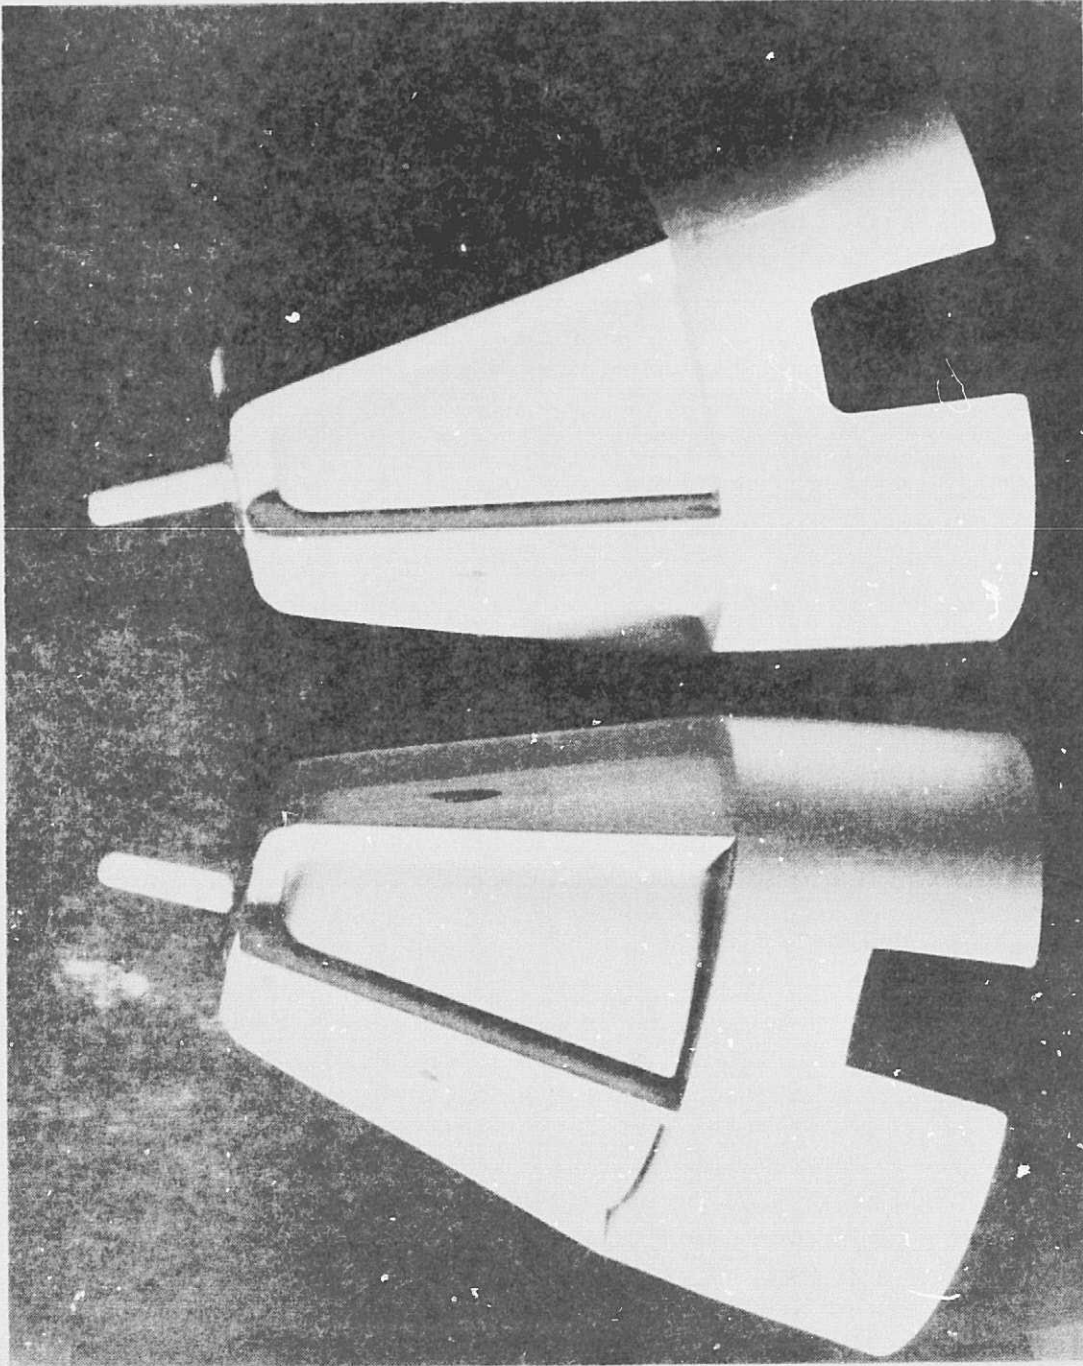
Figure 6. Tube support cup insert.

The tube support cup insert (Fig. 6) is the only plastic component identified as a potential problem area. A maximum temperature of 205°F (96°C) was observed at the position of this part. The problem encountered is deformation of the cup insert due to thermal softening during the boilout mode of collector operation. This component could be redesigned to a conical shape to improve distribution of the load transferred to it from the collector tube's closed end. Fabricating this part from a higher temperature material than acrylic-butadiene-styrene (such as polycarbonate or polysulfone) should alleviate this problem.
