NASA CR-135381

LONG-TERM CF6 ENGINE PERFORMANCE DETERIORATION - EVALUATION  
OF ENGINE S/N 451-479

General Electric Company  
Aircraft Engine Group  
Cincinnati, Ohio 45215

February 1978

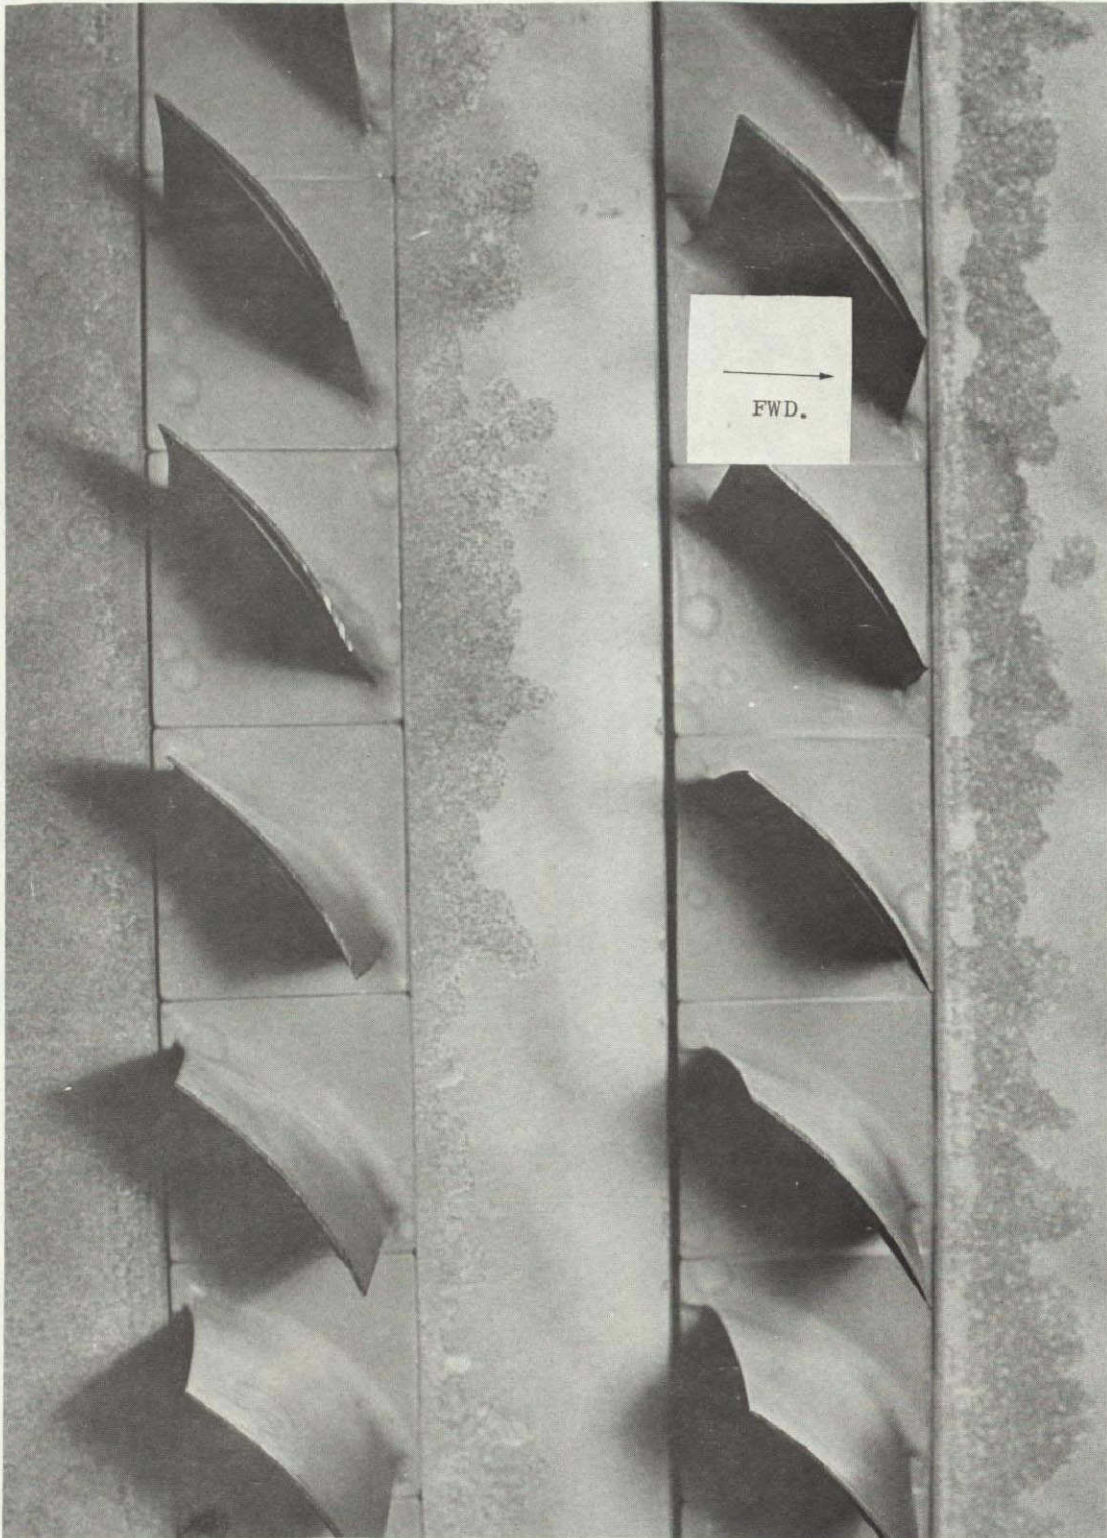
Figure 8-2. HP Compressor Rotor Stages 13 to 15 Land Coating.

The coating of the compressor rotor lands was inspected with the following discrepancies noted (Figure 8-2 in Appendix B):

<u>Stage</u>	<u>Conditions</u>
15 and 16	100% missing
14	20/30% missing
13	30/40% missing
3 - 12	OK

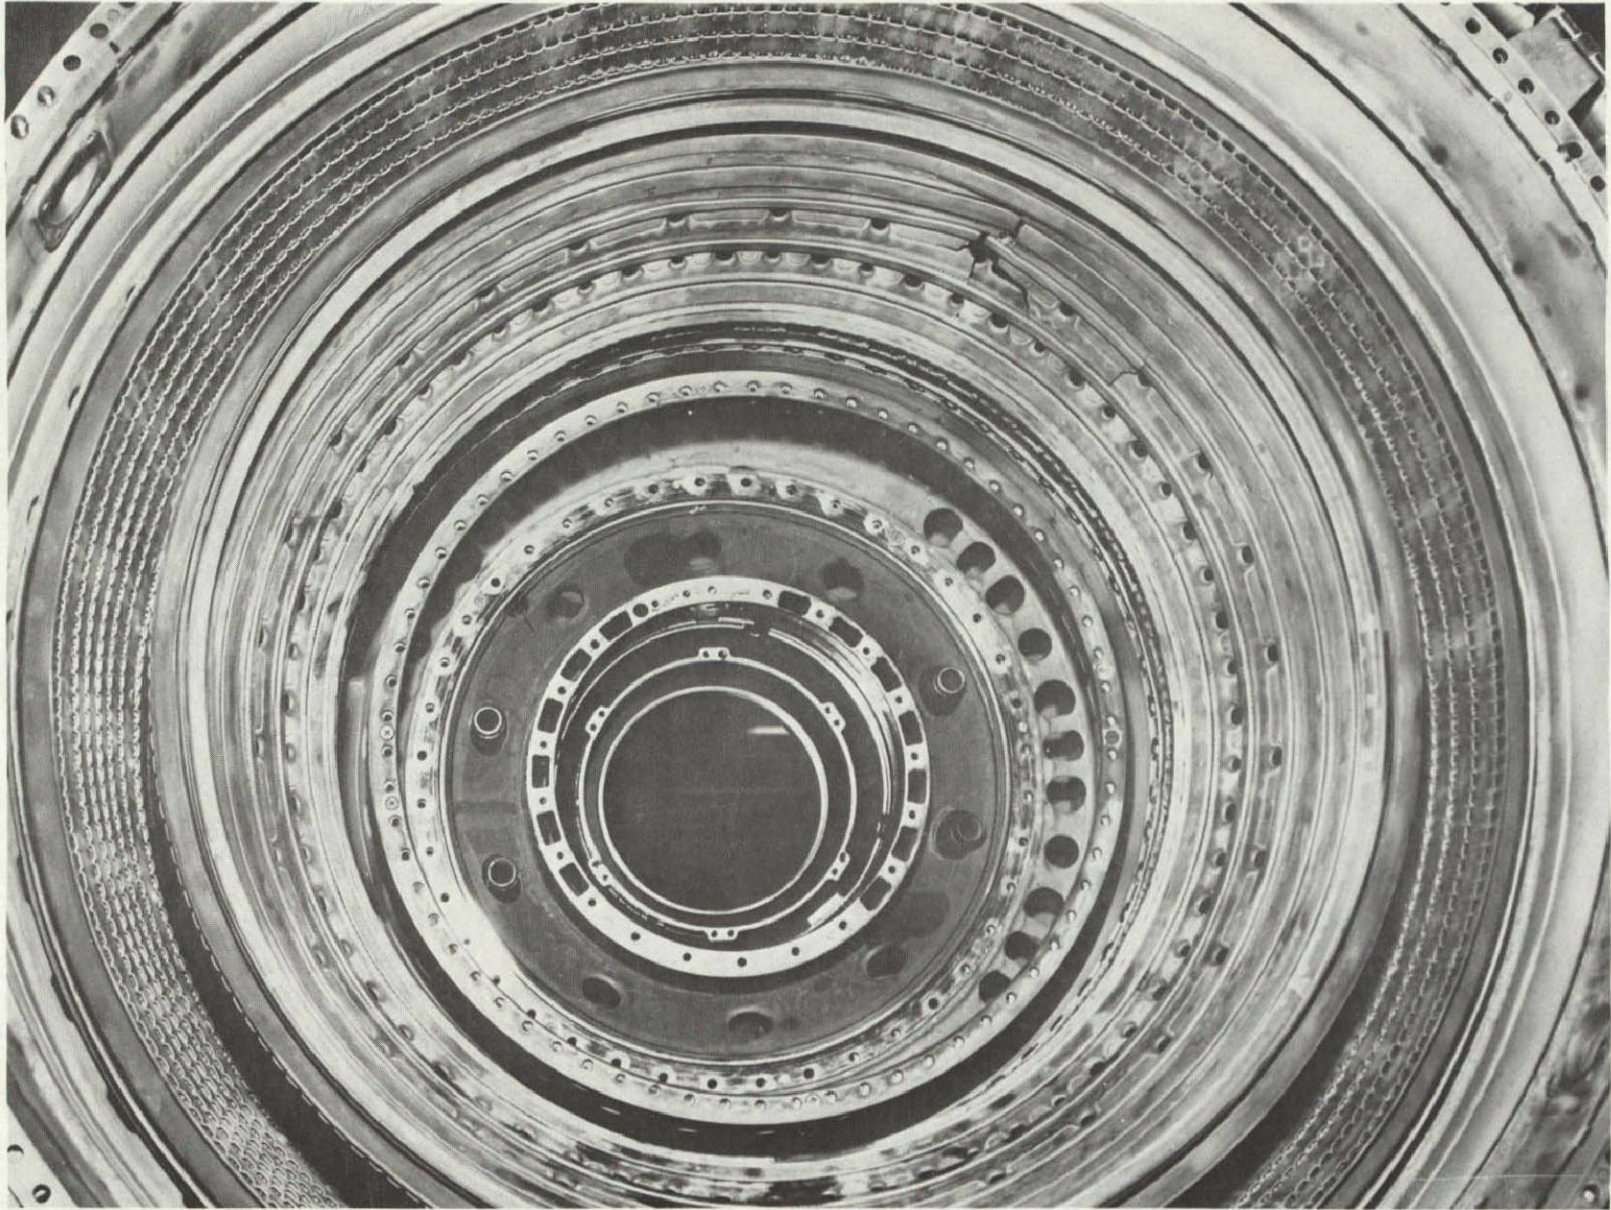
Figure 8-6. Combustor, Overall Cracks.

To expedite the work scope, the combustor was not removed from the rear frame, but rather visually inspected as installed. The combustor had its typical 1/4" to 1/2" cracks, inner and outer liners. The most noteworthy fault was the cracks originating at the inner liner's aft thimble louver at approximately the 7 o'clock location. This particular louver had cracked in four different directions of varying lengths (Figures 8-6 and 8-7 in Appendix B). The cracks were approximately 5/8", 1", and 2-1/2" in length and another about 2-1/4" long connecting with a 4-1/2" circumferential crack. The whole piece was bulged into the airstream approximately 5/8". There were six more of these thimble louvers with cracks ranging from 1/2" to 1-1/4" but these are considered insignificant with regard to performance.

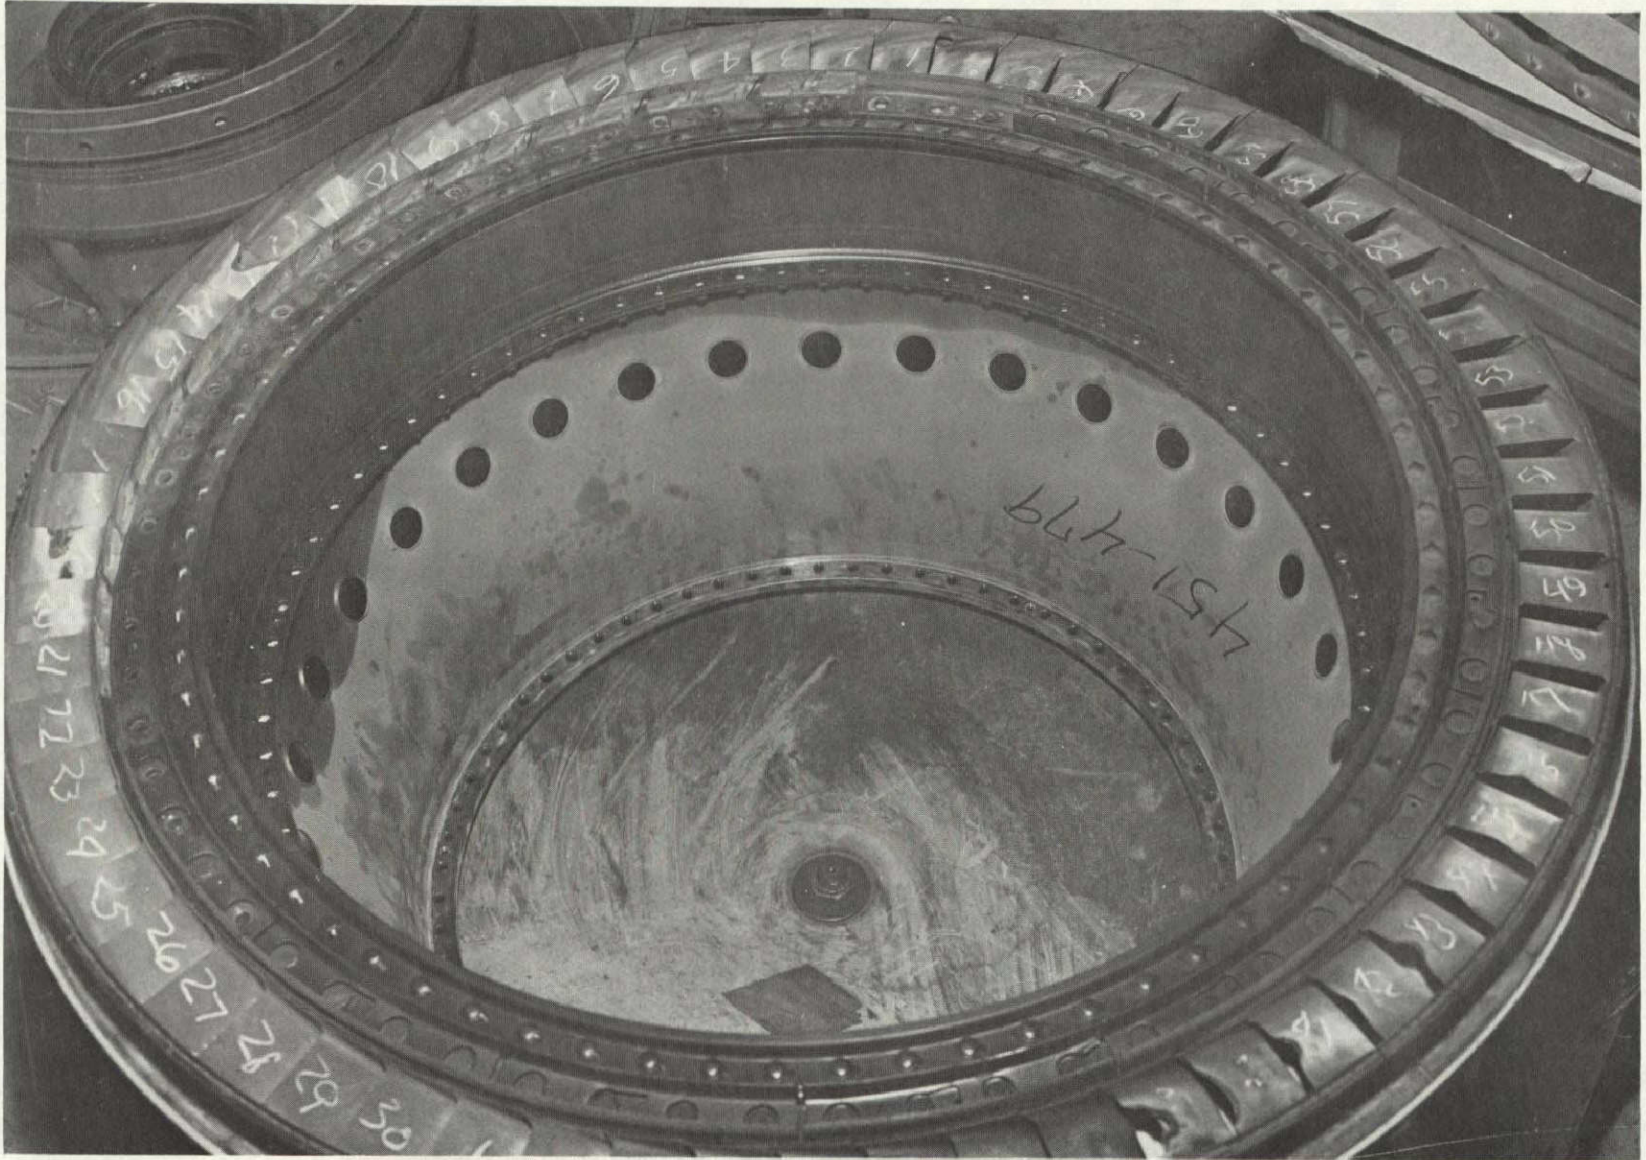
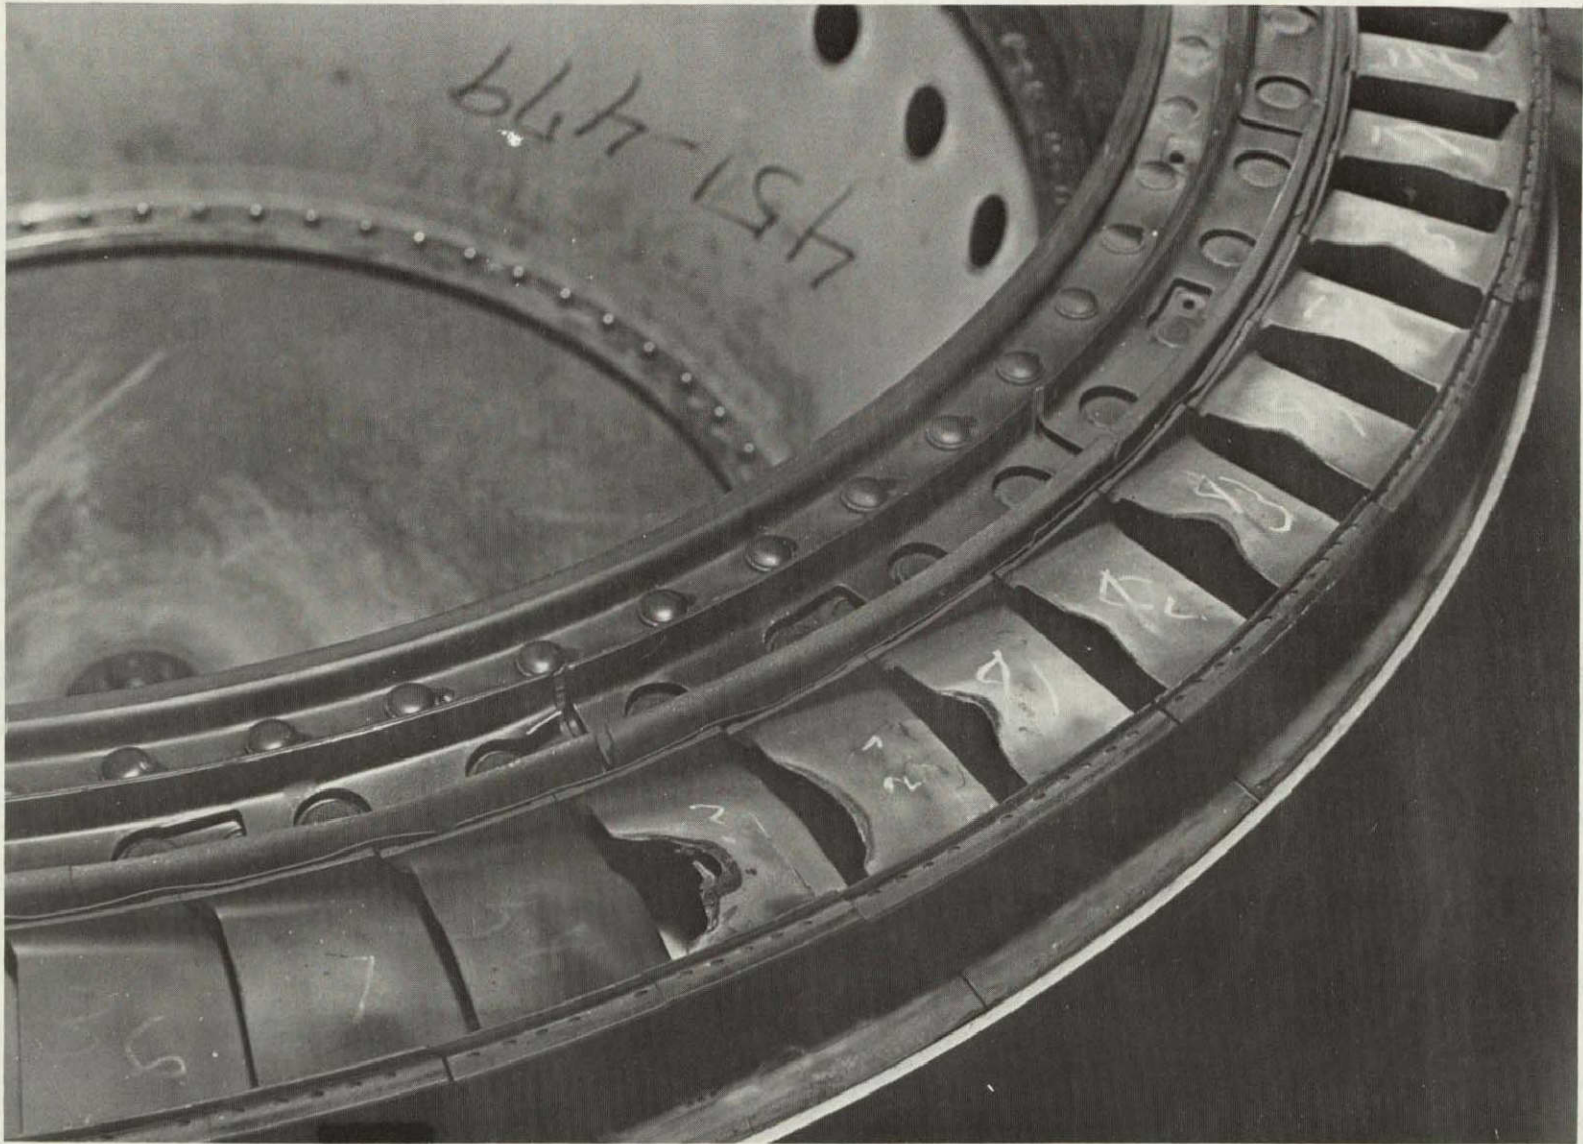
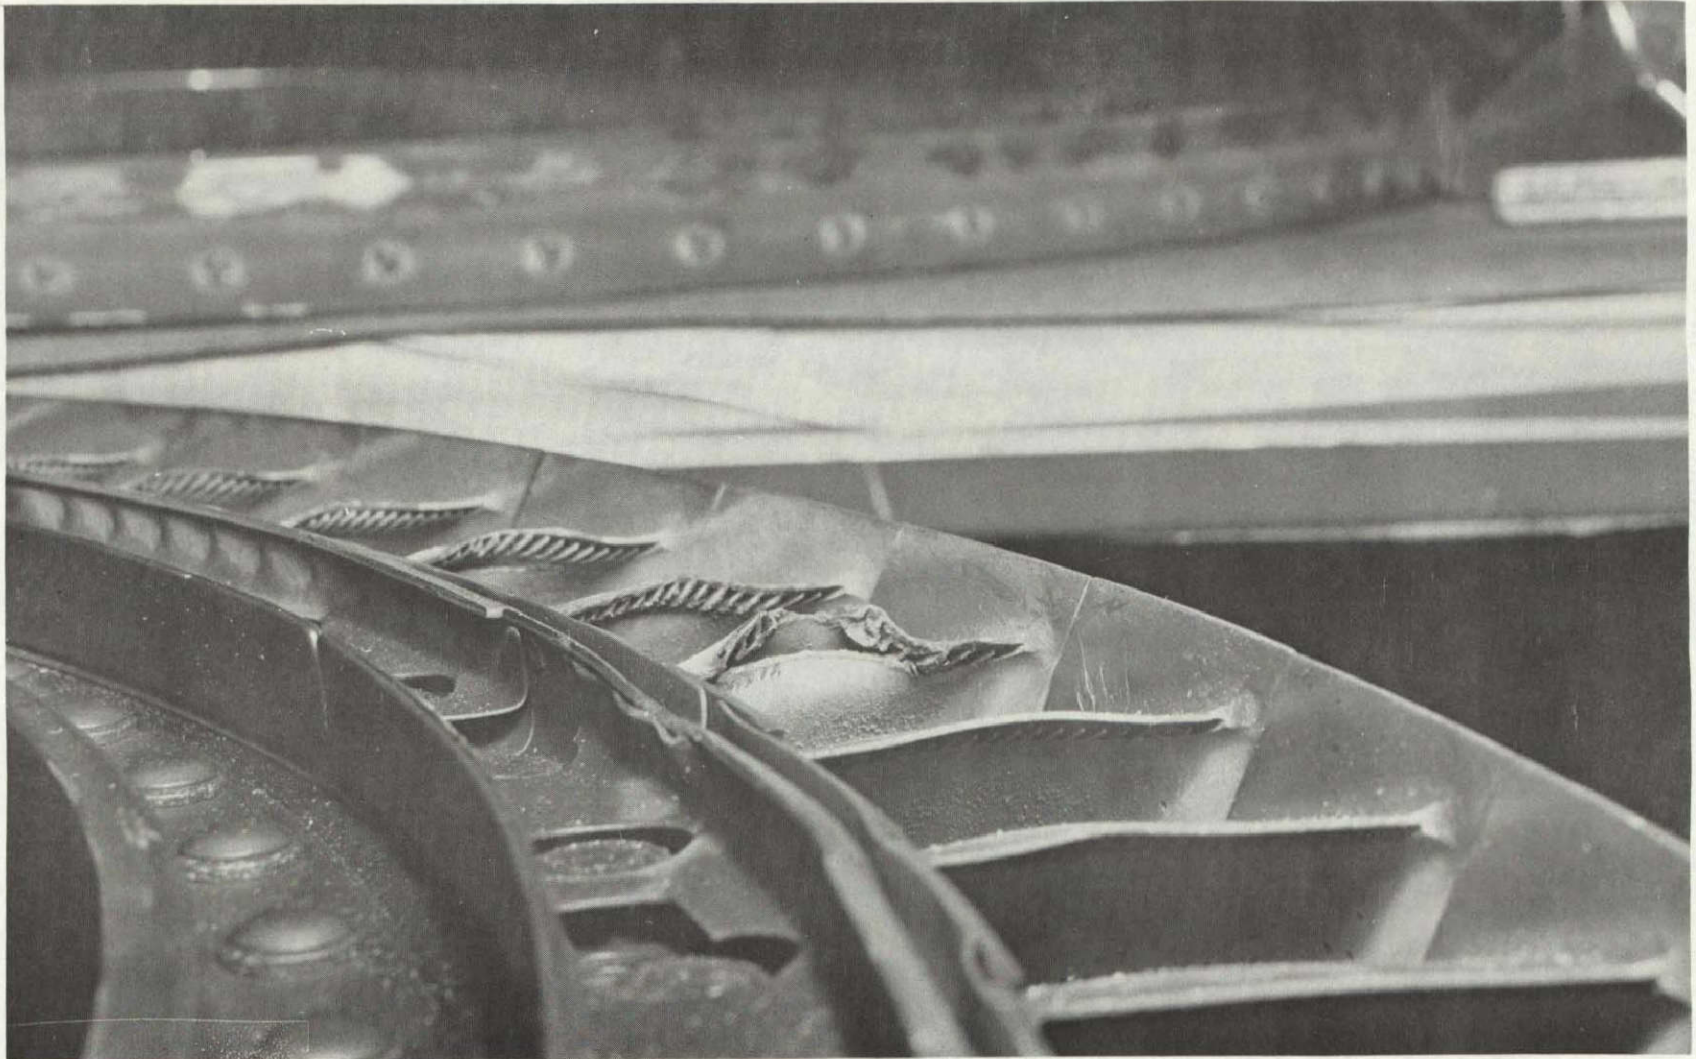
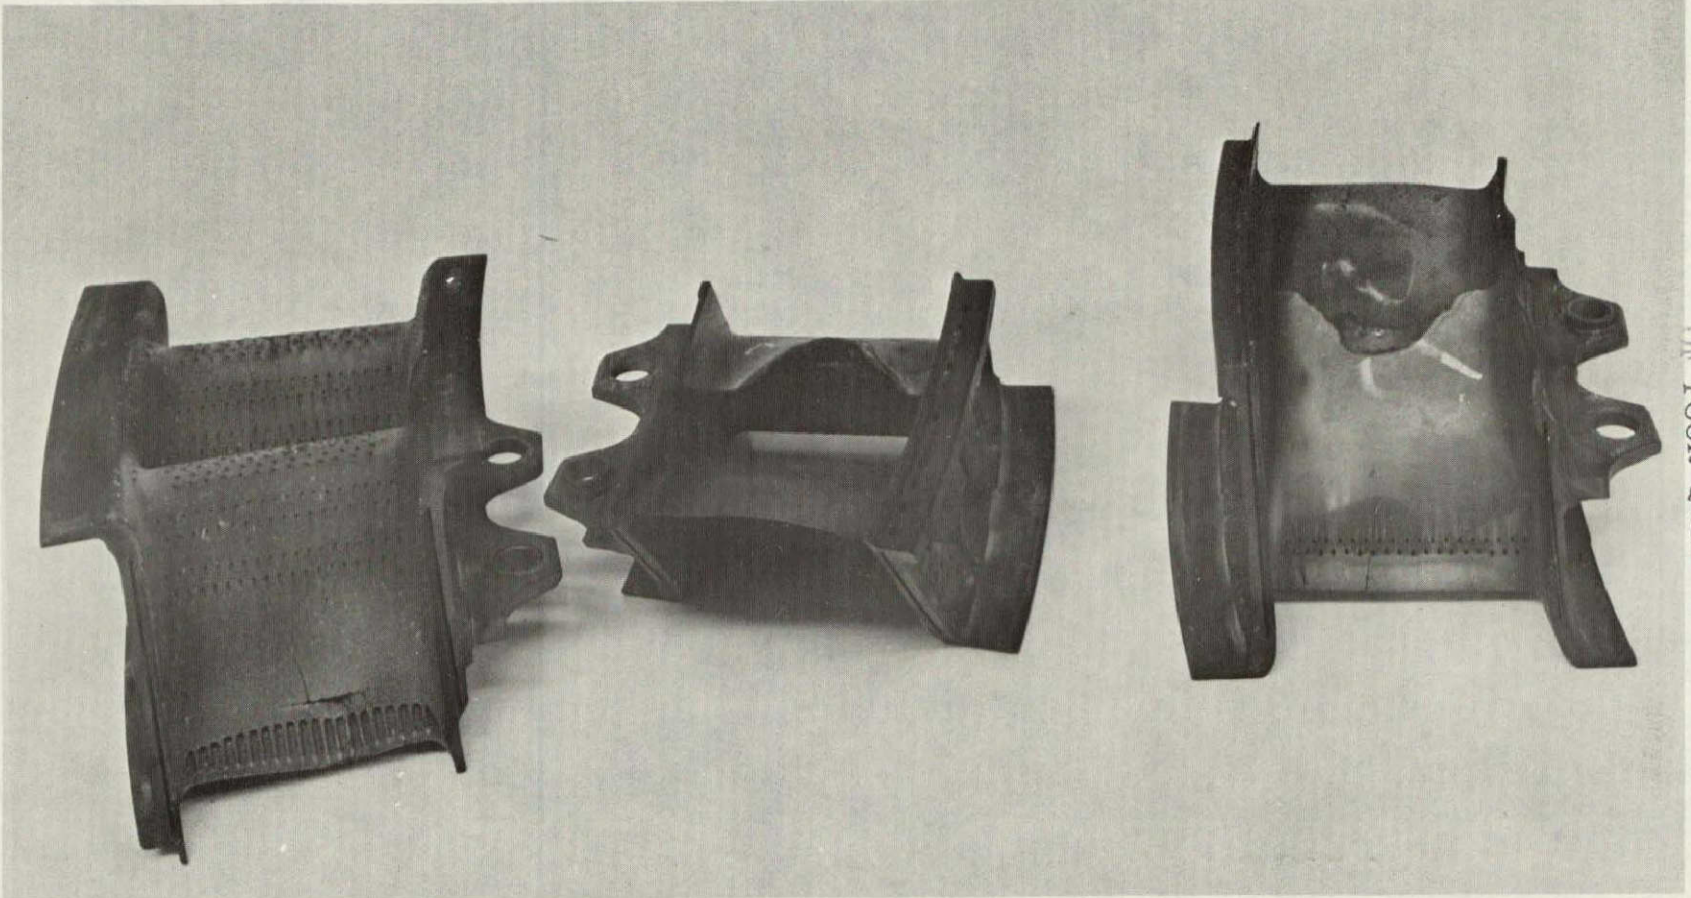
Visual inspection of the Stage 1 HPTN assembly revealed 13 vanes with some degree of burning on the trailing edge, while some 10 other vanes were bowed in the same area. (See photographs in Appendix B, Figures 8-10 through 8-13. Note that the position markings as viewed in the photographs are incorrect. Per B/P, the vane marked No. 18 is really Vane No. 1. From that point, the vanes should be marked in clockwise order. For orientation purposes, all references to vane position numbers in this report are per the actual position and not as depicted in the pictures.) As can be seen in the photographs, all vane distress emanated approximately from the center of the airfoils at the trailing edge, and continued radially outward and inward about the same amount for each particular vane.

All of the vanes that experienced the burning/distortion showed radial cracks of varying lengths on the concave side, depending on the severity of the distress. These cracks were located 3/8" to 1/2" forward of the trailing edge.

Figure 8-11. Stage 1 HP Turbine Nozzle Assembly, Trailing Edge, Burnt/Distorted Vanes.

Figure 8-12. Stage 1 HP Turbine Nozzle Assembly Distress, Aft End.

Figure 8-13. Stage 1 HP Turbine Nozzle, Typical Vane Distress.

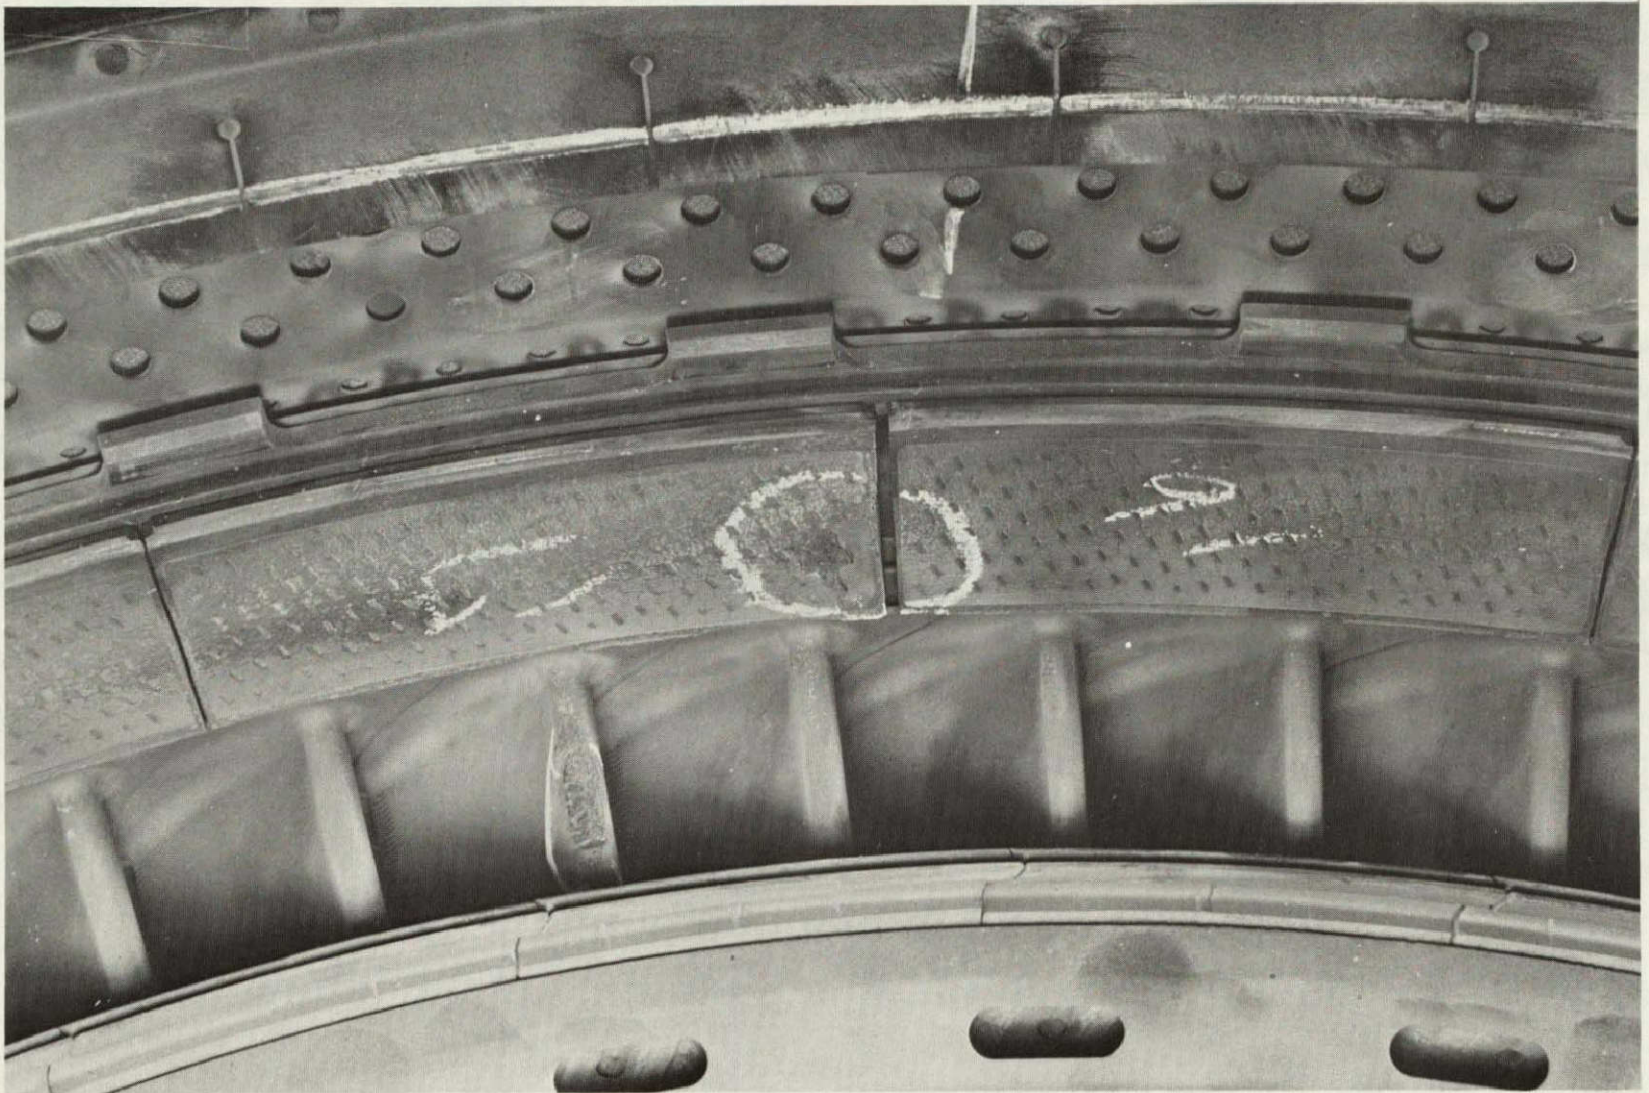
Figure 8-15 . Stage 2 HP Turbine Nozzle, Damage Vane/Stage 1 Shroud.

The Stage 1 shrouds were very rough and eroded/oxidized. One shroud (No. 17) had an irregular shaped piece missing, approximately 1" x 1-1/2" (see photograph in Appendix B, Figure 8-15). This was the only missing section.

The vanes were in excellent condition with no burning noted on any of them. One vane, immediately behind Stage 1 Shroud No. 17, did show some type of impact damage in the center third of the leading edge (see photograph,

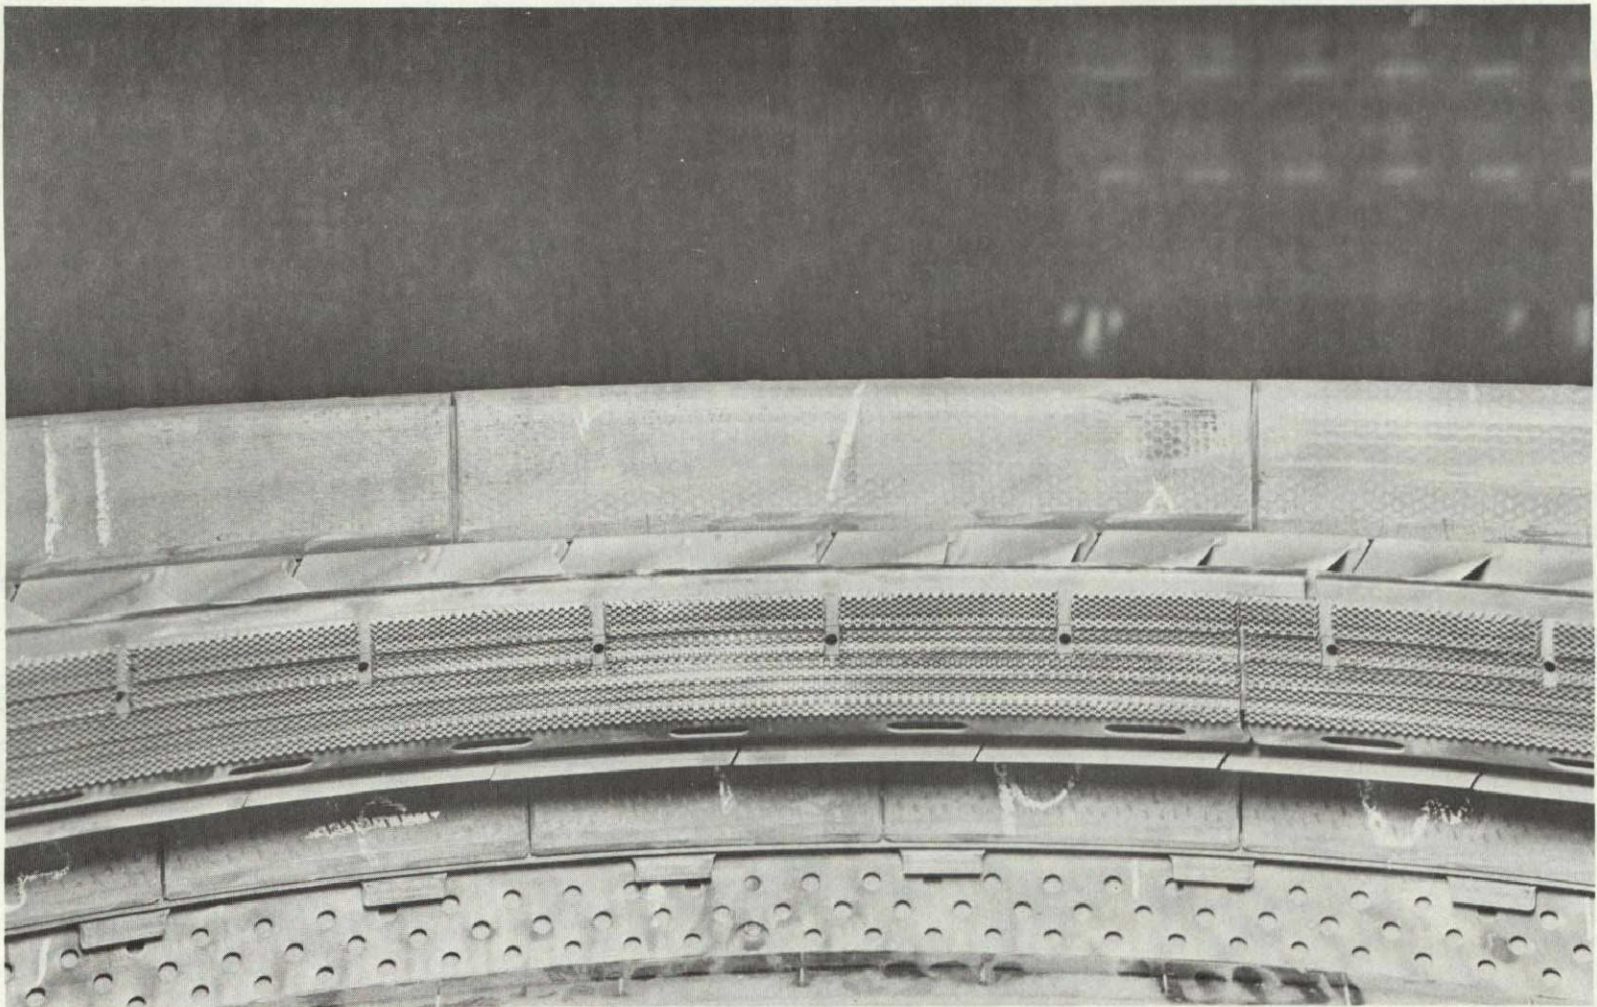
Figure 8-16. Stage 2 HP Turbine Nozzle Stage 2 Shroud Rub.

The Stage 2 shrouds had light erosion/oxidation, with no missing pieces. All shrouds were heavily rubbed, with a more recent rub, approximately 1" x 1-1/2", noted on shroud No. 1 (see photograph, Figure 8-16, in Appendix B).

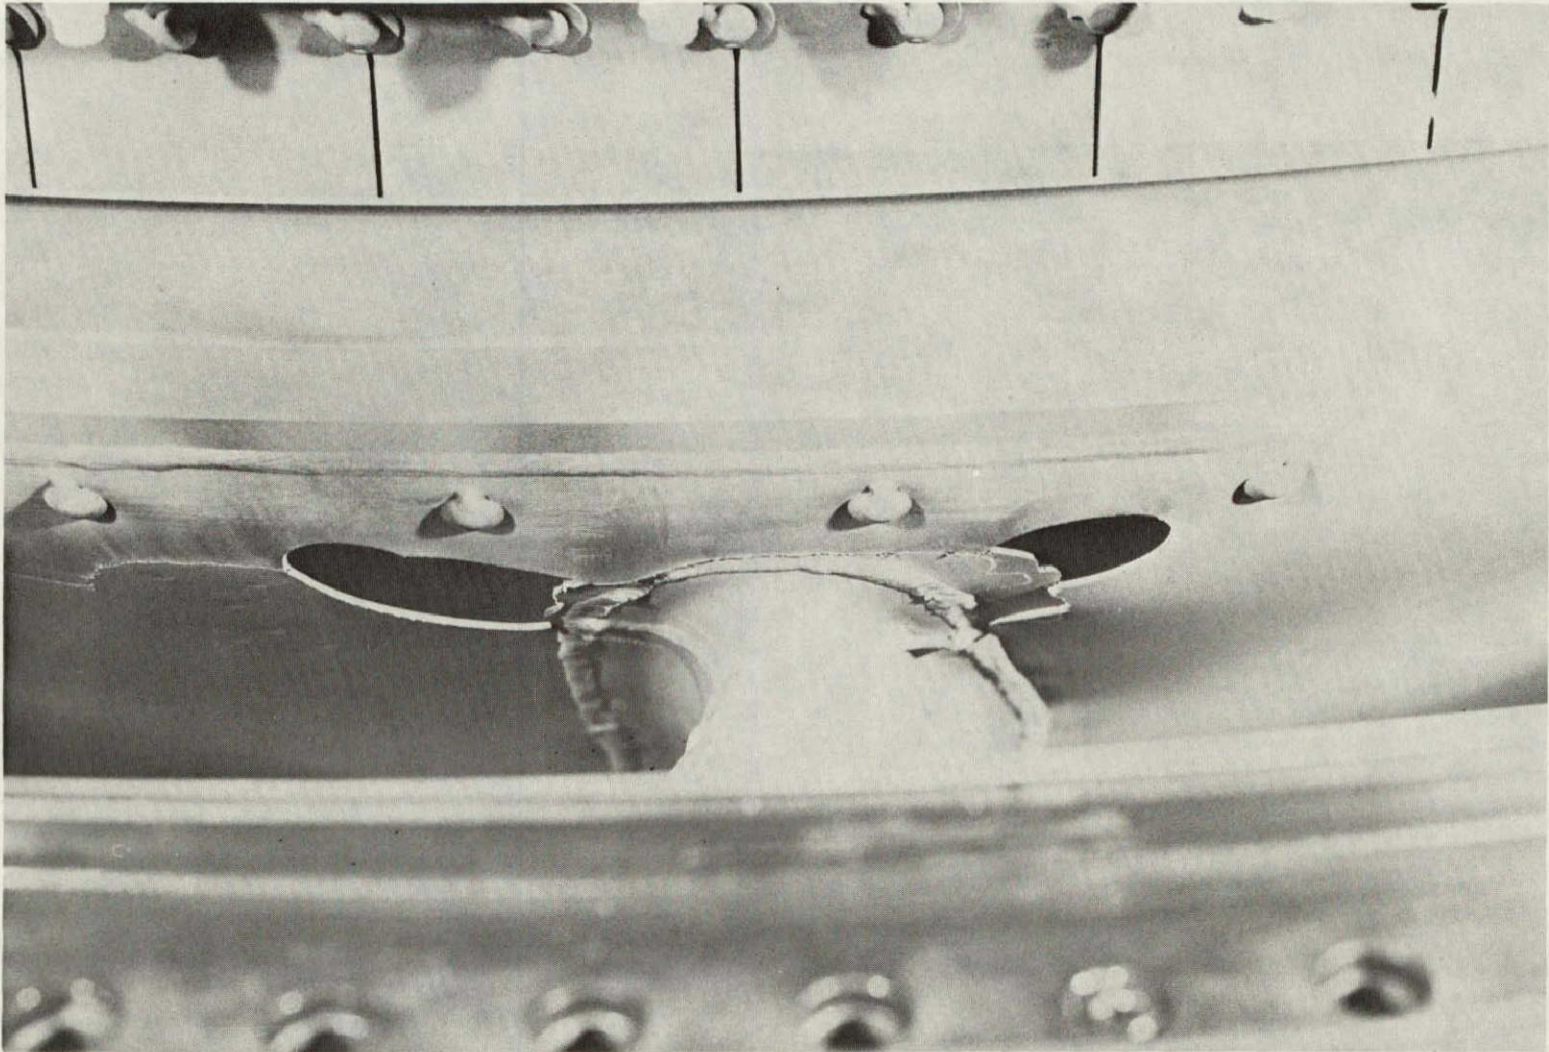
Figure 8-19. Turbine Mid Frame Liner Distress.

Visual inspection of the turbine midframe revealed two holes (3/4" dia. and approximately 1" x 2-1/2") in the inner liner aft of Strut No. 2; one hole on each side of the strut (see photograph, Figure 8-18 in Appendix B). Aft of Strut No. 2, there was a 4" circumferential crack in the liner, and another circumferential crack approximately 9" long was observed in the liner

After removal of the LPT module during the core analytical teardown, the TMF liner was visually inspected, as viewed from the forward end, and no further crack progression was noted. It was noted during this inspection that the buckling of the liner had caused one EGT T/C probe aspirator hole to be immersed in the cooler TMF liner cavity. Another was partially immersed. Possibly this could have been the reason for the inconsistent EGT indicated readings, recorded during the several tests conducted.

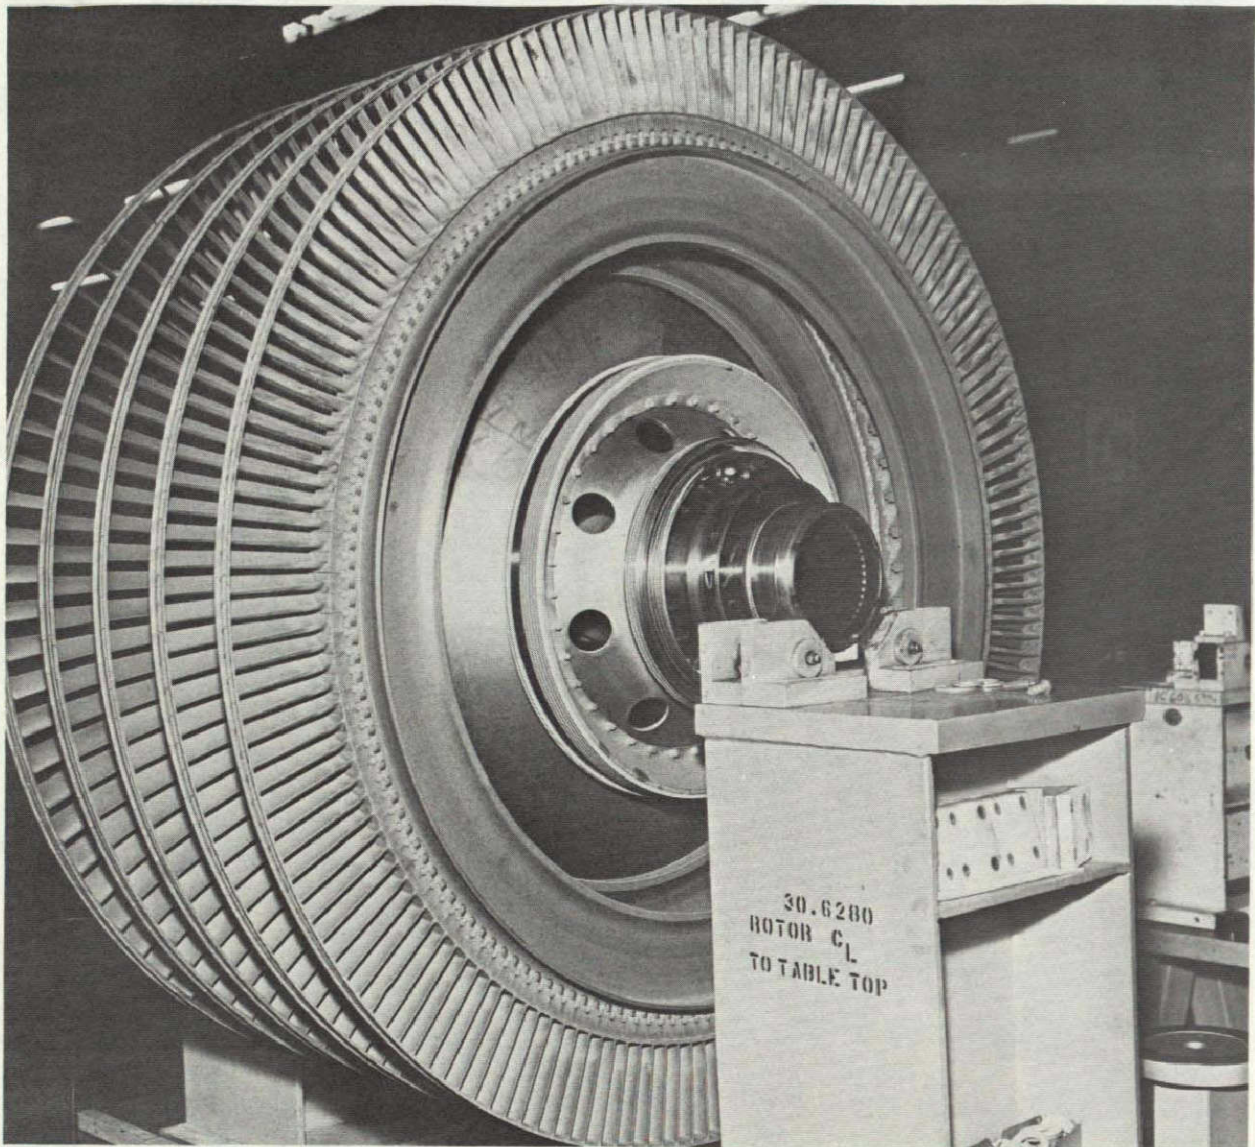
Figure 8-22. LP Turbine Rotor, Overall View.

A visual inspection of the LPT rotor assembly showed it to be in excellent condition. No discrepancies were observed on any of the spool parts. Blades were rough and dirty, typical of blades which have this amount of running time. A photograph of the rotor assembly can be found in Appendix B, Figure 8-22, showing it mounted in the lathe bed for the inspection checks.

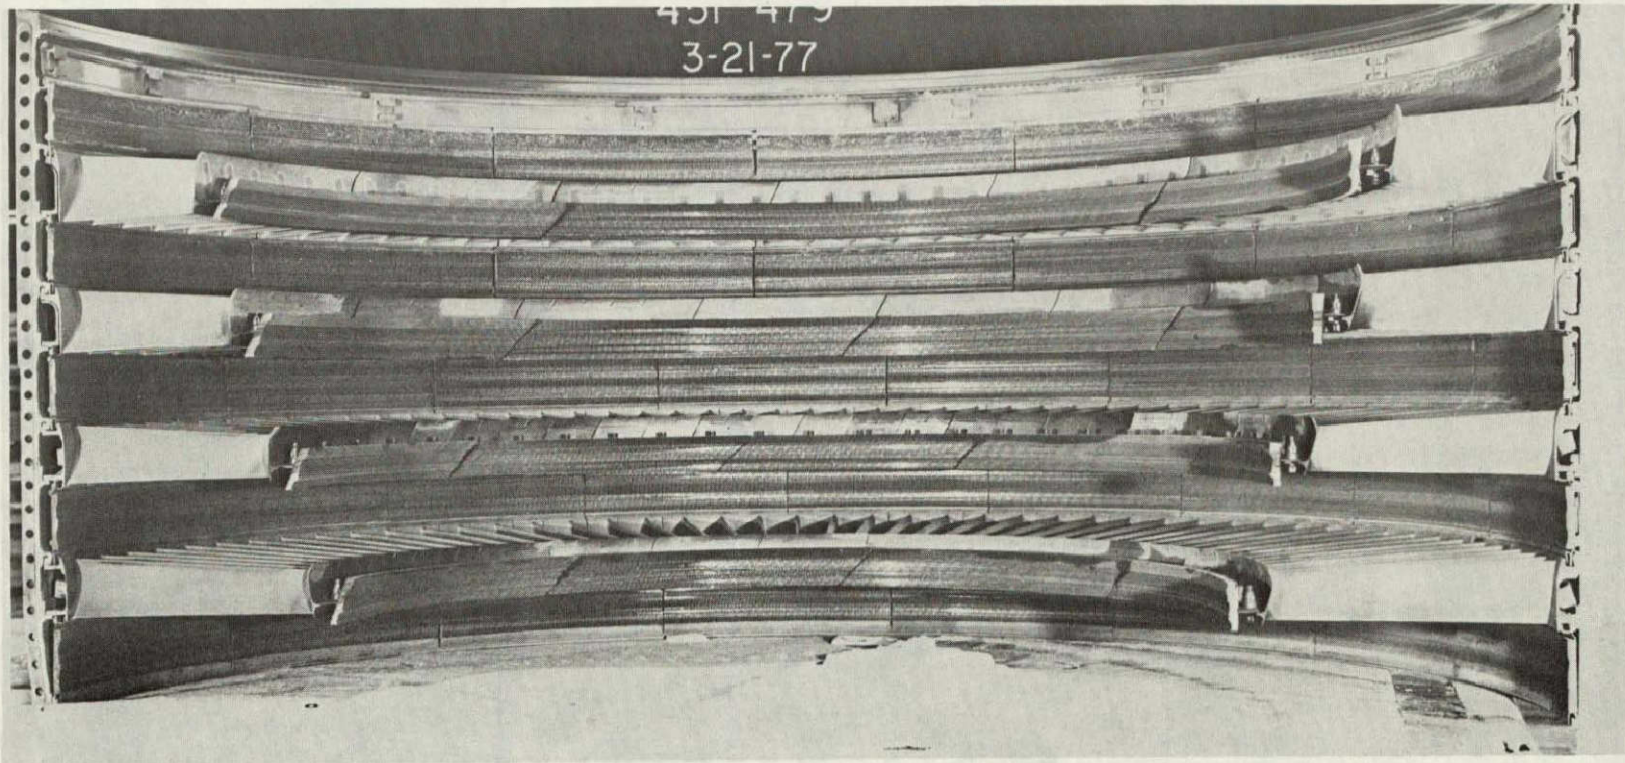
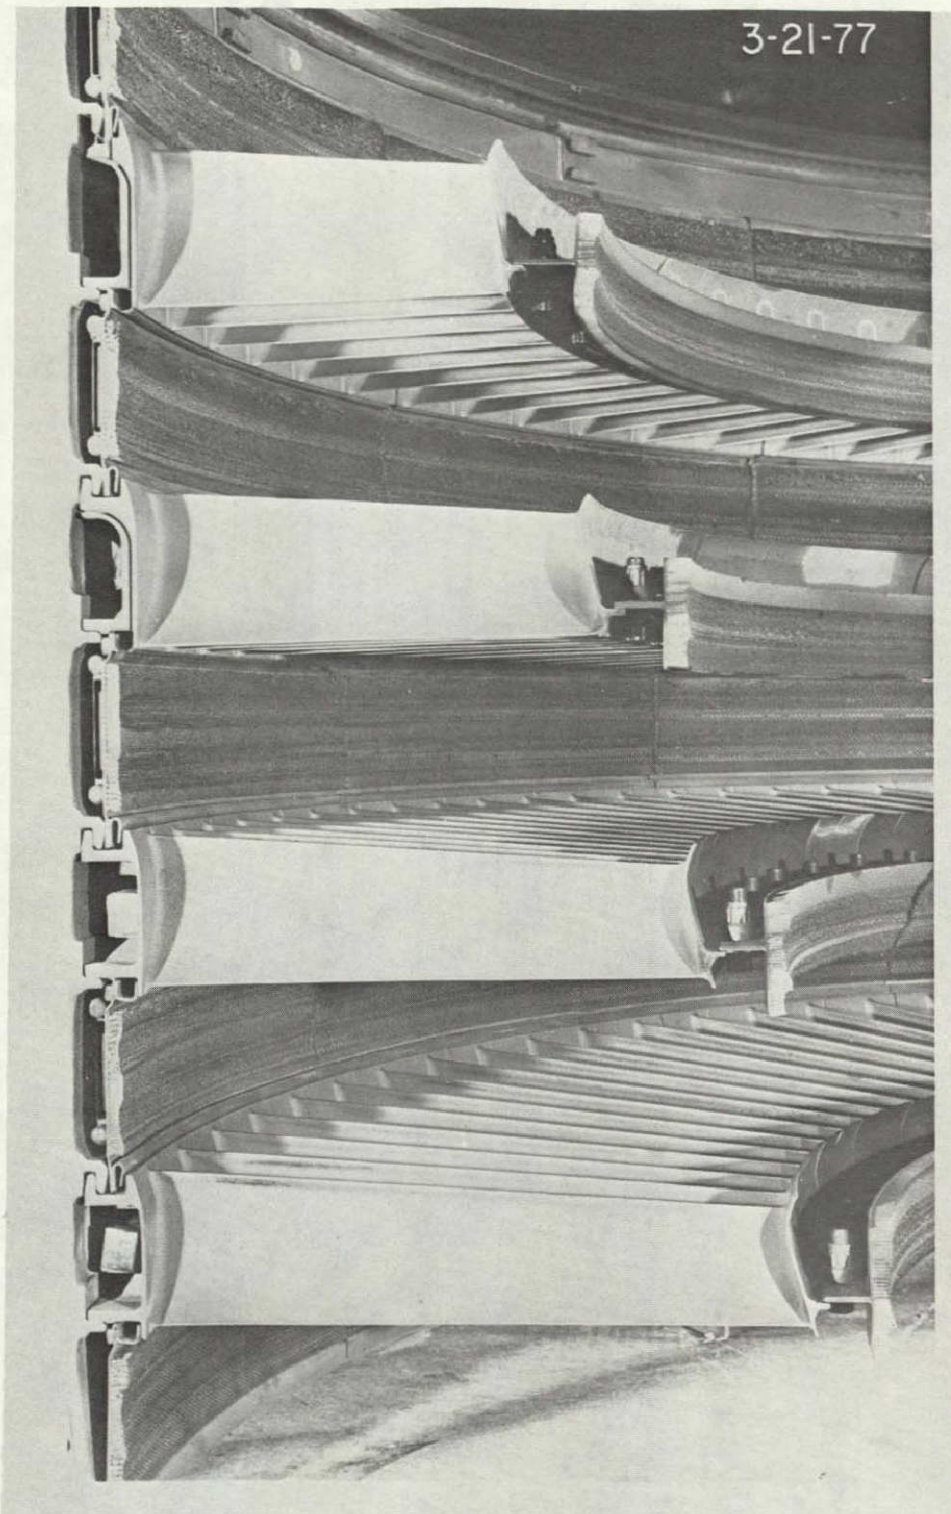
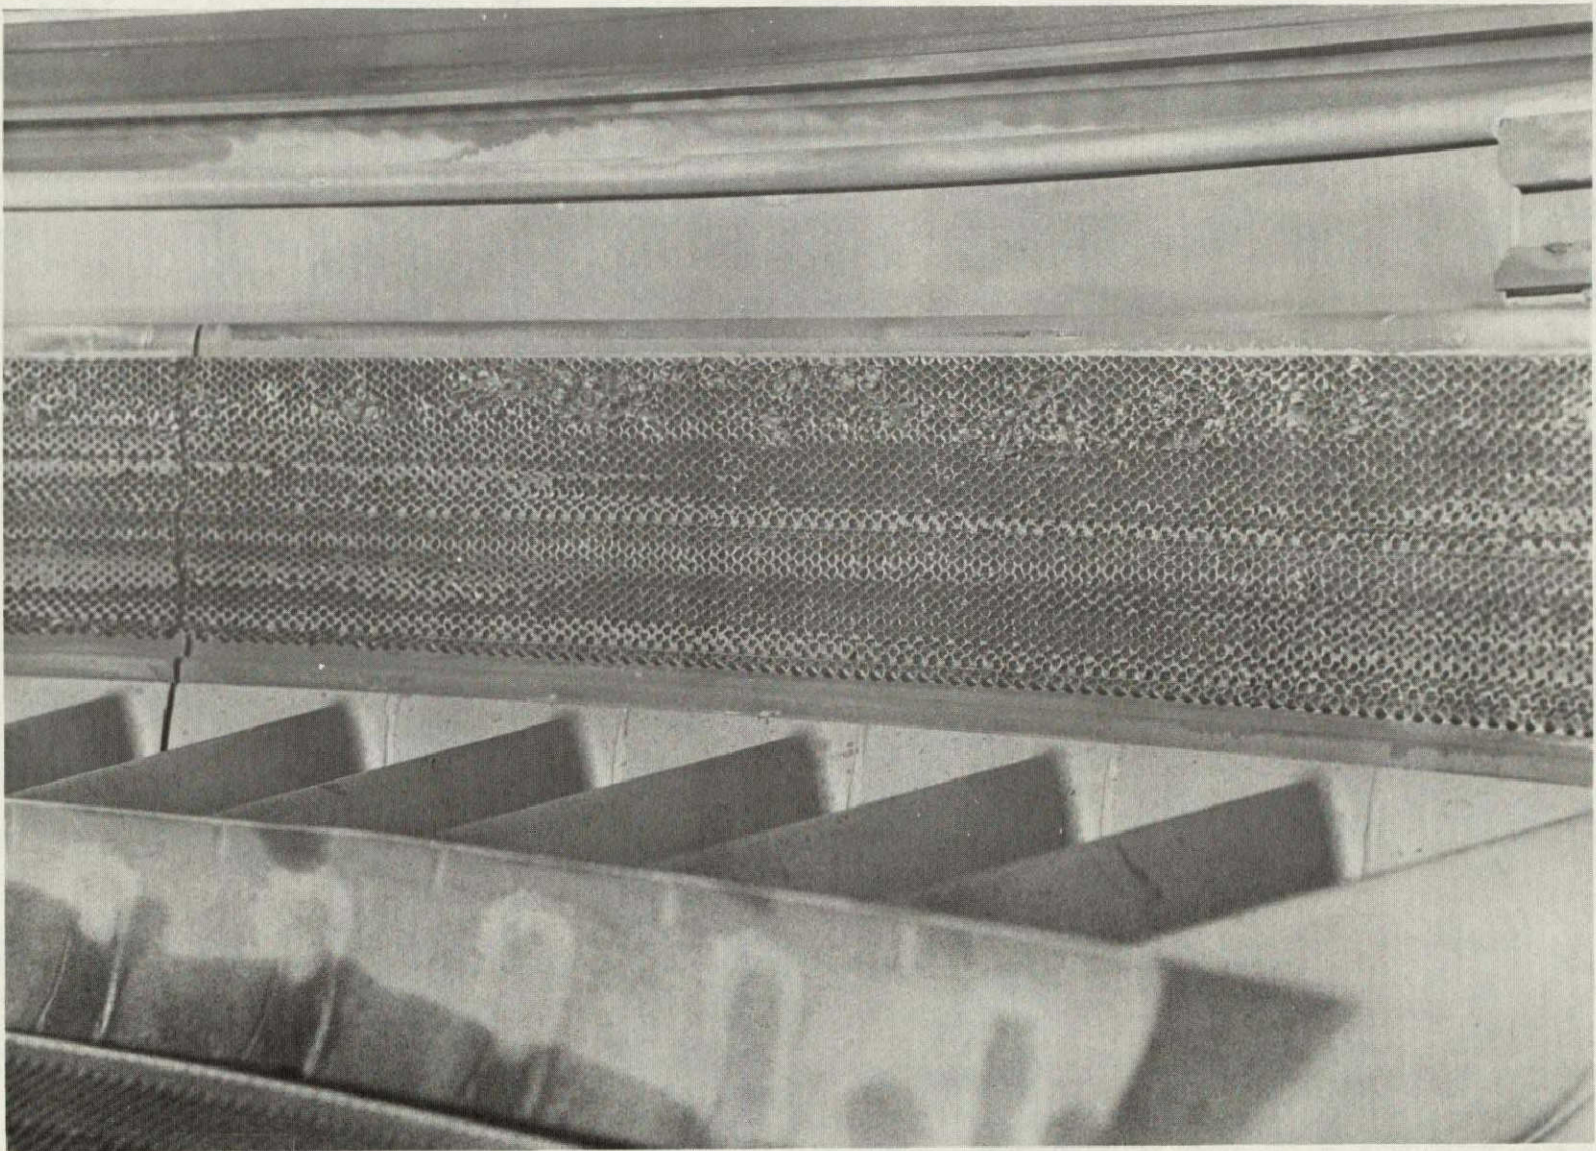
Visual inspection of the LP turbine stator assembly showed it to be in good condition. Rub patterns on the shrouds and seals were typical of those observed in the past. (See photographs in Appendix B, Figures 8-23, 8-24, and 8-25.) Casteone impressions were made of the maximum depth rub pattern visually observed in each casing half for all shrouds and interstage seals. A sketch of each of these is shown in Figure 6-1.

Figure 8-24. LP Turbine Stator Assembly, End View of Shroud and Seal Rubs.

Figure 8-25. LP Turbine Stator Assembly, Stage 1 Shroud Rub Pattern.
