NASA CR-135381

LONG-TERM CF6 ENGINE PERFORMANCE DETERIORATION - EVALUATION  
OF ENGINE S/N 451-479

General Electric Company  
Aircraft Engine Group  
Cincinnati, Ohio 45215

February 1978

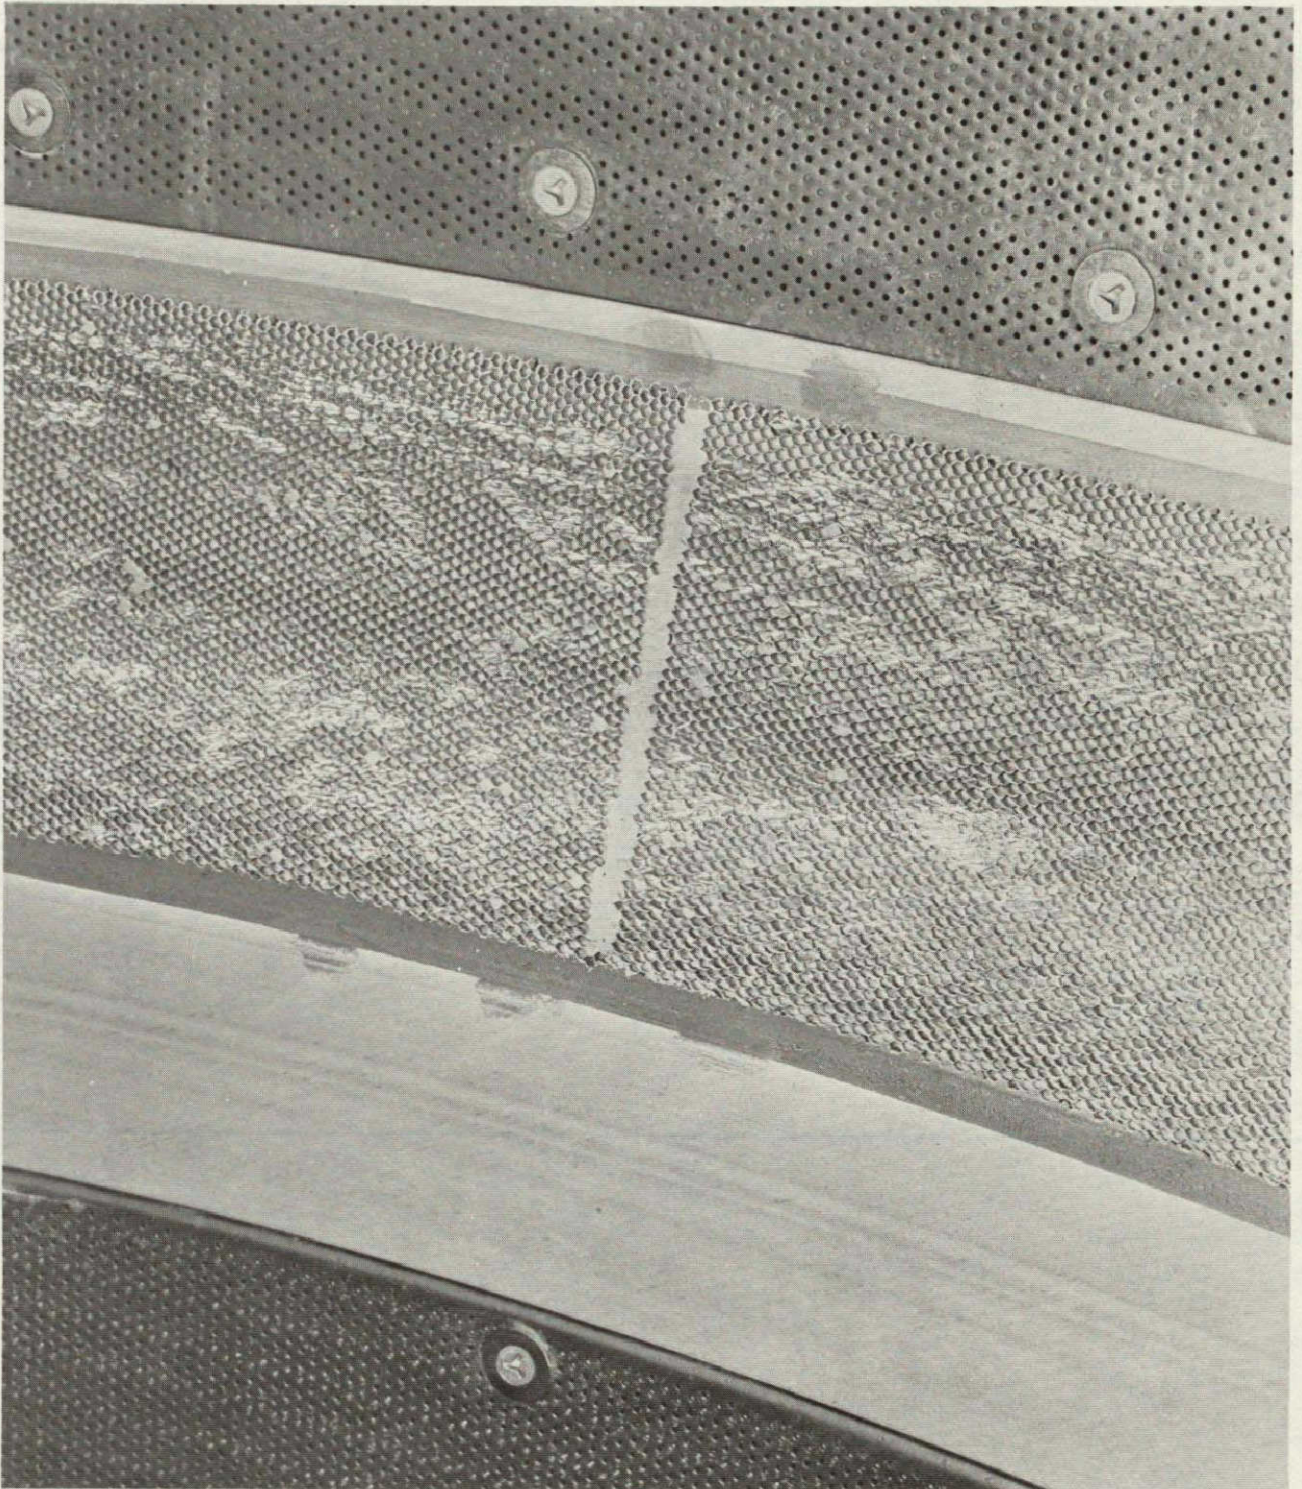
Figure 8-27. Stage 1 Fan Shroud Ice Damage.

The Stage 1 open faced, aluminum honeycomb shroud exhibited typical ice damage. There were approximately 30 pock marks distributed through the full 360° circumference and located in the path of the blades. The typical size indentation was approximately 3/8" x 1-1/2", with the honeycomb mashed to a depth of 0.050"/0.080". In addition, there were many superficial markings the full width and circumference of the shroud. See photograph, Figure 8-27 in Appendix B, which shows a typical section of the damaged shroud.

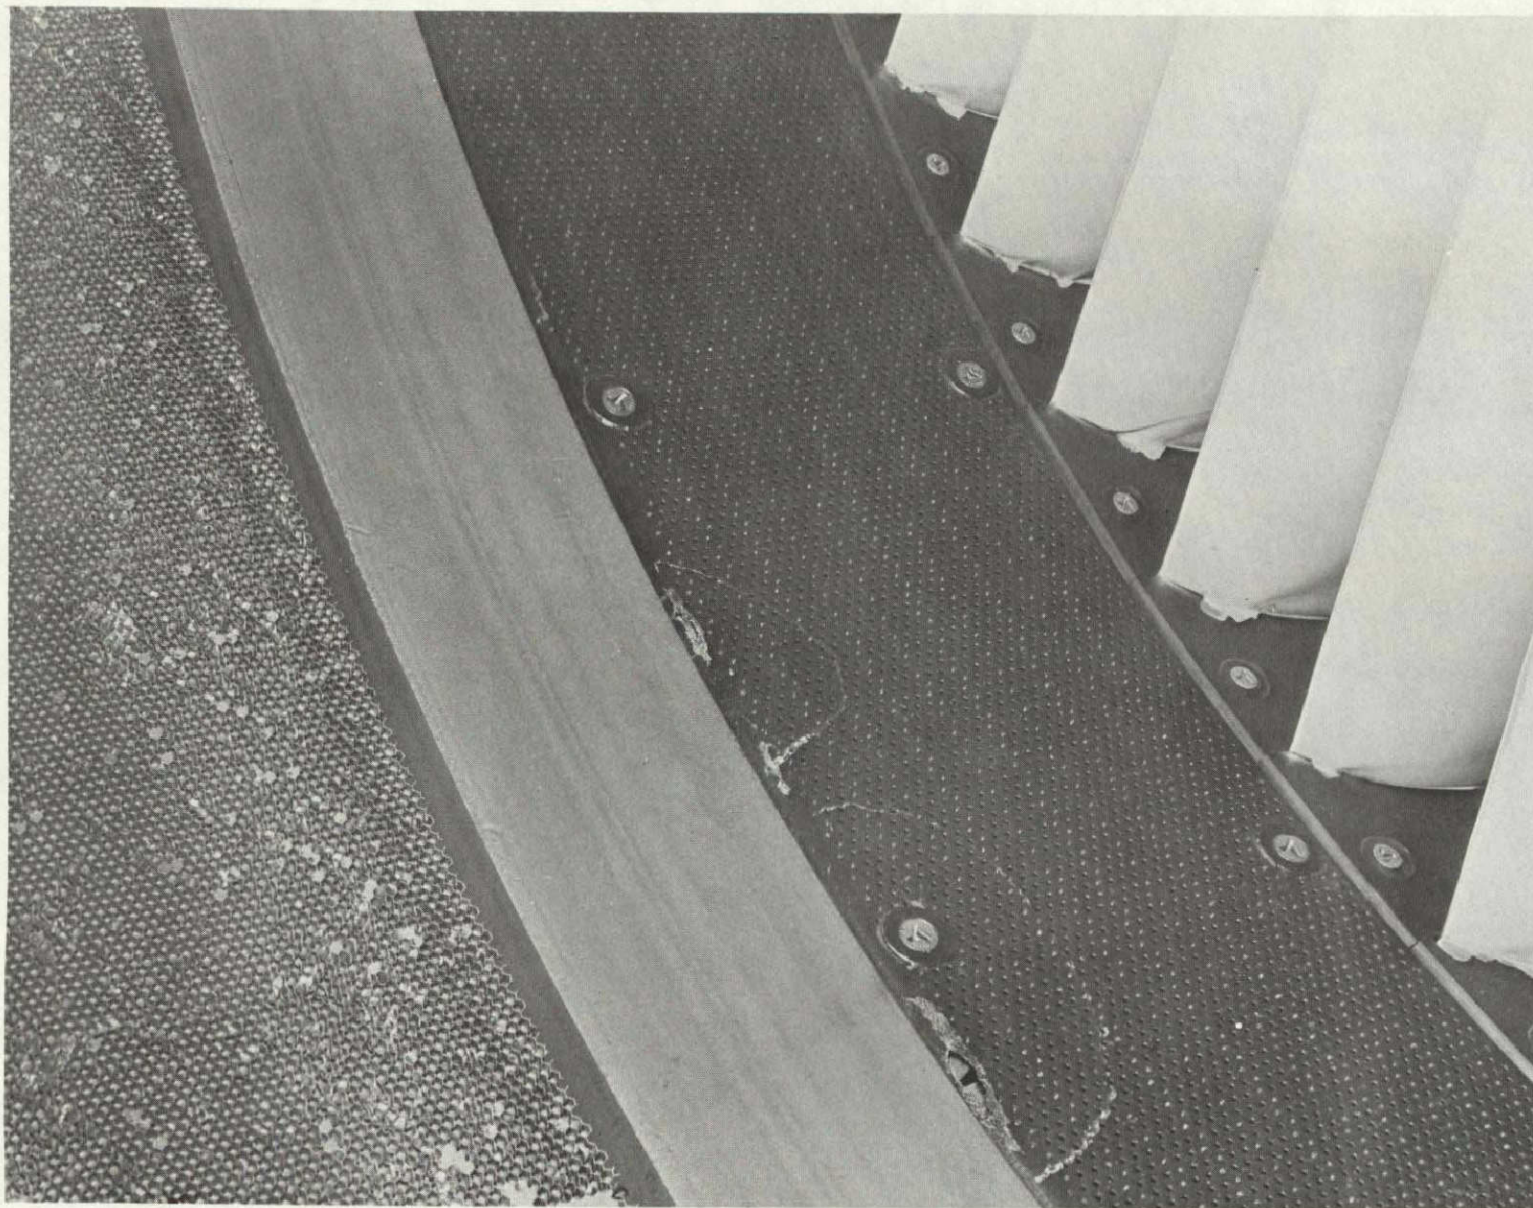
Figure 8-28 . Fan Stator Aft Liner Ice Damage.

Stage 1 fan blade OGV's also were in excellent condition. There was some slight damage on the leading edge of the aft stator case linings. This too can be attributed to ice damage. A photograph showing the worst observed damage can be found in Appendix B, Figure 8-28.
