FINAL REPORT

**DEVELOPMENT OF SPIRAL-GROOVE
SELF-ACTING FACE SEALS**

**AVCO LYCOMING DIVISION
550 South Main Street
Stratford, Connecticut 06497**

JUNE 1977

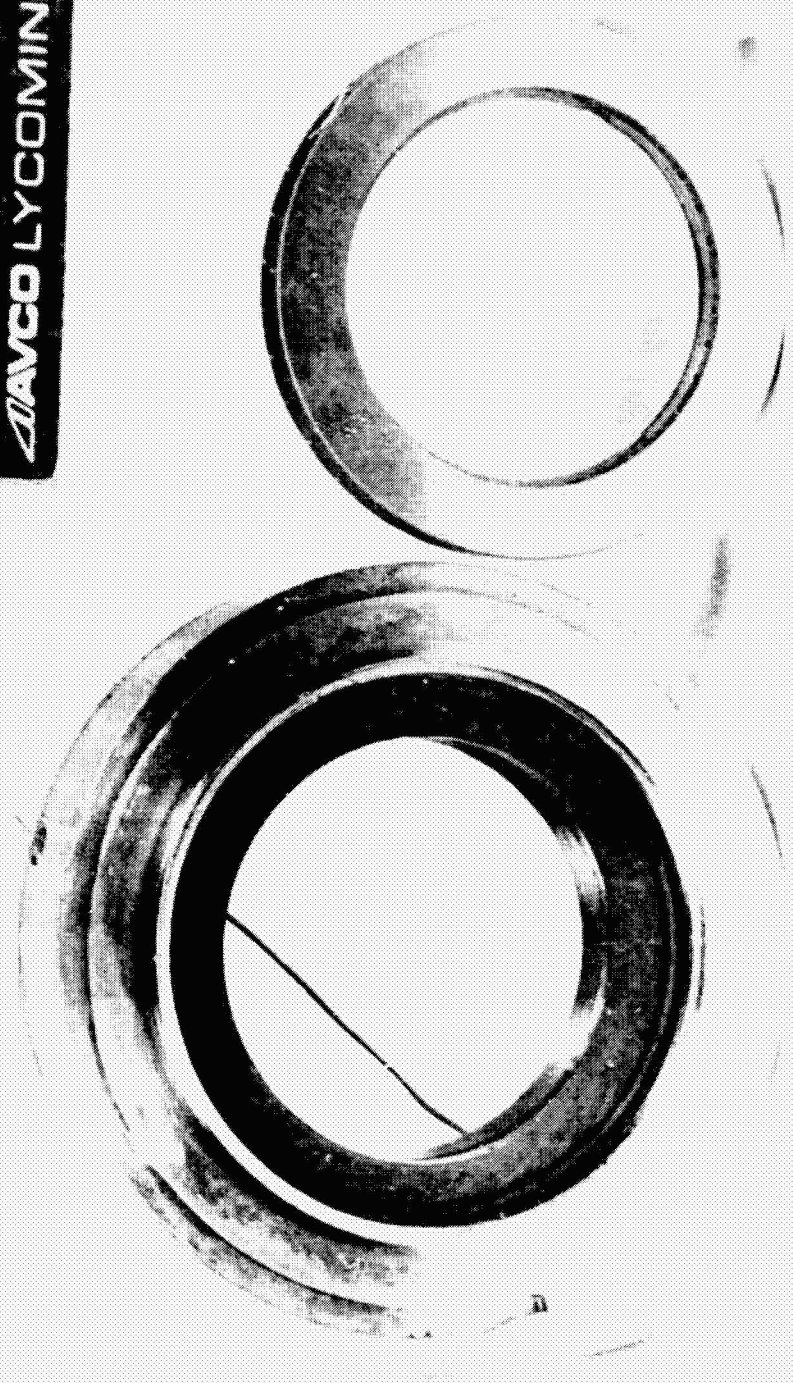
Figure 19. Aft Seal and Seat After Build I Testing.

Wear was found to be greatest and the appearance of rubbing most evident near the ID of the face. Wear of the sealing dam was uniform and very light in comparison with that experienced in previous programs (Reference 1). Figures 18 and 19 show the forward and aft seal assemblies after test. Close-up views of the spiral grooves and seats are shown in Figures 20 through 23.

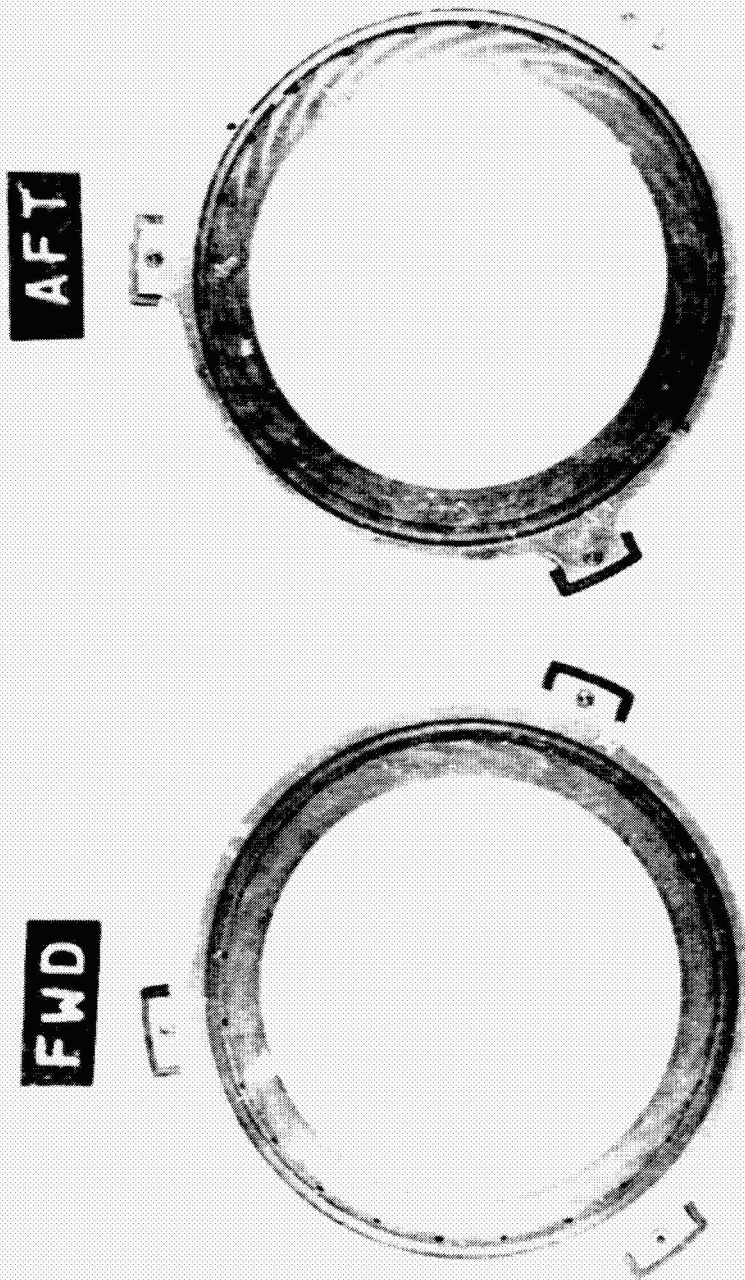
Figure 24. Forward and Aft Sealing Elements After Build II Testing.

The forward sealing element experienced extremely heavy wear operation under this condition. The aft seal experienced heavy wear also but appeared to be in good condition, despite operation with the loose seat. Initial spiral groove depth of the aft seal was .00287 cm (.00113 in.) compared to .001349 cm (.00055 in.) depth of the forward seal groove. Because of the initially deeper grooves, the aft seal was still usable despite the wear. Observed seal wear was as follows:

Figure 24 illustrates the forward and aft sealing elements after Build II testing. Figure 25 illustrated the back (normally nonsealing side) of seal seats with the forward seat illustrating contact marks from sealing element due to it being reversed. A wear ring on the aft seat, caused by unclamped operation can be seen. Figure 26 shows the opposite side (normally the sealing side) of the seats (contact side for aft seat). The forward sealing element, exhibiting heavy wear and shallow spiral-groove geometry, was replaced with a new part of Build III testing. Table IV illustrates changes in face dimensions after Build II testing.

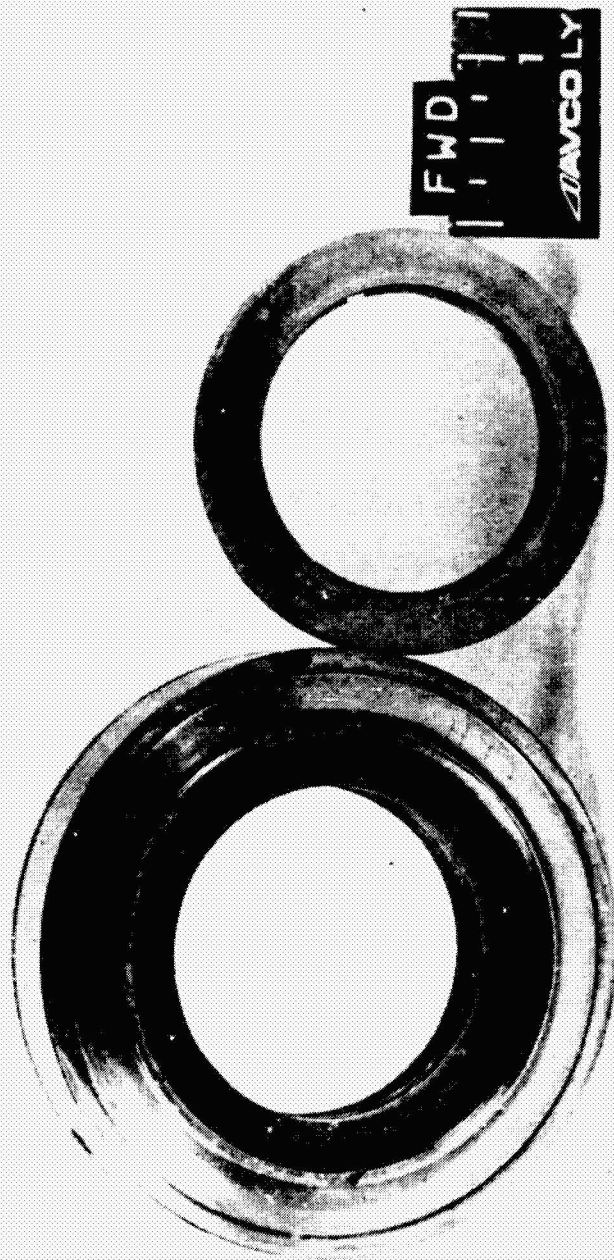
Figure 31. Forward Seal After Build III Testing.

The post-test condition of the seals was documented in Figure 31 and 32. Changes in the seal face dimensions after Build III testing were measured with the following average wear results:

Surface near ID	-	.000445 cm (.000175 in.)
Face average	-	.000293 cm (.000115 in.)
Average rate	-	.000048 cm/hr (.000019 in./hr)
Minimum remaining groove depth	-	.002349 cm (.000925 in.)

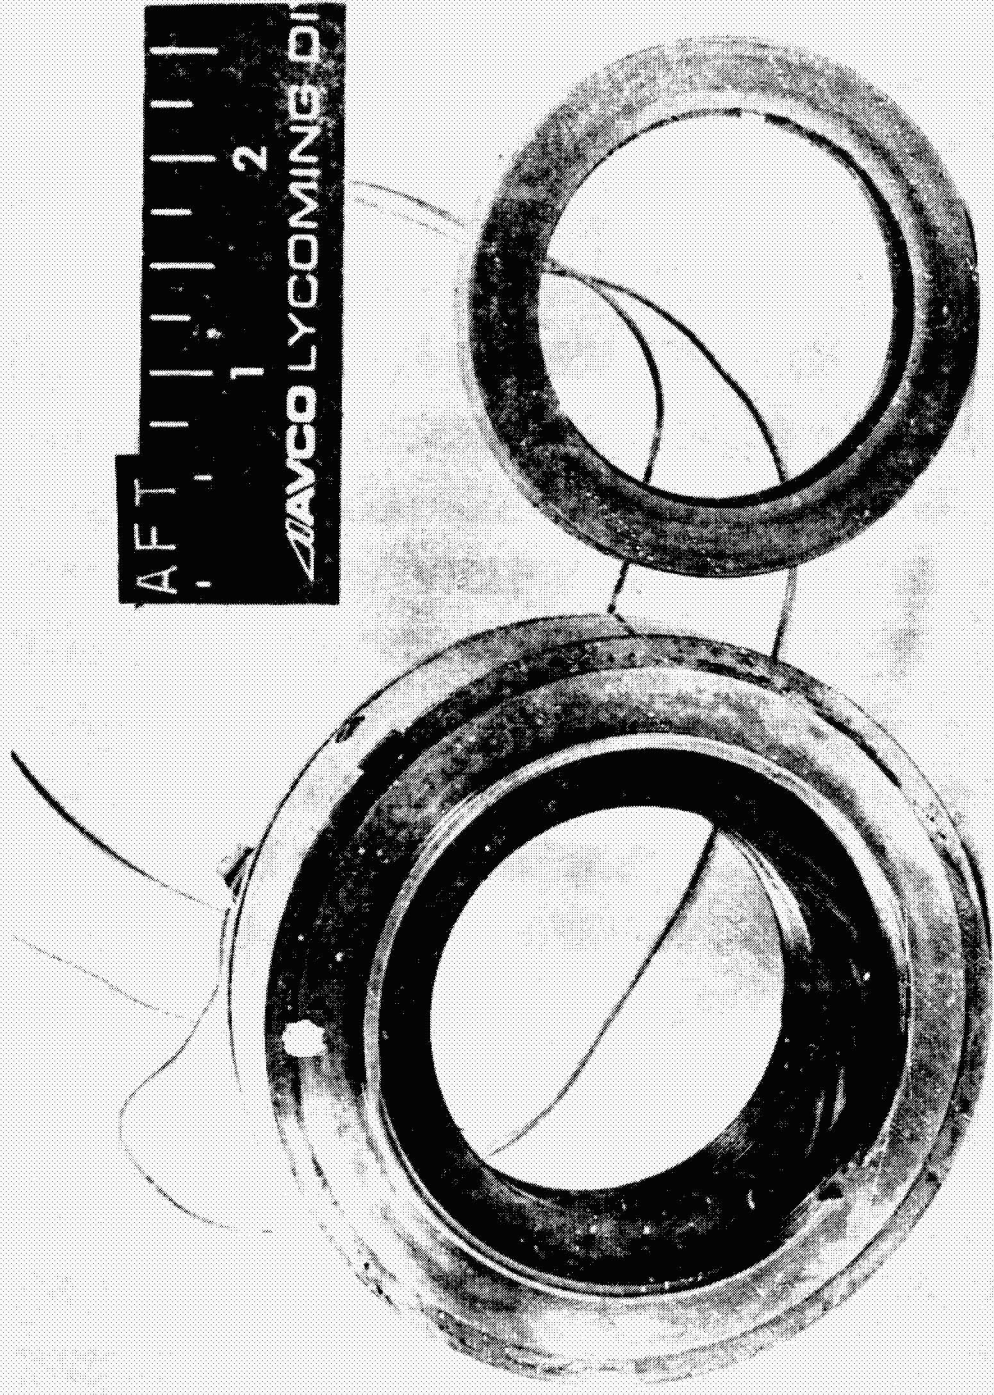
Figure 32. Aft Seal After Build III Testing.

Maximum wear occurred at the surface near the ID of the sealing element. Average remaining groove depth (self-acting mechanism) was .002570 cm (.000101 in.) for the forward seal and .003030 cm (.001190 in.) for the aft seal. Face dimensions are summarized in Table VI.

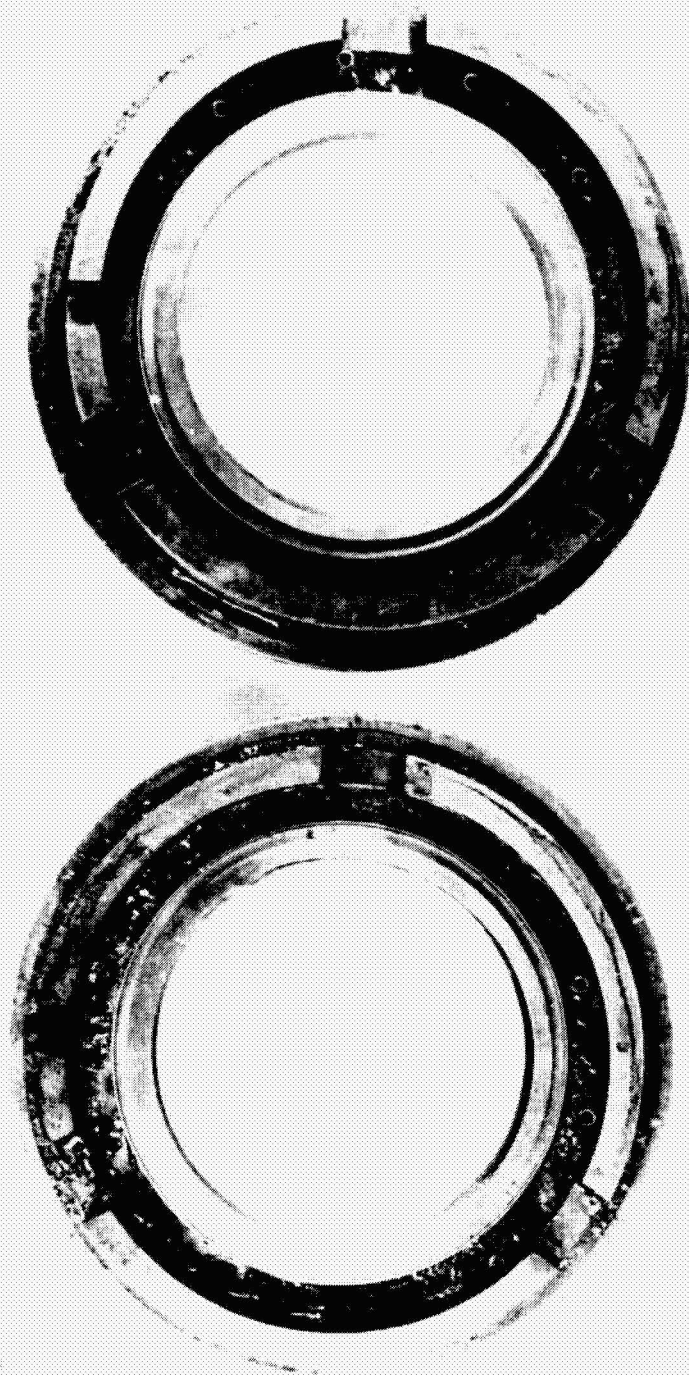
The endurance test encompassed 100.2 hours of operation at surface speeds to 243 m/s (800 ft/sec), sealed pressure to 148.14 N/cm² abs (215 psia), and sealed air temperatures of 645.4 K (702°F). A summary of the data points run is presented in Table VII. A test rig bearing problem necessitated interruption of the endurance test after 45 hours of operation. The test rig was rebuilt and seal hardware (seats, piston ring carriers, piston rings, and primary sealing elements) was changed. The damaged seal assemblies are pictured in Figures 23 through 38. During the failure, the seal seats contacted the seal housing, and the shaft rubbed the ID of the carbon sealing elements. The spiral-groove geometry remained intact except for radial cracks. Wear data was obtained but may have been influenced by the failure. These data are presented in Table VIII. Inspection of the seal housings revealed substantial oil coking within the housings and on some of the compression springs, tending to clog the coils. The interior of both seal housings and some typical coked springs are shown in Figure 38. The piston

Figure 38. Coking of Housing and Springs After Endurance Test, Build I.

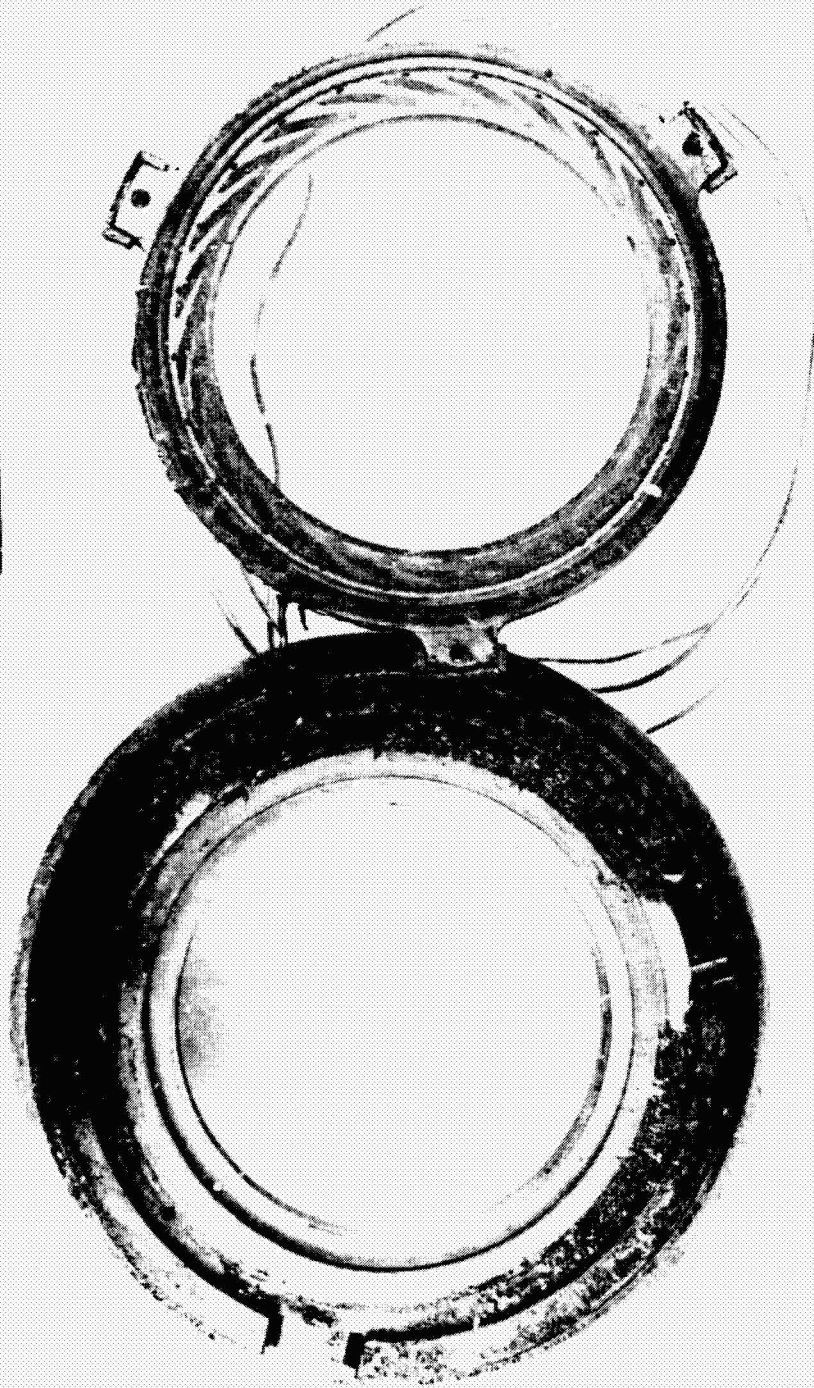
Figure 40. Internal Coking of Forward Seal After Endurance Test, Build II.

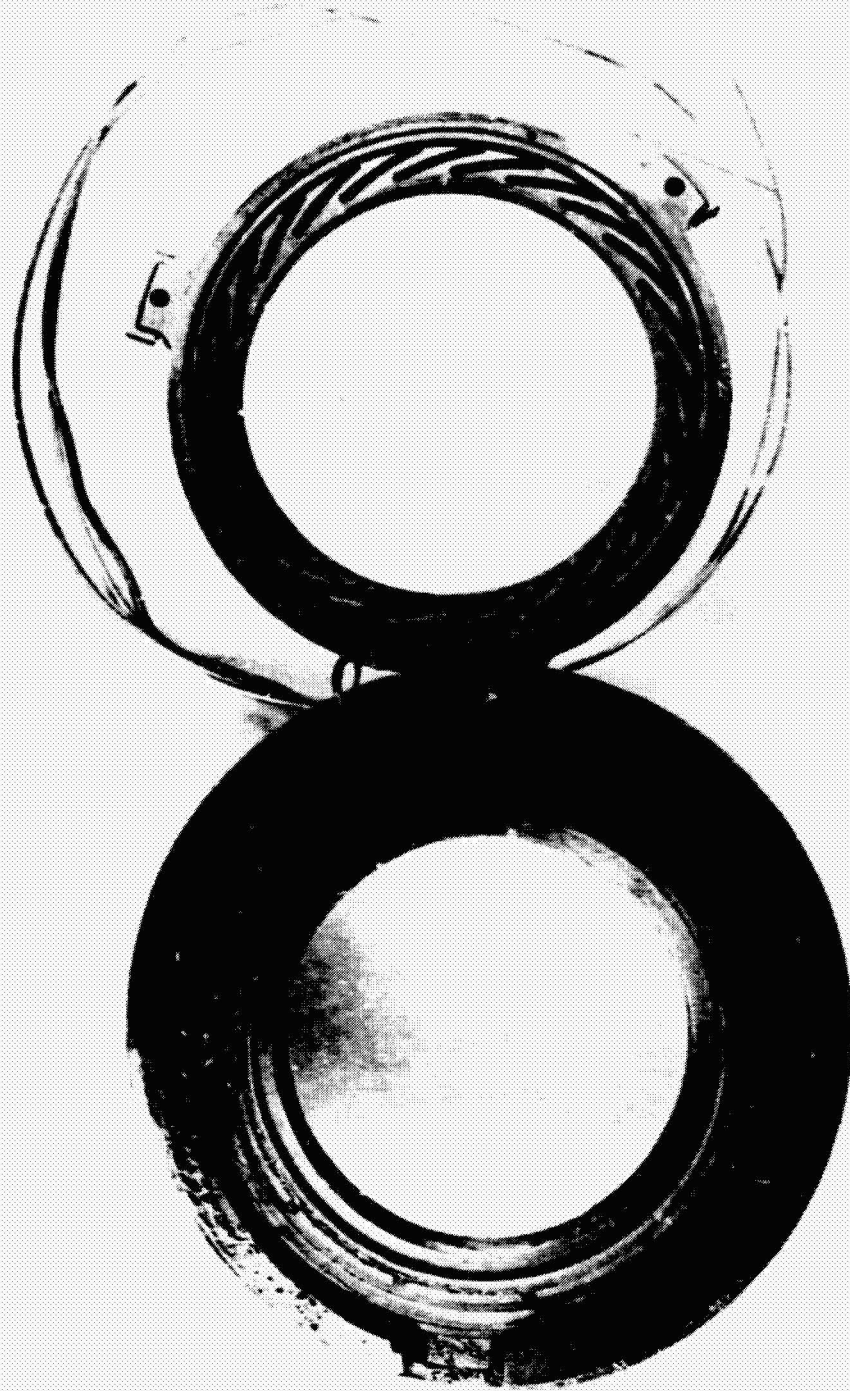
Figure 41. Internal Coking of Aft Seal After Endurance Test, Build II.

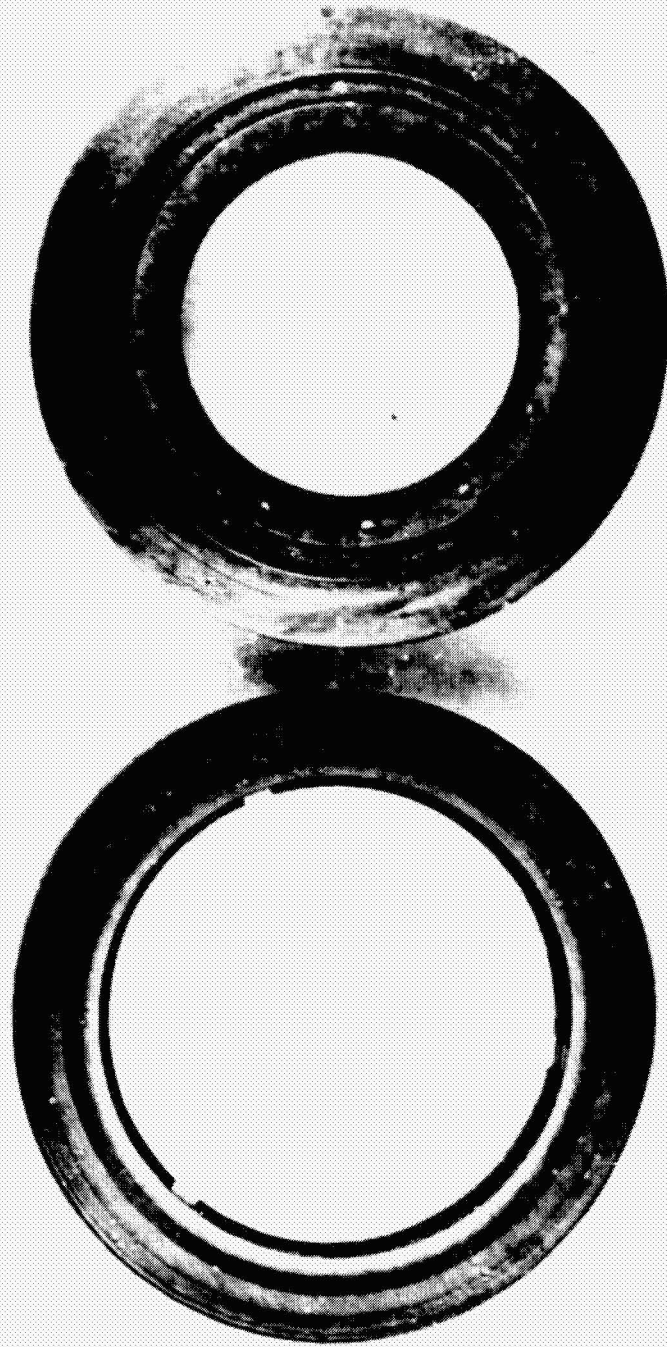
Figure 44. Forward Seal Seat and Dam After Endurance Test, Build II.

The seal seats exhibited radial cracks in the chrome carbide surface coating originating at the seat ID. The seats were otherwise in good condition as exhibited in Figures 44 and 45.

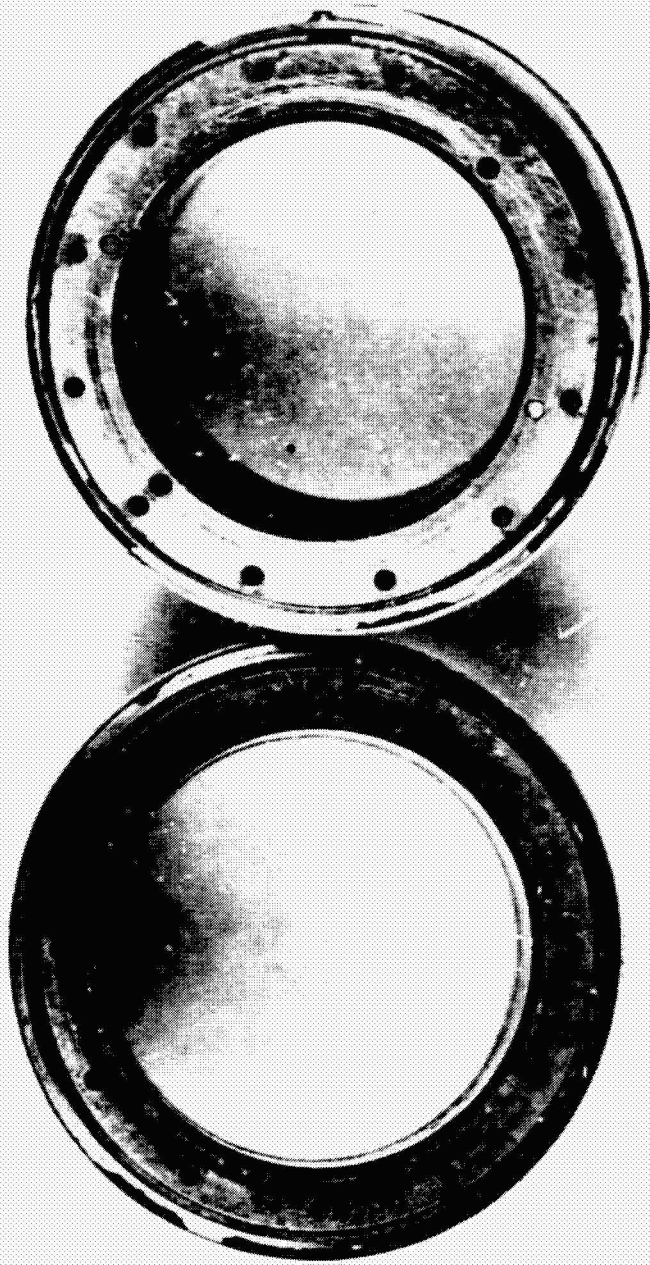
Figure 47. Forward and Aft Windbacks With Bellows Spacers After Endurance Test, Build II.

The bellows clamping spacers acted as centrifugal separators for small particulate matter in the seat cooling oil. The deposits can be seen in Figure 47.

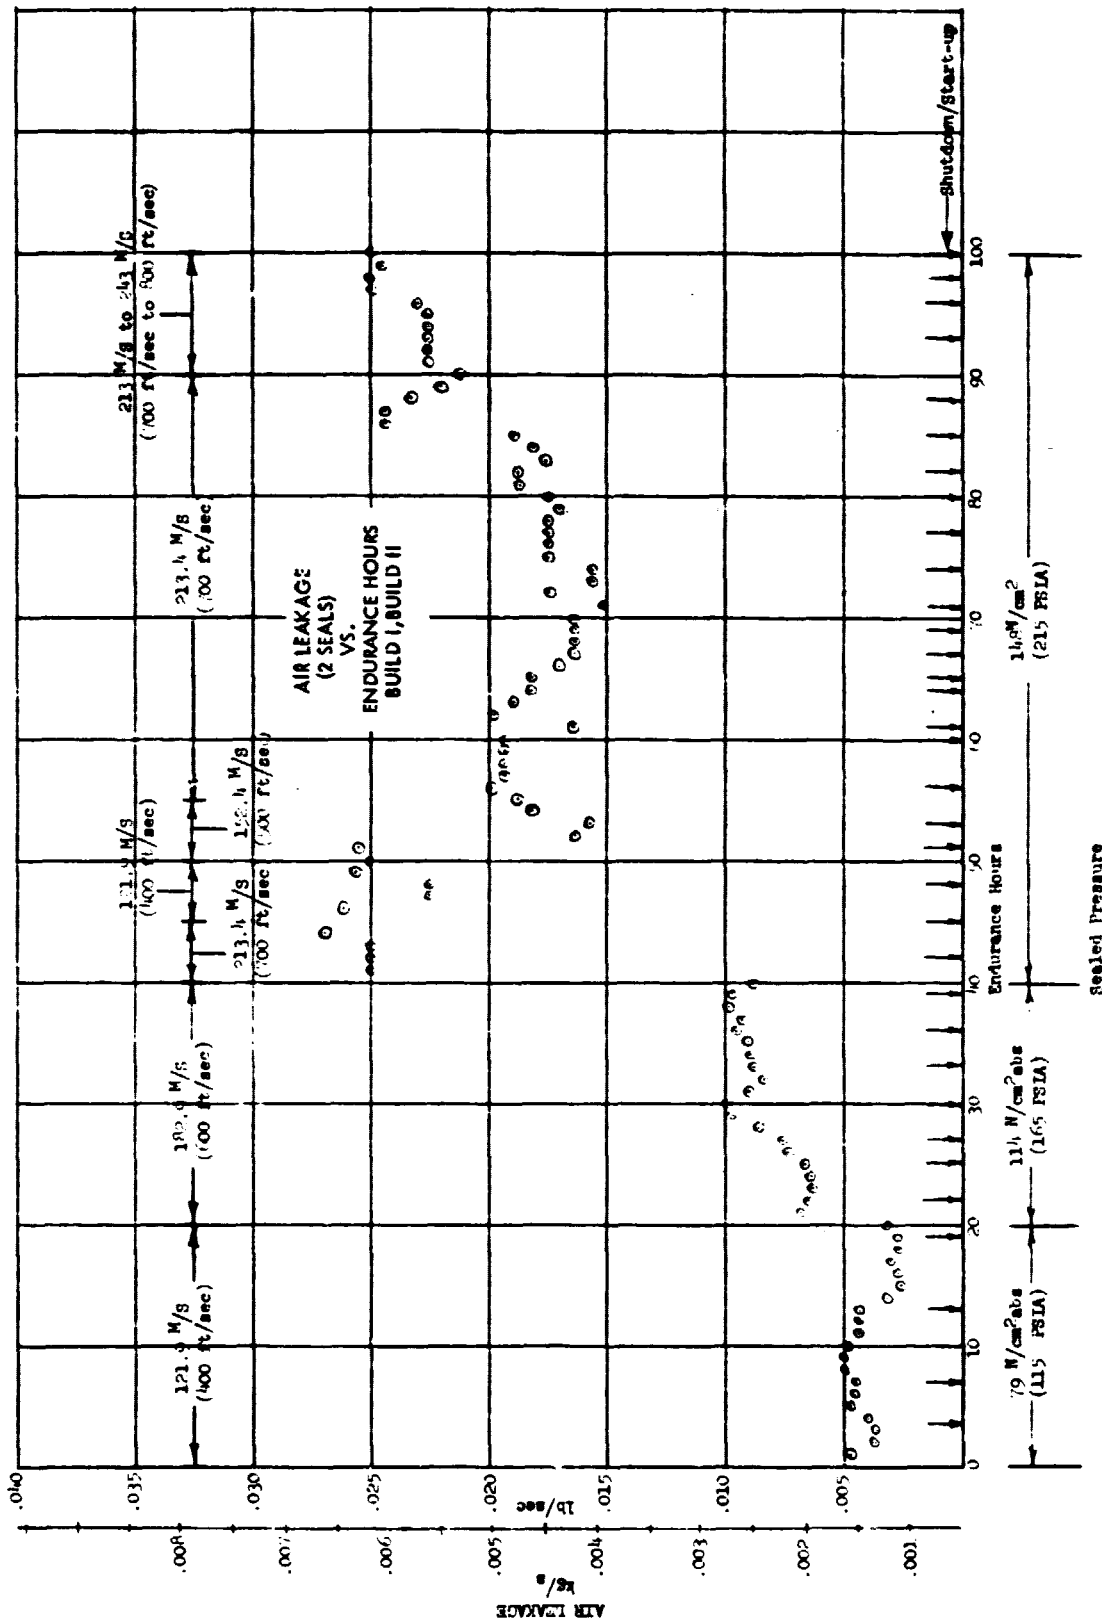
Figure 52. Air Leakage Versus Endurance Hours, Build I, Build II.

Air leakage was plotted as a function of endurance hours and is presented in Figure 52. Changes in operating parameters are indicated on the plot. What appears to be a disproportionate increase in air leakage is seen prior to the bearing problem during Build I. A 60 percent reduction in air leakage is seen at equivalent conditions after the rebuild (Build II).
