NASA TM-73724

**RELIABILITY ANALYSIS OF FORTY-FIVE STRAIN-
GAGE SYSTEMS MOUNTED ON THE FIRST FAN
STAGE OF A YF-100 ENGINE**

by Raymond Holanda and Lloyd N. Krause
Lewis Research Center
Cleveland, Ohio 44135
September 1977

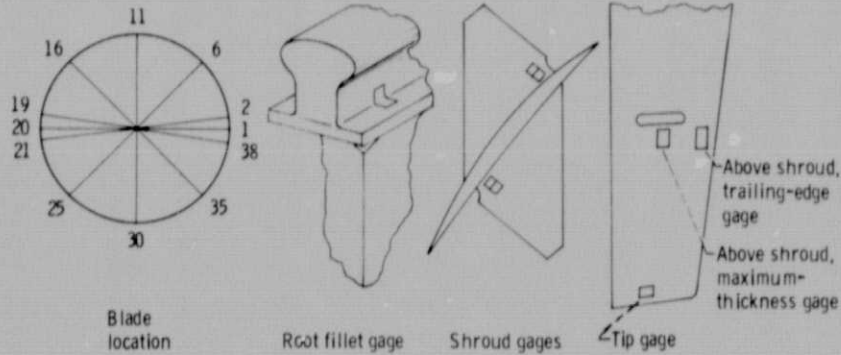
Figure 1. - Strain-gage location map.

Table III shows the 25 gage system failures tabulated according to the gage sensor location on the blade. No location was exempt from a high failure rate, and the rates are distributed with a small deviation about the mean. Table IV lists these gage failures according to installation method and installer. Flame-sprayed gage installations suffered significantly higher failure rates than did the epoxy installations. Table V shows the gage resistance measurements taken at various stages of the investigation. On the basis of these measurements and the visual inspection of the blades, the types of gage failure can be isolated and grouped as shown in table VI. The failures were analyzed according to these groups.

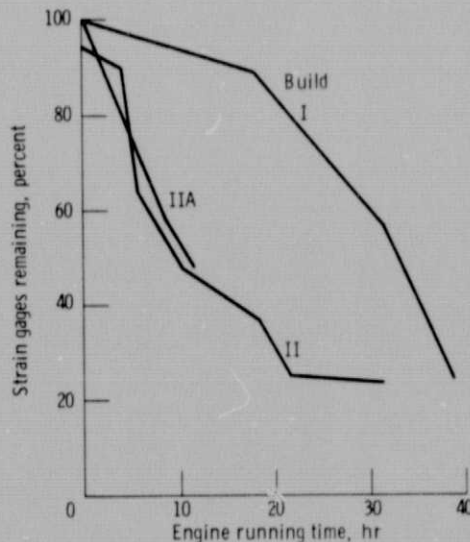
Figure 2. - Strain-gage failure rates for various builds.

The running schedule of the engine for build IIA is shown in table II. Inlet air temperatures up to 340⁰ F and rotor speeds up to 8500 rpm were experienced. At the conclusion of the testing, 23 strain gages were recorded as inoperative at the control room monitoring station. In addition, an inspection added two other gages to the failure list, one that had been intermittent and one with a section of lead wire hanging loose whose failure was imminent, bringing the total apparent failures to 25. The failed gages are shown by the shading on the gage location map (fig. 1), and the rate of gage failure is compared in figure 2 with the rates of failure for builds I and II. The time in flutter for build IIA was about 20 minutes.

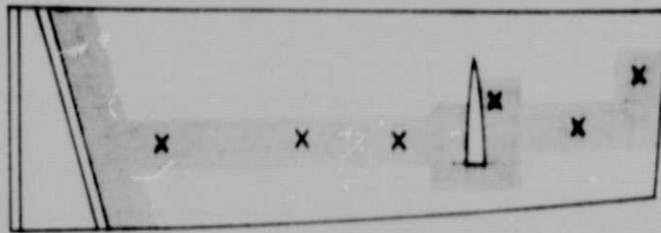
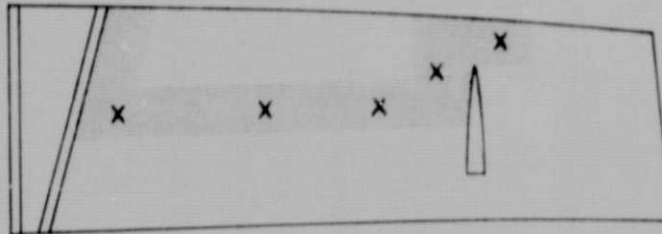
Figure 3. - Strain-gage installation patterns (shaded areas), indicating locations of thickness measurements.

The erosion problem was evaluated by thickness measurements made at various points on the blade (fig. 3) and by visual inspection. The convex side of the blade showed negligible erosion for both flame-sprayed and epoxy materials; the concave side showed high erosion rates.

Assuming zero erosion for the convex side, and assuming that the initial thicknesses of concave and convex installations were the same for a particular blade, the erosion rates for the concave side were determined from the thickness measurements. The results showed a 35-percent erosion rate for epoxy on the concave side between the root and the shroud during the 11 hours of testing. An extrapolation would lead to 100-percent gage failure in a 50-hour test, assuming a linear erosion rate. The flame-sprayed installations eroded about 10 percent, but a greater variation from gage to gage makes this value less certain. Indications are that few failures would be attributed to this mode in a 50-hour test.

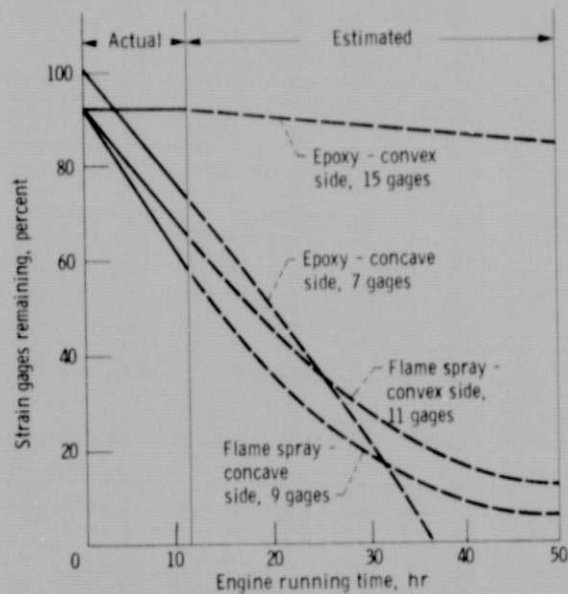
Figure 4. - Strain-gage failure rates for build IIA, failures on the blade. (Figure does not include three root gages.)

A strain-gage failure curve of the type shown in figure 2 appears in figure 4. The failures include only those occurring on the blade, and they are grouped according to the installation method and the side of blade on which the gages were installed. The curves have been extrapolated to 50 hours of engine running time. The extrapolations are based on post-test examination of the blades and take into account such things as erosion rates and rates of increase of gage resistance. The curves dramatically depict the superiority of epoxy-cemented gages on the convex side of the blade both in the actual and in the estimated portions of the curve.

The primary cause of failure in flame-sprayed gages is high gage resistance, probably from high stress levels imposed by the severe running conditions of the flutter program. Temperatures encountered in these tests are considered low for flame-sprayed installations. During portions of the program, some strain gages were subjected to strain levels up to about ± 600 microstrain. This value of strain is near the upper endurance limit for conventional flame-sprayed installations, assuming a typical vibration frequency of 1000 hertz and 20 minutes of flutter time for build IIA. It is possible that gage location on the blade could be changed to deal with this problem.

Because of their superior fatigue strength, the epoxy-installed strain gages were not adversely affected by these strain levels. The primary cause of gage failure in epoxy-cemented strain gages was erosion, but only on the concave side. Wherever possible, a high-endurance foil gage cemented with epoxy on the convex side of the blade should be used. Epoxy-cemented gages maintain a fatigue strength advantage over flame-sprayed installations up to a temperature of about 500⁰ F.

1. The primary cause of blade-mounted failures of the epoxy-installed gages was erosion, but only on the concave side (pressure side) of the blade. Erosion rates on the convex side were mild enough for such an installation to withstand a 50-hour test. It is recommended that epoxy-cemented gages mounted on the convex side be used whenever testing programs operate within the temperature
