**NASA TM-73700**

**FRACTURE SURFACE CHARACTERISTICS OF OFF-AXIS COMPOSITES**

by J. H. Sinclair and C. C. Chamis  
Lewis Research Center  
Cleveland, Ohio 44135

TECHNICAL PAPER to be presented at the  
Fourteenth Annual Meeting of the Society of Engineering Science, Inc.  
Bethlehem, Pennsylvania, November 14-16, 1977

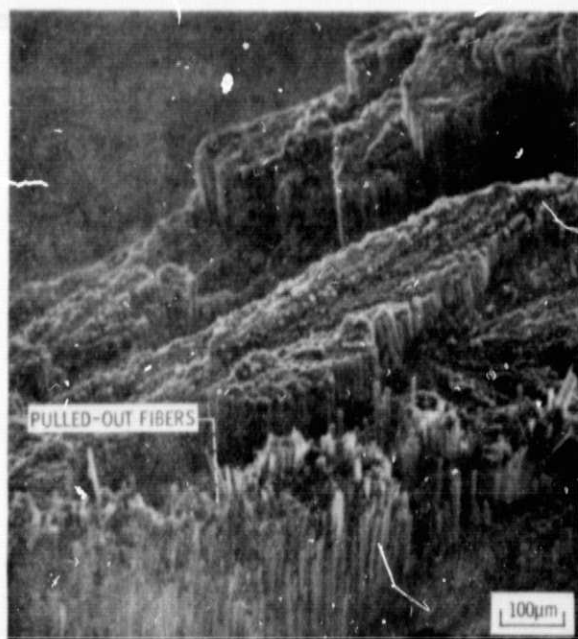
(a) GENERAL VIEW

The fracture surface of the  $0^\circ$  specimen is shown in figure 6. As can be observed, in figure 6(a) the fracture surface is irregular. An area replete with pulled-out fibers that broke off at varying lengths can be observed in the left foreground of figure 6(a). This type of

fracture suggests poor bonding between matrix and fibers. The remaining areas of figure 6(a) show irregularly shaped tiered or stepped surfaces that are typical of the fracture surface of specimens tested in longitudinal tension. At some regions, fibers over relatively large areas fractured at approximately the same level, and they show little fiber pull-out. This is the type of fracture surface shown in figures 6(b) and (c). There was strong bonding between the fibers and matrix in these areas. The fracture mode of the resin was cleavage (fig. 6(c)). Lateral fiber surfaces of these stepped zones show some evidence of sheared resin lying between the fibers as seen in the upper left of figure 6(c).

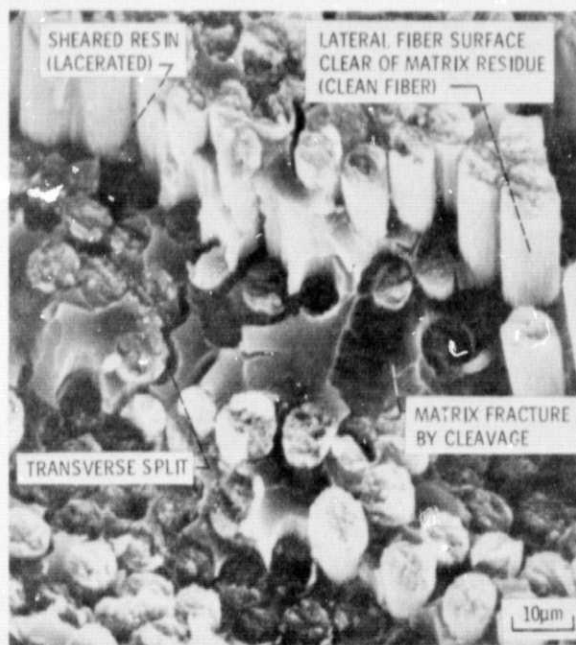
(c) ENLARGEMENT OF DETAIL IN (b) TO SHOW FRACTURE MODE.

The fracture surface in figure 6(c) reveals several distinct features. These features and some significant implications following therefrom are as follows:

1. The fiber fracture surface is irregular but appears to be symmetric from the perimeter towards the center. This type of fiber fracture surface morphology will be considered to be typical of tensile fracture.
2. The matrix fracture surface between fibers at the same level is smooth indicating tensile brittle fracture by cleavage.
3. The matrix fracture surface between fibers at different levels is lacerated indicating fracture by tear which will be considered to "fracture by intralaminar shear."
4. The surface of fibers that pulled-out appears to be clear of matrix residue, in general. This indicates weak interfacial bonding which may be construed to imply that "the interfacial bond is predominantly mechanical."
5. The transverse split in the left foreground is probably caused by the elastic energy release after fracture "back-lash."

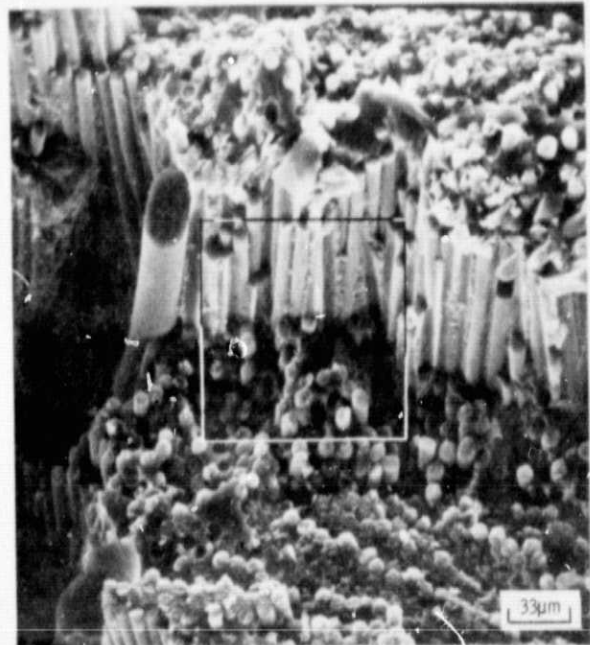
(b) DETAILED VIEW

The fracture surface of the 5° off-axis tensile specimen, figure 7, reveals the following features:

1. Surface tiering (fig. 7(b)) and matrix cleavage (fig. 7(c)) both of which are indicative of tensile fracture.
2. Extensive matrix surface lacerations indicating substantial fracture by intralaminar shear.
3. Fiber pull-out and surfaces free of matrix residue indicating weak interfacial bonding. Recall that all of the above features were observed in the fracture surface of the 0° tensile specimen.

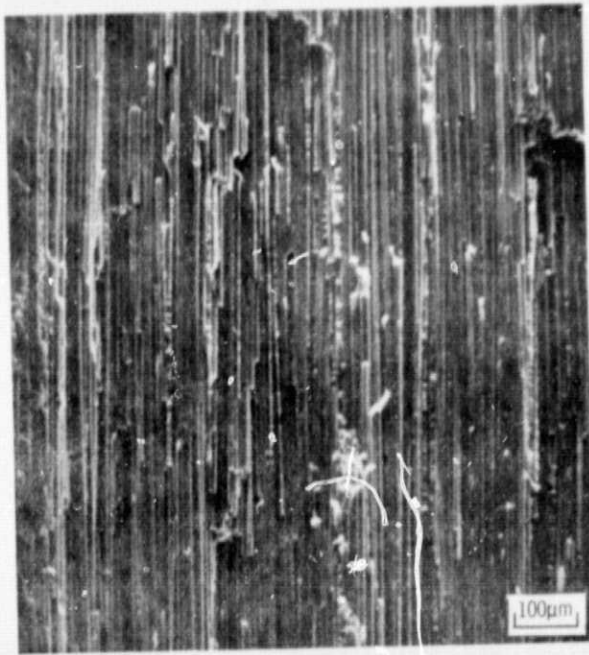
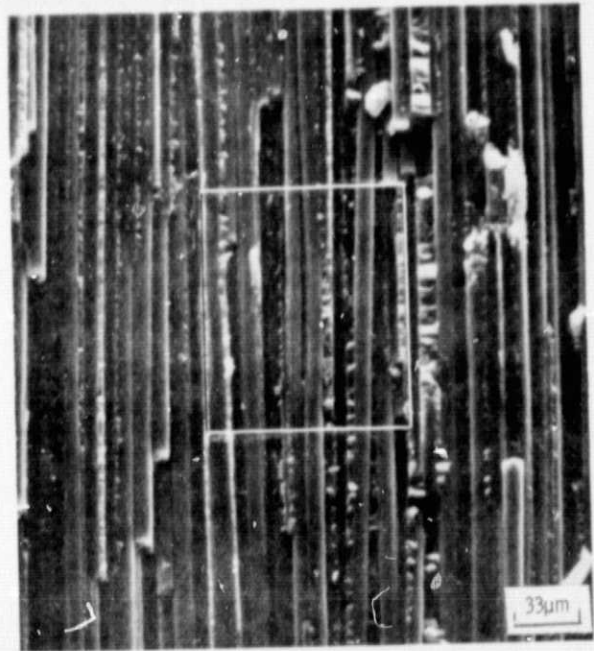
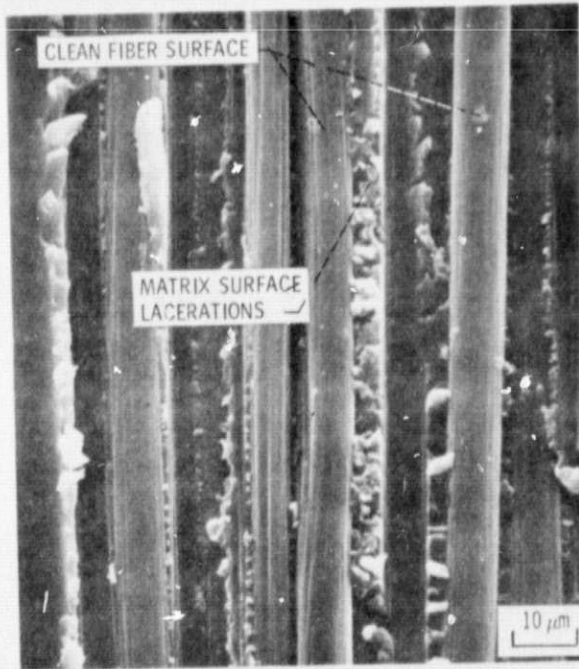
Figure 8. - Scanning electron photomicrographs of fractured surface of MOD/Epoxy composite tested at 10 degrees to the fiber direction.

The fracture of the 10° off-axis tensile specimen of figure 8 reveals: (1) matrix surface lacerations and (2) fiber surfaces free of matrix residue. Both of these features indicate that the intralaminar shear fracture mode became dominant between the 5° and 10° off-axis loadings. We will consider this angle range to fracture by intralaminar shear stress. This observation as well as certain theoretical considerations not covered herein led to the recommendation that: "The 10° off-axis tensile specimen is suitable for intralaminar shear characterization of unidirectional fiber composites [2]."

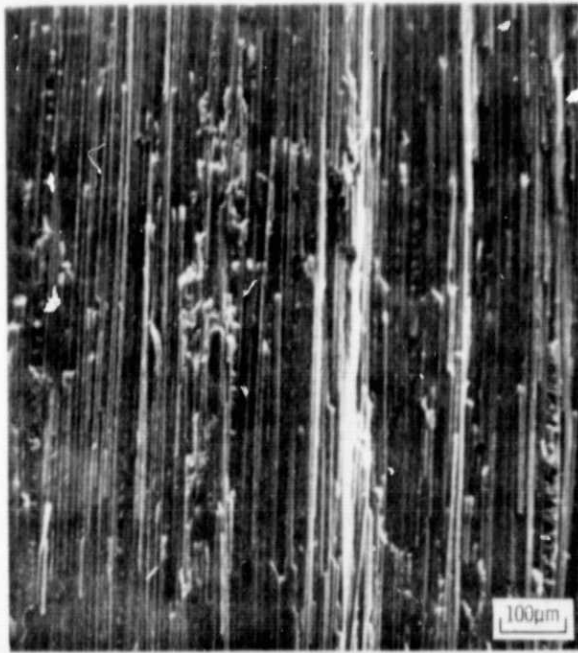
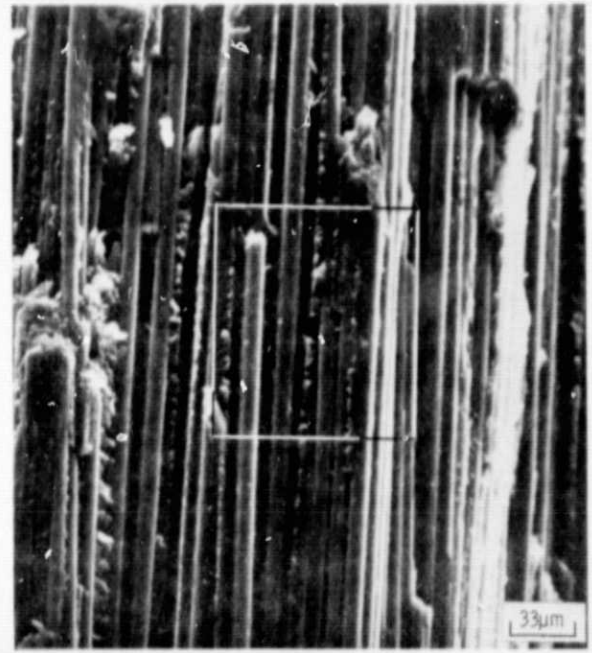
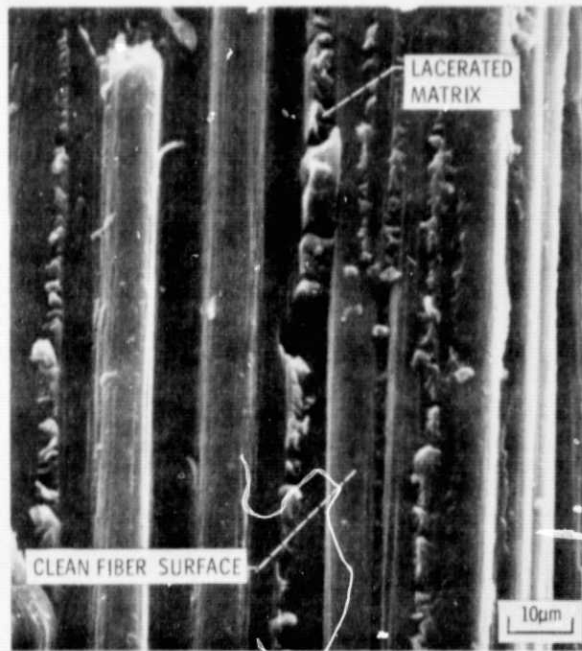
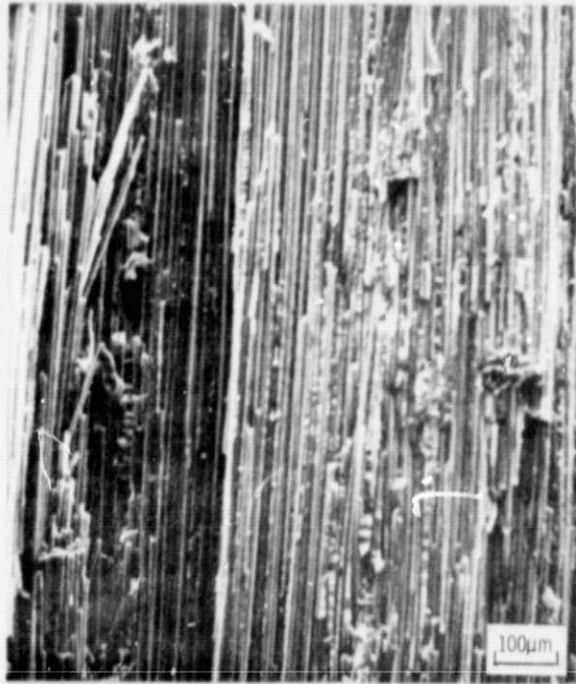
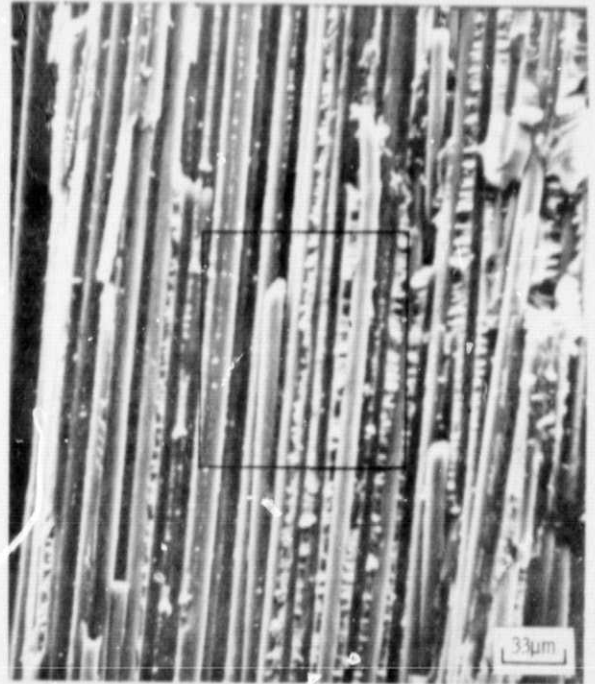
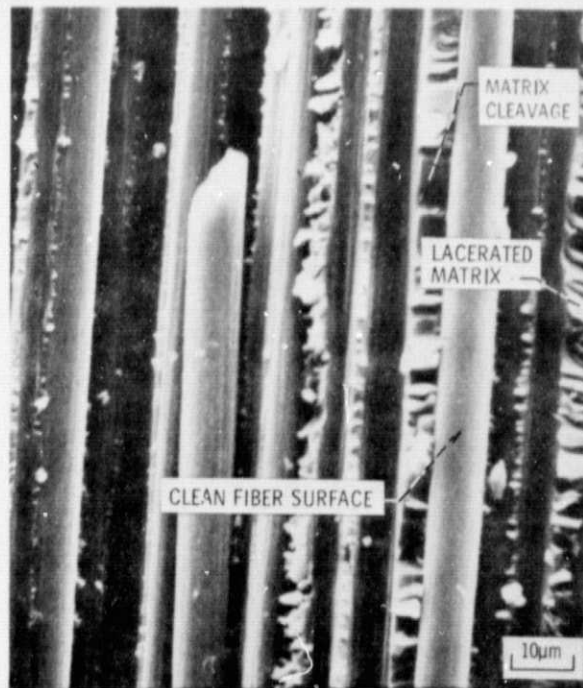
The fracture surfaces of the 15° and 30° off-axis tensile specimens figures 9 and 10 reveal similar features to those of the 10° off-axis tensile specimen. These surfaces, too, indicate that fracture was induced mainly by intralaminar shear stress.

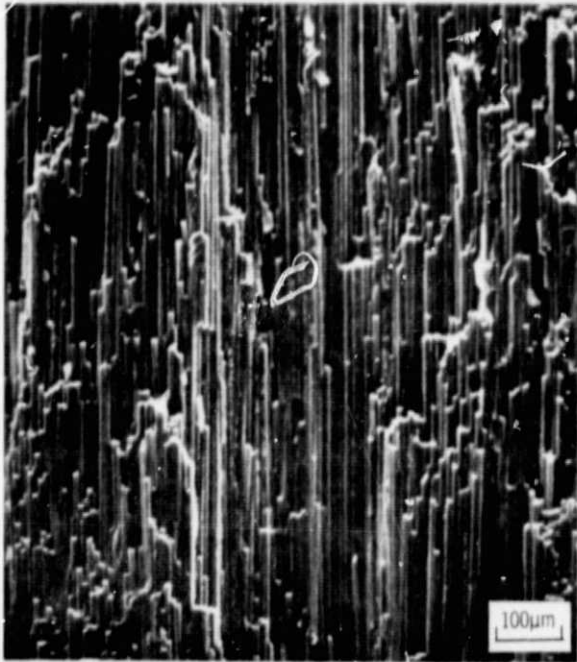
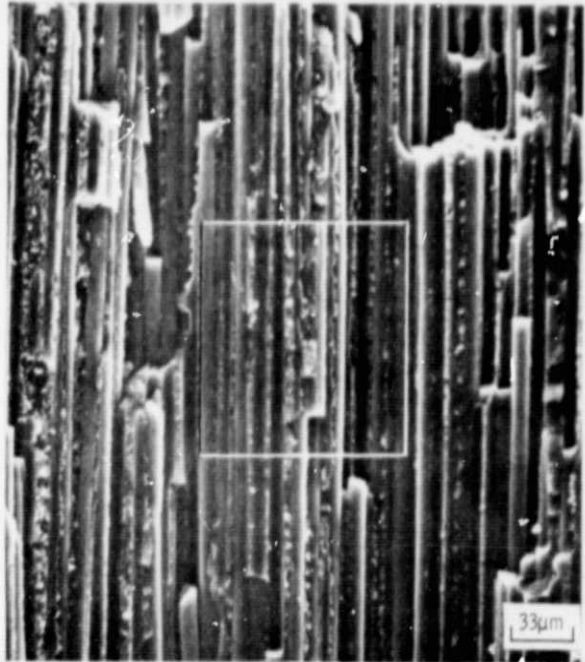
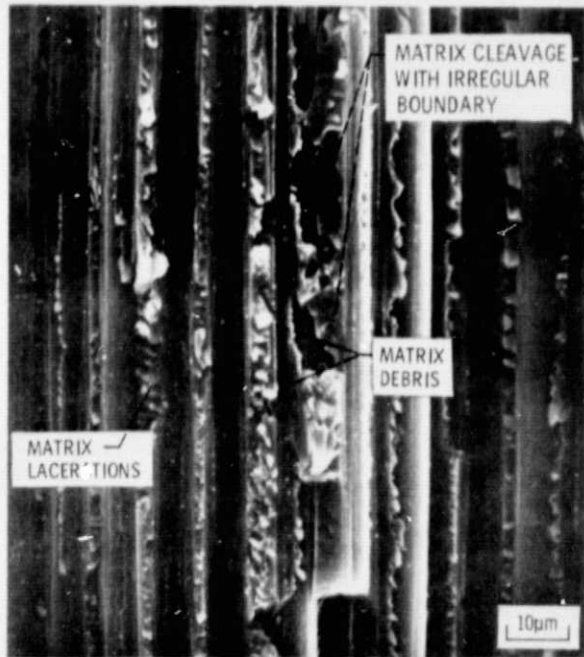
Figure 11. - Scanning electron photomicrographs of fractured surface of MOD/Epoxy composite  $[0]_g$  tested at 45 degrees to the fiber direction.

The fracture surface of the 45° off-axis, figure 11, tensile specimen reveals the following features:

1. Matrix cleavage with irregular boundary indicating some transverse tensile fracture.
2. Matrix debris resulting probably from tensile matrix fracture.

3. Some matrix lacerations indicating some intralaminar shear stress fracture interaction.

The above surface fracture features show that another fracture mode becomes active somewhere between a load angle of  $30^\circ$  and  $45^\circ$ . This mode will be construed to be induced by the transverse tensile stress.

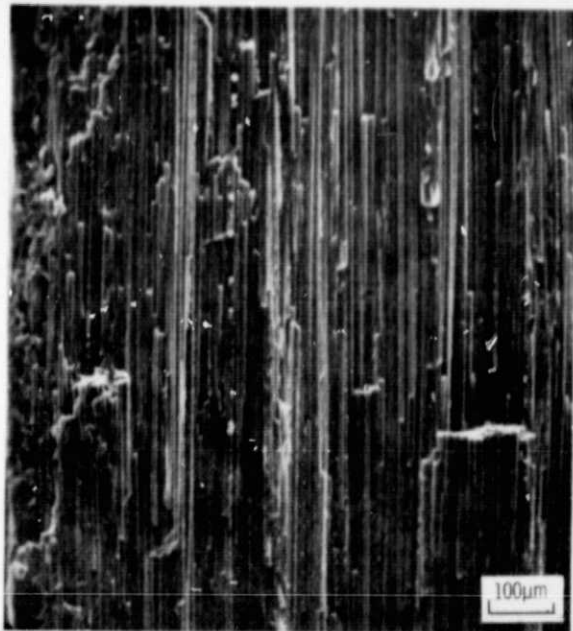
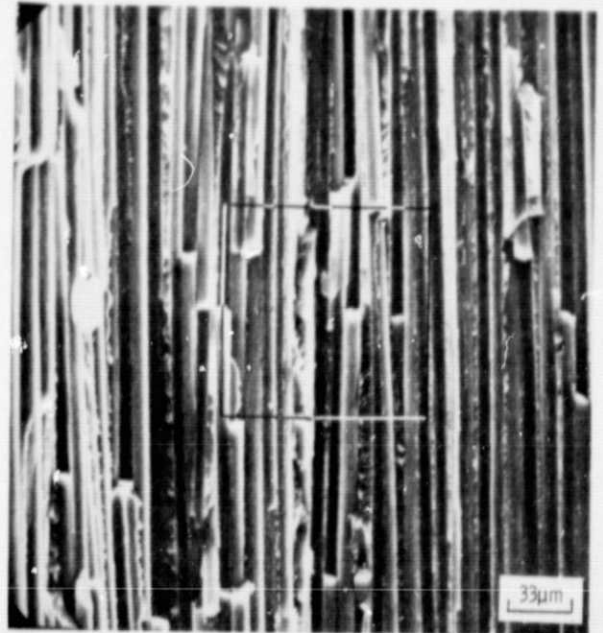
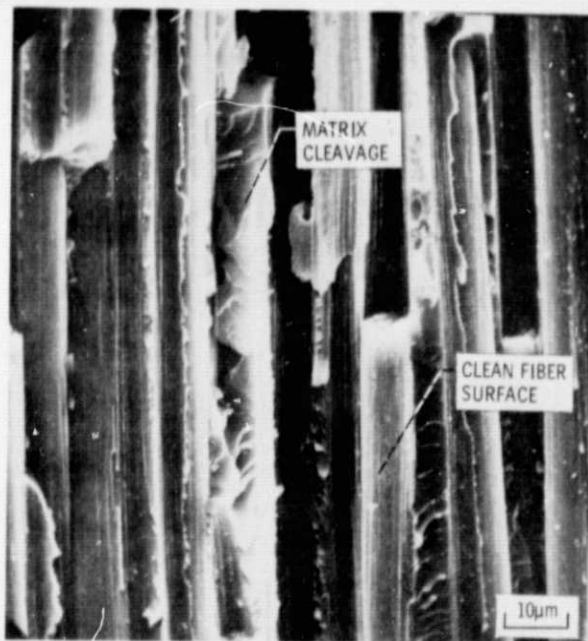
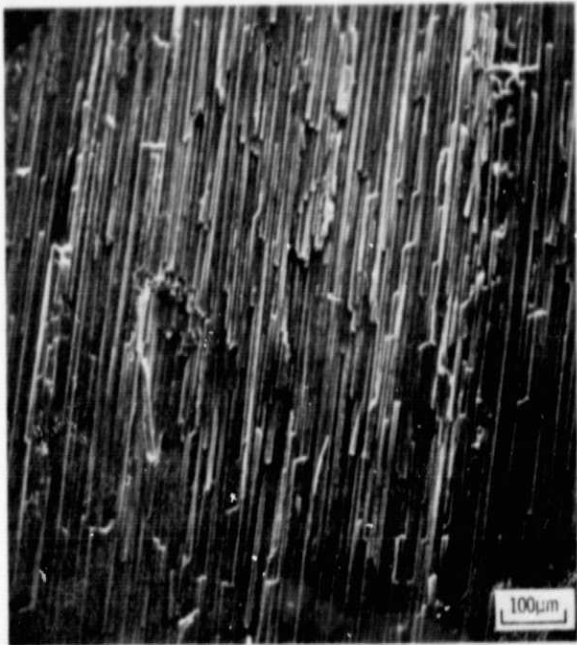
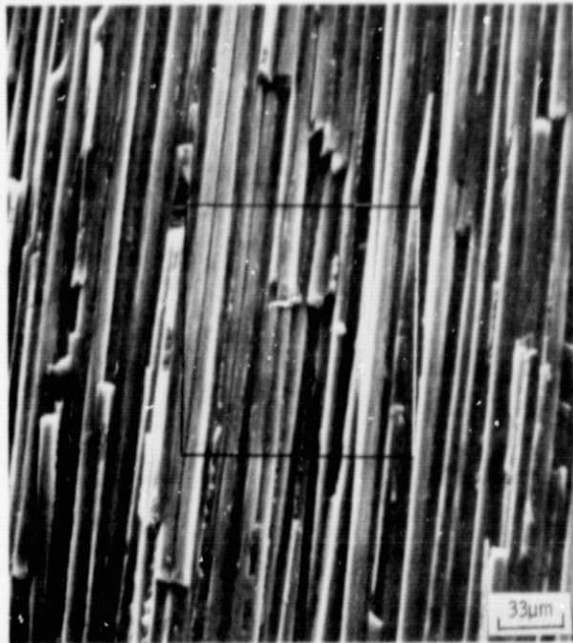
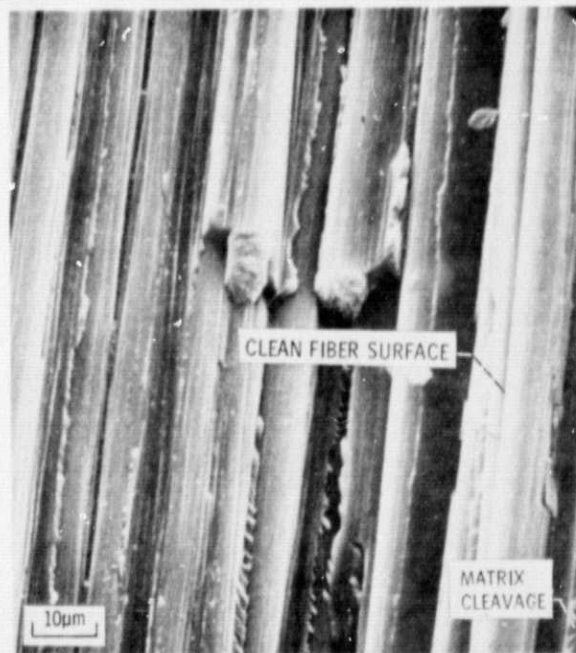
The fracture surfaces of the  $60^\circ$  off-axis tensile specimen, figure 12, and the  $75^\circ$ , figure 13, reveal mainly matrix cleavage and some fiber surface free of matrix residue; both of these features indicate that fracture was induced by transverse tensile stress.

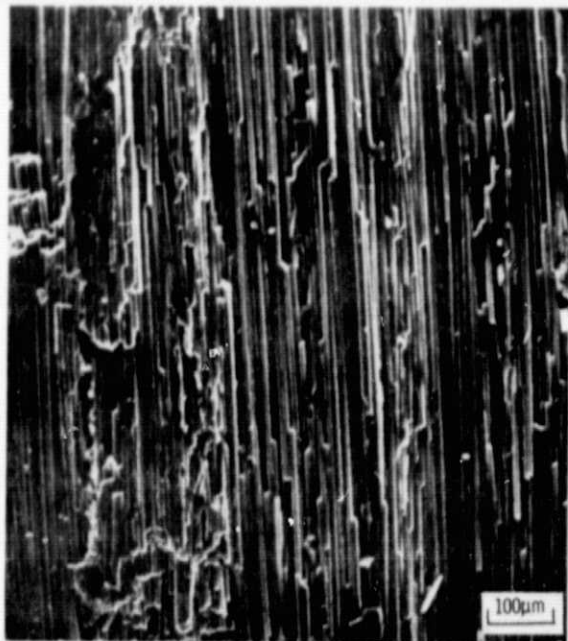
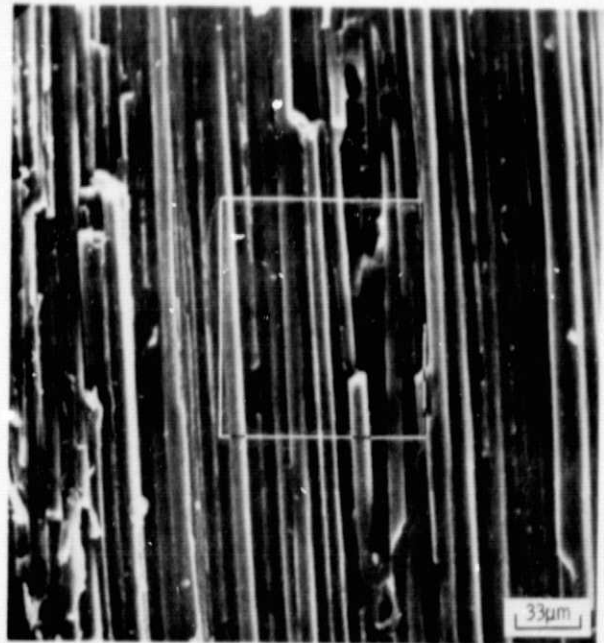
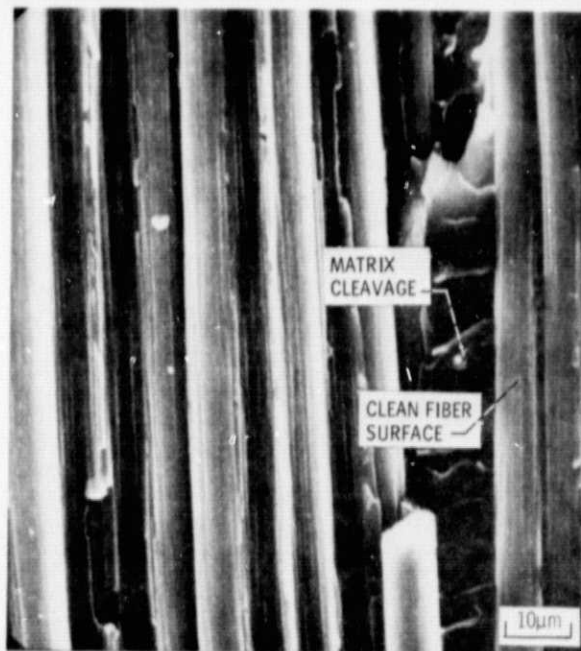
Figure 14. - Scanning electron photomicrographs of fractured surface of MOD I/Epoxy composite [0]<sub>g</sub> tested transverse to the fiber direction.

The fracture surface of the  $90^\circ$  tensile specimen, figure 14, reveals the following features:

1. Matrix cleavage indicative of tensile fracture of brittle materials
2. Fiber surfaces free of matrix residue indicative of weak interfacial bond as was already mentioned.

The above features indicate that transverse tensile stress produces fracture surfaces characterized by: (1) matrix cleavage and (2) fiber surfaces clear of matrix residue.
