1. Report No. NASA CR-144984	2. Government Accession No.	3. Recipient's Catalog No.	
4. Title and Subtitle 737 GRAPHITE COMPOSITE FLIGHT SPOILER FLIGHT SERVICE EVALUATION		5. Report Date May 1976	6. Performing Organization Code

737 GRAPHITE COMPOSITE FLIGHT SPOILER FLIGHT SERVICE EVALUATION

Robert L. Stoecklin
Boeing Commercial Airplane Company

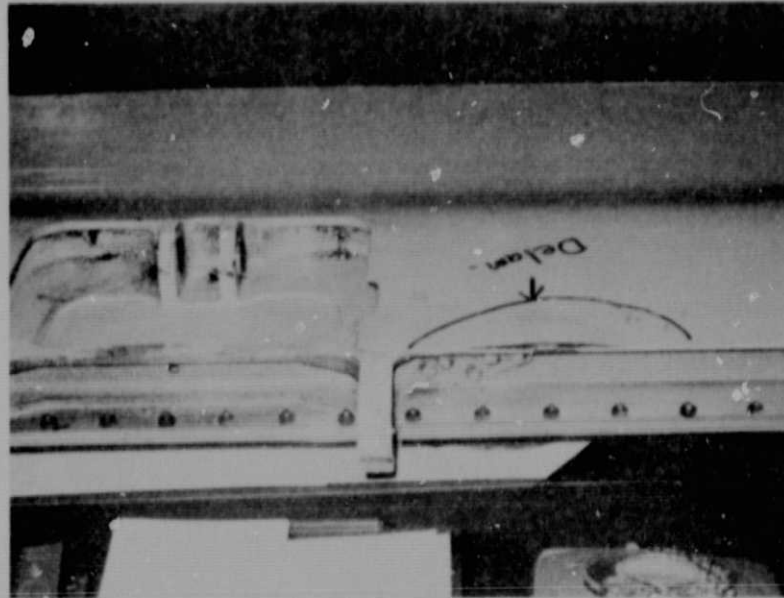
On January 28, 1976 New Zealand National Airways (NZNAC) reported a problem of delamination along the front spar/skin interface of spoiler S/N 0050 (fig. 2). The panel was removed from the aircraft. Additional inspection activity at NZNAC identified another spoiler, S/N 0009, which exhibited a similar though less severe delamination. Both panels were returned to Boeing for evaluation.

Figure 2.—Delamination Resulting from Exfoliation Corrosion Under Skin

Detailed examination of both units revealed that the fundamental problem was one of exfoliation corrosion of the aluminum spar element. The corrosion commenced at the hinge fitting/spar butt joint and progressed outboard within the spar chord. Expansion of the corroding aluminum generated the expanding force which precipitated the skin delamination. The corrosion was contained entirely on the spar side of the adhesive bondline and no evidence was found to suggest that the presence of the graphite skin accelerated the corrosion. No corrosion was found in the center hinge fitting nor in the aluminum core adjacent to the corroding spar. The corrosion is attributed to intrusion of moisture through a crack in the sealant material and through a suspected defect in the BAC 5555 surface preparation. Spoiler S/N 0050 has been removed from the program; S/N 0009 is being evaluated further.

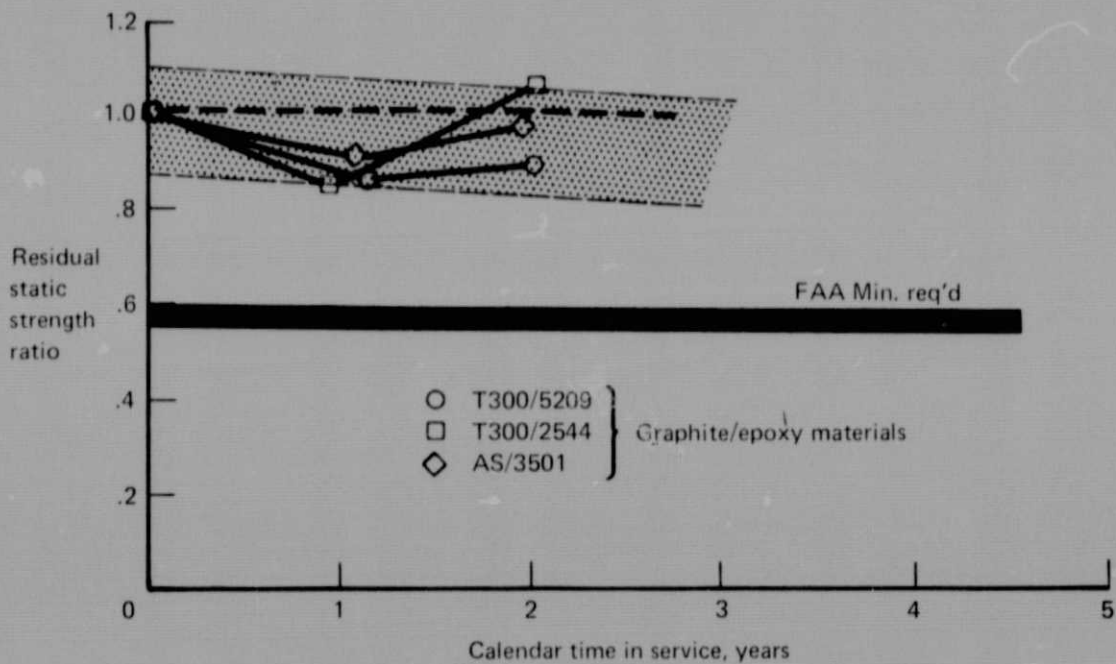
It is significant to note that all three spoilers destructively tested yielded residual static strengths greater than the corresponding part-numbered units tested after 1 year of

service. Figure 4 shows a plot of all test data plotted as a function of time. This data points out the potential scatter in the strength data being collected, and at the same time defines a degradation with time significantly lower than was indicated following completion of the first years testing. The test failures of the second year specimens are shown in figures 5 through 10.

Figure 4.—Residual Static Strength of Graphite-Epoxy Spoilers After Removal From Flight Service

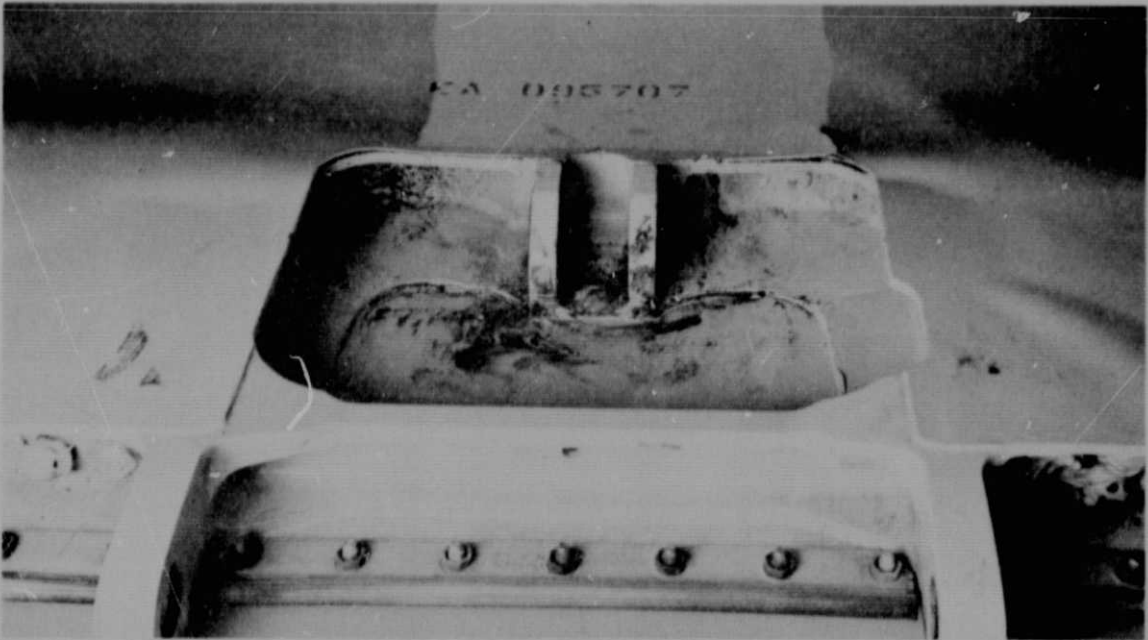
Figure 7.—Failed Static Test Specimen S/N 0057

Figure 8.—Failed Static Test Specimen S/N 0057
