NASA Technical Paper 1042

Light Airplane Crash Tests at Impact Velocities of 13 and 27 m/sec

Emilio Alfaro-Bou and Victor L. Vaughan, Jr.

NOVEMBER 1977

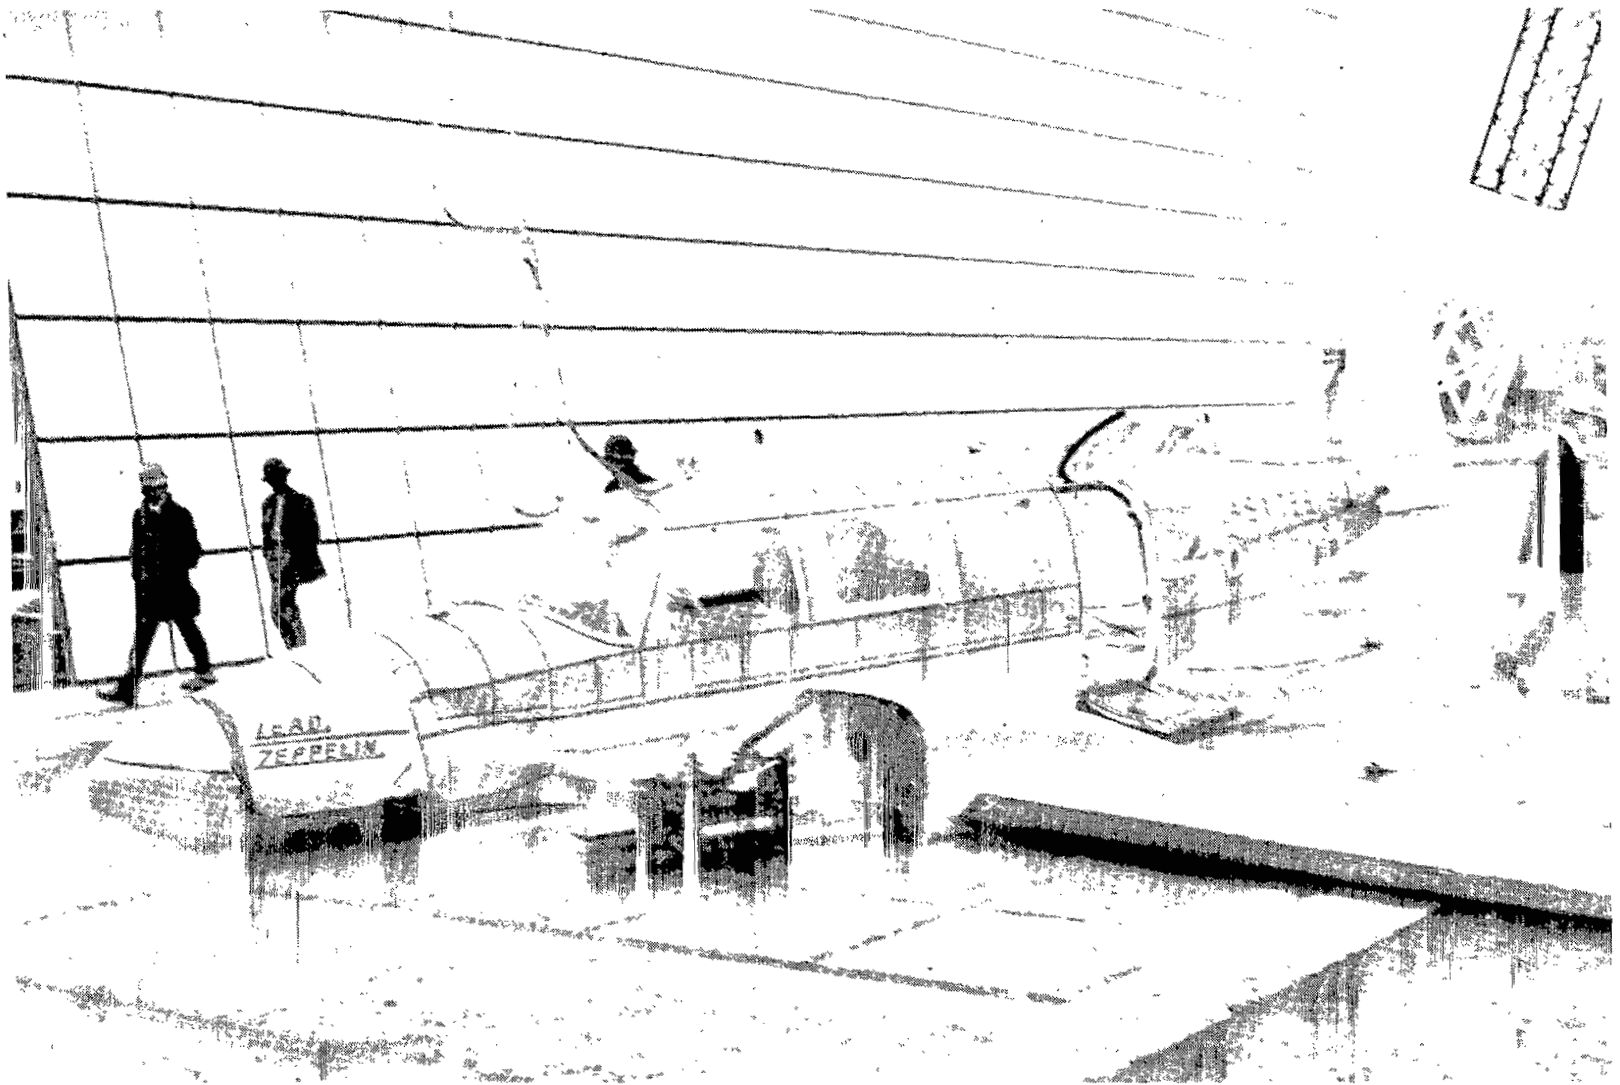
Photographs showing external damage to the specimens for tests 1 and 2 are shown in figures 10 and 11, respectively. The damage to the nose area of the specimen was approximately the same for both tests. (See figs. 10(a) and 11(a).) The crash forces in the nose area were more intense and the damage more severe than in other parts of the specimen. However, the damage was restricted to the cowling and fire wall where most of the impact energy was absorbed by crushing of the structure during nose contact. Some of the remaining energy in the form of small attenuated forces and motions was transmitted to the cabin area.

(a) Overall damage.

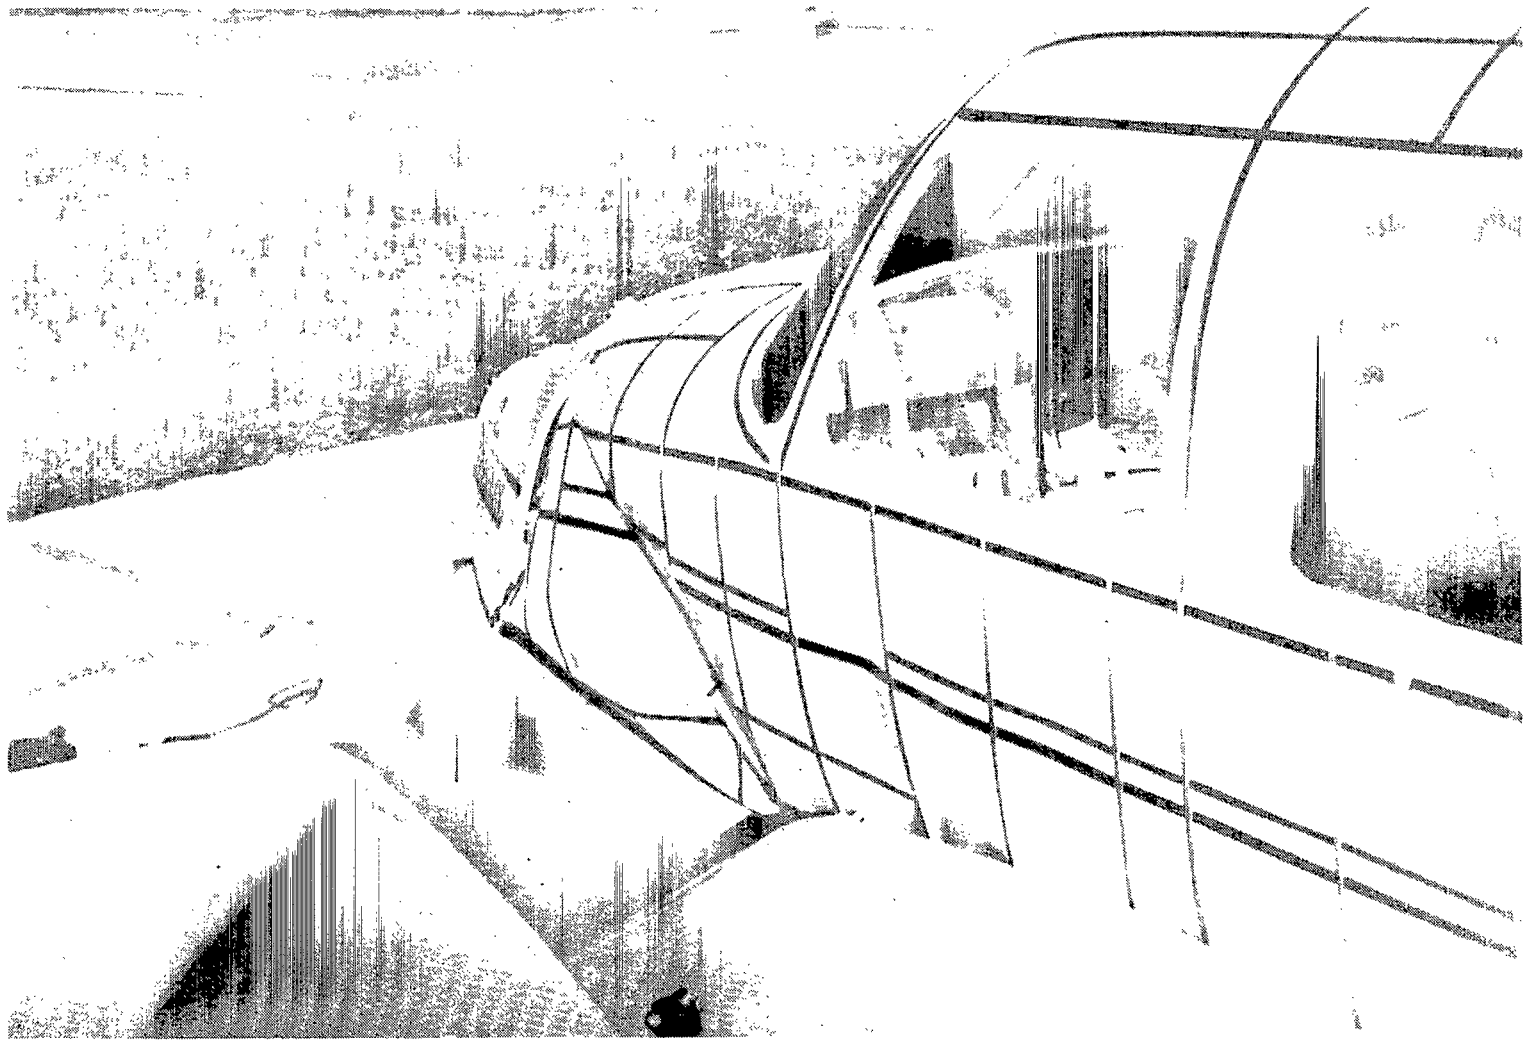
(b) Closeup of nose damage.

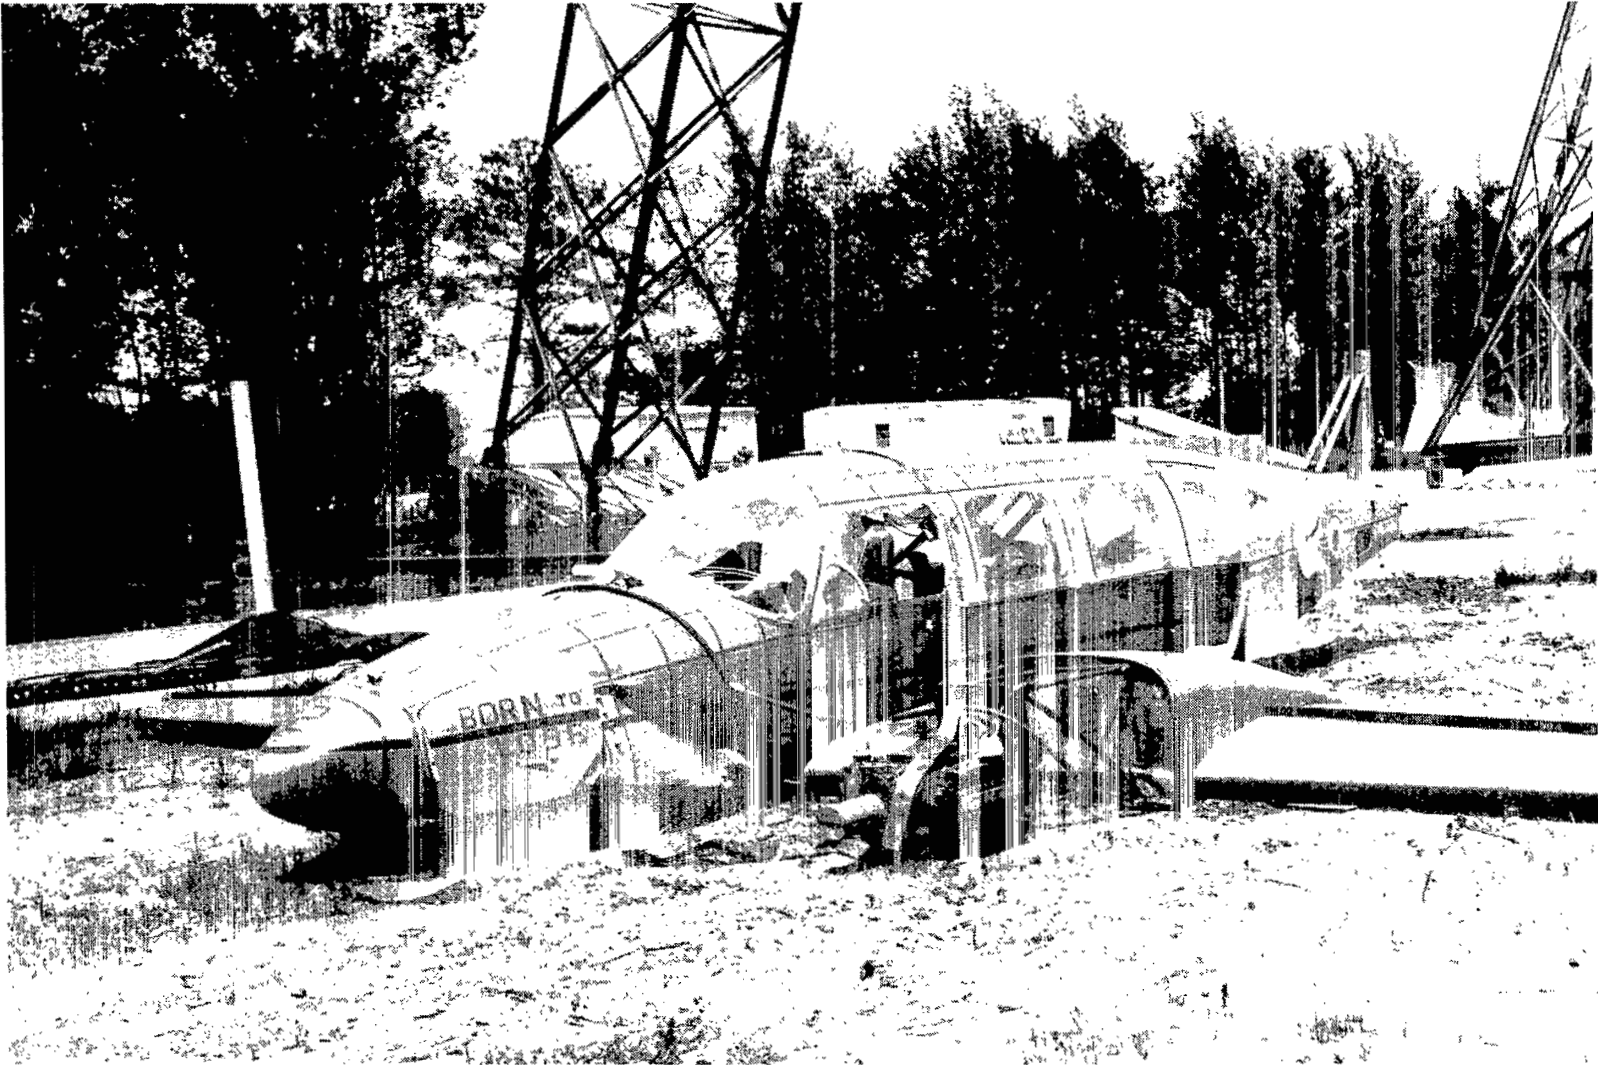
(a) Overall exterior damage.

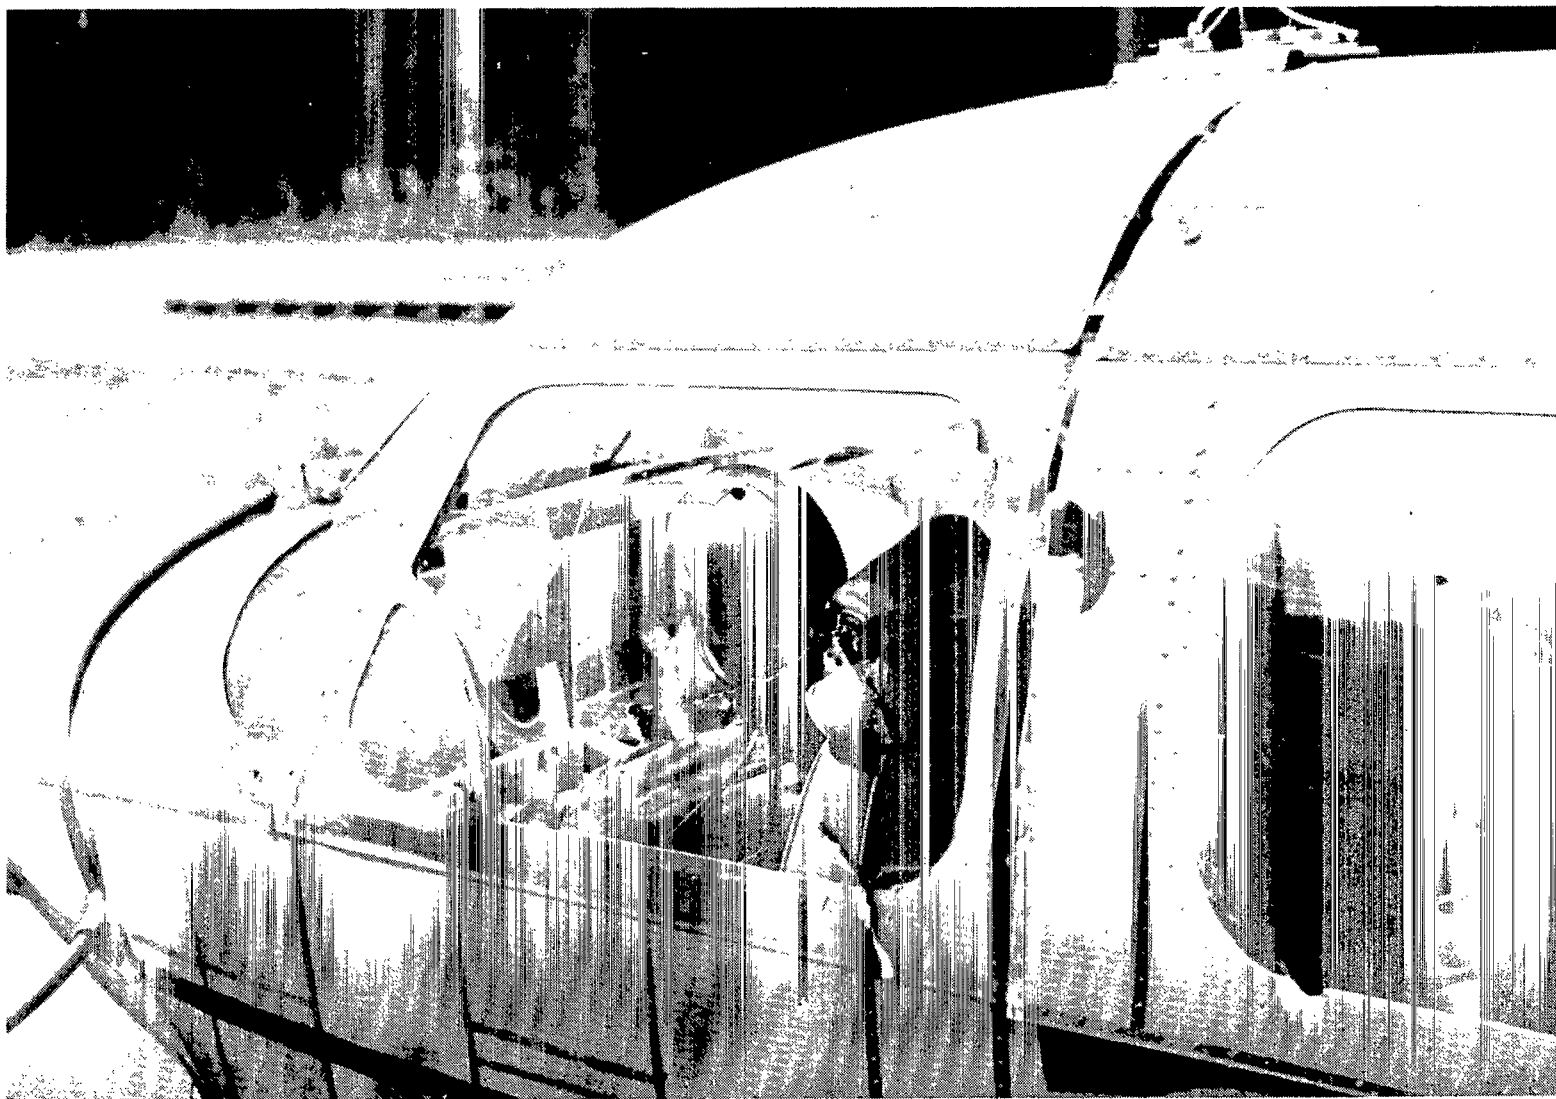
In test 2 the skin wrinkled from nose to tail on both sides of the fuselage. The overlapping sheet metal on top of the fuselage separated along the rivet line behind the first window due to rivet shear. Similar breaks occurred along the rivet line at the base of the windows. (See figs. 11(a) and 11(b).) The separation along the rivet line on top and along the side of the fuselage occurred during second impact when the roof continued to move downward as the floor was brought to rest and this movement caused a lateral expansion of the cabin.

(b) Sheet metal separation along rivet lines.

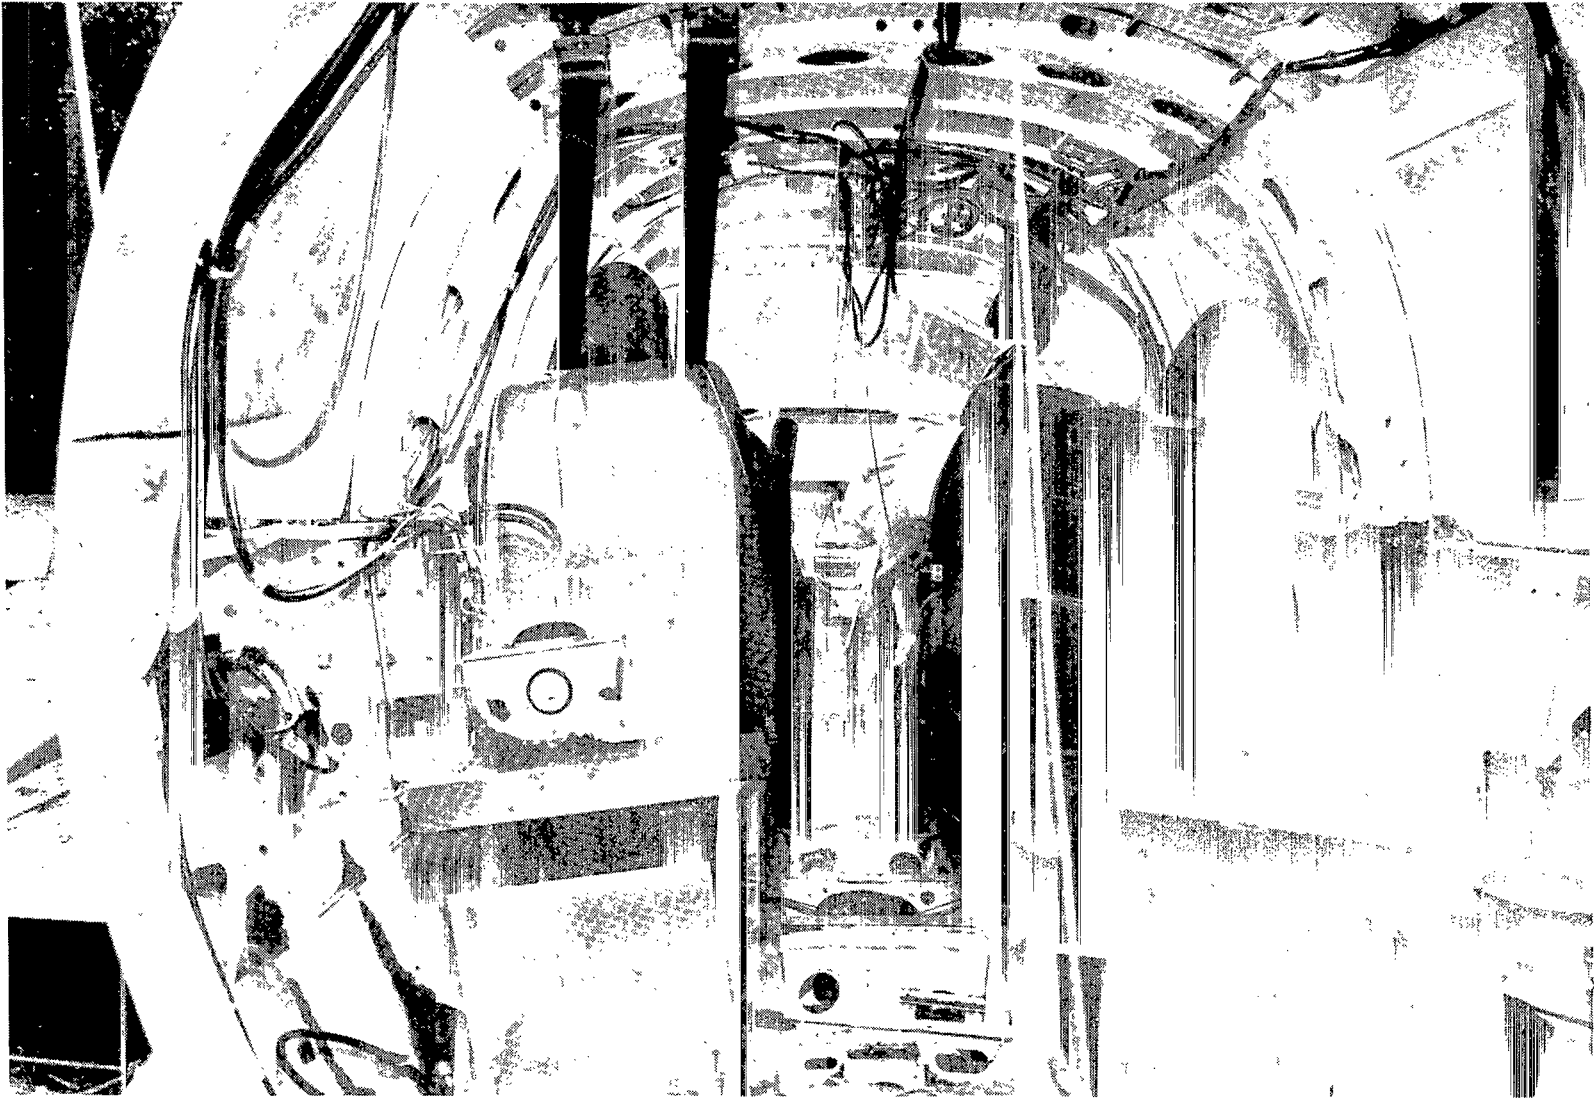
The interior damage to the cabin in test 1 was relatively mild, significant damage occurring in the fore cabin in the vicinity of the instrument panel and fire wall. The damage to the cabin interior for test 2 is shown in figures 11(c) and 11(d). In test 2 the cross members in the floor structure under the front legs of the pilot and copilot seats collapsed. This was due to the forward and downward thrust of the seats and occupants. In the cabin area aft of the main spar (fig. 11(c)), the structural damage is evident in the deflection of the two outer floor panels about the floor beams. During second impact, the rounded

bottom portion of the fuselage beneath the floor beams contacts the ground and is flattened. As the impact progresses, the vertical motion of the floor beams is arrested while the roof and sides of the cabin continue to move downward. This downward movement of the sidewalls causes the two floor beams to appear to move upward and outward. This deformation pattern continues until the impact energy is dissipated in deforming the cabin structure. At maximum cabin deformation the support frames yielded on their sides and the cabin assumed an oval shape (fig. 11(d)). In test 2, at maximum cabin deformation the sides of the airplane moved outward 21 cm at the center and the distance between the roof and the floor was reduced by 23 cm. Figure 12 presents peak-to-peak normal and longitudinal accelerations at longitudinal stations along the specimen structure. Peak-to-peak accelerations measured normal to the floor beam for tests 1 and 2 are shown in figure 12(a). They give a general idea of the acceleration levels at various locations adjacent to the floor beams. The average peak-to-peak acceleration was 78 percent higher in test 2 than in test 1. For both tests, the accelerations were higher at the nose and near the main spar, and lower at the fire wall and toward the rear of the cabin.

(c) Interior damage.
