NASA TM X- 74039

HYPERVELOCITY IMPACT TESTS ON SPACE SHUTTLE ORBITER
THERMAL PROTECTION MATERIAL

Donald H. Humes
Langley Research Center

June 1977

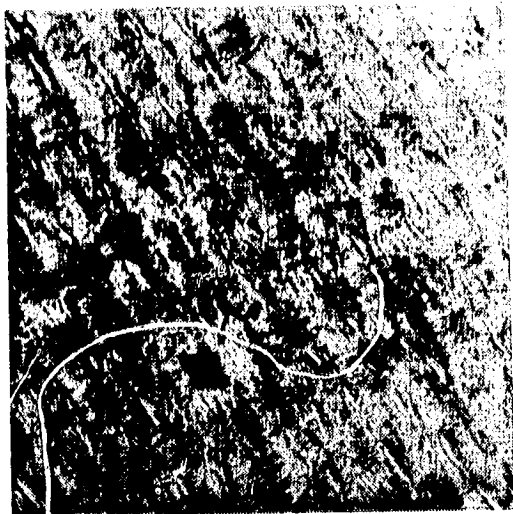
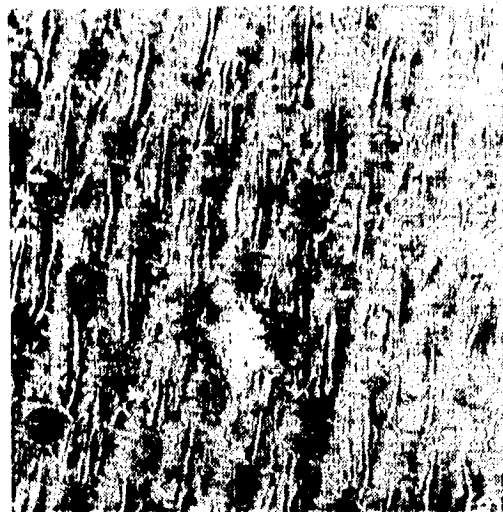
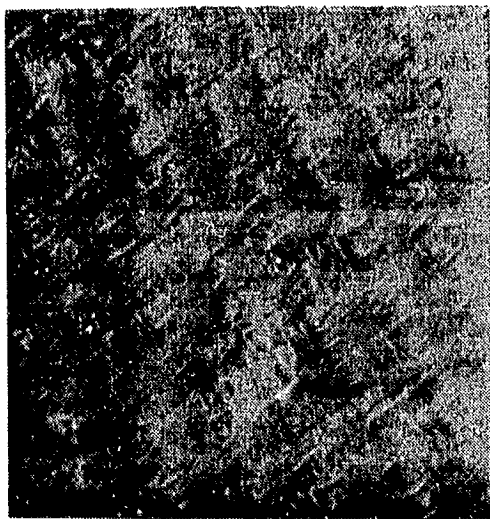
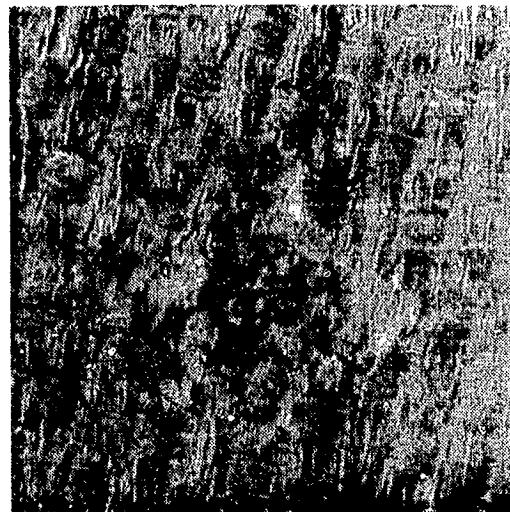
Only the front surface was cratered when the impact energy was 3 J, or less. Photographs of the front surface of the four specimens which were damaged only on the front surface are shown in figure 3. At 3 J a trace of the black carbon interior was exposed. At lesser energies only the exterior layers were penetrated. The exterior layers have good resistance to penetration but are brittle and spallation occurs around the impact point; see the front surface area damaged in table I. Information on how brittle the material is and how much resistance to penetration it has can be obtained by comparing the damage with that done to cold rolled steel under the same impact conditions. The test using specimen 3-74 provides an excellent comparison. In that test, three glass projectiles were launched (see figure 1(b)). The projectiles were all the same size and were accelerated to the same

(a) specimen 3-78
0.2 J

(b) specimen 3-70
0.3 J

(c) specimen 3-74
0.3 J

(d) specimen 3-80
3 J

Figure 3.- Photographs of the front surface of specimens struck by projectiles with kinetic energy of 3 J or less.

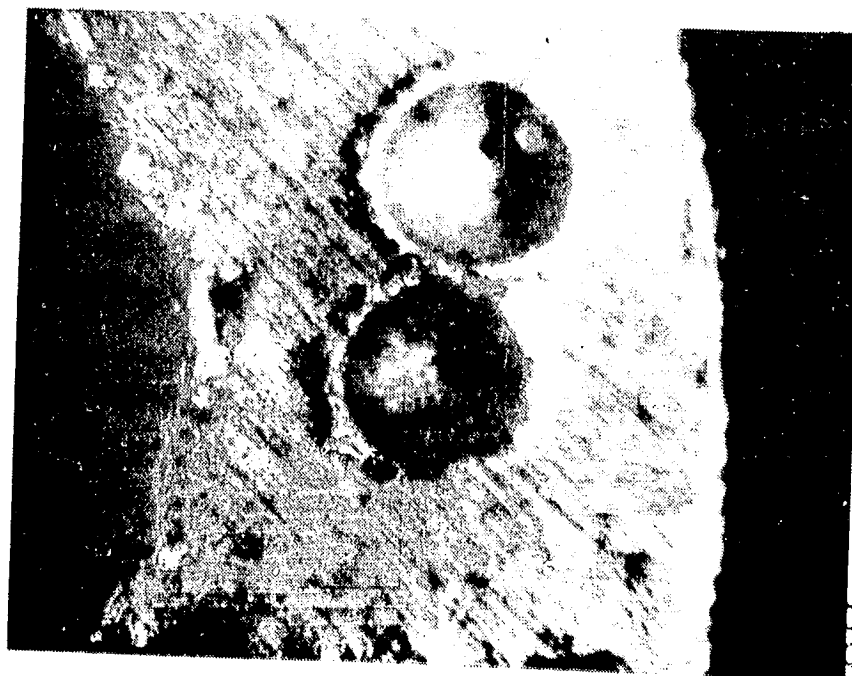
velocity. One projectile struck specimen 3-74 while the other two struck the cold rolled steel baffle. The photographs in figure 4, which are at the same magnification, show the damage produced in the specimen and the steel. The area damaged on the LESS material specimen is 6 times the area damaged on the steel. The depth of penetration was about 480 μm in the LESS material and about 240 μm in the steel. That shows good resistance to penetration especially since the LESS material is only about 1/5 as dense as steel.

(b) cold rolled steel
0.3 J

Figure 4.- Photographs of damage caused by 0.27 mm glass projectiles
at 5.4 km/s.

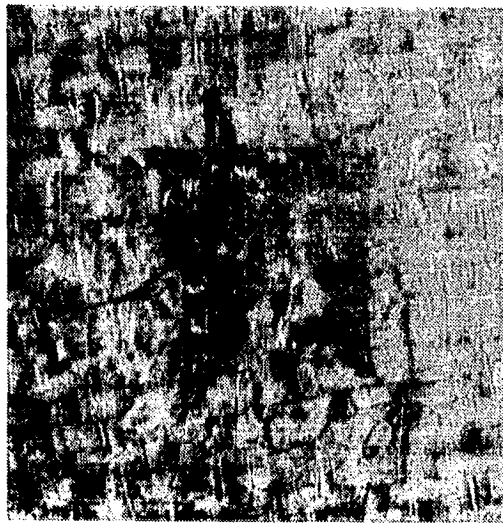
The impact at 11 J in specimen 3-72 produced an impact crater on the front surface and a spallation crater on the back surface, although there was no hole through the material. Photographs of both sides of specimen 3-72 are shown in figure 5. Notice the similarity in the damage to both sides. Spallation is common in hypervelocity impacts into brittle materials, even in aluminum and steel (see ref. 1), which are not nearly so brittle as the LESS material.

(a) front surface

(b) back surface

Figure 5.- Photographs of specimen 3-72. Kinetic energy of projectile was 11 J.

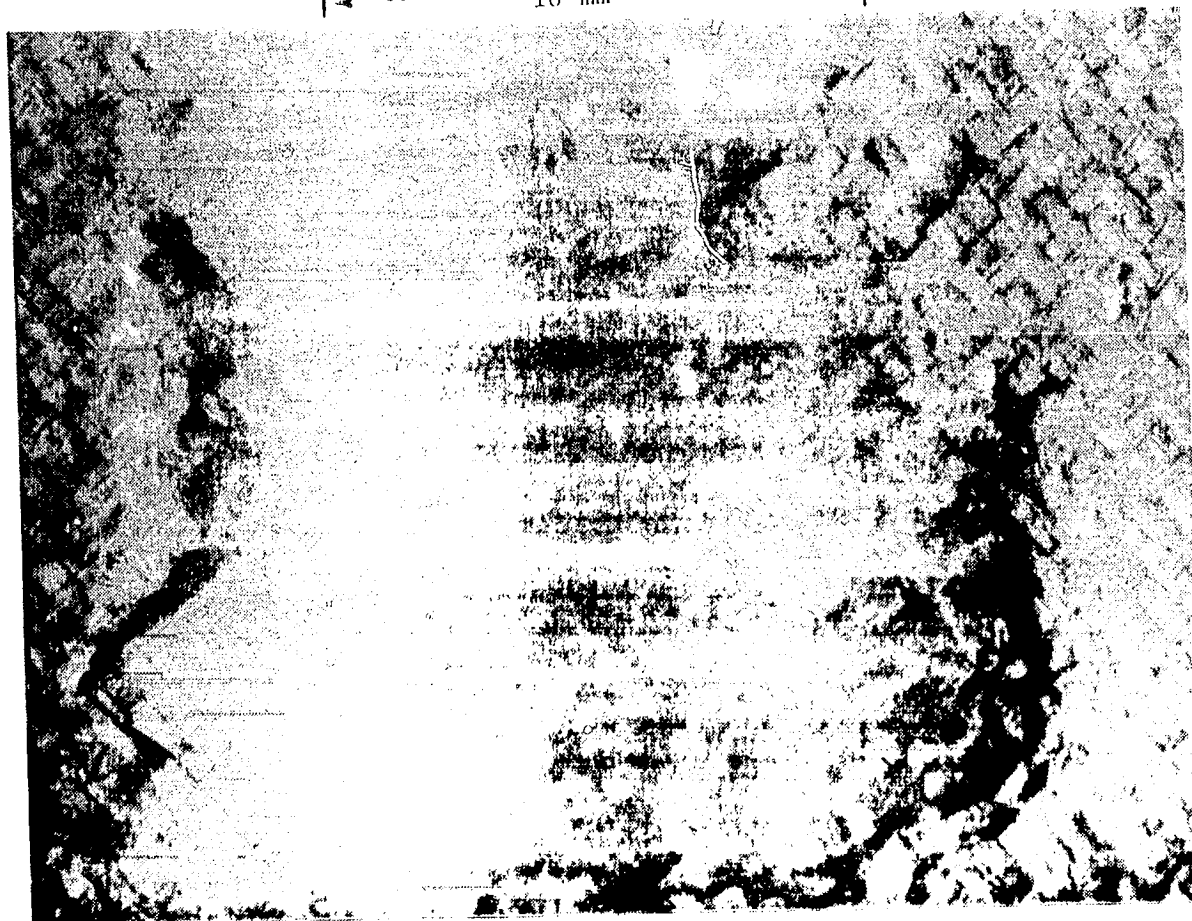
The specimens were completely penetrated when the impact energy was 34 J or greater. The size of the hole is given in table I. The area damaged on the front and back surfaces is also given in table I. Notice that the rear surface was damaged more extensively than the front surface. The shock wave originating at the impact site caused delamination near the back surface when it was reflected from that surface. Much of the delaminated material was lost as detached spall while some remained attached. Photographs of the front and back surfaces of the three specimens which were completely penetrated are presented in figure 6.

front surface

back surface

Figure 6(a).- Photographs of front and back surface of specimen 3-76.
Kinetic energy of the projectile was 74 J.

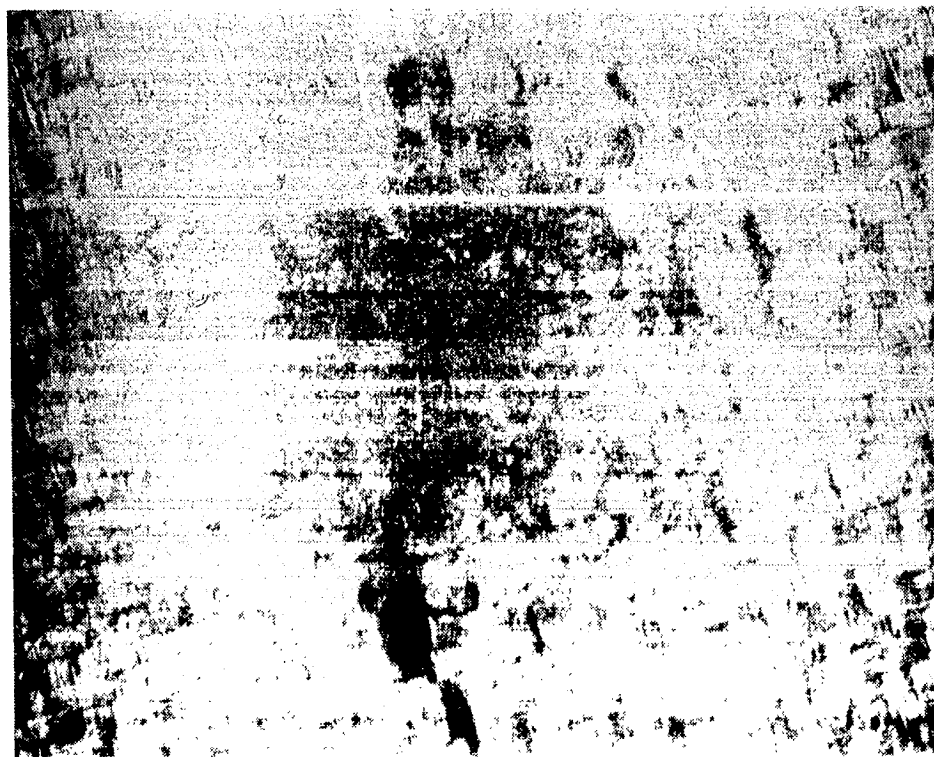
front surface

back surface

Figure 6(b). Photographs of front and back surface of specimen 3-77.
Kinetic energy of the projectile was 57 J.

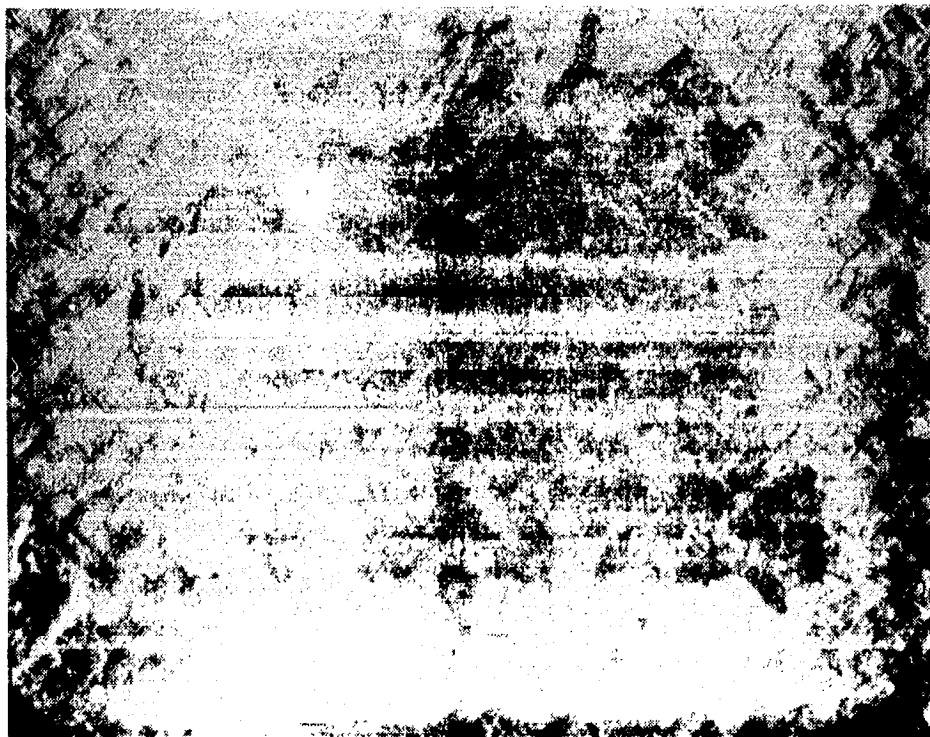
front surface

back surface

Figure 6(c).- Photographs of front and back surface of specimen 3-73.
Kinetic energy of the projectile was 34 J.

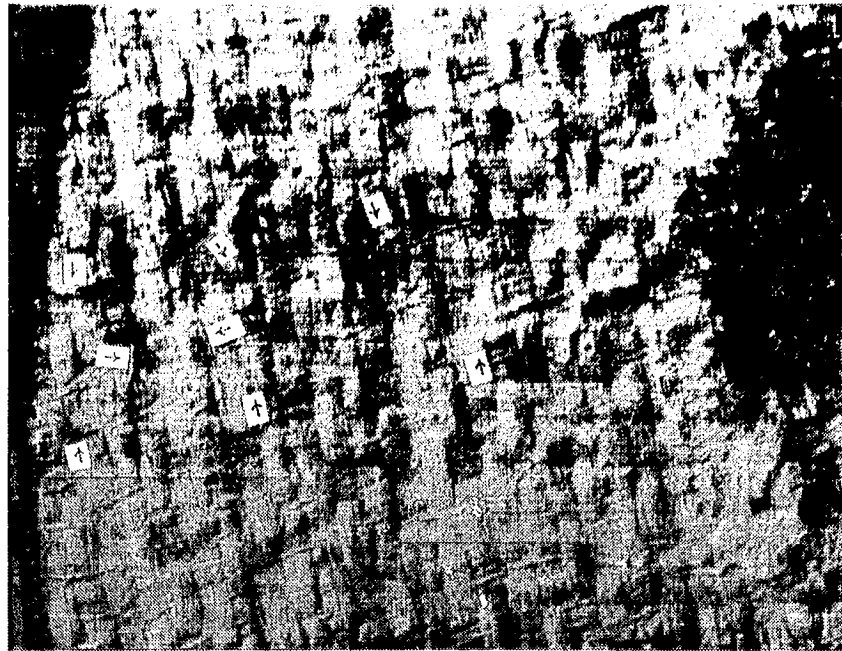
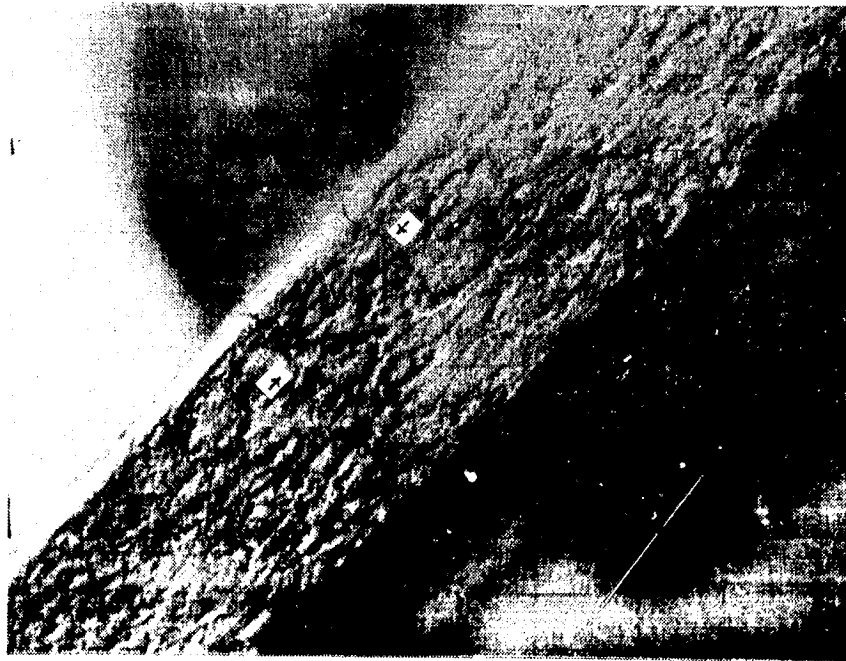
One of the specimens developed cracks during the hypervelocity impact test. The cracks, which are on the back surface and edge of specimen 3-73, did not cause the specimen to fragment or to lose material. The photographs in figure 7 show two cracks running from the impact site to the edge of the specimen and other cracks perpendicular to these. No attempt was made to determine the depth of the cracks or the degree to which they effect the strength of the material. The impact site on specimen 3-73 was just 15 mm from the edge of the target. The cracking occurred near the shortest path from the impact site to the edge. None of the other specimens showed any evidence of cracking, even though, in two cases, the impact energy was greater than that for specimen 3-73. In these cases, however, the impact sites were 29 mm or more from the edge of the specimen, see table I.

The probability that cracks will be produced in the LESS material on the Shuttle Orbiter was not calculated because the dependence of crack formation on projectile properties and impact conditions is not known. Apparently the proximity of the impact site to an edge is an important factor. If this is the case, then the probability of cracks being produced would also depend on the size of the segments covering the nose and leading edge.

(a) back surface

(b) edge

Figure 7.- Photographs of specimen 3-73 showing cracks on the back surface and edge.
