RESURVEY OF SITE STABILITY QUADRILATERALS
OTAY MOUNTAIN AND QUINCY, CALIFORNIA

Supplementary Report

July 1977

C. H. Scholz

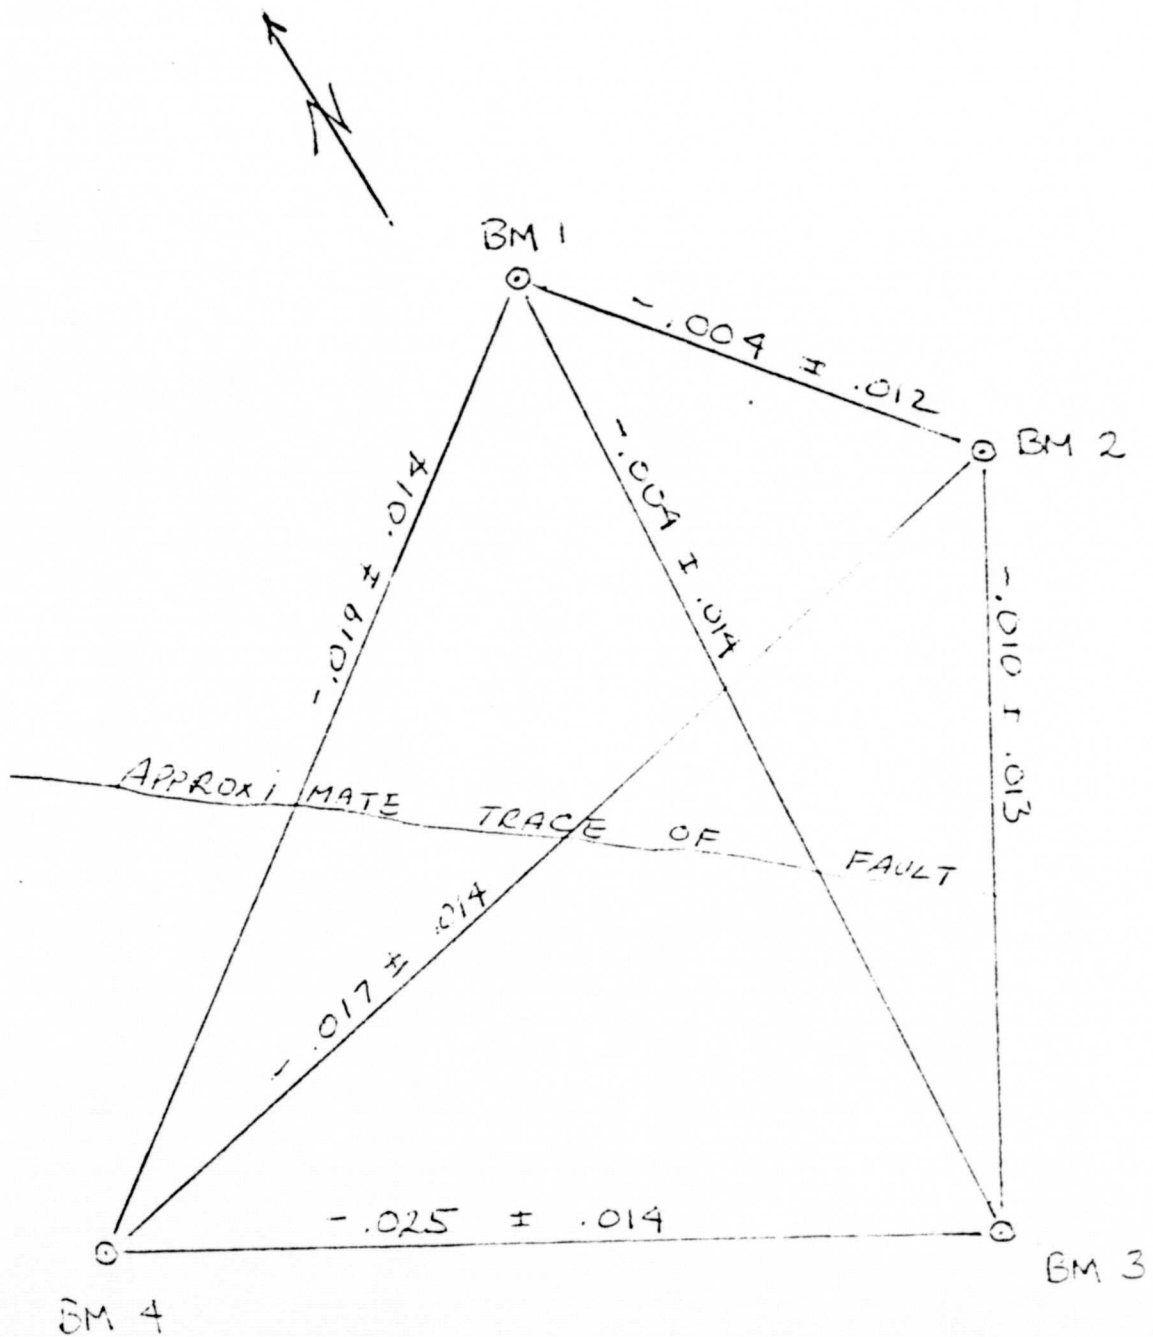
FIG. 1

The survey figure is in the form of a braced quadrilateral (Figure 1). All four benchmarks installed in 1972 were found to be in good condition in 1976.

The results of the resurvey are shown in Figure 1 and Table 1. Uncertainties quoted are two standard deviations of the theoretical uncertainty.

The results show no significant motion on the lines 1-2, 1-3, and 2-3. The lines to BM 4 all show similar shortening in the order of 2 cm which is just above the level of significance. The shortening of these three

lines, however, is not consistent with motion of the fault since it occurs on a line (4-3) which does not cross the fault and it does not appear on the other two fault-crossing lines 1-3 and 2-3. It is interpreted as indicating a local movement of BM 4 to the NE. BM 4 is located at the edge of a NE facing cliff and this local motion may indicate an instability of this BM, with motion towards the cliff face.

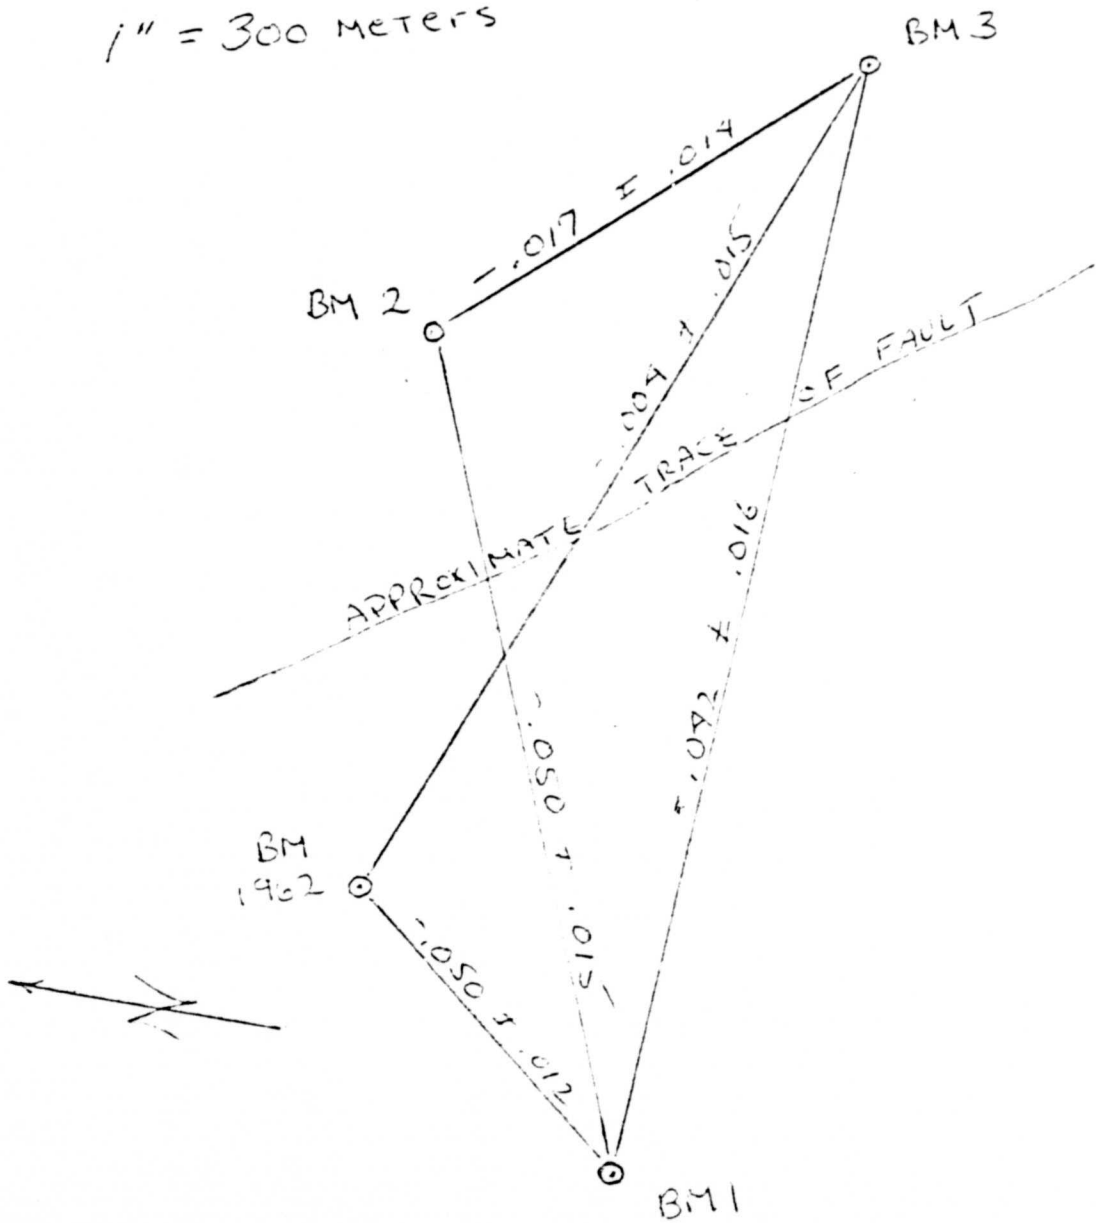
FIG. 2

The Otay Mountain quadrilateral is located 5 km east of the Otay Mountain laser tracking site. The figure was composed of 5 benchmarks. Four of the BM's were found in good condition in 1976, the fifth having been disturbed by local mining activity.

The results of the resurvey are shown in Figure 2 and listed in Table 2. These results are similar to those obtained at Quincy. No significant motion was observed on lines 2-3 and BM 1962 - 3. Nearly 5 cm of convergence was observed on the fault-crossing lines 2-1 and 3-1, but a similar convergence was also observed on the line BM 1962 - 1 which does not cross the fault. We attribute the convergence of these lines to instability of BM 1, and not to motion on the fault. BM 1 is located on the E side of a steep hill, and downhill creep of that BM would be consistent with the shortening of all lines emanating from that BM.
