NASA CR-145141

FLIGHT SERVICE EVALUATION
OF KEVLAR-49/EPOXY COMPOSITE
PANELS IN WIDE-BODIED COMMERCIAL
TRANSPORT AIRCRAFT

THIRD ANNUAL
FLIGHT SERVICE EVALUATION REPORT

March 1977

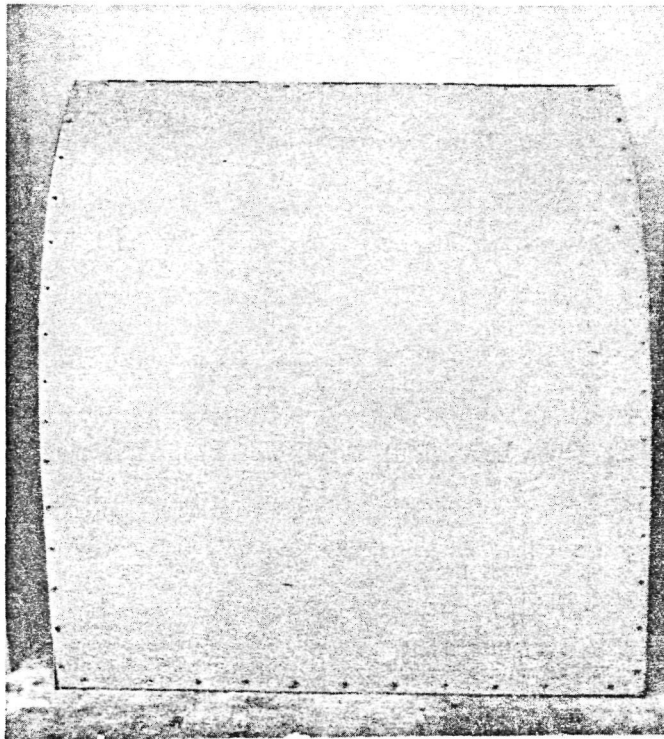
- 1) The panel weight was 6.91 kg (15.24 lb).
- 2) The panel exterior appearance was satisfactory (Figure 1). Paint chipping was noted around the fasteners, and in some areas the paint had been sanded. Flame spray was intact in all areas, however.

Figure 1. Eastern RH Wing-Body Fairing - Exterior Surface

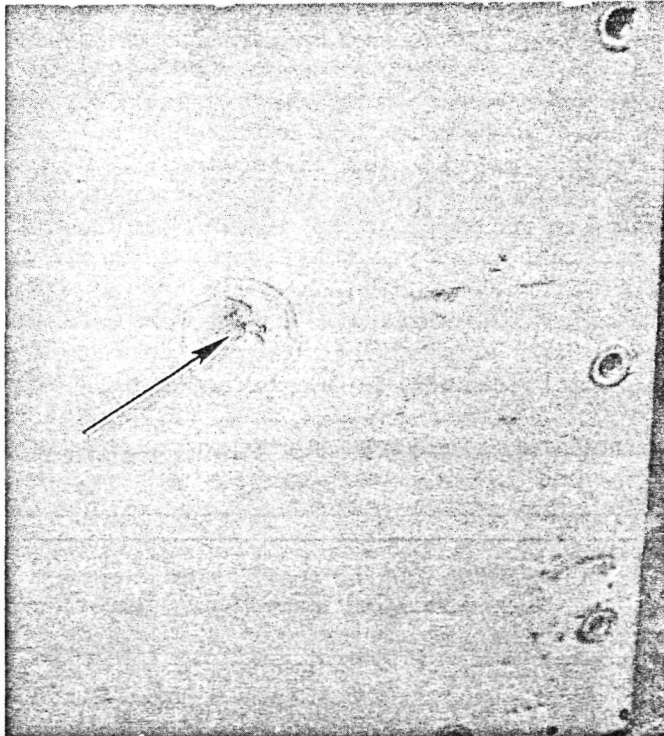
- 3) Two cracks were observed on the exterior surface which had also been noted in the 1975 inspection. One was in the lower, forward area and was 0.8 cm (5/16 inch) in length (Figure 2), and the other was 0.3 cm (1/8 inch) long in the aft center area. Both were unchanged in appearance and had not propagated in the intervening year.

Figure 2. Eastern RH Wing-Body Fairing - 0.8 cm (5/16 inch) Crack, Exterior Surface

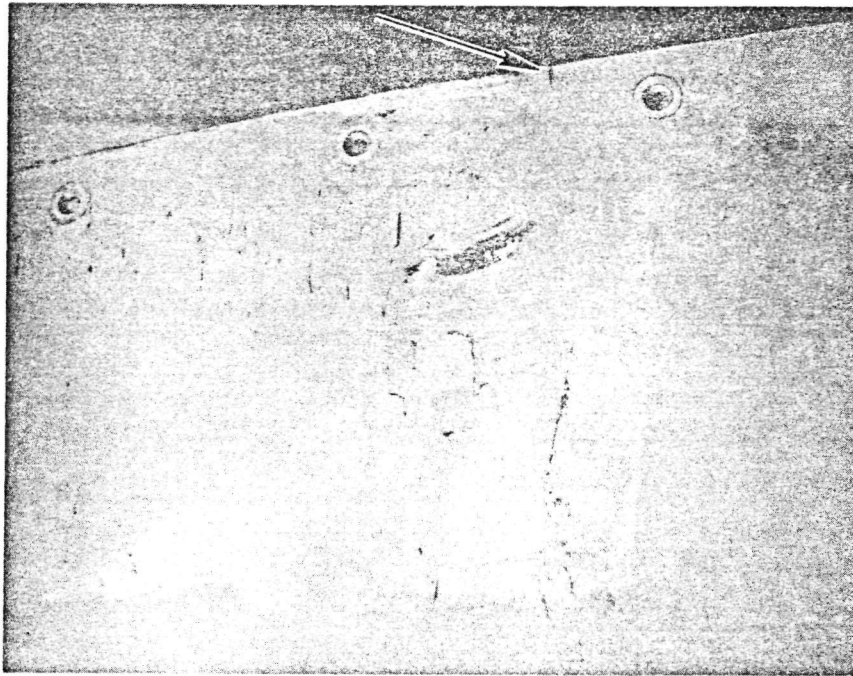
- 4) Two additional cracks were observed on the exterior which were not observed in 1975. One crack was 1.3 cm (1/2 inch) long extending inward from the forward edge between the 5th and 6th fastener holes from the top (Figure 3). A crack, 0.6 cm (1/4 inch) long, was noted near the exact center of the panel with an associated scratch in the paint extending several inches forward and upward. The flame spray was intact in this area. A slight ding was observed in the lower center area, with an associated 0.3 cm (1/8 inch) long indication which may have been only in the paint.

Figure 3. Eastern RH Wing-Body Fairing - Crack at Forward Edge
(With Paint Chipping in Surrounding Area)

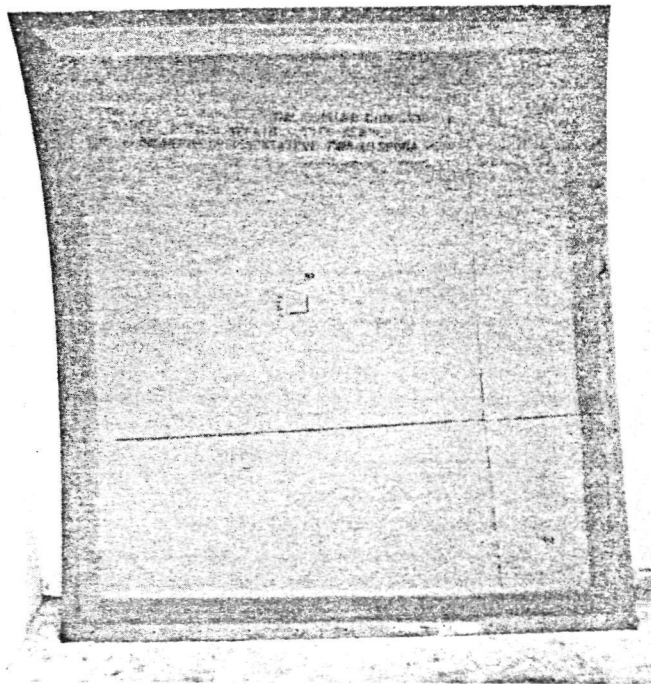
- 6) The interior surface appearance was satisfactory (Figure 4), with no cracks or debonding of Tedlar except as noted below around fastener holes. One very small debond area was located 23 cm (9 inches) from the top edge, associated with a vertical line (marked on the face) which was slightly depressed. A similar depressed line coinciding with this line was detected on the exterior face, and similar horizontal lines were detected 56 cm (22 inches) from the bottom edge. No other debonds were associated with these lines, which are apparently core splice locations.

Figure 4. Eastern RH Wing-Body Fairing - Inner Surface

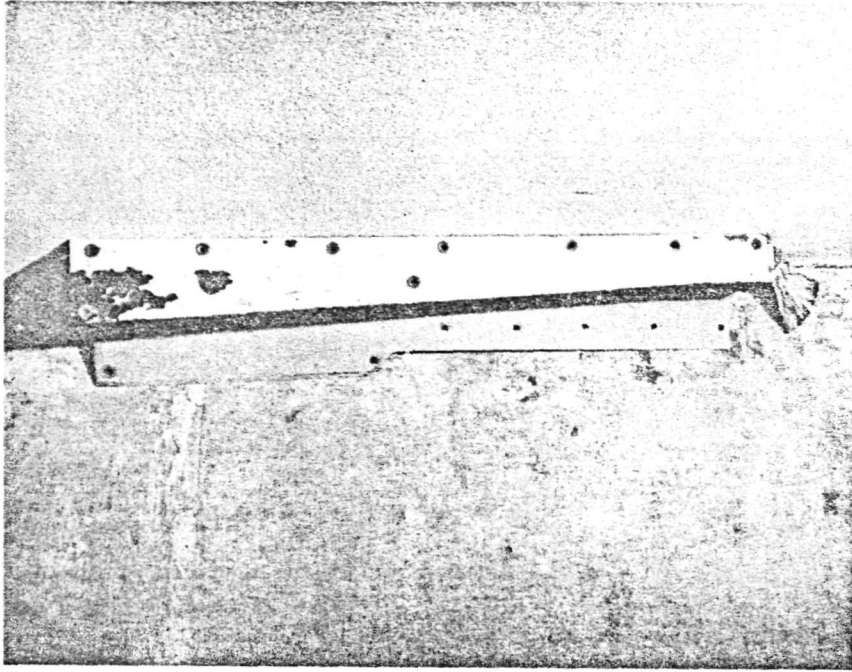
- 1) The panel weight was 1.01 kg (2.22 lb). \triangle
- 2) The exterior surface was in satisfactory condition with no surface damage to the Kevlar-49 despite considerable loss of paint in the upper, aft area (Figure 5). This area is not flame sprayed and the bare Kevlar was showing. In the lower area there was some paint loss and exposed flame spray around the fasteners.

Figure 5. Eastern RH Wing-Body Fillet - Exterior Surface Showing Bare Kevlar-49 Area

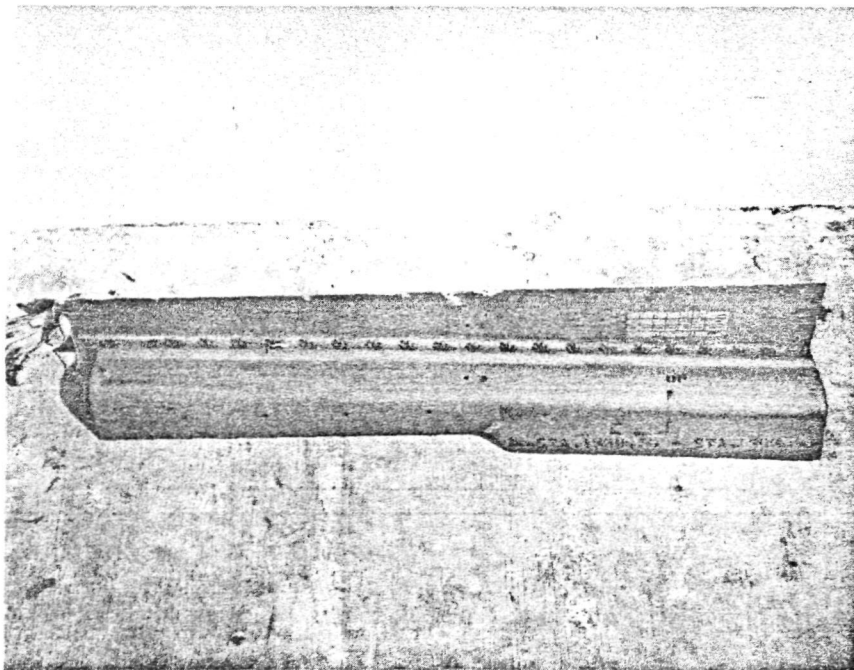
- 3) The interior surface was free of defects or damage (Figure 6).
- 4) Fastener holes showed slight fraying when viewed from the inner surface. The fraying was more pronounced in four of the holes, and was accompanied by evident hole deformation (Figure 7). These included two holes each in the upper forward and lower aft portions of the part. The loss of paint mentioned previously was observed around these holes. The hole deformation was not visible from the exterior surface, but slight fraying of these holes could be observed from the exterior.

Figure 6. Eastern RH Wing-Body Fillet - Inner Surface

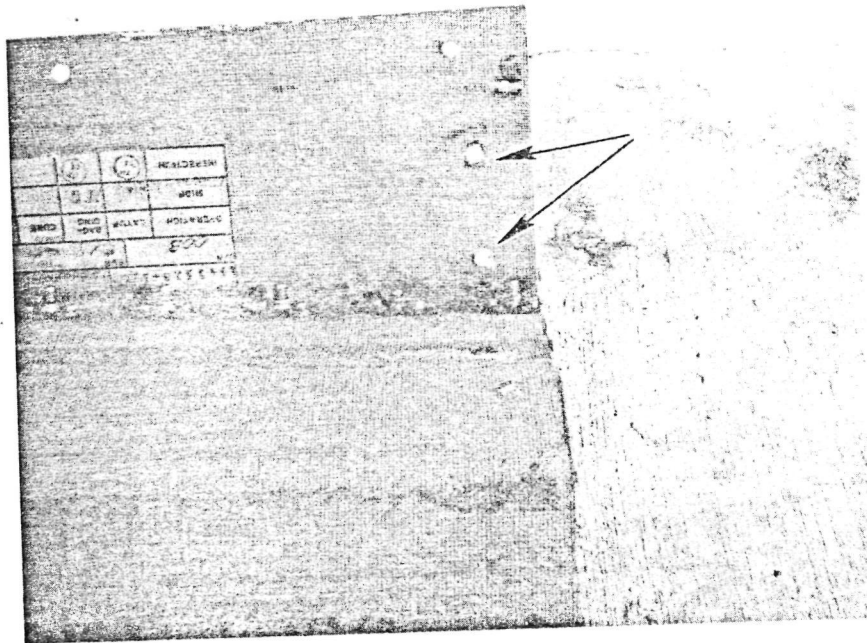
Figure 7. Eastern RH Wing-Body Fillet - Frayed and Elongated Fastener Holes

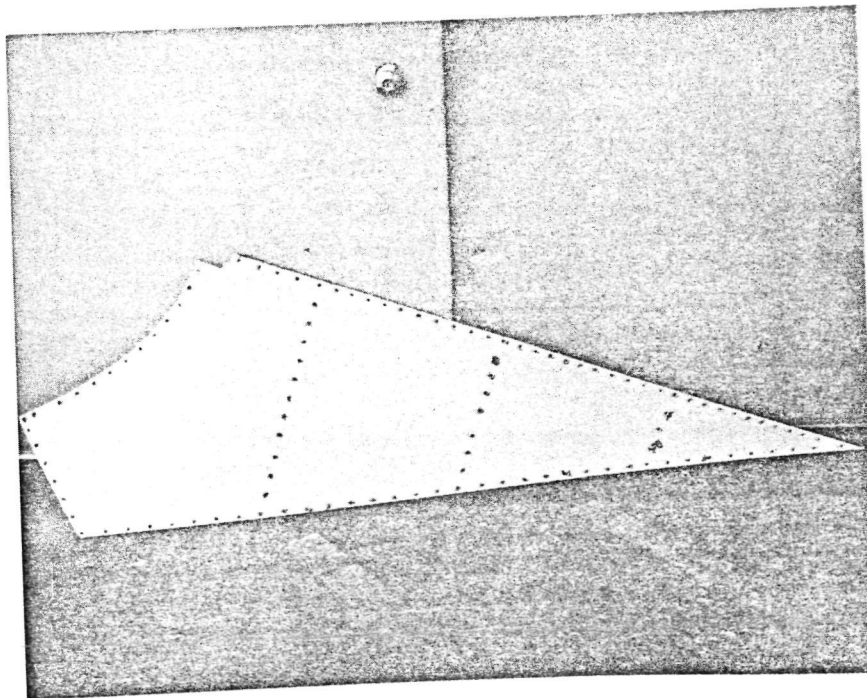
- 1) The panel weight was 2.3 kg (5.10 lb). Initial weight was 2.0 kg (4.5 lb).
- 2) The exterior surface appearance was satisfactory with no damage, and only slight paint loss around some holes at the forward inter-costal (Figure 8).

Figure 8. Eastern RH Aft Engine Fairing - Exterior Surface

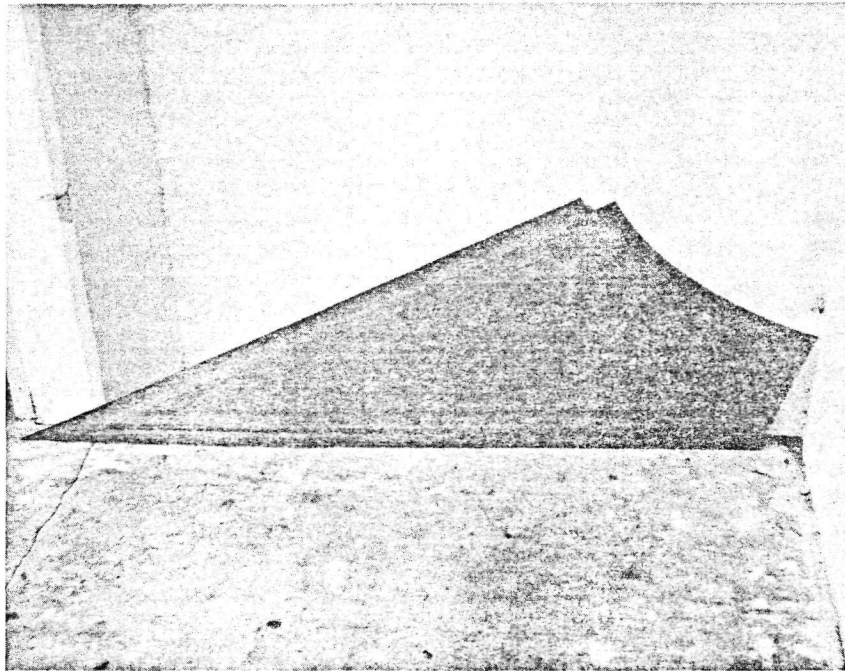
- 3) The interior surface appearance was also satisfactory with no damage or Tedlar debond (Figure 9). No delaminations, cracks, or skin-core debonds were evident on either surface.
- 4) All fastener holes had a frayed appearance viewed from the inner surface (Figure 10). From the exterior, fraying was visible on about 1/2 of the fastener holes.

Figure 9. Eastern RH Aft Engine Fairing - Inner Surface

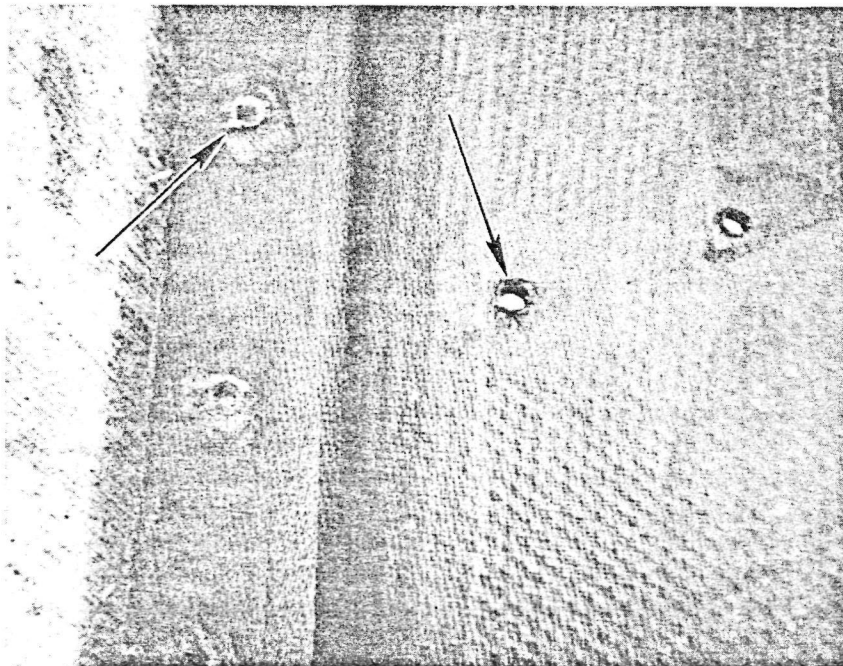
Figure 10. Eastern RH Aft Engine Fairing - Frayed Fastener Holes

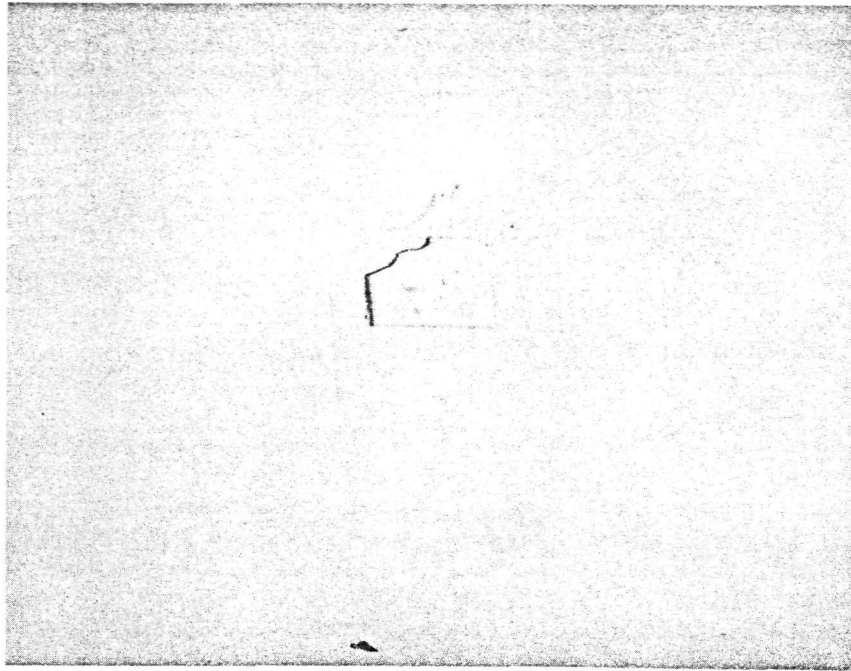
Figure 11. Eastern LH Wing-Body Fairing - External Tape Patch

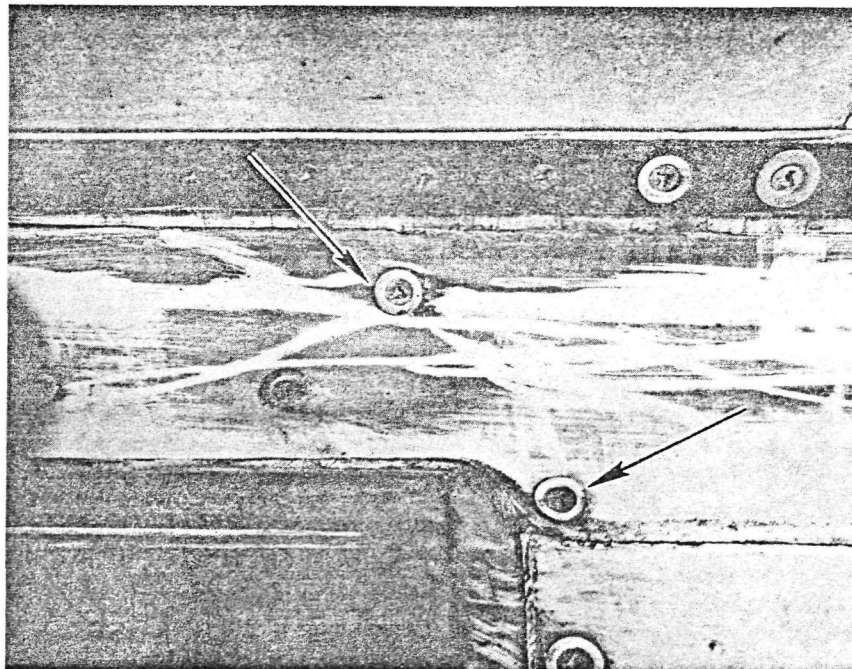
Figure 12. Eastern LH Wing-Body Fairing - With Misaligned Fasteners

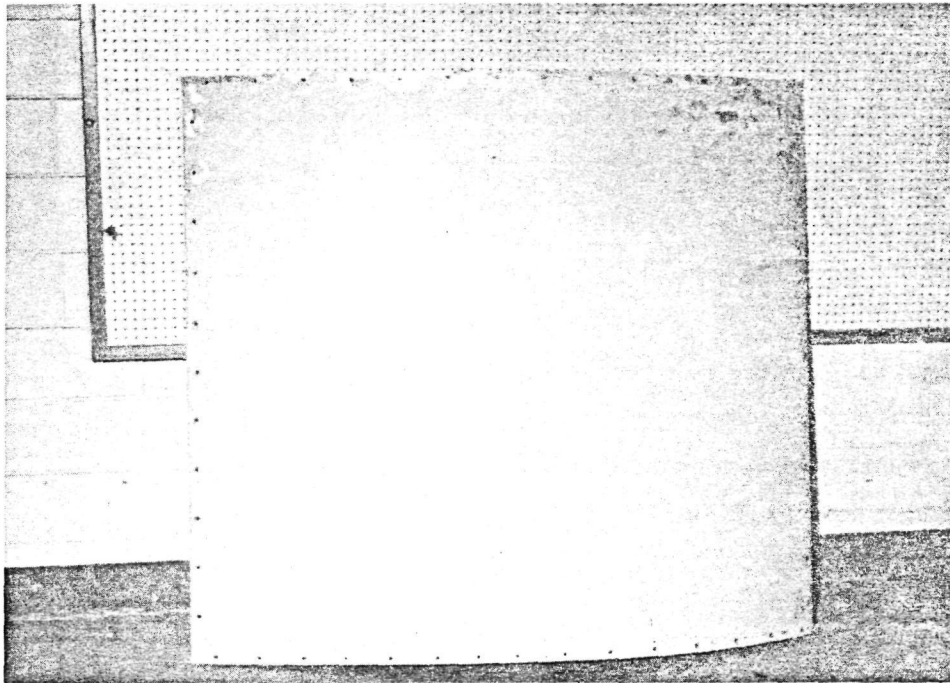
- 1) The panel weight was 6.72 kg (14.81 lb). Original weight was 7.0 kg (15.5 lb).
- 2) The exterior surface was satisfactory in appearance (Figure 13), except for one crack which was the result of impact damage. This was a 3.2 cm (1-1/4 inch) long crack in the upper aft area (Figure 14), with a slight delaminated area extending 0.6 cm (1/4 inch) to either side of the crack. This crack was observed in the 1975 inspection and had not grown or propagated. This was the only delamination or skin-core de-bond noted on either surface. A second crack-like indication 1.3 cm (1/2 inch) long, observed in the 1975 inspection, was not visible and apparently had only been in the paint. Extensive paint chipping and blistering were observed around the fastener holes, but flame spray was intact.

Figure 13. Air Canada LH Wing-Body Fairing - Exterior Surface

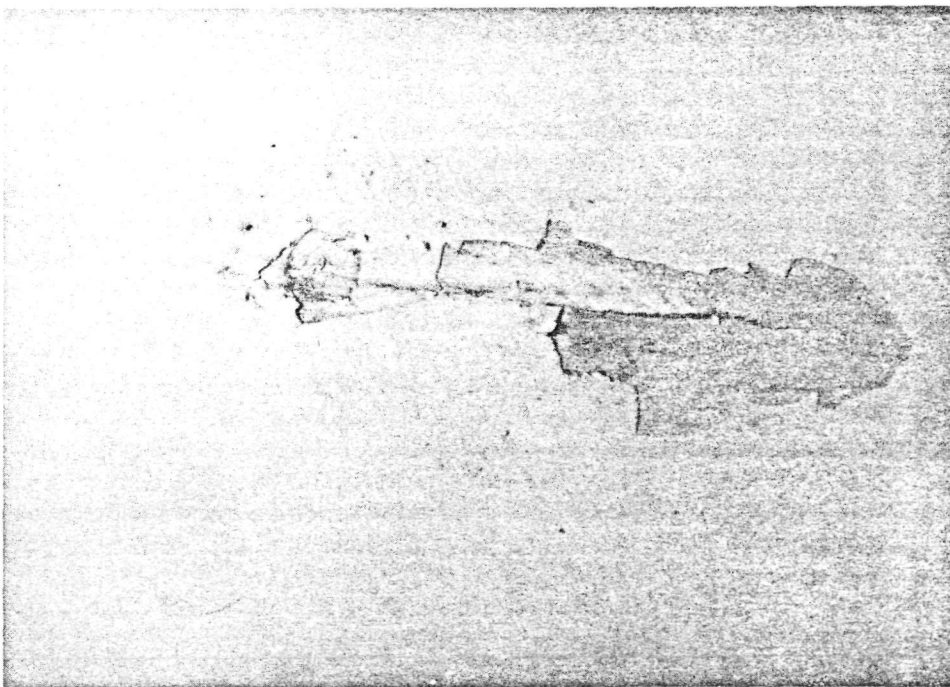
Figure 14. Air Canada LH Wing-Body Fairing - 3.2 cm (1-1/4 inch) Crack, Exterior Surface

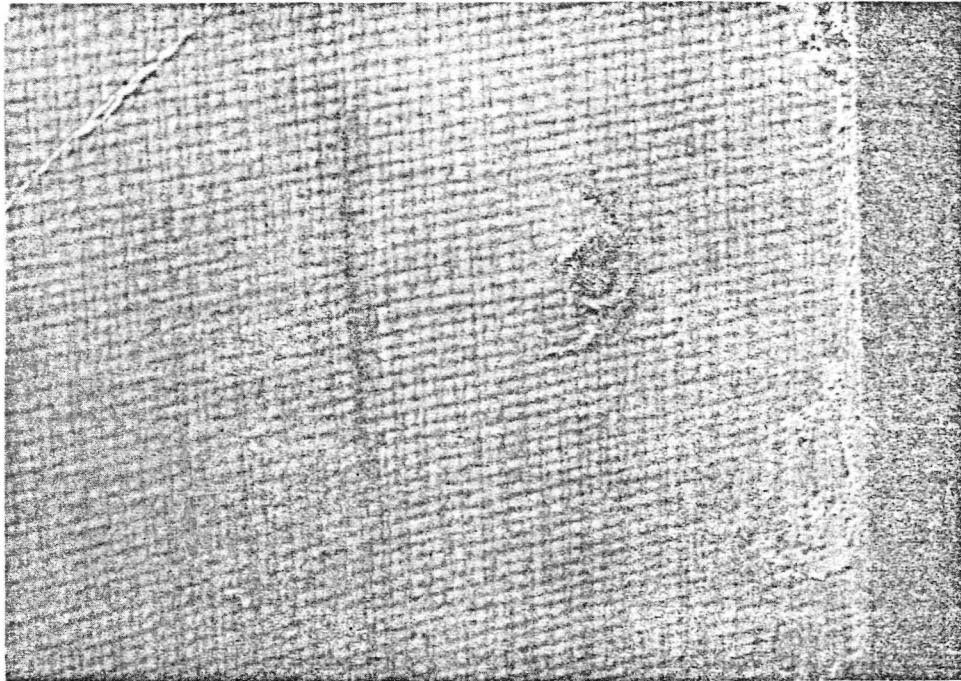
- 3) The interior surface was satisfactory in appearance with no cracks, delaminations, skin-core or Tedlar de-bonds.
- 4) Slight fraying was observed on most fastener holes. No hole elongation was observed, but there was a slight convex laminate deformation around several holes on the lower edge (Figure 15).

Figure 15. Air Canada LH Wing-Body Fairing - Frayed Hole With Associated Laminate Deformation

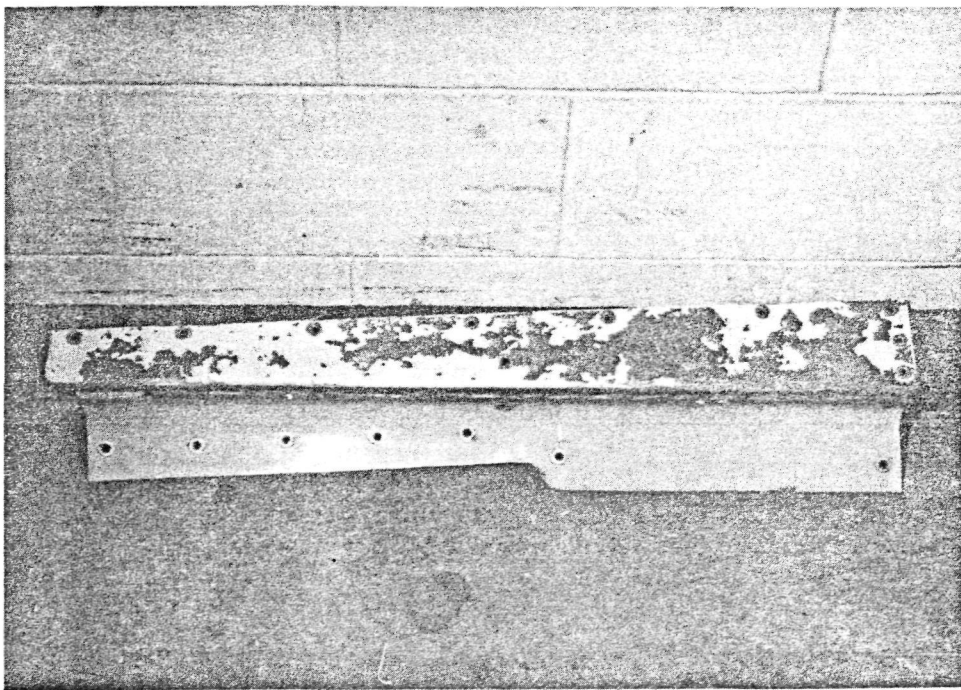
- 1) The panel weight was 0.6 kg (1.31 lb).
- 2) There were no cracks or observable defects or damage on either surface (Figure 16). The upper and lower areas both had extensive

Figure 16. Air Canada LH Wing-Body Fillet - Exterior Surface

paint loss, with exposed Kevlar-49 in the upper portion since this area is not flame sprayed.

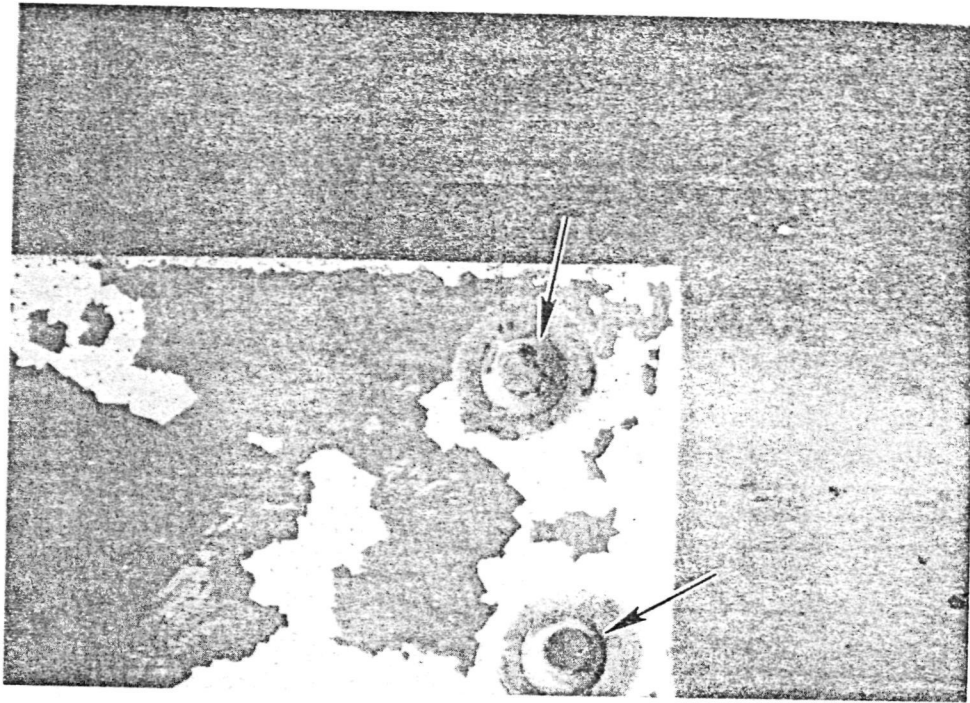
- 3) Some fraying of fastener holes was observed, to a greater degree than on the wing-body fairing. One hole had a small associated delamination, and another had a slight convex laminate deformation around the hole. Hole deformation was observed on six holes, including the two mentioned above (Figure 17). These were located mostly in the upper portion of the part. The worst deformation gave the holes (nominally 0.5 cm (3/16 inch) in diameter) a maximum dimension of 0.63 cm (1/4 inch).

Figure 17. Air Canada LH Wing-Body Fillet - Frayed and Elongated Fastener Holes

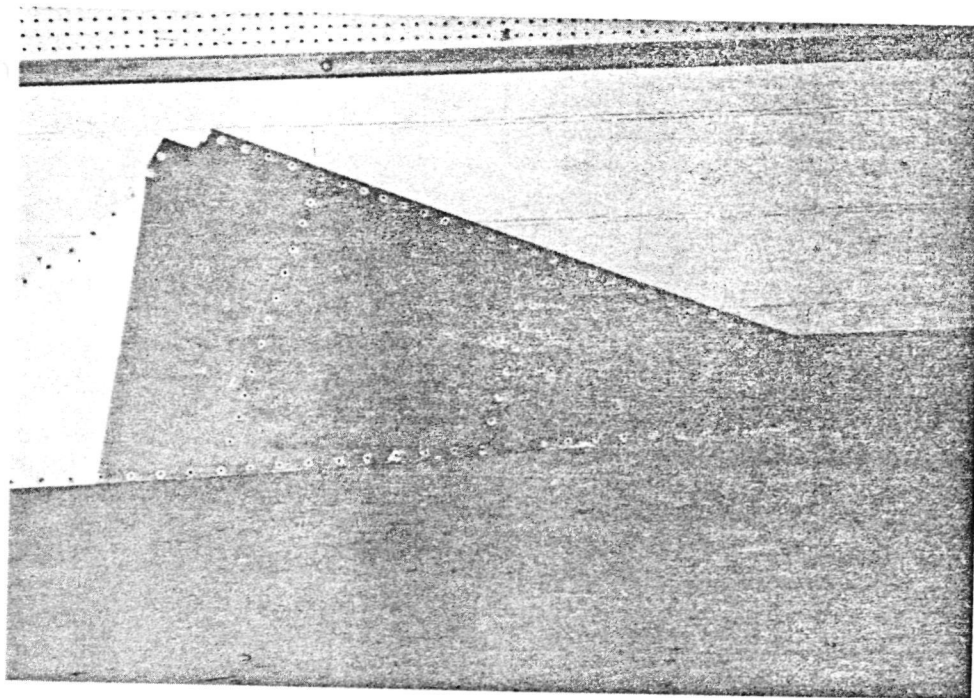
- 1) The panel weight was 2.3 kg (5.0 lb). Original weight was also 2.3 kg (5.0 lb).
- 2) The exterior surface was satisfactory with no cracks, debonds, or delaminations (Figure 18). This part had been noted in earlier inspections to have extensive paint blistering which is still occurring despite repainting.

Figure 18. Air Canada RH Aft Engine Fairing - Exterior Surface

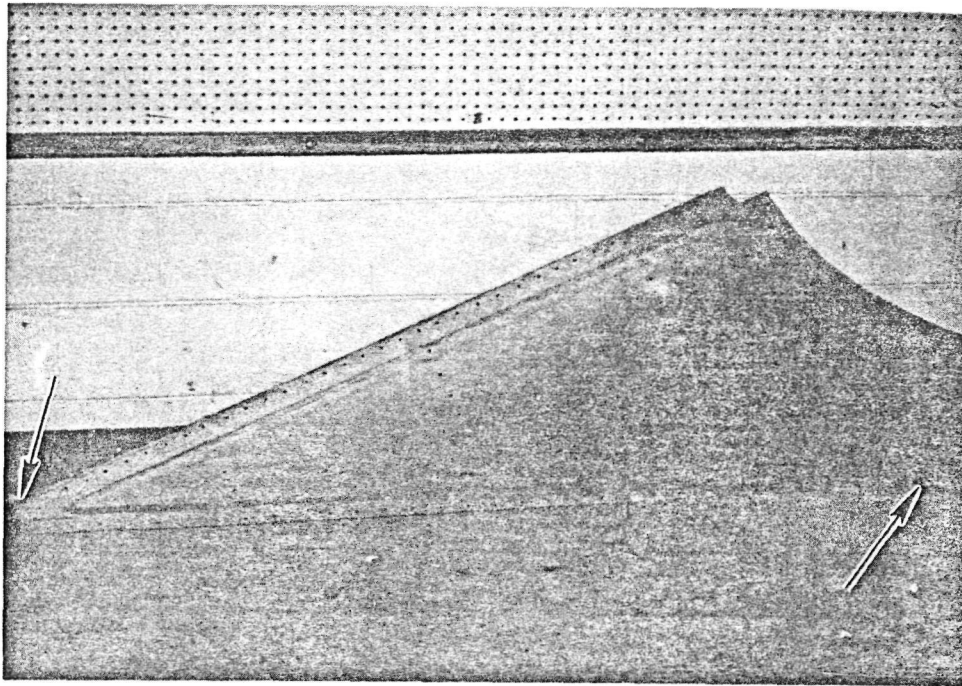
- 3) The interior surface (Figure 19) was free of any defects or damage.
- 4) Fraying was noted on most fastener holes to a slight degree (Figure 20). This fraying was significantly less severe than on the other aft engine fairings observed on the Eastern and TWA aircraft. A few holes (about 21 out of 100) had slight deformations which were more noticeable viewed from the exterior. Four of these were along the intercostals (Figure 21) which unlike any other holes in the three parts are through potted honeycomb core.

- 5) Repair patches observed in the 1974 inspections were unchanged in appearance. These are on the extreme forward wedge end and the extreme aft corner. Air Canada has no record of this repair, and materials and procedures are unknown. The patch color is black (Figure 19) and has a fibrous appearance. This suggests some type of electrical tape overcoated with resin.

Figure 19. Air Canada RH Aft Engine Fairing - Inner Surface With Repair Patch

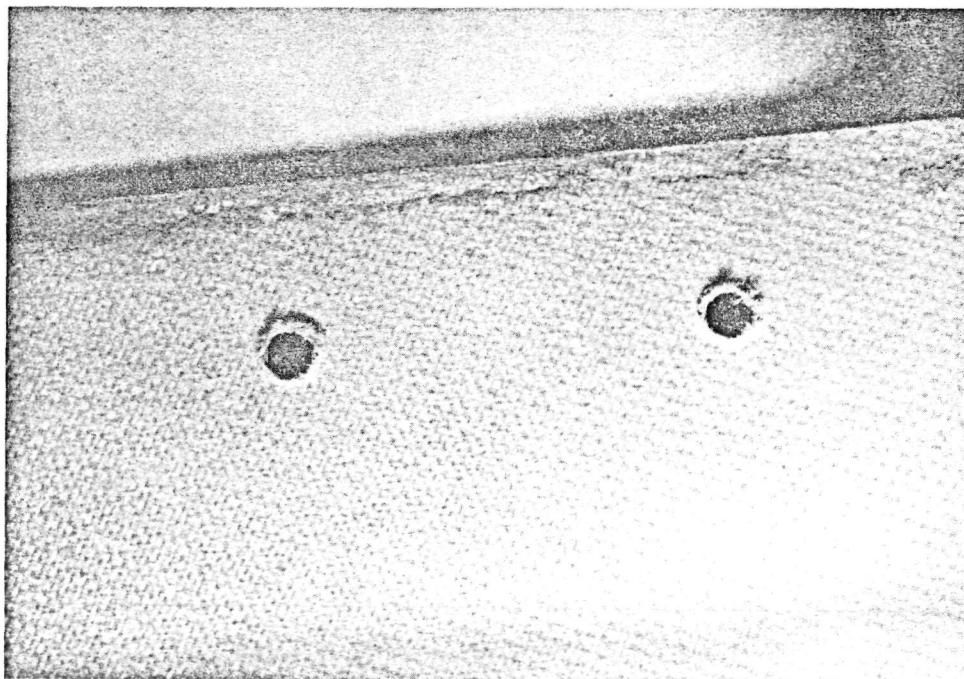
Figure 20. Air Canada RH Aft Engine Fairing - Frayed Fastener Holes

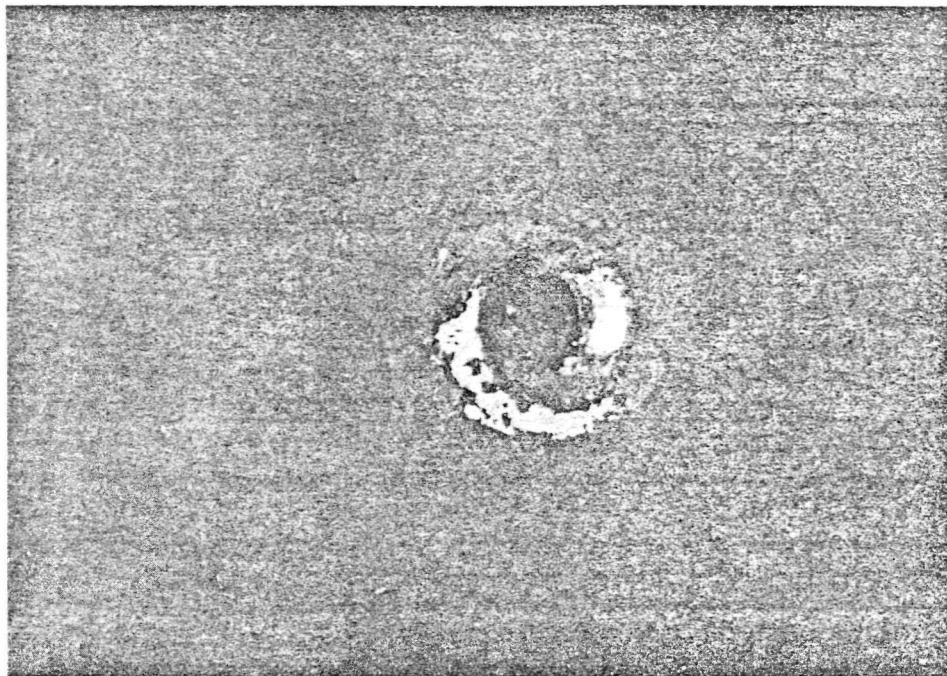
Figure 21. Air Canada RH Aft Engine Fairing - Elongated Intercostal Fastener Hole

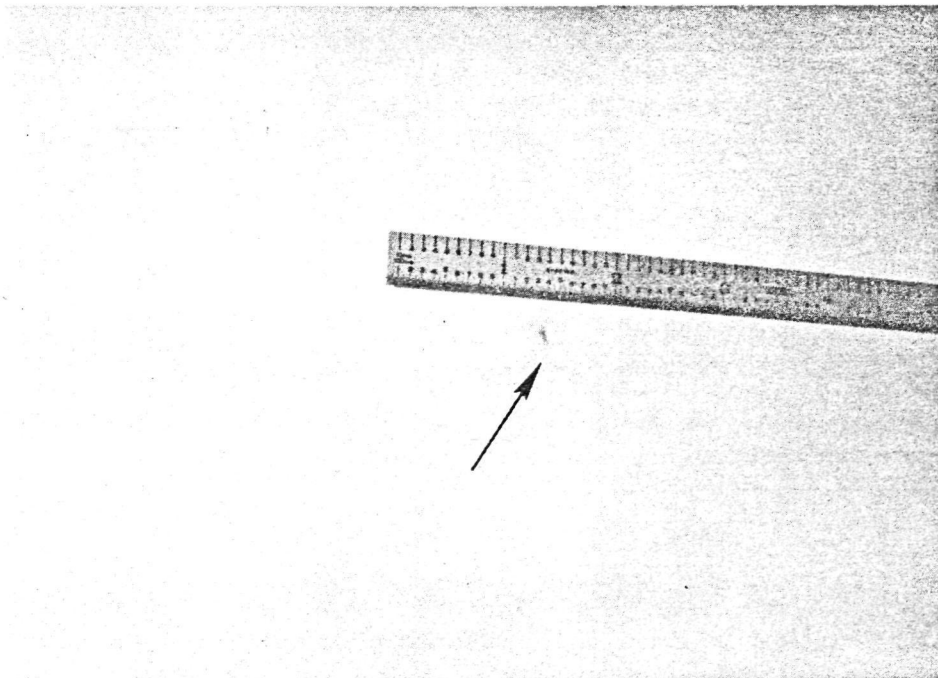
- 1) The exterior surface was satisfactory in appearance with no delaminations or de-bond but with two minor cracks due to impact damage. A crack 0.6 cm (1/4 inch) long in the center, forward area was observed in 1975, and had not grown or propagated. A new crack was observed near the panel center. This was 0.3 cm (1/8 inch) long and rather deep (Figure 22). The panel was very clean, with much less paint loss than the left-hand panel.

Figure 22. Air Canada RH Wing-Body Fairing - 0.3 cm (1/8 inch) Crack, Exterior Surface

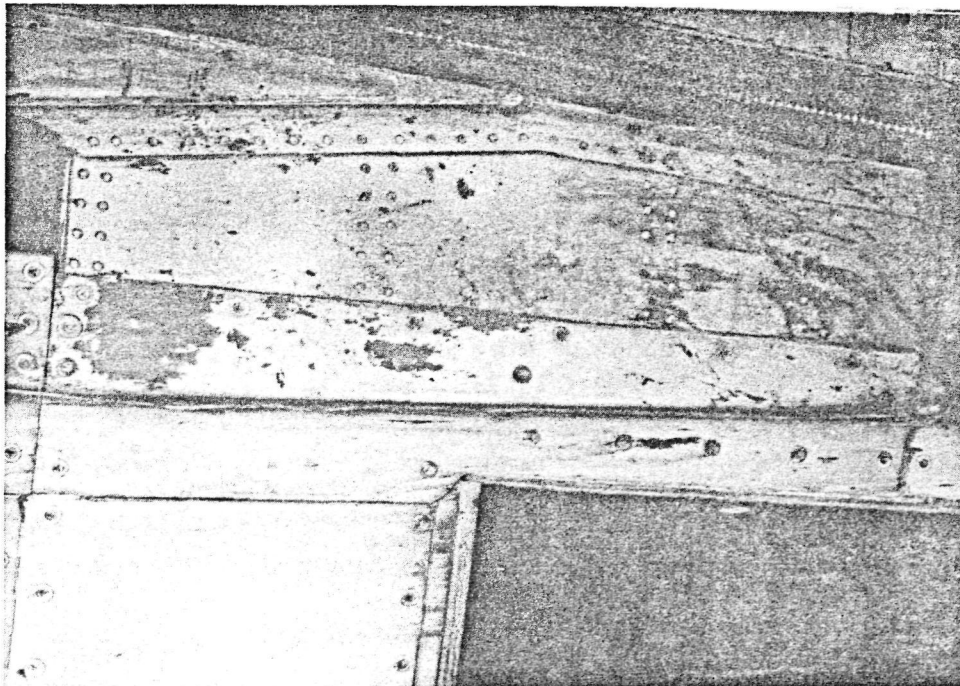
- 1) The exterior surface had no cracks or other observable damage (Figure 23). There was some paint loss and exposed Kevlar-49.
- 2) This part was observed in the 1975 inspection to have badly out-of-line fasteners with the lower panel bulged outwards as if the part had been forced to fit. Air Canada subsequently removed and reinstalled the part, and the condition was greatly improved with only slight fastener gaps and misalignment, and no panel bulges.

Figure 23. Air Canada RH Wing-Body Fillet - Exterior Surface Showing Bare Kevlar-49 Area

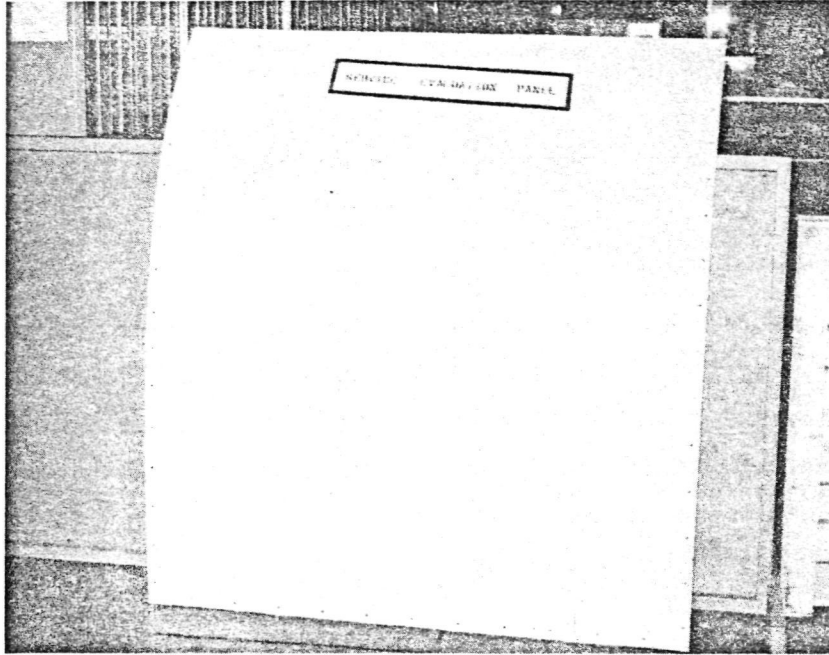
- 1) The panel weight was 7.3 kg (16.1 lb). Original weight was 7.0 kg (15.5 lb).
- 2) The exterior surface was satisfactory in appearance with no delaminations or de-bonds (Figure 24). A slight loss of paint was noted along the forward edge, but flame spray was intact in all areas. A small crack 0.3 cm (1/8 inch) long, was noted in the lower aft area, which may have only been through the paint. A slight depressed area, 2.5 cm x 0.6 cm (1 inch by 1/4 inch), was observed near the aft edge which is the probable location of a repair made after the 1974 inspection prior to reinstallation of the panel on Ship 1111.

Figure 24. TWA RH Wing-Body Fairing - Exterior Surface

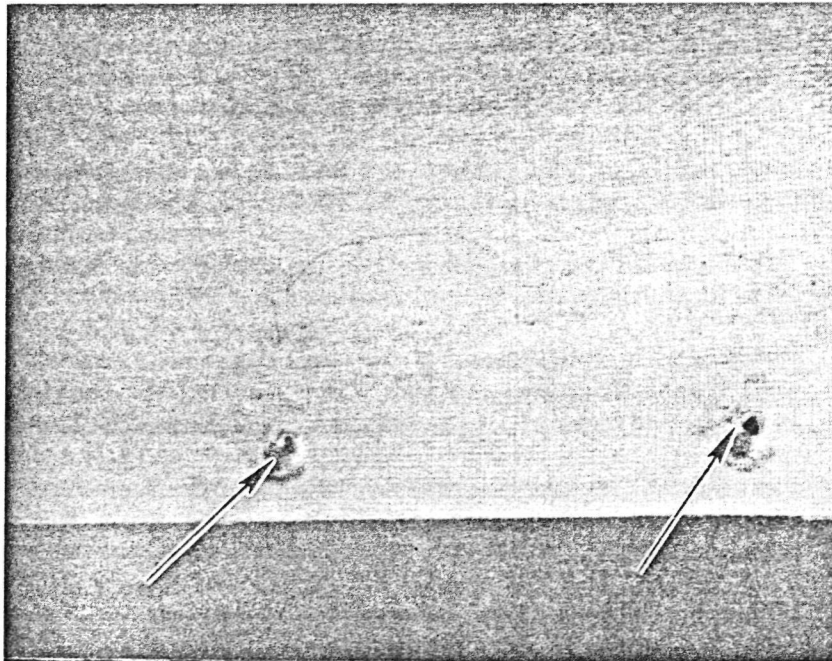
Figure 25. TWA RH Wing-Body Fairing - Frayed Fastener Holes Adjacent to Filled Fastener Holes

- 5) The two aft holes on the bottom edge had been re-located when the panel was reinstalled on Ship 1111. These holes were not the ones showing deformation and were frayed to about the same degree as the other holes. One hole had been drilled partly through the filled area where the holes had been previously located, but there was no deformation in this area. The filled areas (which contained a chopped fiberglass filled epoxy resin) showed no visible defects or damage (Figure 25).

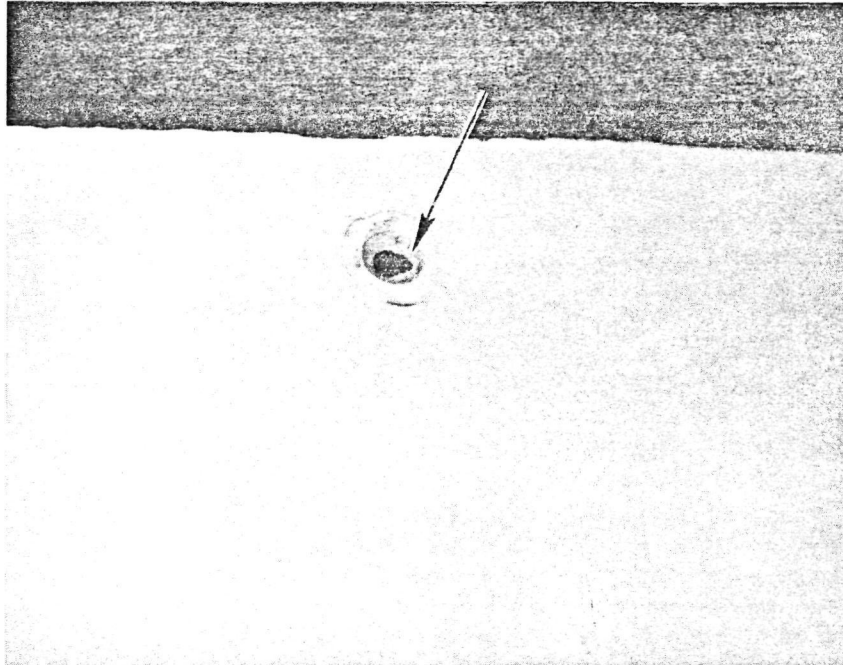
Figure 26. TWA RH Wing-Body Fairing - Elongated Fastener Hole

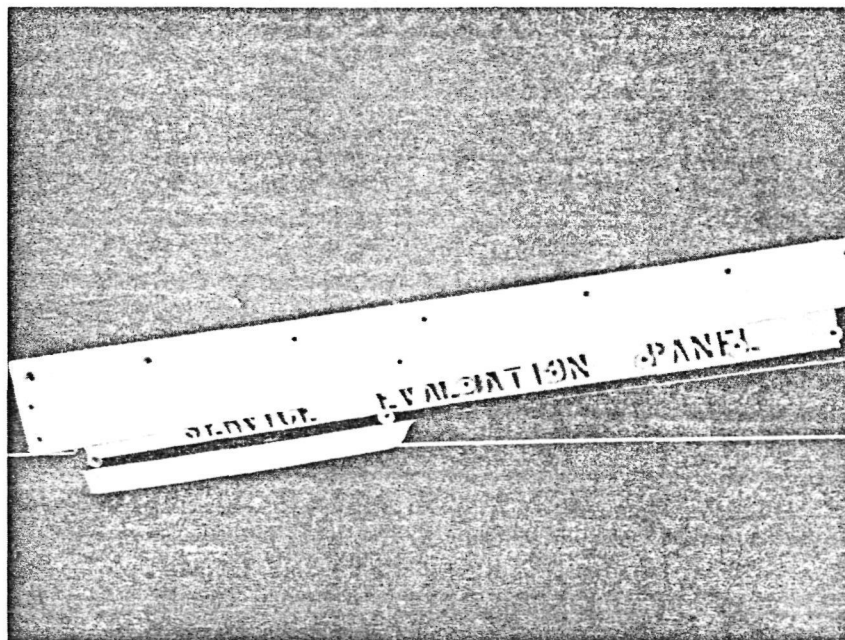
- 1) Panel weight was 0.64 kg (1.4 lb).
- 2) No cracks, delamination, loss of paint, or other defects or damage was noted on exterior or inner surfaces (Figure 27).
- 3) Fraying of holes was not visible from the exterior, but from the inner surfaces slight fraying was visible around most fastener holes. Two holes on the lower aft edge were heavily frayed and showed hole deformation and elongation (Figure 28). Six holes on the upper edge were deformed, with three on the aft end slightly elongated and three in the forward end more severely elongated. Maximum elongation was to a dimension of 0.3 cm (1/4 inch) from the nominal 0.5 cm (3/16 inch) diameter.
- 4) One hole in the lower aft corner had been relocated. The relocated hole was not drilled through the filled area. The filled area showed no visible defects or damage.

Figure 27. TWA RH Wing-Body Fillet - Exterior Surface

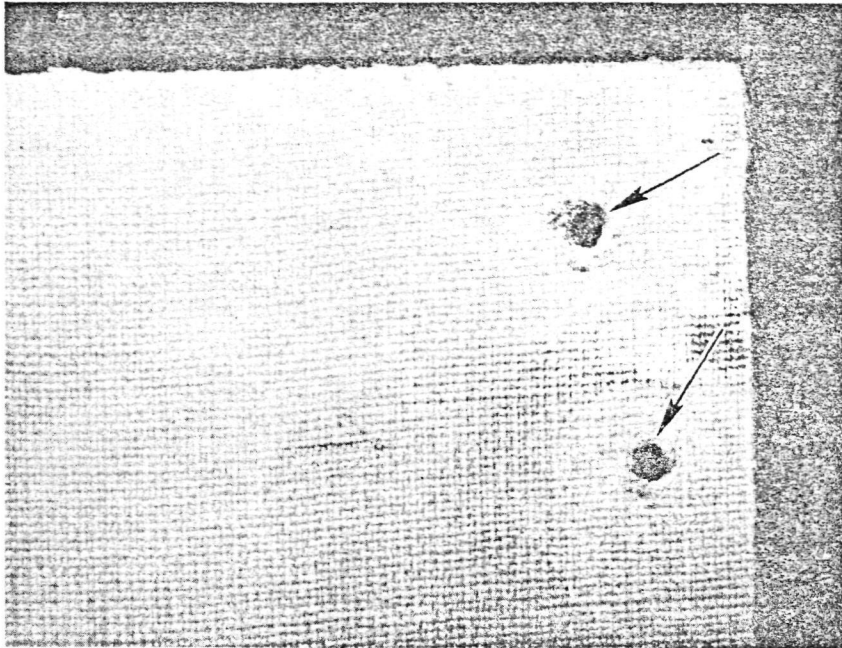
Figure 28. TWA RH Wing-Body Fillet - Frayed and Elongated Holes

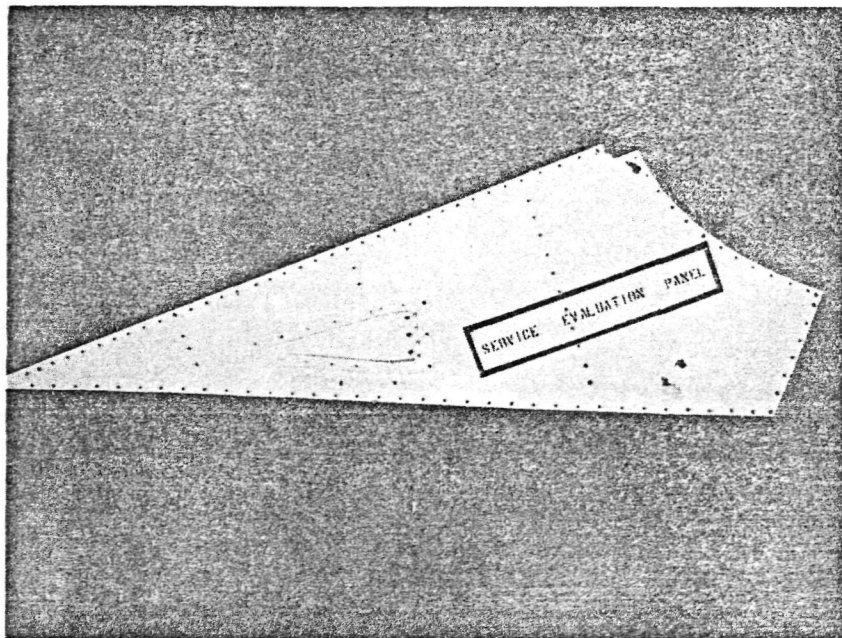
- 1) Panel weight was 2.40 kg (5.3 lb).
- 2) The exterior surface was free of cracks, delaminations, skin-core debonds, or other defects or damage (Figure 29), but there was some paint loss. In about half of this area, the flame spray had also been lost (Figure 30). The flame spray on this part was re-applied during the reinstallation on Ship 1111.

Figure 29. TWA LH Aft Engine Fairing - Exterior Surface

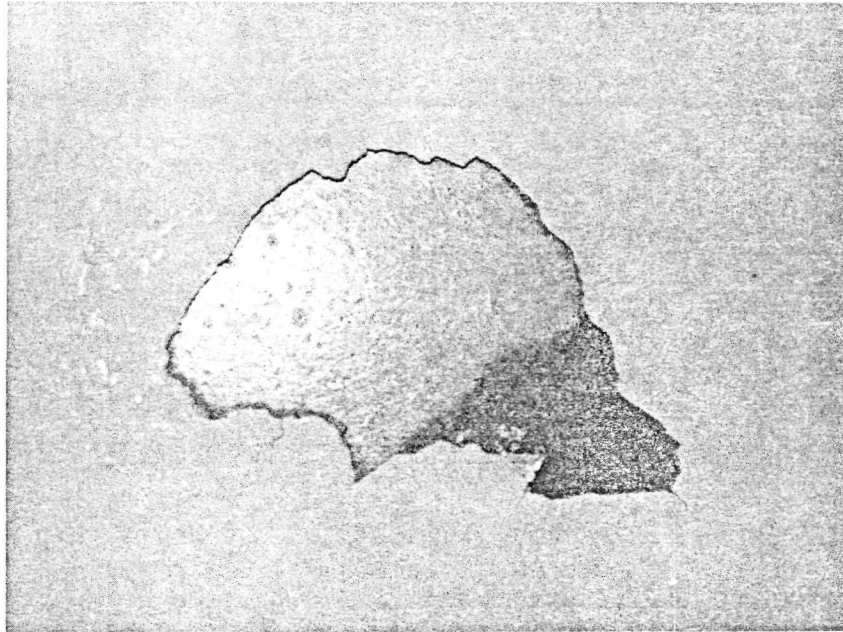
Figure 30. TWA LH Aft Engine Fairing - Showing Loss of Paint and Flame Spray

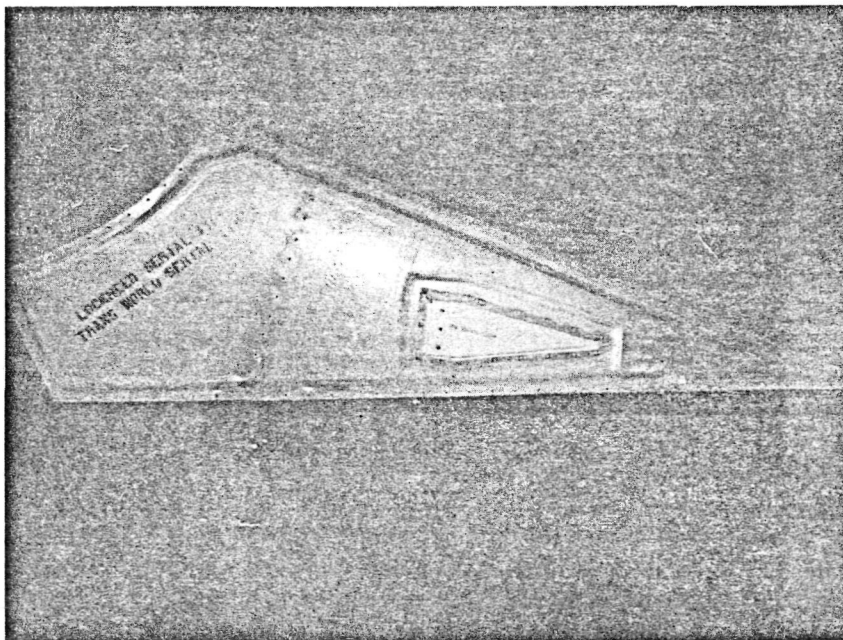
- 3) The inner surface was also free of defects or damage (Figure 31). The repair on the inner surface, where a skin-core delamination had occurred during panel rework, showed no visible delamination or other defects or damage. The vapor barrier coating, applied to the inner surface during rework, was adhering satisfactorily and had no signs of damage. Some porosity was noted, however.

Figure 31. TWA LH Aft Engine Fairing - Inner Surface Showing Vapor Barrier Coating

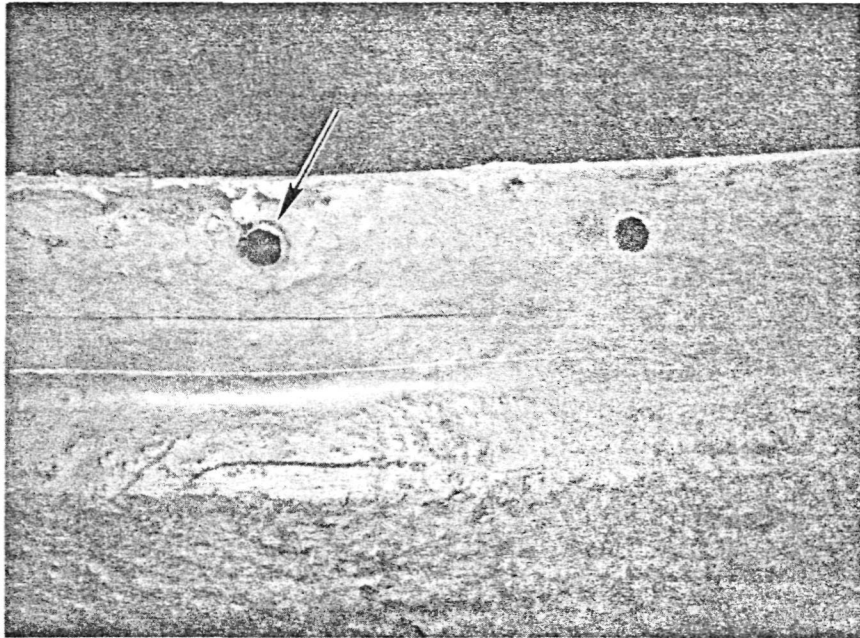
- 4) No fraying of fastener holes was visible from the exterior surface. From the inner surface much less fraying was visible than on the other panels (Figure 32). All the fastener holes were relocated

Figure 32. TWA LH Aft Engine Fairing - Fastener Holes

on this panel prior to reinstallation, and a single strip of resin impregnated 120 glass cloth had been applied over the filled holes on both surfaces. This accounted for the lack of Kevlar-49 fiber fraying.

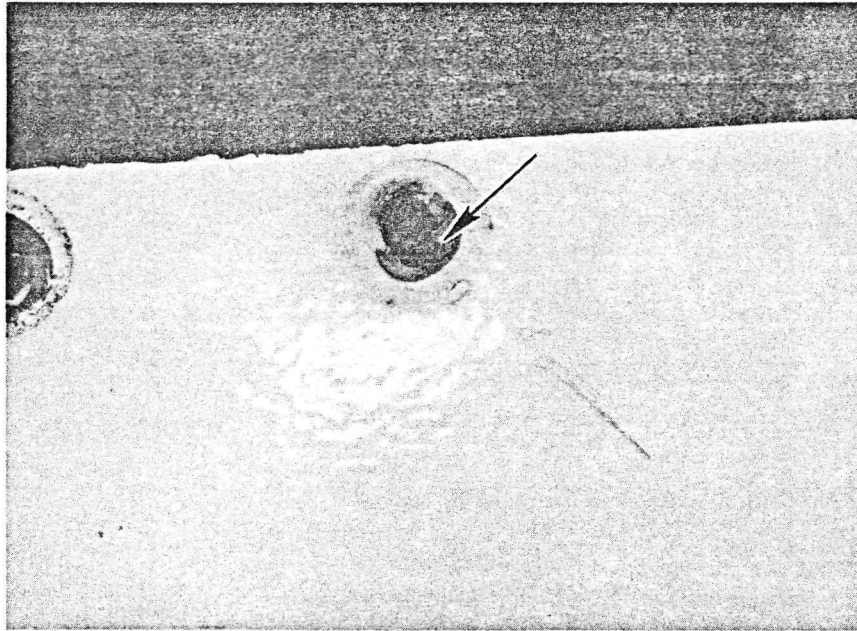
- 5) The majority of holes were not significantly deformed, but several holes showed more severe elongation than noted in any of the other panels on the three ship sets. Six holes were elongated to a maximum dimension of 1.6 cm (5/8 inch), and seven holes were elongated to 0.6 cm (1/4 inch) dimension (Figure 33). These holes were mostly on the lower edge with the rest along the aft edges. Two holes in the aft intercostal, which are drilled through filled honeycomb and which were also relocated, showed some elongation; but the other intercostal holes had no deformation.

Figure 33. TWA LH Aft Engine Fairing - Elongated Fastener Hole
