NASA CR-145141

FLIGHT SERVICE EVALUATION
OF KEVLAR-49/EPOXY COMPOSITE
PANELS IN WIDE-BODIED COMMERCIAL
TRANSPORT AIRCRAFT

THIRD ANNUAL
FLIGHT SERVICE EVALUATION REPORT

March 1977

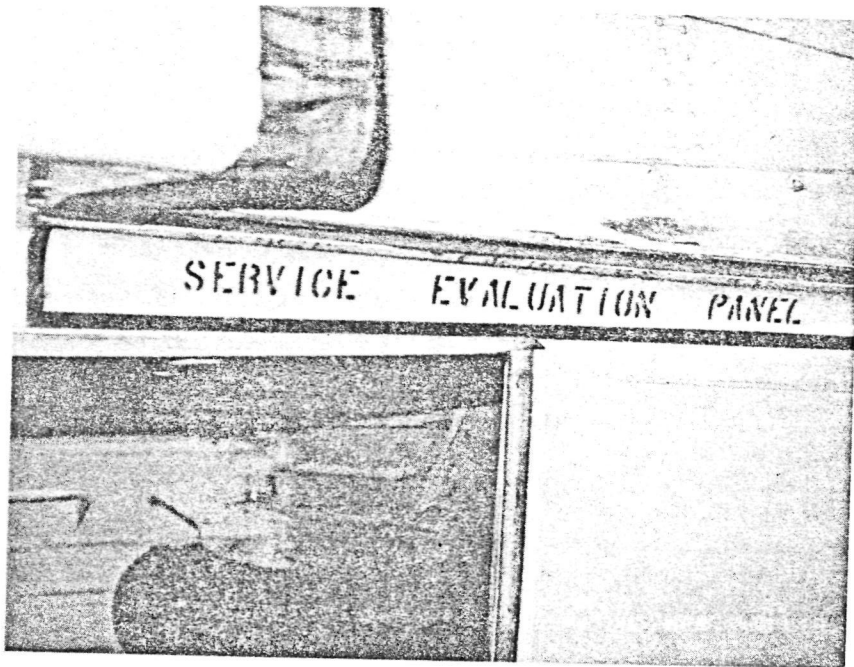
- 1) No cracks, delamination, loss of paint, or other defects or damage noted. No misalignment of fasteners noted (Figure 34).
- 2) The upper portion of the panel was extremely dirty, but there was no evidence of Skydrol contamination.

Figure 34. TWA LH Wing-Body Fillet - Exterior Surface

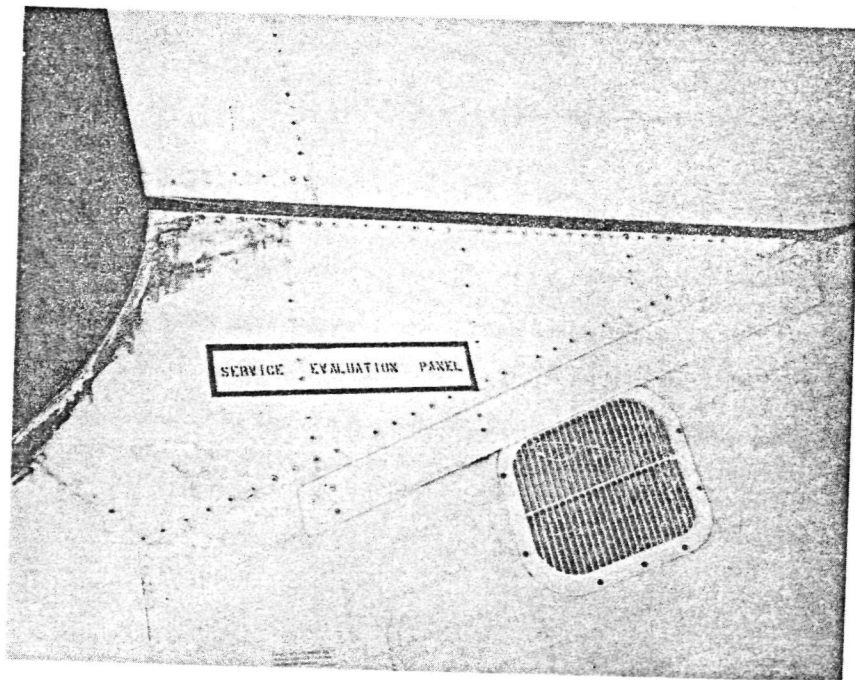
- 1) The exterior surface showed no cracks, delaminations, debonds or other visible defects or damage (Figure 35). Some loss of paint was noted, but flame spray was intact.
- 2) There was no significant fastener misalignment or excessive gaps between the fastener heads and the panel. A slight bulge was noted in the panel along the lower aft edge, however, indicating the panel may have been forced to fit in that area.

Figure 35. TWA RH Aft Engine Fairing - Exterior Surface
