NASA TECHNICAL MEMORANDUM

NASA TM X-73390

INVESTIGATIONS FOR THE IMPROVEMENT OF SPACE SHUTTLE MAIN ENGINE ELECTRON BEAM WELDING EQUIPMENT

April 1977

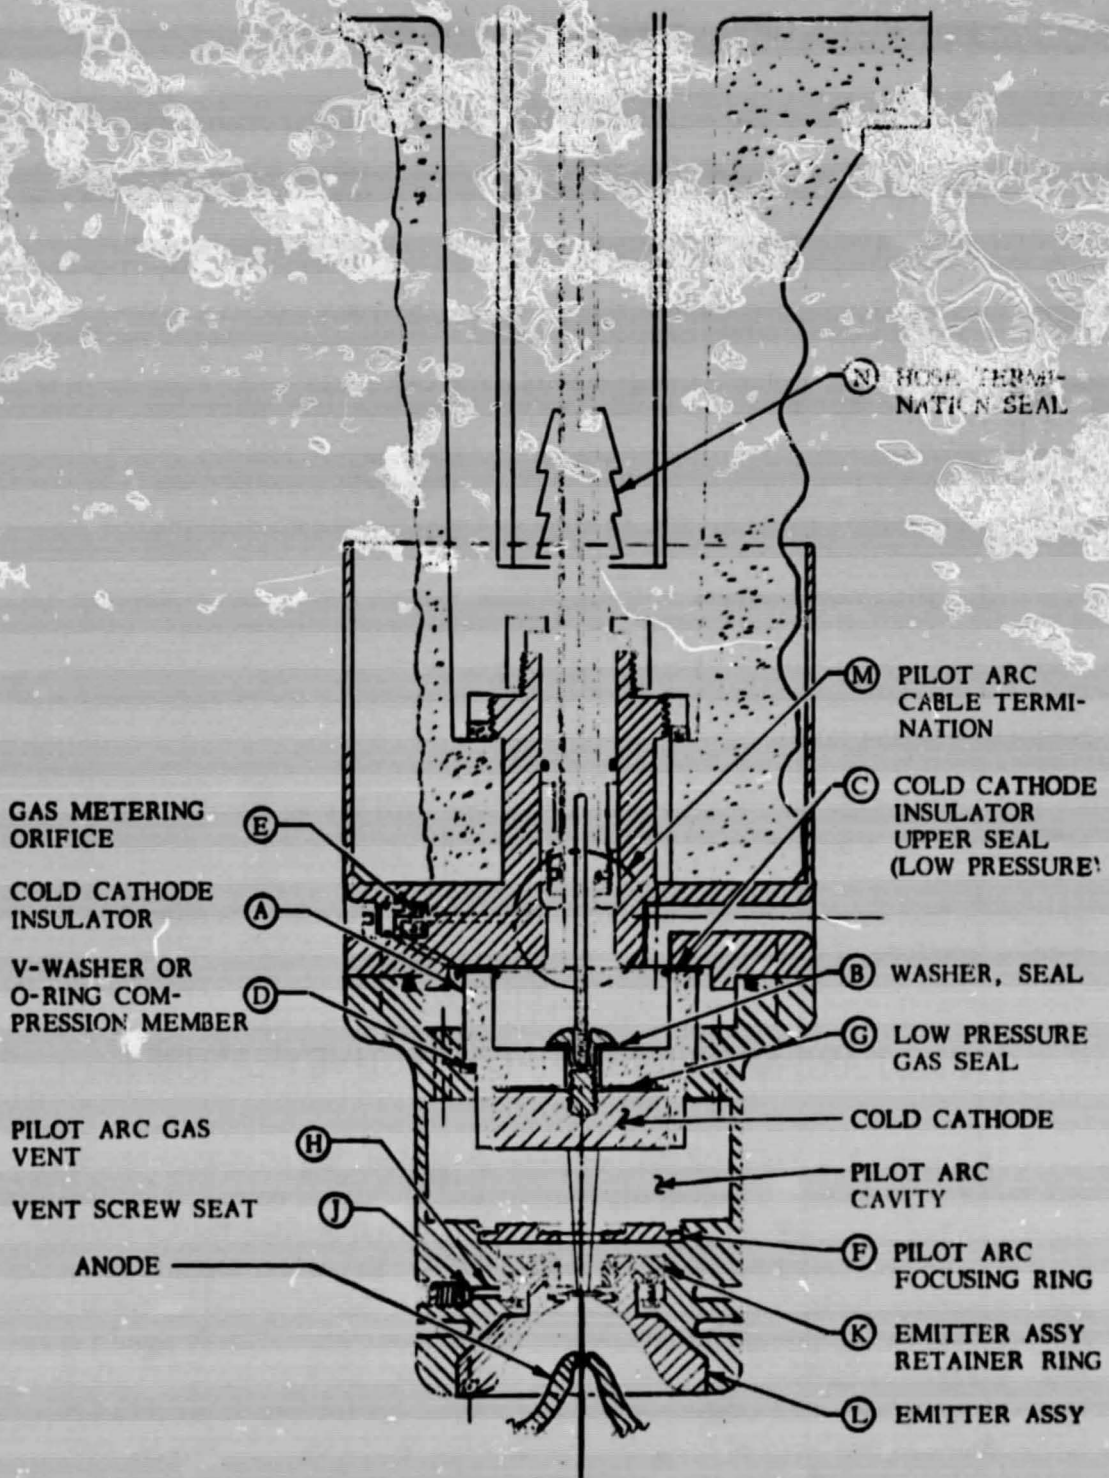
Figure 3. Cross section, EB gun.

When the EB gun (Fig. 3) was disassembled, the pilot arc chamber was found to be severely coated with carbon and aluminum oxide. This indicated extensive impingement of the pilot arc on the electron emitter holder carbon washers and erosion of the pilot arc cold cathode. Relatively thick rings of nonsymmetrically deposited thin film carbon were visible on the aluminum cold cathode, indicating that the pilot arc was not as symmetrical as it should be. Also, streaks of carbon vapor deposition on the back side of the cold cathode insulator at A indicated slight gas leakage around the lead washer seal at B. Other faults in this area of the gun were that the lead seal at C leaked, the compression Viton O-ring at D would not stand the heat causing it to lose

resilience, and the 0.0127 mm (0.0005 in.) diameter nitrogen gas metering orifice at E was almost totally clogged with a foreign metallic substance. The orifice required scrubbing in a solution of nitric acid to remove the restriction but was later replaced with a new orifice disk to meet the flow requirements of 40 to 60 bubbles/min. Modifications to the gun proper are as follows with reference to Figure 3:

1. The pilot arc chamber and focusing ring F were thoroughly cleaned with sodium hydroxide and polished. It was learned that deposits of aluminum oxide on the focusing ring aperture tend to cause defocusing and dissymmetry of the pilot arc. This causes partial impingement of the pilot arc on the carbon tungsten emitter washer rather than totally upon the tungsten emitter. This condition results in poor pilot arc efficiency as evidenced by loss of output weld current and carbon implosion.

2. Graphoil (A UCC product) seals were used to replace lead washers at B and C to prevent leakage of nitrogen pilot arc gas and resultant erratic gun operation. In the past, the lead seals in these locations were coated with a light coating of vacuum grease prior to installation. However, the Graphoil seals work best installed dry. Also, it has been found that vacuum grease, when heated, offgasses and contaminates the pilot plasma arc causing erratic gun operation. It also dries, flakes, and clogs the 0.0127 mm (0.0005 in.) orifice.

4. An Inconel V-washer (Figure 4a) was used to replace the Viton O-ring at D to maintain sealing pressure at C. Actually, the maintenance of sealing compression at C is one function of the O-ring, or V-ring, at D. The other function is to cushion the cold cathode ceramic insulator.

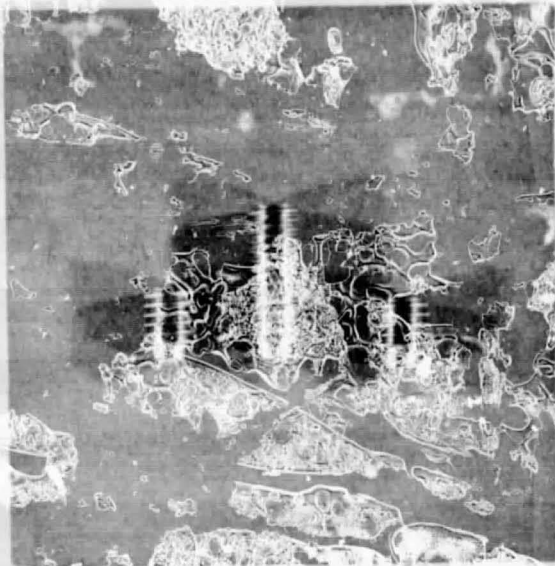
b. Vent screws — Center original design. Cone point new design.

b. A cone point was machined on the two vent screws (Fig. 4b), and flat seats were machined into the cathode housing at J for finer adjustment of the gas vents.

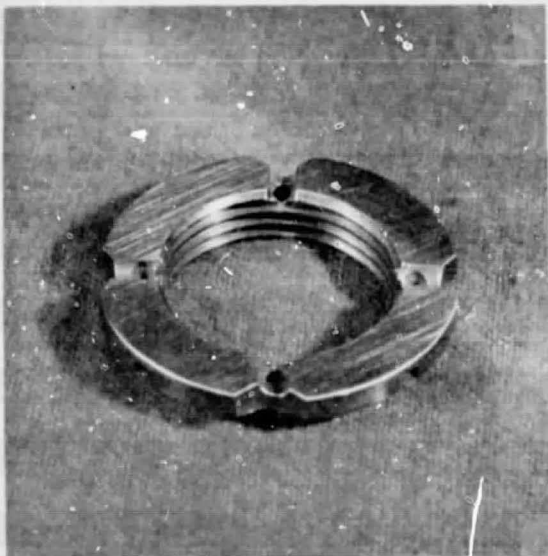
c. Retainer ring — lateral ring grooves shown enlarged

c. Enlarged vent grooves were machined in the retainer ring K (Fig. 4c).

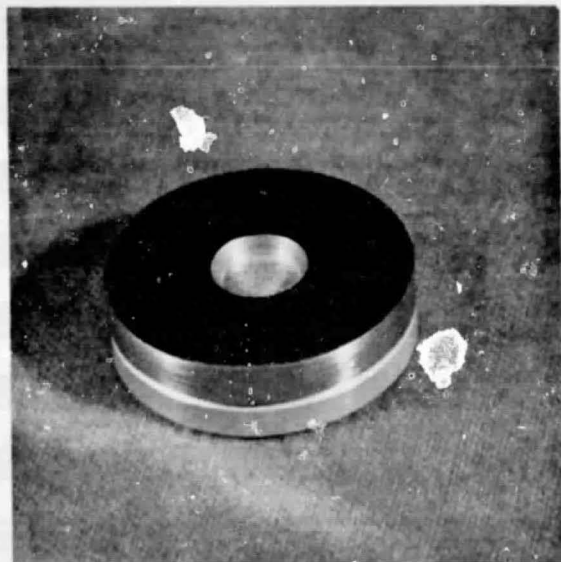
d. Titanium-aluminum cold cathode.
Titanium face shown up.

Once all of these changes were incorporated into the gun, start-up problems were resolved. However, it was still apparent that the cold cathode configuration needed improvement. This was evidenced by (1) operational values of pilot arc relative power (percent) greater than factory recommended, (2) excessive carbon and aluminum oxide vapor deposit accumulation in the pilot arc cavity, and (3) suspected arcing from the cold cathode to the gun internal wall. At the suggestion of UCC, a Lanthanum Hexaboride, LaB_6 , cold cathode

was procured and tried. Before the cold cathode could be tested, UCC discovered a flaw in the design and recommended changing to aluminum-titanium as shown in Figure 4d. UCC provided a cold cathode of aluminum-titanium for test purposes. It was theorized that titanium, being a poorer electron emitter than aluminum at gun operating temperatures, would help prevent arcing between the cold cathode and gun wall. The aluminum disk exposed in the center of the titanium-aluminum cathode is the actual cold cathode emitter material. Pilot arc power for the given beam current range was reduced to UCC recommended levels, and the pilot arc relative power for different electron beam power levels repeated consistently. All indications are that focusing and distribution of the pilot arc are now stable and operate as the gun developer intended. The titanium-aluminum cathode, as received from UCC, proved satisfactory and, therefore, the proposed testing of the LaB₆ cathode was omitted.

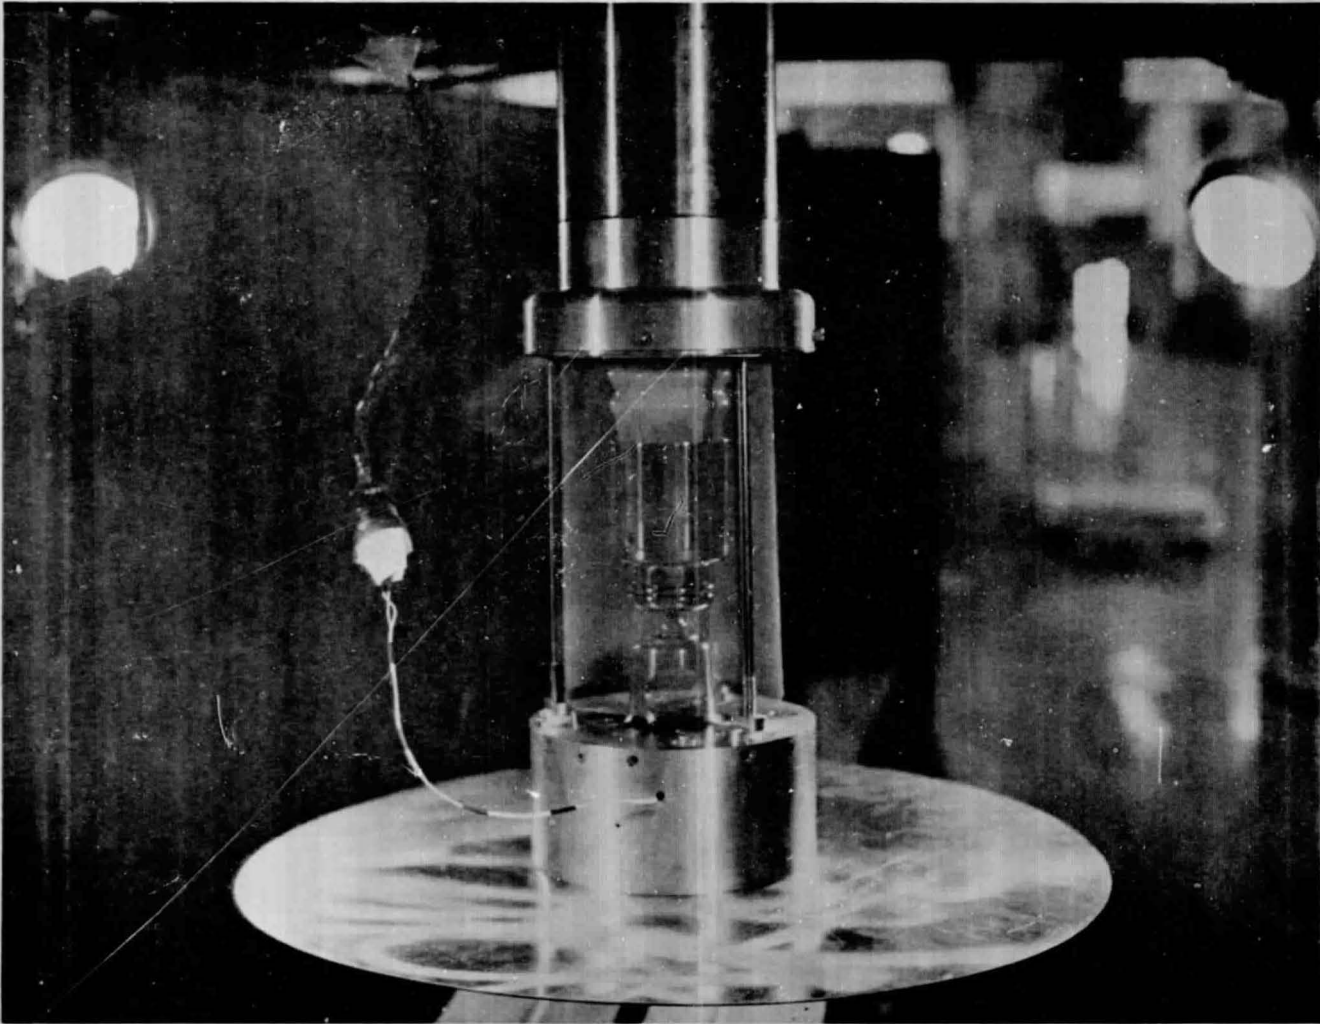
Figure 6. ERI EB gun open, see-through fixture with focus coil.

was excellent and probably superior to copper from the viewpoint of arc suppression. No anode overheating was observed, or evident, and pitting due to arcs was minimal — much less than previously observed with copper anodes. The question of titanium versus copper anodes, though, has not yet been thoroughly tested or evaluated.

While the special fixture was being used, the interior surfaces of the gun housing were honed and lapped to a mirror finish to improve the gun-to-housing dielectric characteristics. In addition, a new, highly polished corona shield was added to the gun. The relatively sharp edges on the new shield, as received from UCC, were rounded and polished to a mirror finish and then satisfactorily tested in the open fixture. To verify if the EB gun would now operate as "arc-free" in the polished standard housing as it did in the open, "see-through" fixture, the gun was reassembled in the newly polished housing and tested. With the gun mounted vertically, ten 2 min runs and twelve shorter duration runs were made within a time span of less than 90 min. A total of 23 min of operation was thus achieved with the gun operating at the power supply full rated power of 60 kV and 125 mA. One arc-out occurred during this 23 min of testing, causing the equipment to shut down normally. This test was repeated a second time with substantially the same results. Thus, operating time between arc-outs at 60 kV tested approximately 20 times better than when the investigation first started. Previously the welder would rarely operate for more than 1 min at 55 to 60 kV without an arc-out. Further testing is planned, but these results indicate that the gun operated in the polished standard 30 kW rated housing essentially equal to its operation in the open fixture with the gun mounted vertically. Orientation is mentioned because horizontal operation of the ERI EB gun is not normally quite as free from arcs as when the gun is mounted vertically.
