NASA CR-135169  
R76-189

# AEROSPIKE THRUST CHAMBER PROGRAM FINAL REPORT

ROCKETDYNE DIVISION  
ROCKWELL INTERNATIONAL

NASA Lewis Research Center  
Contract NAS3-20076

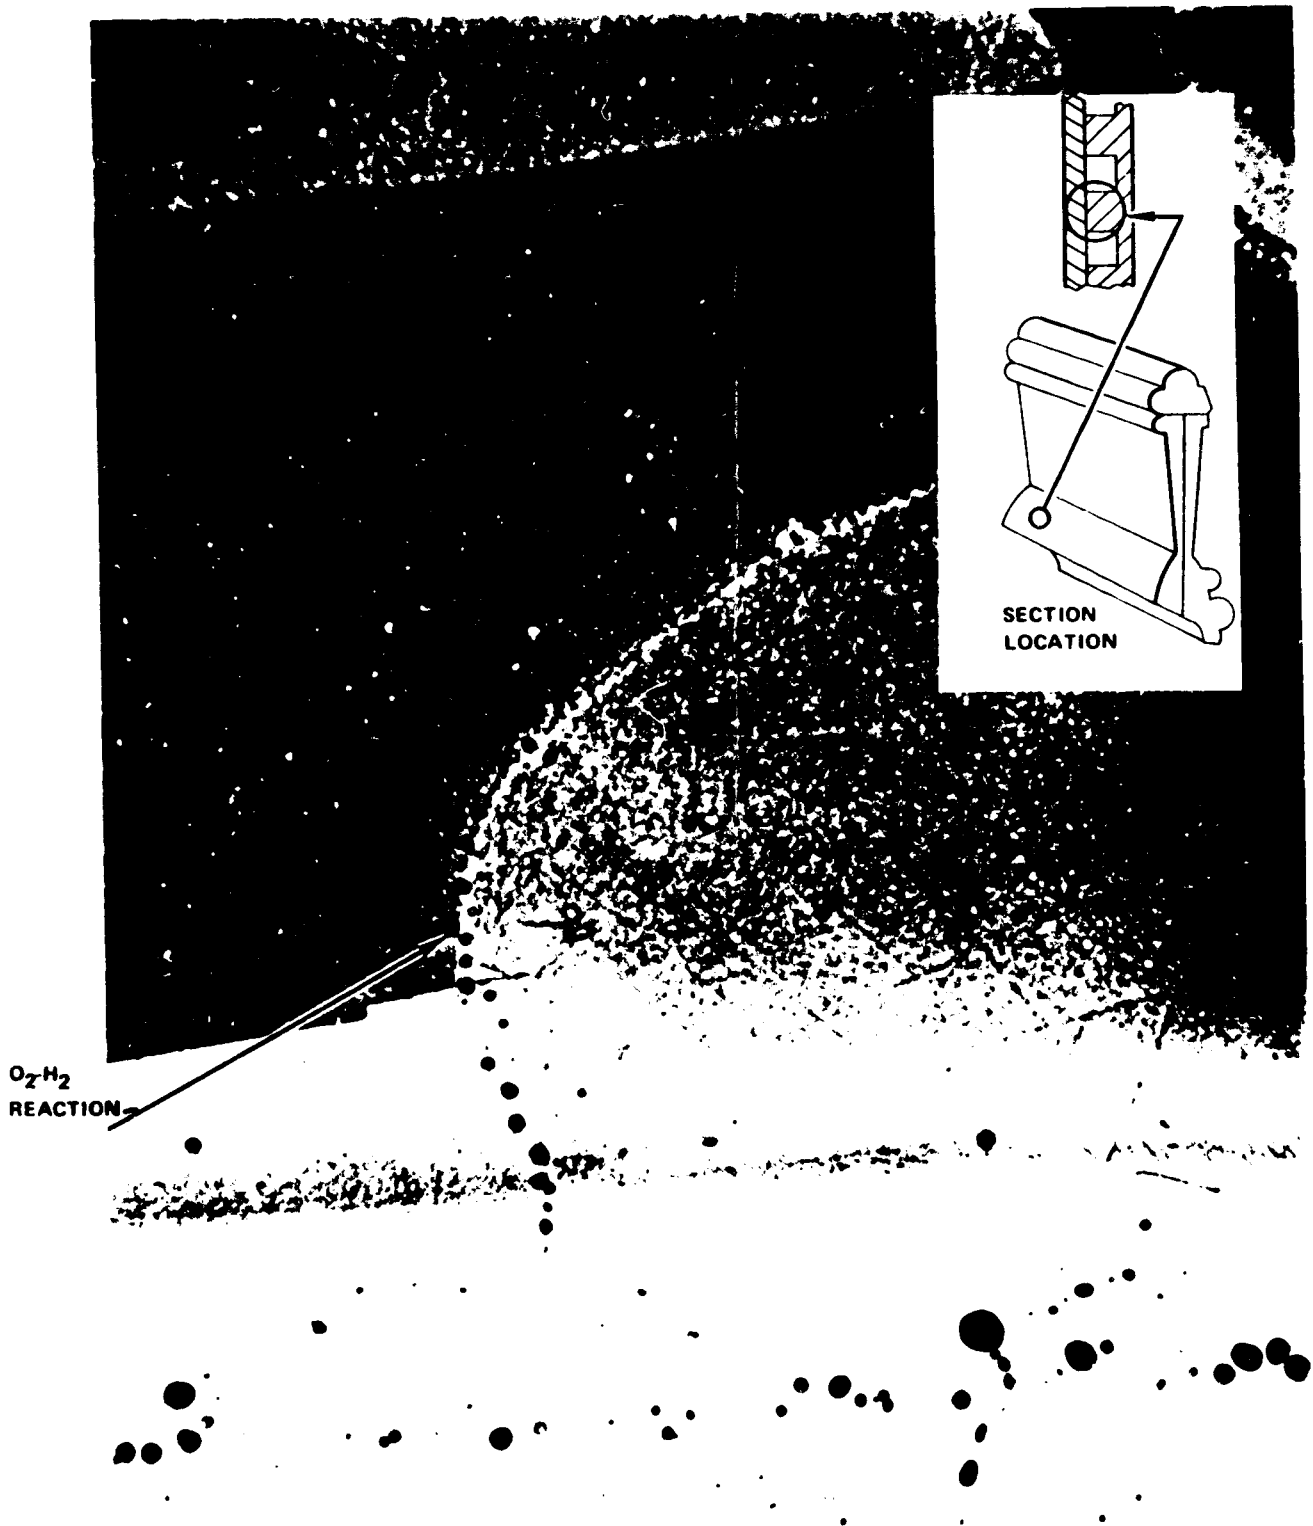
The NARloy-A cracking encountered on units 507R and 510R was so nontypical that it engendered a metallurgical and historical investigation, concurrent with the repair effort on 507R and 510R, to understand the problem and to assess its implications for all the combustors. Methods of removing samples from existing combustors were developed which permitted metallurgical examination of the NARloy material and, if necessary, replacement of the removed sample so as to be able to fire the combustor. Microscopic examination of these samples indicated that the fundamental cause of the cracking of 507R and 510R was that the NARloy material properties had been degraded by the reaction of hydrogen with previously dissolved oxygen. Figure 4 is a photomicrograph of material removed from unit 510R. It shows the voids along the grain boundaries that result when steam is formed. The source of hydrogen was readily ascribed to the hydrogen atmosphere furnace brazing that had been utilized during the initial fabrication of the combustors. An investigation was conducted as to the source of oxygen and it was determined that the most probable source was oxidation of the inner surfaces of **the liners** and cover-sheets during the initial fabrication (i.e., in 1974). This inner surface oxidation had apparently occurred despite the utilization of inert atmospheres during these operations and despite the imposition of well-developed disciplines for the maintenance of cleanliness.

The results of the metallurgical examination of all combustors sampled are presented in Table 2, which indicates a correlation between the presence of embrittled NARloy-A and the conduct of final brazing cycles in a hydrogen atmosphere. On the basis of the data displayed in Table 2, the conclusion appears inescapable that a large majority of the combustors have been affected by the hydrogen/oxygen phenomenon during their initial fabrication (prior to the start of this contract), and will display substantially reduced ductility under conditions of thermal strain. As it had been demonstrated during the repair procedures on 507R and 510R that the thermal strains involved in cryogenic testing did result in cracking of the embrittled NARloy, and as the test program planned for the thrust chamber assembly

Figure 4. Section Near Crack in Outer Half of Segment 510 (400X)

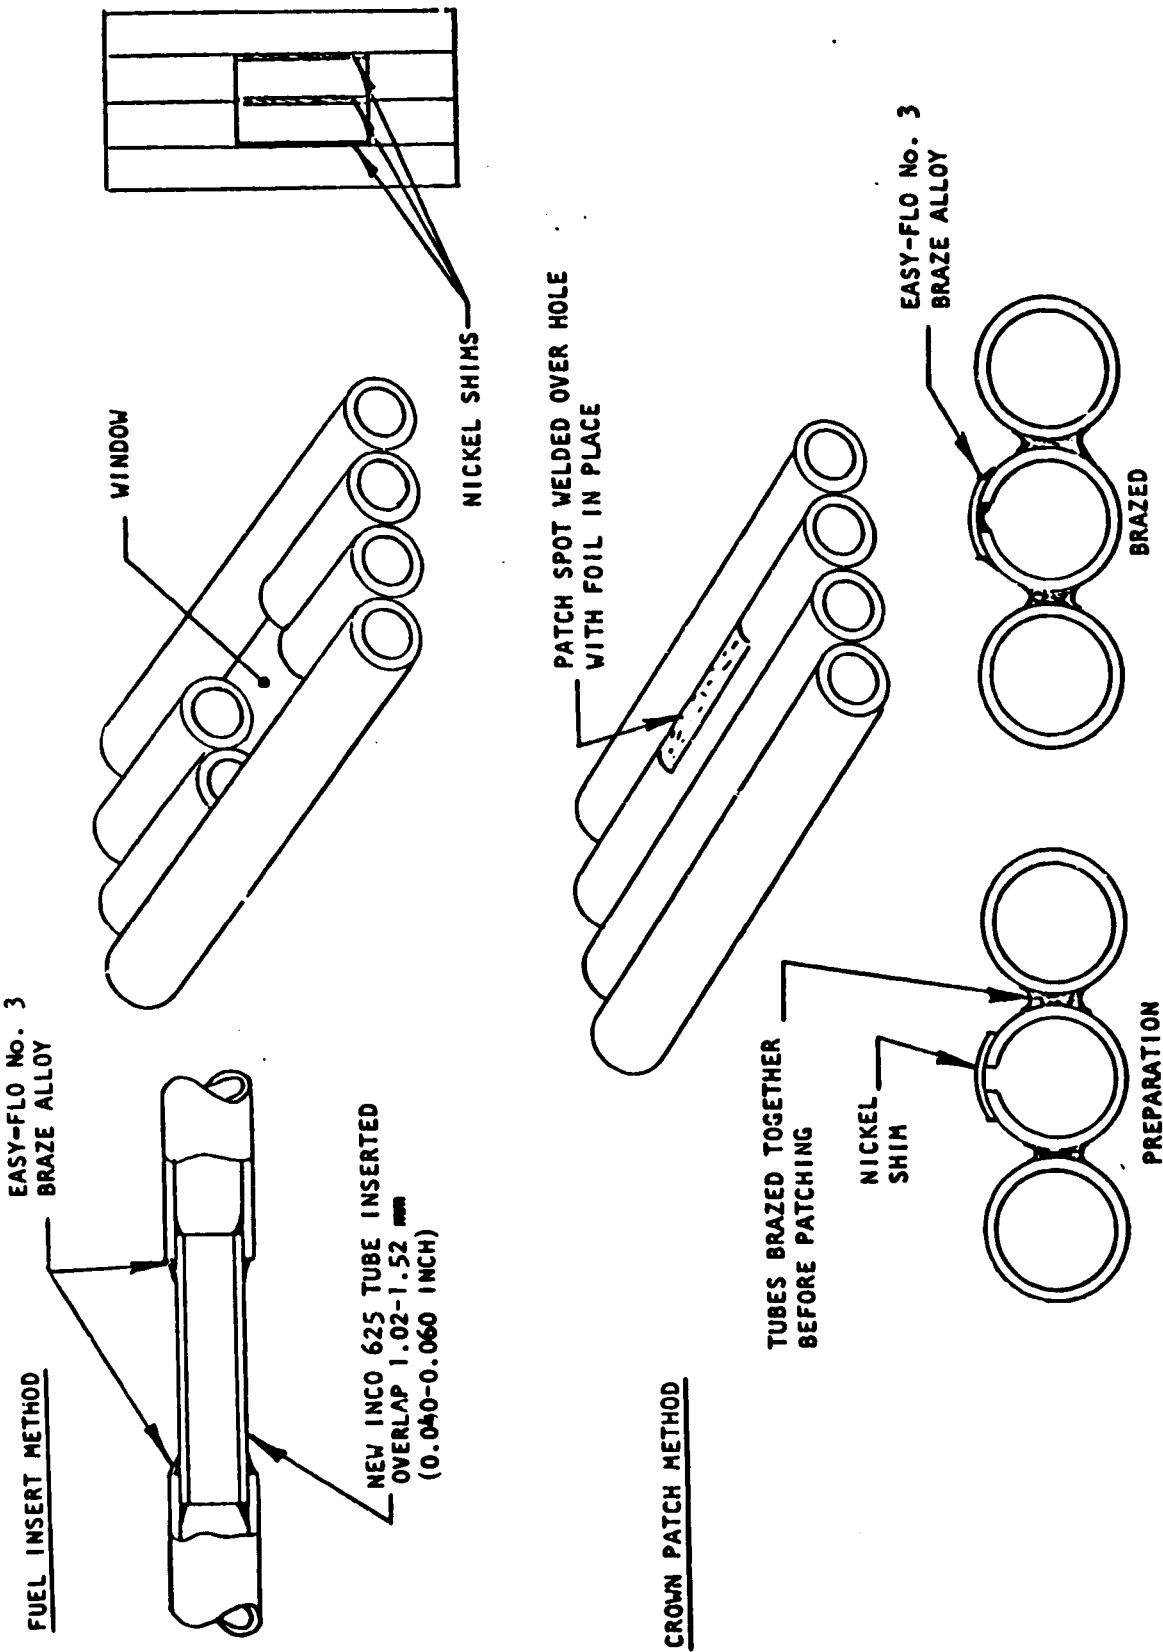
During the test stand fire which terminated the Air Force program, the nozzle had suffered localized overheating on its interior portions (i.e., the "cold" side), because it was sprayed with molten titanium from the burning inner combustor support ring. Repairs to this type of tubular nozzle had not previously been attempted on the scale represented in this instance. Because of a general need for developing the technology for repairing complex lightweight tubular nozzles, a company-sponsored technology program was undertaken which utilized the 111 kN (25K) aerospike nozzle for development purposes. Two basic methods of repair were developed, the saddle-patch repair and the inserted tube repair as defined in Fig. 5. When properly applied, these two methods sufficed to repair all of the damage that had been incurred by the 111 kN (25K) aerospike nozzle.

Figure 5. Tube Repair Methods

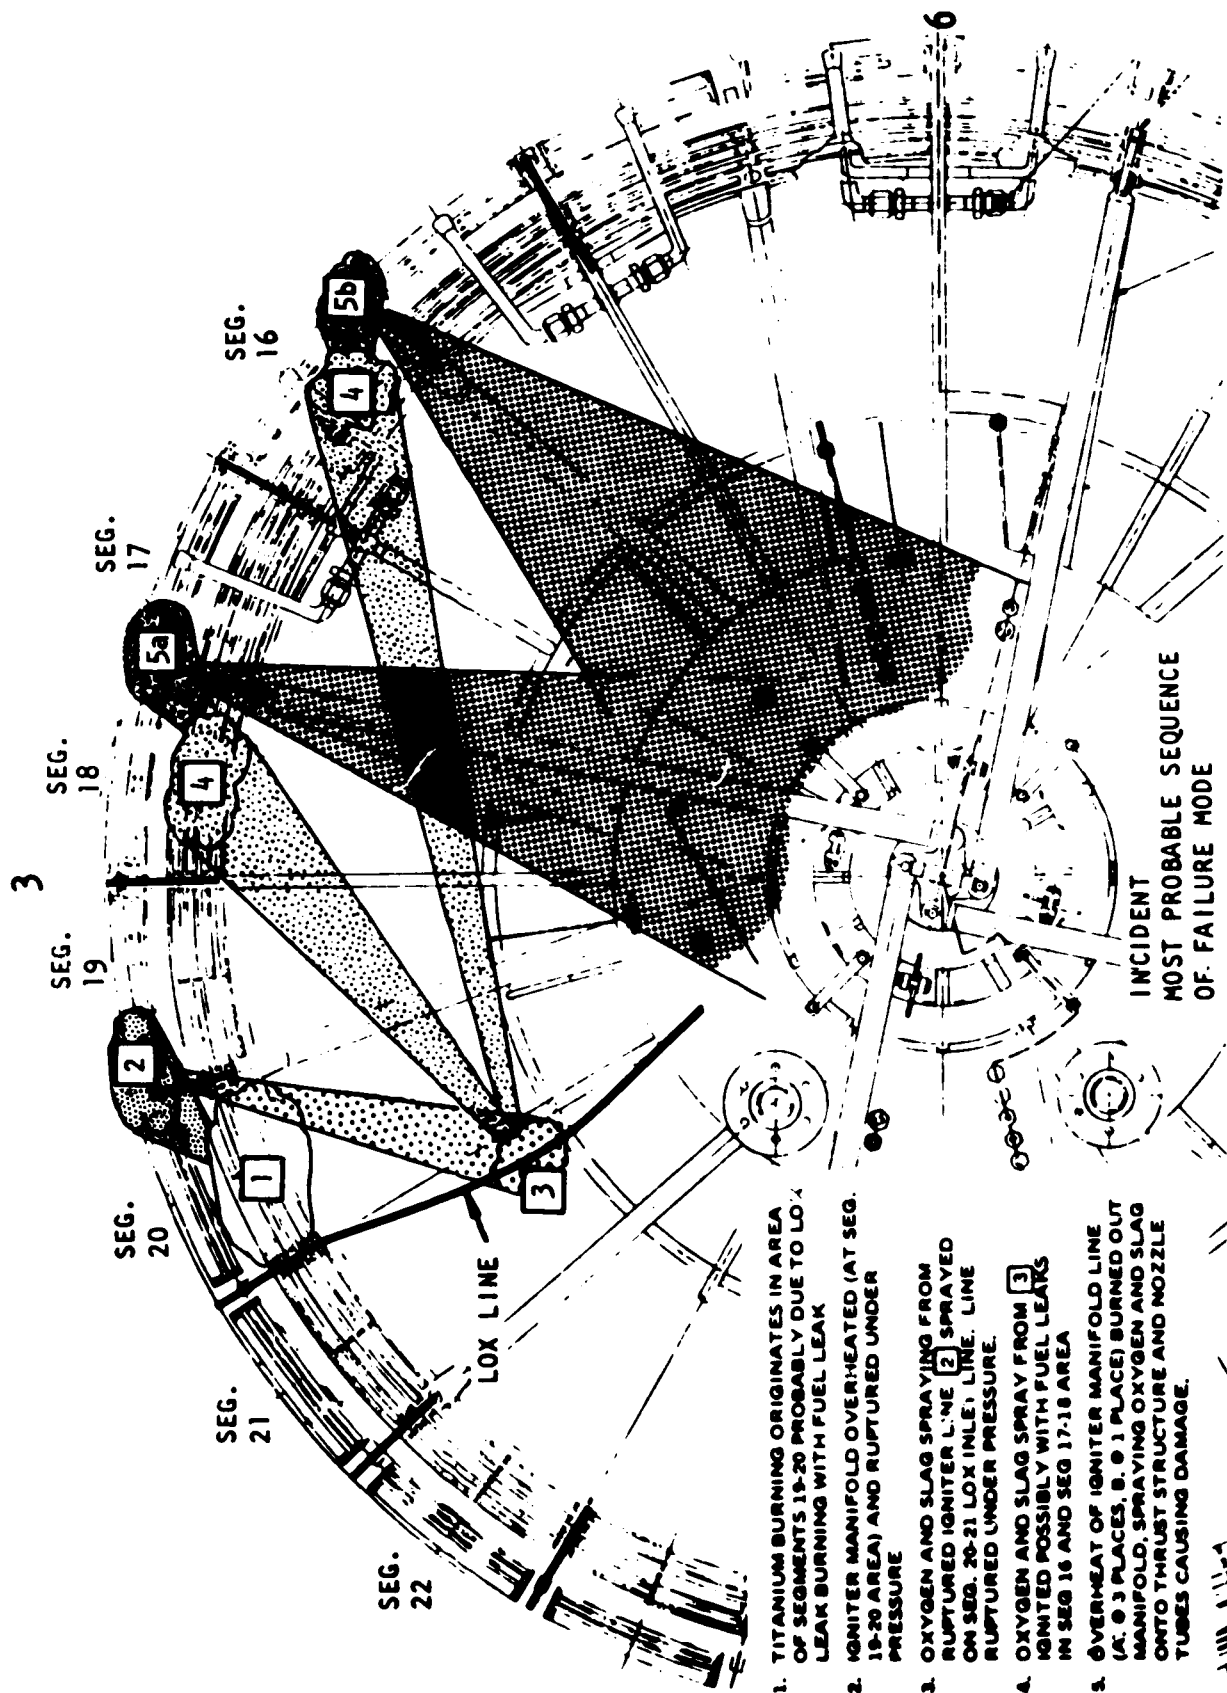
Figure 26. Failure Mode Sequence Schematic

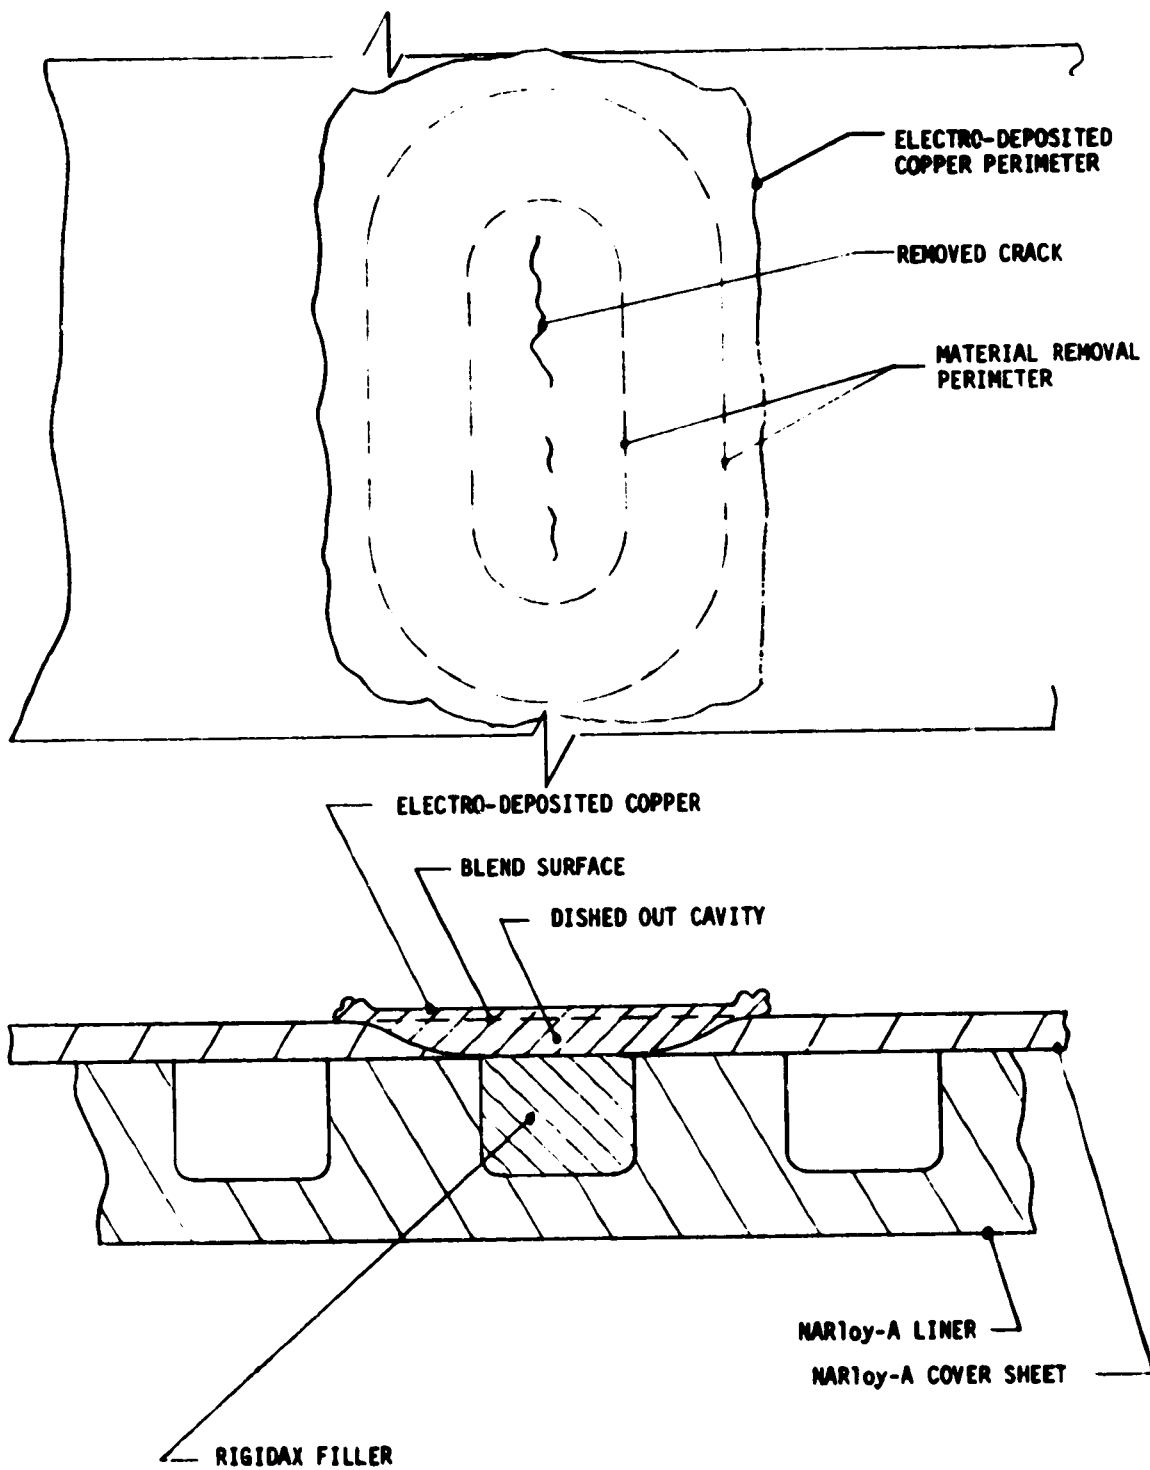
Figure 34. Crack Repair Concept

A repair concept was developed for the NARloy-A cover-sheet cracks of units 507R and 510R which involved dishing out the cracked areas and electrodepositing copper into the groove. Both cell plating, in which a small electroplating cell is clamped to the side of the part to be repaired rather than submerging the whole part in plating solution, and tank plating were successfully employed on the crack areas of the cover-sheets that were accessible. However, on completion of the repairs, and the conduct of cryogenic shock testing and hydrostatic pressure testing, it was found that additional cracking had occurred. On the basis of this experience, it was determined that neither 507R nor 510R was suitable for assembly to the thrust chamber.

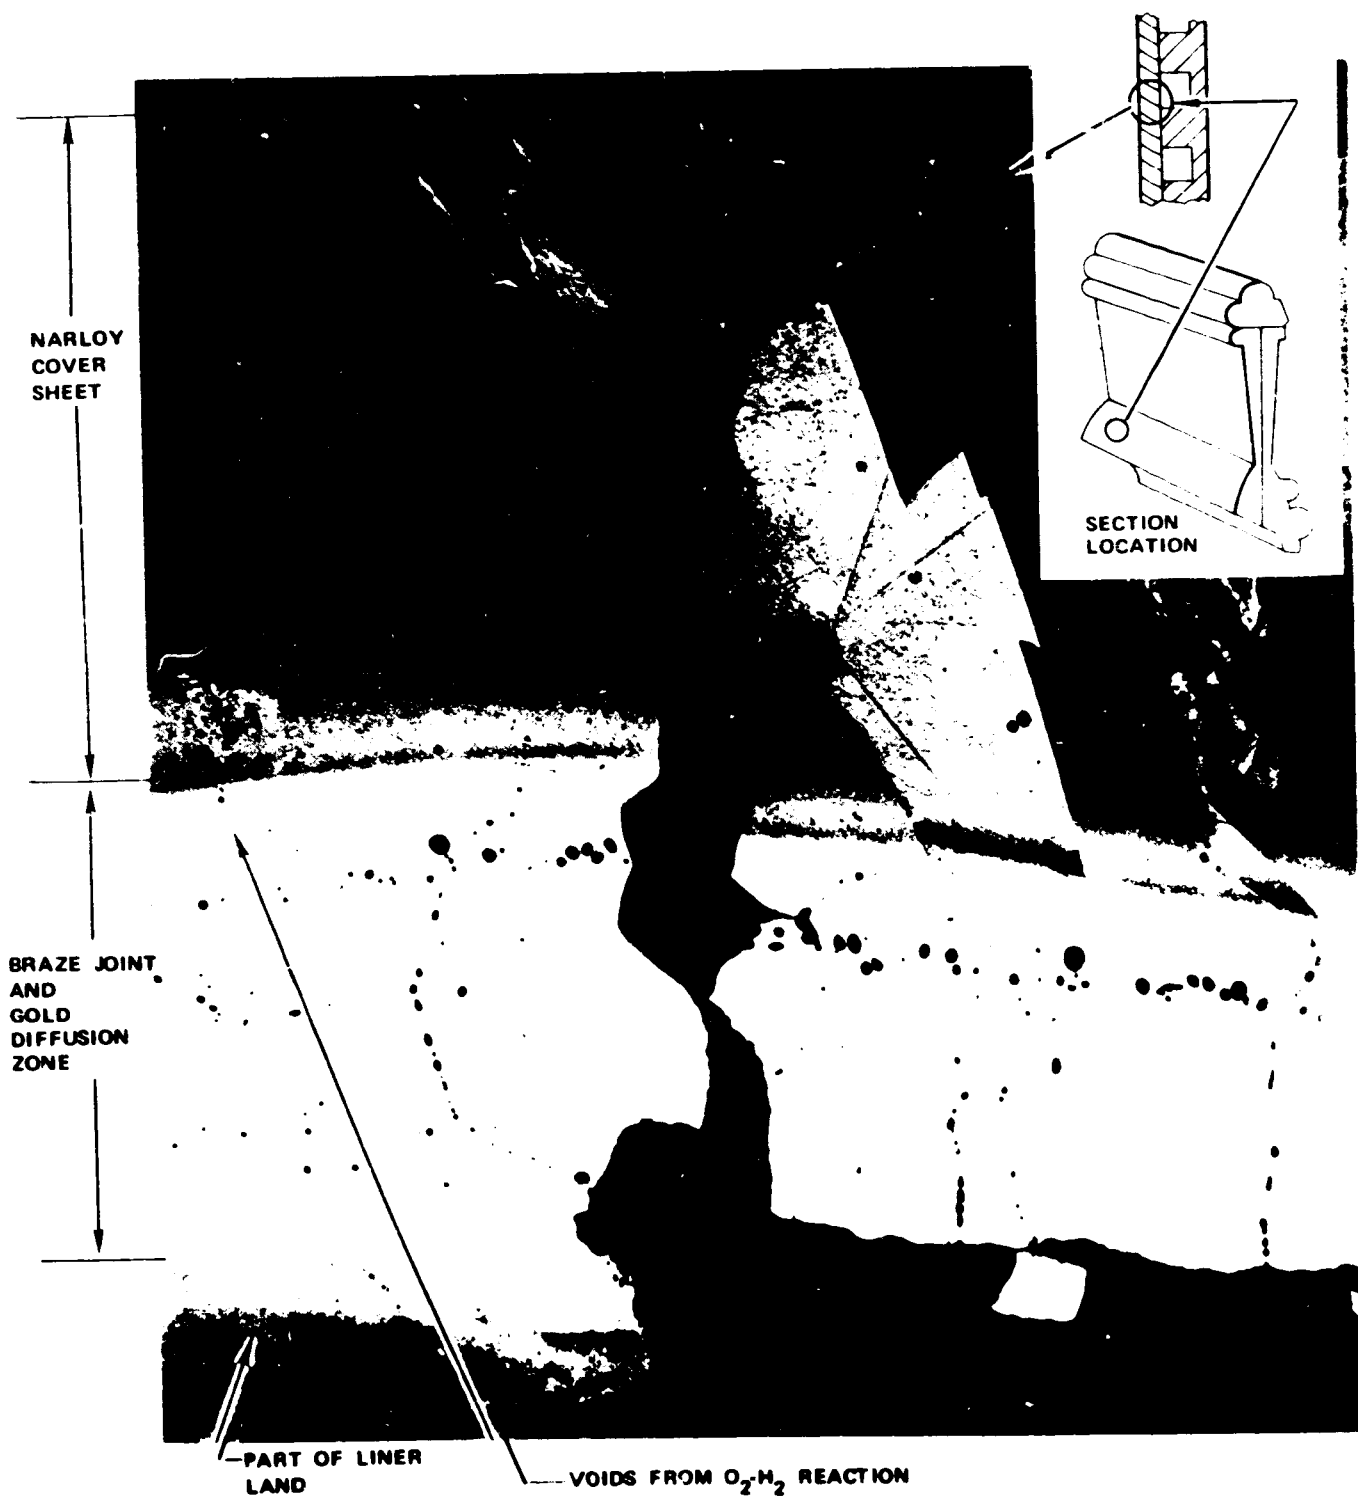
Figure 38. Section Through Crack In Outer Cover Sheet of Segment 510 (200X)

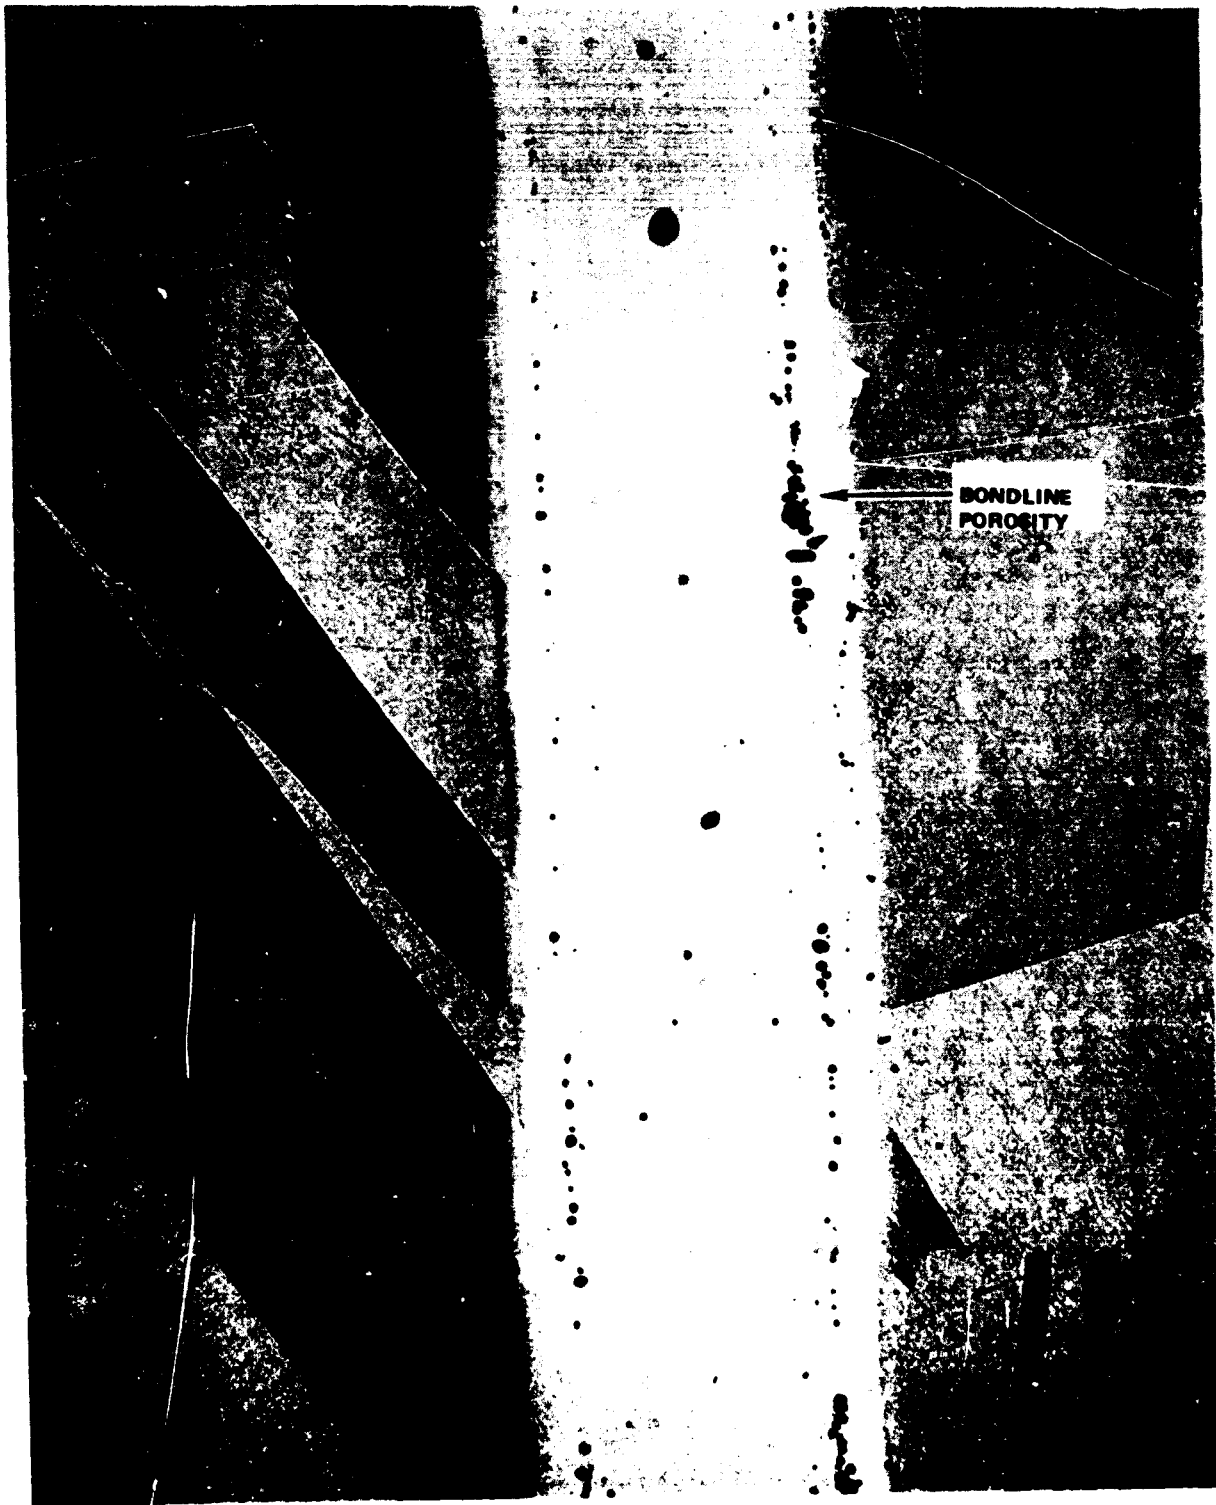
Figure 40. Test Specimen From a Gold-Plated Cover Sheet Subjected to One Braze Cycle in  $H_2$  After Thorough Surface Cleaning (Material is the Same as Segments) (200X)

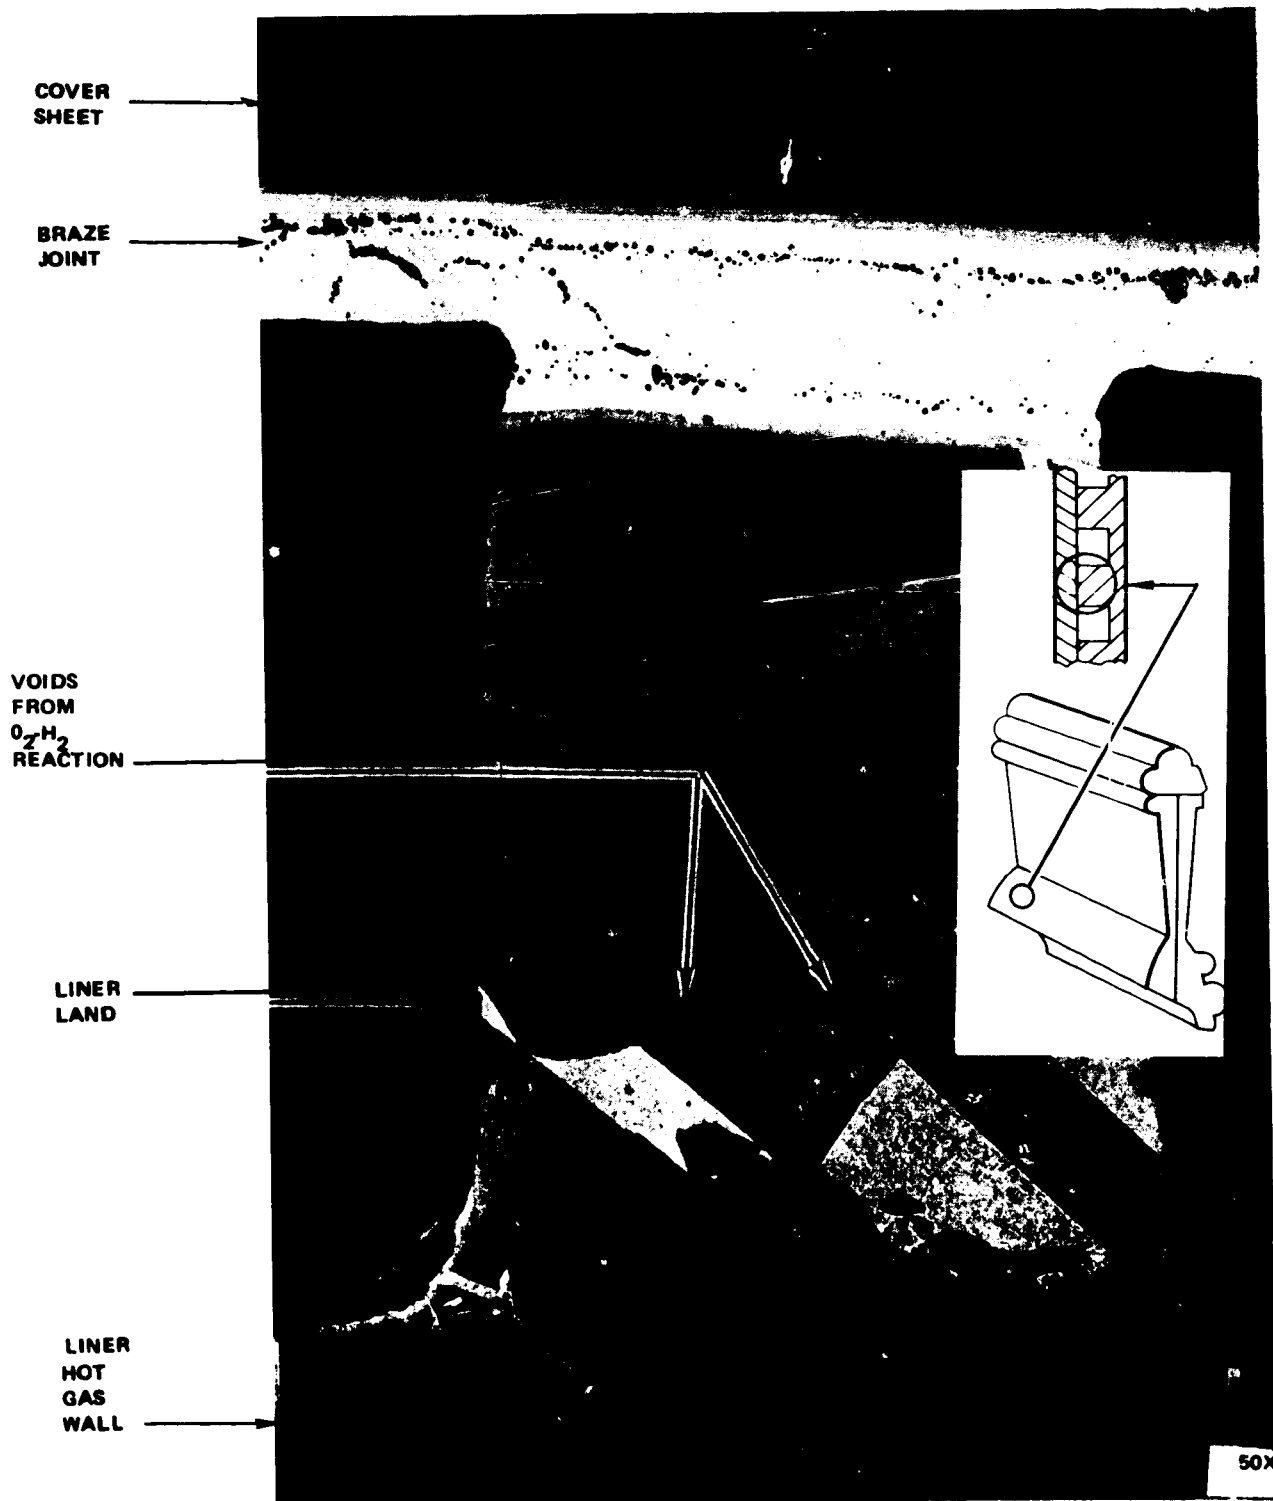
Figure 41. Section From Outer Half of Segment 514 Showing Severe  $O_2-H_2$  Reaction (100X)

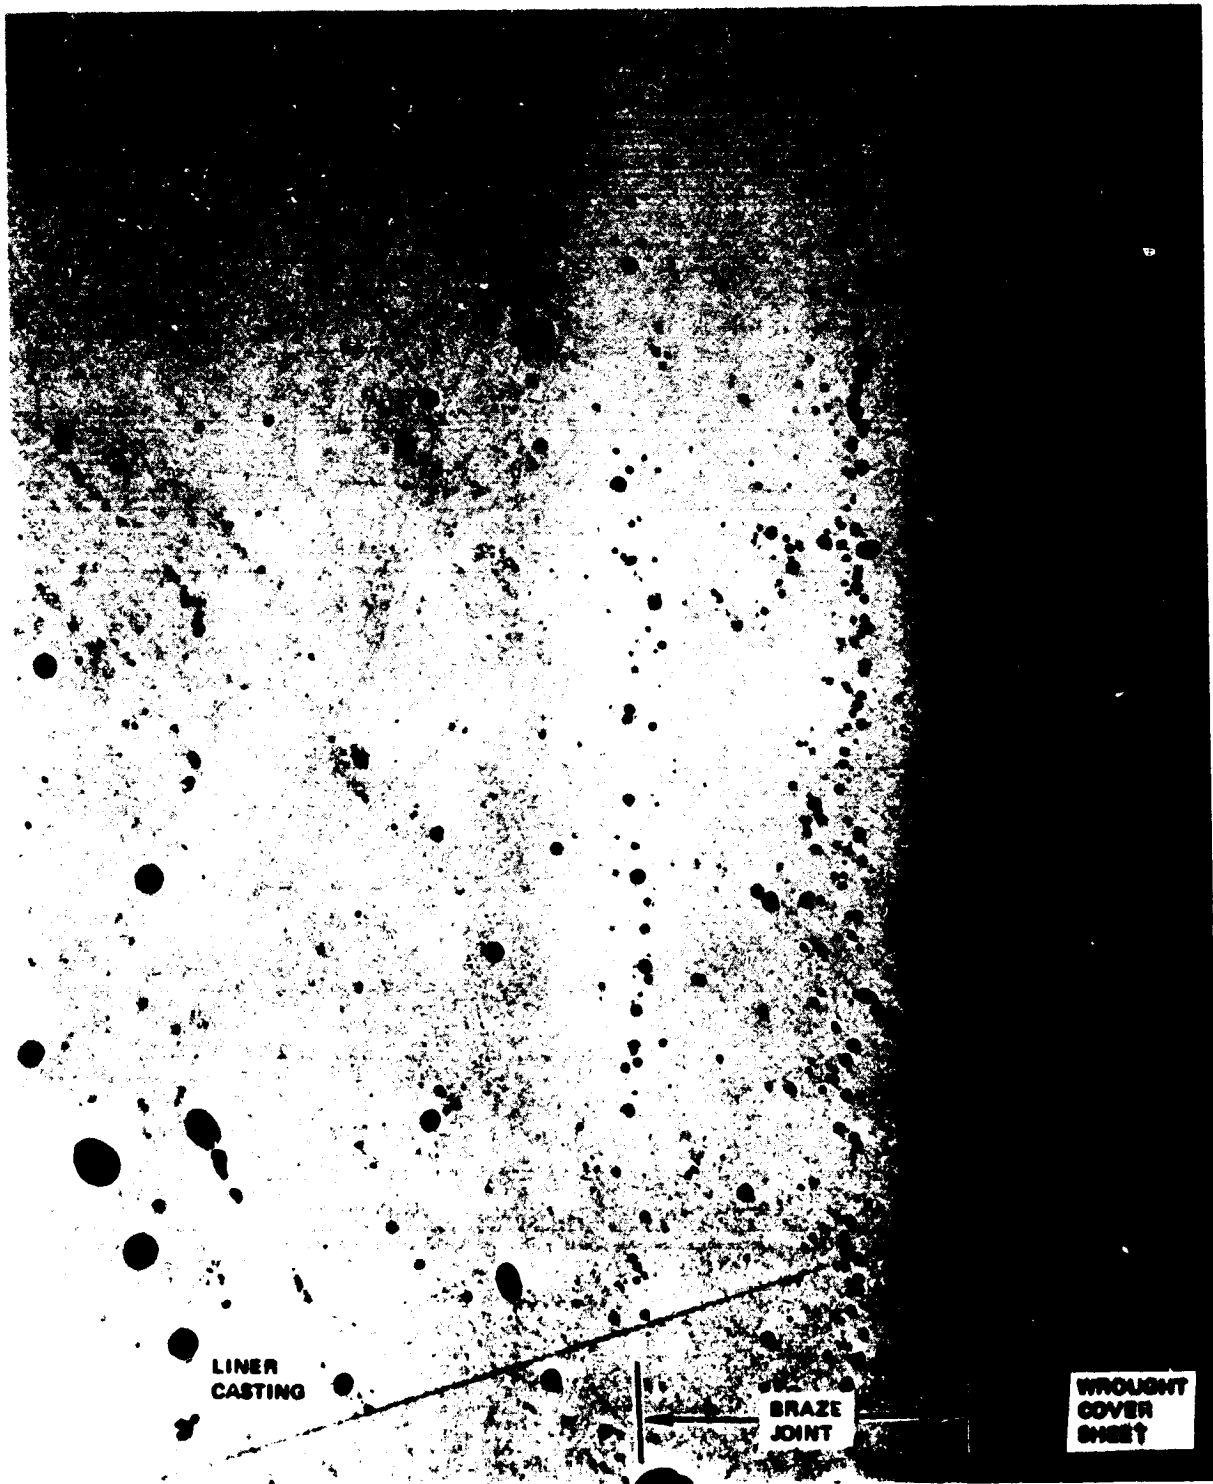
Figure 50. Section From outer Half of Segment 504  
(No  $O_2-H_2$  Reaction Present) (200X)

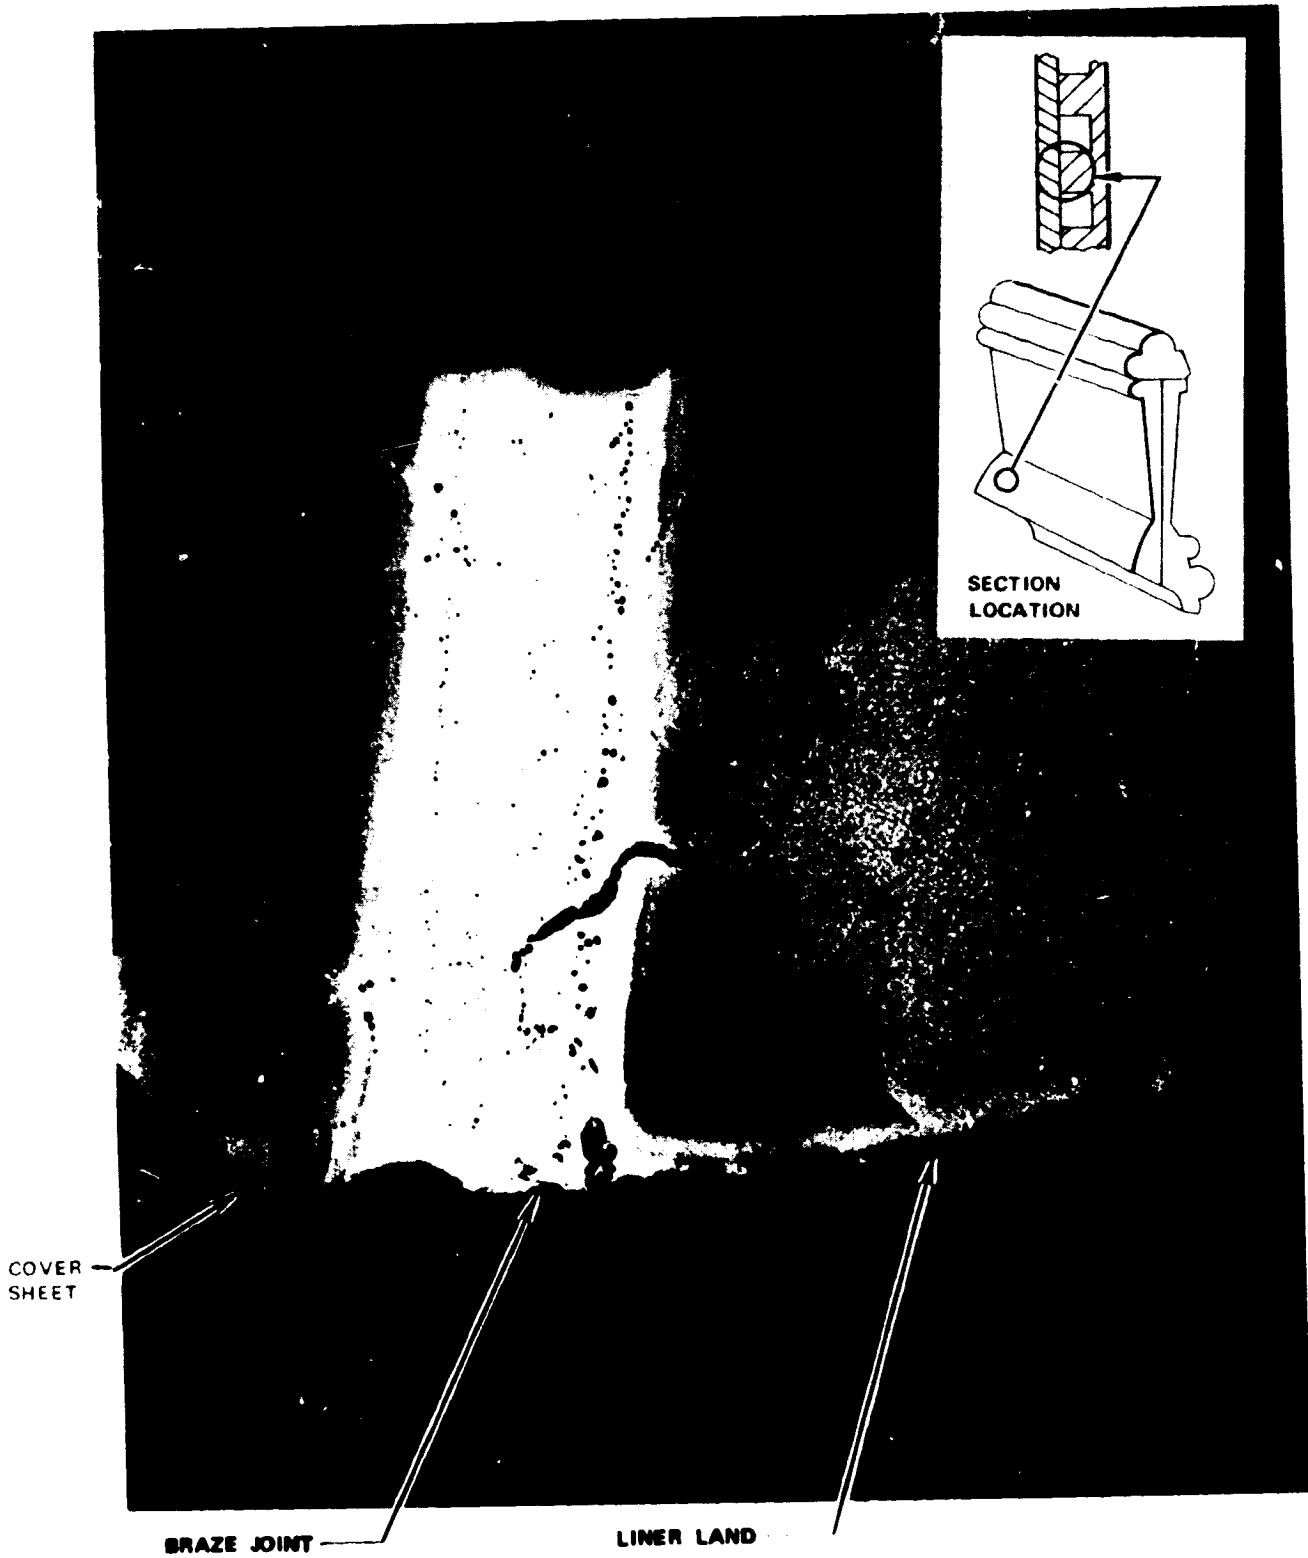
Figure 53. Section From Outer Half of Segment 512, Showing Severe  $O_2-H_2$  Reaction (100X)

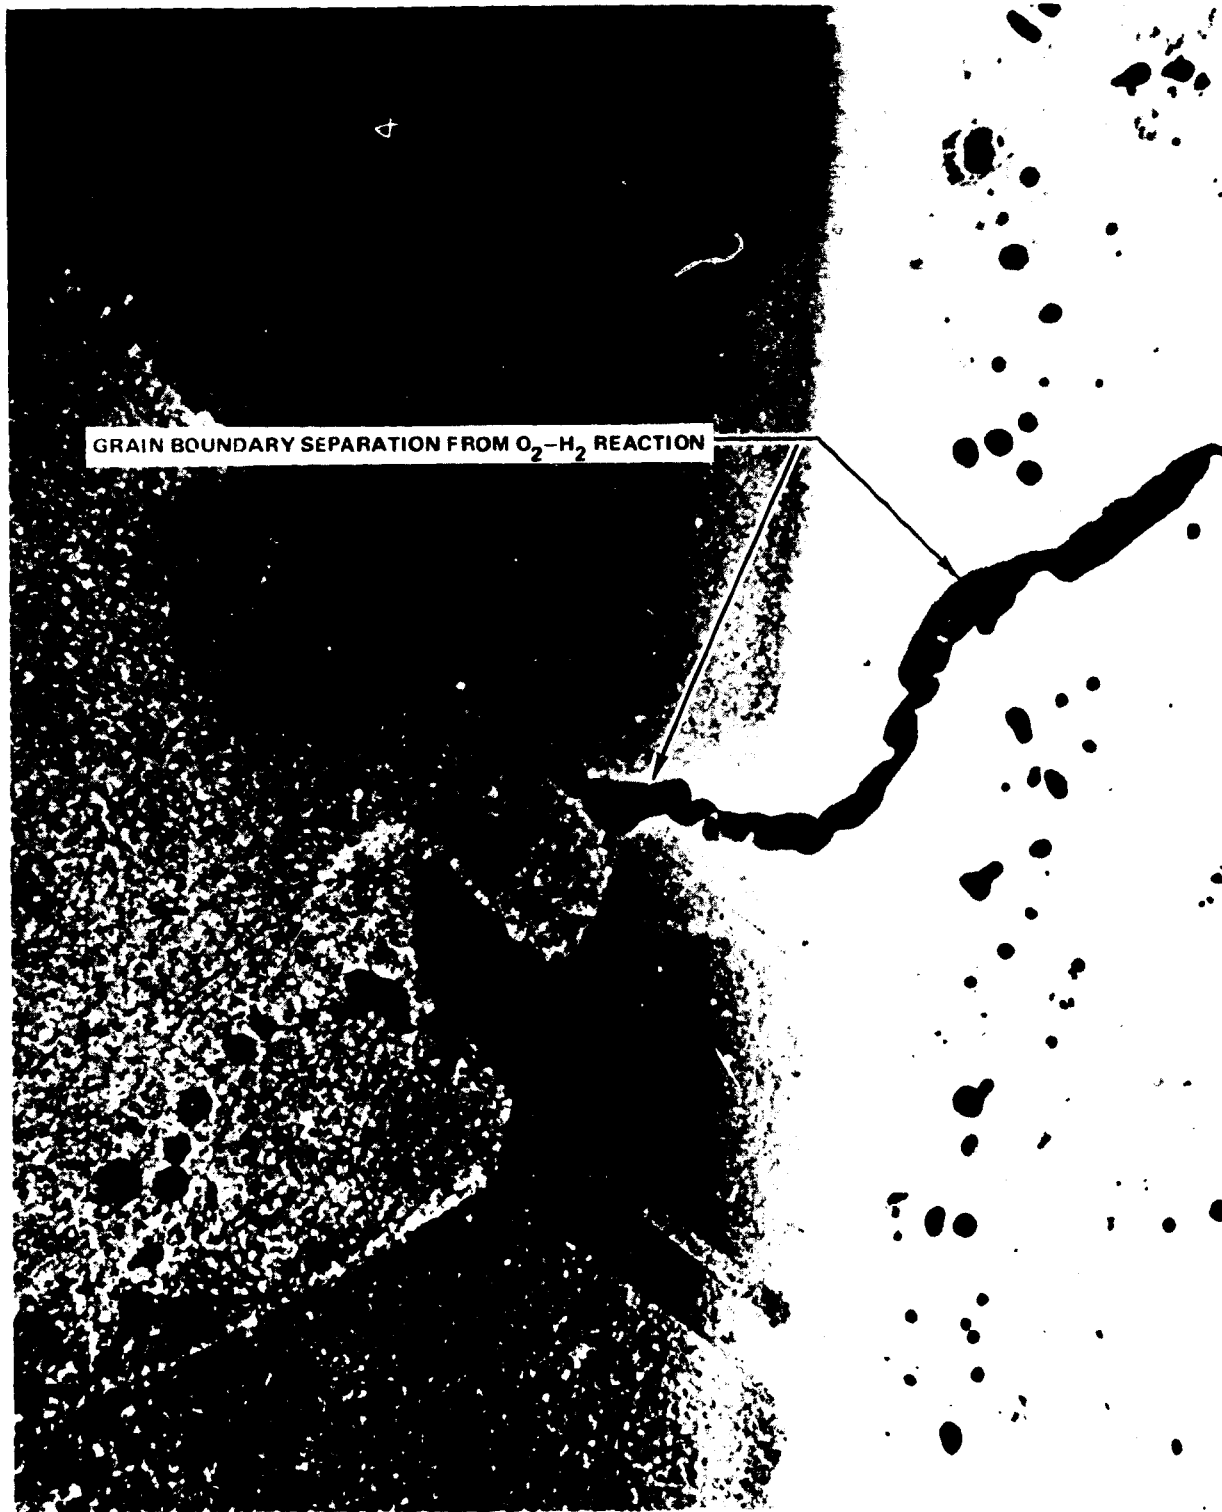
Figure 54. Section From Outer Half of Segment 512, Showing Severe O<sub>2</sub>-H<sub>2</sub> Reaction (400X) (Blowup of Fig. 53)

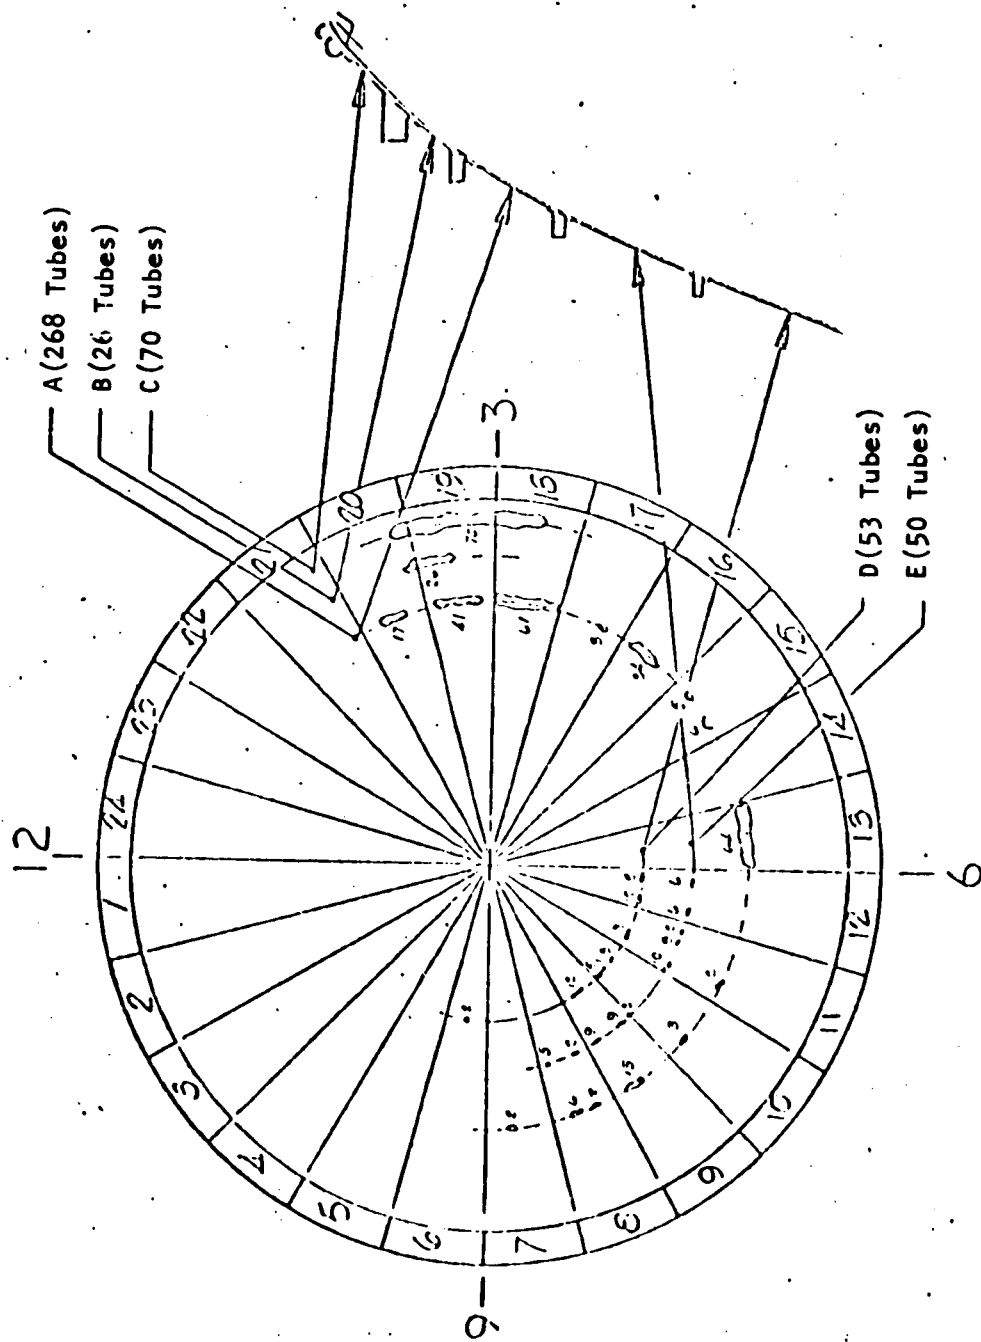
Figure 61. Location of Tube Damage
