NASA CR-135169  
R76-189

# AEROSPIKE THRUST CHAMBER PROGRAM FINAL REPORT

ROCKETDYNE DIVISION  
ROCKWELL INTERNATIONAL

NASA Lewis Research Center  
Contract NAS3-20076

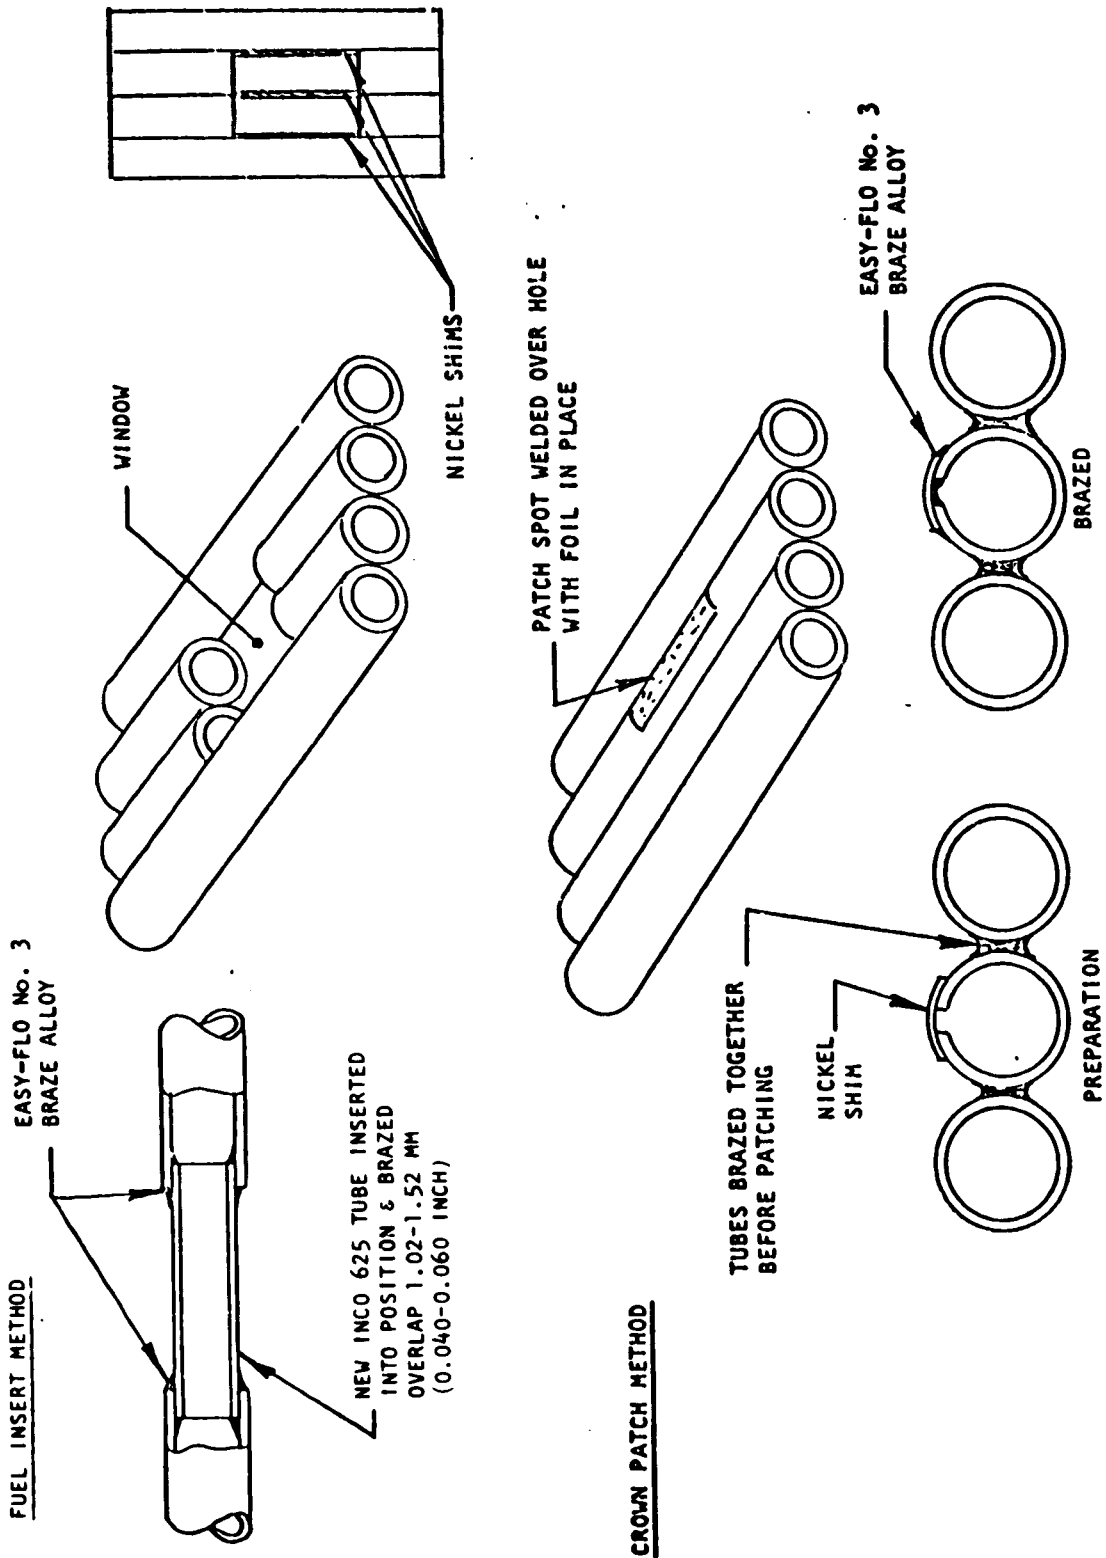
Figure 62. Tube Repair Methods

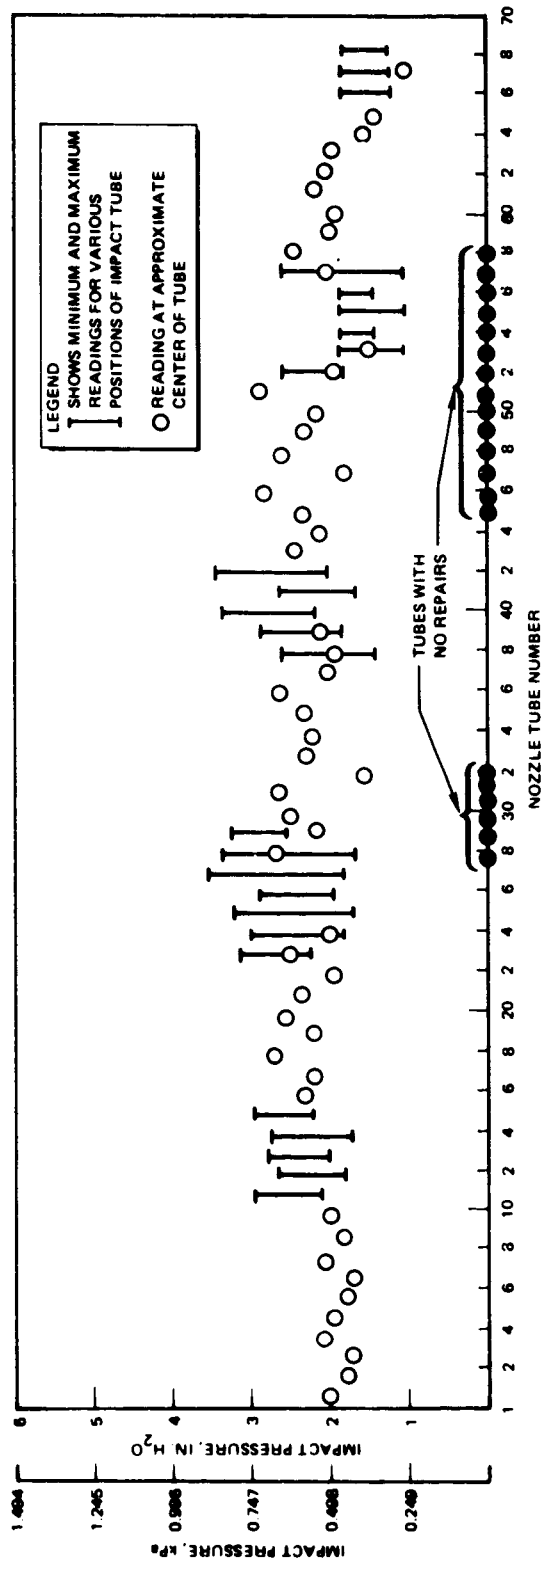
Figure 66. Typical Results -- Flow Check of Repaired Nozzle Tubes, Unit 526
