NASA TM X-73569

**INSPECTION OF TWO BRAYTON ROTATING UNITS
AFTER EXTENSIVE ENDURANCE TESTING**

by James H. Dunn
Lewis Research Center
Cleveland, Ohio 44135
December 1976

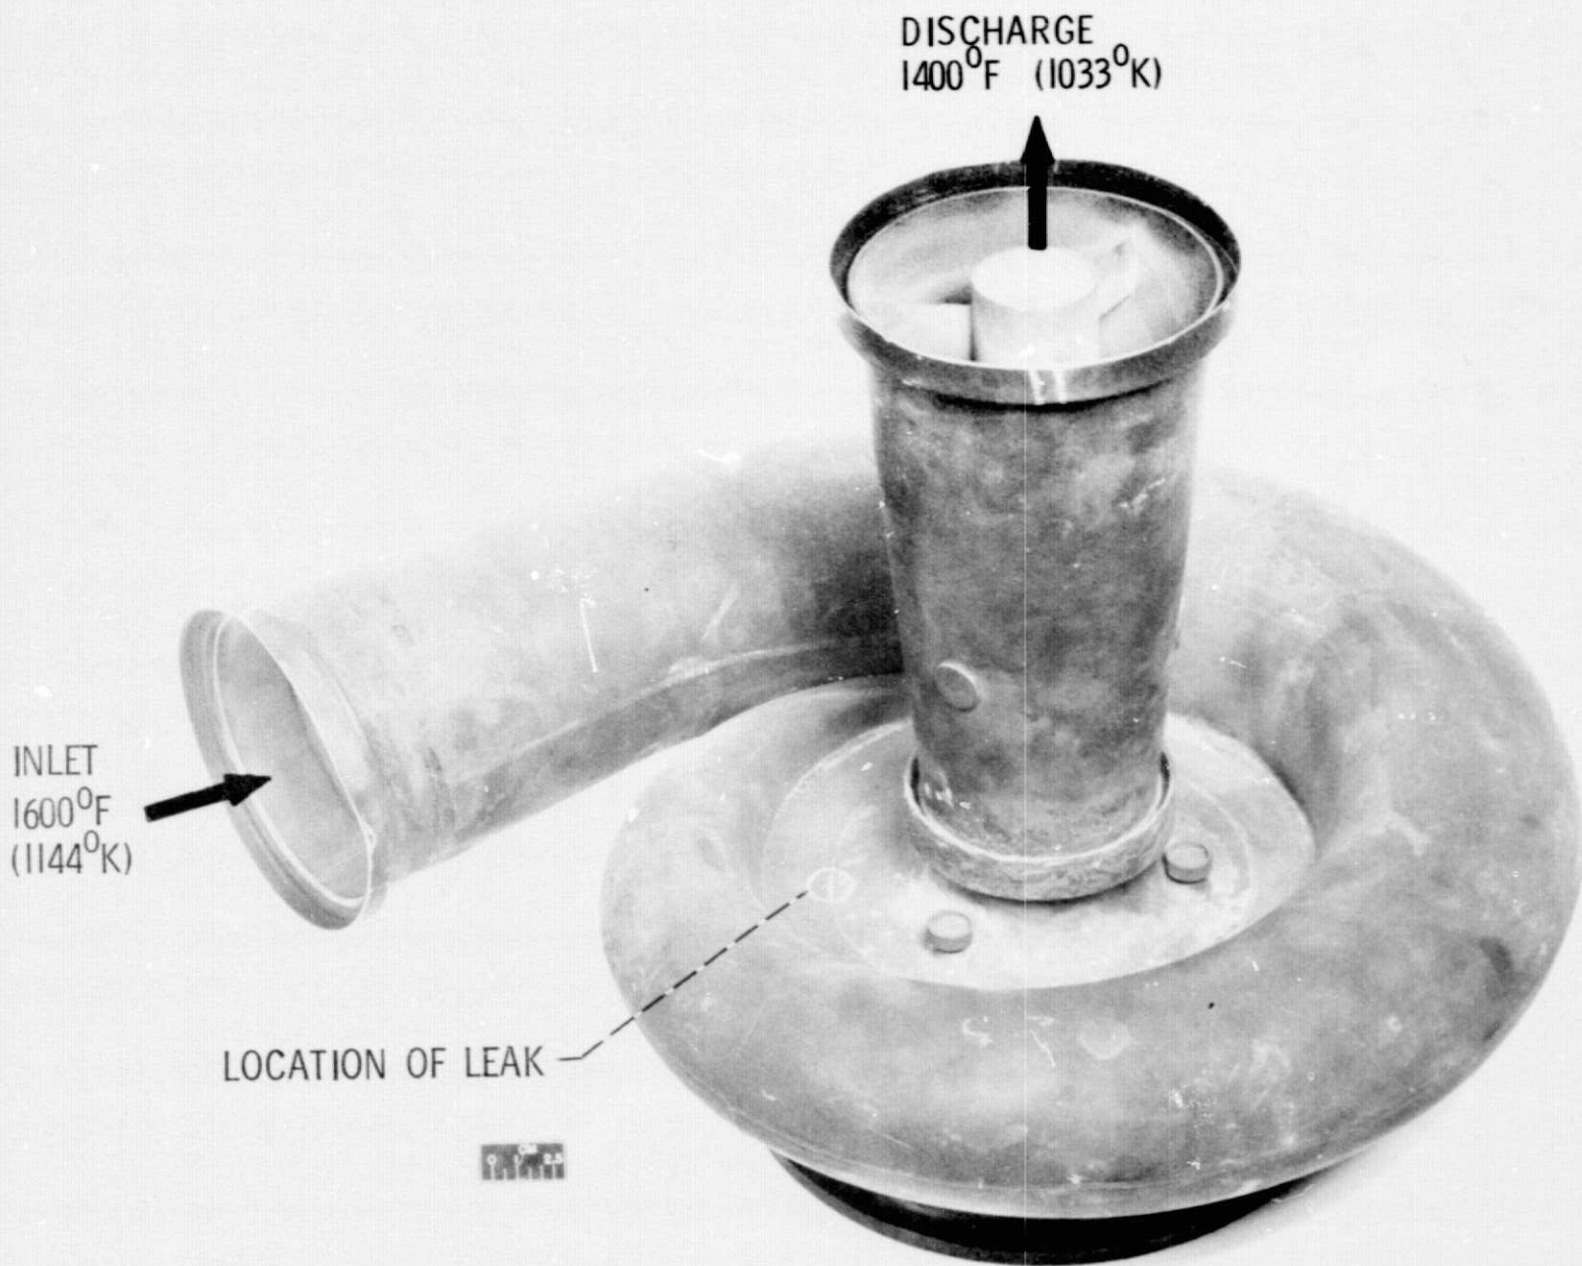
Figure 7. - Turbine scroll brayton rotating unit no. 2.

After removal from the Brayton engine (21 000 hrs operation) and prior to disassembly, BRU-2 was helium leak checked. This check revealed a crack that had developed in the turbine scroll along one of the welds (see fig. 7). No other leaks were detected.

The turbine scroll is the only potential life-limiting component identified in the BRU's after 21 000 hours of operation. This weakness (weld failure) can be eliminated by changing the configuration from the conventional torus, as used in the BRU, to a simple plenum. The plenum configuration is much simpler to fabricate and eliminates most of the present welds. Wall thickness can be increased in the plenum, thus reducing the operating stresses and increasing cycle fatigue life.

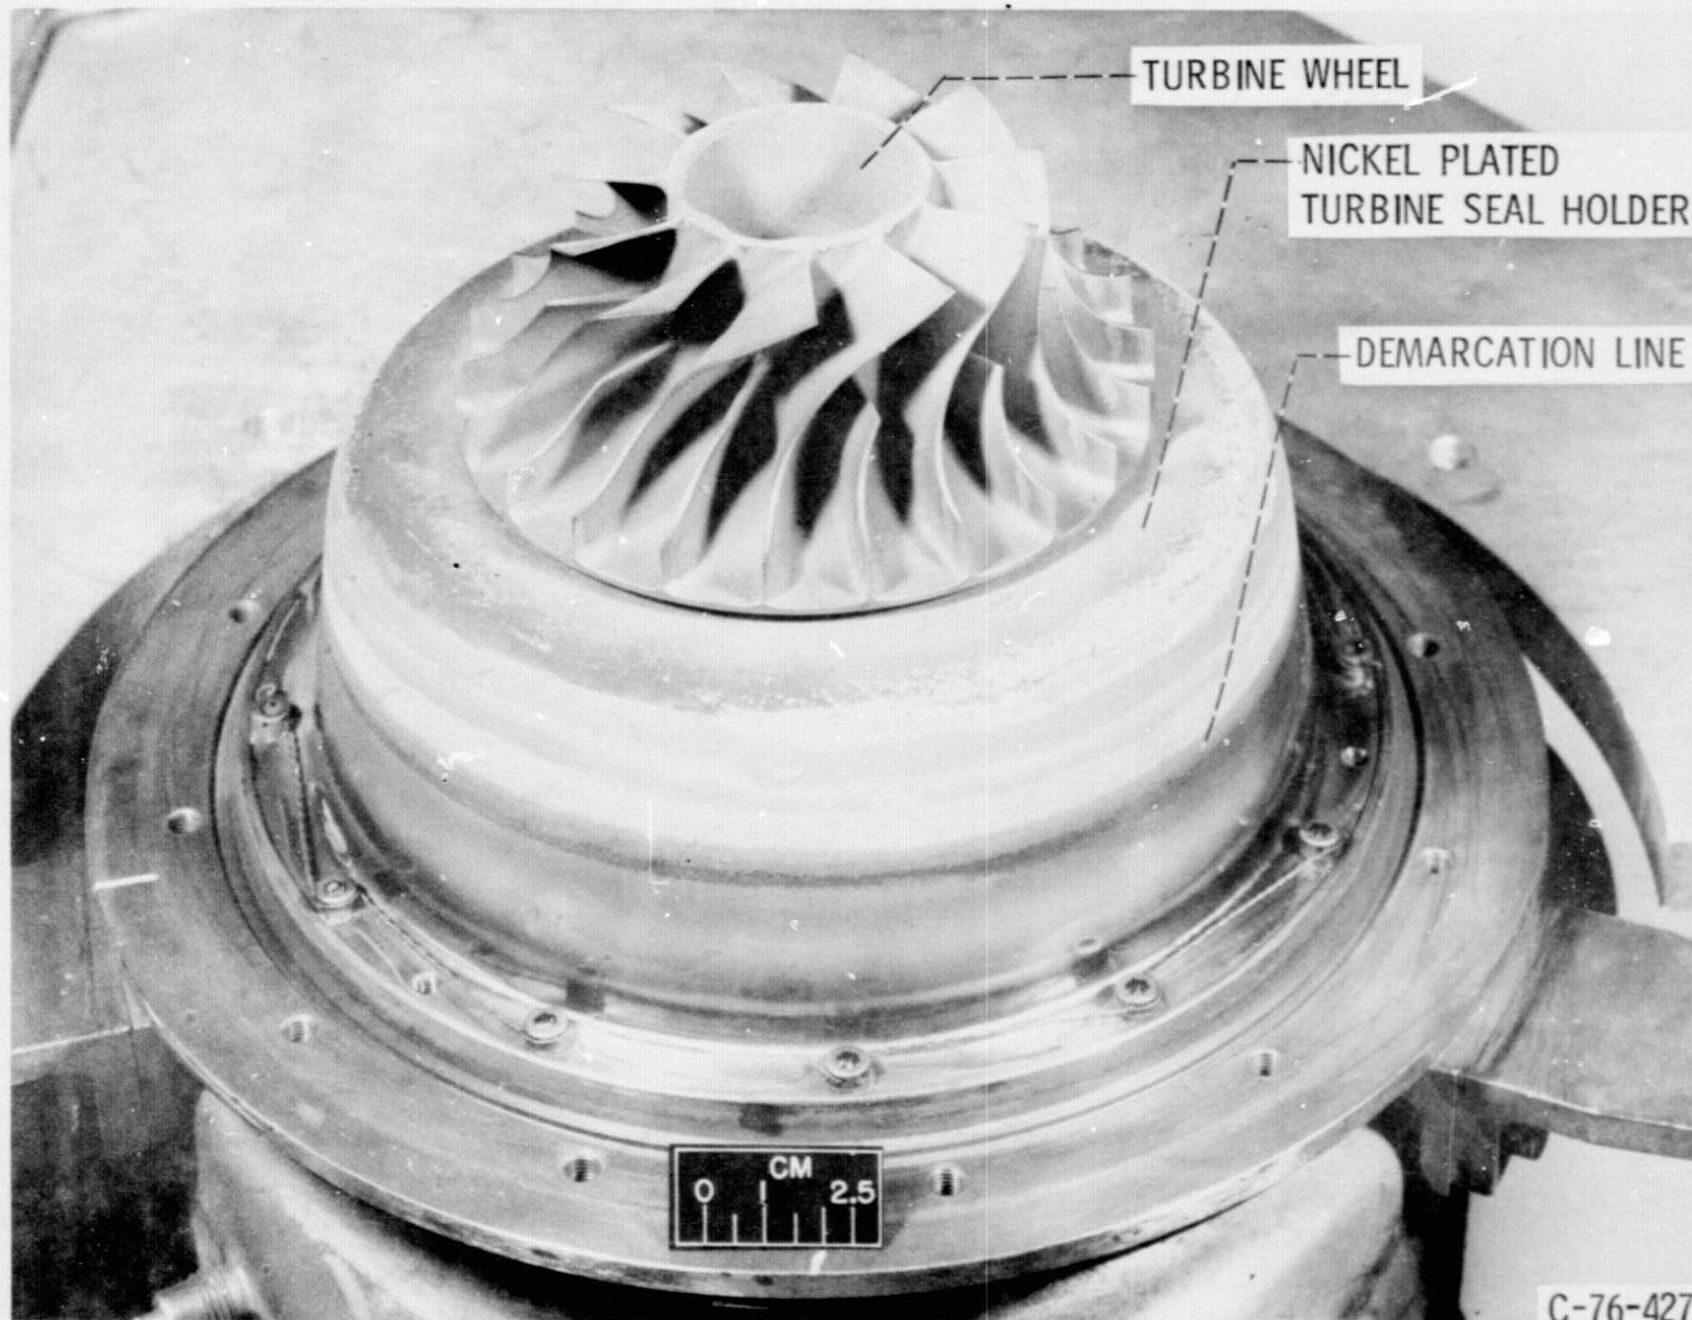
Figure 8. - Turbine wheel and seal holder bru no. 2.

(1) The backswept portion of the turbine blades and the hub were coated with a fine black powder that had the appearance and characteristics of lamp black.

(2) The turbine seal holder was originally plated with nickel and polished to produce a highly reflective surface. The outside surface down to the demarcation line shown in figure 8 and the entire inside surface (fig. 9) had a thin coating that had the rust-colored appearance of iron oxide. The lower outside portion of the holder material was discolored a dark blue. No evidence of the original nickel plating was found.

The black powder on the turbine wheel contained mostly manganese, with nickel and chromium. The rust-colored coating on the seal shroud contained mostly iron, copper, and manganese. The predominate element in the white powder on the copper heat shunt and in the turbine end of the alternator was silicon.

The deposits found on both turbine wheels consisted primarily of manganese with some chromium and nickel. The most likely origin of these elements was the facility heat source. The resistance heating elements in the heater were Inconel 600 tubes. The tubes were supported by ceramic headers. These headers were no doubt the source of the white powder found on the copper heat shunt and in the alternator cavity of BRU-2.

BRU-2 has been reassembled with the original parts. Removal of the surface deposits was the only rework performed. In this build-up all the internal instrumentation (proximity probes and thermocouples), except three alternator hot-spot thermocouples, has been eliminated. The unit has again been placed on endurance test and is presently operating unattended.

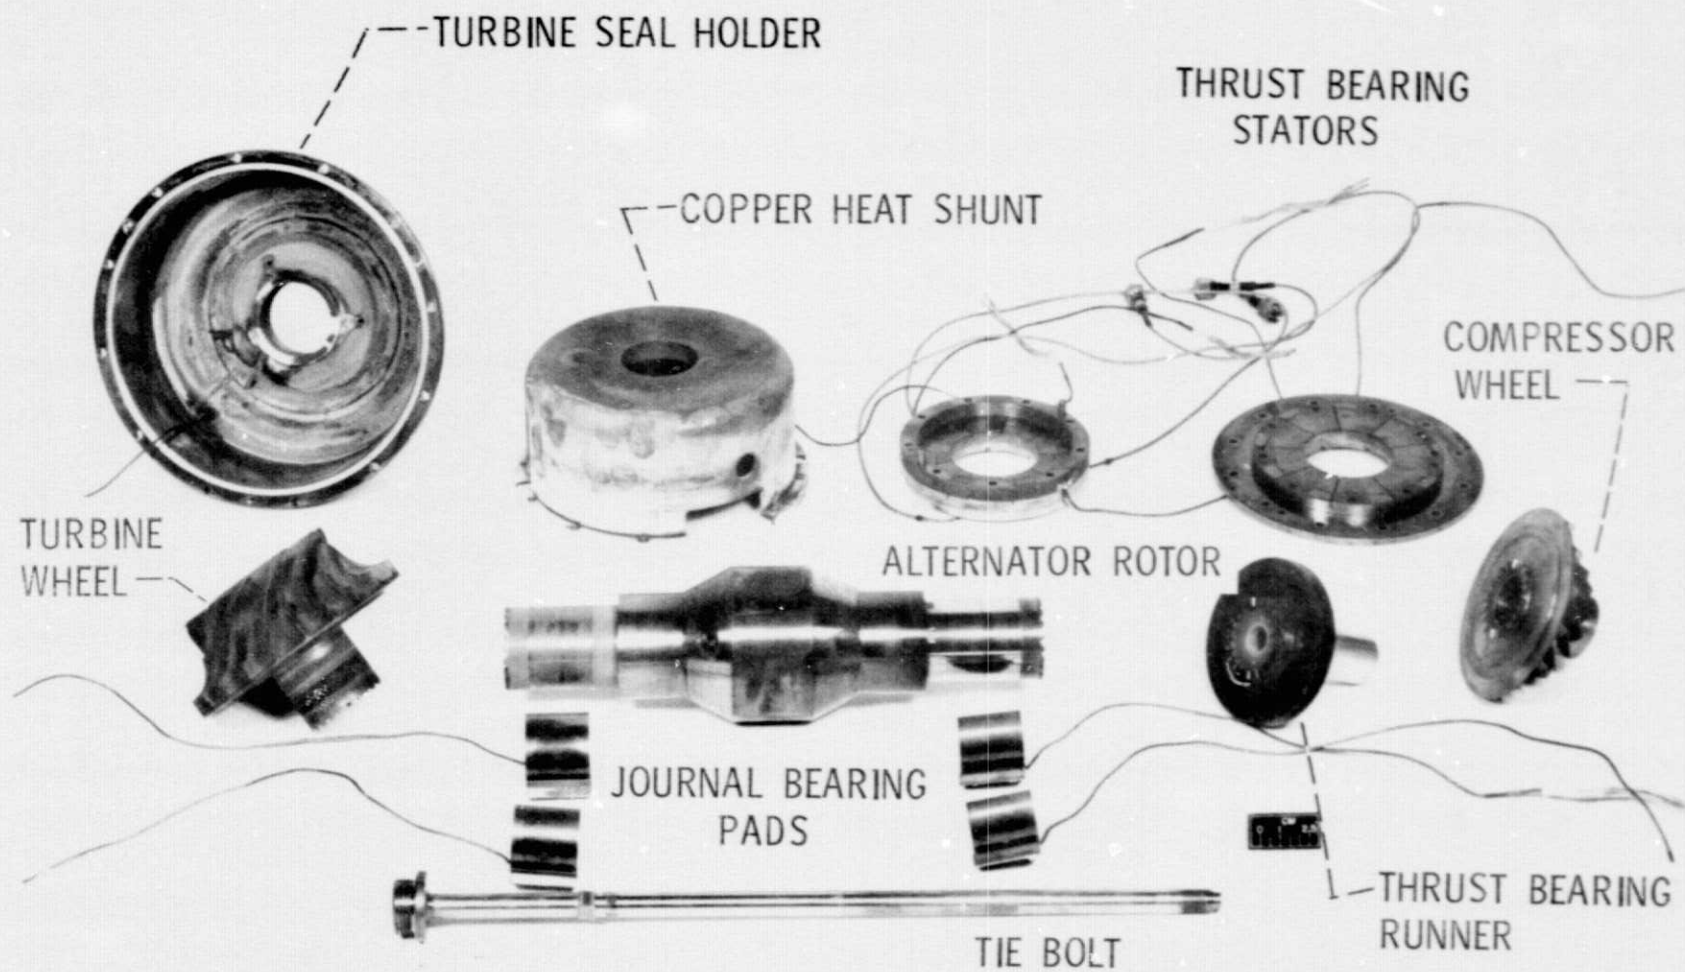
Figure 9. - Brayton rotating unit components - bru no. 2

(3) The copper heat shunt (fig. 9) was plated with gold to provide a reflective surface. None of the gold plating remained and the cylindrical surface was lightly coated with a fine white powder.

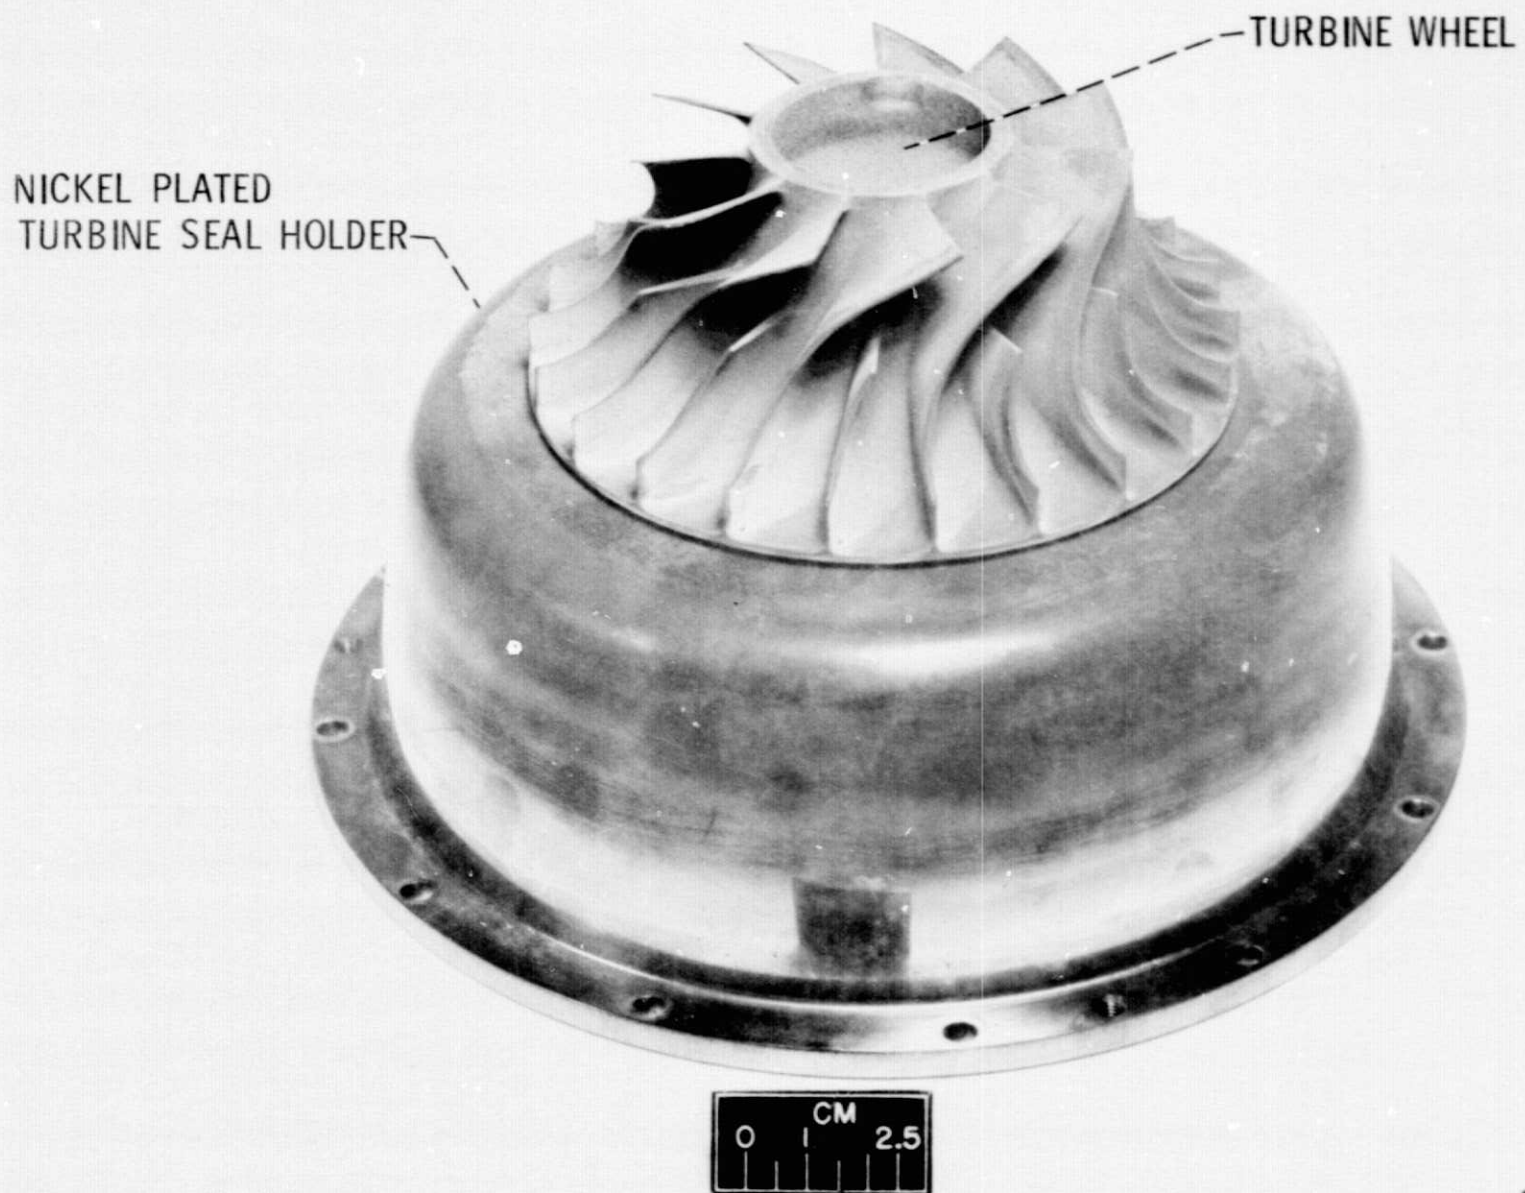
Figure 10. - Turbine wheel and seal holder - bru no. 4

(1) The turbine wheel (figs. 10 and 11) was coated with what appeared to be the same black powder found on the turbine wheel in BRU-2.

(2) The dark area of the seal shroud (figs. 10 and 11) was a dark blue color. The nickel plating in this area was gone. This condition also existed on the inside surface.
