NASA CR-145043

PROGRAM FOR ESTABLISHING LONG-TIME FLIGHT SERVICE
PERFORMANCE OF COMPOSITE MATERIALS IN THE
CENTER WING STRUCTURE OF C-130 AIRCRAFT
PHASE IV - GROUND/FLIGHT ACCEPTANCE TESTS

September 1976

by W. E. Harvill and J. A. Kizer

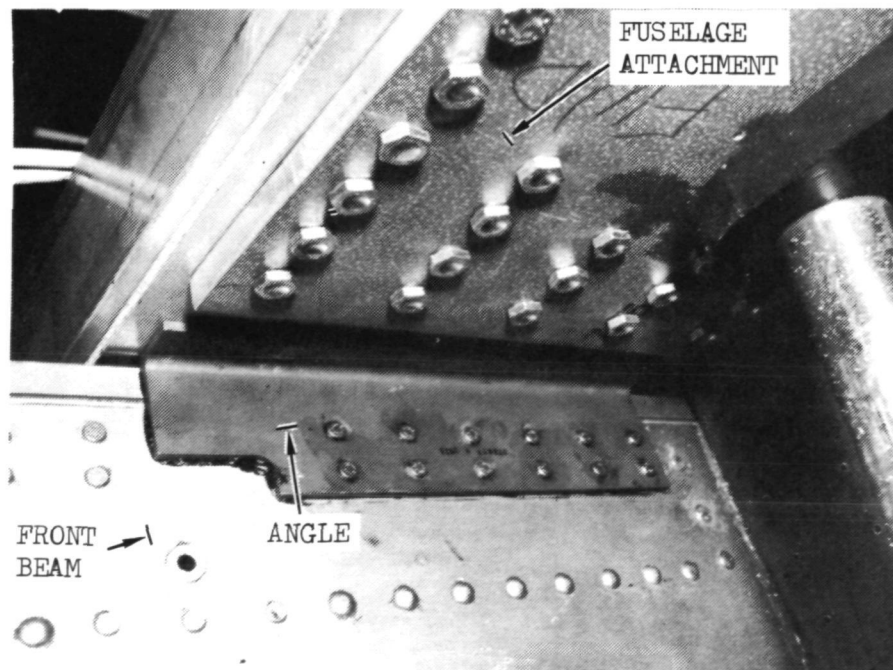
FIGURE 36.-TYPICAL INSTALLATION OF REINFORCEMENT ANGLE

Cyclic loading of the fatigue test article was accomplished for the first lifetime and only minor difficulties were encountered with the test system. Upon completion of the first lifetime of testing, both visual and ultrasonic inspections were performed on the fatigue test article. No visual damage was revealed and no changes were detected in the bondlines of the fatigue test article during the ultrasonic inspection including the disbonds discovered after the proof test. Although no fatigue cracks were detected during the visual inspections, it was discovered that two small reinforcement angles had not been installed during manufacture of the fatigue test article. These angles attach to a wing surface panel and the lower front beam cap at Wing Station 68, left and right. In the normal production sequence, these angles are installed when assembling the center wing into the fuselage. Since the fatigue test article was not installed in an operational aircraft, installation of the reinforcement angles was inadvertently omitted. The angles were not critical for the fatigue test, but they were installed prior to initiating cyclic testing into the second lifetime. A typical installation of a reinforcement angle is shown in Figure 36.

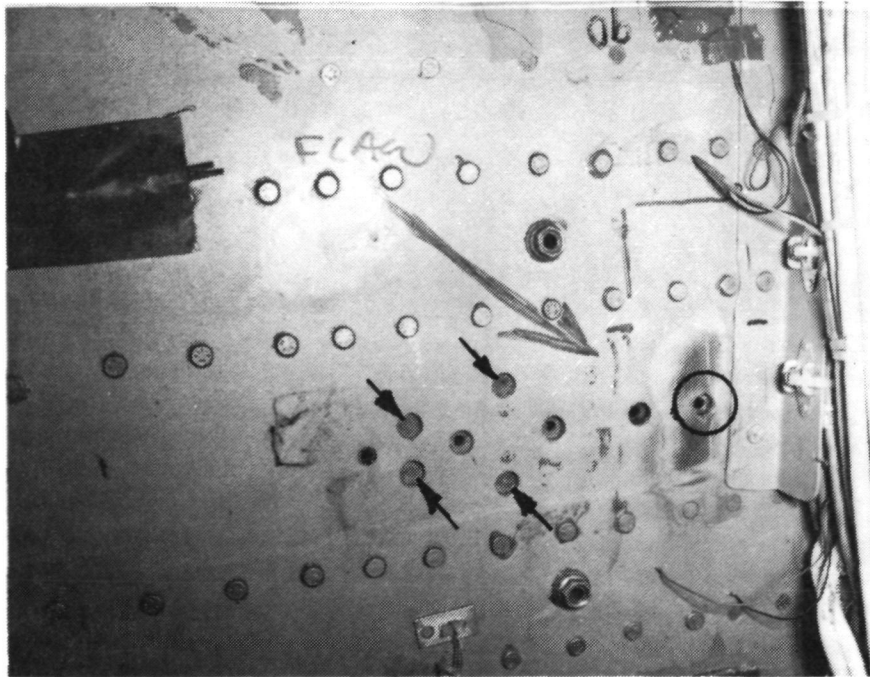
FIGURE 66 - DAMAGE IN LOWER SURFACE AT APPROXIMATE W.S. 214L. CIRCLED HOLE HAS NOTCHES. ARROWS POINT TO HOLES BORED IN SKIN TO FACILITATE DISBONDING.

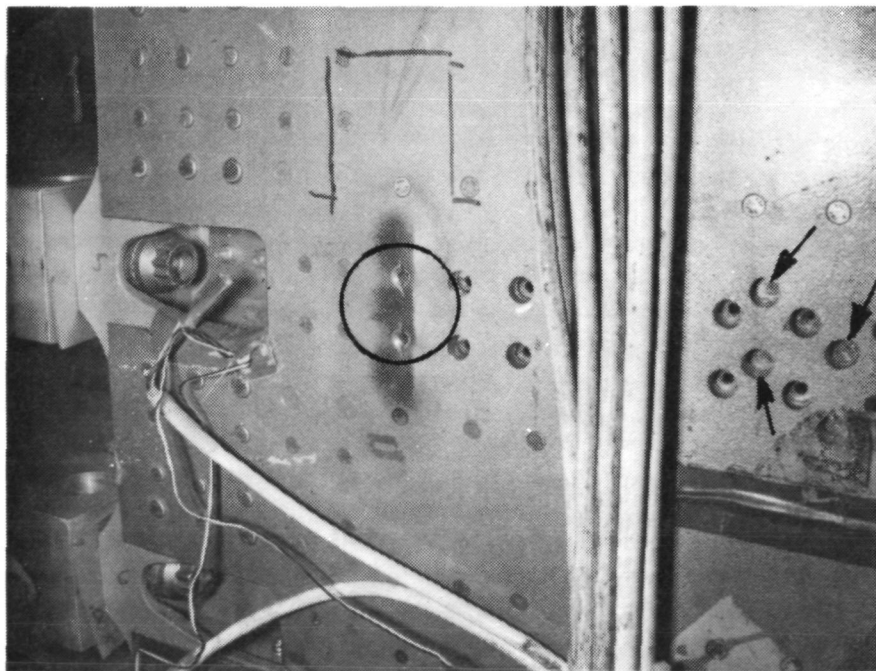
FIGURE 67 - DAMAGE IN UPPER SURFACE AT APPROXIMATE W.S. 214L. CIRCLED HOLES HAVE NOTCHES. ARROWS POINT TO HOLES BORED IN SKIN TO FACILITATE DISBONDING.

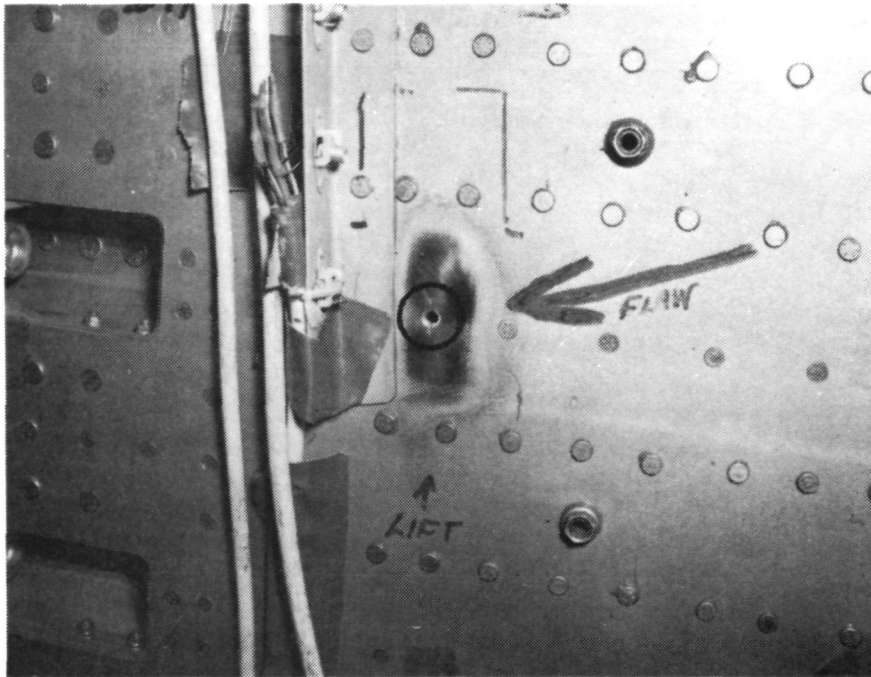
FIGURE 68 - DAMAGE IN LOWER SURFACE AT APPROXIMATE W.S. 214R. CIRCLED HOLE HAS NOTCHES.

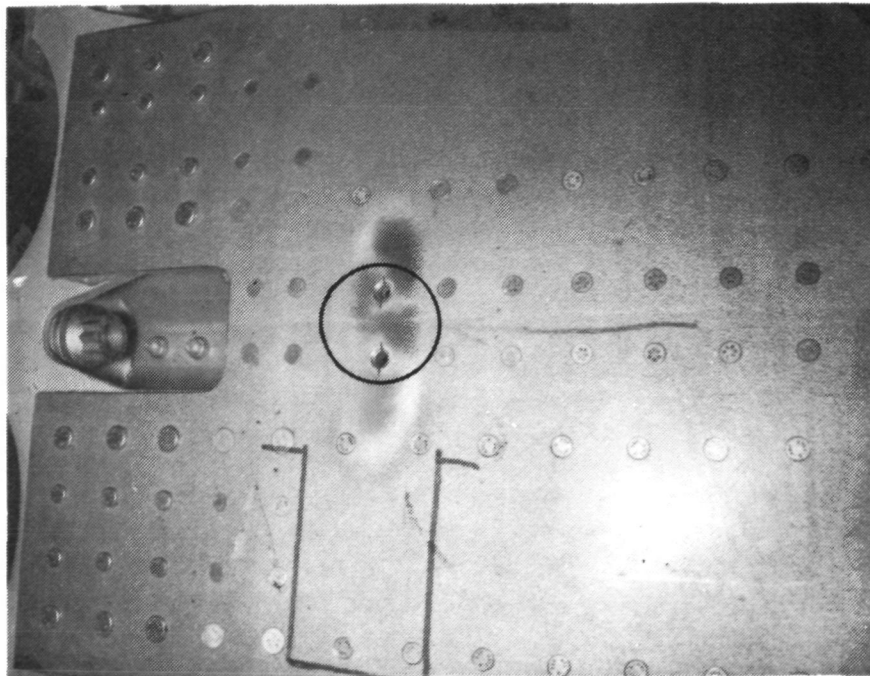
FIGURE 69 - DAMAGE IN UPPER SURFACE AT APPROXIMATE W.S. 214R. CIRCLED HOLES HAVE NOTCHES.

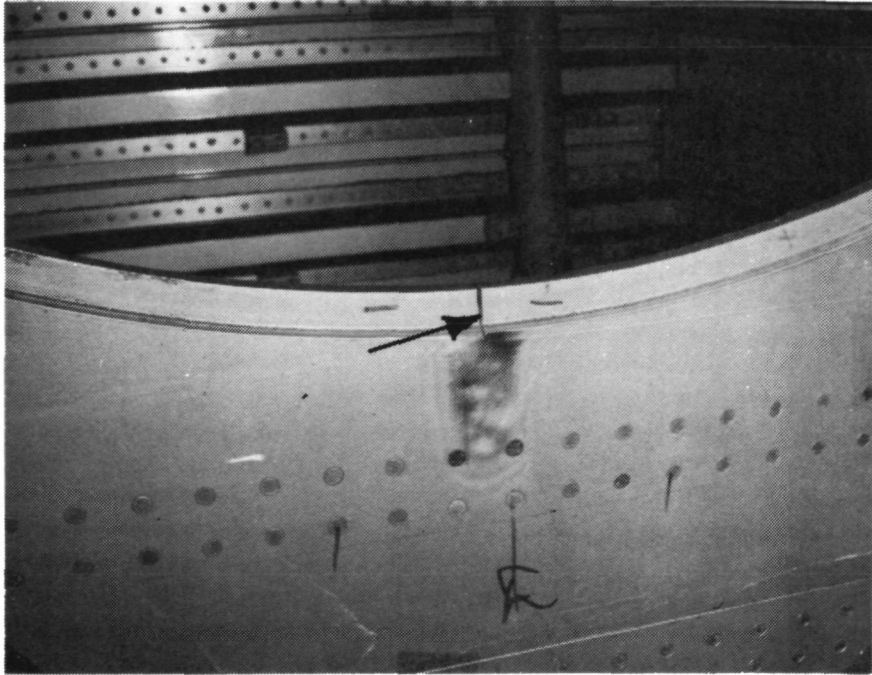
FIGURE 70 - CUT BESIDE LOWER SURFACE ACCESS DOOR -
TYPICAL FOR W.S. 120 R AND L.

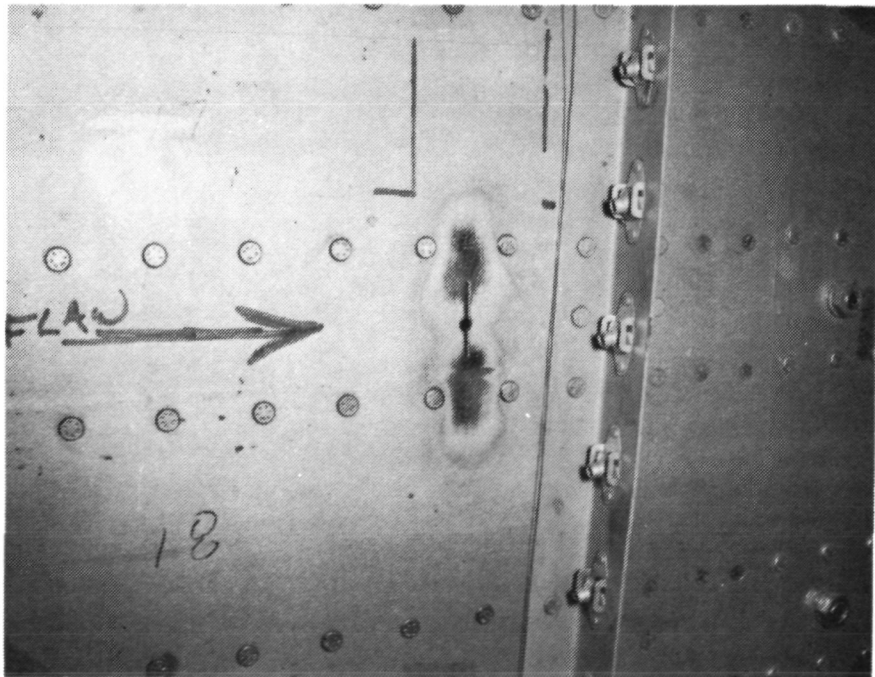
FIGURE 71 - CUT IN LOWER SURFACE WING PLANK -
TYPICAL FOR W.S. 180 R AND L

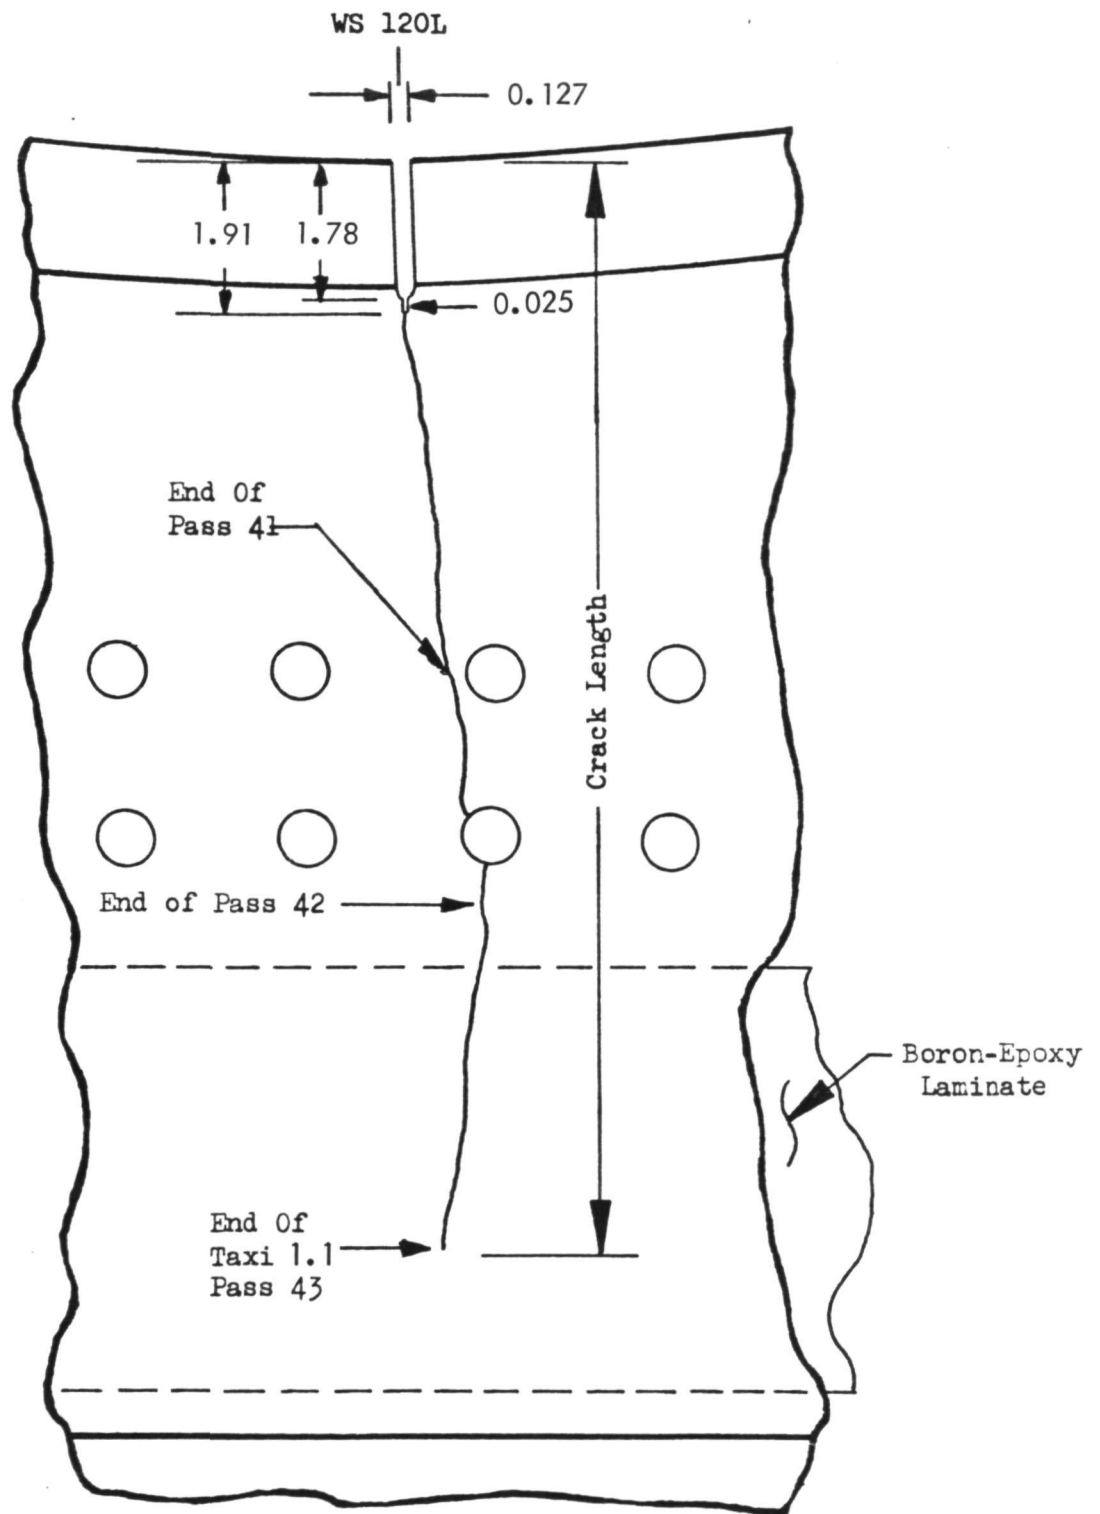
* Cracks were detected in hat-section Stringer 20 at Wing Station 120, Left and Right.

FIGURE 72 - CRACK GROWTH HISTORY IN LOWER WING SURFACE PLANK AT W.S. 120 LEFT

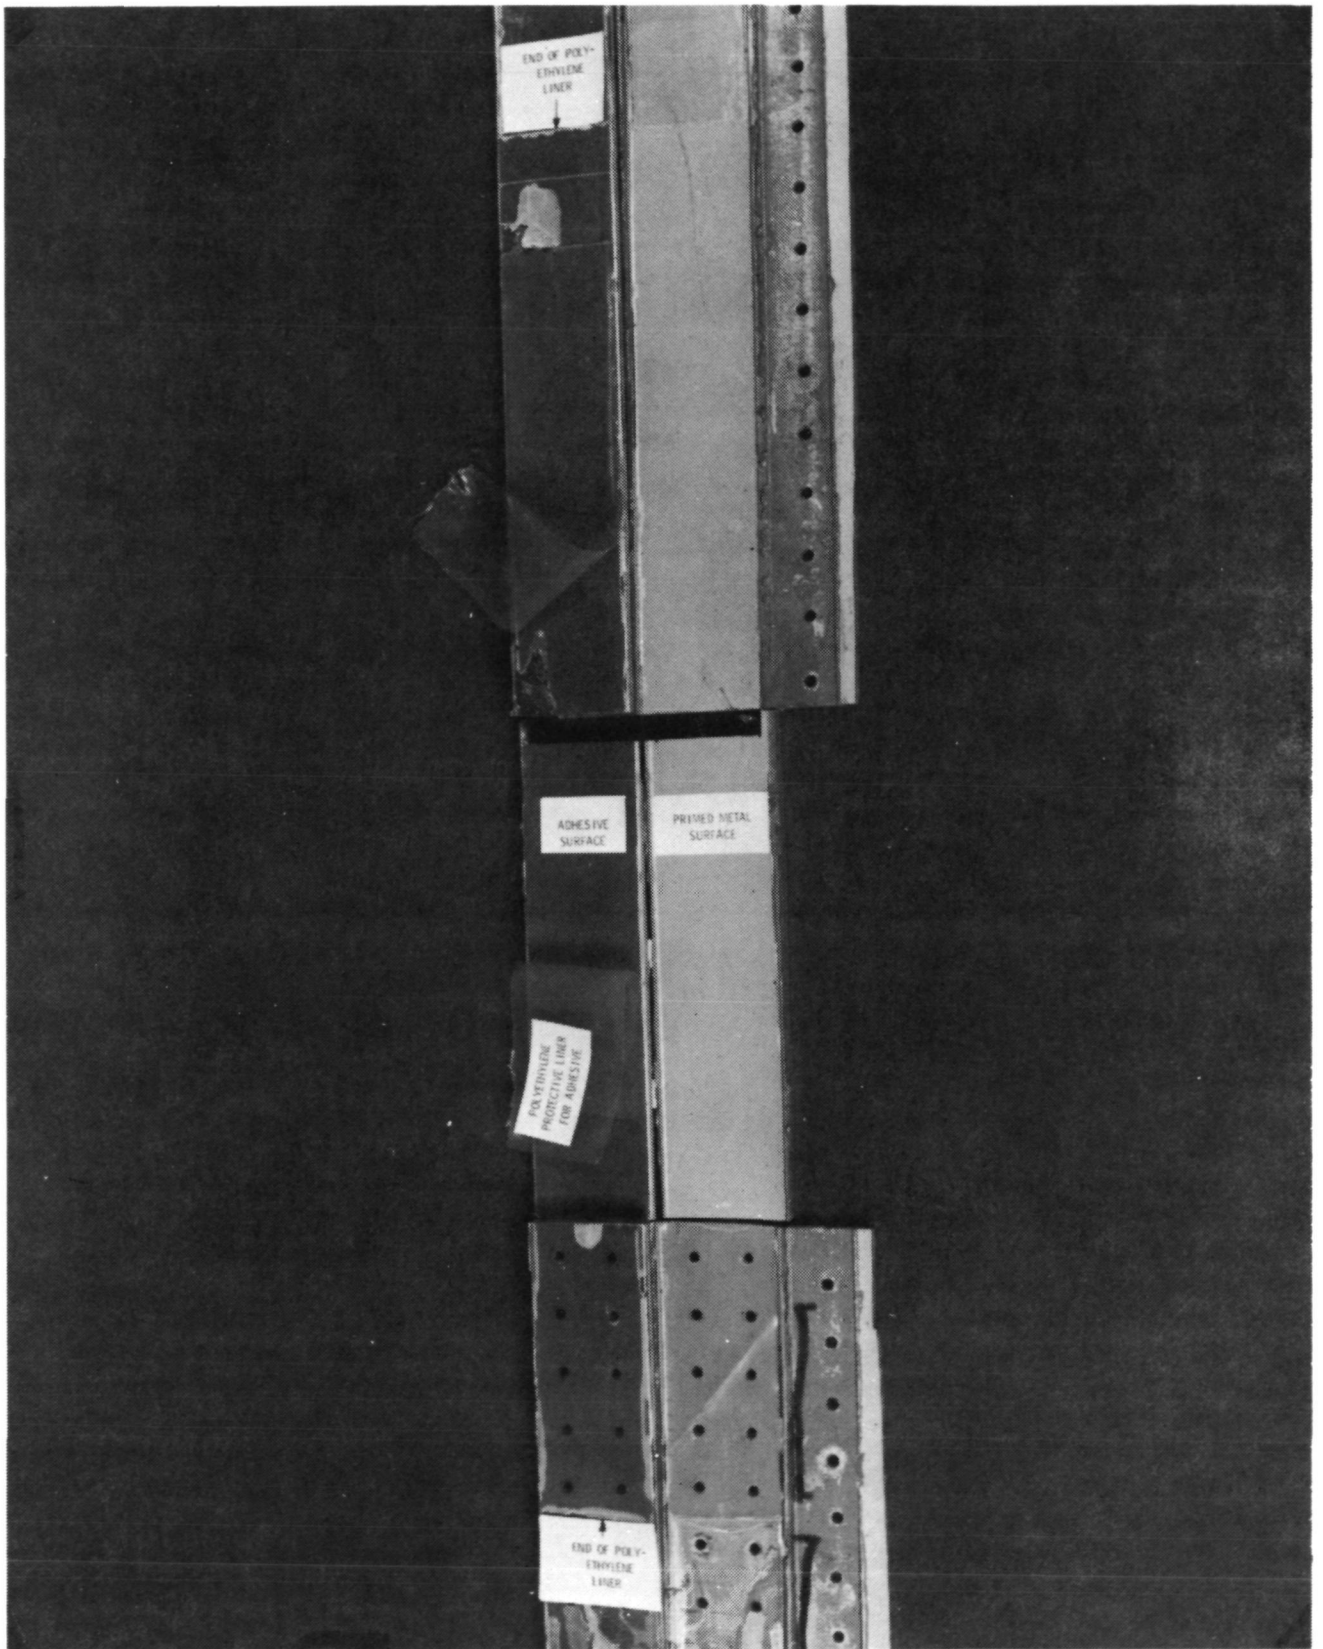
Upon completion of the last static test on the fatigue test article, verification of the disbonds was accomplished after removal of the section of the wing upper surface containing the disbonds. Both contact and immersion ultrasonic inspections were conducted on the section of the wing upper surface that was removed. These inspections confirmed the disbonds that were detected previously. Then, the wing surface plank-to-laminate bondline containing the disbonds was physically separated. The separation revealed a section of polyethylene protective liner for the adhesive approximately twenty-four inches in length. The polyethylene liner had been inadvertently left in the bondline during assembly. Figure 75 shows the bondline after separation including the extremities of the polyethylene liner. It is noted that the liner extended into the repaired area of the bondline which is identified by the fastener hole locations on Figure 75. Separation of the bondline over the area containing the polyethylene liner showed a total disbond of the adhesive to the boron-epoxy laminate. Contact ultrasonics did not reveal the disbonded area during the inspection conducted immediately after the bondline was cured because the laminate was pressed sufficiently tight against the polyethylene liner to allow transmission of the ultrasonic wave through the bondline. (Note: The ultrasonic inspection technique does not discriminate a weak bond from a strong bond. It only establishes that a bond does or does not exist.) After the application of the first proof load to the center wing test article, the condition between the boron-epoxy laminate and the polyethylene liner changed sufficiently to prevent ultrasonic transmission during subsequent inspections which indicated the presence of disbonds.

FIGURE 75 - BONDLINE AREA CONTAINING POLYETHYLENE PROTECTIVE LINER FOR ADHESIVE

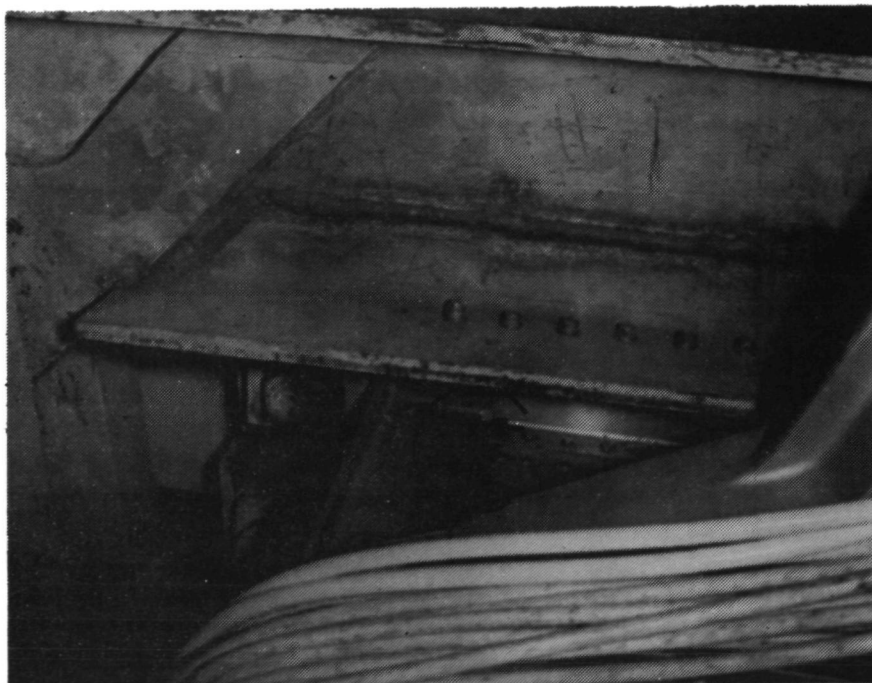
REMARKS:
 Three Huk-bolts in 388196-47 strap had broken heads. Fracture surfaces had fatigue markings. Eddy current inspection of hole walls revealed no cracks. Holes were reamed to accept HL-56 fasteners which were installed wet with STM 40-111 sealant.

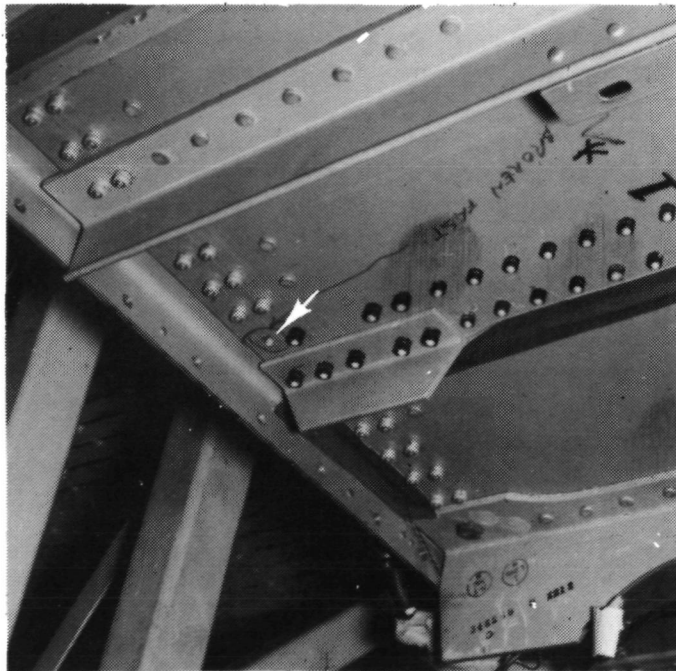
REMARKS:
No cracks were detected upon inspection of hole with eddy current meter. Fastener was replaced with HL-18 Hi-Lok installed wet with STM 40-111 sealant.

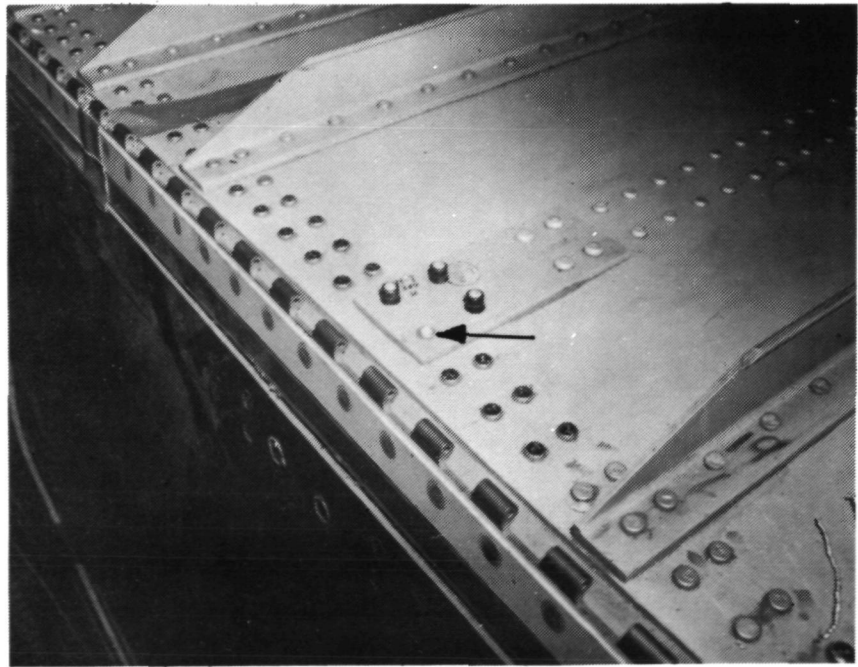
REMARKS:
A 3/16-inch diameter Huk-bolt common to the 370532-5 web and the 341929-6 Plate had failed at the collar. Fracture surface had fatigue markings. Failed fastener was replaced with an HL-18 fastener installed wet with STM 40-111 Sealant.

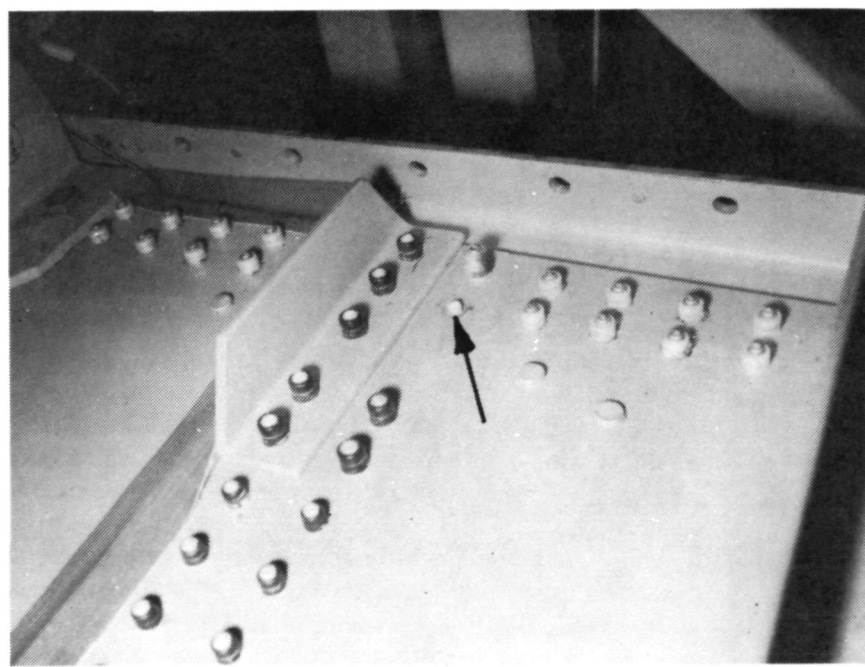
REMARKS:
A 3/16-inch diameter Huk-bolt in the 370539-1 web had failed at the collar. Fracture surface had fatigue markings. Failed fastener was replaced with an HL-18 fastener installed wet with STM 40-111 Sealant.

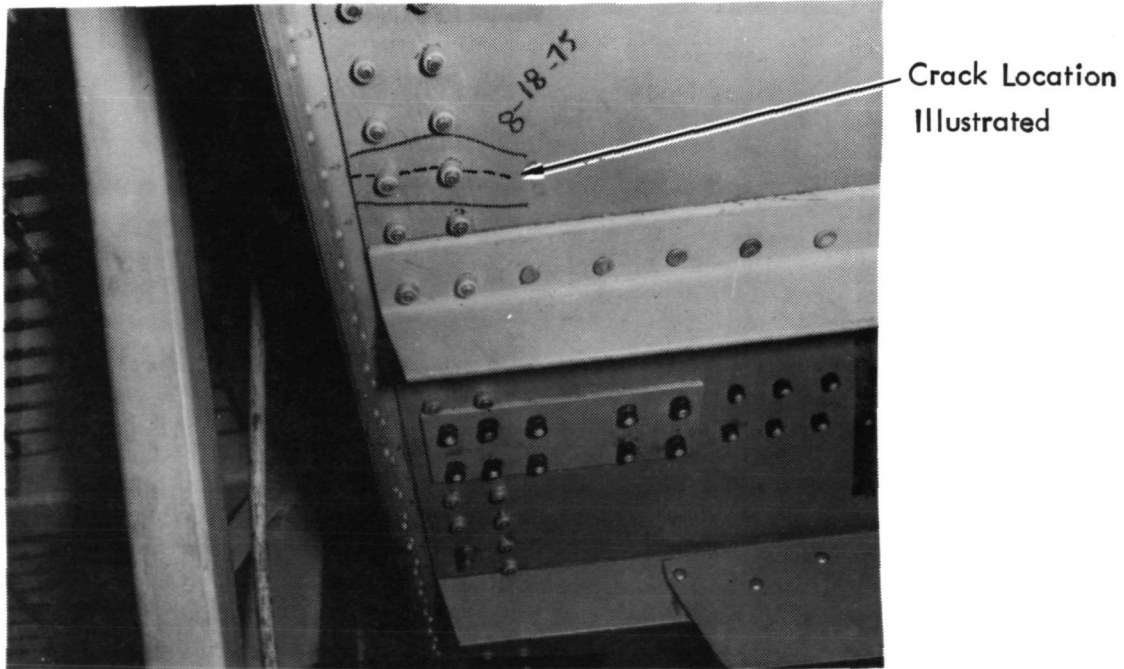
REMARKS:
The 370539-3 Web, Rear Beam had a 2.0-inch long crack starting at a fastener hole common to the Rear Beam Cap at WS 145.5L. The crack was stop drilled and a TL 200-3 fastener was installed in the stop drill hole. A 7075-T6 aluminum alloy doubler, 0.126 inch thick, was installed with HL 18-6 fasteners to reinforce the cracked area.
