NASA TM X-73504

**INSPECTION OF COMPOSITES USING A COMPUTER-BASED
REAL-TIME RADIOGRAPHIC FACILITY**

by Ernest Roberts, Jr., and Alex Vary
Lewis Research Center
Cleveland, Ohio 44135

**TECHNICAL PAPER to be presented at the
Second Conference on Automated
Inspection and Product Control
Chicago, Illinois, October 19-21, 1976**

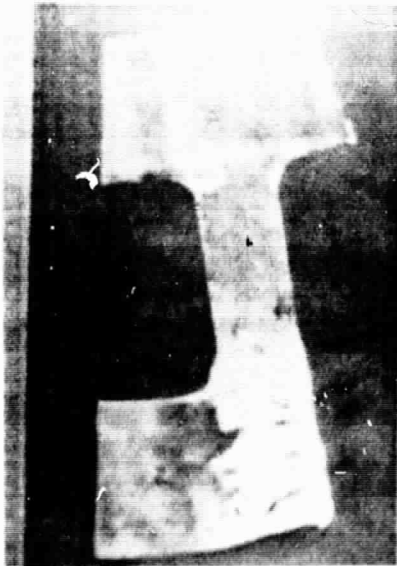
(a) ENTIRE OBJECT.

test was conducted at 2 MHz. The result is shown in figures 4 (a) and 4 (b). Figure 4 (a) shows the scan of the entire object. Figure 4 (b) is a close-up of the area of interest. Because of extensive delamination in the damaged zone, little information is apparent in that figure. However, it indicates the existence of damage, and shows its location and approximate extent.
