**NASA TN D-8301**

**APOLLO EXPERIENCE REPORT -  
COMMAND AND SERVICE MODULE  
CONTROLS AND DISPLAYS SUBSYSTEM**

*Aaron B. Olsen and Robert J. Swint*

*Lyndon B. Johnson Space Center*

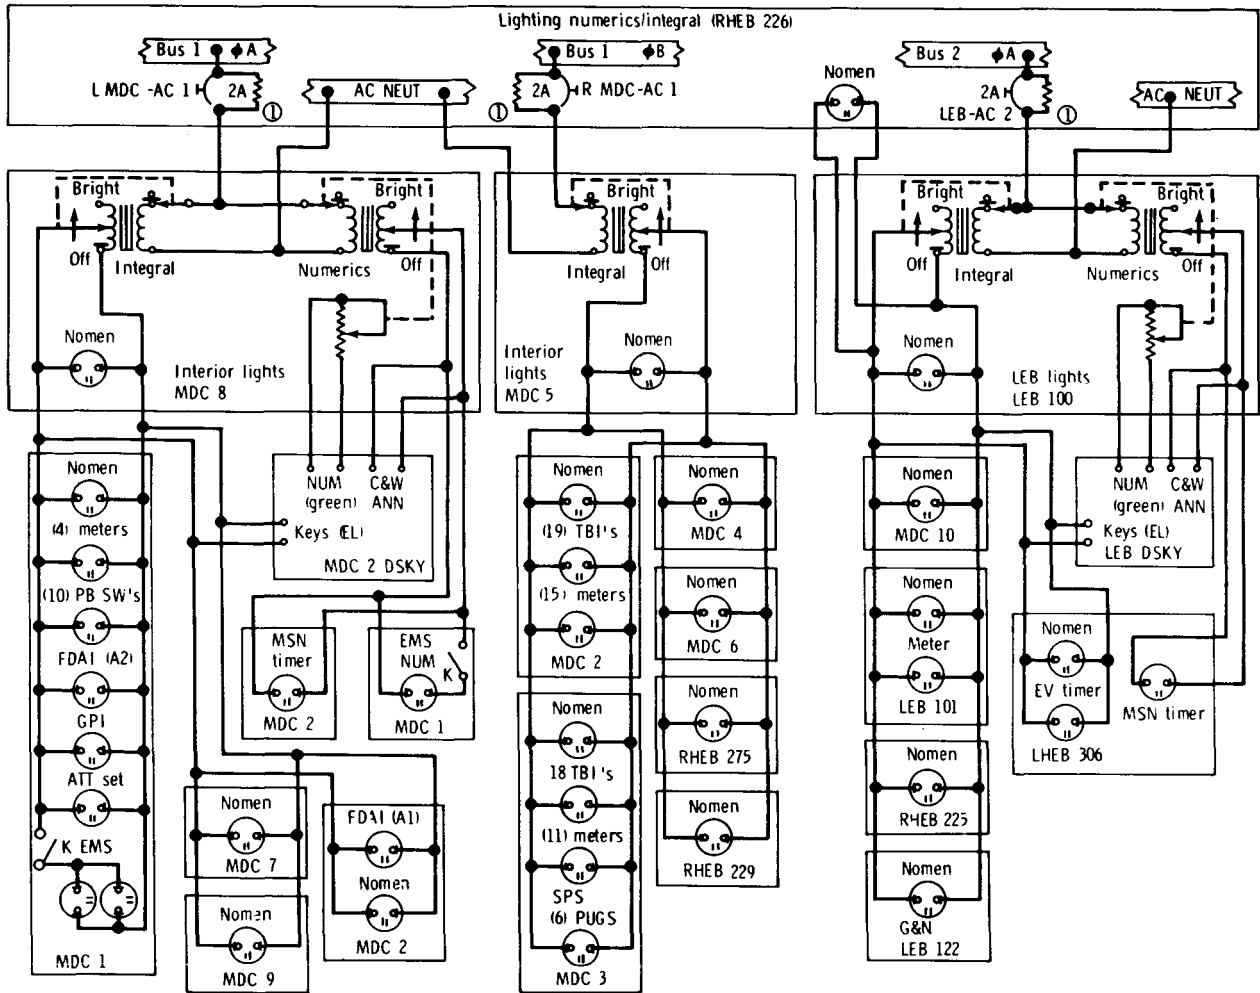
Figure 2. - Panel lighting schematic (integral and numerics).

Transient susceptibility. - In July and August 1966, floodlight failures were attributed to transient susceptibility of the lamp circuitry, which created conditions that allowed the lamp assembly to draw excessive current that, in turn, opened the fuse. The circuitry was redesigned to limit the current flow by the addition of an input filter, a time-delay network, and a zener diode.

Transient protection. - To protect against the effects of switch contact bounce, the input filter chokes were replaced with 0.25-ohm resistors, and the 6.8-microfarad input filter capacitance was increased to 68 microfarads. Also, a 102-millisecond time-constant delay network and a zener diode were added to limit the maximum voltage that could be applied to the trigger circuit.

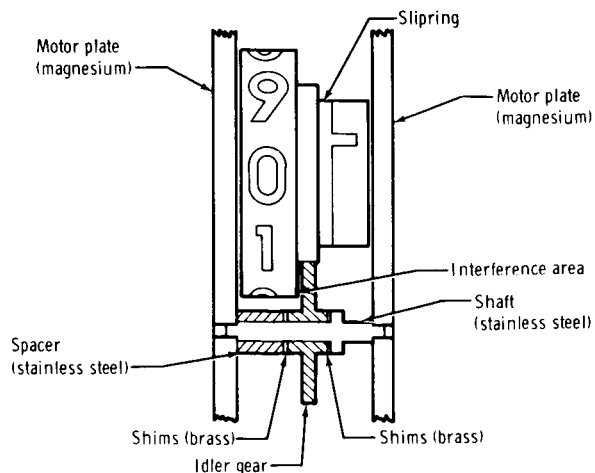
Figure 8.- Apollo 15 DET anomaly.

The DET was an electromechanical device that counted up or down in minutes and seconds to a maximum of 59 minutes 59 seconds. There were two DET's on each CM: one on panel 1 for flight control and one on panel 306 for navigational purposes. The DET would reset to zero and begin counting up when a lift-off or an abort signal occurred. Timer controls to stop, start, count up and down, and slew each digit were on the same panel with the timer. Of the 22 failures that occurred, 5 were electrical, and the remaining 17 were caused by mechanical problems in the counting-wheel mechanism. Only four of these failures occurred during flight (one each on CSM 106 and CSM 113 and two on CSM 112). Although the electrical problems were varied (EL lighting, timer failing to stop on "reset," and broken wire), they were not difficult to correct.

The mechanical problems consisted of interference between the gear and the counter wheels and contamination of the brushes and the sliprings. These problems were first attributed to the looseness of the dimensional tolerances, which allowed the idler gear (figs. 8 and 9) to rub against the number wheel and dislodge paint particles from it. Being nonconductive, the paint particles would adhere to the slipring and prevent the brush from making contact, which, in turn, would prevent the counting pulse from being transmitted to the next counter wheel. When brass shims, inserted between the idler gear and the spacers on the shaft to provide more clearance, did not correct the problem, a more thorough investigation was made. During this investigation, it was found that the stainless-steel shaft on which the idler gear turned was not fastened securely to the magnesium motor plates. This slack allowed the shaft to turn, and the small moment applied to the end of the shaft by the idler gear eroded the shaft hole to an oval shape. The end-plate erosion was sufficient to allow the shaft to move and to cause the idler gear to rub the paint off the number wheel. Because the timer was not mission critical and because only one flight remained in which the timer would be used very often, the decision was made to visually inspect the timers before flight rather than to attempt a redesign and refurbishment program.

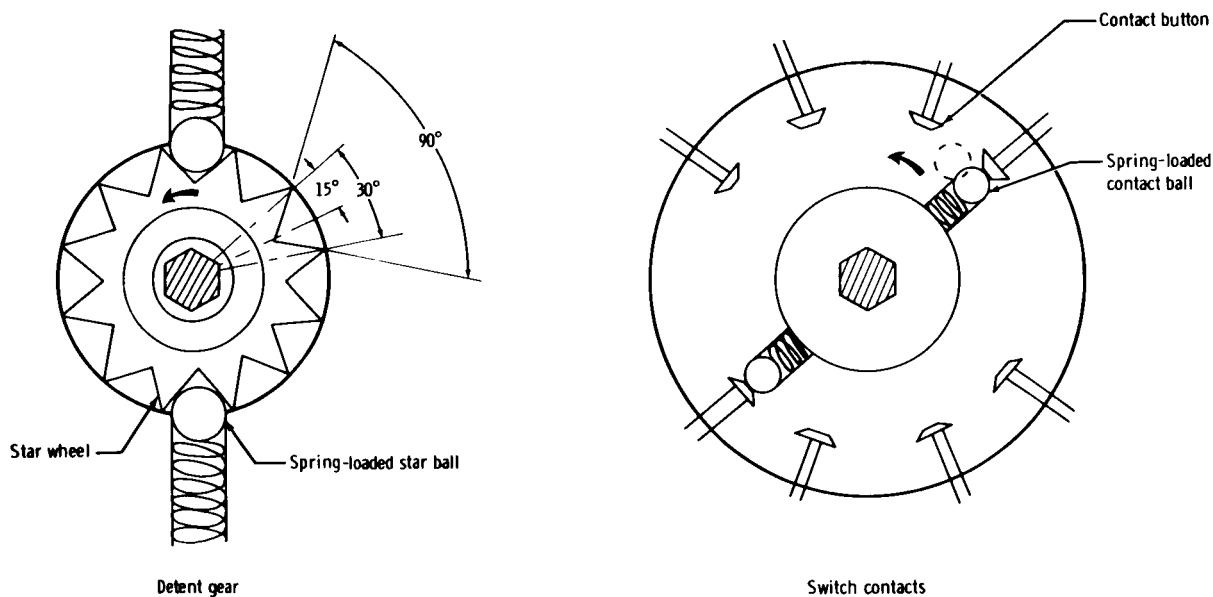
Figure 10. - Rotary switch.

The "extra" detent indication was a development problem first noticed on spacecraft 008 and 012 (both block I vehicles). The irregularity had been previously noticed but no corrective action was taken until a short circuit occurred between contacts. When the short circuit occurred, the switch was in the extra or "false" detent position because assurance had been given that no current flow would occur when the switch was in that position. As a result, a redesign and reevaluation effort was made, and the switches delivered for spacecraft 012 changeout were of the redesigned configuration. The extra detent difficulty is explained in the following discussion.

The span between positions was  $30^\circ$  (fig. 10). During the first  $15^\circ$  of rotation, the spring-loaded star ball was climbing the ramp of the star wheel, and the spring-loaded contact ball was going down the ramp of the contact button. During the last  $15^\circ$  of rotation, the spring-loaded star ball was going down the ramp of the star wheel, generating enough force to permit the spring-loaded contact ball to climb the ramp of the contact button. Extra detent was felt at the  $15^\circ$  point because the spring-loaded contact ball was starting to climb the contact button ramp and the spring-loaded star ball was not yet going down the ramp of the star wheel. Because the star ball was at the point of the star, no force was being generated for climbing the ramp of the contact button. This effect was more noticeable on multiple-pole, multiple-deck switches where there were many contact button ramps to climb. Because of the tolerance build-up at this midway position, the number of contacts made could not be readily determined.

To remedy the extra detent problem, the vendor lowered the ramp angle on the contact buttons and improved tolerances by changing the tooling jigs. The spacecraft 012 deliveries were the first to have these modifications.

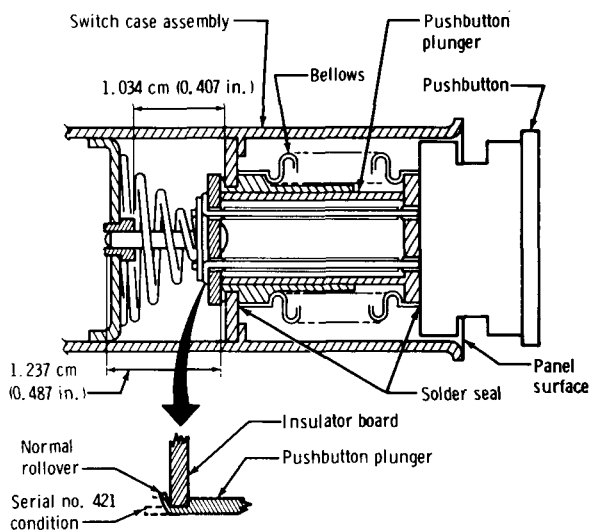
Figure 11. - Pushbutton switch plunger cutaway.

Pushbutton switches were used as backup controls for the initiation of events that would normally occur as automatic functions and as the C&WS MA reset. No flight failures were recorded, but several failures occurred during vehicle testing. One of these failures, which forced the removal of approximately 57 switches from vehicles produced after CSM 107, resulted from the vendor's use of a paraffin-type material in a grinding operation to avoid the entry of ground-off particles around the actuation buttons on the contact portions of the switch. The material hardened and prevented switch actuation. Another vehicle failure resulted from a switch missing one of the manufacturing process steps, which was to have crimped the pushbutton plunger base over the insulation board of the EL lamp lead. The problem occurred in the environmentally sealed portion of the switch. When the external ambient pressure was reduced in the altitude chamber, the plunger, which had been held in by the strength of the EL lead wires as long as the pressures remained equal, pushed the face of the switch out so that it was protruding from the surface of panel 1 (fig. 11).

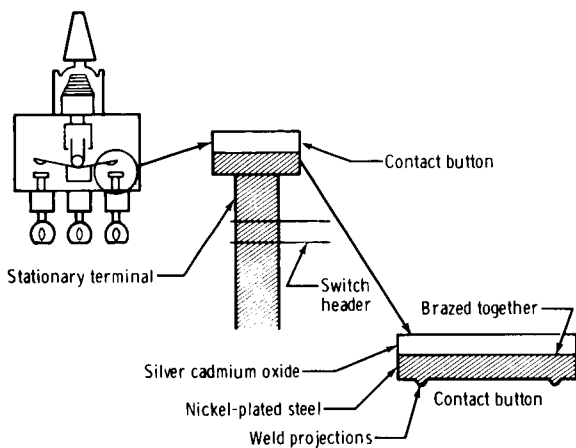
Figure 12.- Toggle-switch problem.

Toggle switches, used as manual control elements on the CM, were configured in one to four poles and in two or three positions and were of a maintained, momentary, or lock type, depending on the use. The block I toggle switch was an environmentally sealed unit with a low failure rate. After the block II requirements were established for a hermetically sealed switch, it was determined that the block I vendor did not manufacture one and did not choose to manufacture one. Consequently, the initial block II toggle switch was a hermetically sealed plunger-type unit with an unsealed toggle mechanism for switch actuation. Early in the block II program, switch problems became apparent. Failures caused by high contact resistance, by mechanical lockup, and by nonfunction at high or low pressure resulted in a change to the present completely hermetically sealed switch. This switch had many serious problems (figs. 12 to 14), such as internal solder balls, extra parts and pieces inside switches, contact buttons welded to a terminal post in an inverted position, defective contact-button welds, auxiliary contact-plate welds, momentary shorting of contact arm with spring, cracked toggle block assembly and bellows, annealing and displacement

of the momentary return spring, spring shorting to contact arm during sinusoidal vibration, and high contact resistance.

Most of these problems were corrected by the addition of inspection stations during manufacturing, by better workmanship, by altering some of the weld processes, and by adding several additional steps to the acceptance test procedure (ATP). One of the most valuable additions was the requirement for multiaxis X-ray exposures. Despite the poor performance during ATP and vehicle test, only one flight failure was
