OH-58 HELICOPTER TRANSMISSION FAILURE ANALYSIS

by D. P. Townsend, J. J. Coy,* and B. R. Hatvani
Lewis Research Center
Cleveland, Ohio 44135
January, 1976

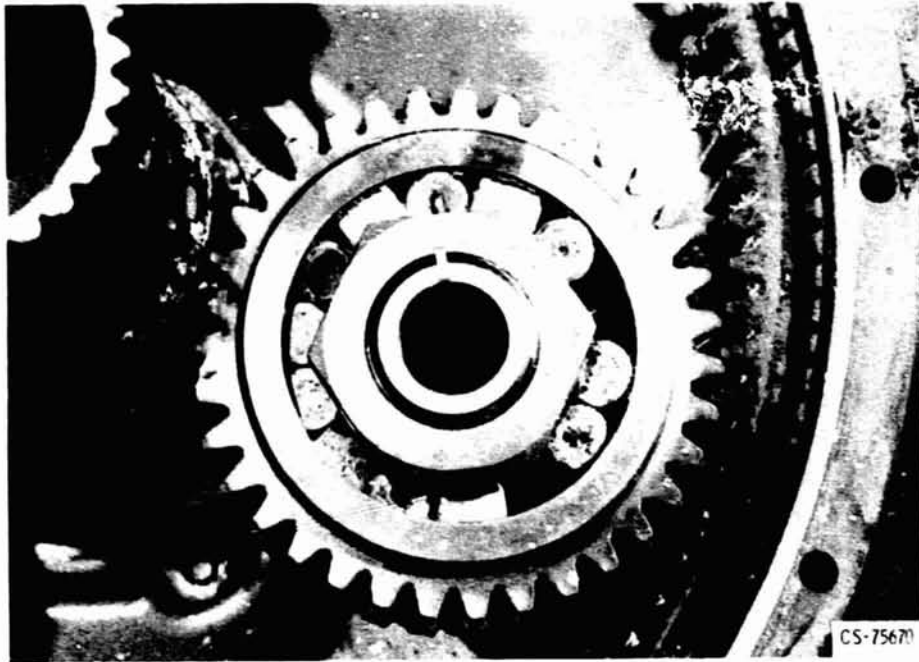
The rate of increase of the pinion temperatures slowed until at approximately 14 minutes the rate began to increase again (figs. 8(a) and (b)). These increases in temperature were caused by additional planet bearing cages melting which allowed the spherical rollers in the planet gear bearings to tumble and slide within the bearings (fig. 11).

Figure 11. - Planet gear support bearing. Badly misaligned and skewed rollers caused high vibration and temperature levels.

3. Change the spherical roller bearings to cylindrical roller bearings with rigid straddle mounting to replace the overhung mounting. This change would reduce the heat generation in the planet bearing up to 30 percent. Further testing would be required.

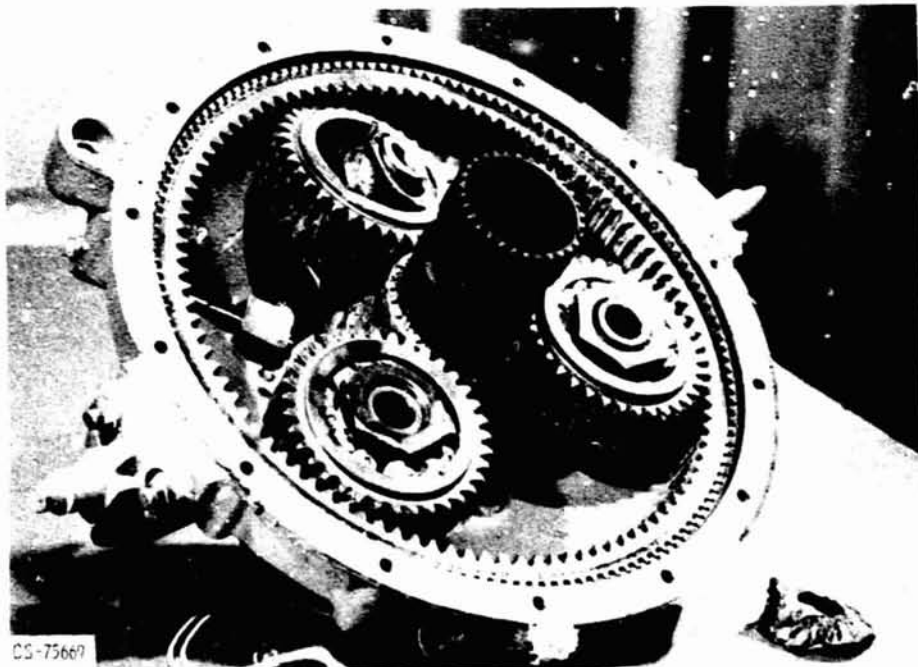
At approximately 27 minutes there is an additional increase in the rate of temperature rise as seen in the planet and (fig. 8(c)), the pinion area (figs. 8(a) and (b)) and to a lesser extent in the bevel gear bearing area (fig. 8(d)). At this point in time the gearbox is approaching complete failure. At these temperatures, the planet gears have very little strength. The lock nut on the planet bearing was being machined by the bevel gear bolt heads (fig. 12). The pinion

Figure 12(a). - Transmission top case with planet gear assembly. Planet lock nut (lower right) was machined to one-fourth original thickness.

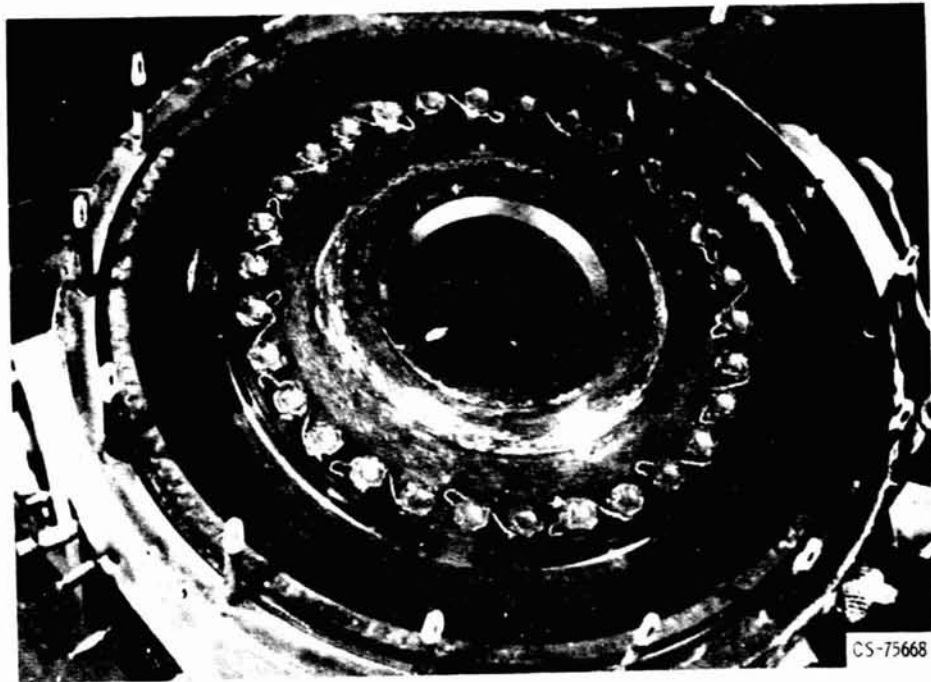
At 27 minutes the vibration levels again increased at the ring gear to the 30 to 40 g level. At that time the shaft nut was being struck by the bevel gear support bolts which were immediately below and on the gear shaft. The relative rotational speed of the planet carrier and the gear shaft was 1300 rpm. The retaining nut was rapidly machined away by the gear shaft bolts. Subsequently, an inner race of one of the spherical roller bearings came off the shaft allowing the spherical rollers to drop out of the bearing. One of the rollers wedged into the ring gear-planetary gear mesh. This caused the planet carrier to lock up. As a result, the teeth on the sun gear were destroyed by the torque overload. At 30 minutes after the oil drain was opened, complete transmission failure occurred.

Figure 12(b). - Transmission lower case with bevel gear shaft and bevel gear mounting bolts showing. Scored area caused by scraping lock-nut is visible.

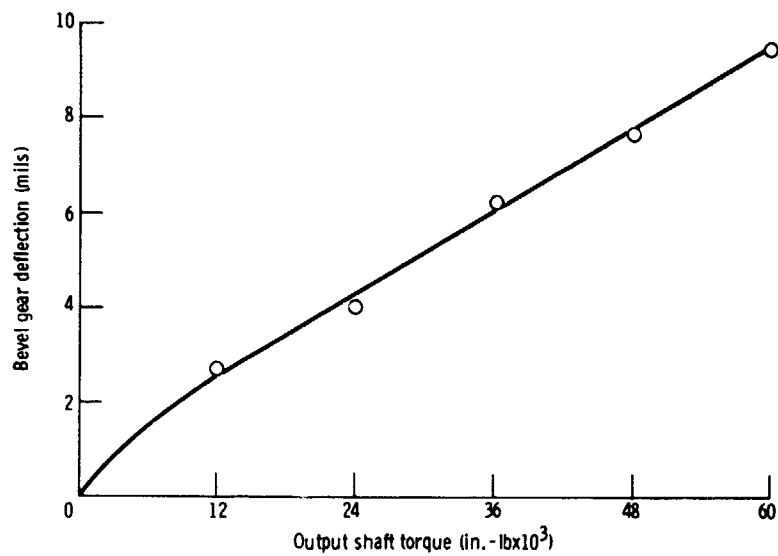
Figure 17 shows the bevel gear deflection as a function of output shaft torque. The deflection is very nearly a linear function of the torque with the spring rate being approximately 6.8×10^6 in.-pound/in. This deflection can cause reduced load capacity and life (ref. 2).

Figure 17. - Bevel gear deflection as a function of output shaft torque. Input speed, 6200 rpm.

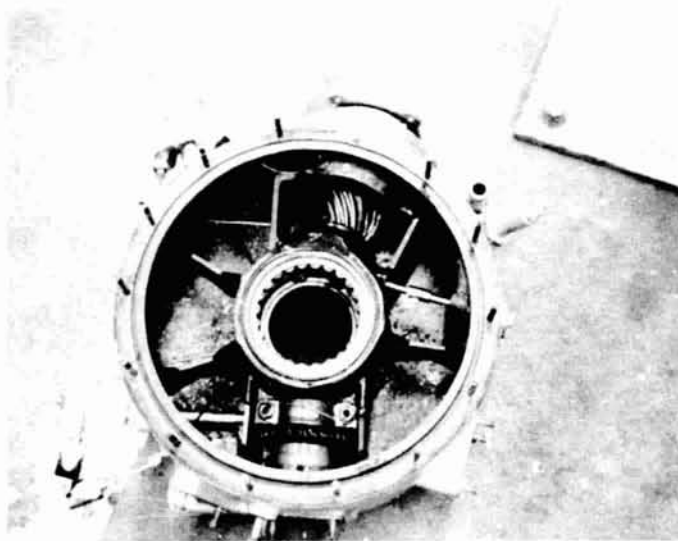
The lower gearbox assembly which comprises the input spiral bevel gear set was not damaged during the survivability test (fig. 19). The maximum temperatures within the lower gearbox assembly were in the range from 325° to 525° F. It would appear from the condition of gearing and bearing components after the survivability test that the materials were adequate for the time duration of the test which was 30 minutes. However, for longer time periods both the bearing and gear materials may be marginal. Consideration should be given to replacing all the bearing materials within the transmission which are AISI 52100, CVM 52 CM, and CVM AISI M-50 with vacuum-induction melted vacuum-arc remelted (VIM-VAR) AISI M-50 steel. This steel has high temperature bearing operating capability to 600° F (refs. 5 and 6) and rolling-element fatigue lives of approximately 20 times current design requirements (ref. 4). Manufacturing specifications incorporating the technology of reference 4 is contained in reference 7.

Figure 19. - Lower gear assembly after survivability test.

Insufficient gear data exists to recommend a high-temperature gear material in place of the AISI 9310 steel currently being used for the bevel gear set. Endurance testing of currently used and prospective gear materials are being performed at the NASA-Lewis Research Center. Out of those potential high-temperature materials studied, Super Nitralloy exhibited lives exceeding AISI 9310 (refs. 8 and 9). Nitralloy N (AMS 6475) is a material which also has high temperature characteristics but has not been endurance tested in rolling-element fatigue. However, this material has found acceptance as a gear material and is used for the sun and ring gear material in the OH-58 transmission. Consideration should be given to changing all the gear materials except as noted below to Nitralloy N (AMS 6475).
